Re: Wetland Delineation Report, Revised
Baird Substation
1770 Stratford Avenue, Stratford, Connecticut

Re: Wetland Delineation - Baird Substation - 1770 Stratford Avenue - Stratford, CT

Re: Federal Jurisdictional Wetland Delineation - Baird Substation - 1770 Stratford Avenue - Stratford, CT

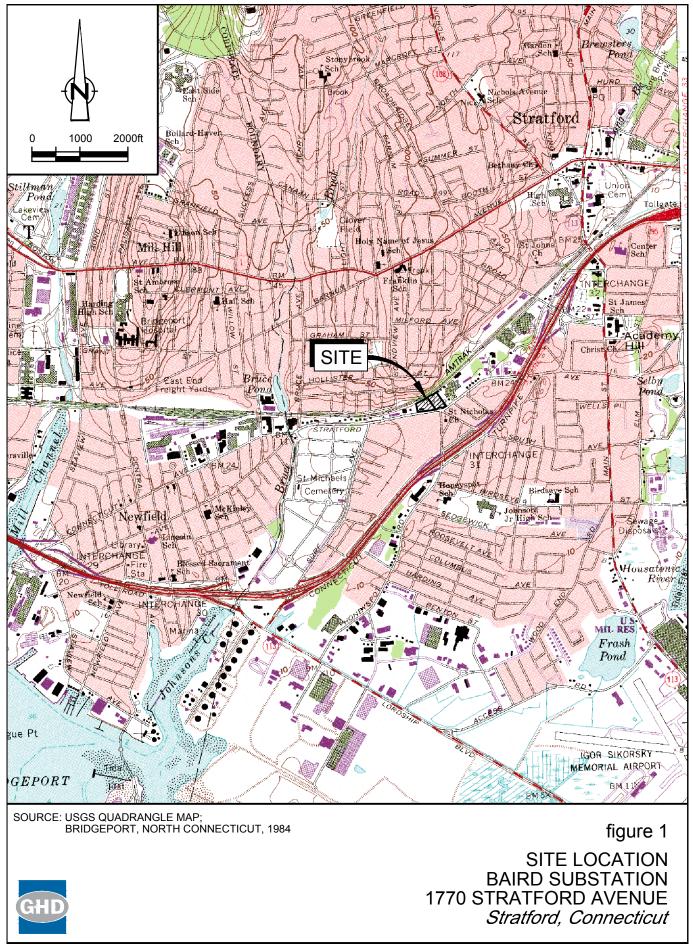
83167-66(CROS013)GN-WA001 OCT 21/2015

The location of the Site and the surrounding properties are shown on Figure 1, which includes a copy of the United States Geologic Survey (USGS) topographic map. Figure 1 shows the topography, nearby water bodies, man-made structures, and access routes. The Baird substation property encompasses 3.52 acres on two parcels of land and located on the north side of Stratford Avenue at the intersection of Stratford Avenue, Honeyspot Road, and Surf Avenue. A recent aerial photograph of the Site, which includes the surveyed location of the wetland delineation flagging are shown on Figure 2.

As shown on Figure 1, the topography on the Site is generally level to gently sloping with an elevation between 10 to 20 feet, North American Vertical Datum 1988 (NAVD88). The aerial photograph, provided as Figure 2, shows the Site bordered by railroad tracks for the State of Connecticut (Metro-North Commuter Railroad) to the north, Stratford Avenue to the south, Two Roads Brewing Company to the east, and Savings Auto Center to the west. There is a 15 foot wide storm water easement along the southern portion of the Site in favor of U.S. Baird Corporation, the former property owner of the Two Roads Brewing Company parcel. Currently, the Site is developed with an existing electrical substation in the western portion, a parking lot in the eastern portion, and an undeveloped wooded portion in the center of the property.

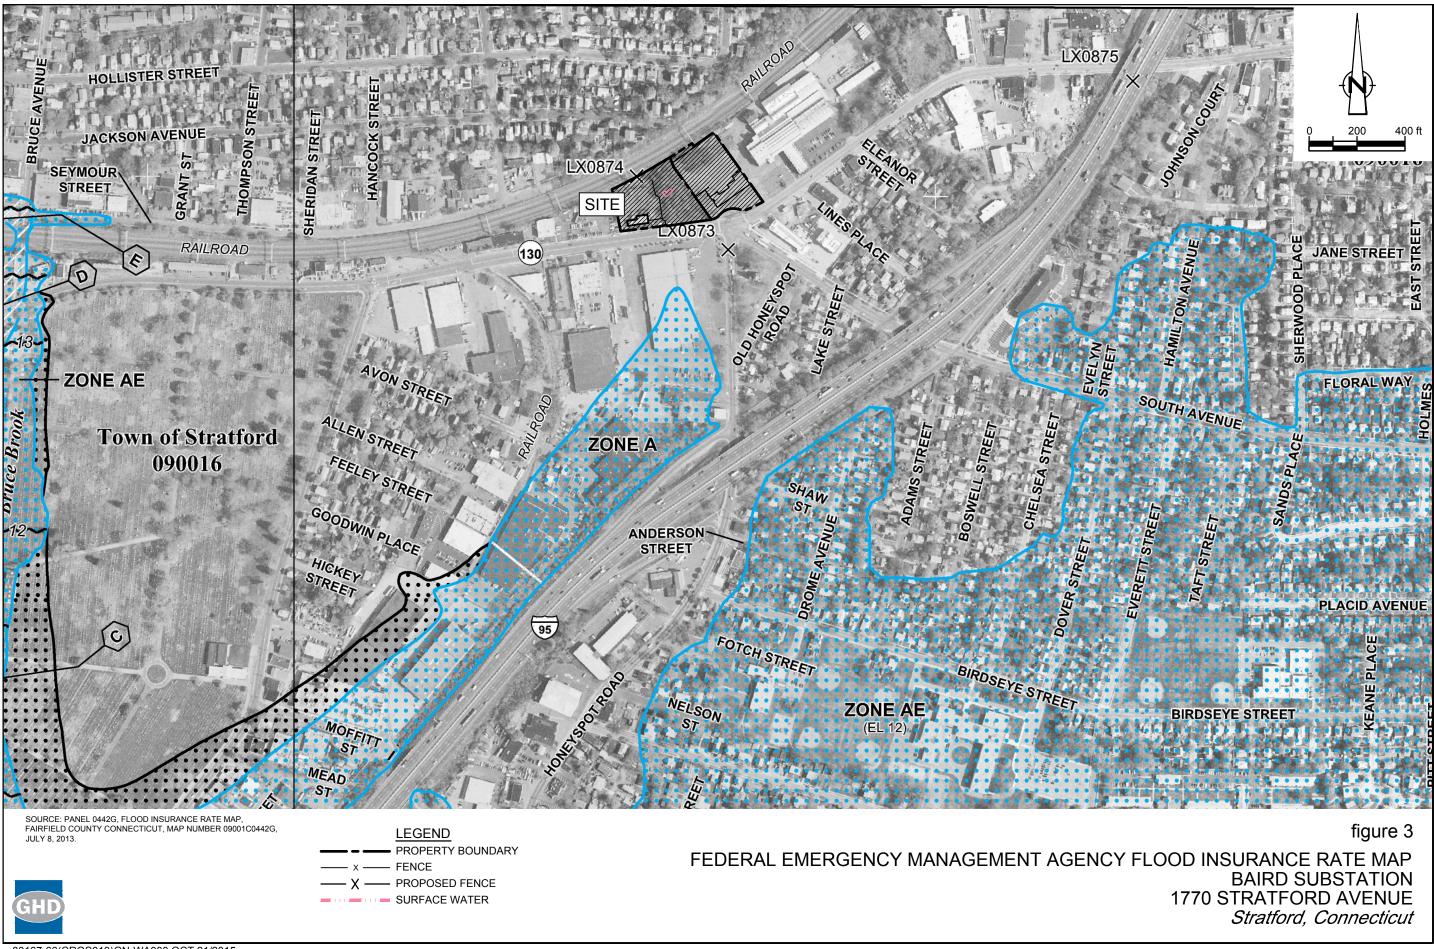
83167-66(CROS013)GN-WA003 OCT 21/2015

As shown on the Federal Emergency Management Agency (FEMA) Flood Insurance Rate Map (FIRM) (see Figure 3), the Site is not located within a mapped Flood Hazard Area. The nearest wetland identified in the National Wetlands Inventory (NWI) Map (Figure 4) is approximately 1,300 feet northwest from the Site. As shown on the National Resources Conservation Soils (NRCS) Web Soil Survey (Figure 5), the following soil series are mapped on and adjoining the Site:

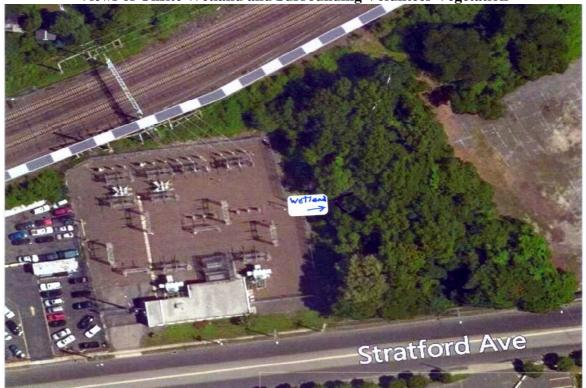
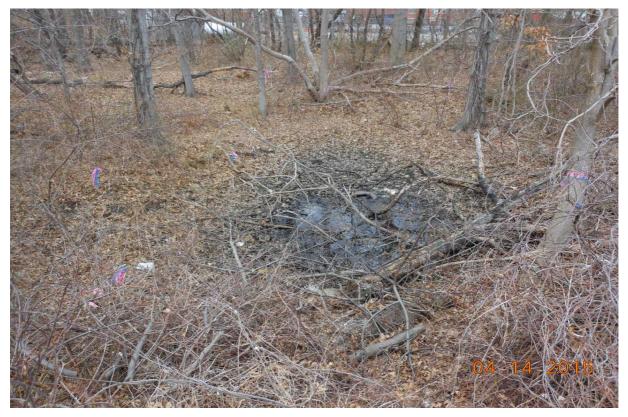
Views of Onsite Wetland and Surrounding Volunteer Vegetation

The wetland and watercourse boundaries were marked with blue plastic flagging numbered **WF-1** through **WF-8**. As no site plan drawing was available I have sketched the approximate limits of the small wetland area on the attached aerial photograph. I have also attached a photograph of the wetland taken on the day of my investigation.

The subject wetland occupies a very small subarea in the west central portion of this site. It is the lowest point on the site. The apparent ground water table is present in the bottom of this subject wetland. No inlet or outlet is associated with this wetland.

No vernal pool habitat conditions or functioning was observed within the small wetland soil area. Only a couple inches of water were observed in the bottom of the wetland. No vernal pool obligate species were present within this wetland. Signs of a rapidly receding water table were also apparent. This area is not a vernal pool.

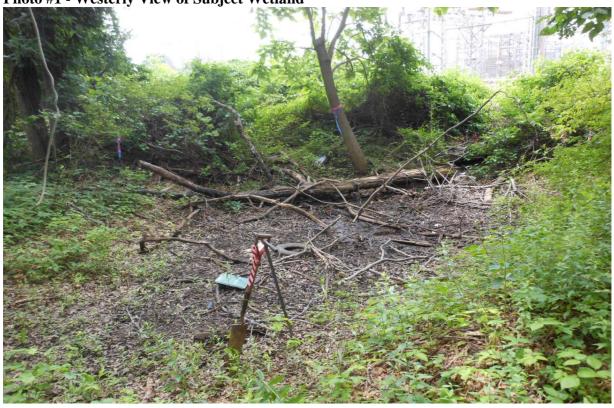
Photo #1 - Westerly View of Subject Wetland

One small wetland area was observed in the central western area of the woods. This shallow depressional pocket is a remnant of past earth moving and re-grading activities. Soils are very disturbed with very little or no original soil profile horizons present. Upland soils are classifiable at the taxonomic level as Udothents - Upland non-wetlands. The soils within the identified wetland are classified as Aquents - disturbed soils with persistent water table conditions at less than 6 inches below existing grades.

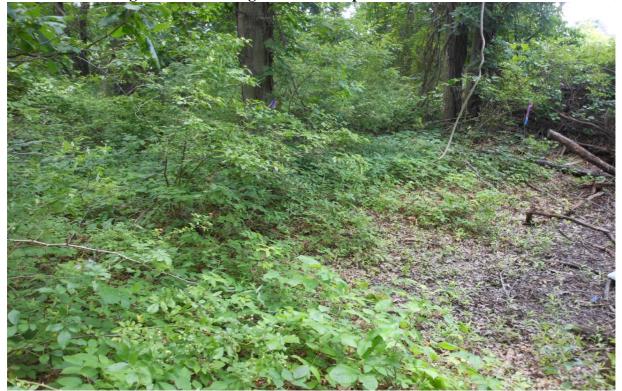
Photo #2 - Existing Character of Vegetation at Sample Points T1A & T1B

The subject site consists of all undeveloped portions of 1770 Stratford Avenue. The study area is wooded with a mixture of volunteer deciduous and evergreen species. Numerous invasive species including Multiflora Rose and Oriental Bittersweet. Poison Ivy is dominant as ground cover and as thick vines and many of the trees and shrubs.

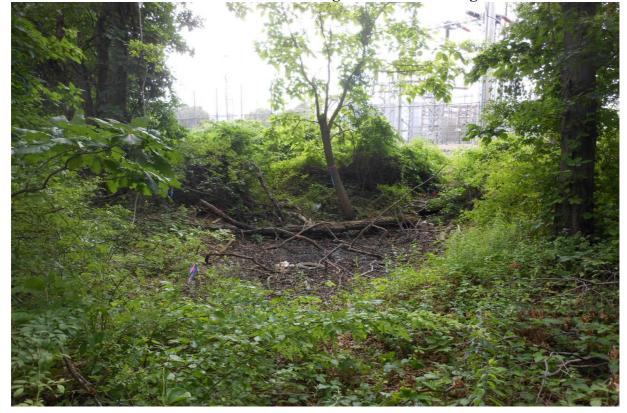
Photo #4 - Overall View of Wetland with Existing Substation in Background

The wetland area is located between an existing electrical substation to the west, the Metro-North rail road right of way to the north, Stratford Avenue to the south, and a parking lot to the west. This area is extremely disturbed due to the development of the property and surrounding properties. Hydrologic conditions are influenced by the storm water runoff, ponding, and groundwater connection. The soil profile is considerably disturbed from historic site activities.

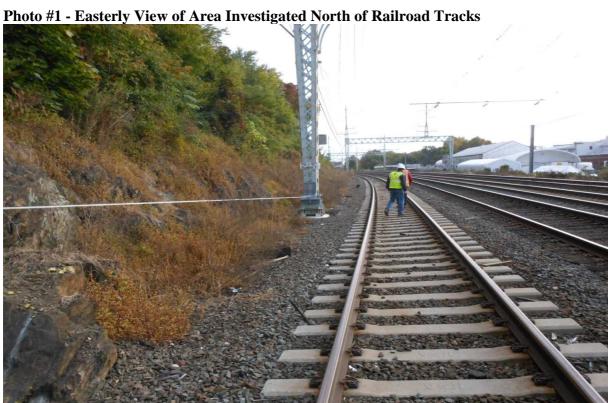
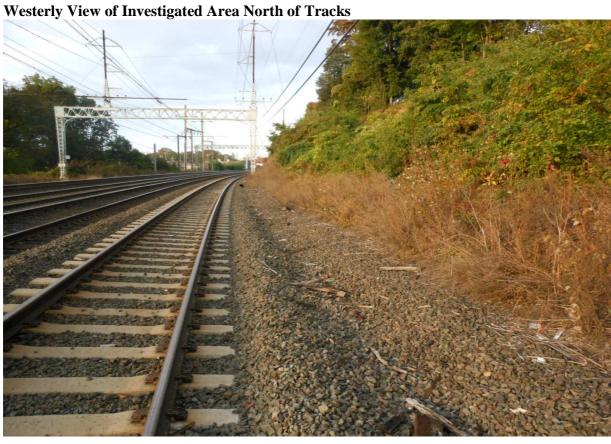
The site area investigated consist of the north side of an existing multi-track railroad bed, adjacent gravel covered drainage swale, and a highly disturbed slope area leading down from the north. The attached photos will provide views of the existing conditions of the area investigated.

This map unit area consists of the gravel covered swale along the north side of the tracks. Designed to convey surface water runoff, no indications of any ground water connection was observed.
