**Subject: Docket No. 468, Plumtree to Brookfield Junction 115-kV Project
Decision and Order Condition #4 – Independent Environmental Inspector Report**

Please find enclosed the Biweekly Independent Environmental Inspector Report, Report #22, for the **July 26th** and **August 2nd 2018** inspection events for the construction of the Eversource Plumtree to Brookfield Junction 115-kV Project.

Docket No. 468- Development and Management Plan Inspection

Southwest Connecticut Reliability Project

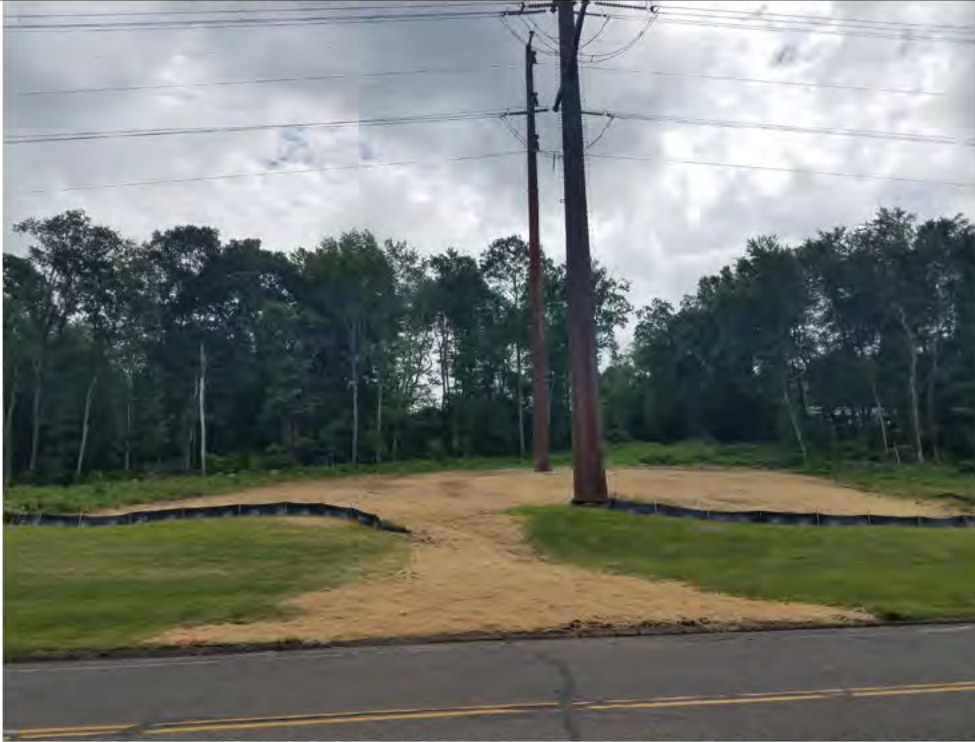
Photo 1: 07/26/2018, Bethel: Map 12, Str1021, work pad restoration performed. Photo taken facing east.

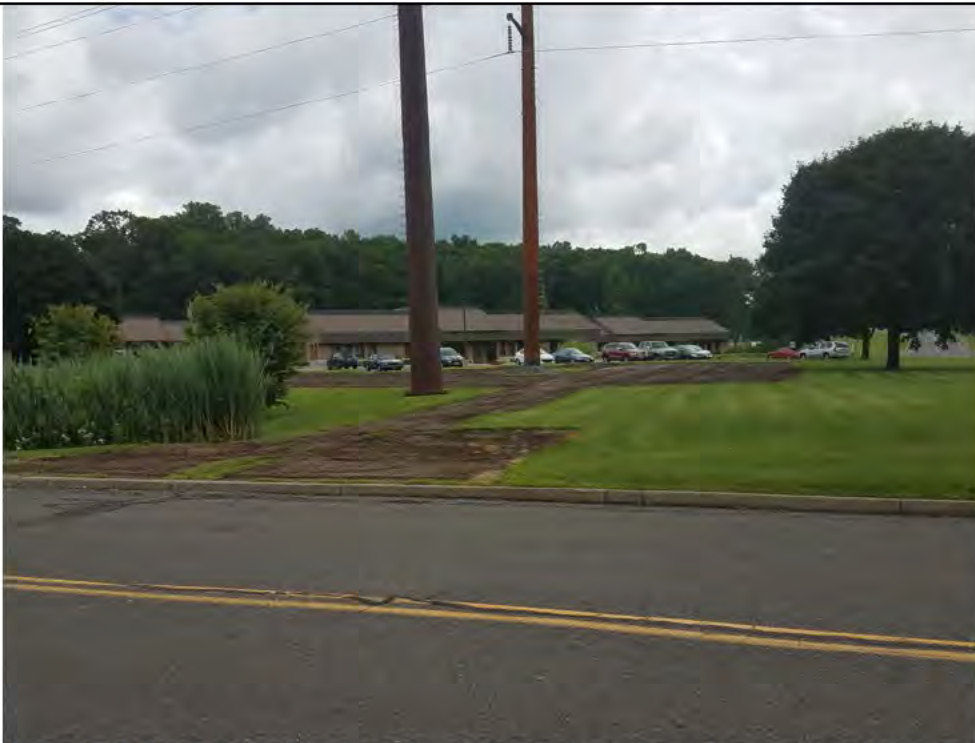
Photo 2: 07/26/2018, Bethel: Map 12, Str1022, access road to the structure area as well as the work pad constructed of wood mats has been removed. Wetland W5 is abutting to the north. Photo taken facing east. All appears to be in accordance with Eversources's BMP Manual. Area will be restored with loam and hydroseeding within the next week.

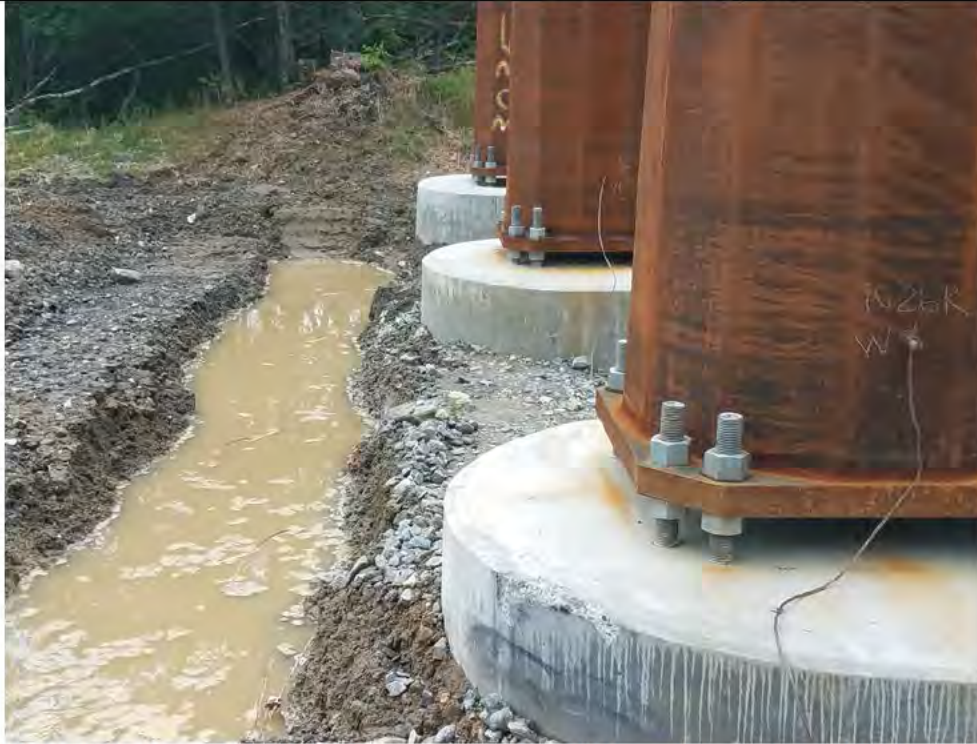
Photo 3: 07/26/2018, Bethel: Map 13, Str1026, trenching and installation of grounding cables for Counterpoise system. Photo taken facing east.

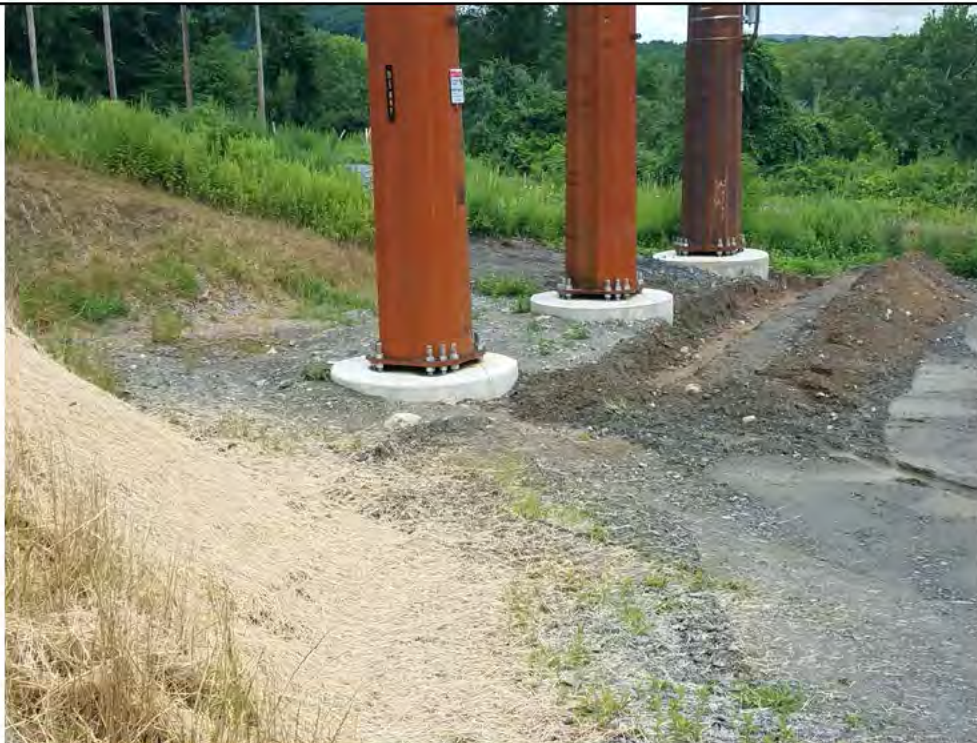
Photo 4: 07/26/2018, Bethel: Map 13, Str1027, trenching and installation of grounding cables for Counterpoise system. Photo taken facing west.

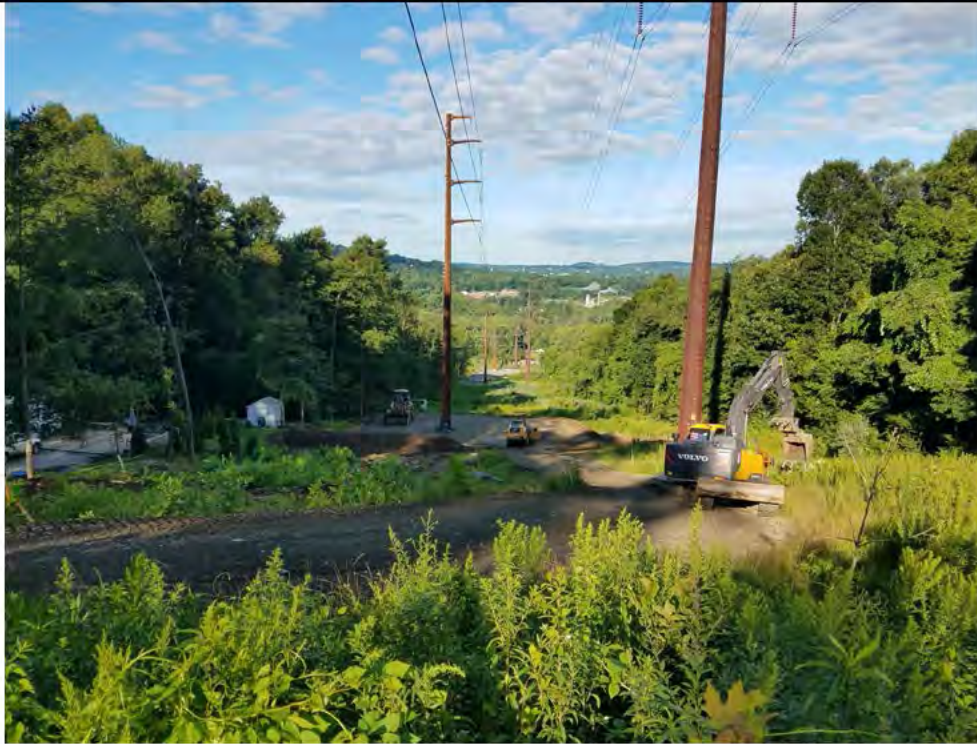
Photo 5: 08/02/2018, Danbury: Map 07, Str1014, work pad and access road restoration being performed by Supreme. Photo taken facing west.

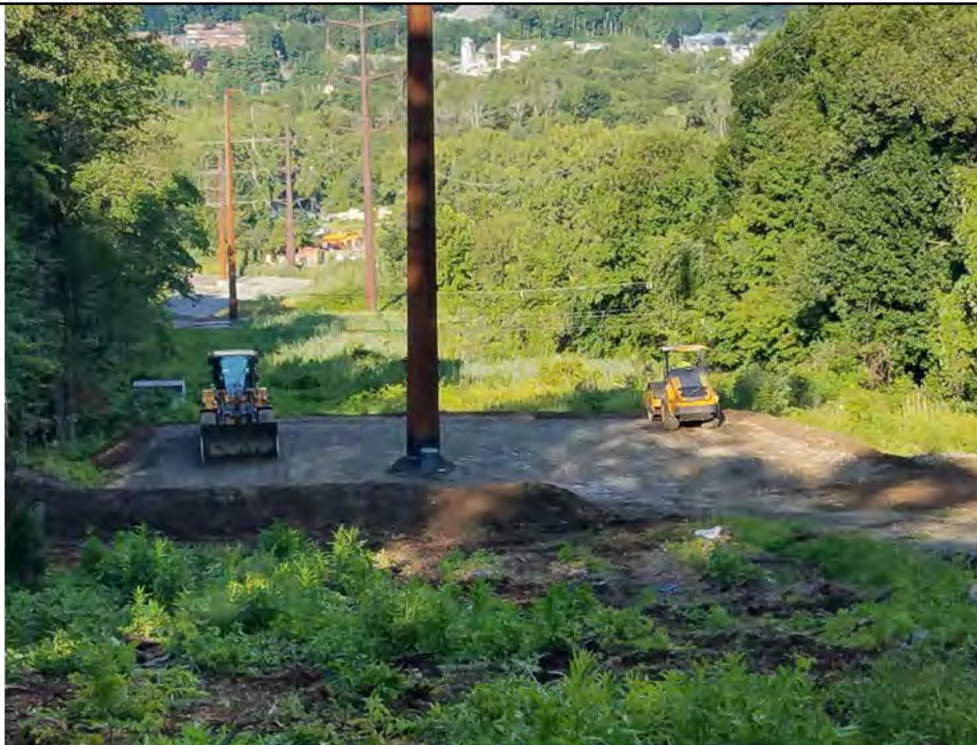
Photo 6: 08/02/2018, Danbury: Map 07, Str1014, work pad restoration being performed by Supreme. Photo taken facing west.

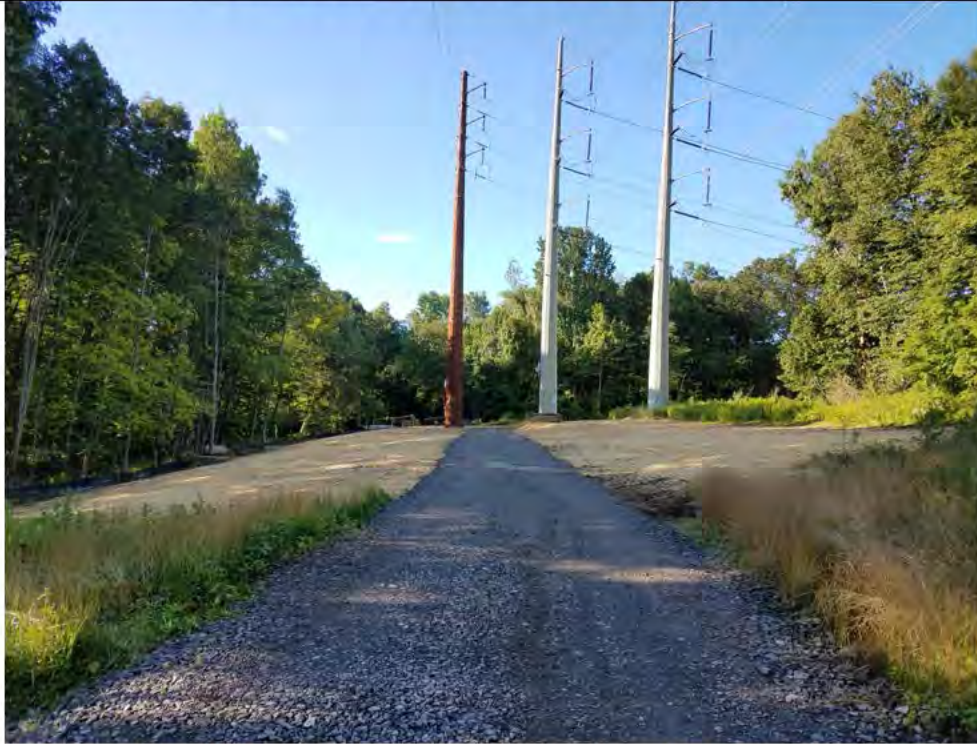
Photo 7: 08/02/2018, Bethel: Maps 07-08, Str1015, work pad restoration. Photo taken facing south.

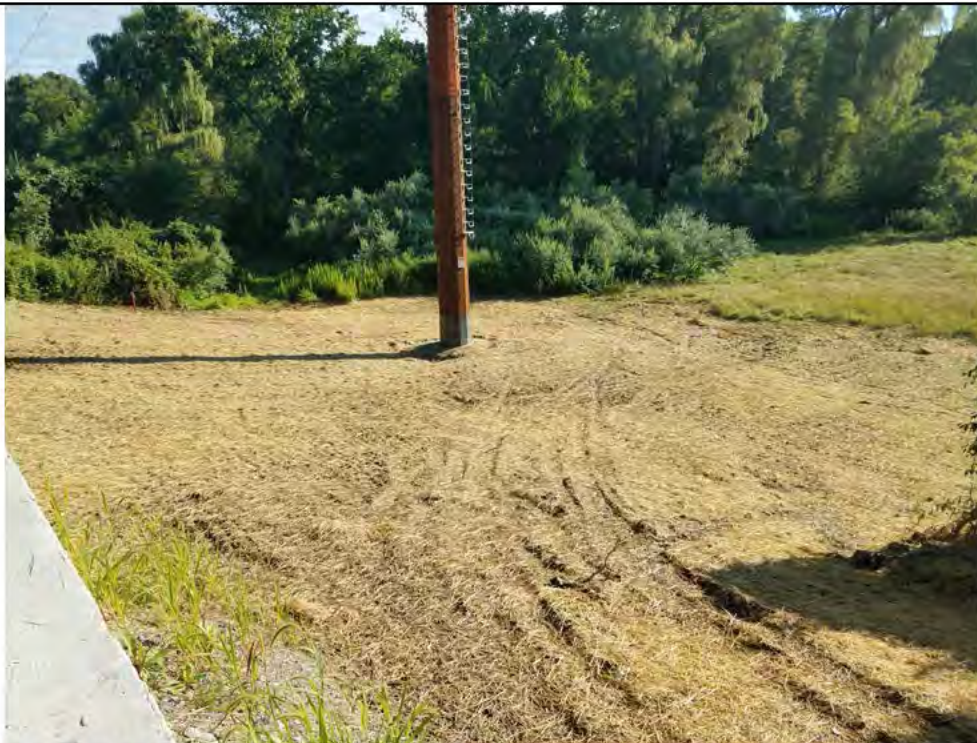
Photo 8: 08/02/2018, Bethel: Map 08, Str1016, work pad restoration. Photo taken facing north.

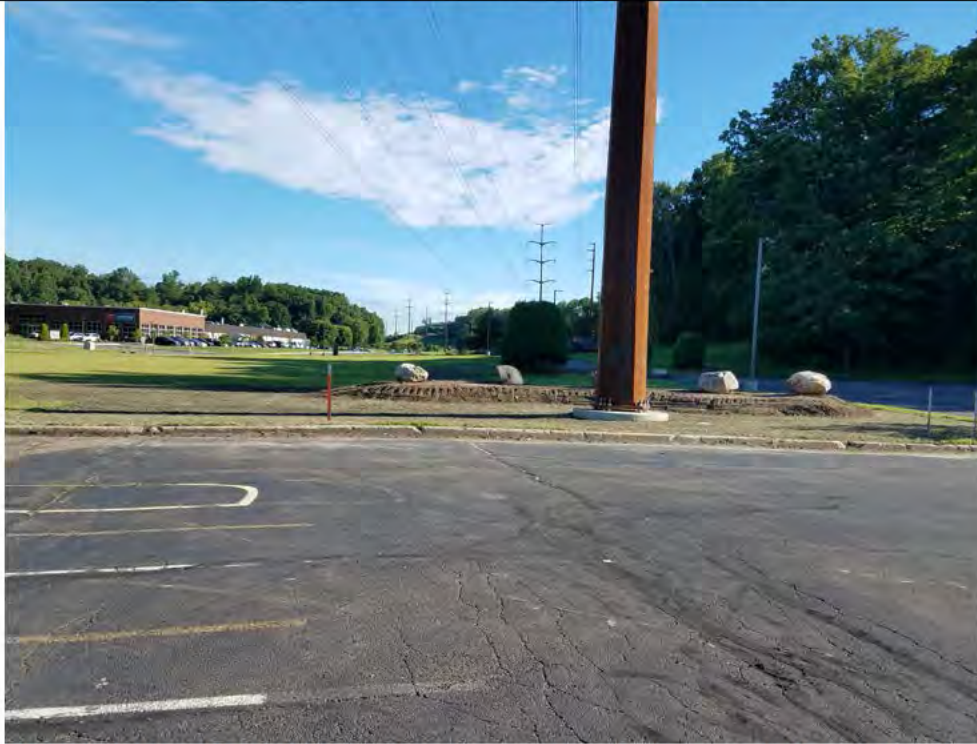
Photo 9: 08/02/2018, Bethel: Map 10, Str1020, work pad restoration, hydroseeded. Photo taken facing north.

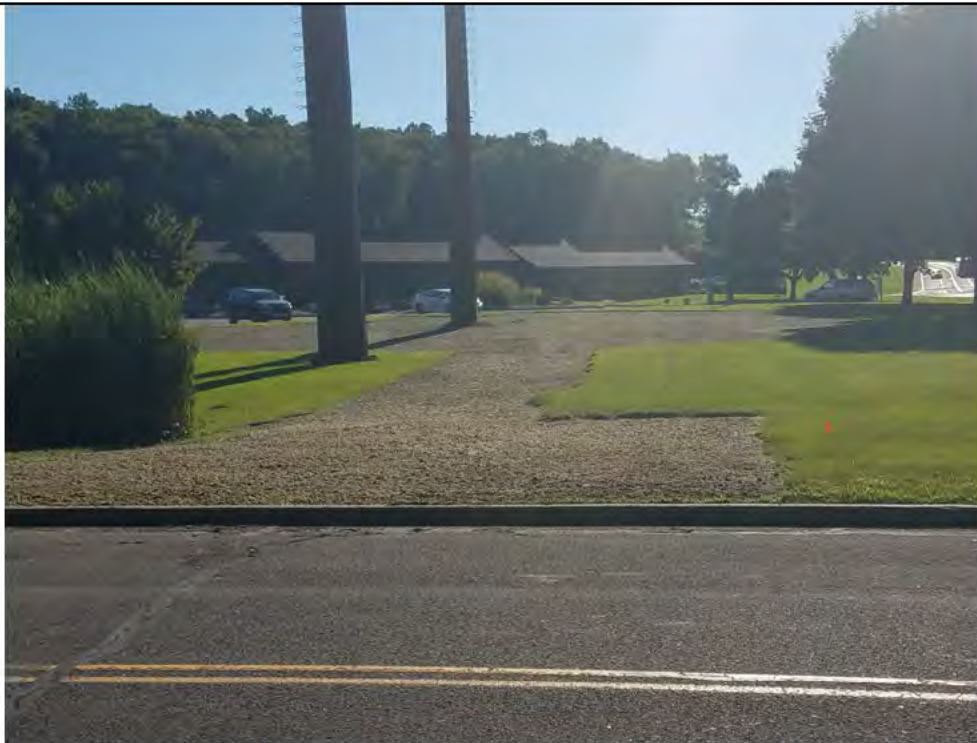
Photo 10: 08/02/2018, Bethel: Map 12, Str1022, work pad restoration, hydroseeded. Photo taken facing east.

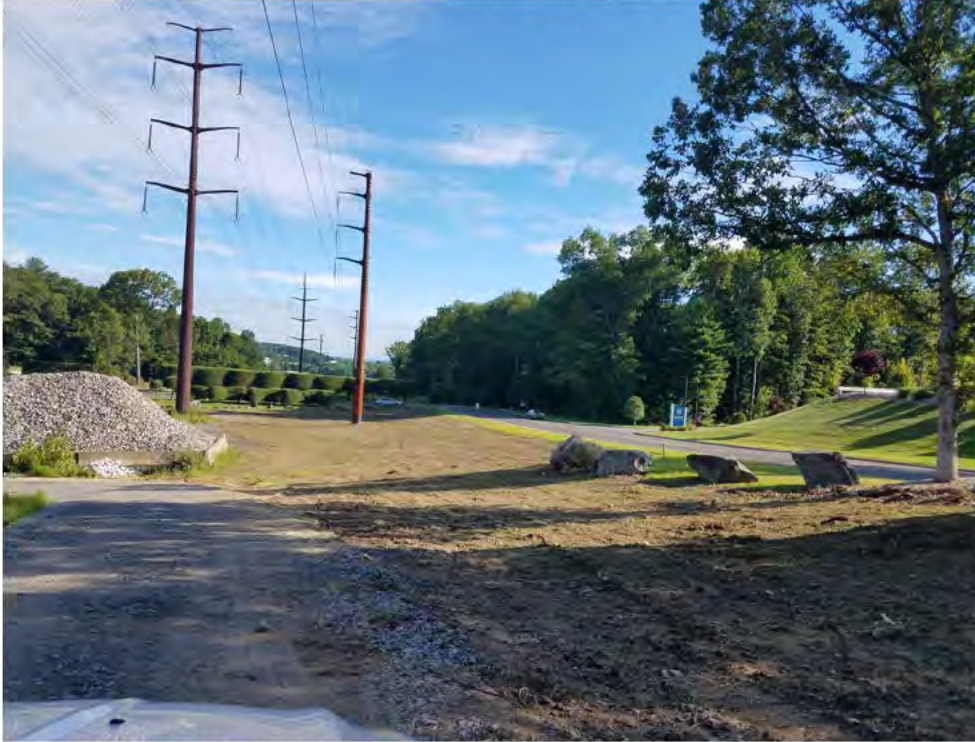
Photo 11: 08/02/2018, Brookfield: Map 13, Str1024, property owner performed work pad restoration (grading and hydroseeding). Photo taken facing north.

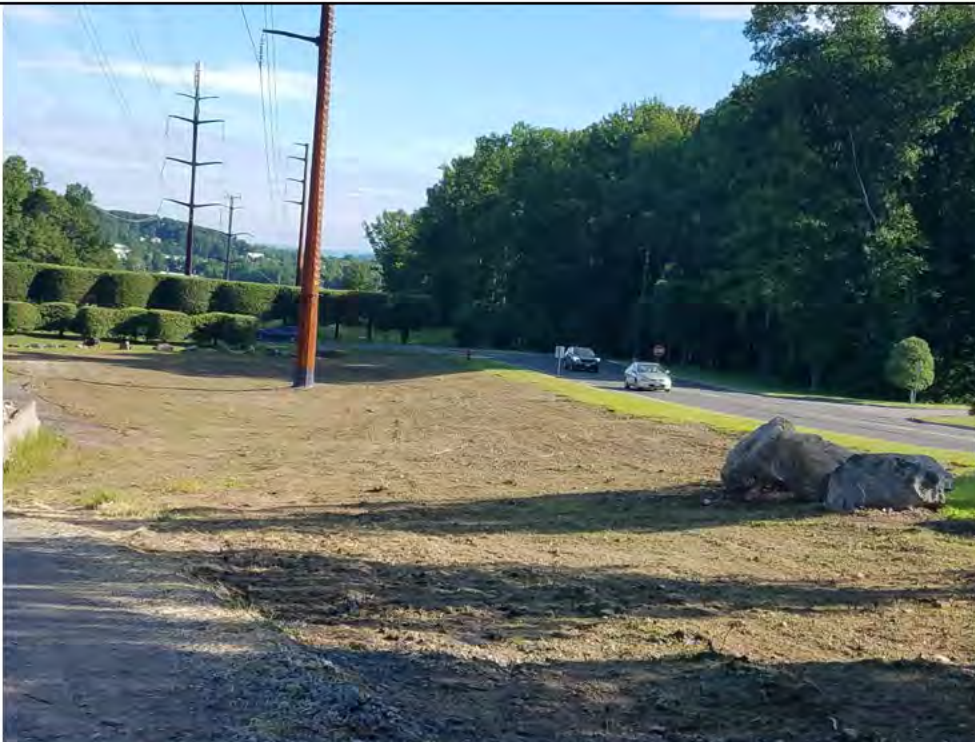
Photo 12: 08/02/2018, Brookfield: Map 13, Str1024, property owner performed work pad restoration (grading and hydroseeding). Photo taken facing north.

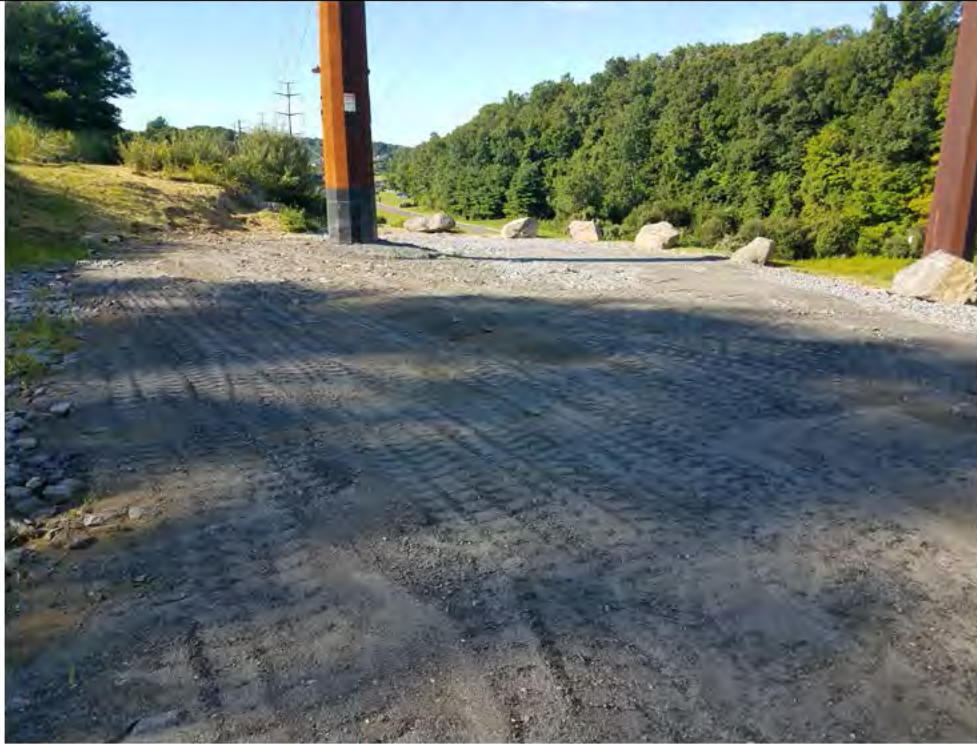
Photo 13: 08/02/2018, Bethel/Brookfield: Map 12, Str1023, work pad restoration (grading and boulder placements). Photo taken facing south.

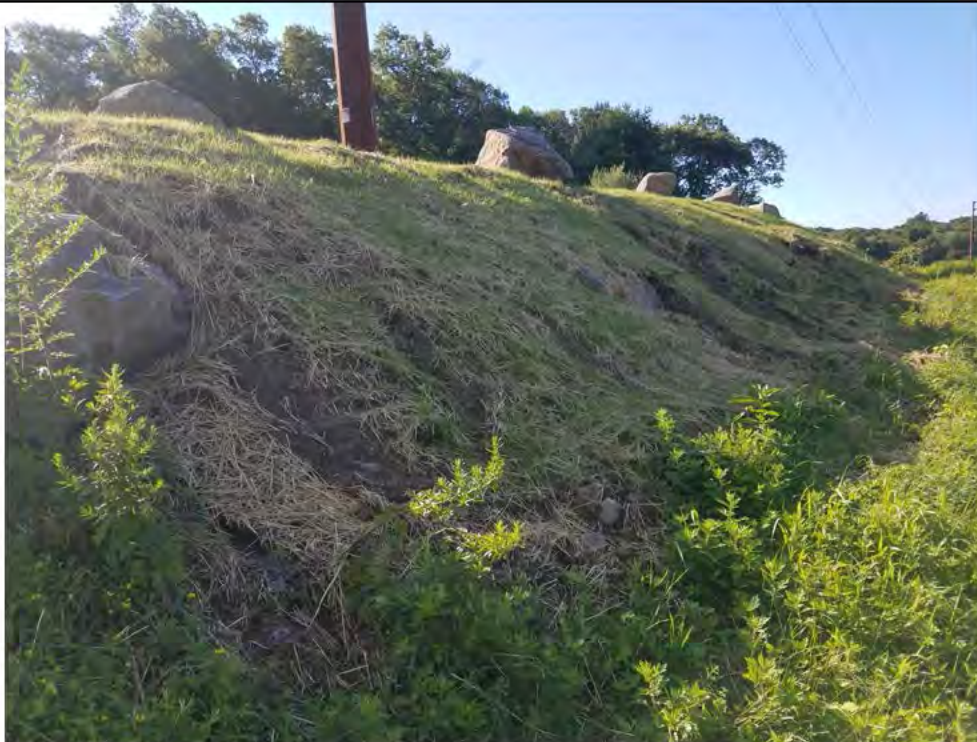
A three day period with intermittent short duration heavy rainfall events impacted the area between 7/31 and 8/2. According to Wunderground.com, the Danbury Municipal Station received 0.96" of precipitation during that period of time.

Photo 14: 08/02/2018, Bethel/Brookfield: Map 12, Str1023, slope erosion, west slope. Reference Additional Comments section Page 6 for additional details. Photo taken facing south.

Eversource and Supreme are aware of the slope erosion at Str1023 and are correcting it by regrading the slopes to remove erosion (rills) as well as reseeding and mulching the area that was previously completed prior to the rain event. No wetlands, watercourses, or sensitive areas were impacted or in danger of impacts due to the erosion event.

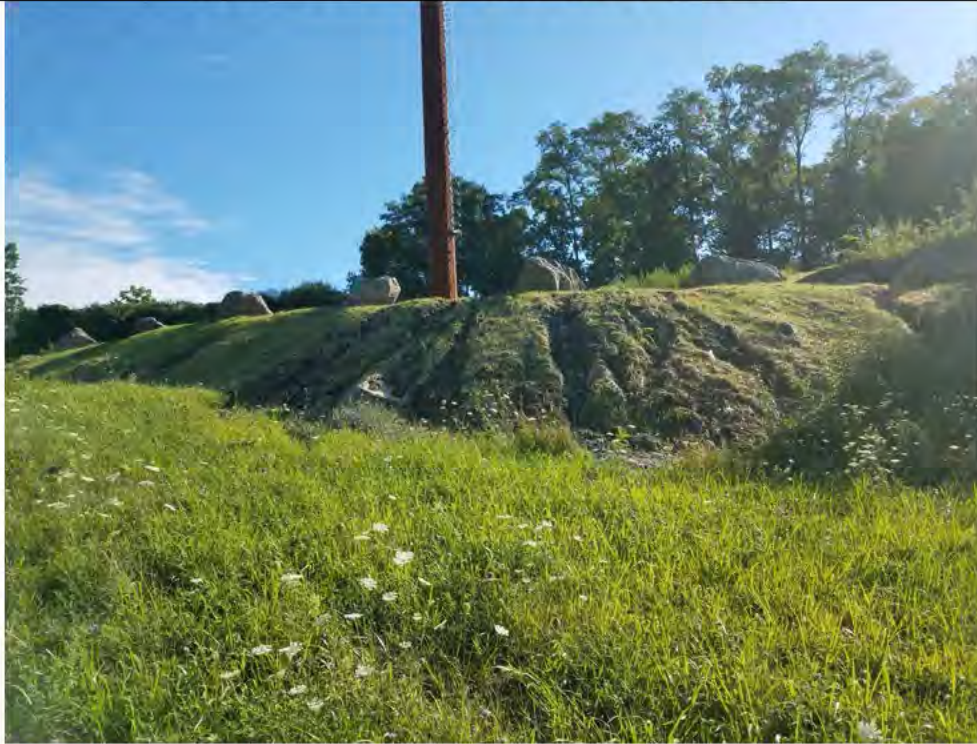
Photo 15: 08/02/2018, Bethel/Brookfield: Map 12, Str1023, slope erosion, south and west slopes. Reference Additional Comments section Page 6 for additional details. Photo taken facing northeast.

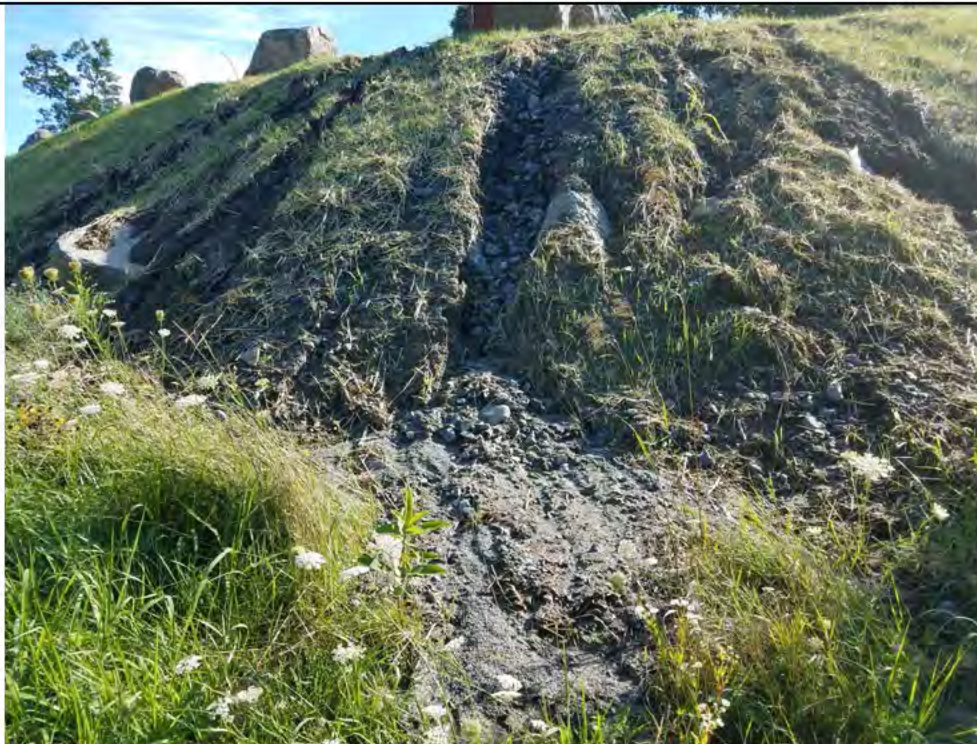
Photo 16: 08/02/2018, Bethel/Brookfield: Map 12, Str1023, slope erosion, southwest corner of slope. Reference Additional Comments section Page 6 for additional details. Photo taken facing northeast.

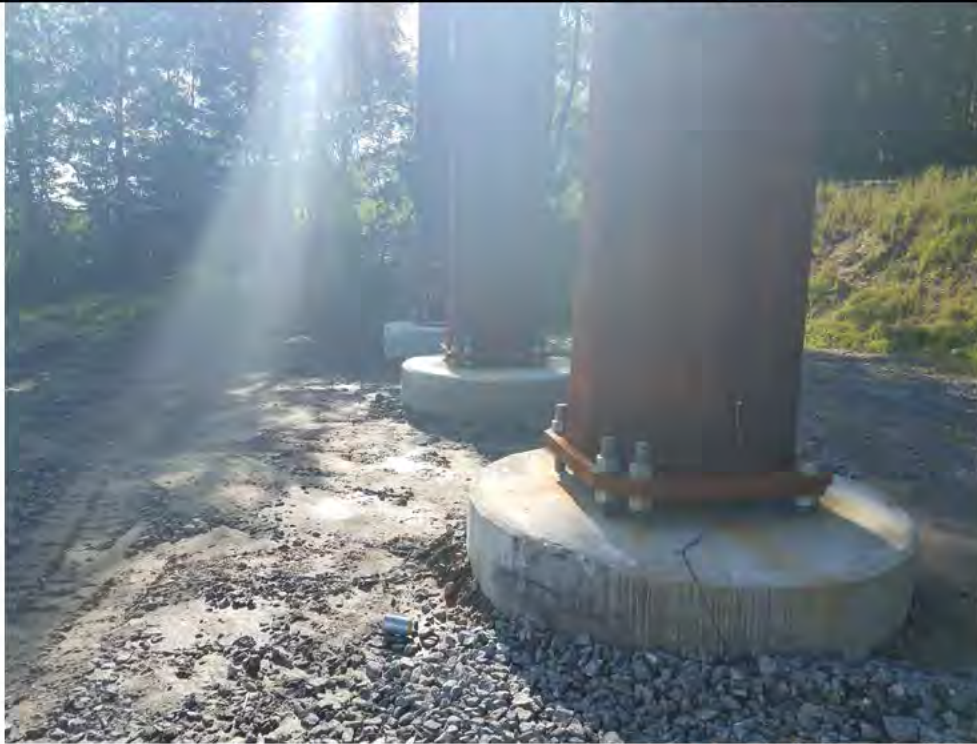
Photo 17: 08/02/2018, Bethel: Map 13, Str1026, Counterpoise system, trench backfilled and graded (see previous photo, Photo 3). Photo taken facing east.

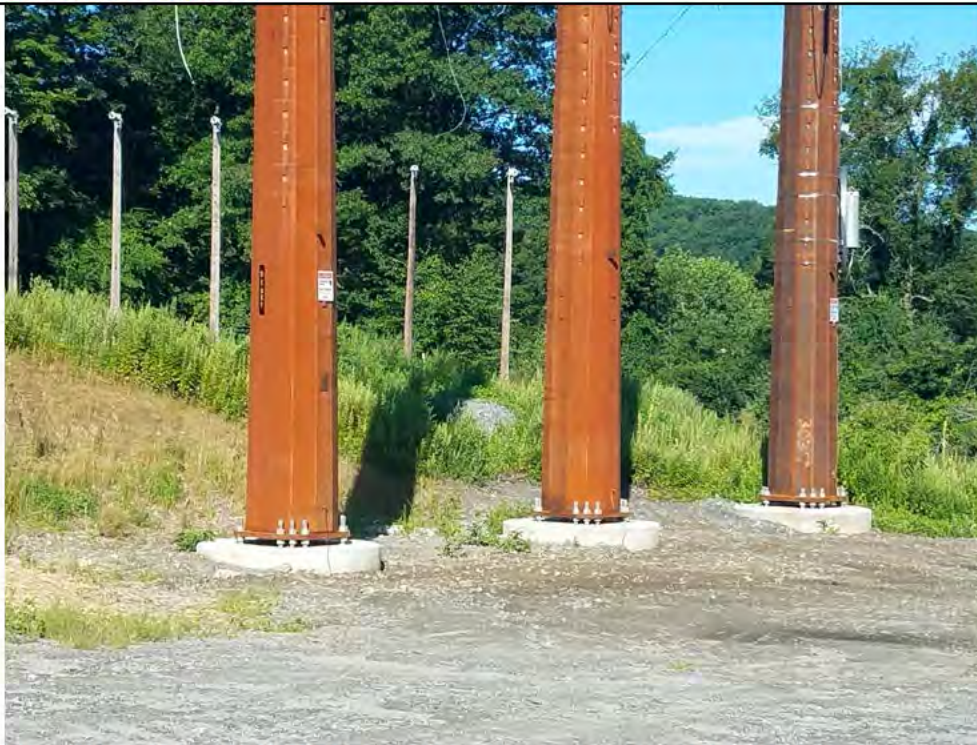
Photo 18: 08/02/2018, Bethel: Map 13, Str1027, Counterpoise system, trench backfilled and graded (see previous photo, Photo 4). Photo taken facing west.
