Re: **Docket No. 469 –520 Bailey Hill Road, Killingly, Connecticut
Environmental Monitoring Daily Site Observation Form – Report No. 2**

ENVIRONMENTAL MONITORING
DAILY SITE OBSERVATION FORM

Report No. 2

Project: Verizon Wireless Dayville CT Facility
 Address: 520 Bailey Hill Road, Killingly, Connecticut

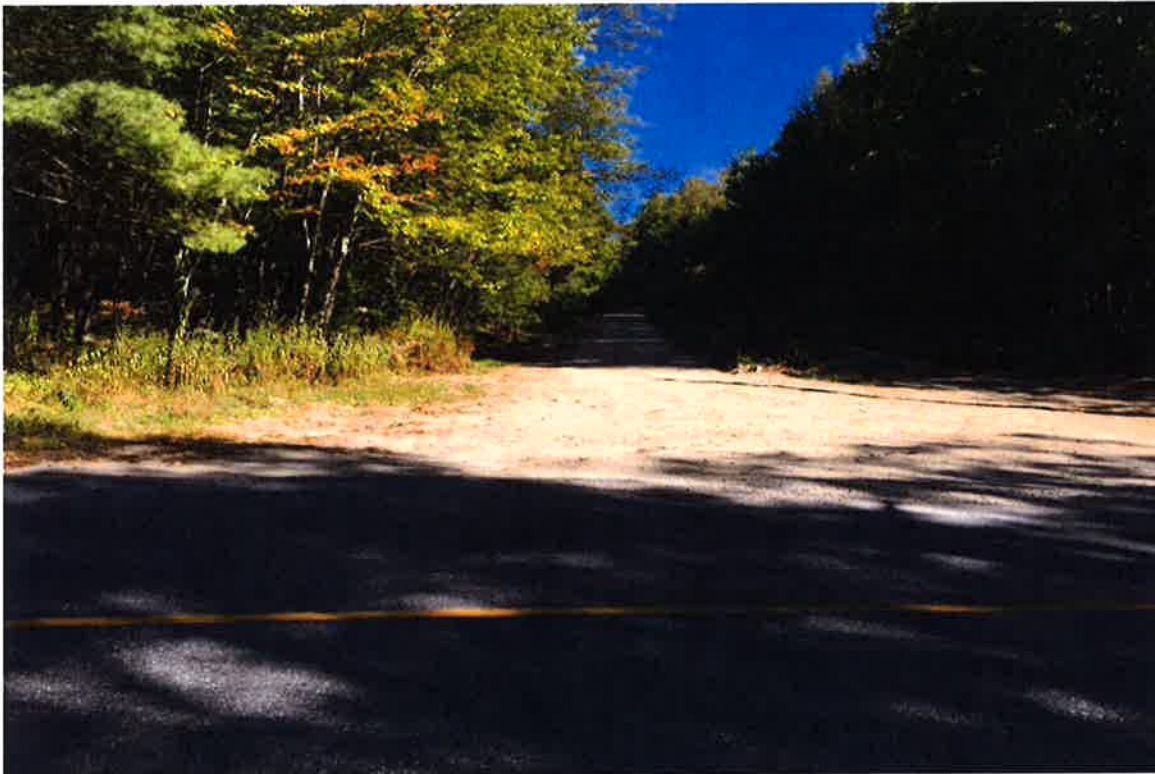
Photo 1: View of access looking east.

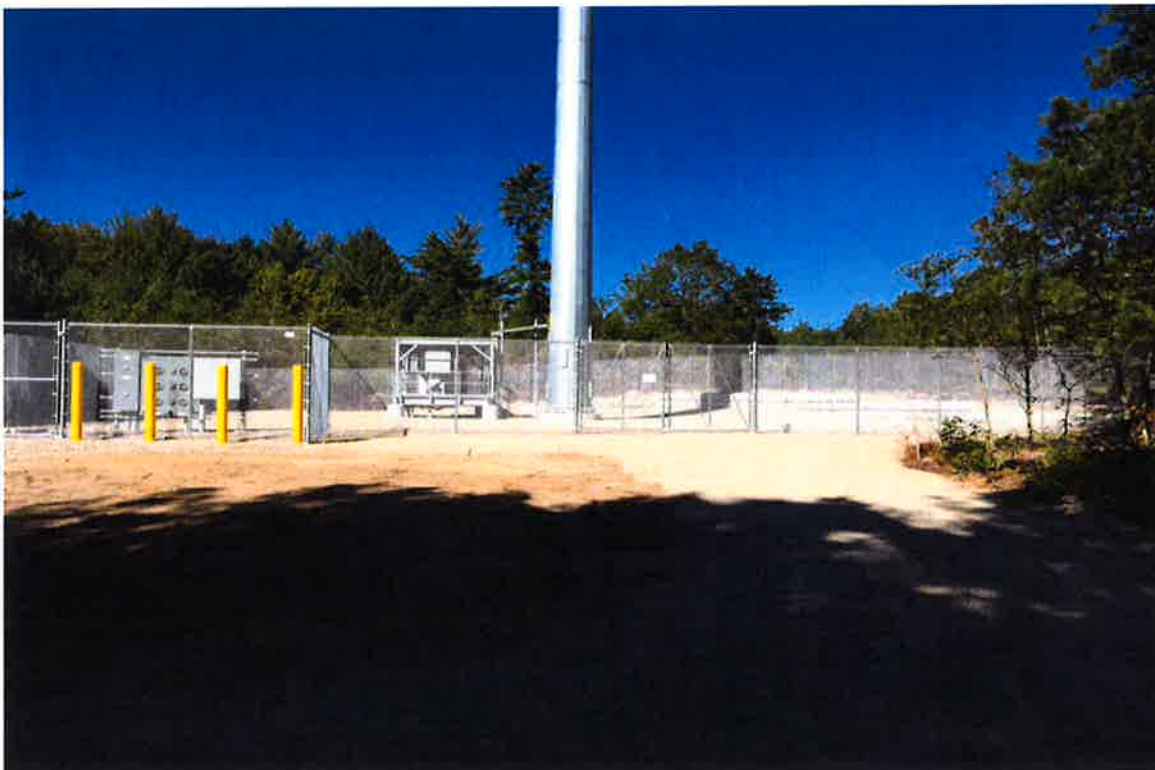
Photo 2: View of compound looking north.

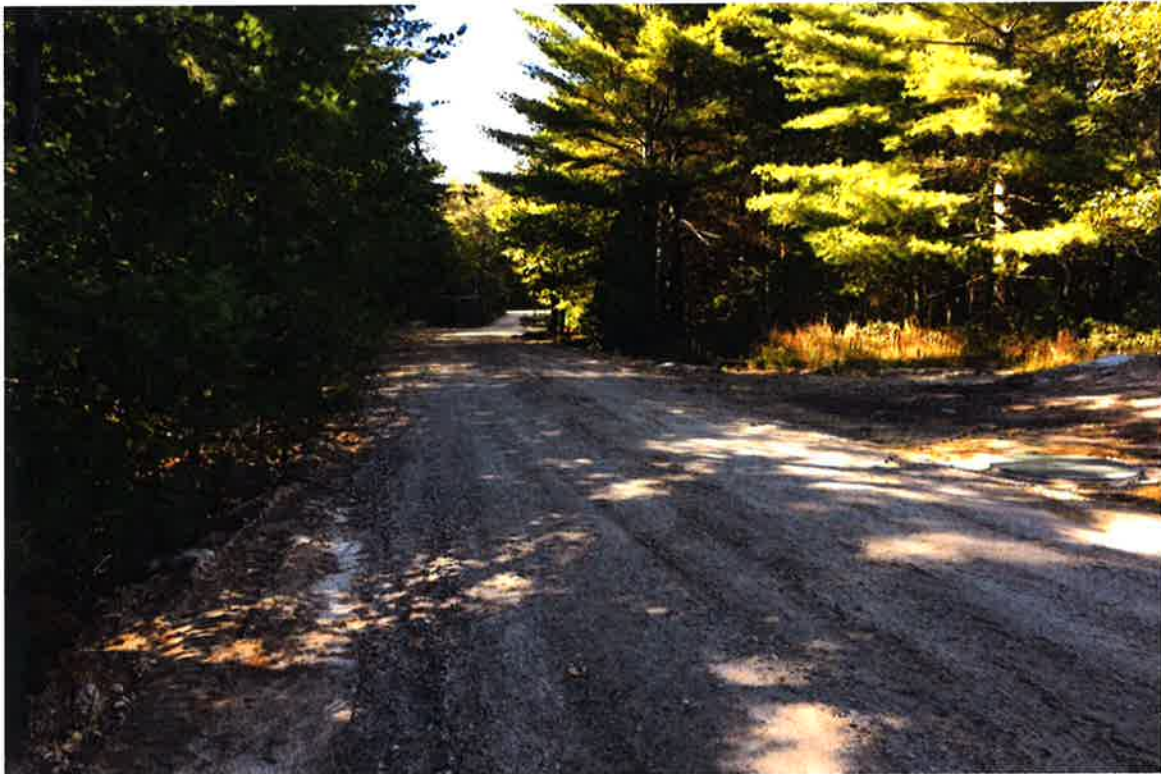
Photo 3: View of gravel access looking west.

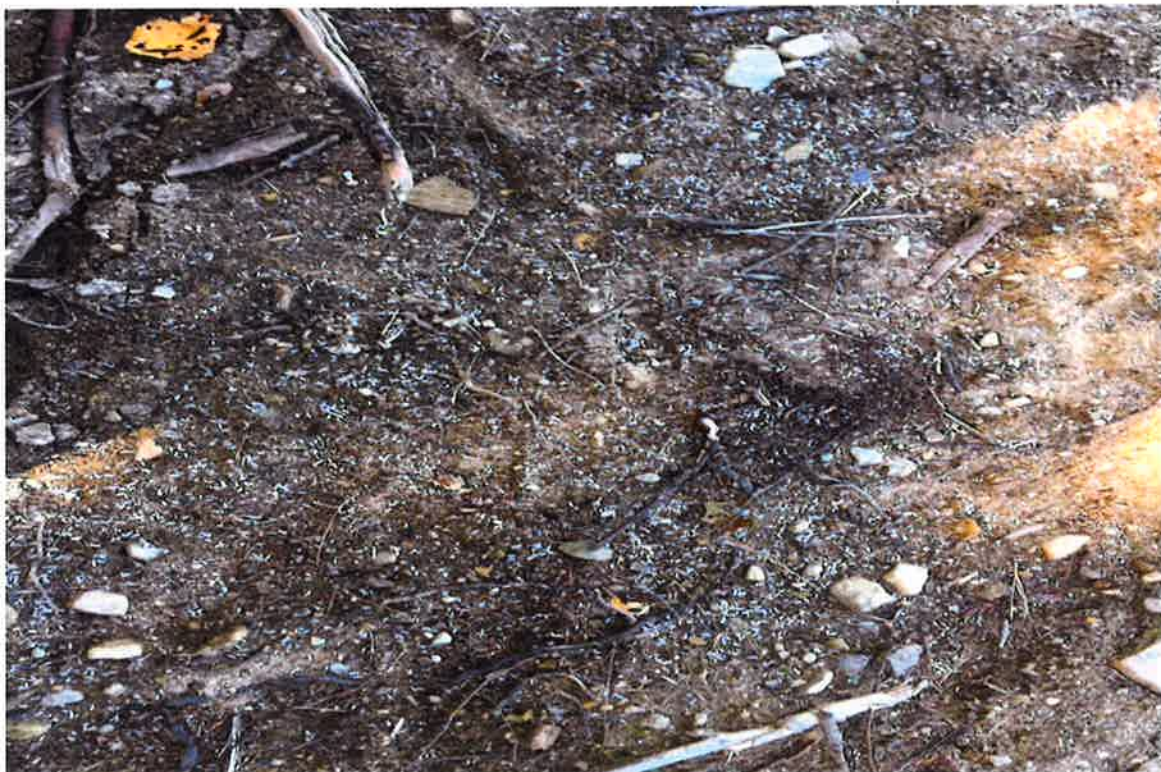
Photo 4: View of seeded slope southwest of compound looking east; no germination observed.

| DESCRIPTION OF OBSERVED ACTIVITY | |
|--|---|
| <p>7/12/17 – site under construction and stable soils observed; no erosion issues identified; erosion and sedimentation controls in good condition.</p> <p>9/29/17 – Site stabilized and no erosion observed. Areas of exposed soil have been seeded; no germination observed yet. Recommend monitoring upper portion of access for potential erosion concern during spring 2018 season, correcting areas as necessary. Leave compost filter socks in place until spring 2018. Once seeded areas have been permanently stabilized with vegetation they can be removed.</p> | |

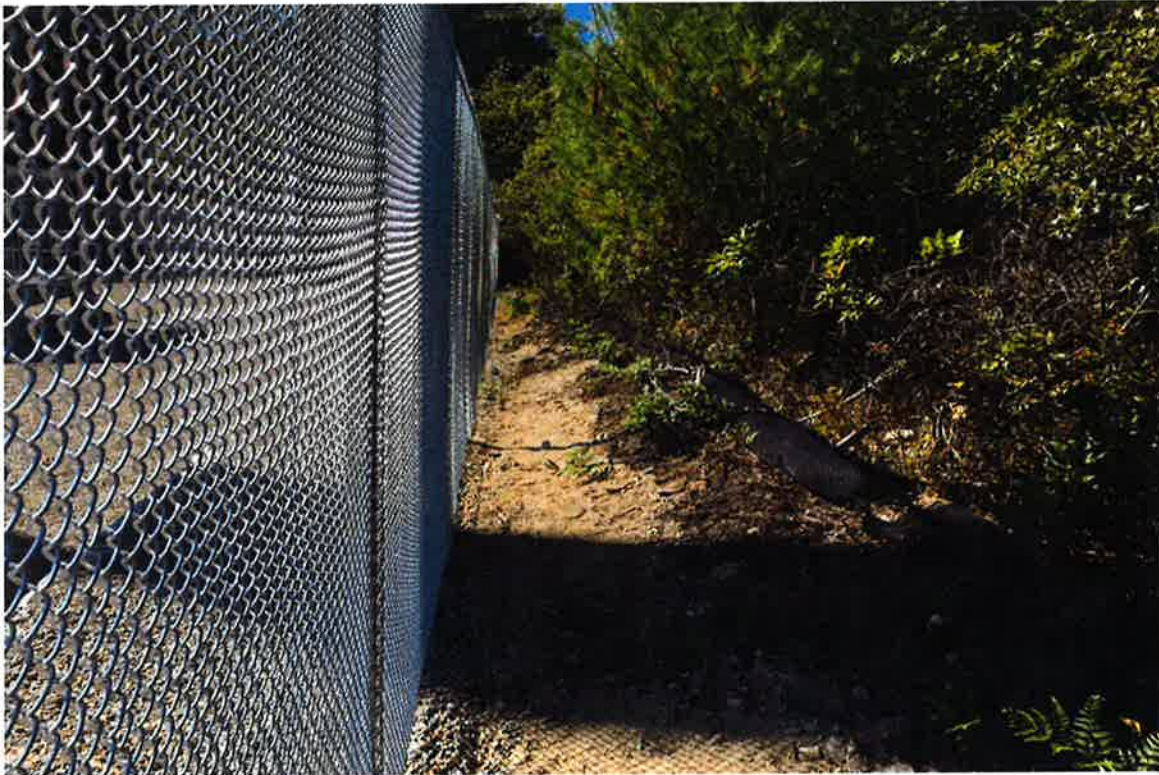
Photo 5: View of north side of compound looking west. Compost filter sock to remain in place until exposed soils are permanently stabilized with seeded vegetation.

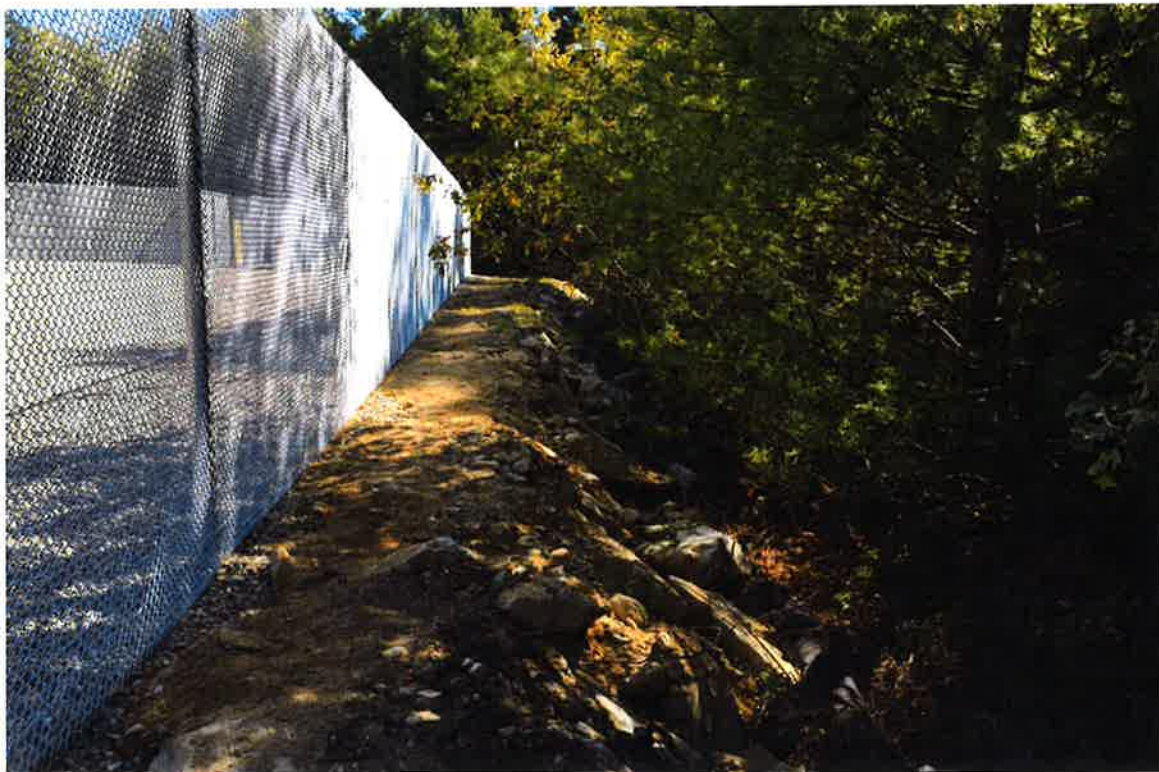
Photo 6: View of west side of compound looking south. Compost filter sock to remain in place until exposed soils are permanently stabilized with seeded vegetation.
