Re: **Docket No. 475 – Cellco Partnership d/b/a Verizon Wireless Application for a Certificate of Environmental Compatibility and Public Need for the Construction, Maintenance and Operation of a Wireless Telecommunications Facility Located South of Folly Lane, Coventry, Connecticut**

**Construction MONITORING  
DAILY SITE OBSERVATION FORM**

**Report No. 14**

Project: Verizon Wireless Coventry NW Facility  
Address: Folly Lane, Coventry, Connecticut

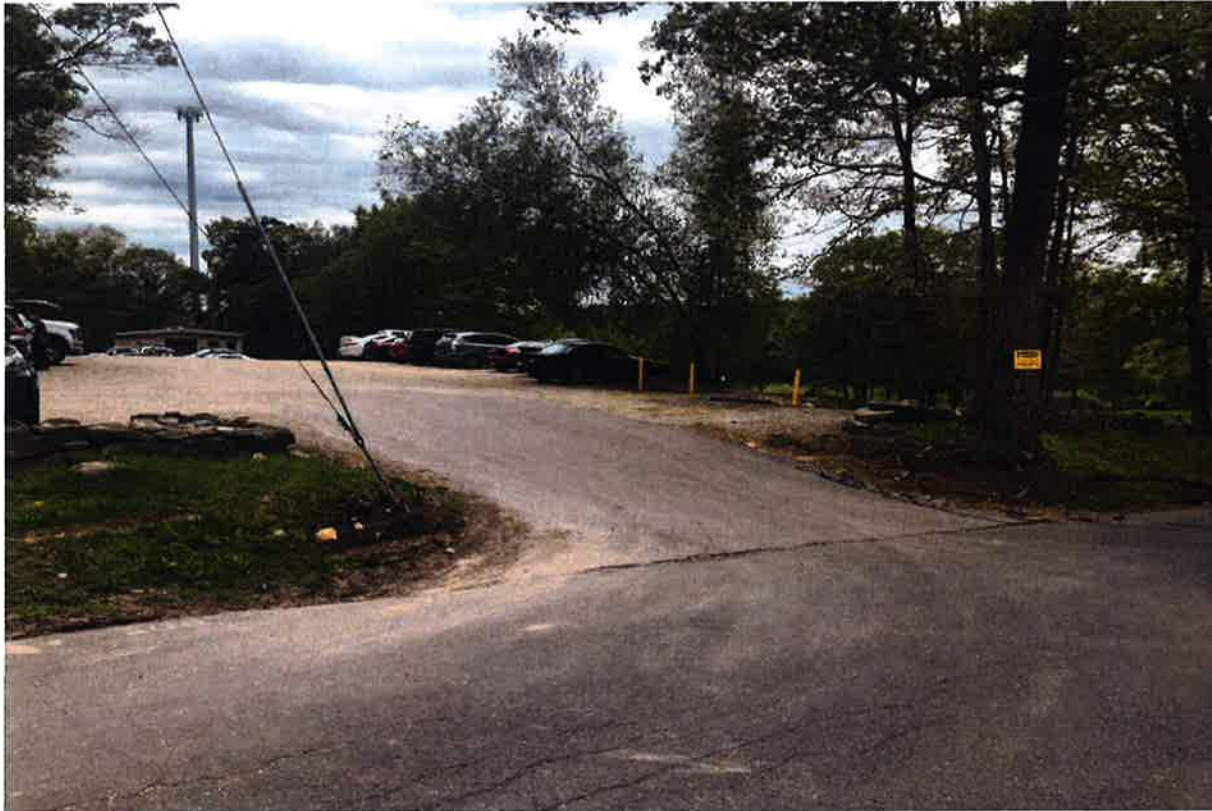
Photo 1: View of construction entrance off Folly Lane.

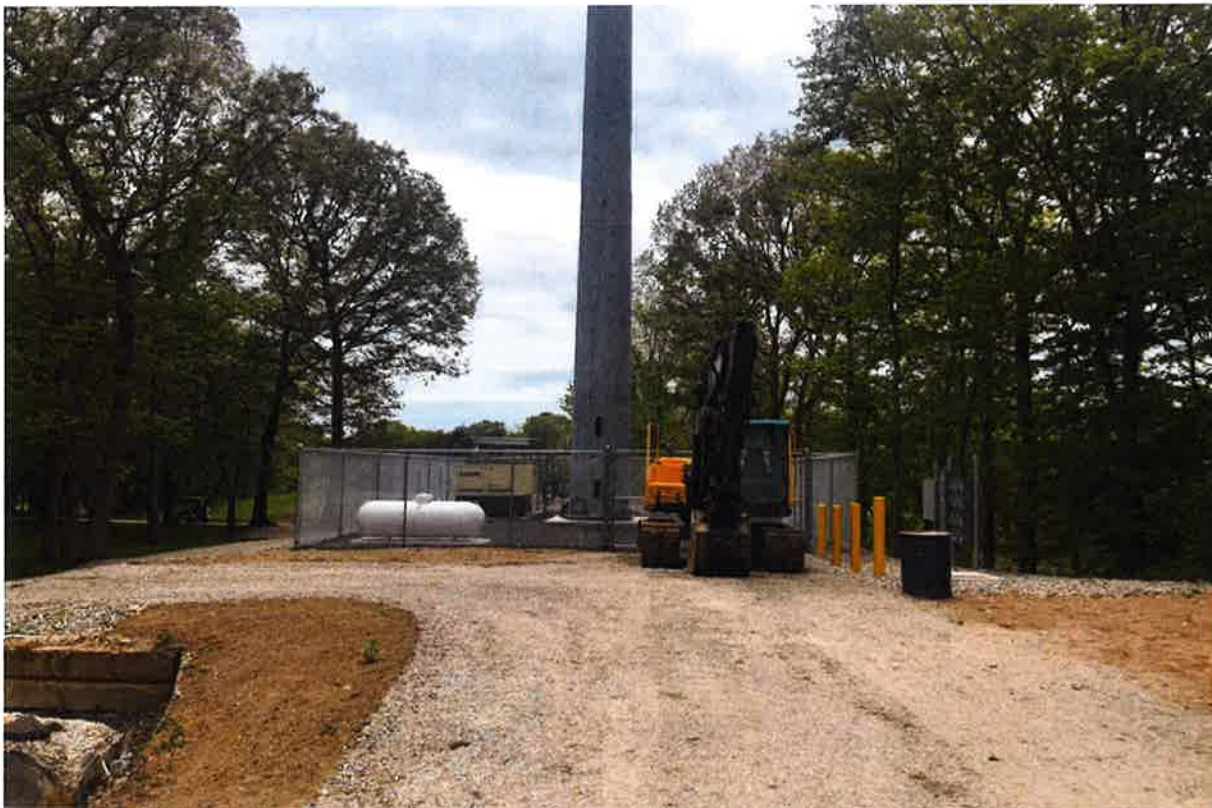
Photo 2: View of compound area/tower.

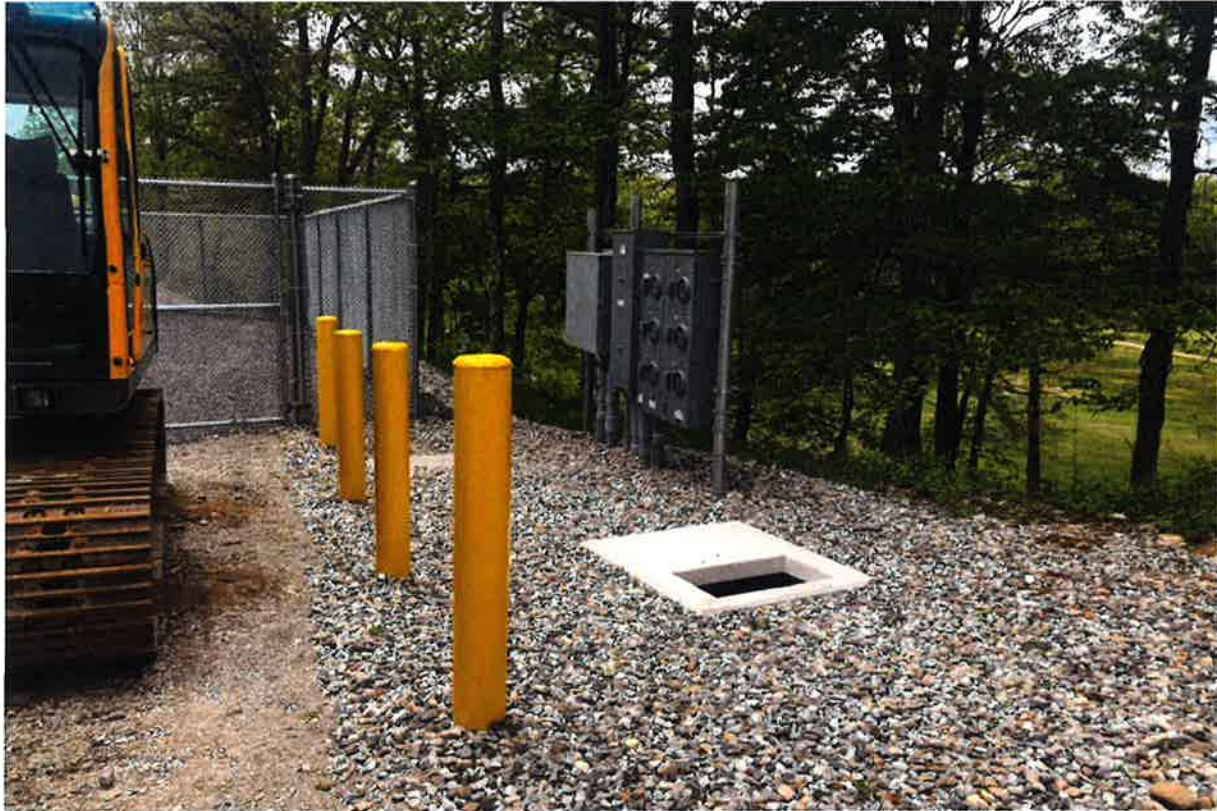
Photo 3: View of electrical board.

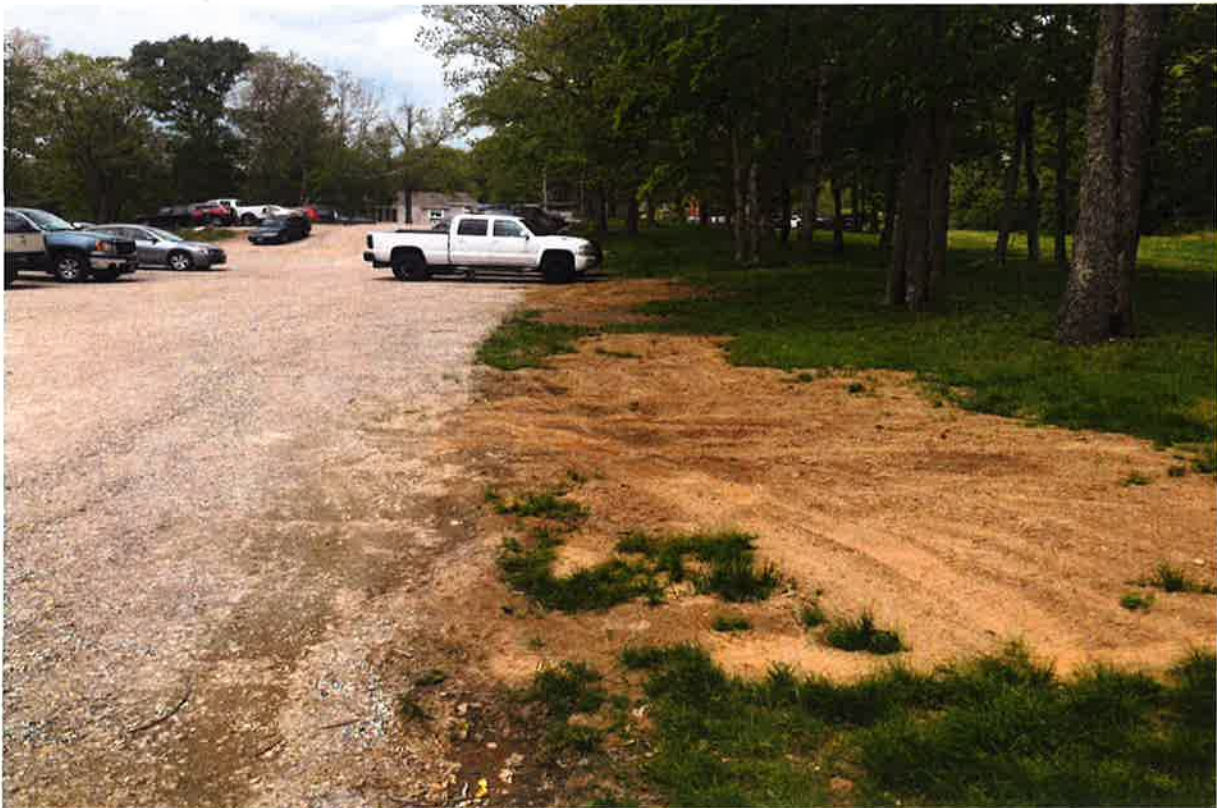
**4/30/19** - All trenching is backfilled and electrical work ongoing. Final restoration and E&S control removal pending.

Photo 4: View of completed and backfilled electrical conduits.

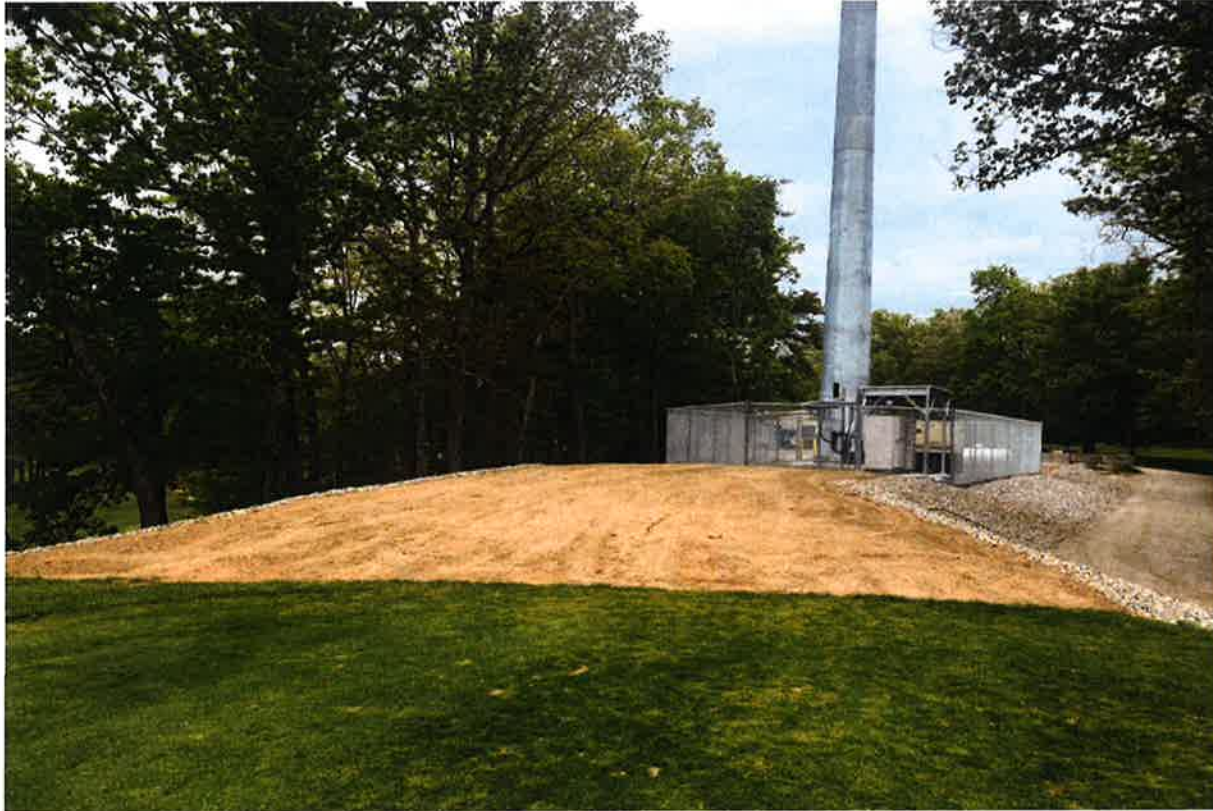
**4/23/19** – Final utility routing is underway. Removal of excavation storage pile pending removal/stabilization.

Photo 5: View of extended tee box with excavation stockpile spoils.

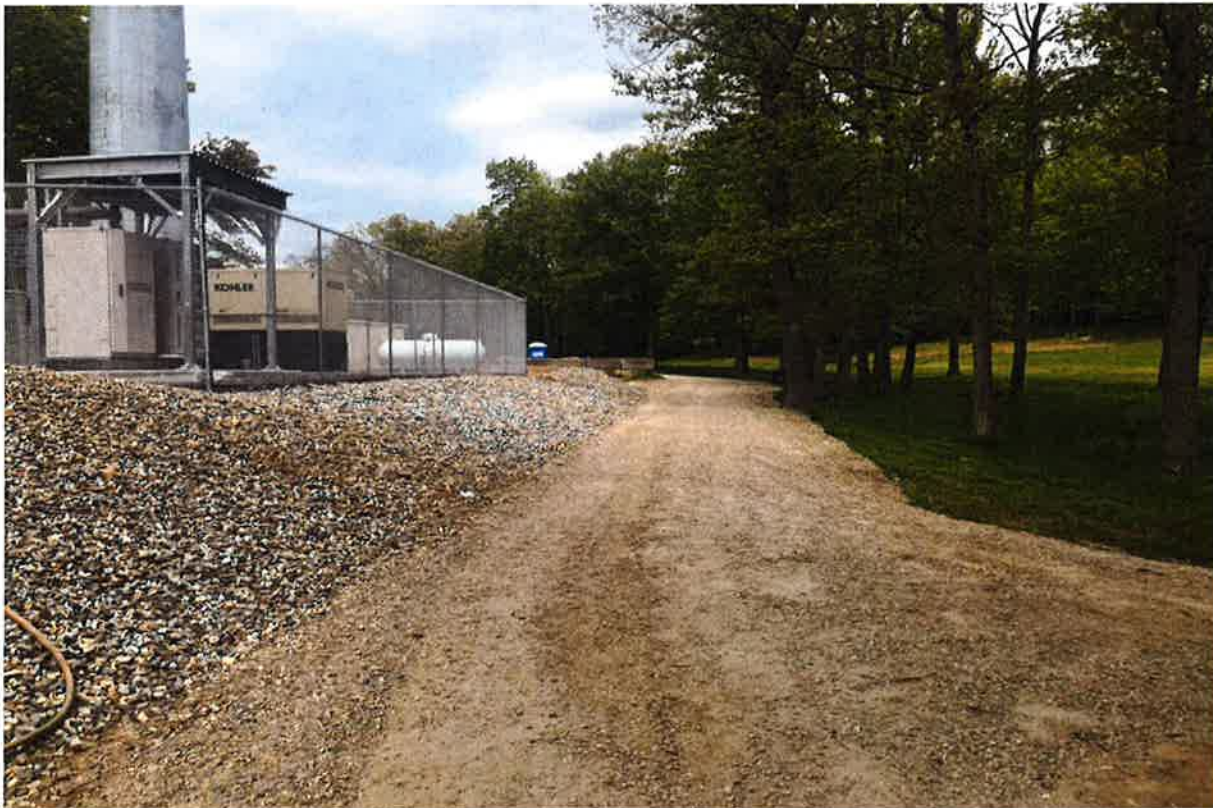
**5/24/19** – All Site work has been complete. All soils are stabilized and silt fence/perimeter controls properly removed. All soil/material stockpile areas have been either removed or properly distributed and stabilized. This report formally documents the completion of all constructed related activities and proper stabilization and restoration of all work areas. No additional construction monitoring is warranted.

Photo 6: View of areas with silt fencing removed.
