Re: Docket 478
Eco-Site, Inc. & T-Mobile Northeast
Proposed Wireless Telecommunications Tower Facility
63 Woodland Street, Glastonbury Connecticut

APPLICATION OF ECO-SITE AND T-MOBILE
NORTHEAST, LLC FOR A CERTIFICATE OF
ENVIRONMENTAL COMPATIBILITY AND
PUBLIC NEED FOR THE CONSTRUCTION,
MAINTENANCE, AND OPERATION OF A
TELECOMMUNICATIONS FACILITY LOCATED
AT WOODLAND STREET, GLASTONBURY,
CONNECTICUT

DOCKET NO. 478

APPLICANTS' SUPPLEMENTAL SUBMISSION

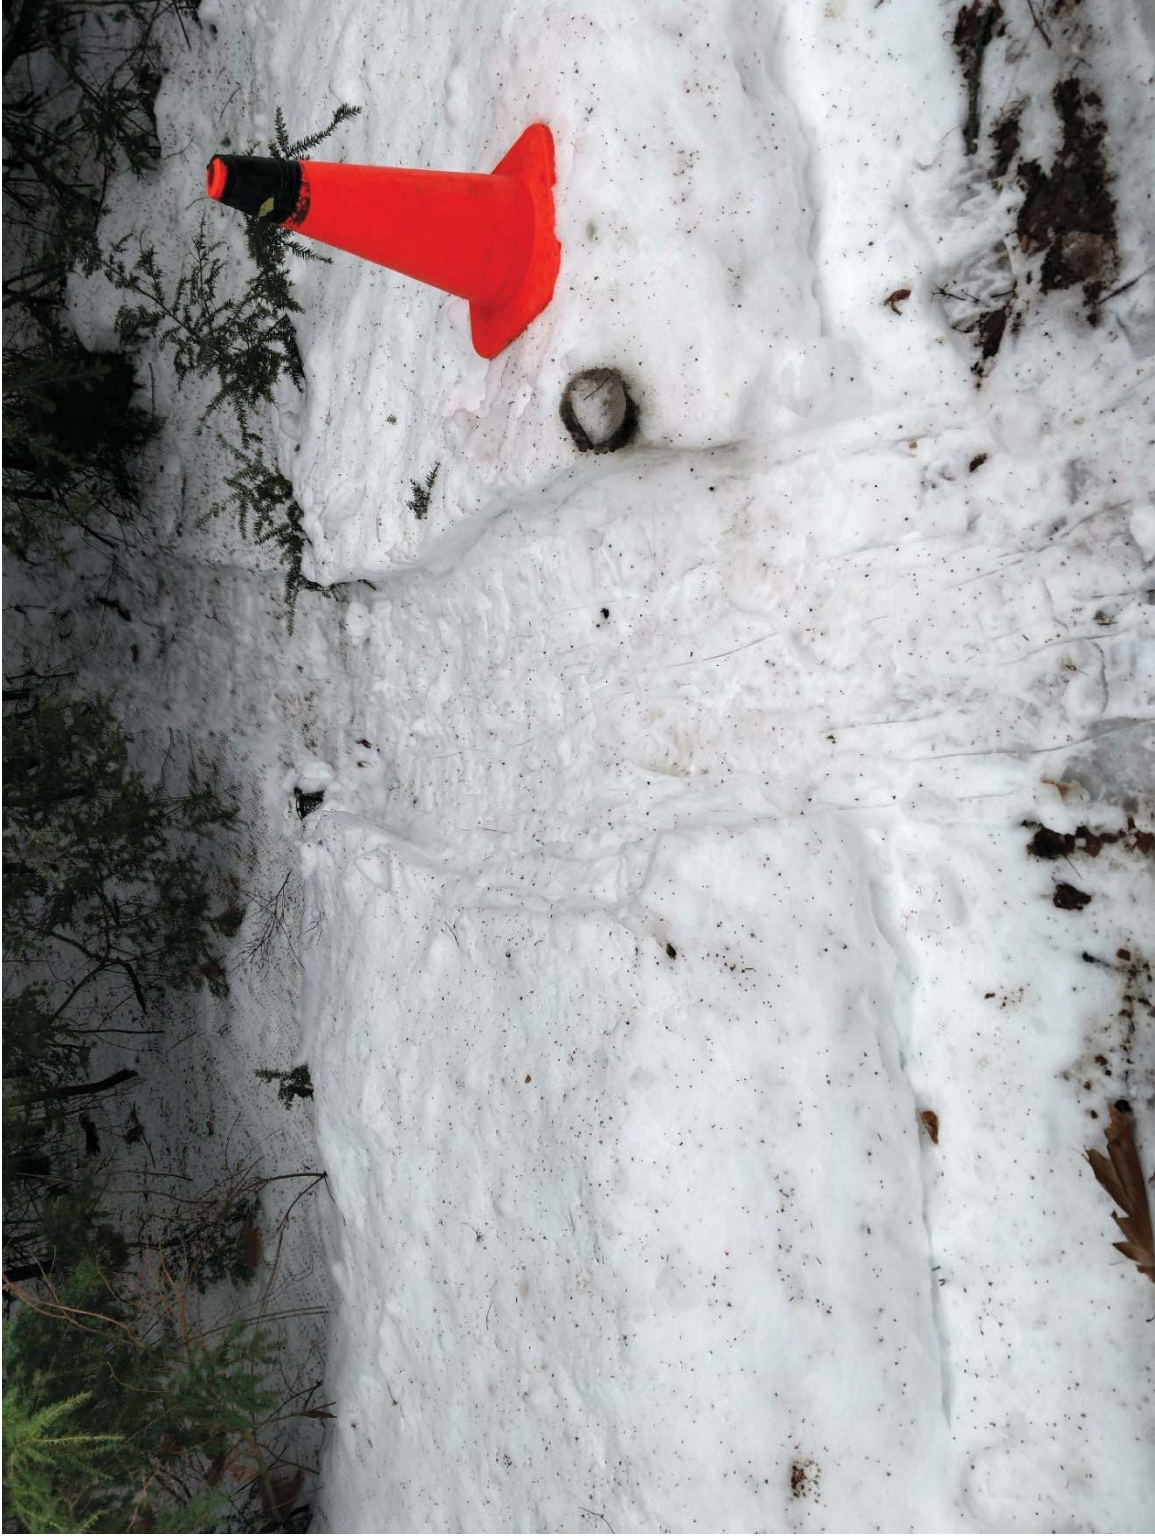
Note: The wooden stake with the blue flagging on it represents the center of the access drive. Location for the path was a less dense area of underbrush.

Photo 13: Along Existing Access Drive

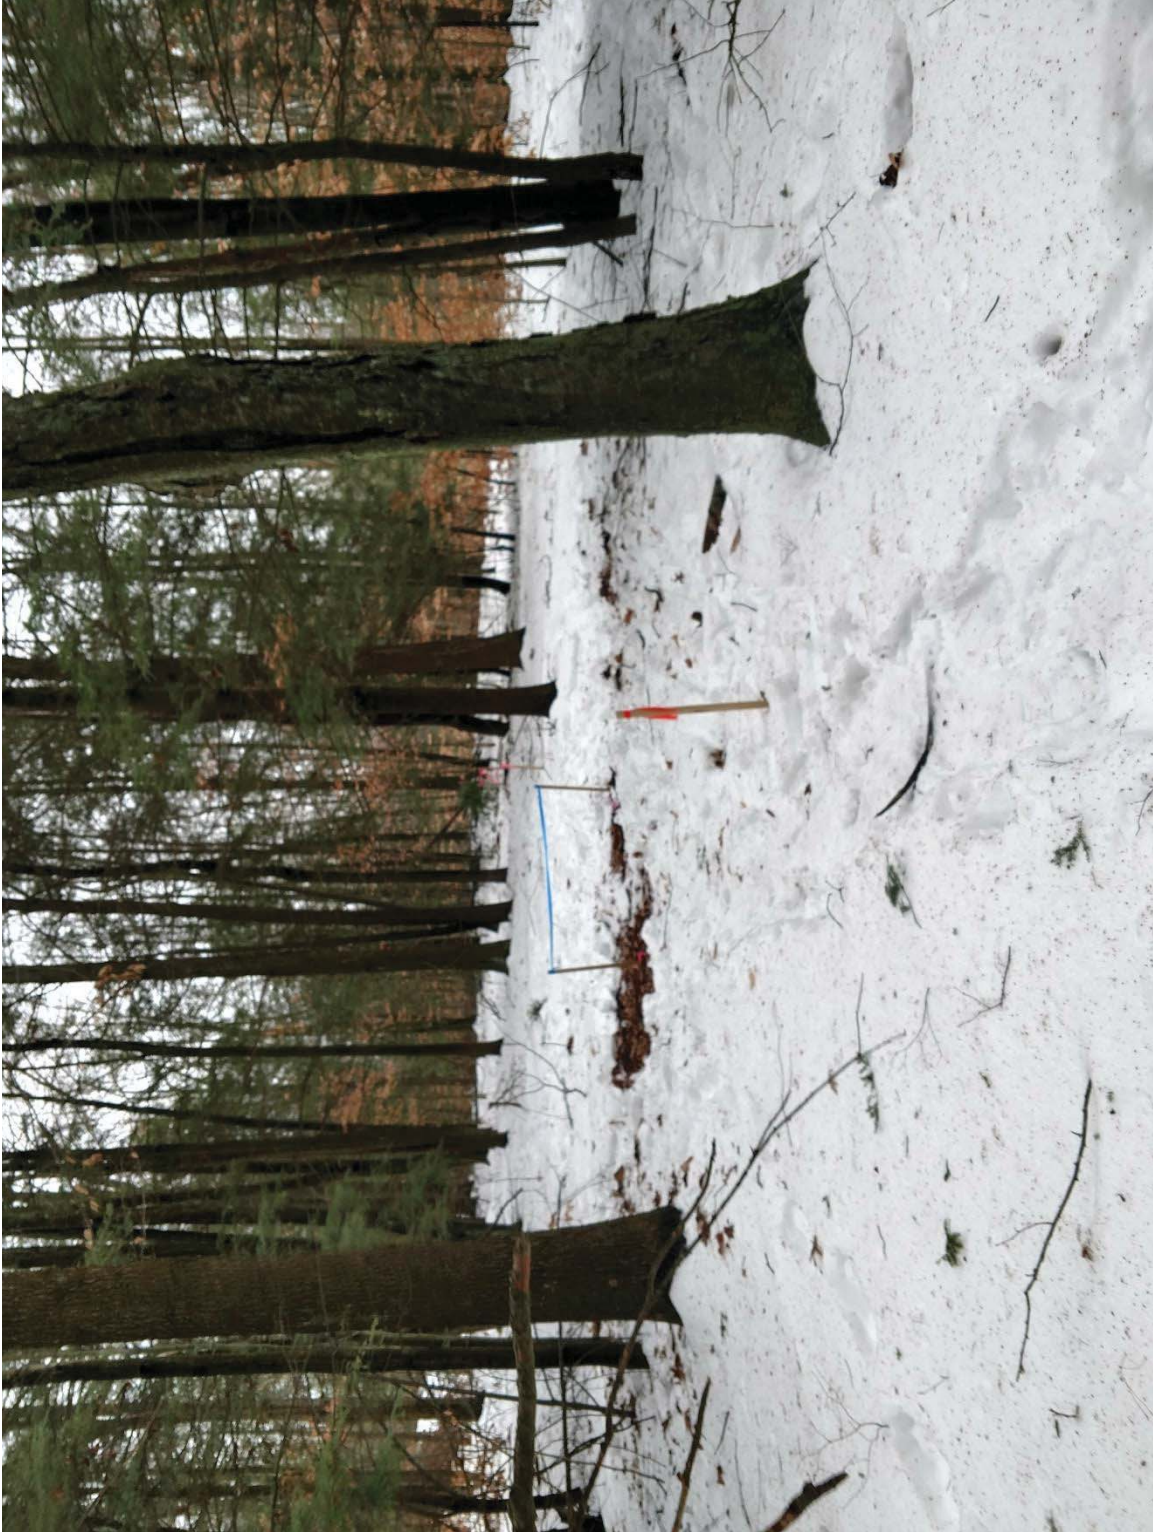
Photo 25: Compound Location

Stake in the foreground is the Northwestern most corner of the lease area.

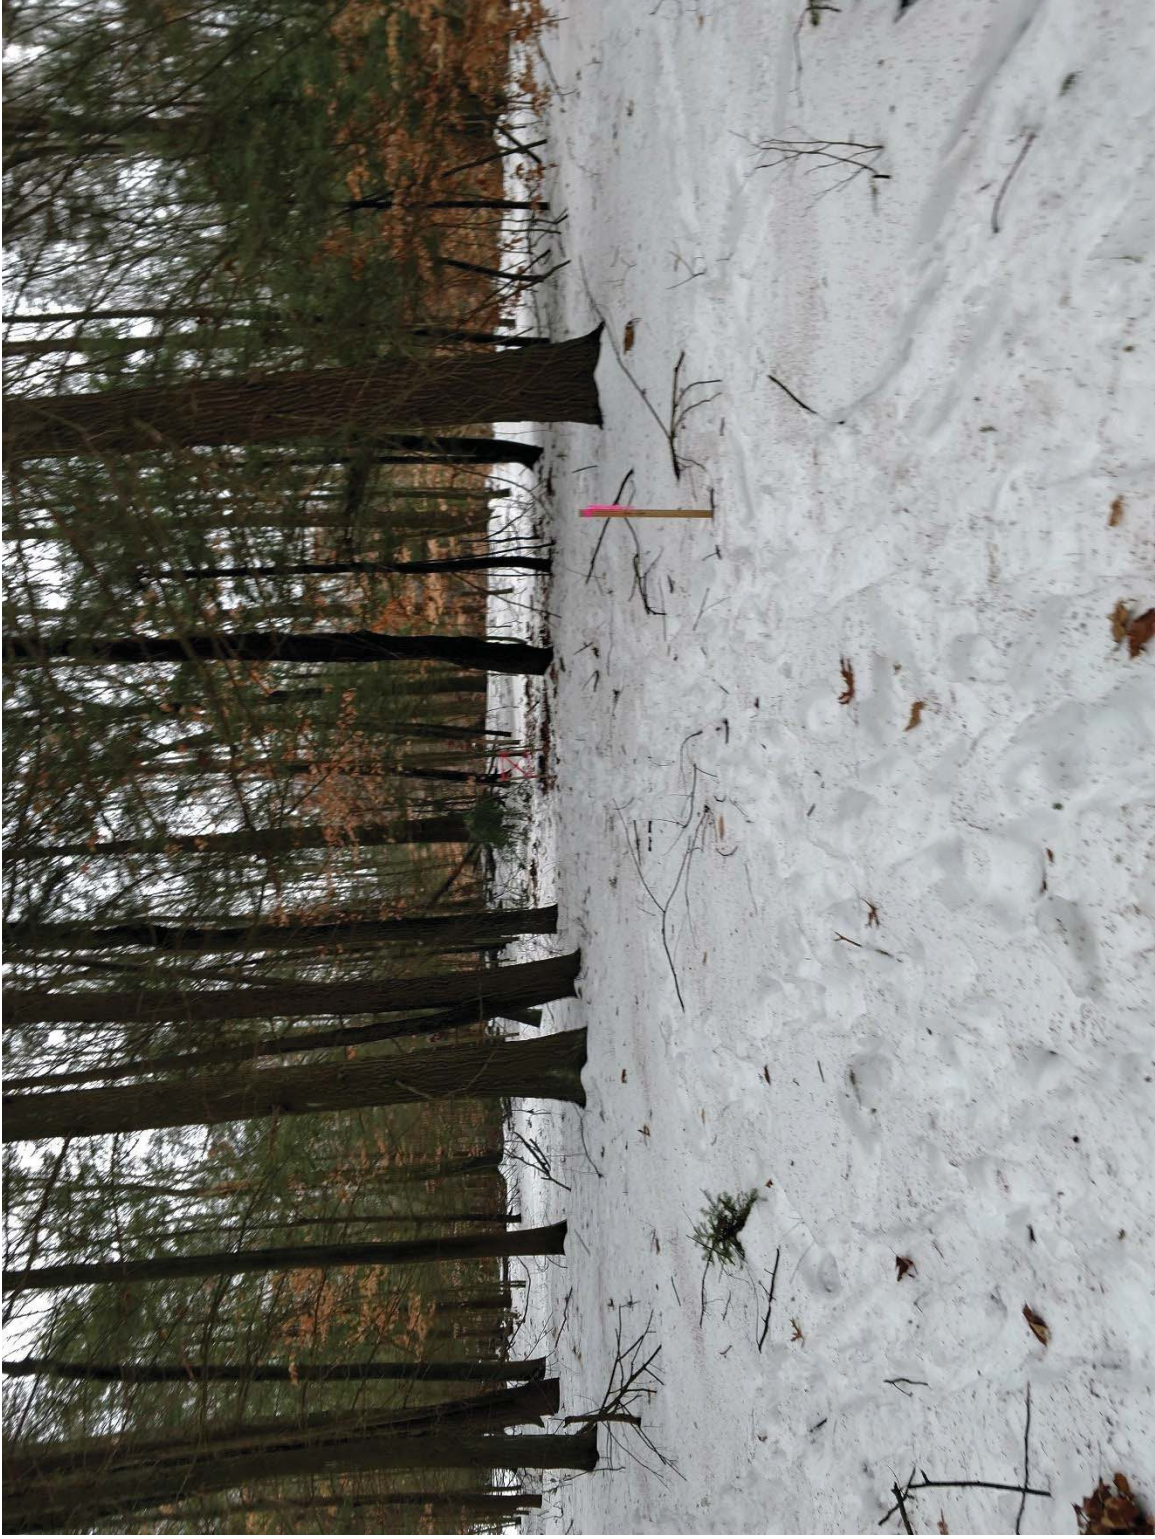
Photo 27: Compound Location

The stake in the center right of photo with pink flagging is the northwesterly most corner of the fenced compound.

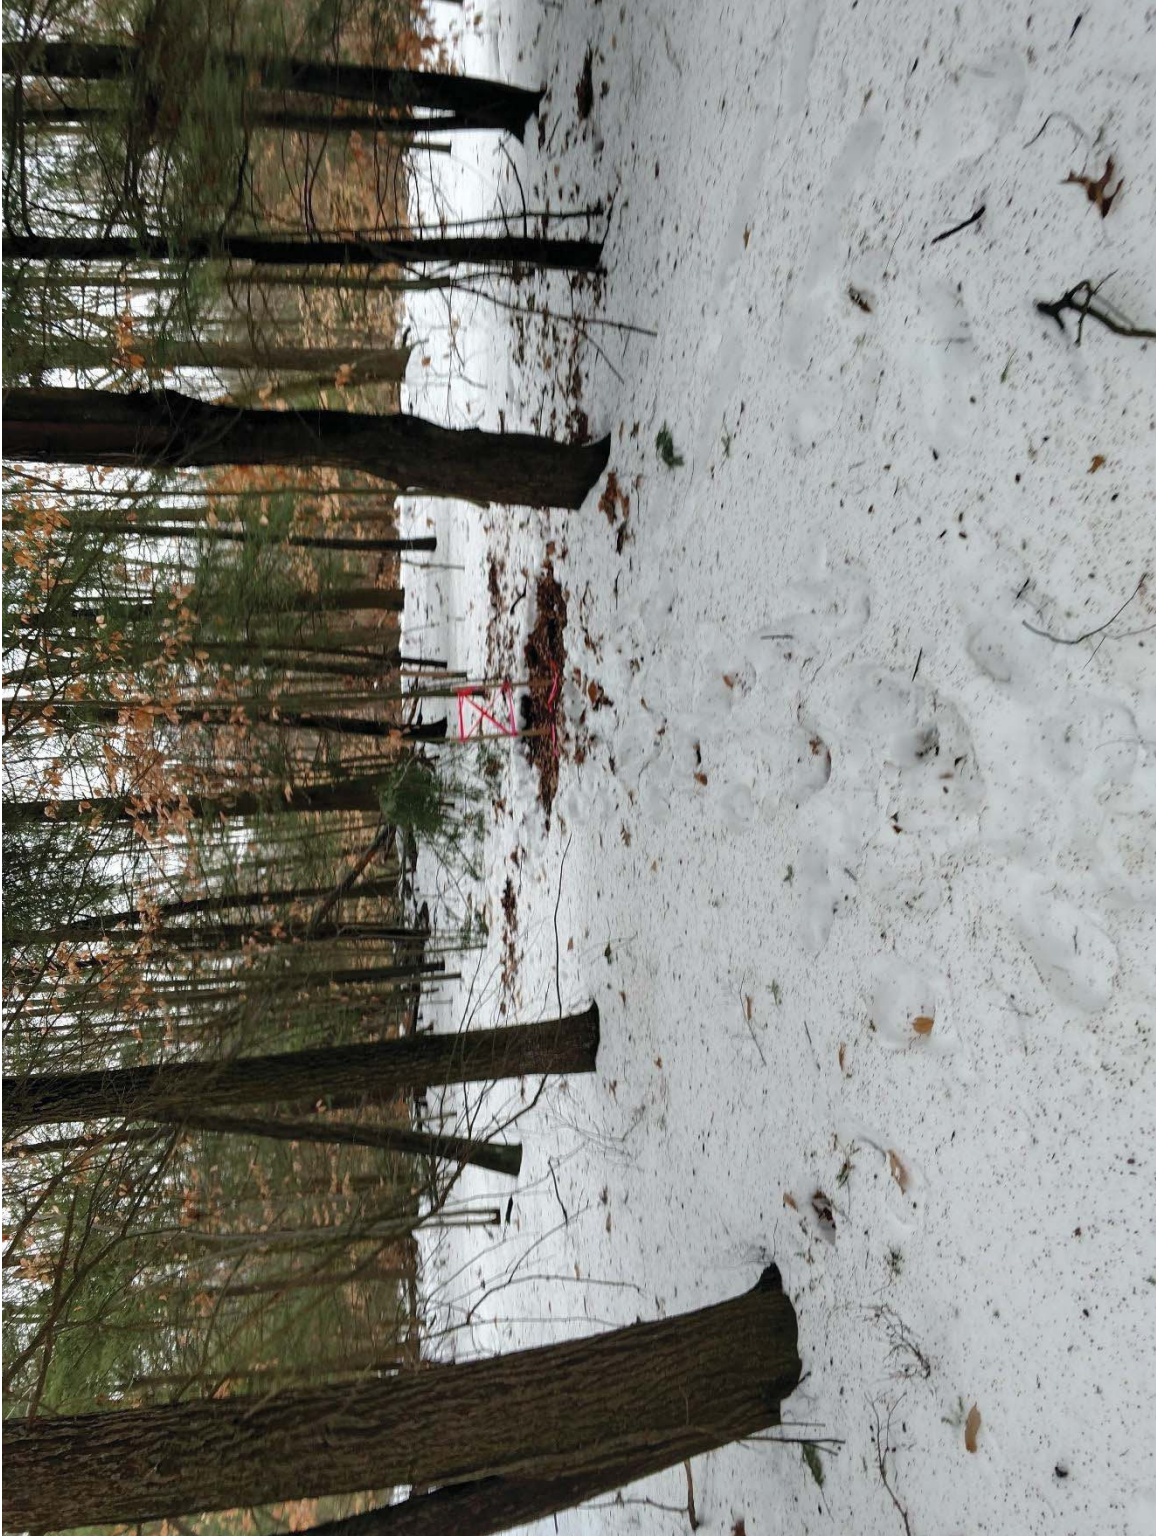
Photo 28: Compound Location

The two vertical stakes with pink flagging and "X" represent tower center; there is a metal pin staked for tower center in subsequent photos.

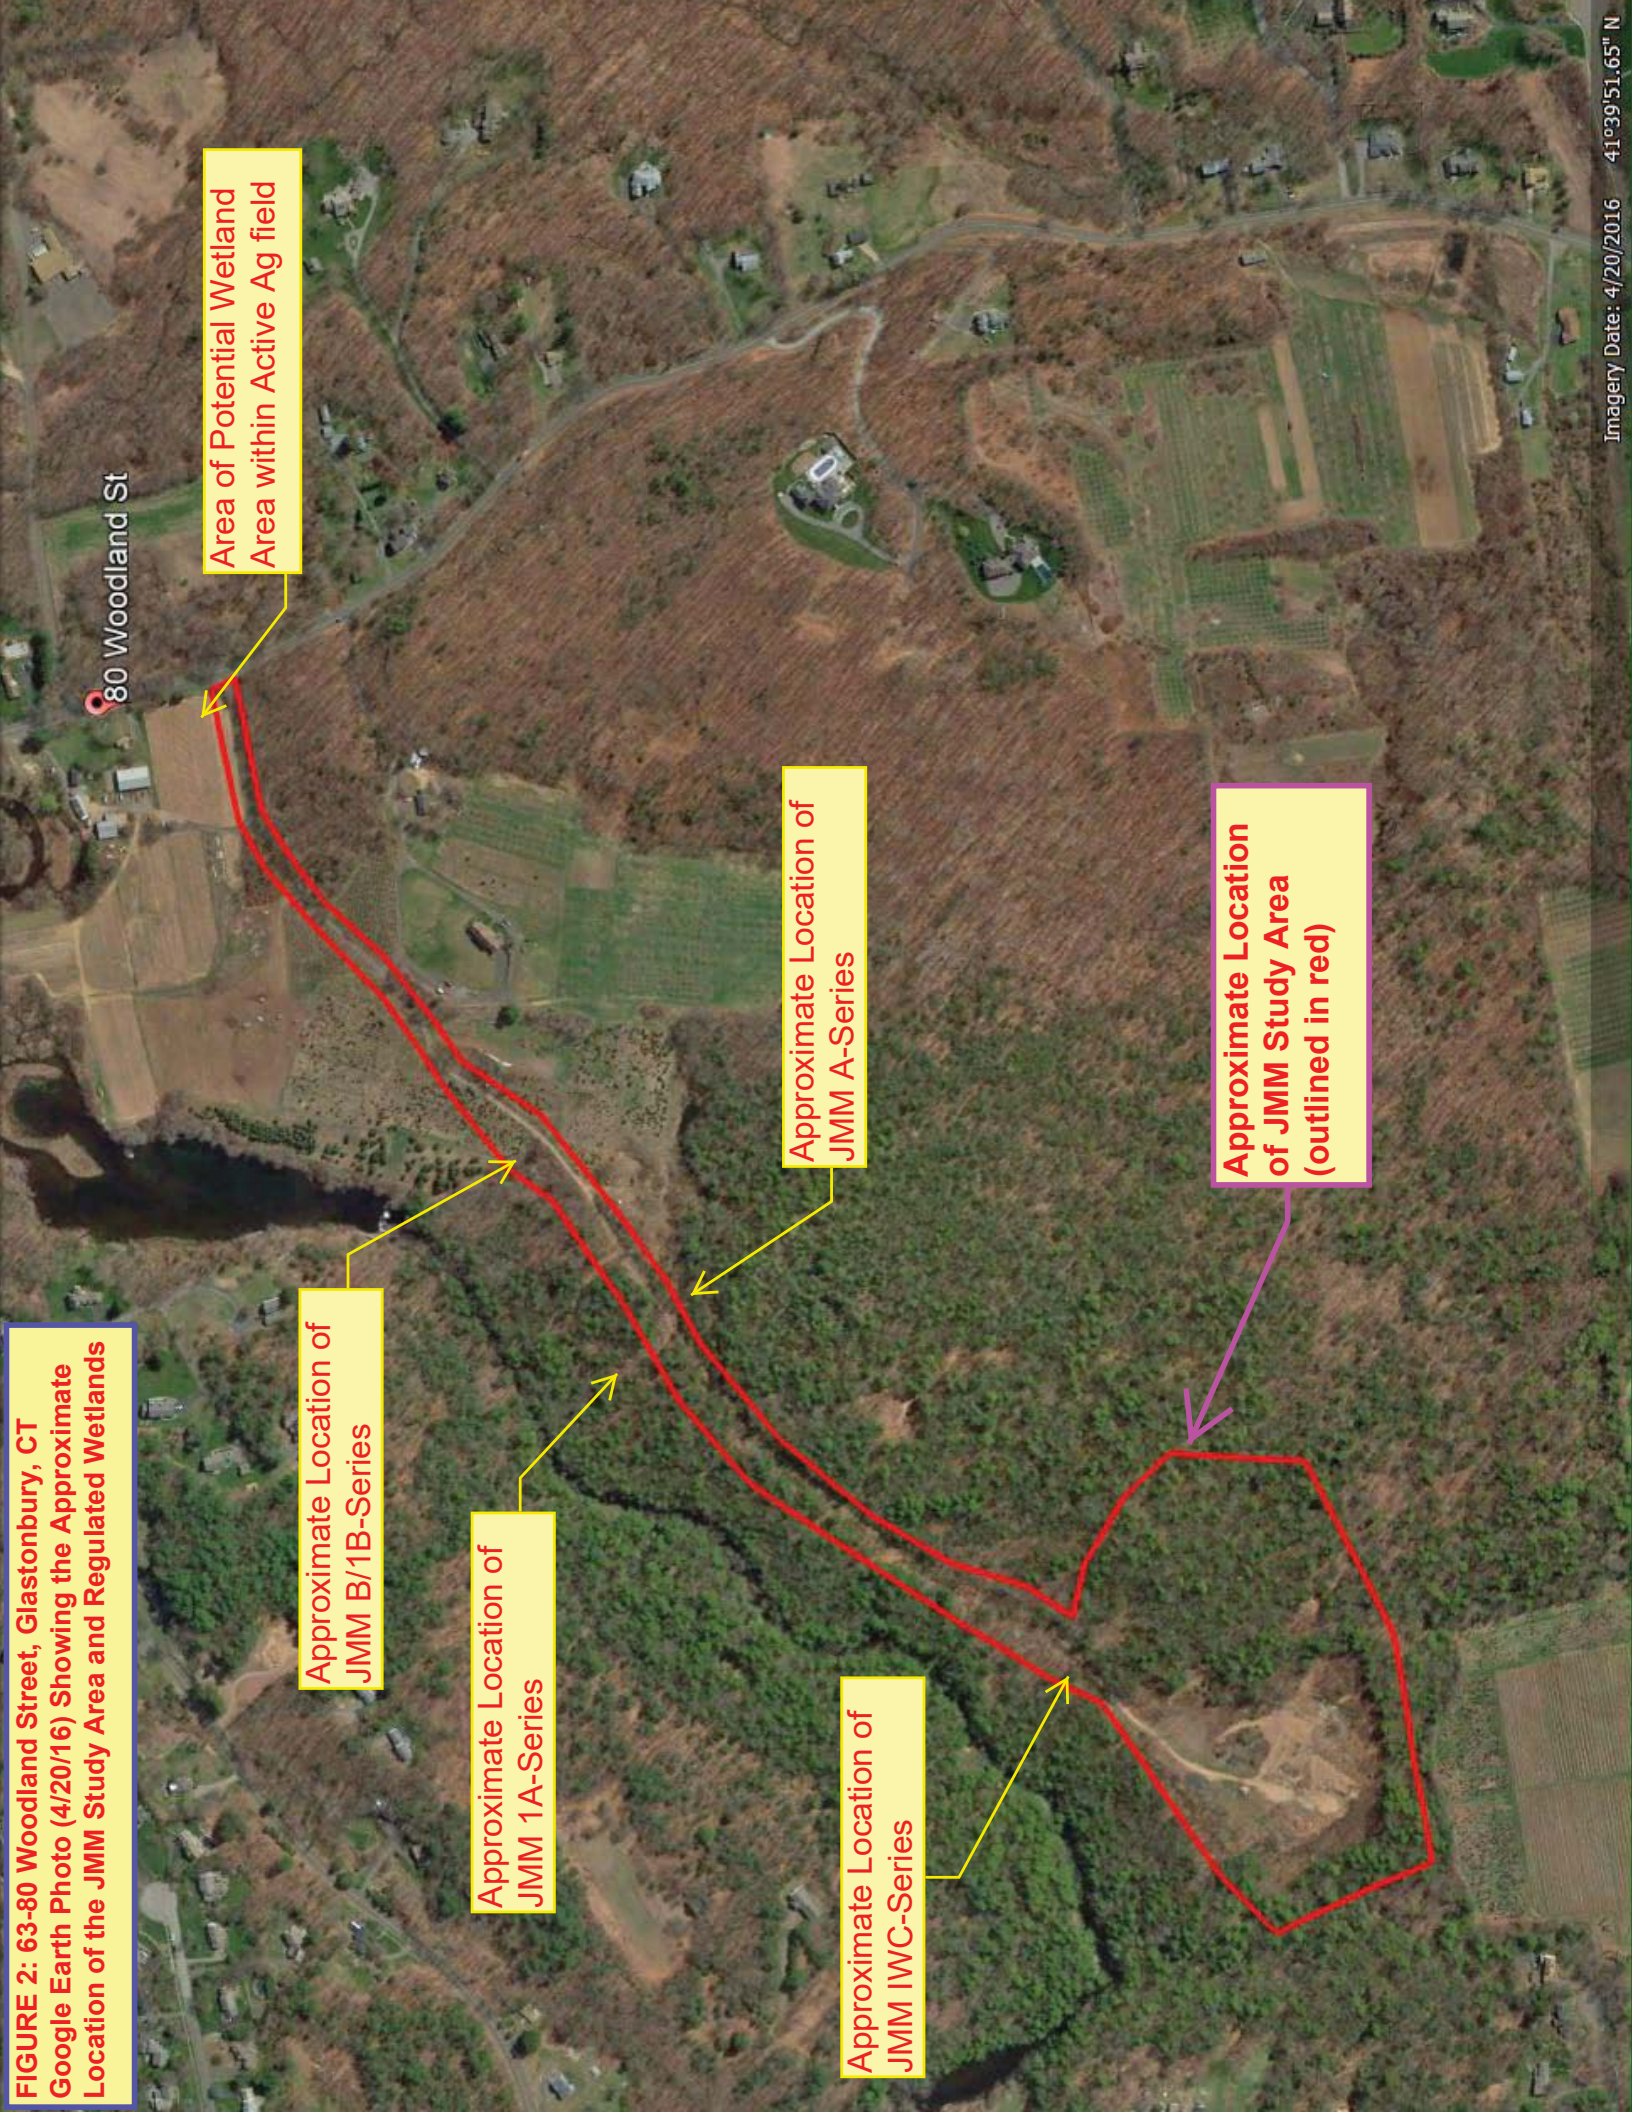
**FIGURE 2: 63-80 Woodland Street, Glastonbury, CT
Google Earth Photo (4/20/16) Showing the Approximate
Location of the JMM Study Area and Regulated Wetlands**

Approximate Location of Access Driveway

Approximate Location of Proposed Cell Tower

Area of Potential Wetland
Area within Active Ag field

One potential wetland area was tentatively identified within the study area located near Woodland Street and just north of the access drive within an active agricultural field (see Figure 2). We estimate that the potential wetland boundary is approximately 25 feet and downgradient from the edge of the access driveway. Due to the snow cover and deep frost at the time of the site inspection, a formal wetland delineation was not possible. However, as soon as conditions allow delineation may be performed as needed.

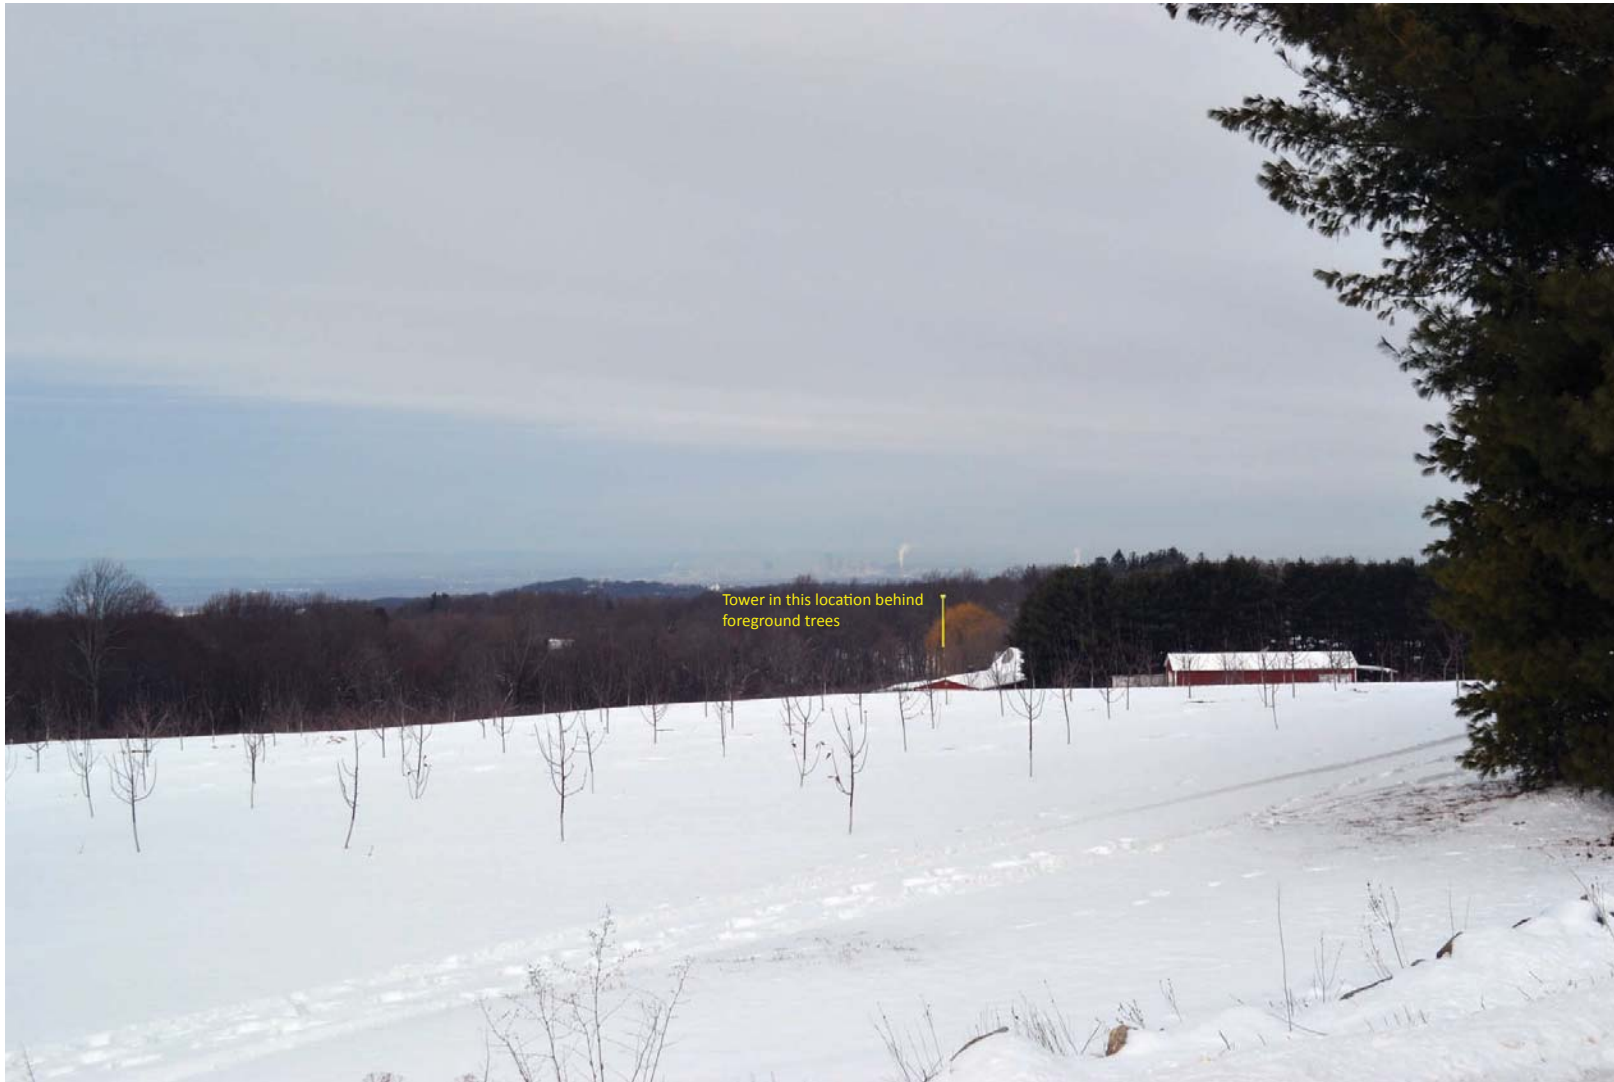
Tower in this location behind foreground trees

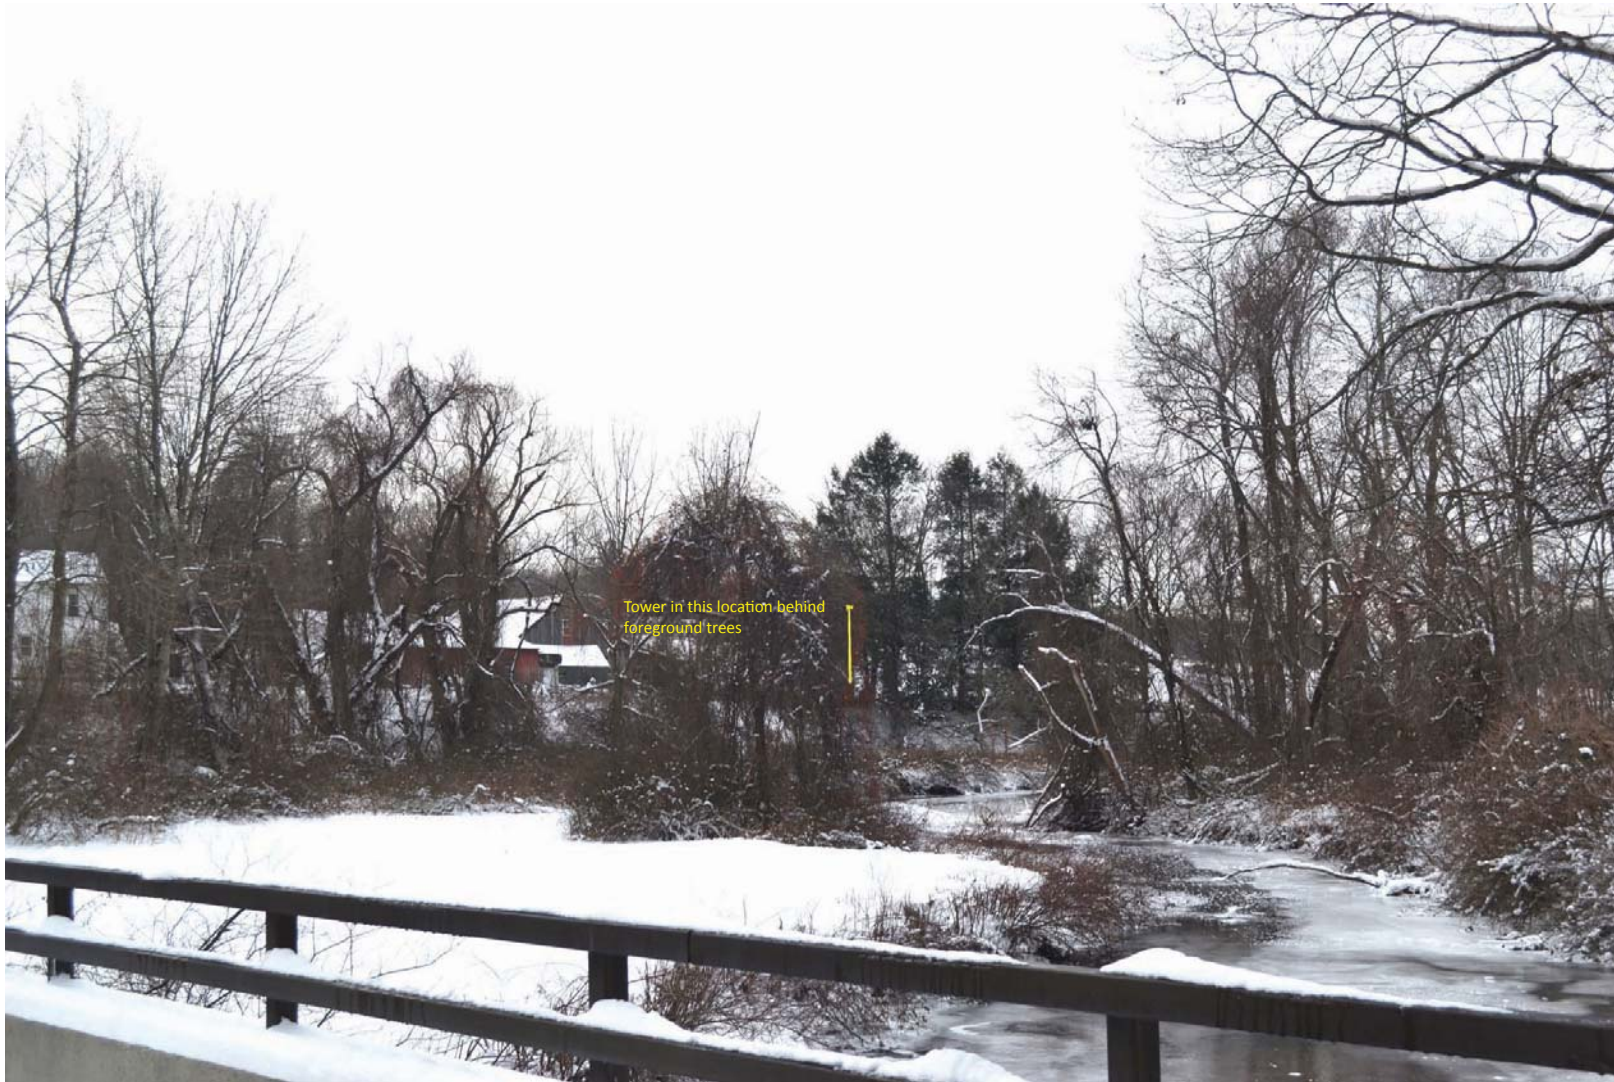
Tower in this location behind foreground trees
