**Post-Construction EMF Measurements**  
**for the**  
**Trumbull Substation**

Prepared for  
**The United Illuminating Company**  
801 Bridgeport Avenue  
Shelton, CT 06484

Enertech Consultants  
494 Salmar Ave., Suite #200  
Campbell, California 95008

June 20, 2008

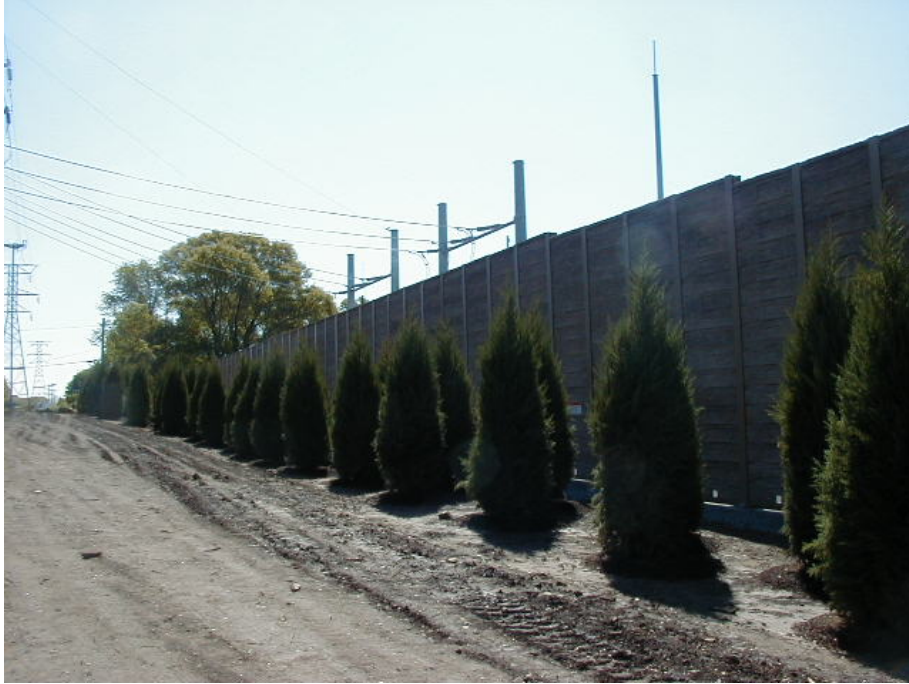
Figure A-1. Substation wall on north side of Trumbull substation.

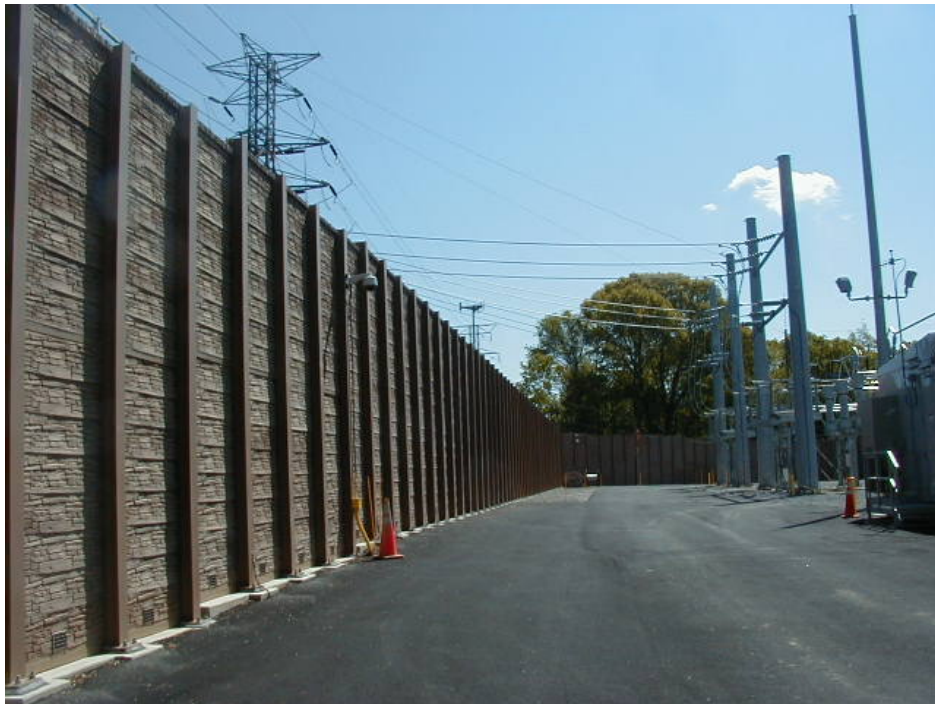
Figure A-4. Interior view of Trumbull substation north wall facing tap structures.
