**APPLICATION TO THE
CONNECTICUT SITING COUNCIL**

**CERTIFICATE OF ENVIRONMENTAL
COMPATIBILITY AND PUBLIC NEED**

Stepstone Substation
Stepstone Hill Road
Guilford, Connecticut

**Volume 2 of 2
Appendices**

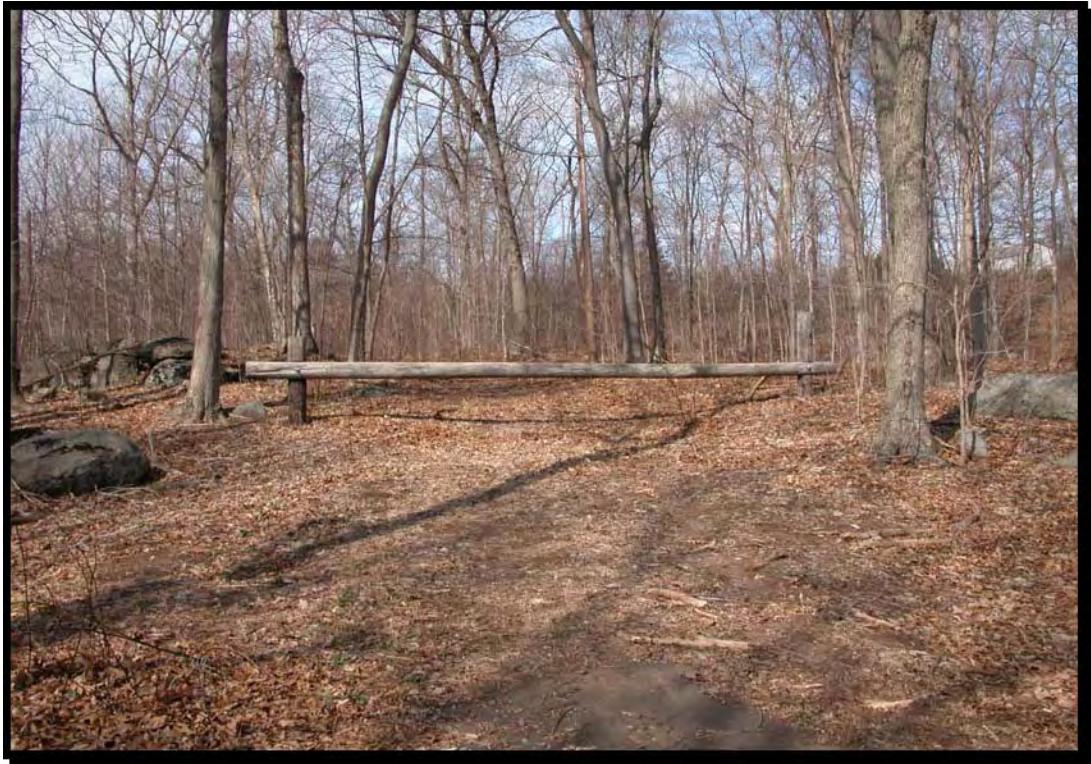
View 1 - Existing entrance off of Stepstone Hill Road.

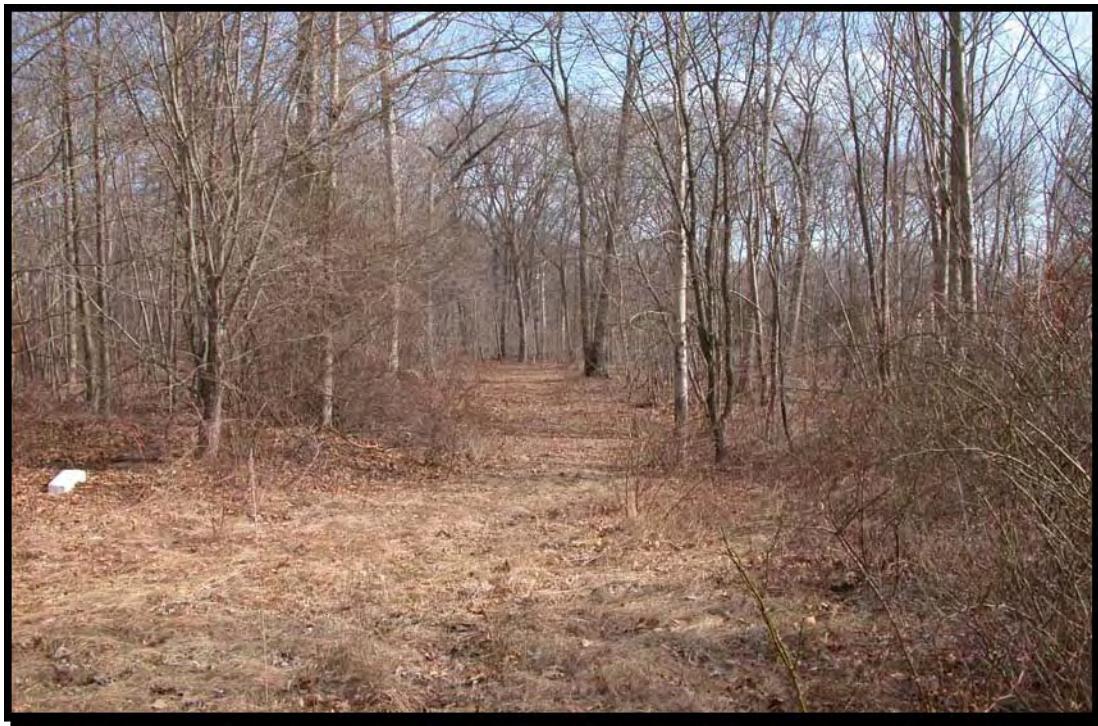
View 2 - Existing access drive.

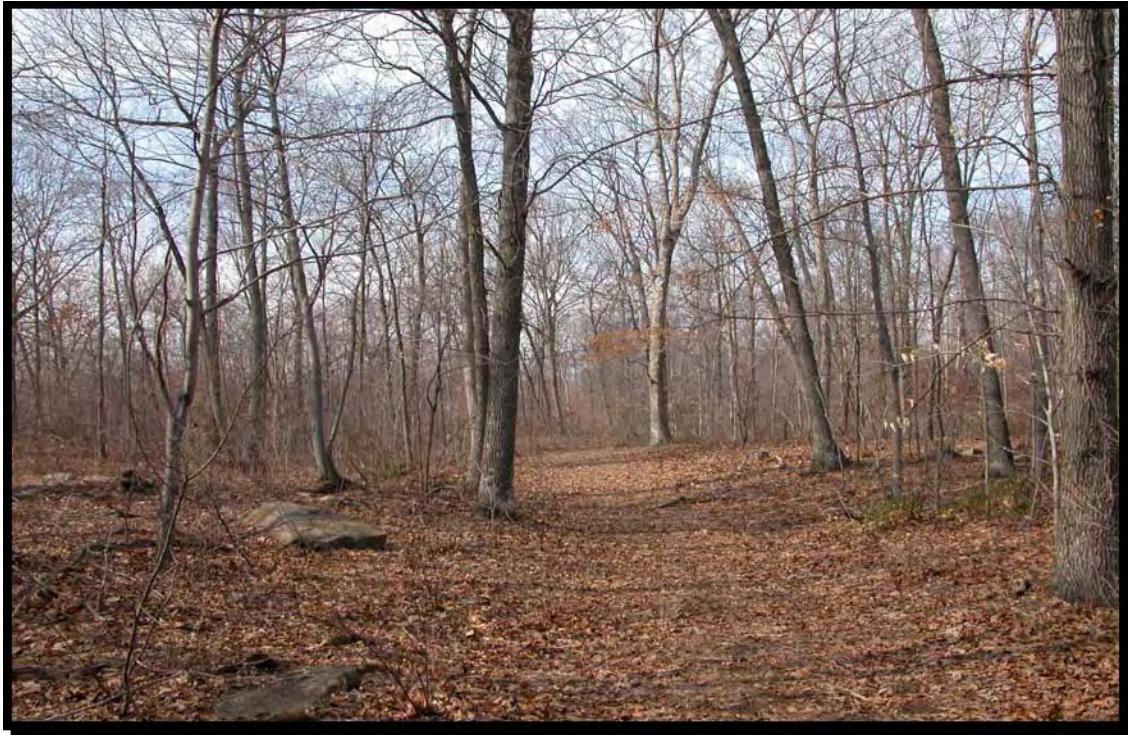
View 3 - General substation location.

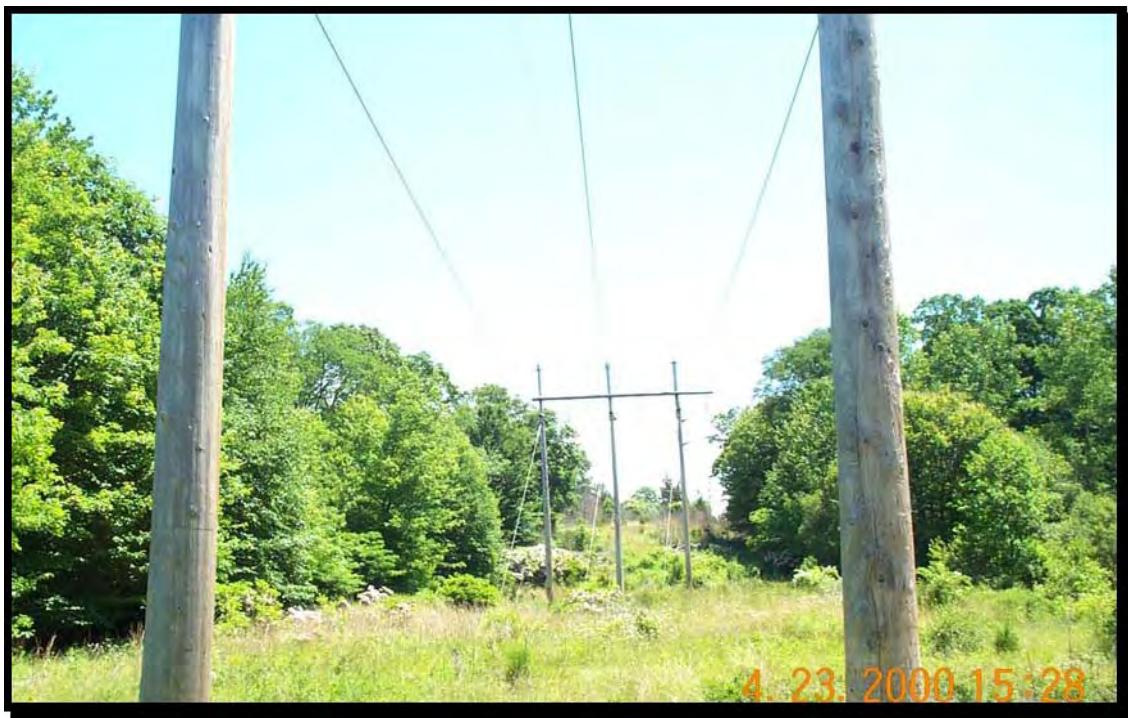
View 4 - Existing transmission corridor on property.

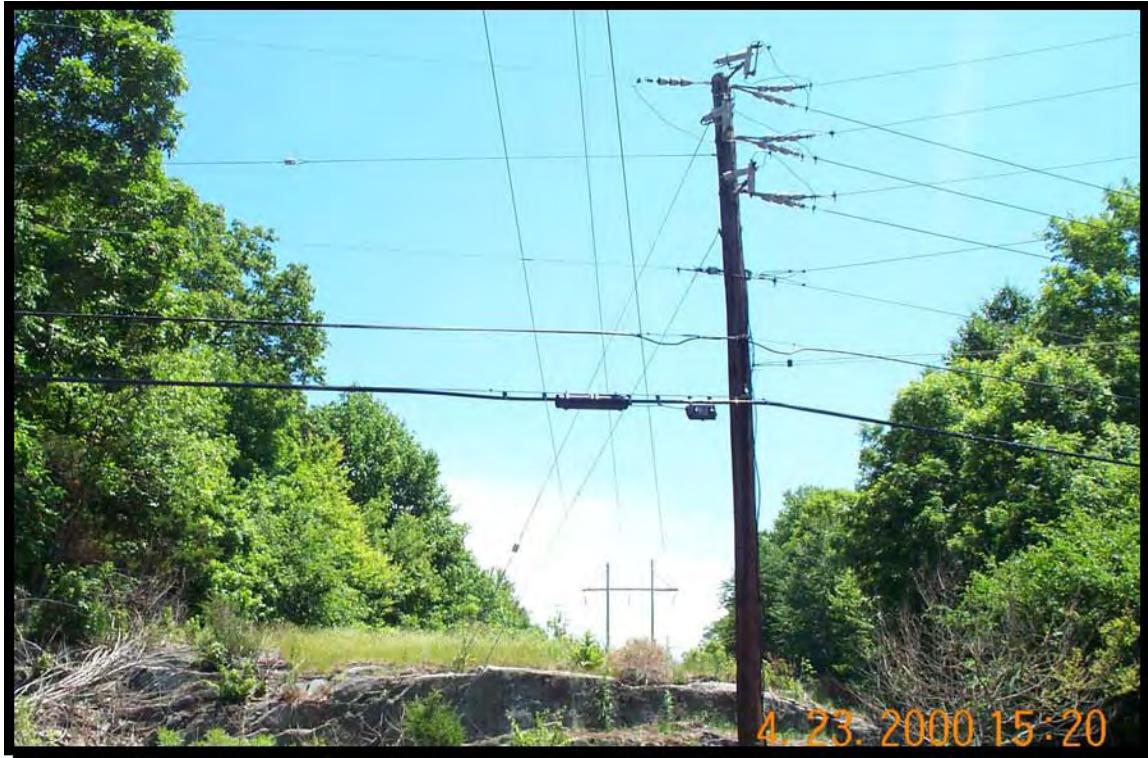
View 5 - Existing transmission corridor at Route 77.

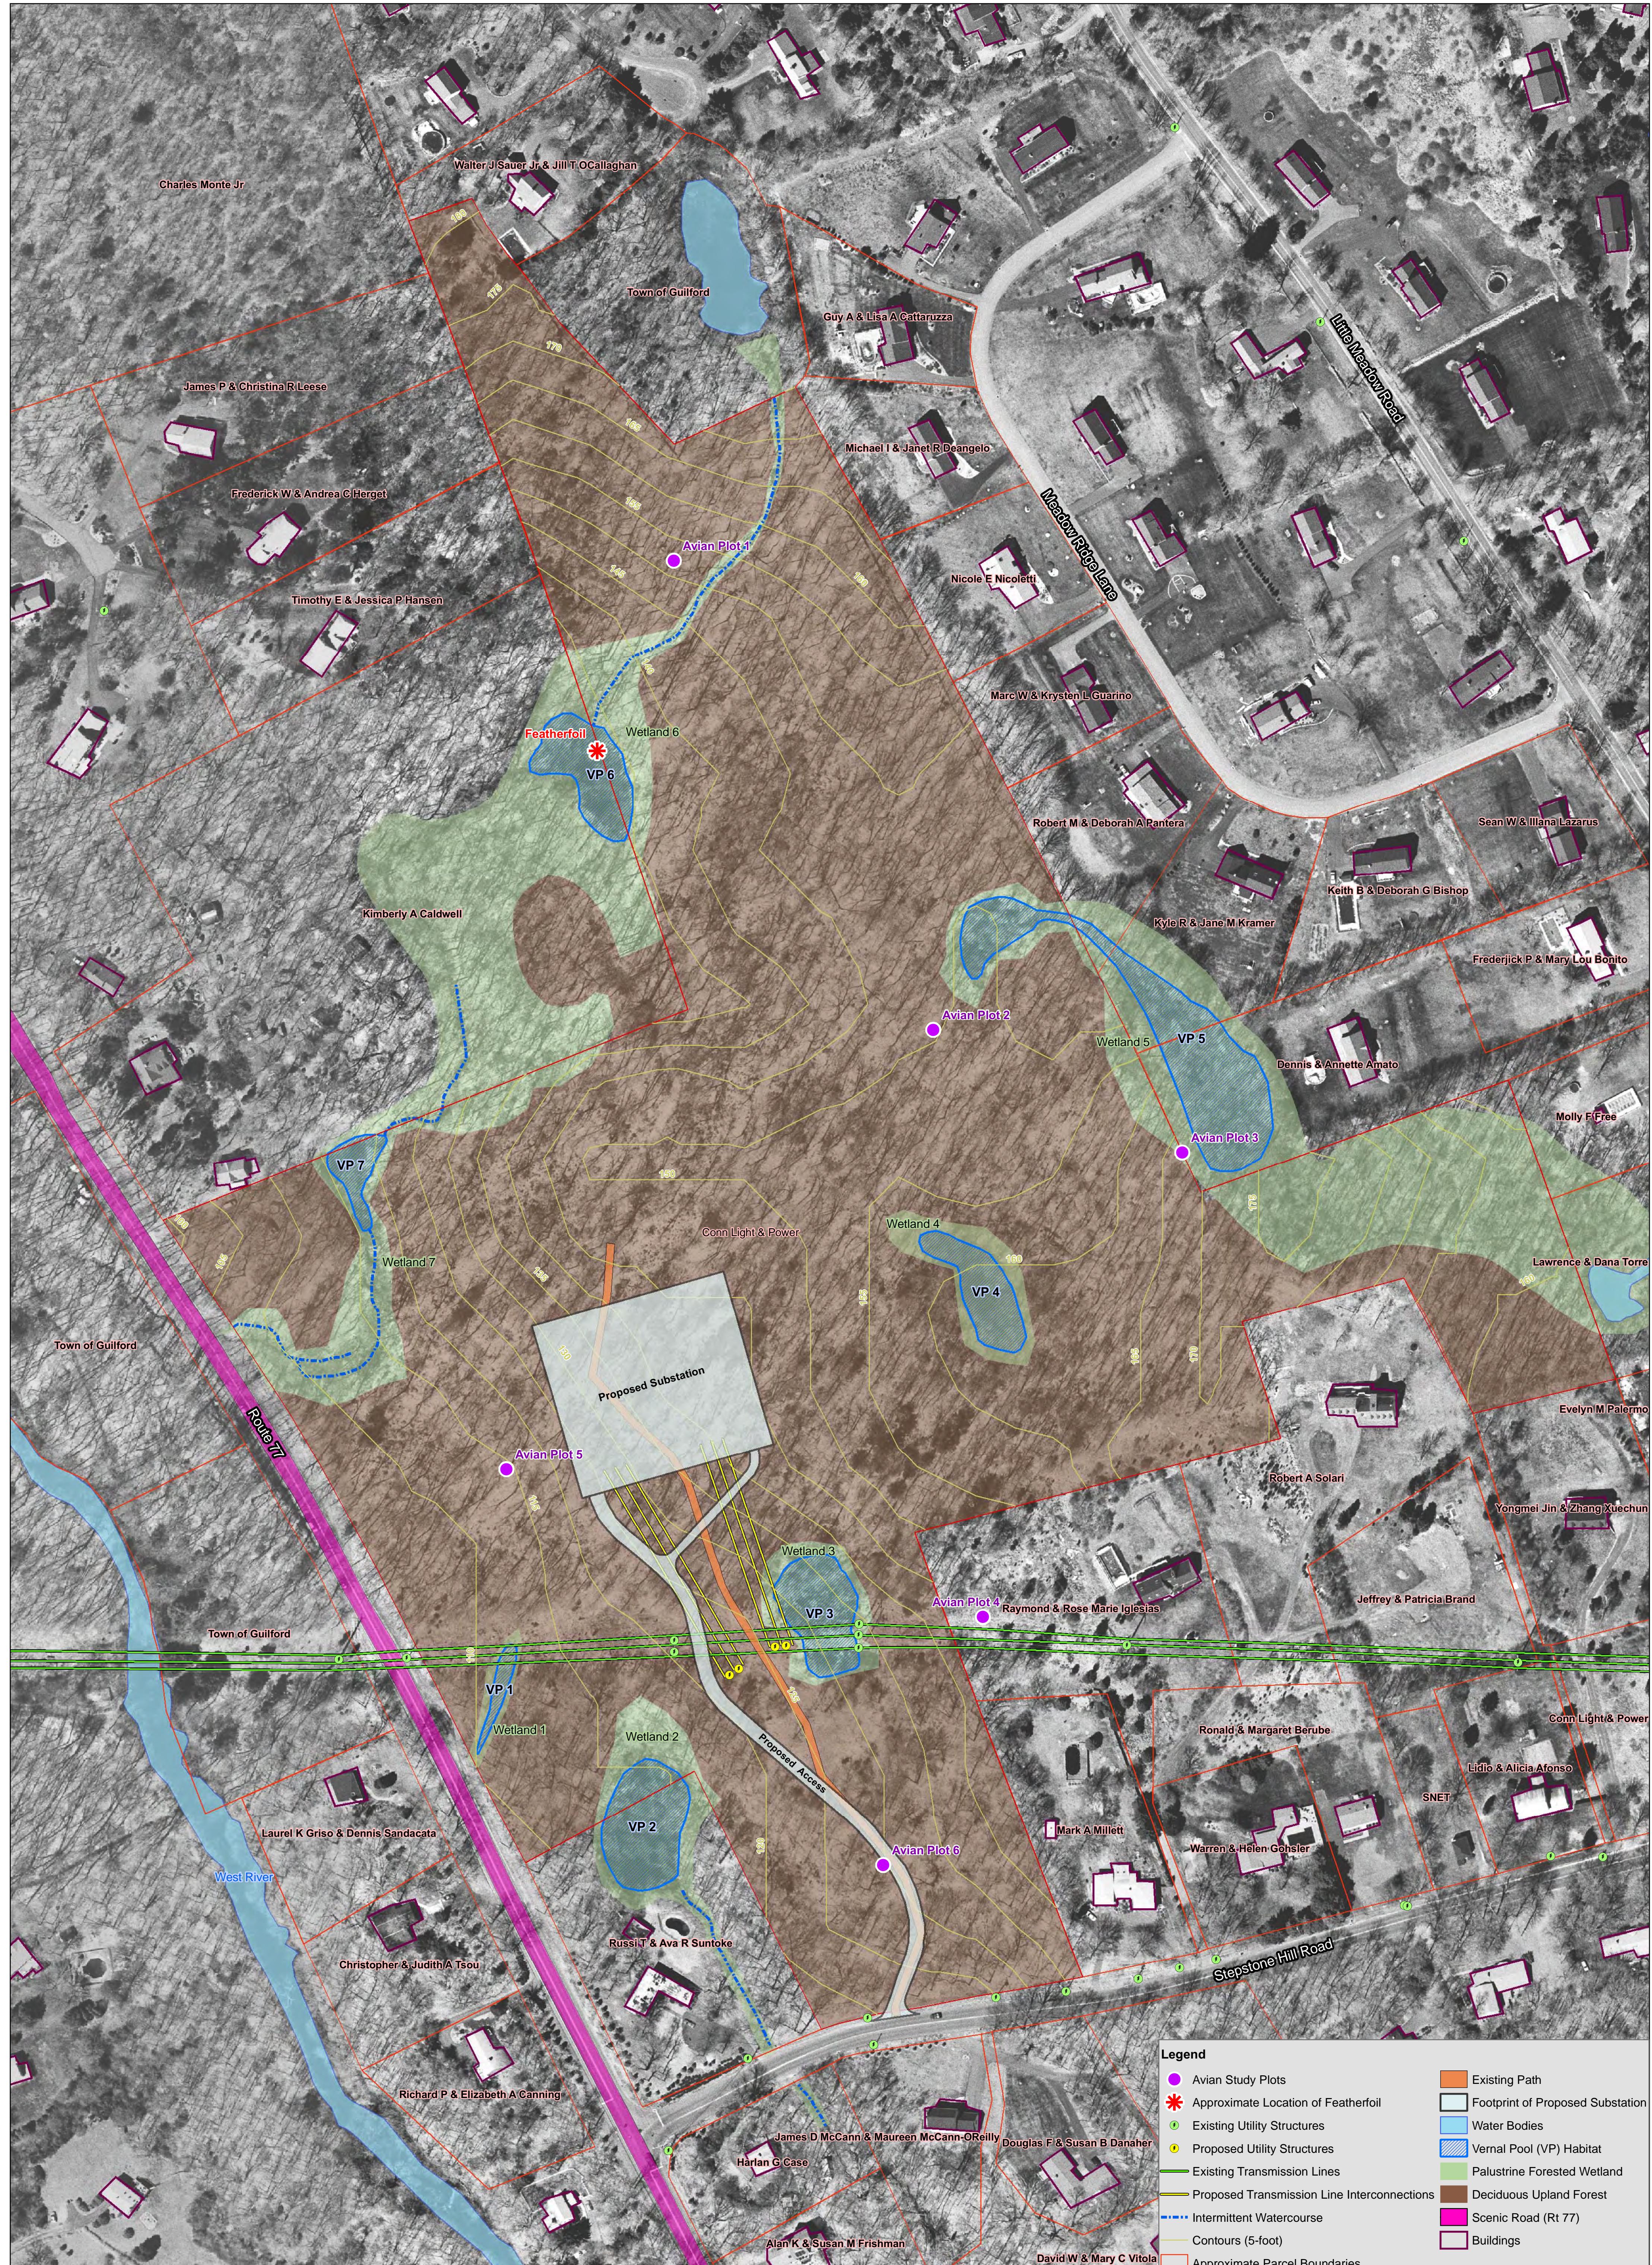
Figure 2: Habitat Assessment

Various habitat structural features were identified and documented for each habitat type. Forested areas were evaluated for canopy cover, perch height and midstory composition. All habitat areas were assessed to determine soil and substrate type, depth to bedrock, slash piles, depth of leaf litter, topography and groundwater elevation. The locations of dirt paths, structures and stone walls were also documented. VHB scientists searched for and documented the occurrence of burrows, tree cavities, snags and vernal pools (seven vernal pool habitats were identified on the Property). Habitat structure assessments were documented for each habitat type on Wildlife Habitat Evaluation Checklists, which are included in Attachment A of this report.

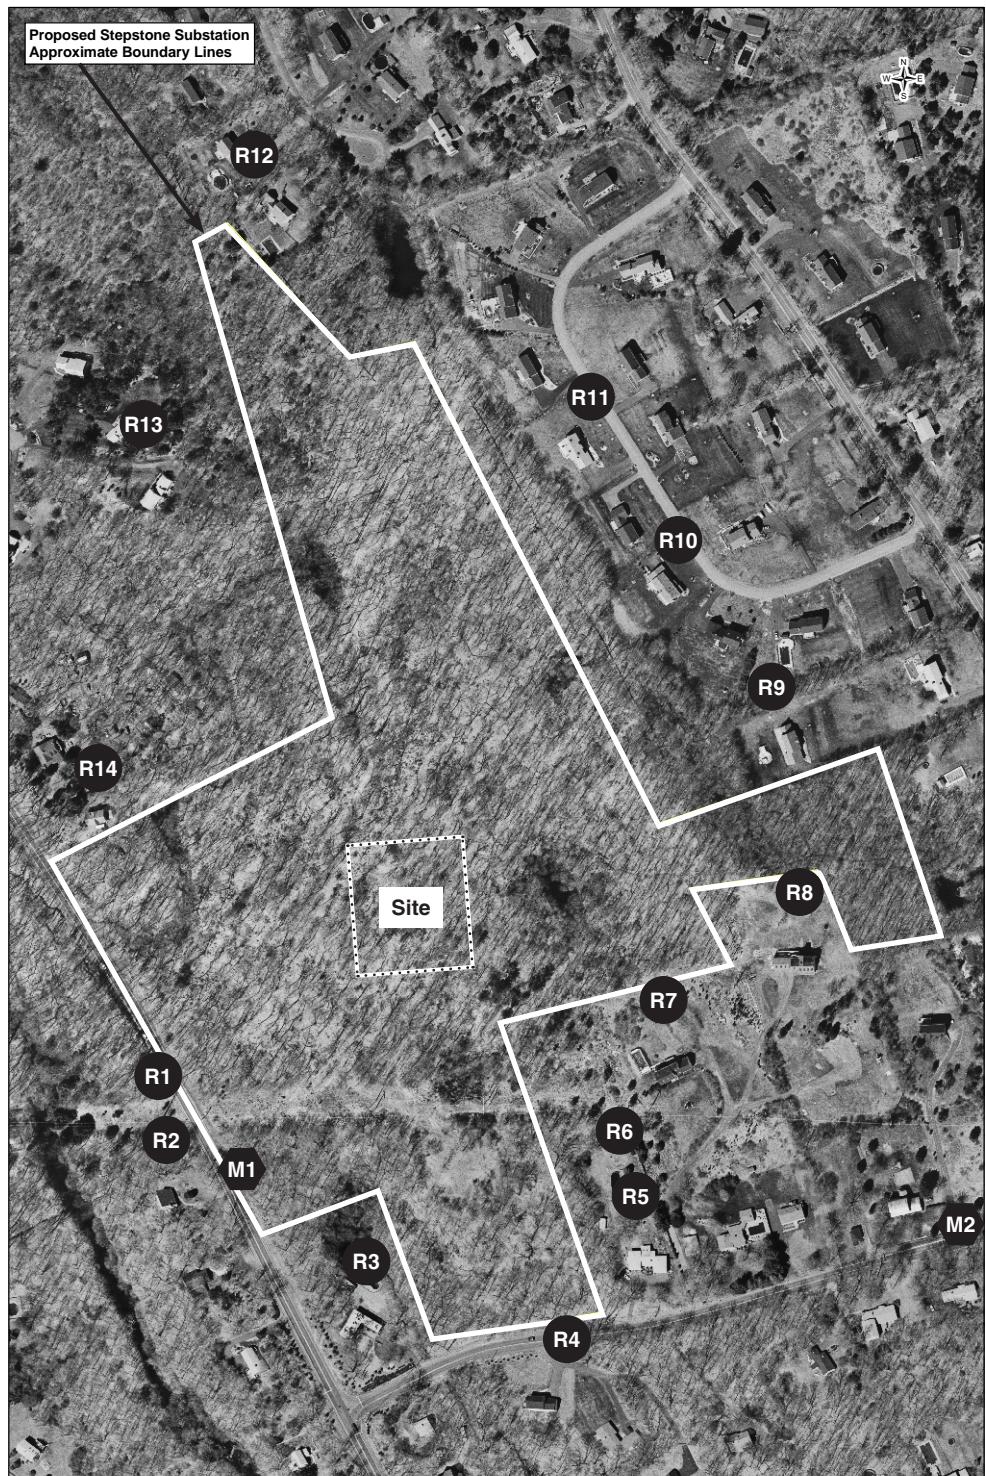
Land use in the vicinity of the Property is predominately residential. The receptor and existing conditions noise monitoring locations used in the noise analysis are presented in Figure 1.

M# Monitoring Locations

R# Receptor Locations

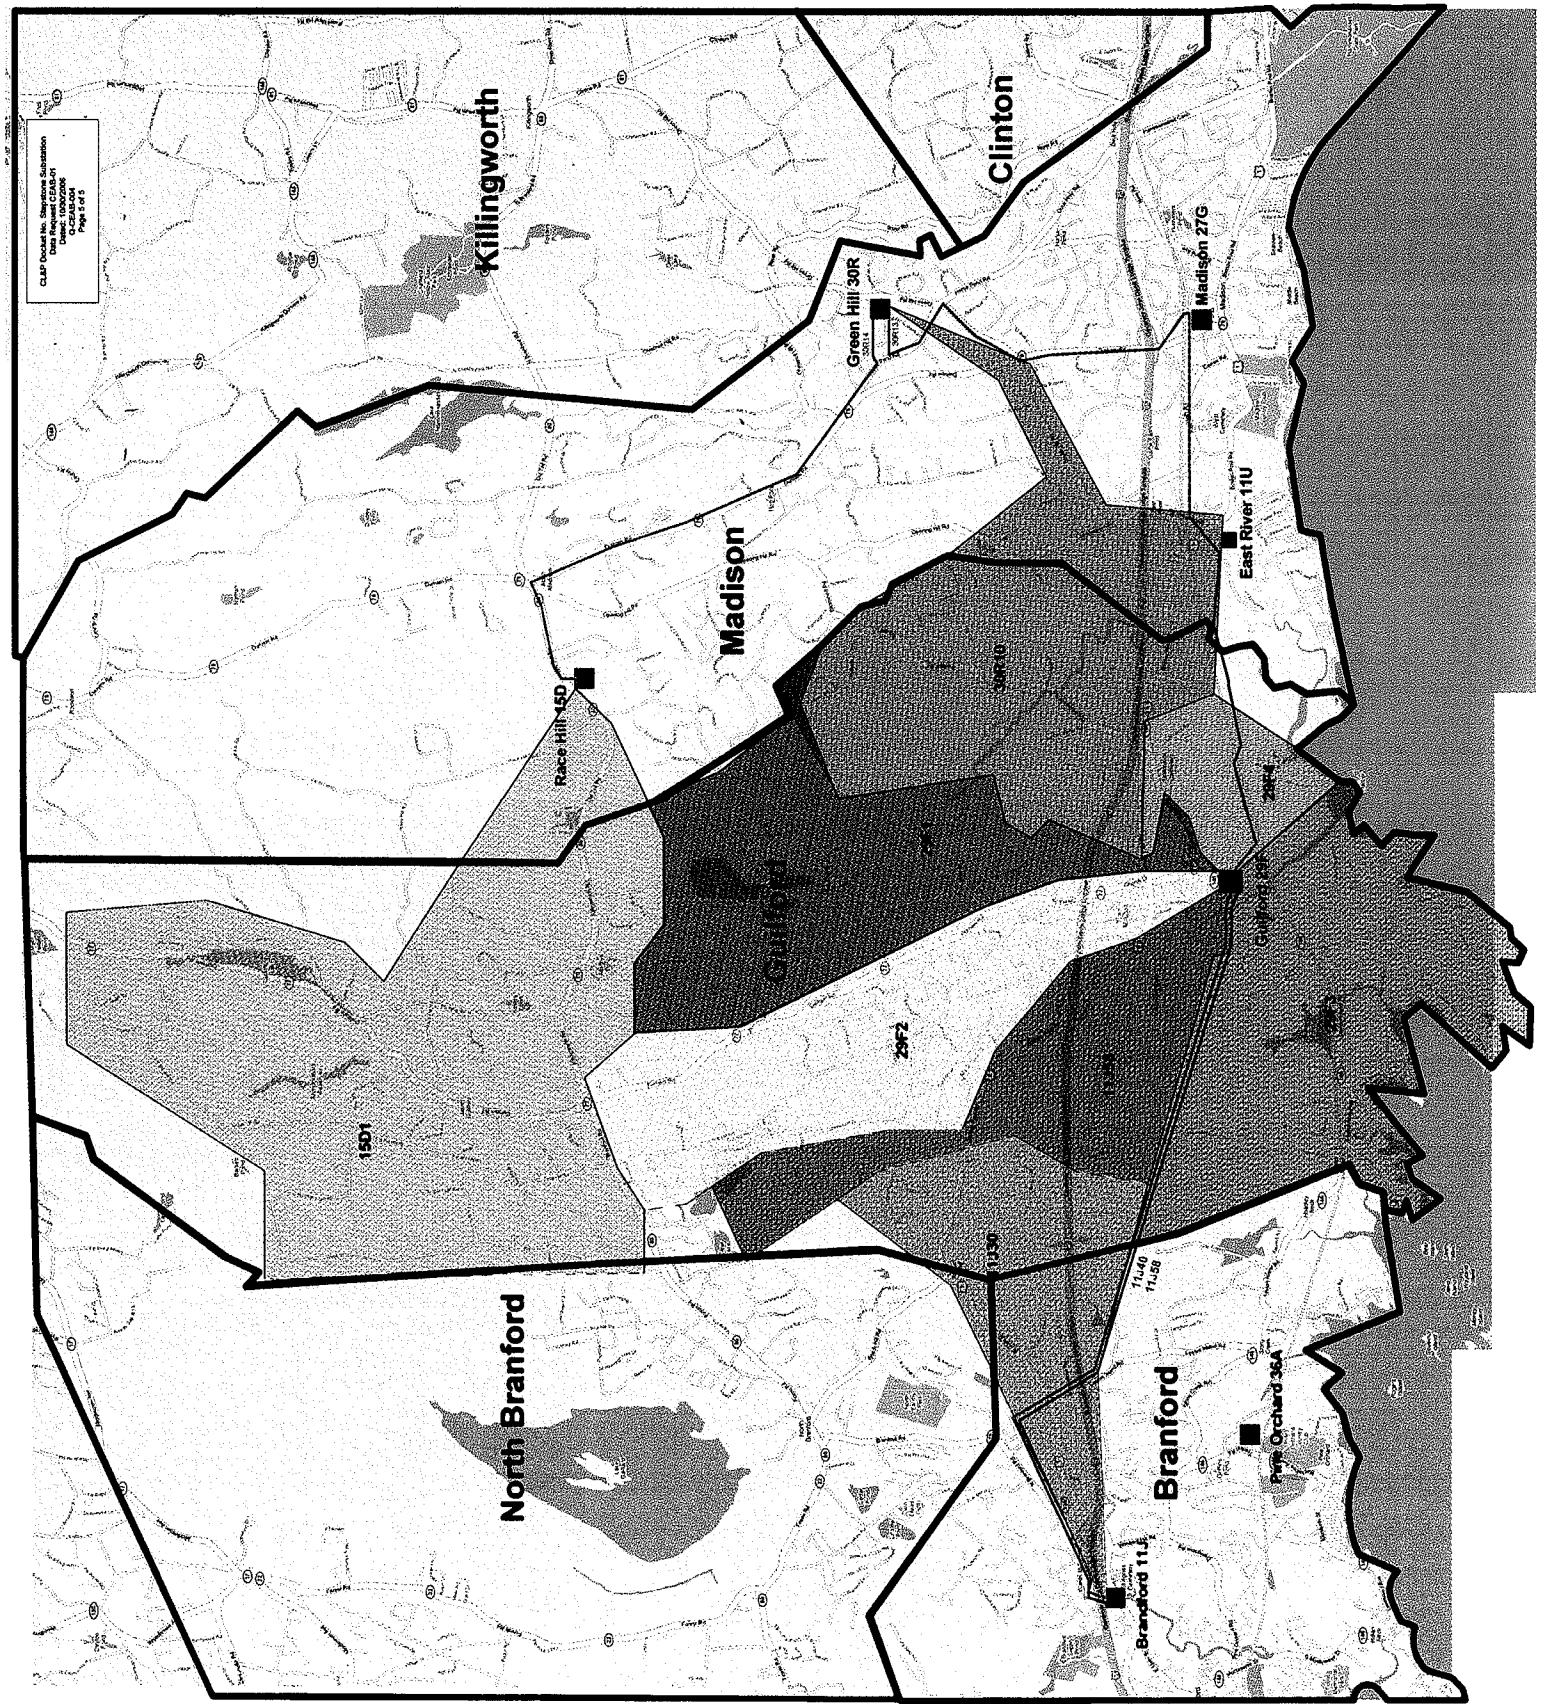
Please see the attached Post-Stepstone Circuit Map.
