Re: **Petition No. 831 - Petition of Waterbury Generation LLC for a
Declaratory Ruling for the Construction of an Electric Generating
Facility and Associated Transmission Line Tap in Waterbury,
Connecticut**

DOCUMENTATION
OF
ANSONIA COPPER AND BRASS, INC., PLANT
WATERBURY, CONNECTICUT

DOCUMENTATION OF ANSONIA COPPER & BRASS COMPANY, INC., PLANT
FORMER HOLMES, BOOTH & HAYDENS COMPANY PLANT

Appendix A - Transmission Line Photos
Waterbury Generation, LLC
Waterbury, CT

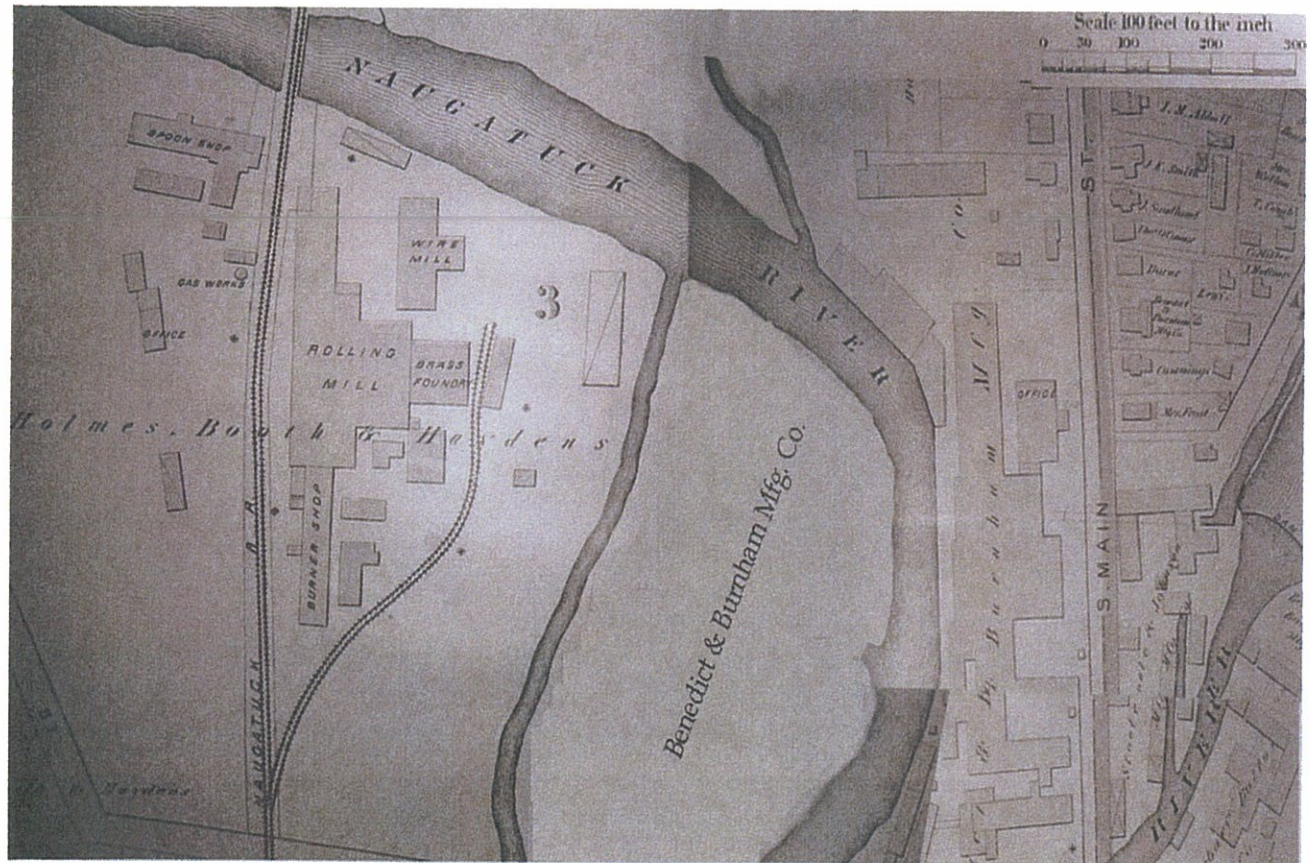
Figure 7. HOLMES, BOOTH & HAYDEN PLANT c1879
(Source: Hopkins)

Plant layout closely matches the view in Figure 6; this is last known image prior to two fires in 1880. Low-lying bend in river between primary and secondary channels is clearly shown.

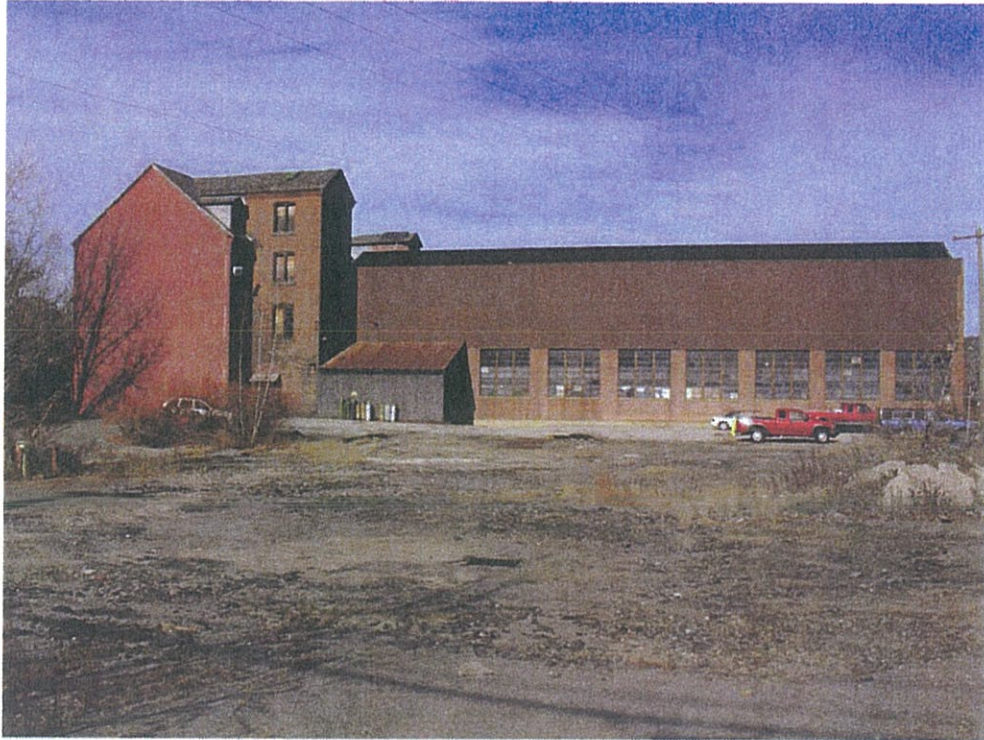
PHOTOGRAPH 1

- 1 View north of south end of main mill (right), loading dock (left center), and truncated end of c1887 factory building (left).
- 2 View northwest of south end of main mill, with stair tower of c1887 factory building (left) and remnant of c1853 foundry now used for office and locker space (right).

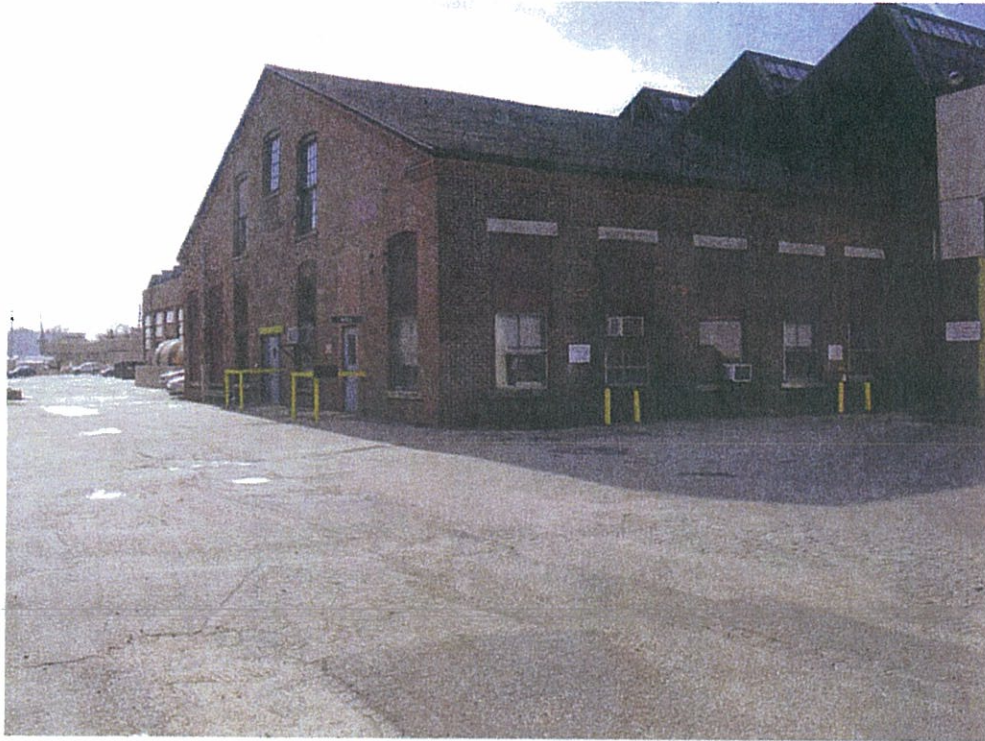
PHOTOGRAPH 5

- 5 View southwest of remnant of c1853 foundry now used for office and locker space.
- 6 View northwest of gable-roofed main mill section which houses extrusion press and induction furnaces.

- On the east side, a portion of the timber-framed, gable-roofed brick foundry survives as a 70-by-56-foot 1-story structure now used for office and locker space. Historical images suggest this section dates to the earliest construction of the mill c1853 (Figures 4, 6-8, 10-13; Photographs 2, 4, 5, 22).

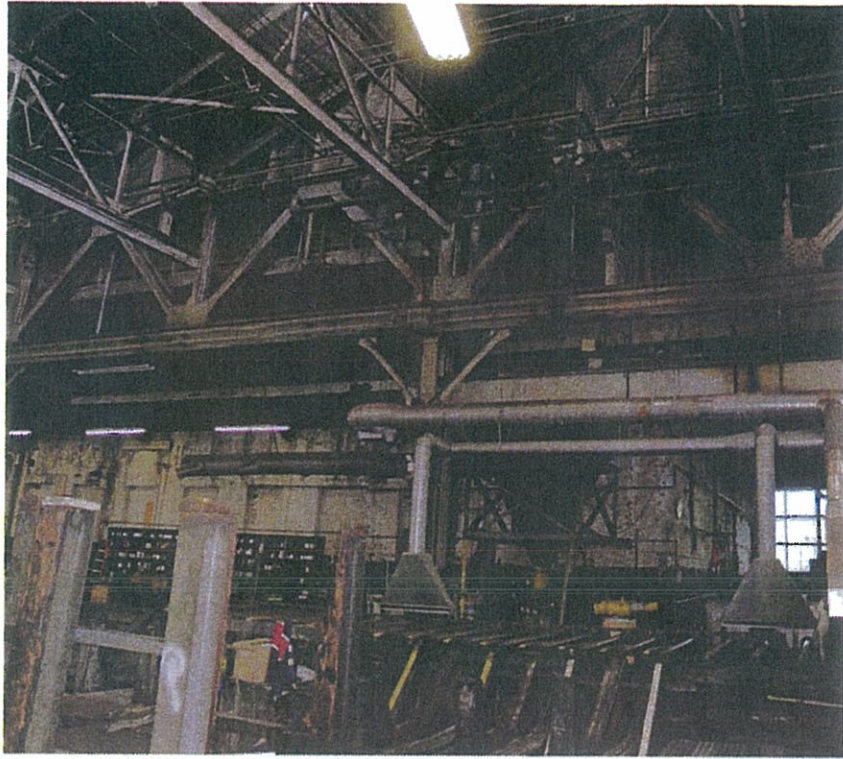
PHOTOGRAPH 21

- 21 View southwest of northeast corner of former exterior wall of c1880 factory, from sawtooth-roofed central bay of main mill.
- 22 View east of truncated end of gable-roofed c1853 foundry building, below sawtooth-roofed east bay of main mill.

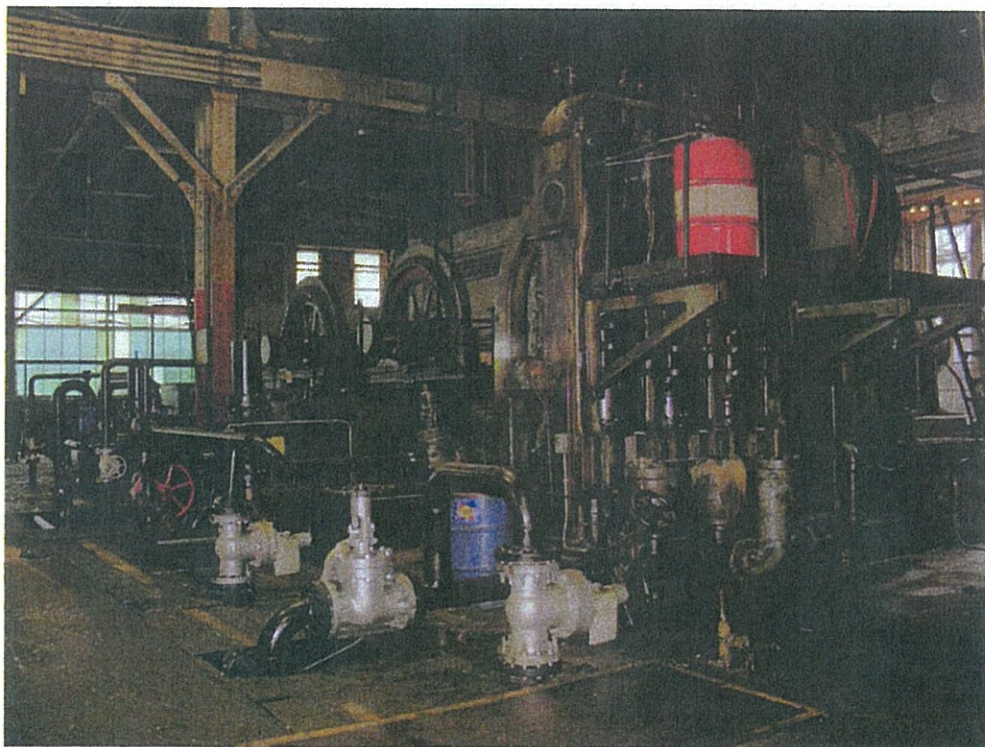
PHTOGRAPH 38

- 38 View northwest of old hydraulic pump (right) with its piping in the foreground. The disused electric motors in Photograph 37 are visible in the background.

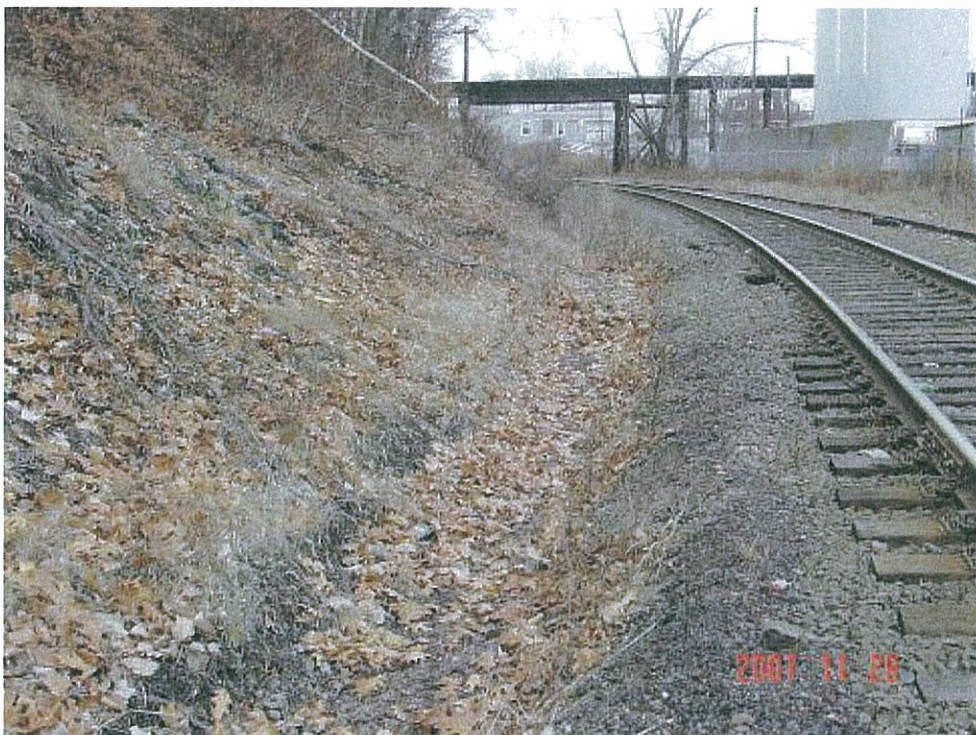
4. Ditch along east side of railroad tracks; view to north

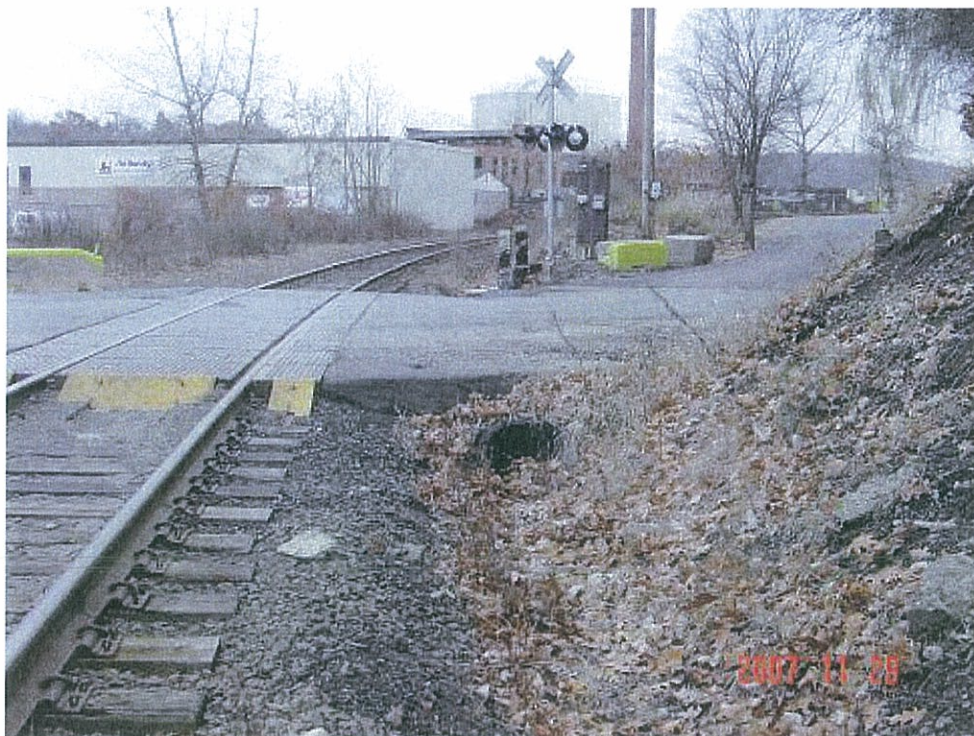
5. Ditch and culvert along local access drive off Railroad Hill Dr.; view to south

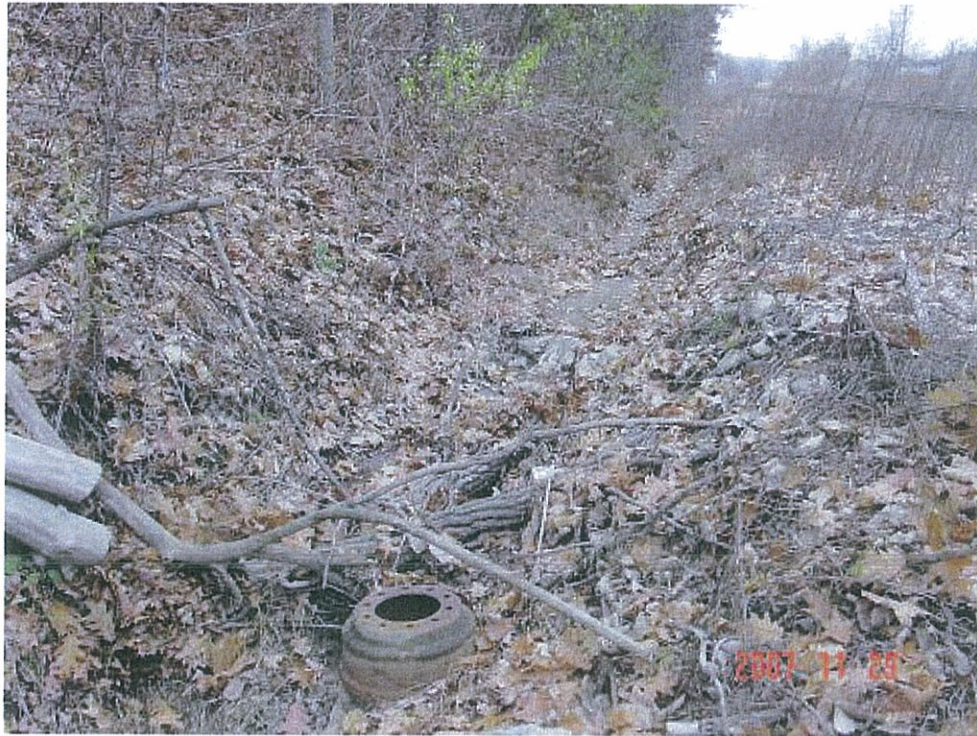
7. Ditch along west side rail tracks; view to north
