**for a Declaratory Ruling for the Location, Construction and Operation  
of a 4.8 MW Wind Renewable Generating Project on Flagg Hill Road in Colebrook,  
Connecticut (“Wind Colebrook South”)**

**Terrestrial Wildlife Habitat & Wetland  
Impact Analysis**

***Wind Colebrook South***

**November 2010**

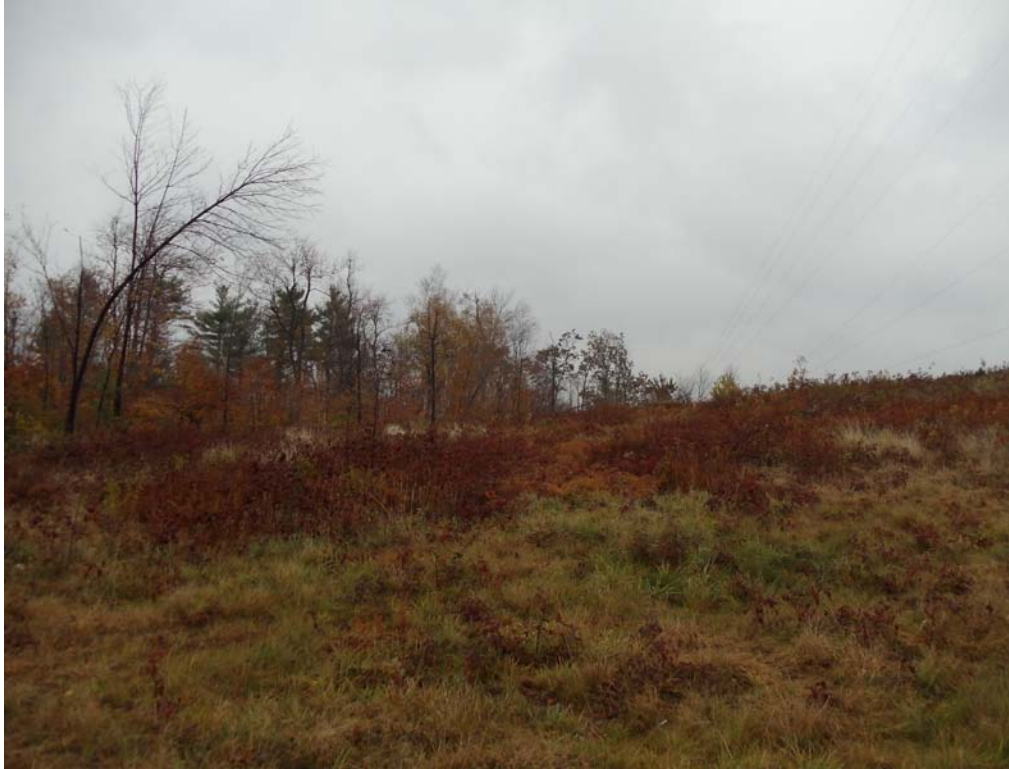
Photo 1: View of recently created early old field meadow habitat.

A recently created hilltop meadow, approximately 3.50 acres in size, is situated in the eastern portion of the Property at the highest elevation. Dominant species observed includes a variety of grasses, *Rubus spp.*, *Solidago spp.*, and New York fern (*Thelypteris noveboracensis*). This area is maintained as a meadow and as such is subject to regular mowing.

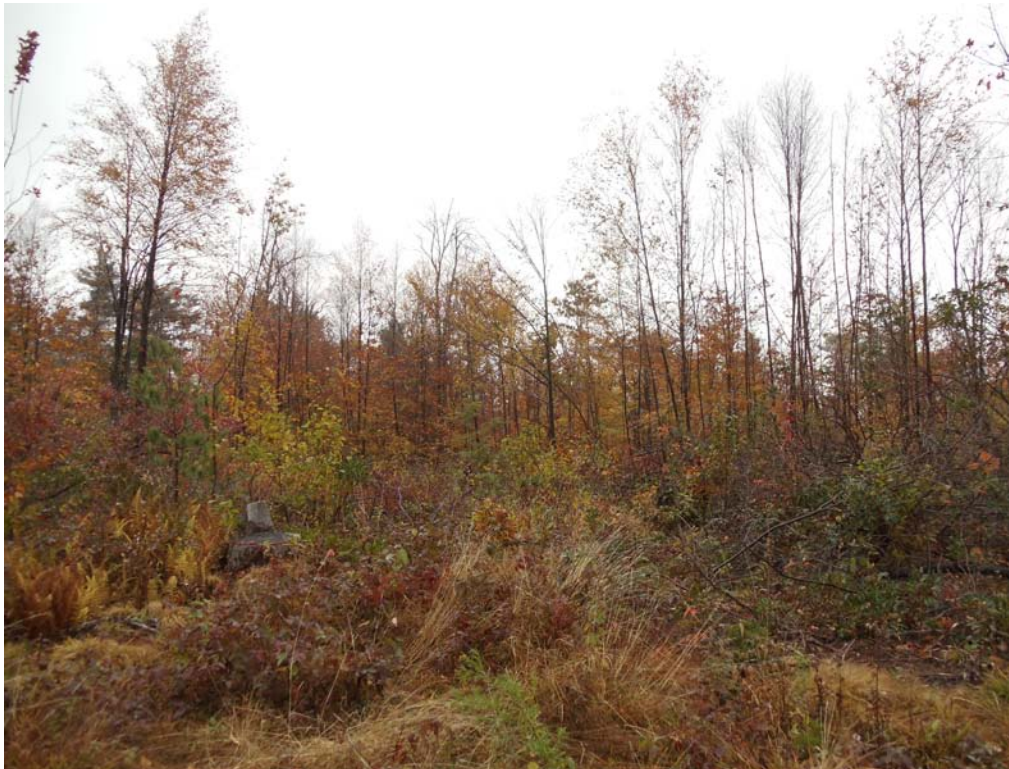
Photo 2: View of early successional forest habitat adjacent to the meadow. This area has been subject to recent and more intensive timber harvesting activities than typical forested areas on the Property.

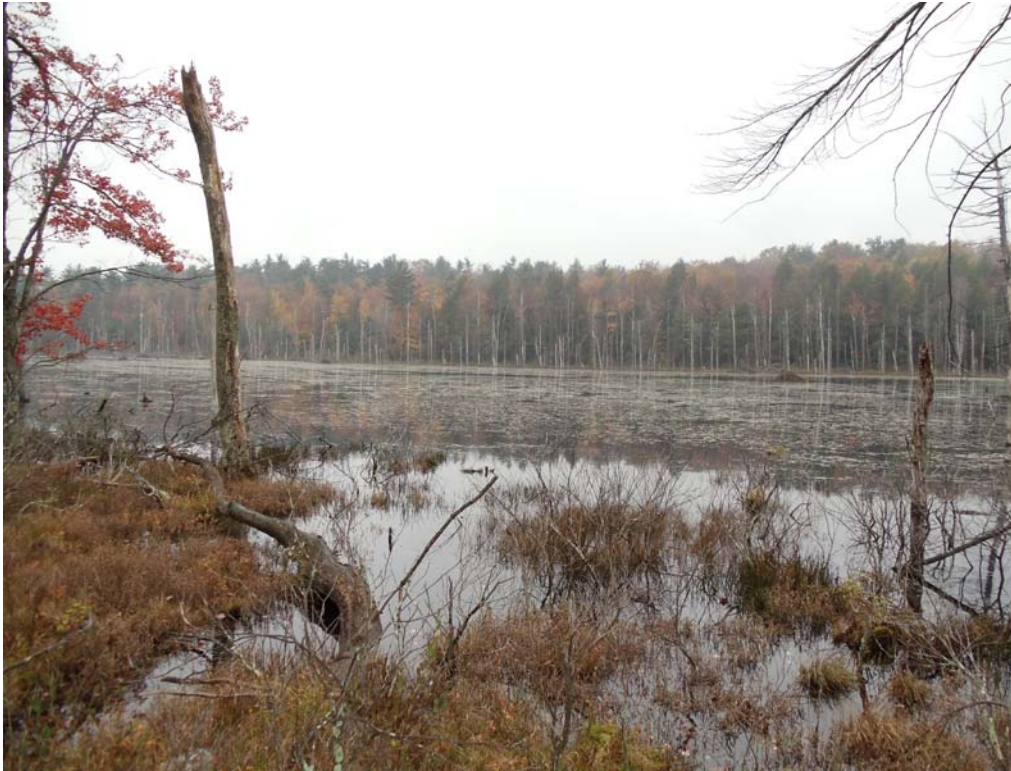
Photo 5: View of the beaver pond looking south/southwest.

A ±6.70-acre beaver pond is centrally located within the Property and is characterized by shallow, open water. The pond contains an abundance of standing dead snags and some occasional basking logs as well as floating-leaved surface plants, which may provide forage for some species. The southeastern side of the pond is fringed by a narrow band of Palustrine Emergent wetlands dominated by various shrubs, *Carex* and *Juncus* species. During January field investigations, the entire pond was frozen over and walkable. Several beaver dams were observed at the southern extent of this pond restricting the outlet to an unnamed perennial watercourse, which flows south from the pond.

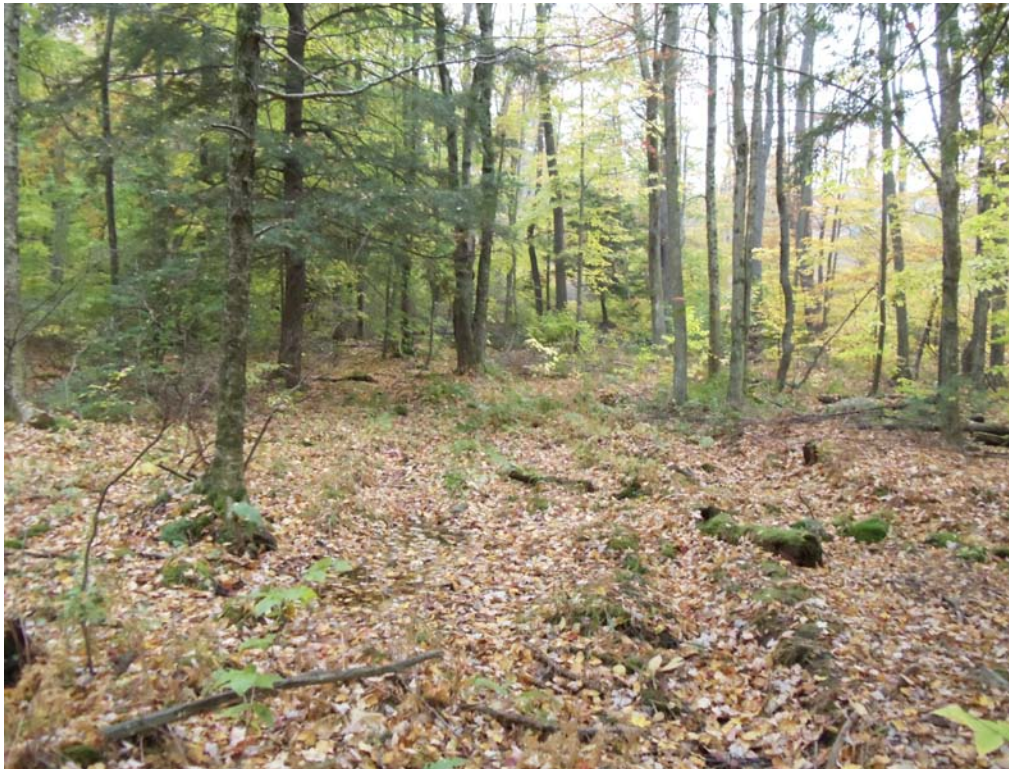
Photo 6: View of the proposed wetland crossing looking west through crossing.
