**Petition of BNE Energy Inc.**

**of a 4.8 MW Wind Renewable Generating Project on Winsted-Norfolk Road in Colebrook,  
Connecticut ("Wind Colebrook North")**

**Terrestrial Wildlife Habitat & Wetland  
Impact Analysis**

## *Wind Colebrook North*

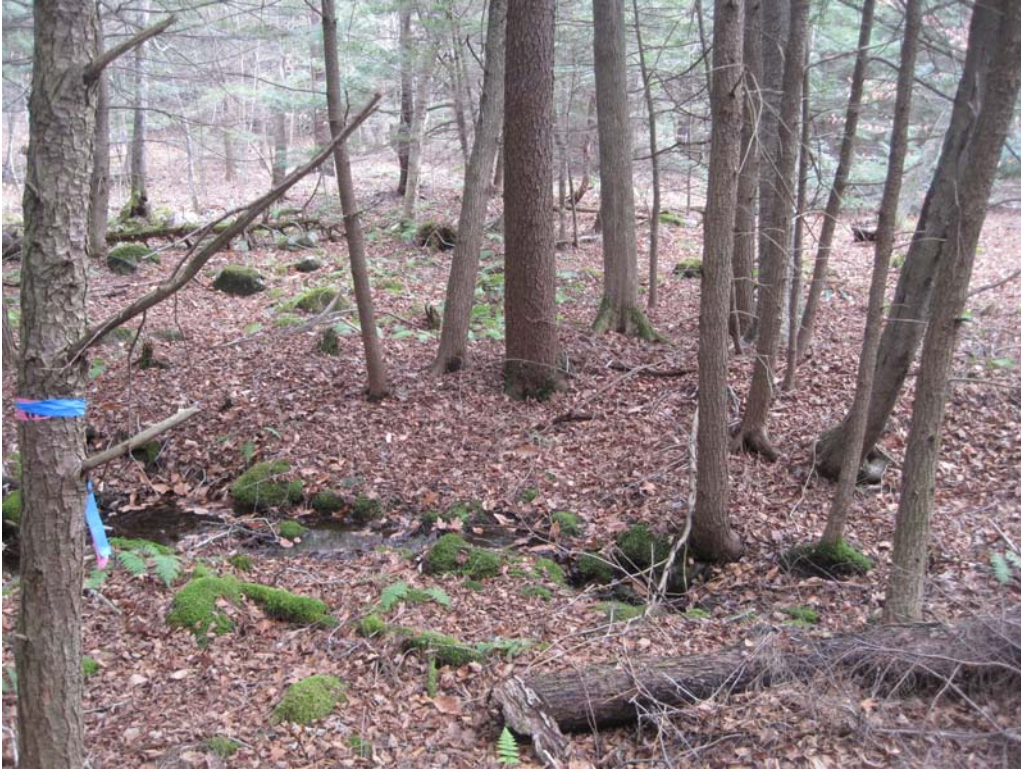
Photo 1: View of approximate location of first of two intermittent watercourse (IWC) crossings looking east. This is the smaller of the two watercourse crossings. Note the right (south) side of the watercourse where the channel terminates and drainage is sub-surface.

The proposed Project would require permanent direct wetland impacts associated with the construction of a gravel access road and intermittent watercourse crossings totaling approximately 3,194 square feet as well as approximately 1,785 square feet of temporary direct impacts related to tree clearing. The wetland area that will be subject to permanent impacts provides Wildlife Habitat and Sediment/Shoreline Stabilization functions at a principal level. By incorporating stream crossing measures as recommended by CTDEP as well as adequately stabilizing the streambanks as described, the proposed gravel access road will not result in a likely significant adverse impact on these functions. Following construction activities, wetland areas subject to temporary disturbance related to clearing will be restored with a variety of native trees, shrubs and herbaceous vegetation.

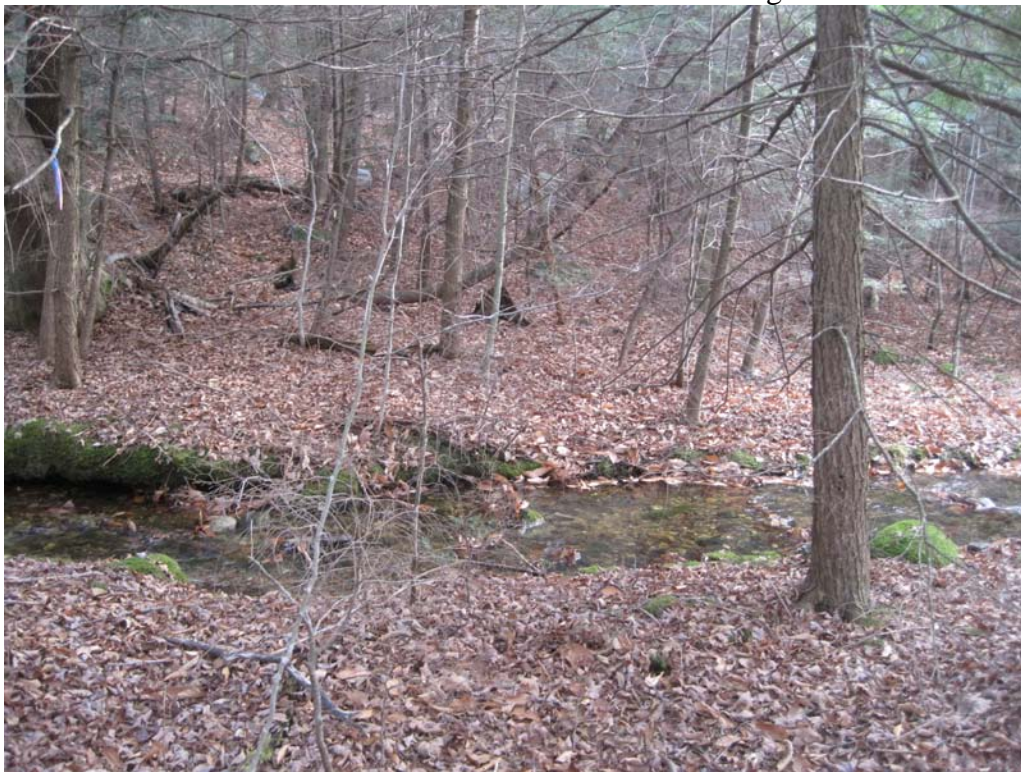
Photo 2: View of approximate location of second of two IWC crossings looking east. This is the larger of the two IWC crossings.

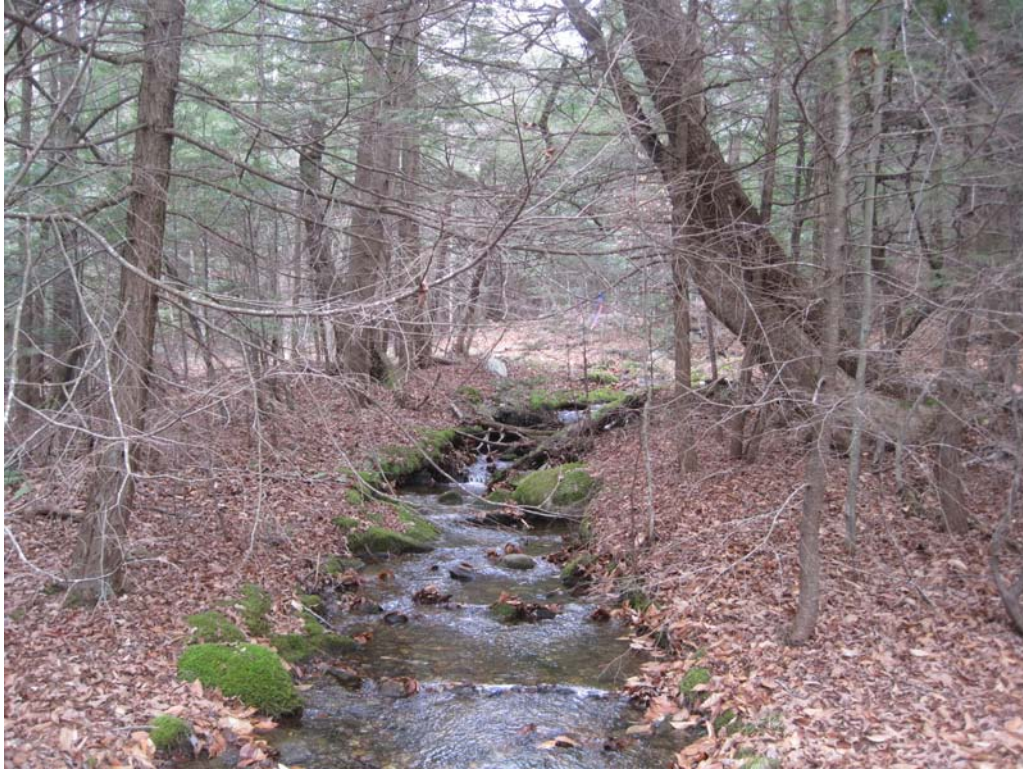
Photo 3: View of larger IWC crossing looking north from the approximate location of the proposed access road crossing.

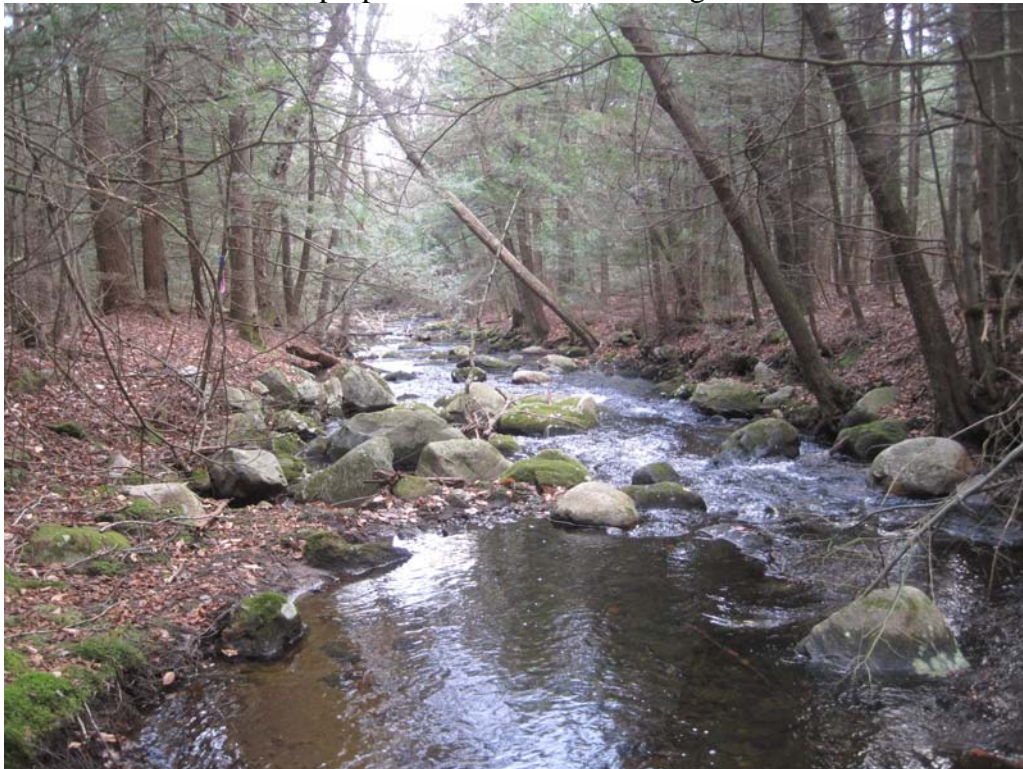
Photo 4: View of Mill Brook.

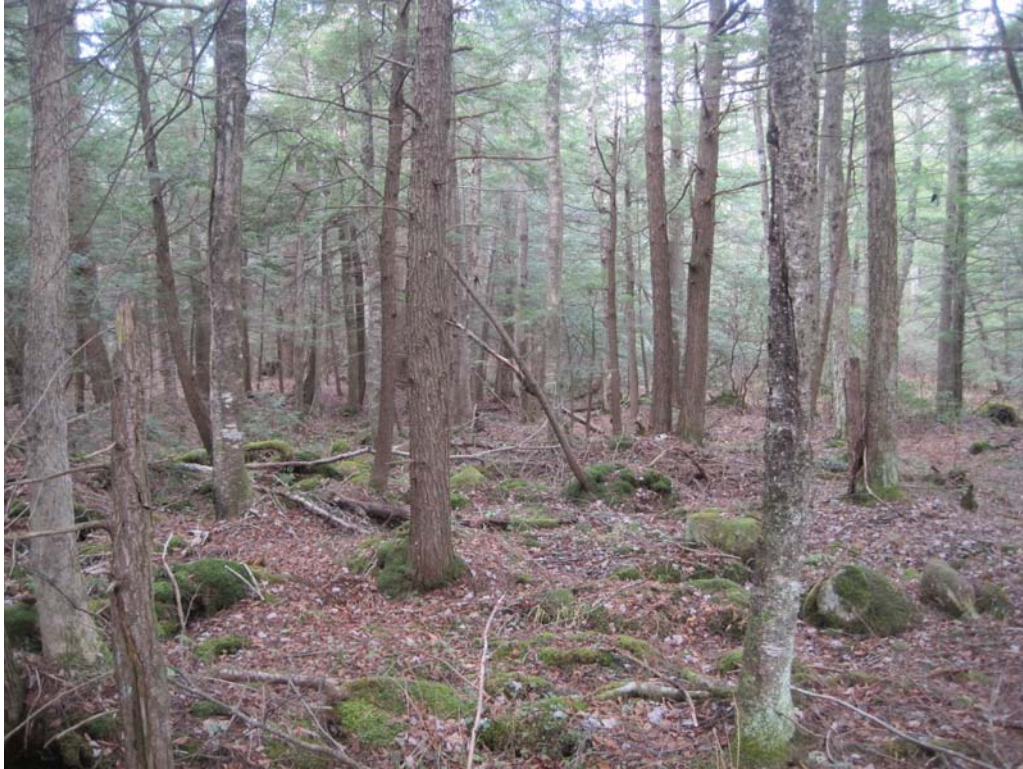
Photo 5: View of typical forested wetland.

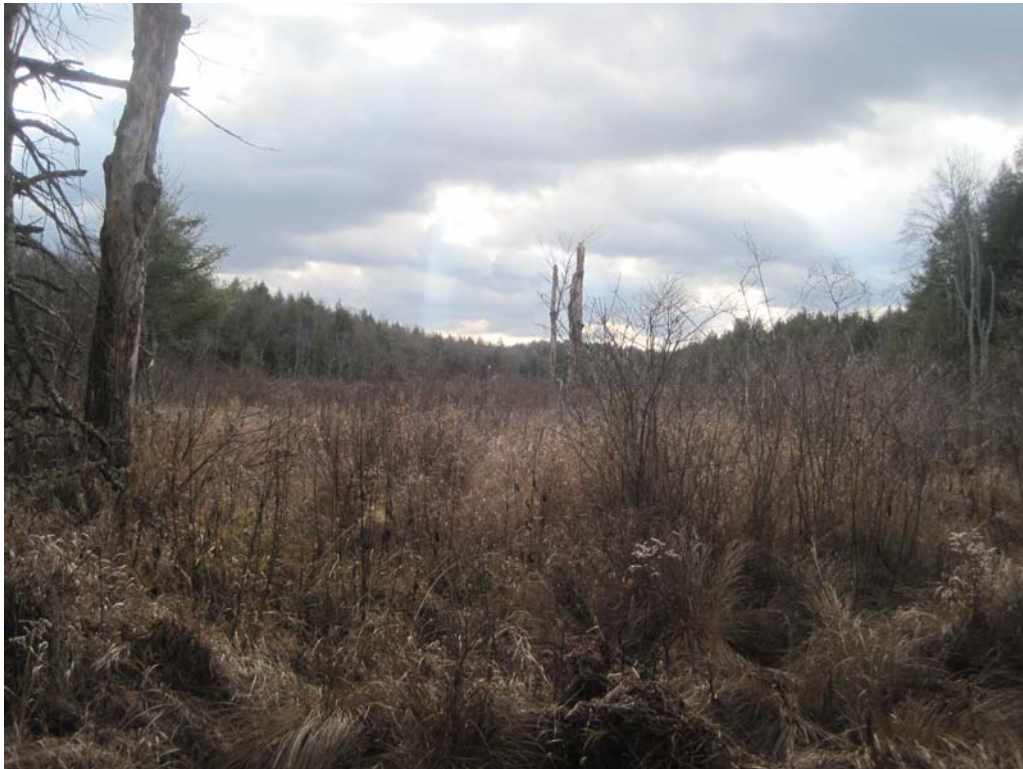
Photo 6: View of shrub swamp along the southern Property boundary.

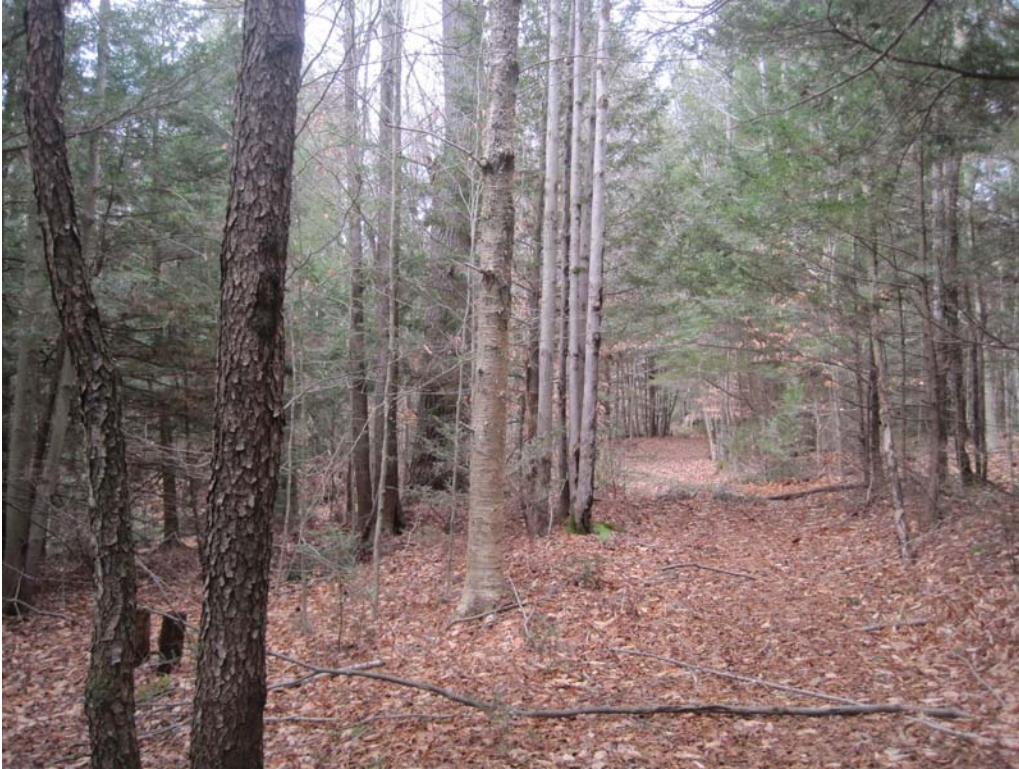
Photo 7: View of typical second growth Northern Hardwoods-Hemlock-White Pine forest type.

The dominant habitat type on the Property is second growth upland forest. The dominant size class is sawtimber (trees 12 inches diameter at breast height [DBH] and greater). The forest type is described as Northern Hardwoods, which is a broadly defined type characterized by enormous variability among the dominant species. Trees associated with a Northern Hardwood Forest type are often shade tolerant species that thrive on moist, fertile soils. The eastern portion of the Property is characterized as a Northern Hardwoods-Hemlock-White Pine forest type dominated by eastern hemlock (*Tsuga Canadensis*). This type is most dominant at lower elevations, adjacent to the Mill Brook wetland complex. At higher elevations, further east on the Property the forest is characterized as a Northern Hardwoods type dominated by deciduous species such as American beech (*Fagus grandifolia*). Beech trees on the Property have suffered from substantial and widespread infestation of beech bark disease. Beech bark disease results when trees are attacked by beech scale (*Cryptococcus fagisuga*) which causes wounding to the bark and ultimately infection from fungi in the genus *Nectria*. Mortality rates due to secondary infection are high. Infested areas of the Property contain numerous beech snags. This area has been subject to selective timber harvesting as evidenced by decayed stumps and widespread logging roads.

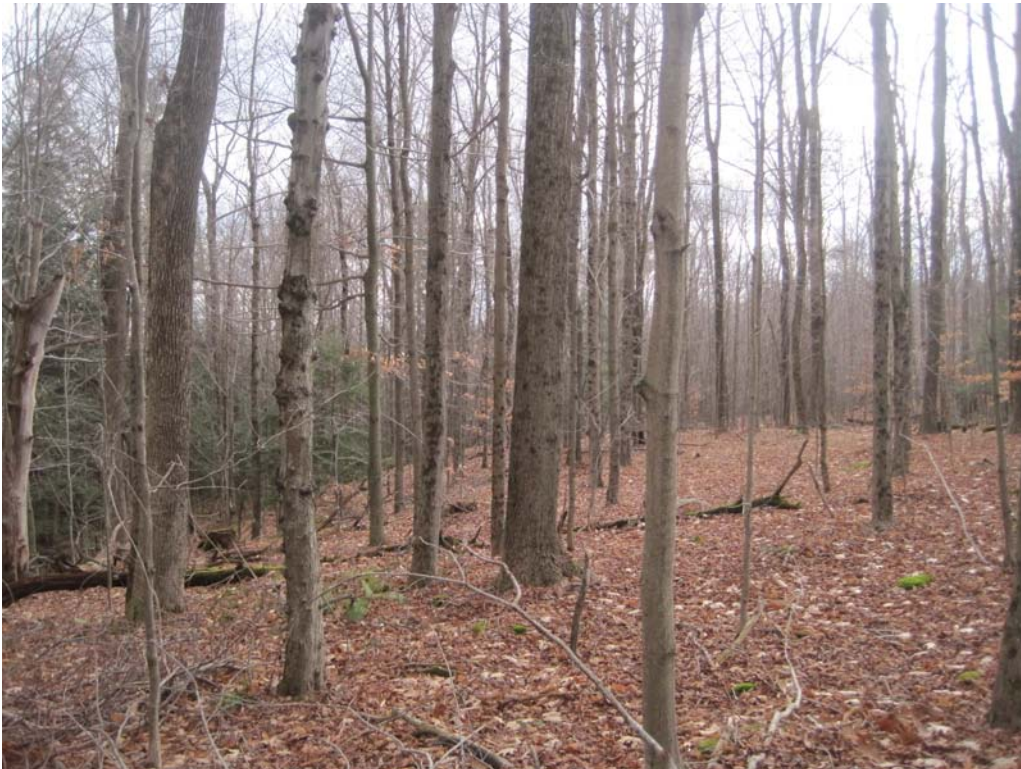
Photo 8: View of typical second growth Northern Hardwood forest type.

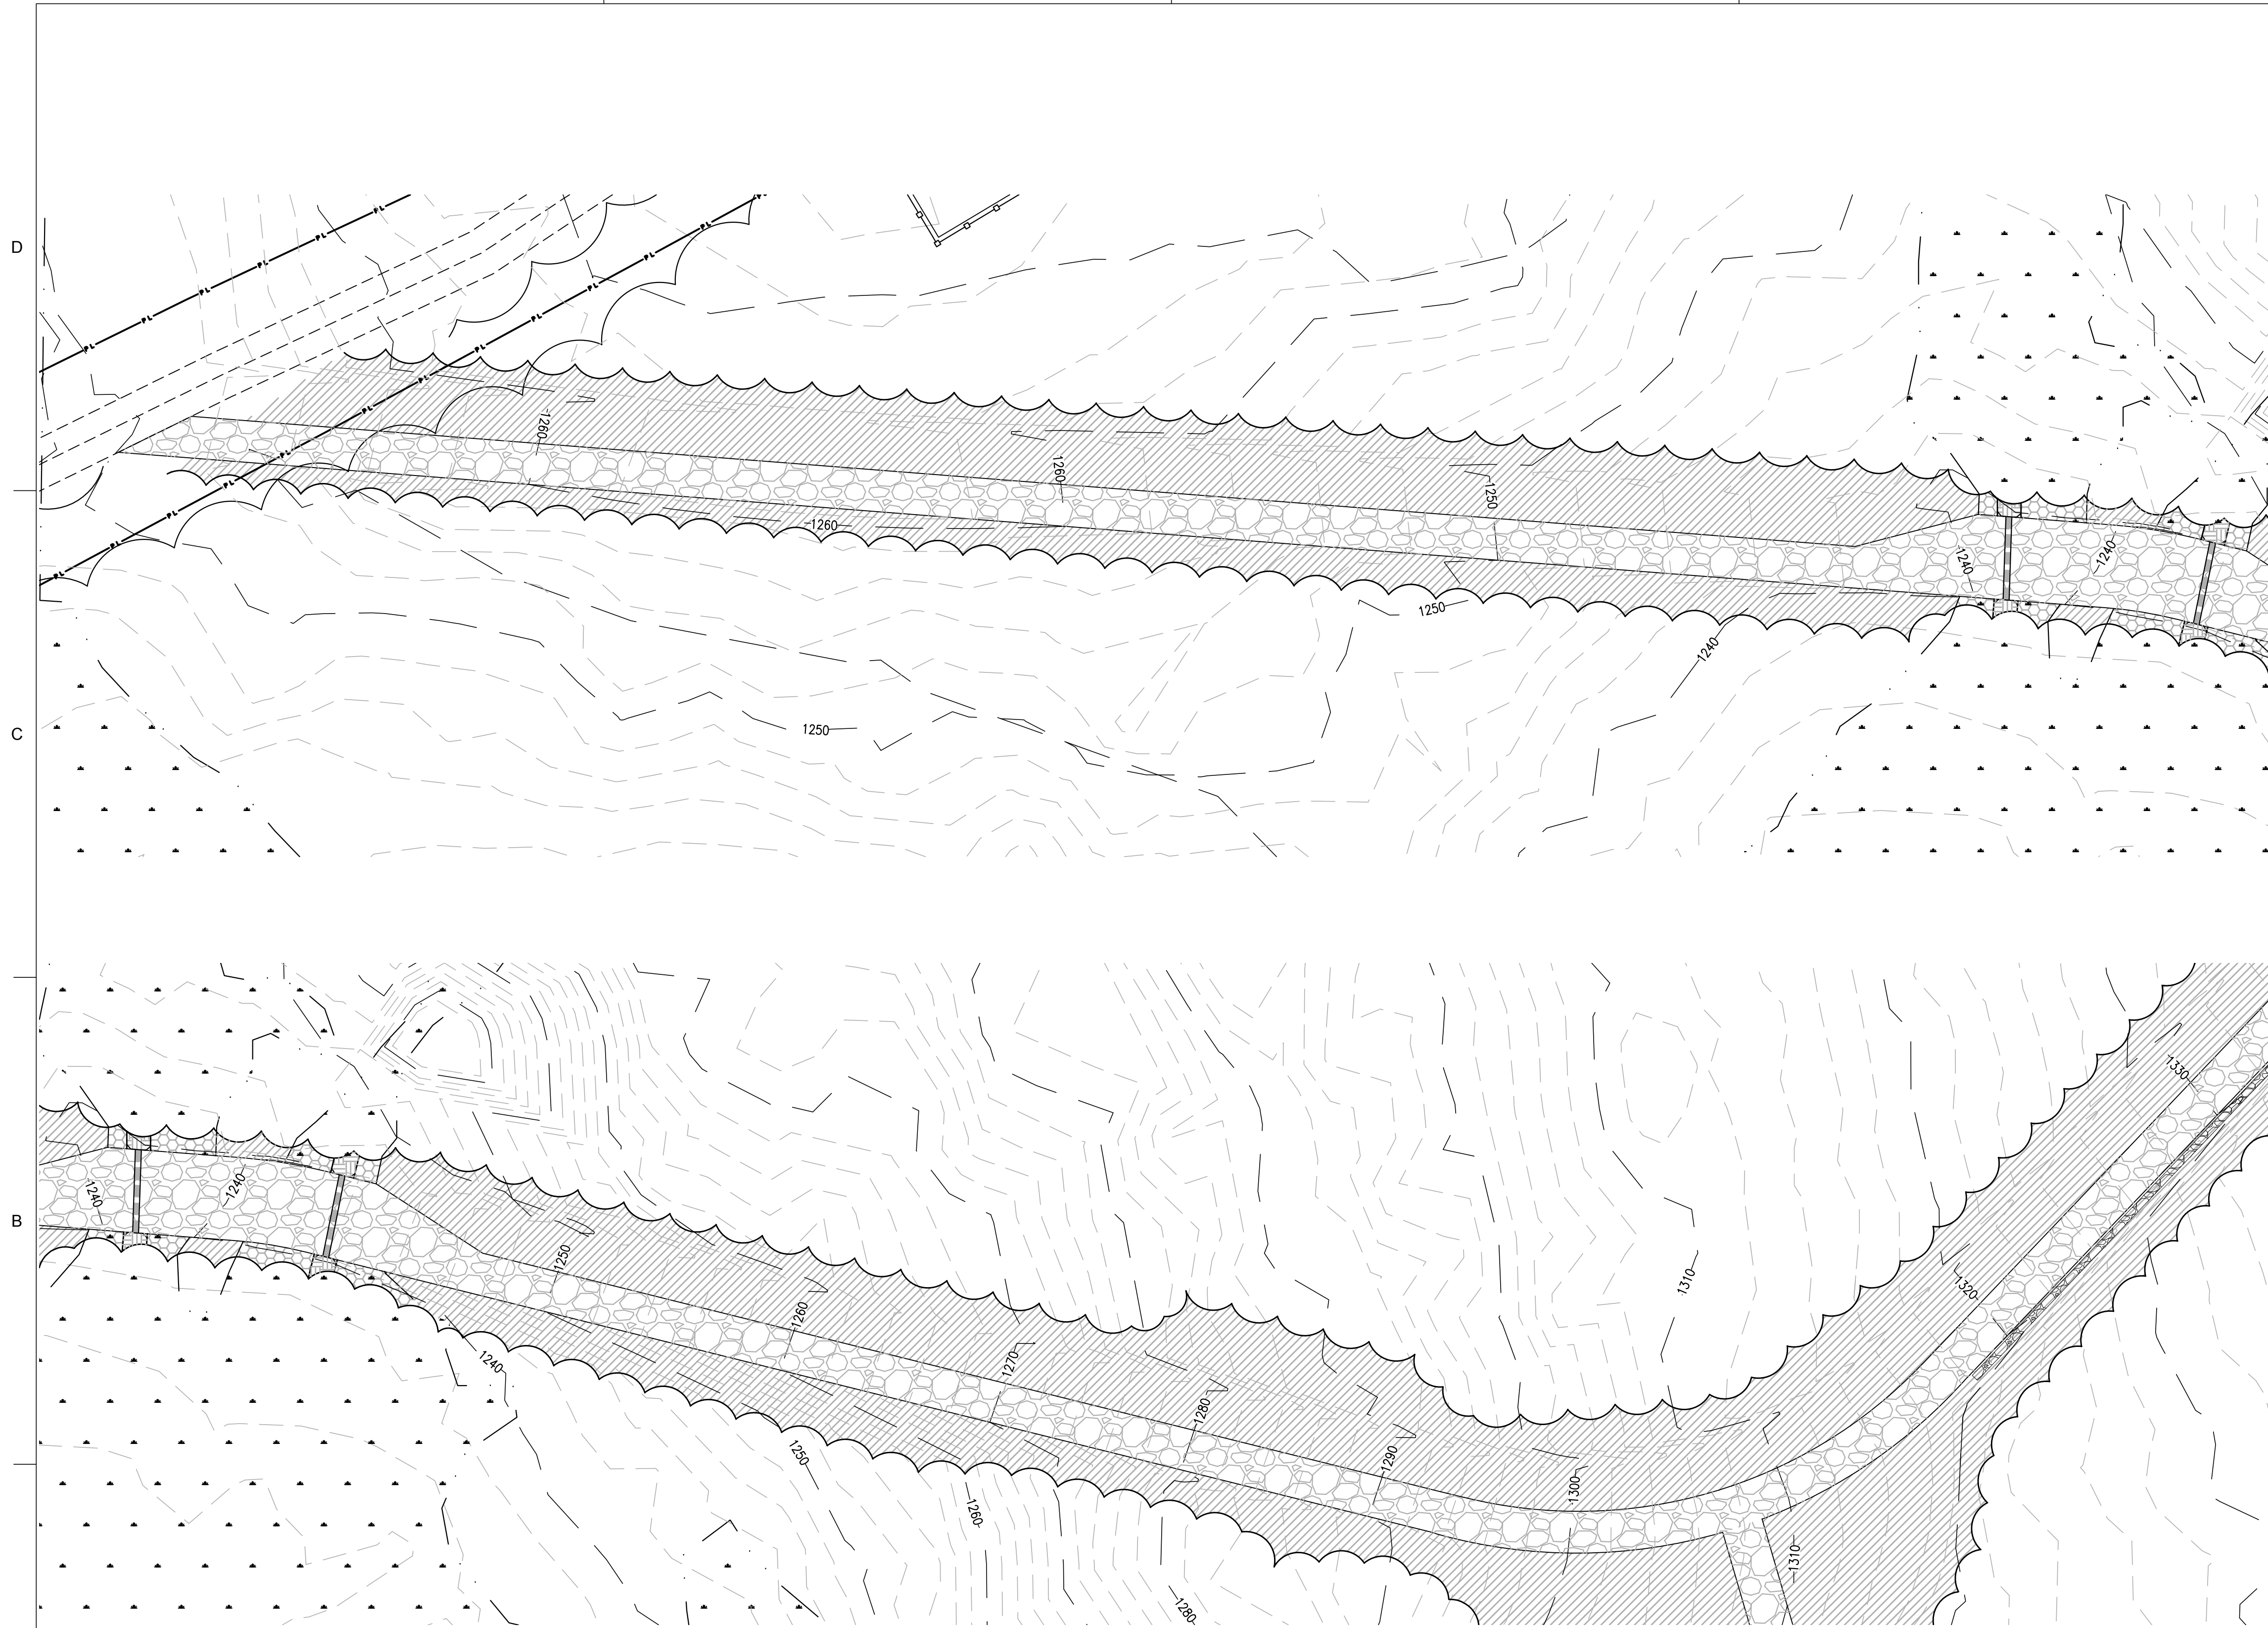
SHEET IDENTIFICATION  
**C-316**

**WETLAND RESTORATION AREA CONSTRUCTION SEQUENCE AND PLANTING SCHEDULE**

1. PRIOR TO ANY EARTHWORK, A SILT FENCE EROSION CONTROL BARRIER WILL BE INSTALLED BETWEEN THE EXISTING WETLAND AND WETLAND RESTORATION AREA.
2. A QUALIFIED WETLAND SCIENTIST RESPONSIBLE FOR THE WETLAND RESTORATION AREA SHALL BE NOTIFIED A MINIMUM OF SEVEN (7) BUSINESS DAYS PRIOR TO ANY PHASE OF THE MITIGATION PROJECT.

WIND COLEBROOK NORTH  
 WINSTED-NORFOLK ROAD  
 COLEBROOK, CONNECTICUT  
 CRANE ROAD STA: 0+00 TO 17+00  
 UPLAND MEADOW CREATION AND RESTORATION  
 AND WETLAND RESTORATION PLAN
