Herpetological Assessment of Colebrook Wind Energy (BNE) Proposed Wind Turbine Sites, a.k.a.
Colebrook North, Rock Hall Road, Colebrook, CT

Prepared for Vanasse, Hangen, and Brustlin in RE: CT Siting Council Petition 984

May 1, 2011

PHOTO DOCUMENTATION
Herpetological Assessment of Colebrook North Wind Generating Project
April 29, 2011

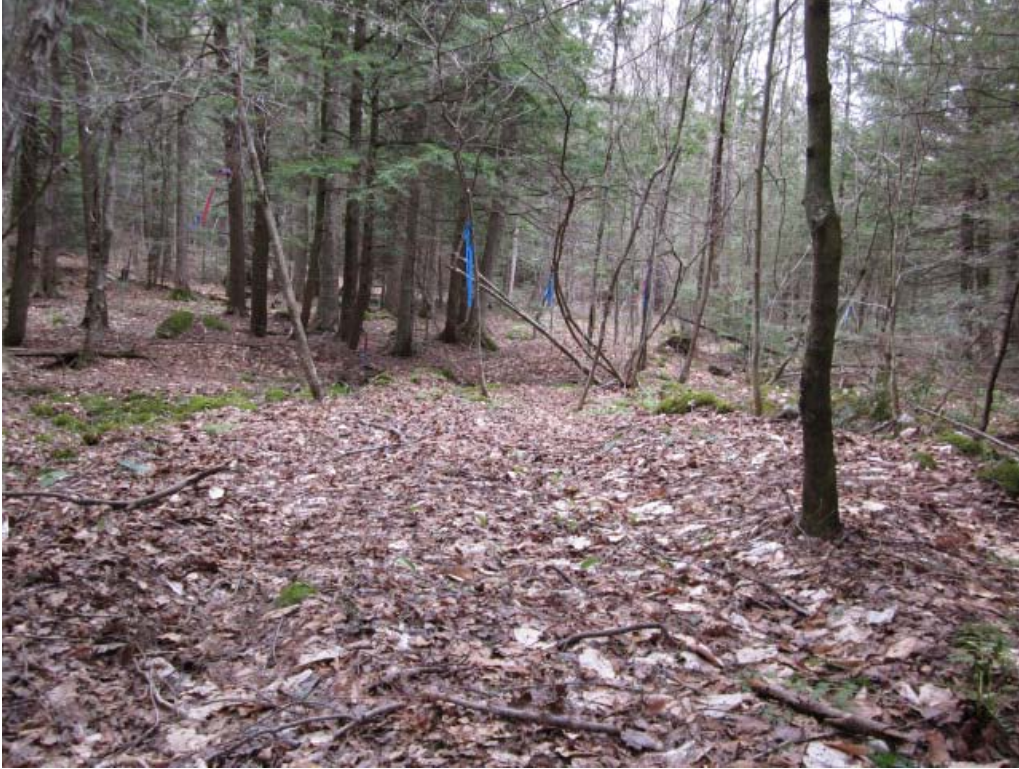
Photo 1: Proposed new watercourse crossing looking south (blue flagging tape marks approximate road center, watercourse is between two flags). This route corresponds to an abandoned woods road which is evidenced by a lack of mature trees, level grade and stones marking the edge of historic fill. The clearing limits associated with the original crossing location are immediately to the right of photo.

Wetland 1 (Mill Brook) is fed by seepage wetlands. The most extensive areas of habitat are on the northern portion of the site and need to be crossed to access Turbines 2 and 3. These areas appear suitable for spring salamanders and both dusky salamanders (*Desmognathus fuscus*) and two-lined salamanders (*Eurcyea bislineata*) were found in these hillside seepage areas. These smaller salamanders are key prey items for spring salamanders, and in the case of the dusky salamander, indicate high quality seepage areas. Dusky salamanders were especially abundant at WF(Wetland Flag) 1-249 and WF 1-368. Dusky salamanders are an indicator of streams able to support spring salamanders. Forest clearing around these seepage areas should be minimized, and the loss of hemlock especially avoided. In order to avoid impacts to this hillside seepage area, I have suggested that the roadway be re-routed about 40 feet upslope onto an old woods road that is relatively level and dry and already has a relatively open canopy of young deciduous trees. This will avoid placing the road and clearing across high quality seepage areas by making use of an abandoned, old, built-up roadbed that already has had the seepage areas around it channelized. This realignment will reduce considerably the loss of mature hemlocks that shade the seepage area where to road was previously aligned through. I met with Curtis Jones of Civil 1 late in the afternoon of April 29th to discuss with him in the field the relocation of the road to protect this potential spring salamander habitat. I also would suggest that the clearing for stormwater basins alongside the road be minimized/eliminated to the maximum extent practical. I believe that Mr. Jones will discuss these plan modifications in his continued testimony before the Siting Council. I am appending to this report two photographs illustrating the road realignment that I am proposing.

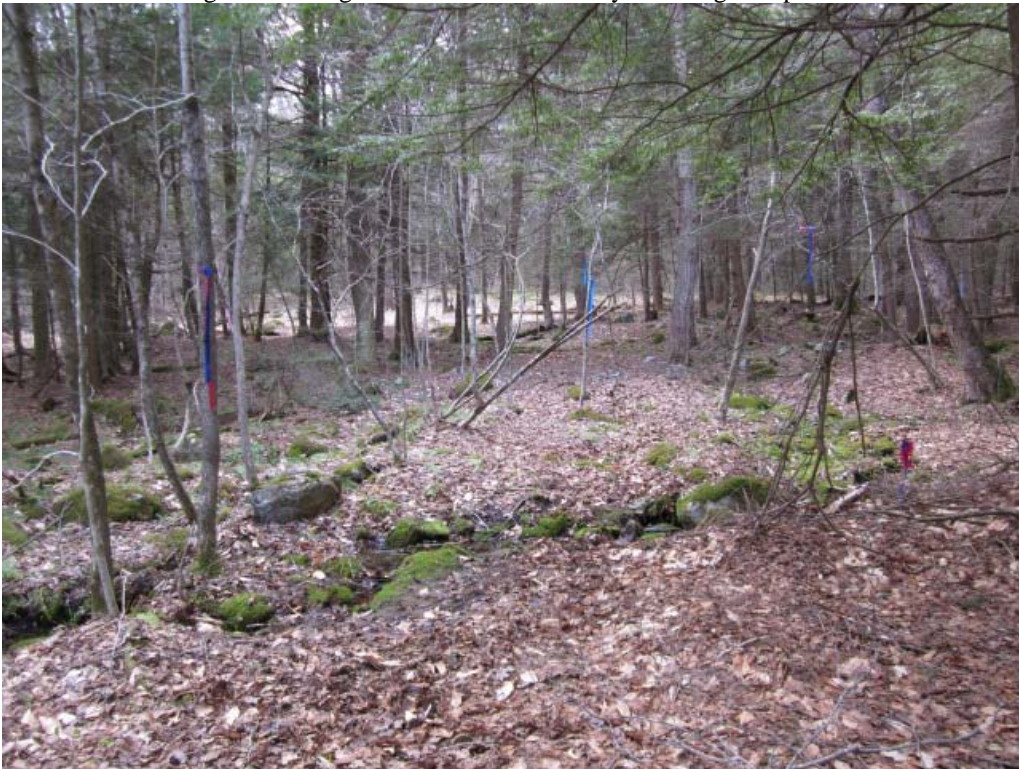
Photo 2: Proposed new watercourse crossing looking north. Intermittent watercourse is in center of photo. The watercourse is conveyed within a narrow, clearly defined channel at this location.
