Re: **EM-VER-082-210715 – Cellco Partnership d/b/a Verizon Wireless  
Telecommunications Facility, 393 Jackson Hill Road, Middlefield, Connecticut**

# Final Report of Inspections

Project: *Verizon Equipment Upgrade Project on an existing Monopole*  
Site Name: **Middlefield South CT** (Location Code: **467144**; Fuze ID: **16244625**)

## Antenna Mount Post-Modification Inspection Report

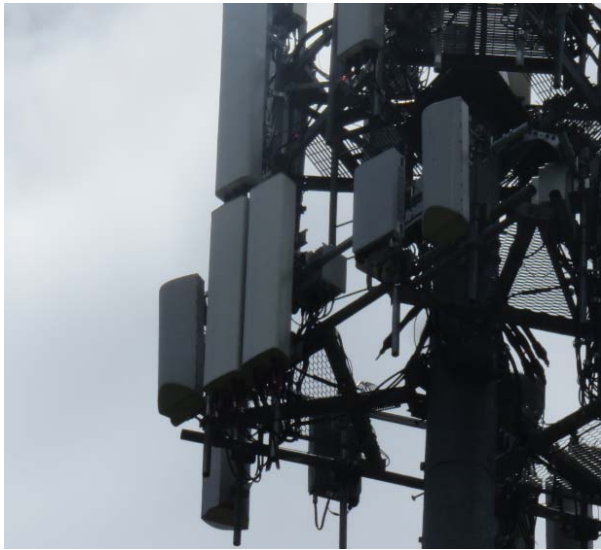
Verizon Sector with new radios

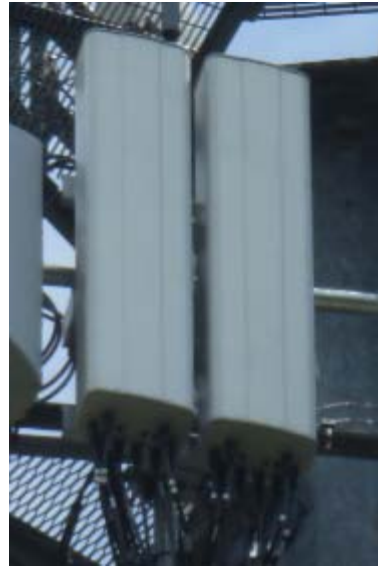
Dual mount panel antennas

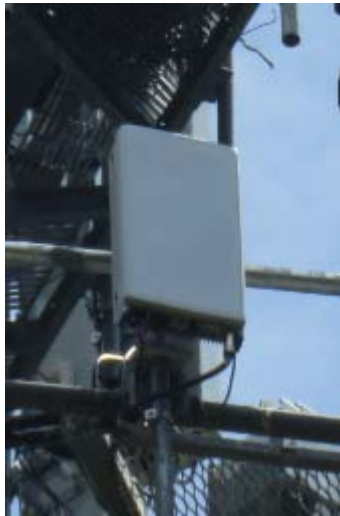
New Verizon Antenna

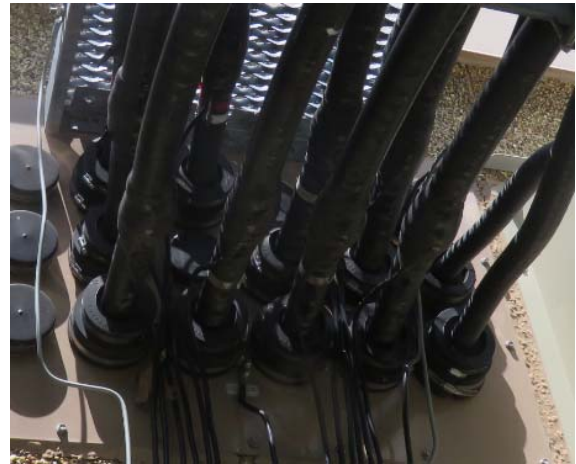
Verizon Cable entry at shelter

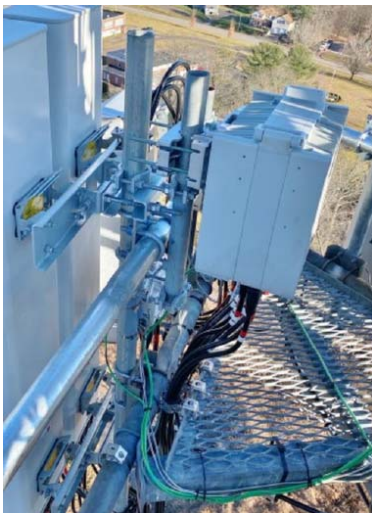
RRH mounted to separate pipe which differs from original design, but is an acceptable installation.

Per our call and your discussion with Derek, the new support rail is at only 2'. This gives insufficient room above the grating for running lines out the bottom. So the RRHs need to straddle over the support rail. To do this, it is proposed to use a 24" to 30" length of P2 STD pipe and two parallel pipe clamps to support a parallel pipe inside the support rail. This is approved and will be saved in our files for reference during the PMI. Let me know if you need anything else.

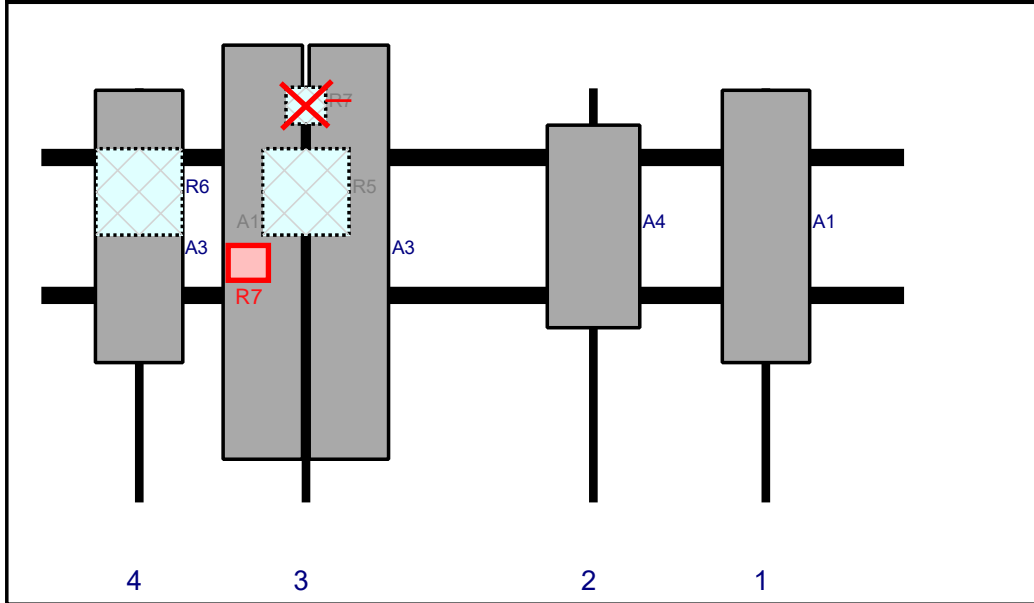
Ref#	Model	Height (in)	Width (in)	H Dist Frm L.	Pipe #	Pipe Pos V	Ant Pos	C. Ant Frm T.	Ant H Off	Status	Validation
A1	LPA-80063/4CF	47.4	15.2	126	1	a	Front	24	0	Retained	02/20/2021
A4	MT6407-77A	35.2	16.06	96	2	a	Front	24	0	Added	
A3	JAHH-65B-R3B	72	13.8	46	3	a	Front	28.5	7.5	Added	
A3	JAHH-65B-R3B	72	13.8	46	3	b	Front	28.5	-7.5	Added	
R5	B2/B66A RRH-BR049	15	15	46	3	a	Behind	18	0	Added	
R7	CBC78T-DS-43-2X	6.4	6.9	46	3	a	Behind	3	0	Added	
A1	LPA-80063/4CF	47.4	15.2	17	4	a	Front	24	0	Retained	02/20/2021
R6	B5/B13 RRH-BR04C	15	15	17	4	a	Behind	18	0	Added
