Post-Mod Antenna Mount Analysis Report and PMI Requirements

SMART Tool Project #: 10073431
Maser Consulting Connecticut Project #: 20777626A

Site ID: 468004-VZW / NEW BRITAIN 3 CT
Site Name: NEW BRITAIN 3 CT
Carrier Name: Verizon Wireless
Address: 167 Lester St
New Britain, Connecticut 06051
Hartford County
Latitude: 41.686211°
Longitude: -72.757042°

Tower Type: 188.0-Ft Monopole
Mount Type: 13.25-Ft Platform

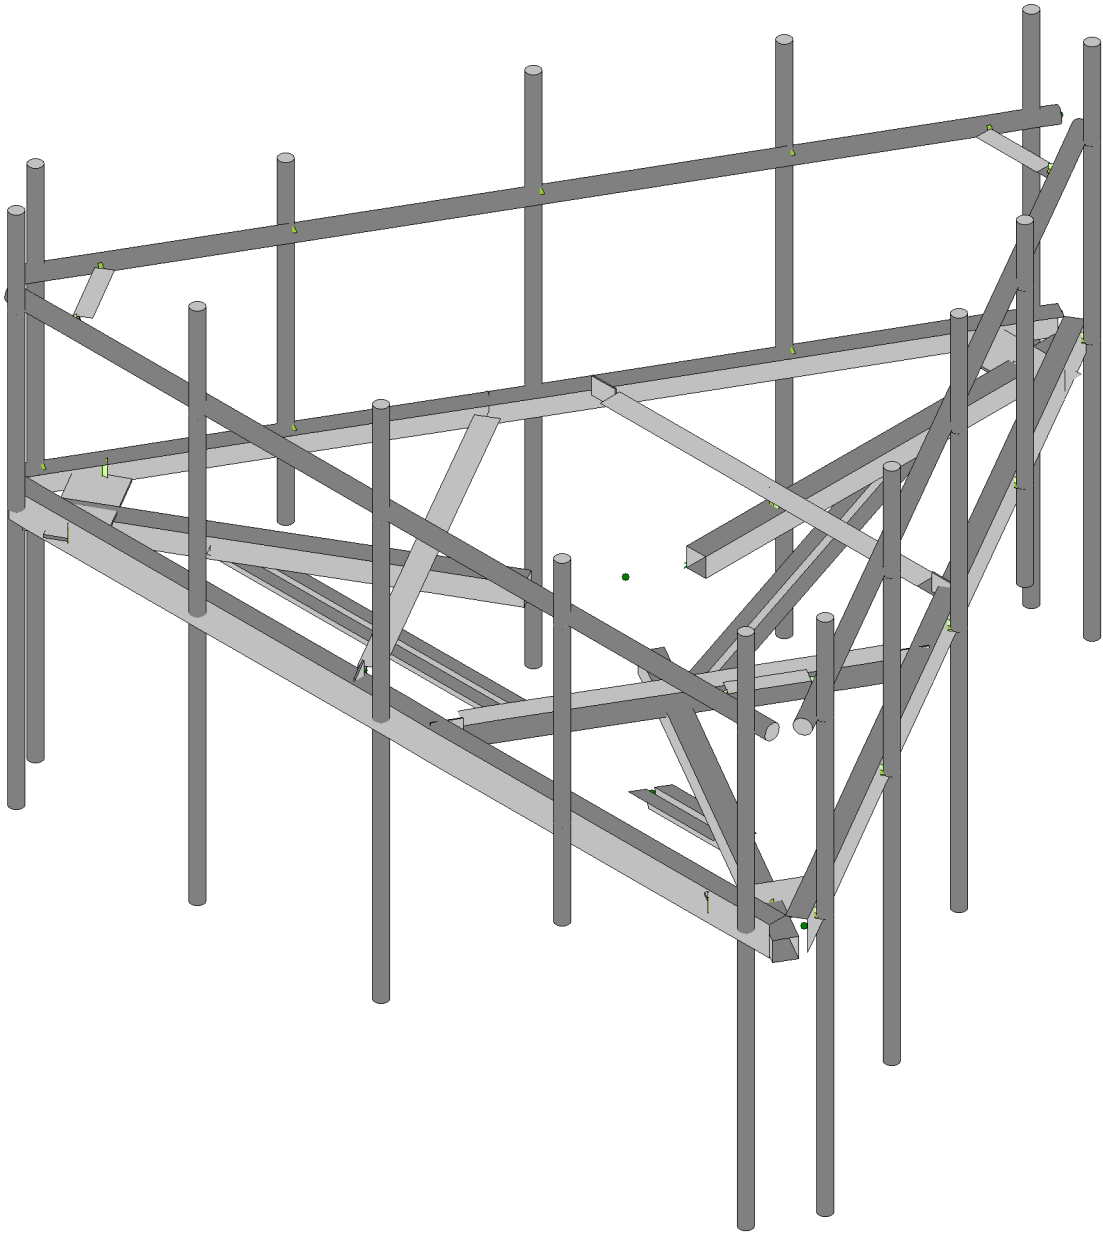
Envelope Only Solution

SK - 1
	468004-VZW_MT_LO_H	May 27, 2021 at 10:54 AM
		LOADED_468004-VZW_MT_LO_H...

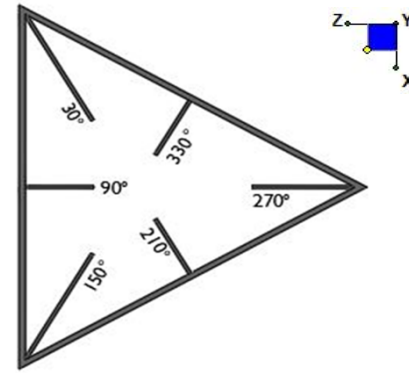
TYPICAL PLATFORM

Nodes (labeled per RISA)	Orientation (per graphic of typical platform)
N26	30
N153A	270
N44	150

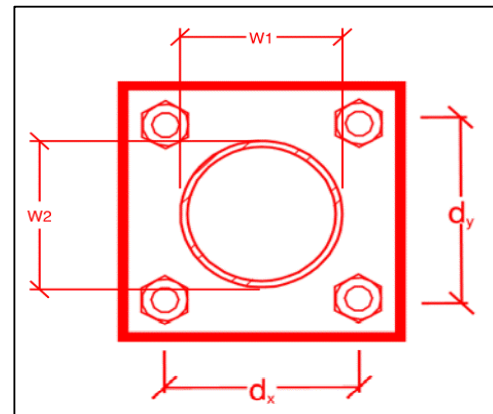
Tower Connection Bolt Checks

yes
4
6.5
6.5
A307
0.625
9.8
4.7
10.0
6.0
24.4%*
19.5%

*Note: Tension reduction not required if tension or shear capacity < 30%

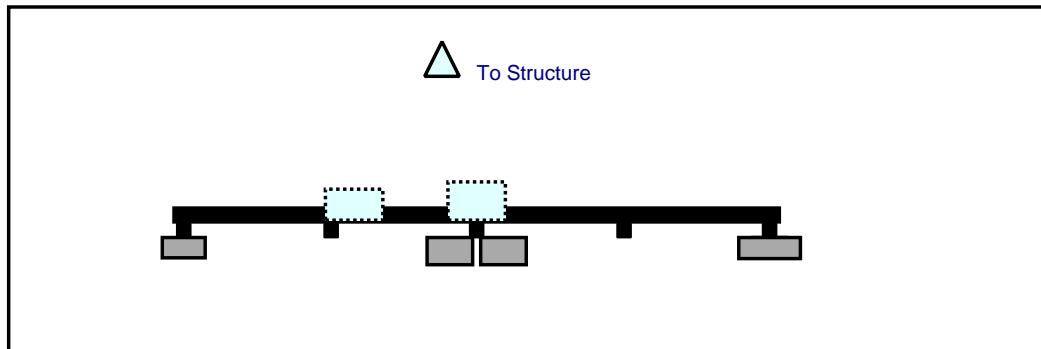
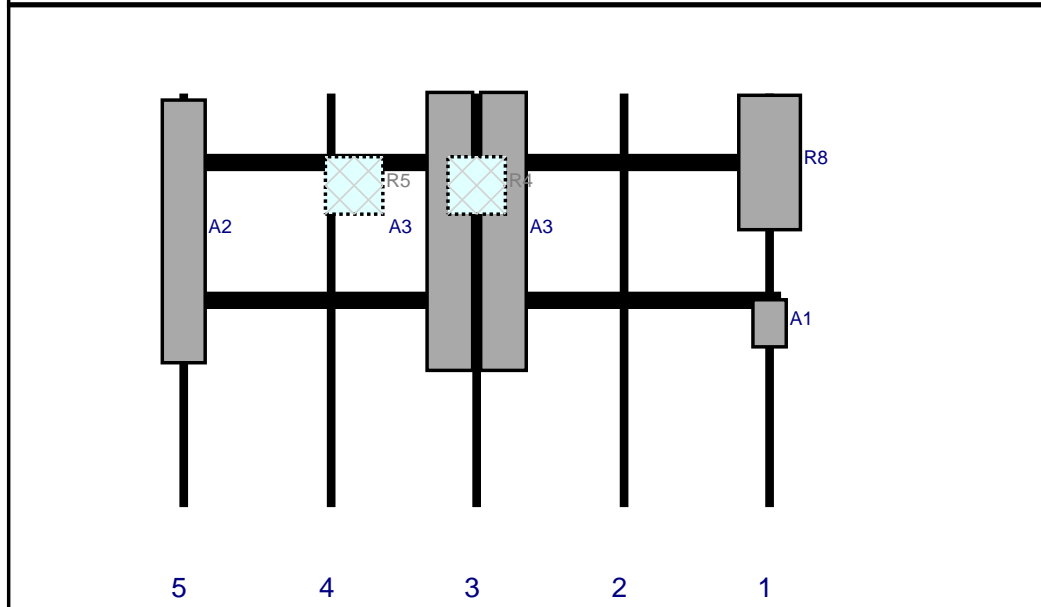
Plan View

Ref#	Model	Height (in)	Width (in)	H Dist Frm L.	Pipe #	Pipe Pos V	Ant Pos	C. Ant Frm T.	Ant H Off	Status	Validation
A1	XXDWMM-12.5-65	12.3	8.7	156	1	a	Front	60	0	Retained	
R8	MT6407-77A	35.1	16.1	156	1	a	Front	18	0	Added	
A3	SBNHH-1D65B	72.6	11.9	79.5	3	a	Front	36	7	Retained	01/16/2021
A3	SBNHH-1D65B	72.6	11.9	79.5	3	b	Front	36	-7	Retained	01/16/2021
R4	B2/B66A RRH-BR049 (RFV01U-D1A)	15	15	79.5	3	a	Behind	24	0	Retained	01/16/2021
R5	B5/B13 RRH-BR04C (RFV01U-D2A)	15	15	41.5	4	a	Behind	24	6	Retained	01/16/2021
A2	BXA-80063-6BF-EDIN-X	68.6	11.2	3	5	a	Front	36	0	Retained	01/16/2021

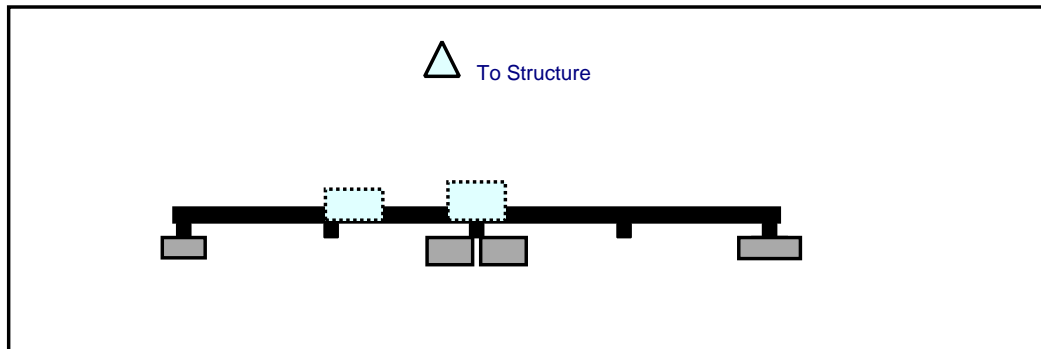
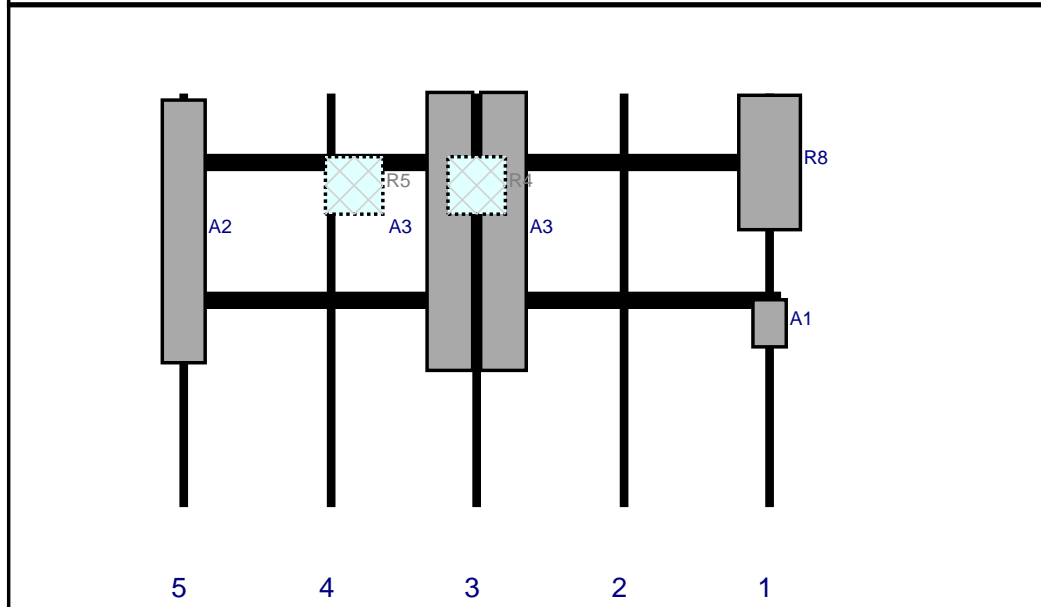
Plan View

Ref#	Model	Height (in)	Width (in)	H Dist Frm L.	Pipe #	Pipe Pos V	Ant Pos	C. Ant Frm T.	Ant H Off	Status	Validation
A1	XXDWMM-12.5-65	12.3	8.7	156	1	a	Front	60	0	Retained	
R8	MT6407-77A	35.1	16.1	156	1	a	Front	18	0	Added	
A3	SBNHH-1D65B	72.6	11.9	79.5	3	a	Front	36	7	Retained	01/16/2021
A3	SBNHH-1D65B	72.6	11.9	79.5	3	b	Front	36	-7	Retained	01/16/2021
R4	B2/B66A RRH-BR049 (RFV01U-D1A)	15	15	79.5	3	a	Behind	24	0	Retained	01/16/2021
R5	B5/B13 RRH-BR04C (RFV01U-D2A)	15	15	41.5	4	a	Behind	24	6	Retained	01/16/2021
A2	BXA-80063-6BF-EDIN-X	68.6	11.2	3	5	a	Front	36	0	Retained	01/16/2021

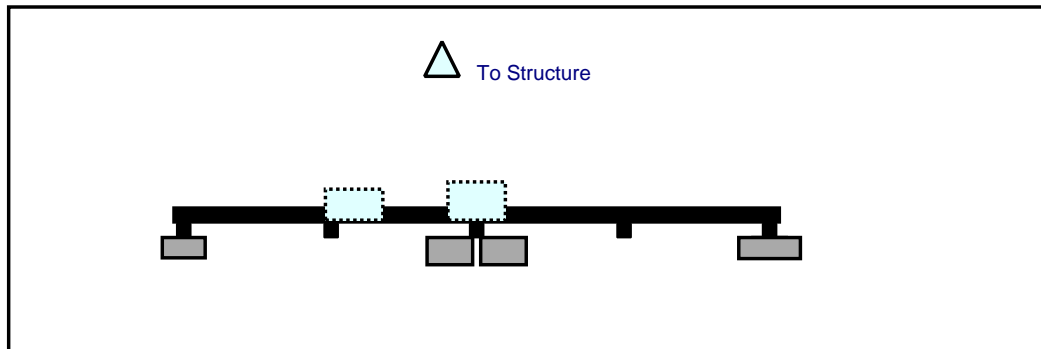
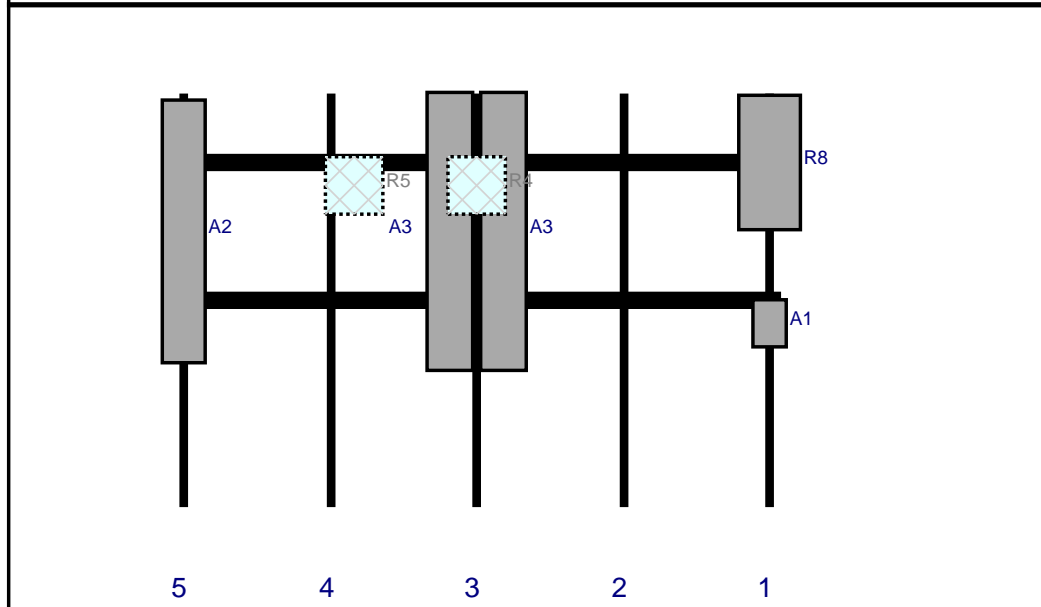
Plan View

Ref#	Model	Height (in)	Width (in)	H Dist Frm L.	Pipe #	Pipe Pos V	Ant Pos	C. Ant Frm T.	Ant H Off	Status	Validation
A1	XXDWMM-12.5-65	12.3	8.7	156	1	a	Front	60	0	Retained	
R8	MT6407-77A	35.1	16.1	156	1	a	Front	18	0	Added	
A3	SBNHH-1D65B	72.6	11.9	79.5	3	a	Front	36	7	Retained	01/16/2021
A3	SBNHH-1D65B	72.6	11.9	79.5	3	b	Front	36	-7	Retained	01/16/2021
R4	B2/B66A RRH-BR049 (RFV01U-D1A)	15	15	79.5	3	a	Behind	24	0	Retained	01/16/2021
R5	B5/B13 RRH-BR04C (RFV01U-D2A)	15	15	41.5	4	a	Behind	24	6	Retained	01/16/2021
A2	BXA-80063-6BF-EDIN-X	68.6	11.2	3	5	a	Front	36	0	Retained	01/16/2021
