Re: **SUB-PETITION NO. 1293 - BMM-01 (Berlin, Middletown and Middlefield)** – Eversource Energy declaratory ruling that no Certificate of Environmental Compatibility and Public Need is required for all transmission facility asset condition maintenance improvements statewide to comply with the updated National Electrical Safety Code clearance requirements.

PHOTOGRAPHIC LOG

Client Name: Eversource

Site Location: Middletown, CT

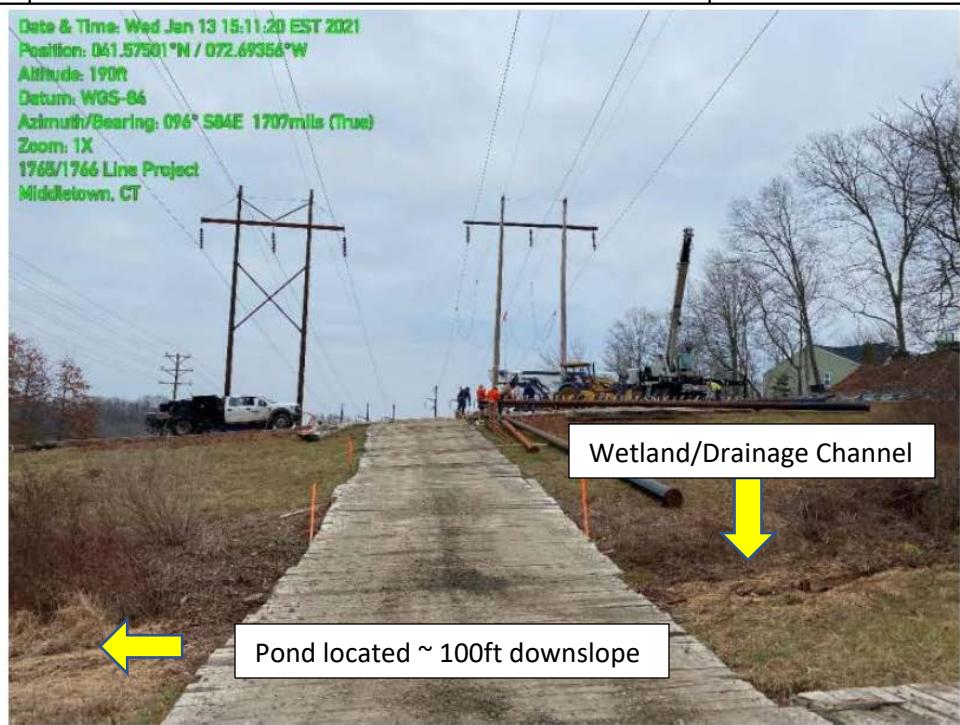
Photo No.: 16 Date: 01/13/21

View facing east of Michel's crew working on structure 6-214 located off Poplar Road in Middletown. No issues noted.

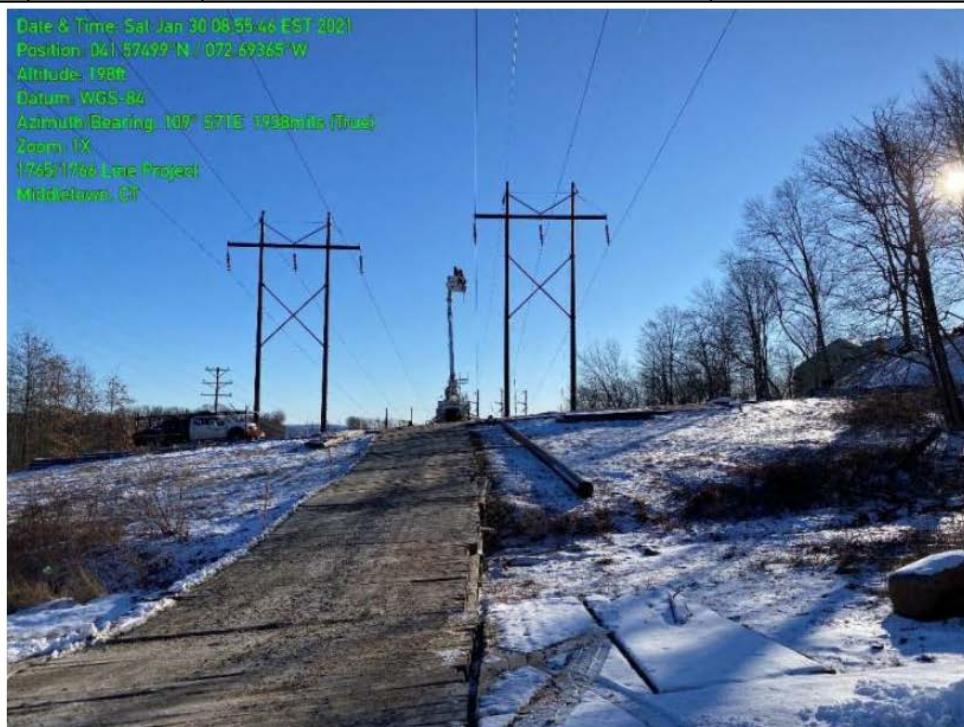
Photo No.: 47 Date: 01/30/21

View facing southeast of Michel's crew working at Structure 6-214 located off Poplar Road in Middletown. No issues noted.

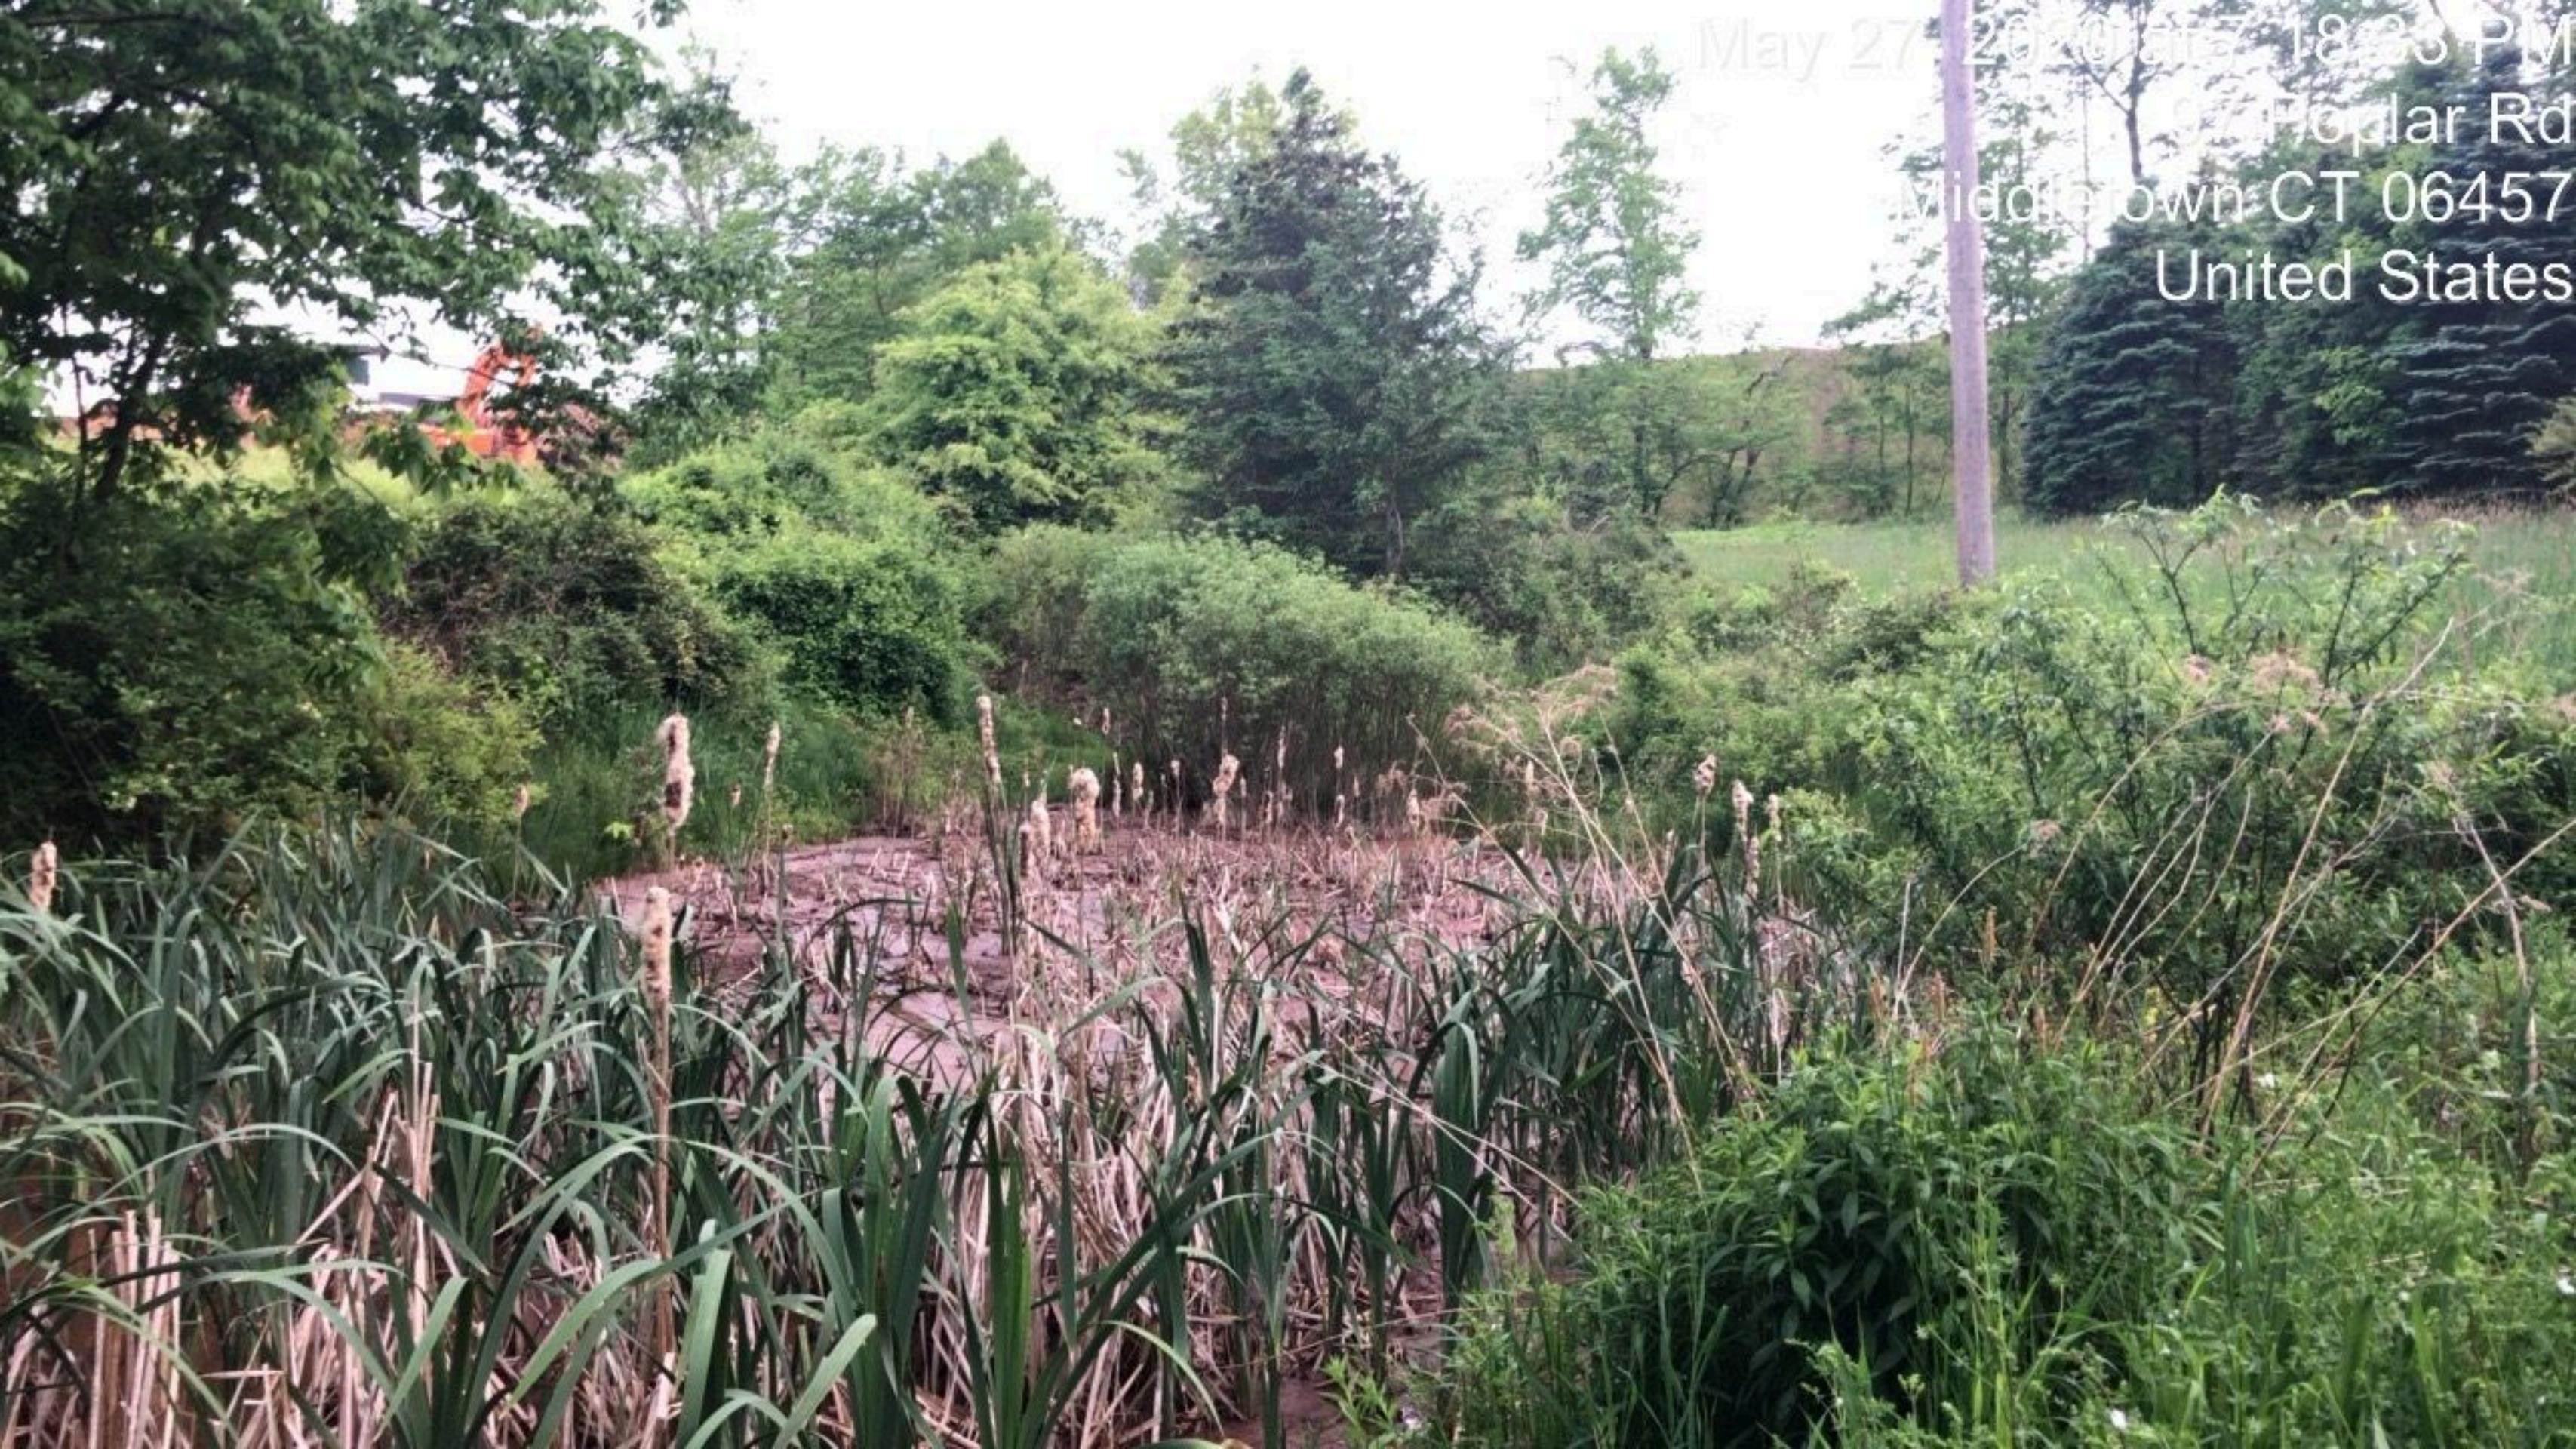
Note: yellow arrow depicting location of temporary construction (timber) matting crossing wetland.

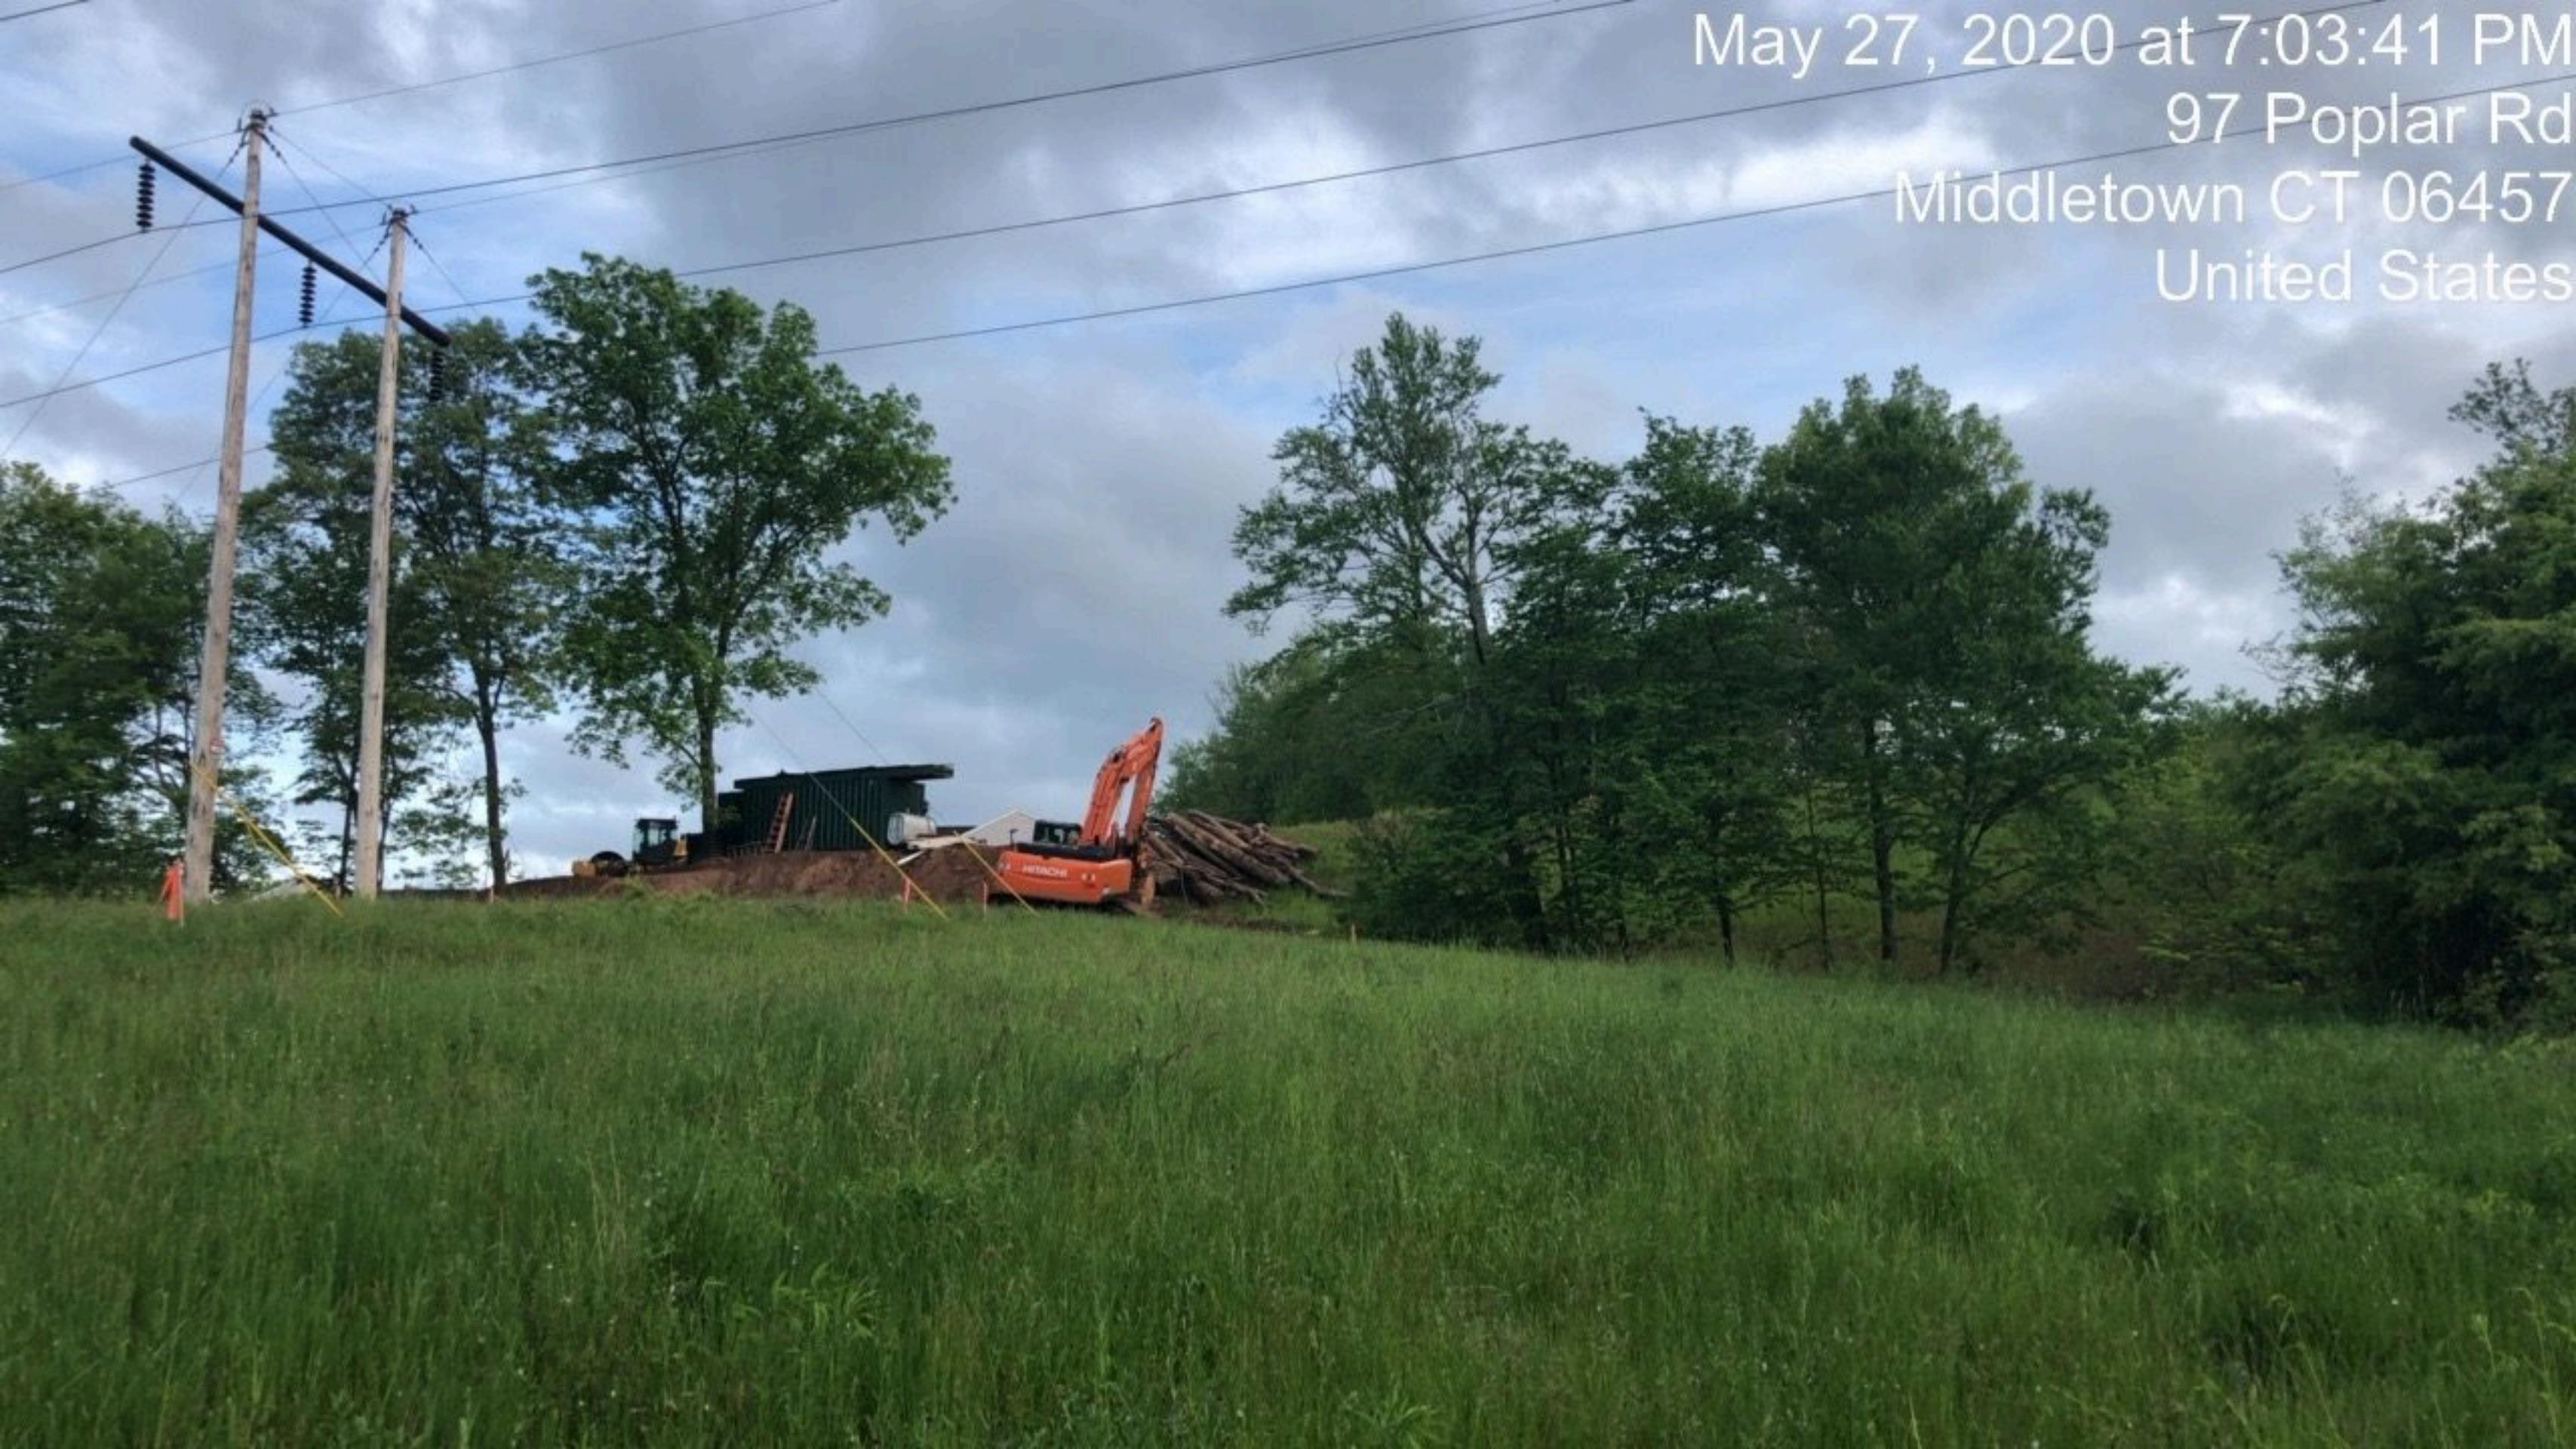
May 27, 2020 at 7:03:41 PM
97 Poplar Rd
Middletown CT 06457
United States

During Eversource's pre-construction walkdown (May 2020) for the ongoing 1765/1766 Project, which involves replacement of existing aged transmission structures, sediment buildup in the pond was observed and documented. The sedimentation in the pond was discussed with the landowner who acknowledged that this was a pre-existing issue resulting from upstream impacts. Photographs taken on May 27, 2020 (attached) depict the pond located at 97 Poplar with substantial sediment within the basin. The second photograph attached, taken facing south, depicts an active construction site completely unrelated to Eversource's work containing soil piles and excavation equipment located upslope of and off Eversource's' ROW.
