## **Attachment C**

Soil Investigations/Mapping  
(Upland – Solar Array Fields)

To: George T. Logan, Rema Ecological Services, LLC  
From: Bill Jackson  
Date: August 15, 2020 [February 15, 2021 – Revised]  
Subject: Spade & Auger Test Holes to Determine Soil Drainage Class  
North Stonington, CT Solar Project

Table A: Vernal Pool Surveys (2017 to 2020); Figures 4 to 26; Annotated Photographs (1 – 47)

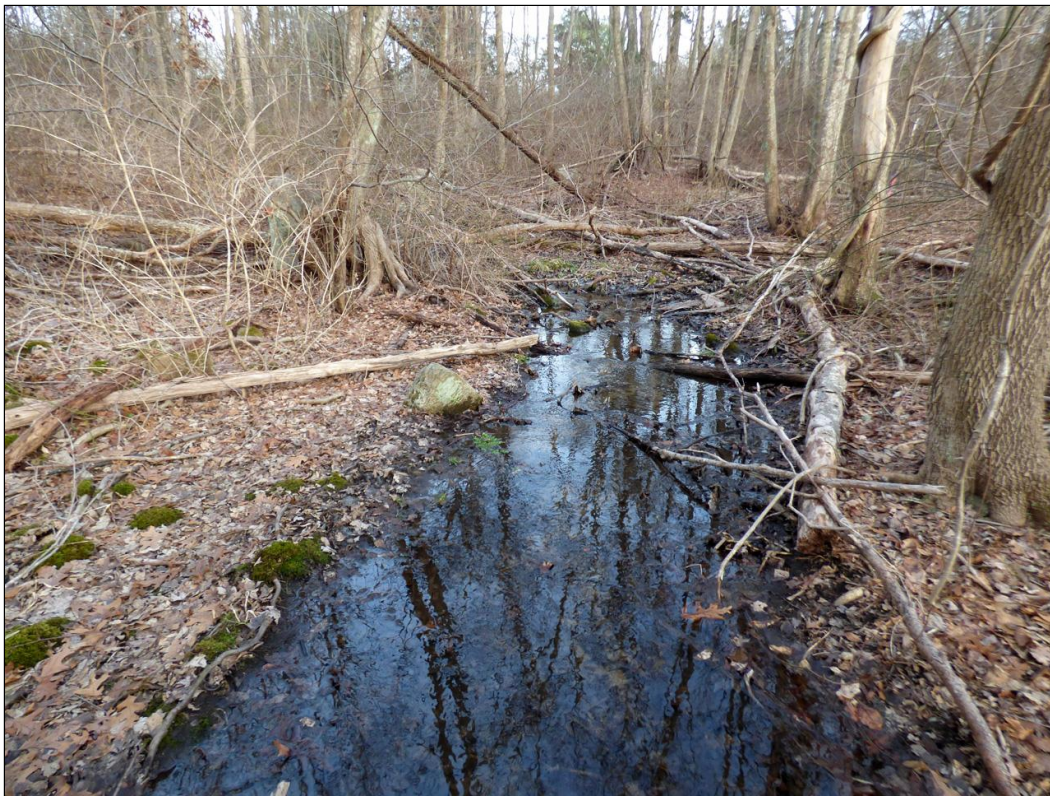
*Photo WB-1Be:* Wetland B/1B; outlet stream near property boundary; facing southeasterly

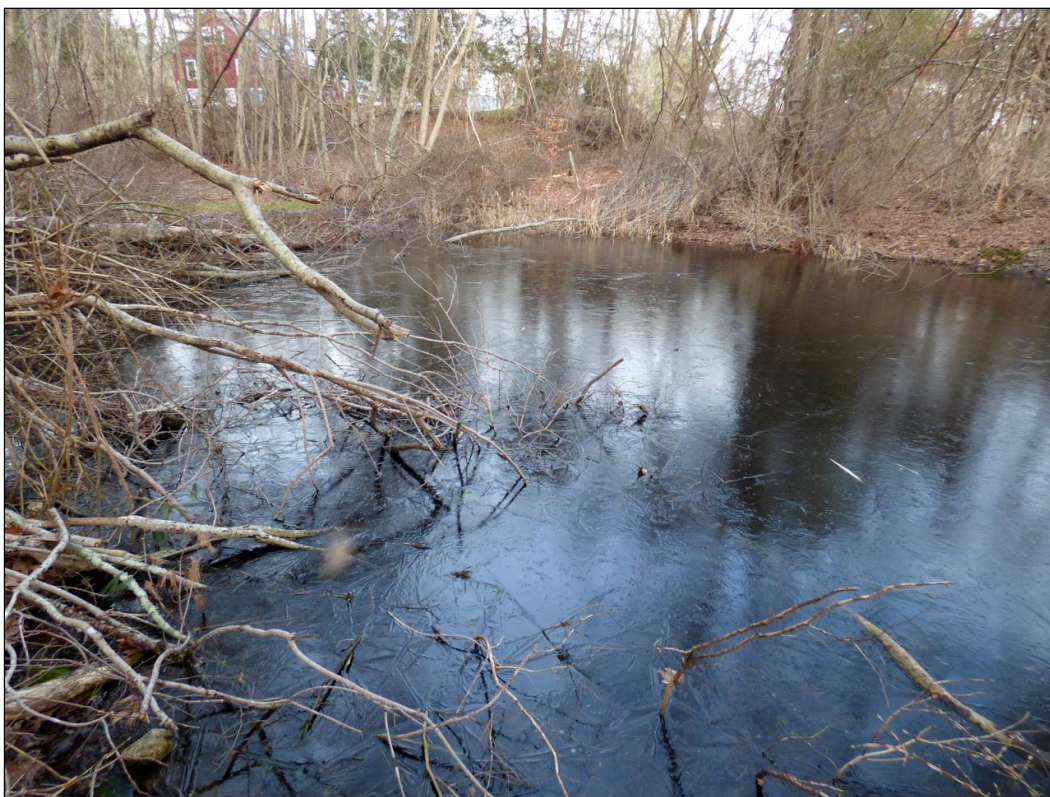
*Photo WB-1Bf:* Wetland B/1B; man-made pond; southern section; facing northeasterly

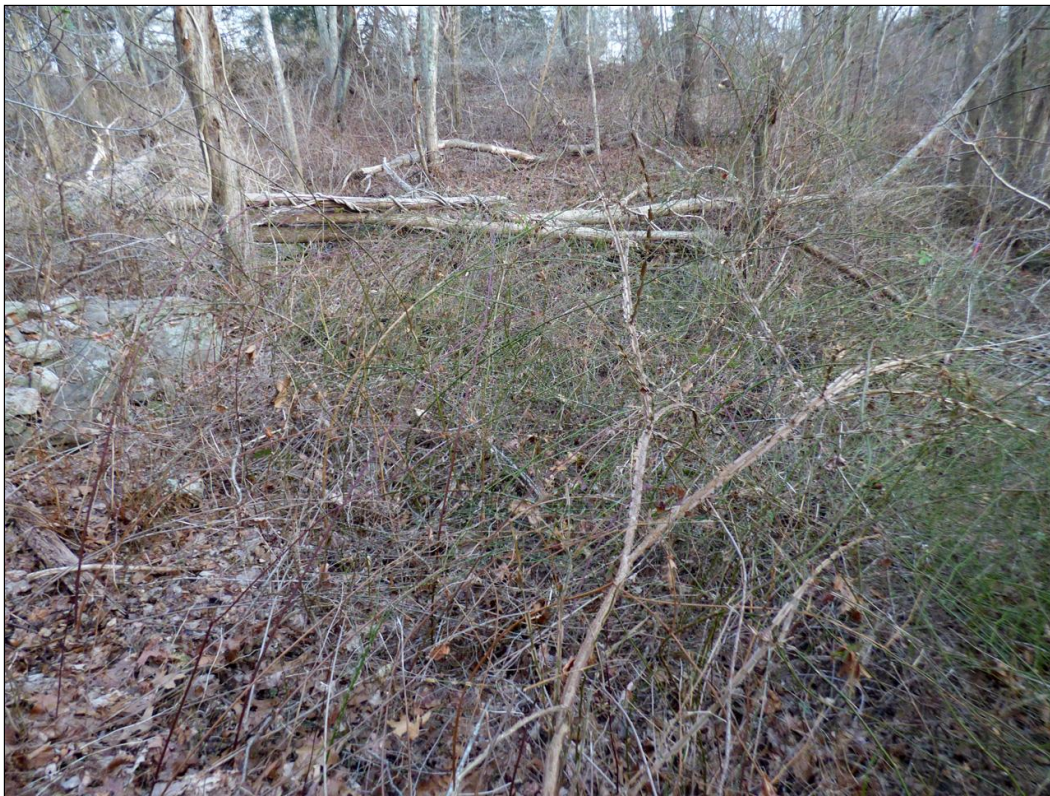
*Photo WB-1Bg:* Wetland B/1B; southern section; infestation of multiflora rose and Japanese barberry; facing northeasterly

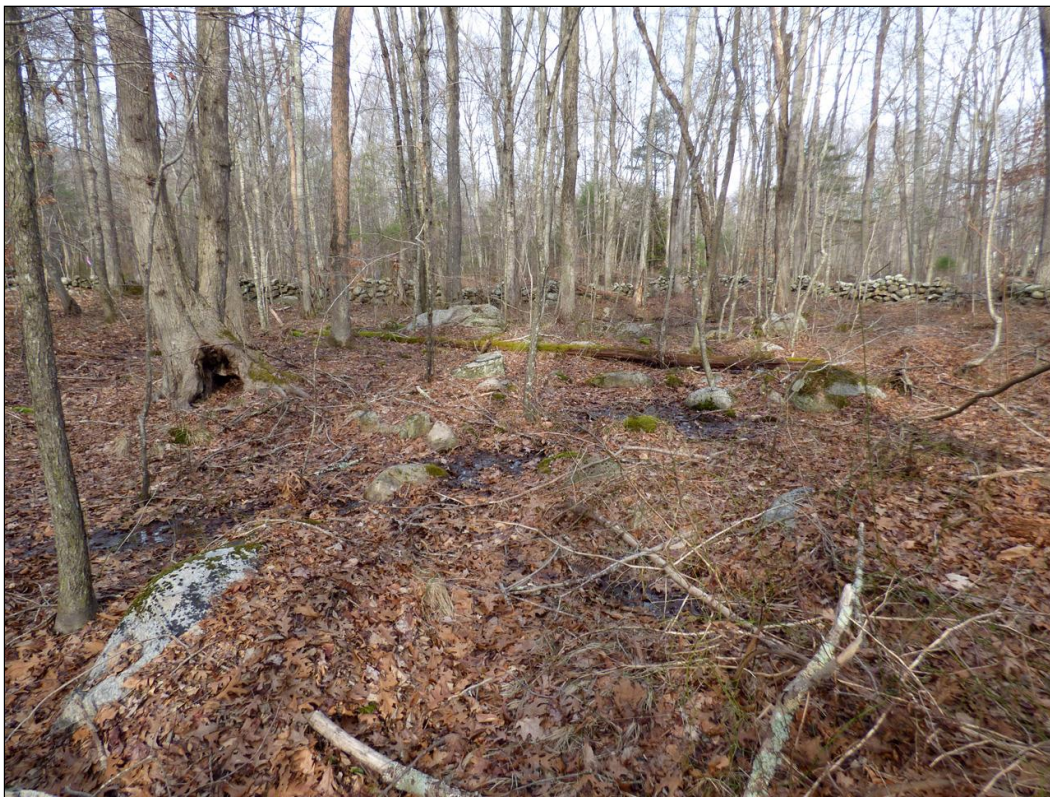
*Photo WB2a:* Wetland B-2; southern section and intermittent watercourse; facing northeasterly

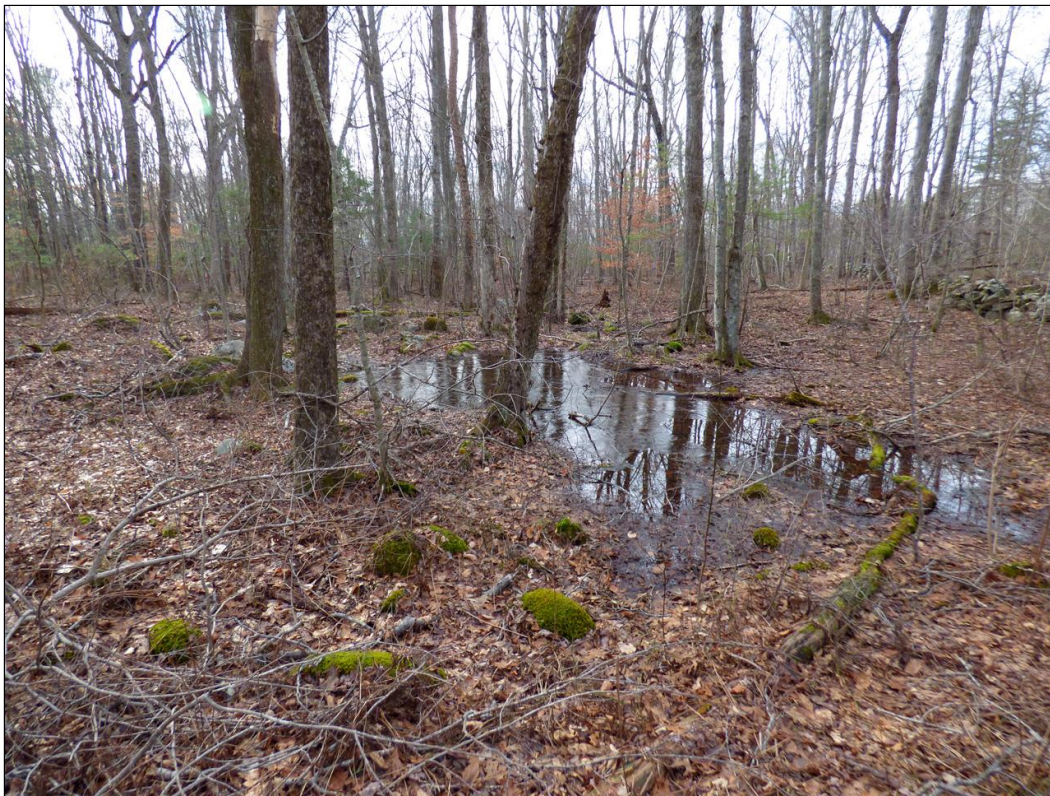
*Photo WB2b:* Wetland B-2; at northeastern corner of northern portion of project area; facing westerly

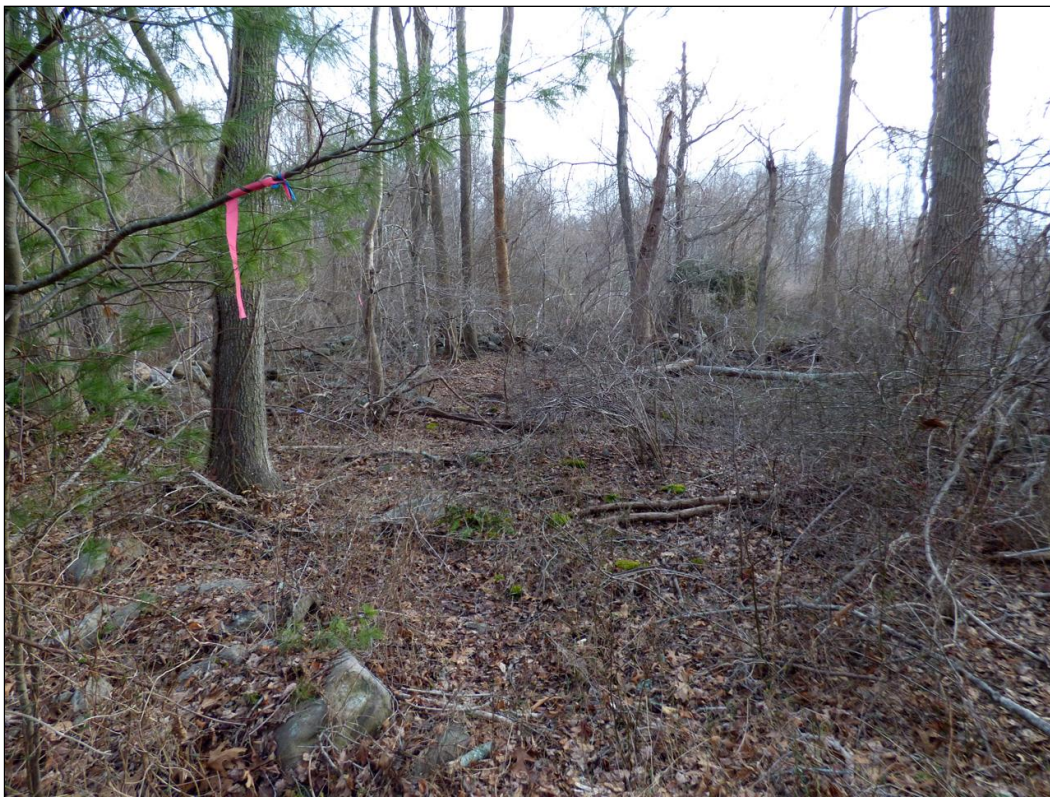
*Photo WC:* Wetland C; wetland boundary; proposed solar array field behind viewer; facing southerly

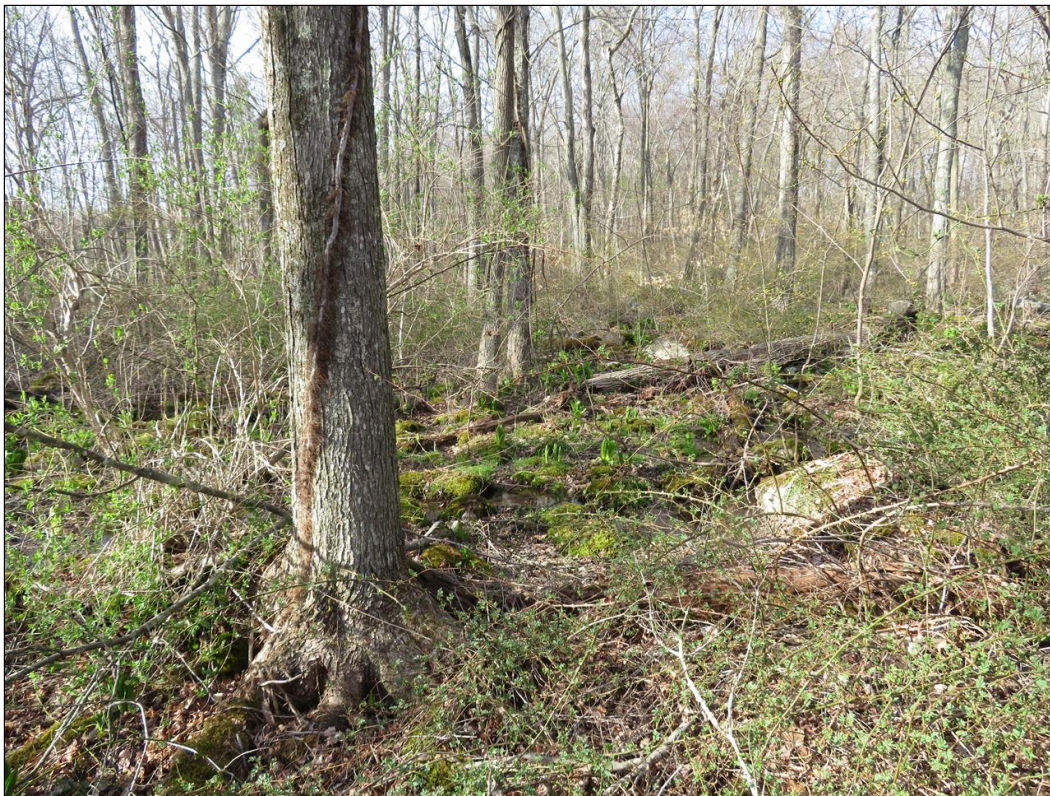
*Photo WEb: Wetland E; April 2017; eastern edge; facing northwesterly*

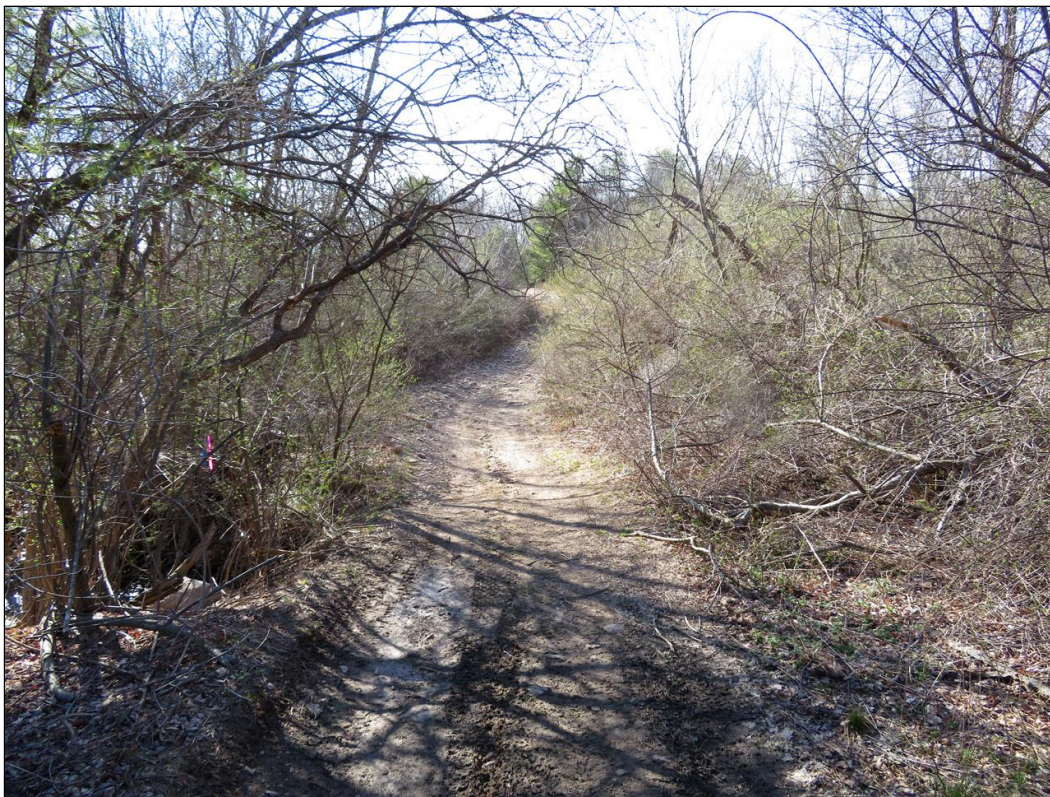
*Photo WEc: Wetland E; old quarry haul road; culverted crossing of wetland corridor; facing westerly*

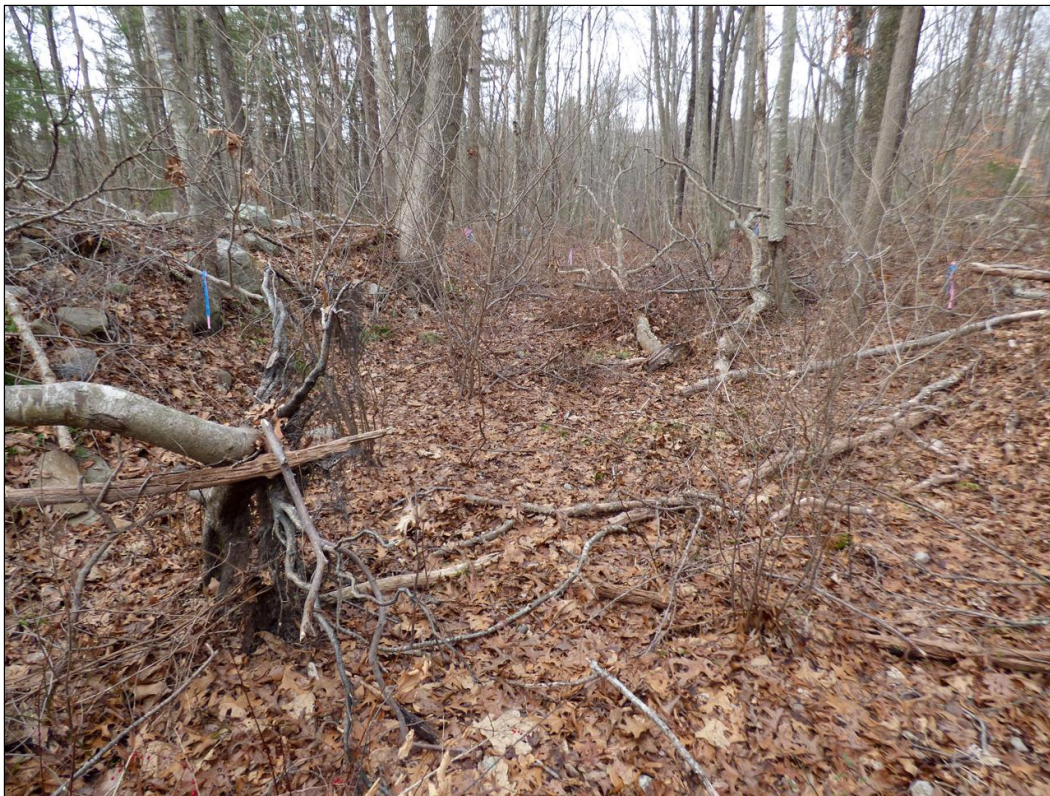
*Photo WC2a:* Wetland C-2; within old roadway bed of Providence-New London Turnpike; facing northwesterly

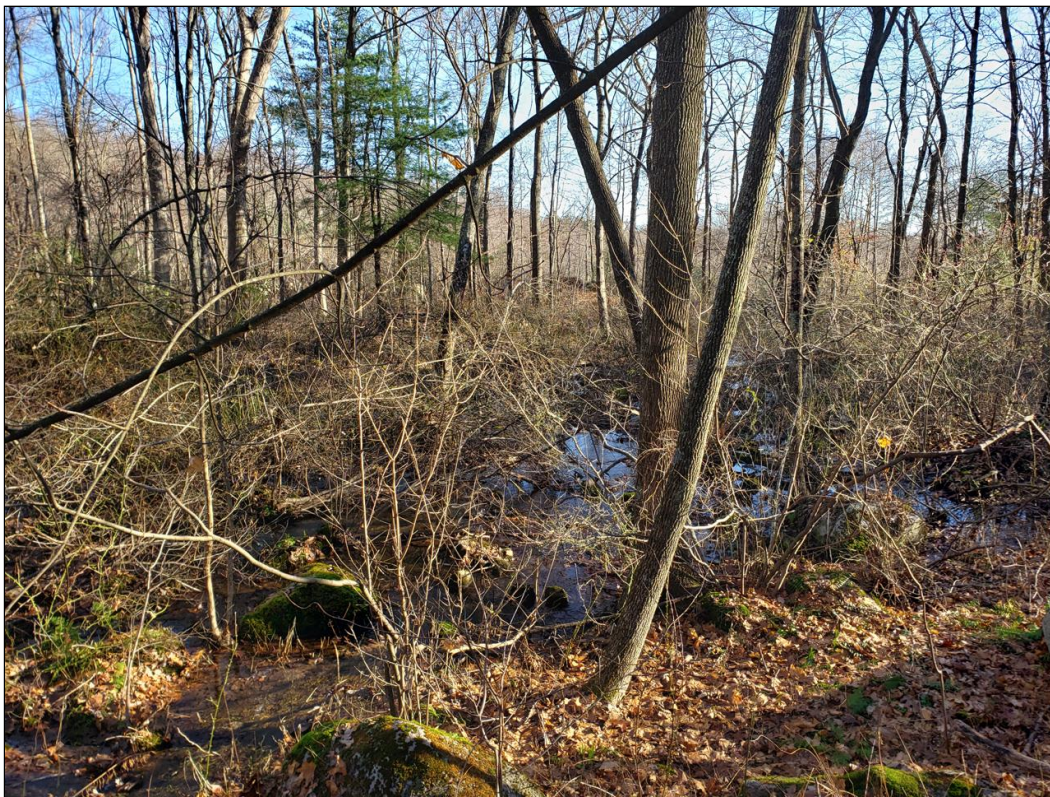
*Photo WEa:* Wetland E; southern portion just northerly of old quarry limits; facing southeasterly

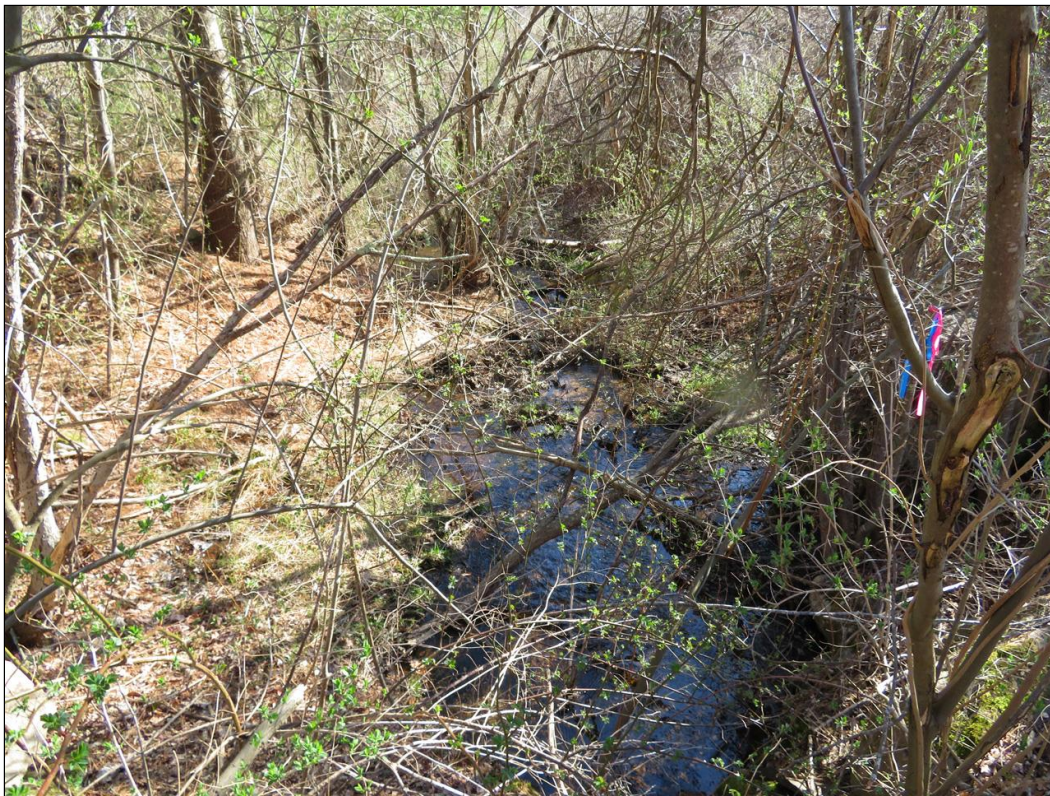
*Photo WEd:* Wetland E; April 2017; wetland corridor below (downstream) of wetland crossing seen in previous photo; facing southerly

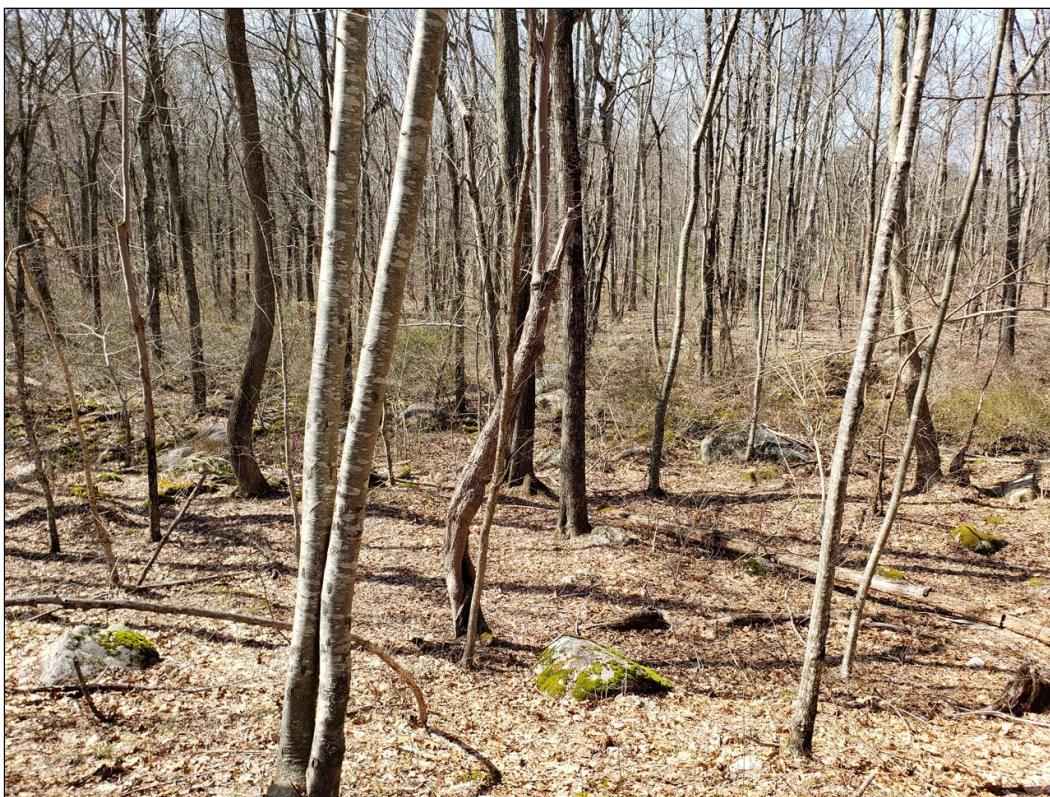
*Photo WEe:* Wetland E; central portion as seen from hillside to east; facing northwesterly

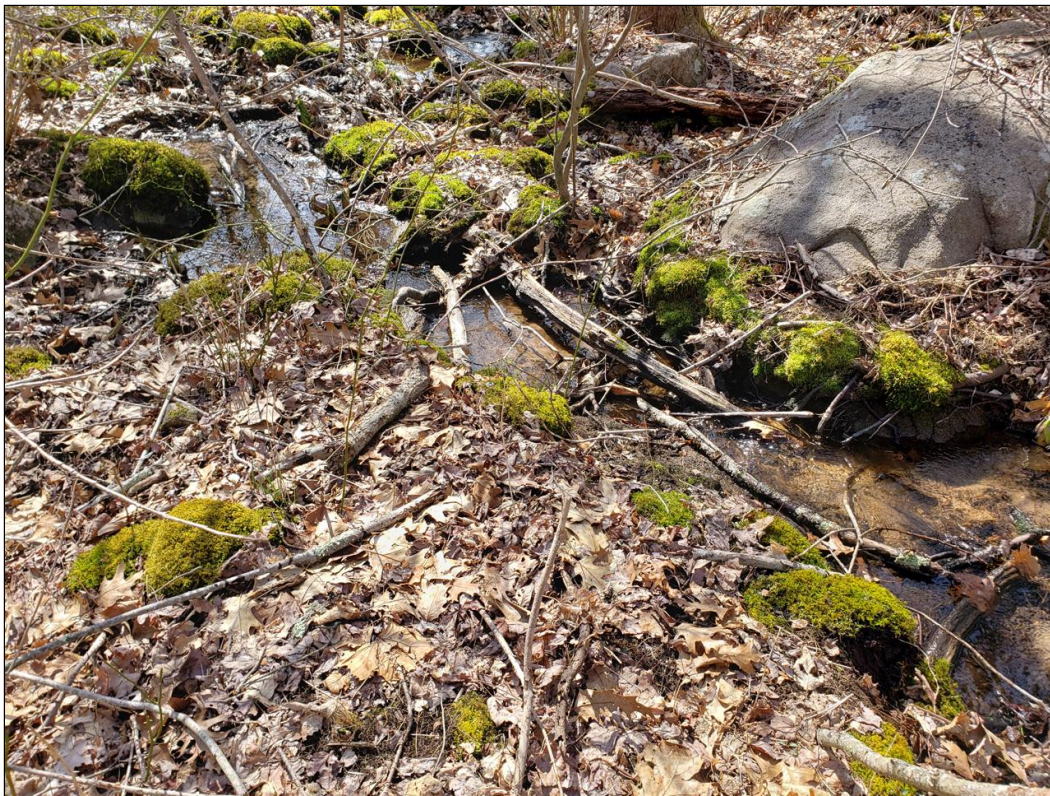
*Photo WEf:* Wetland E; April 2020; intermittent stream through wetland

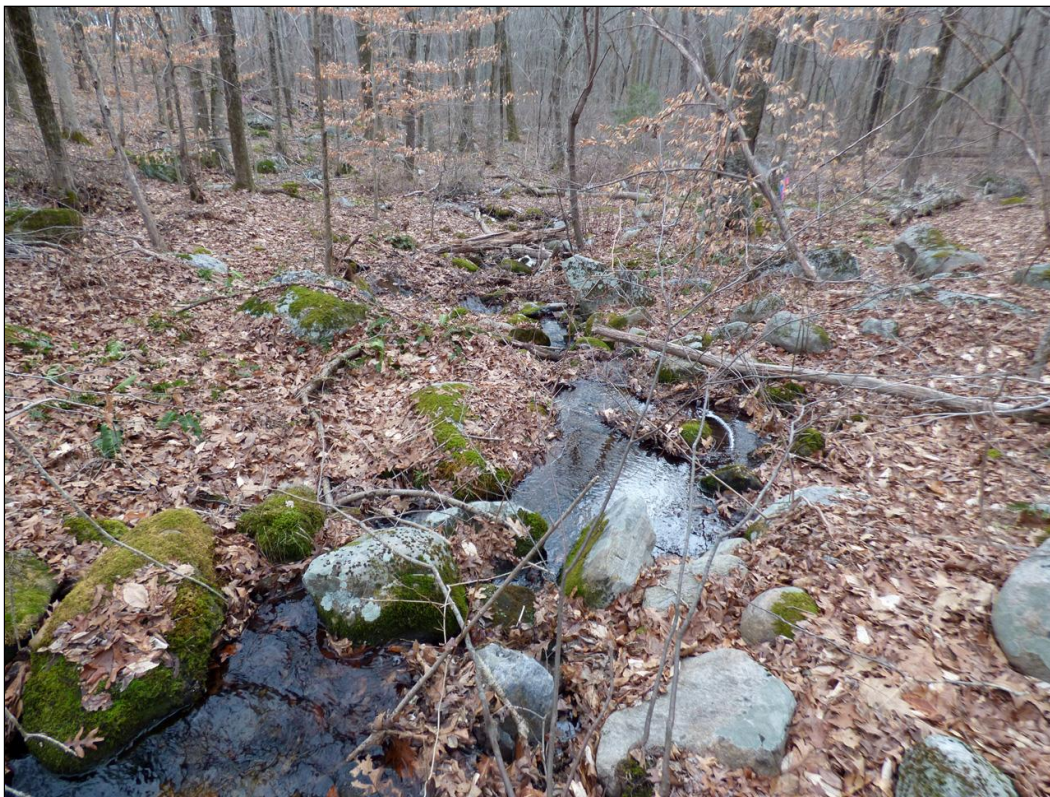
*Photo WEg:* Wetland E; intermittent stream near eastern property boundary; facing southwesterly

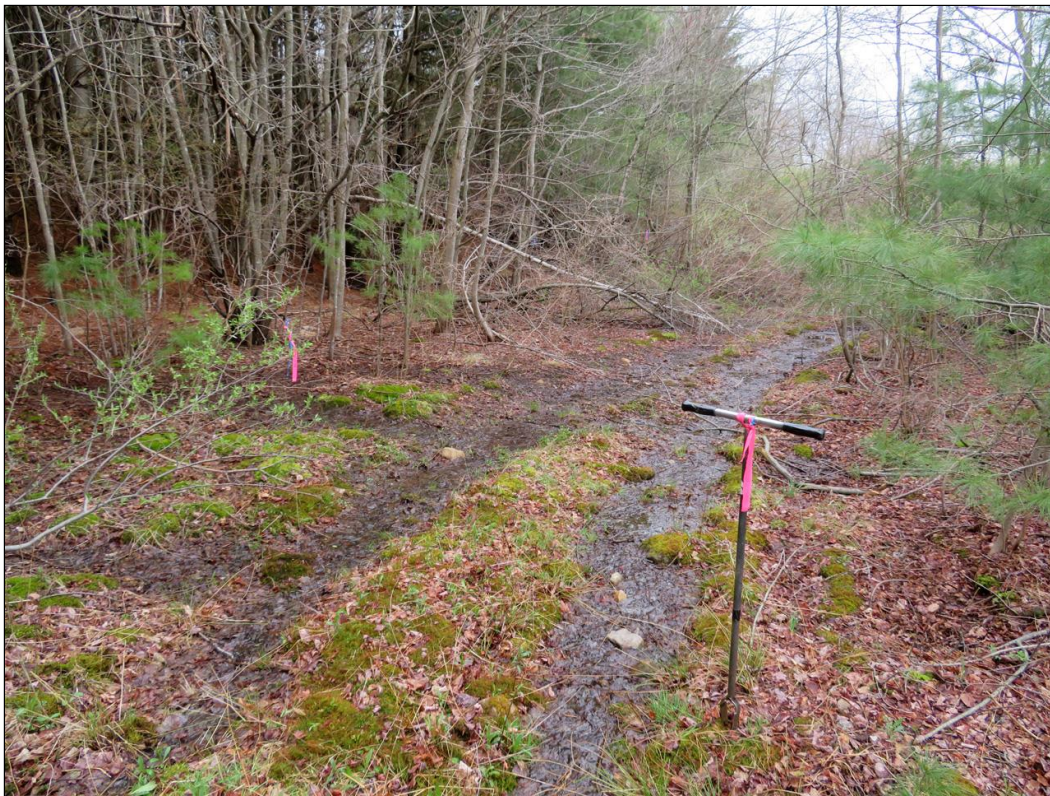
*Photo WFa:* Wetland F; April 2017; straddles an old access roadway; receives seepage from hillside to east (left); facing southerly

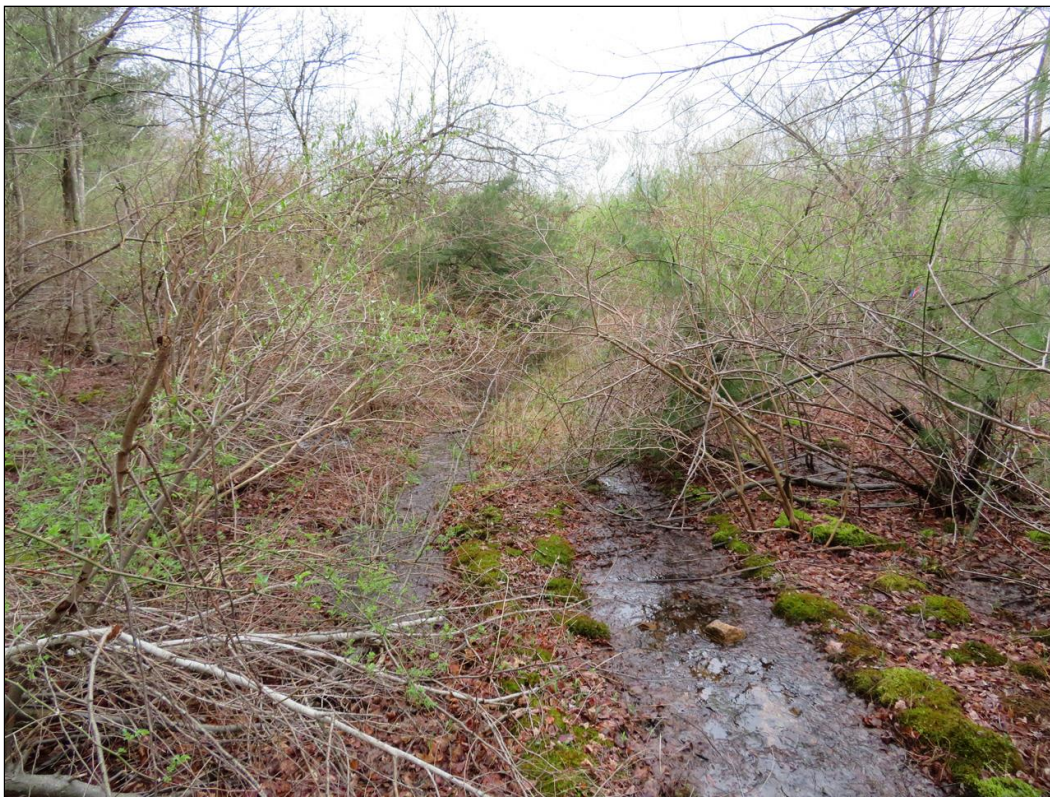
*Photo Wfb:* Wetland F; scrub shrub cover type; adjacent to Upland Cover Type 16 dominated by autumn olive; facing southwesterly

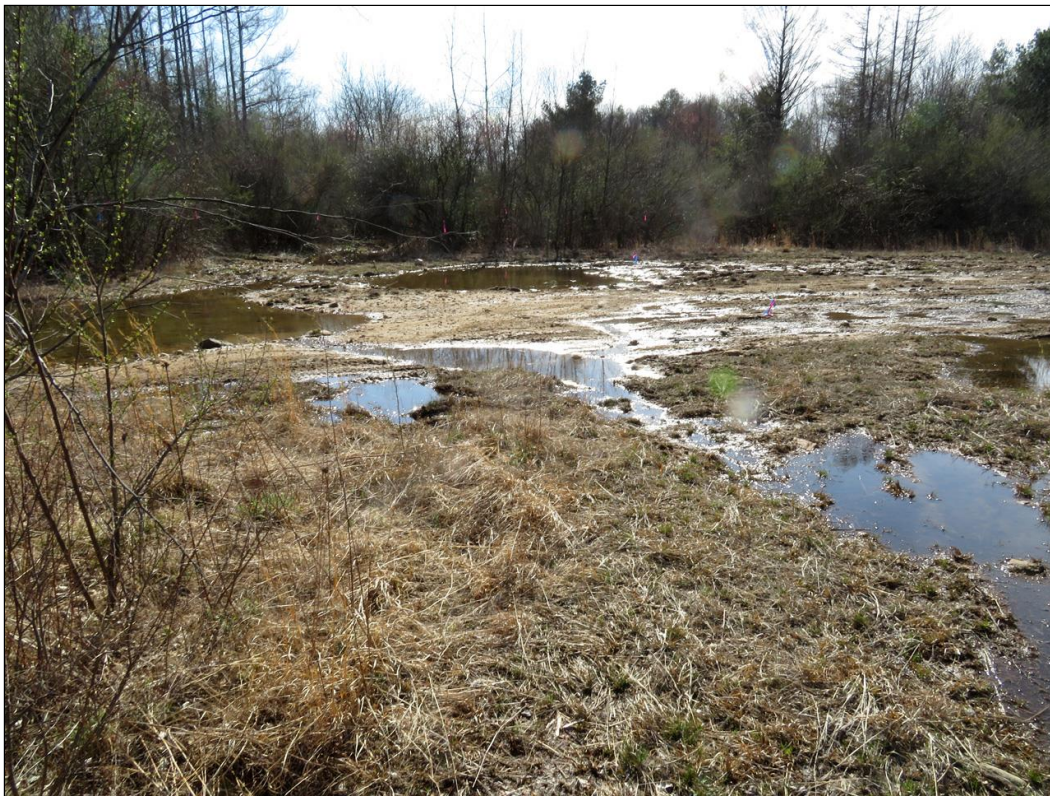
*Photo WGa:* Wetland G; April 2017; also see photos for Vernal Pool G; facing southwesterly

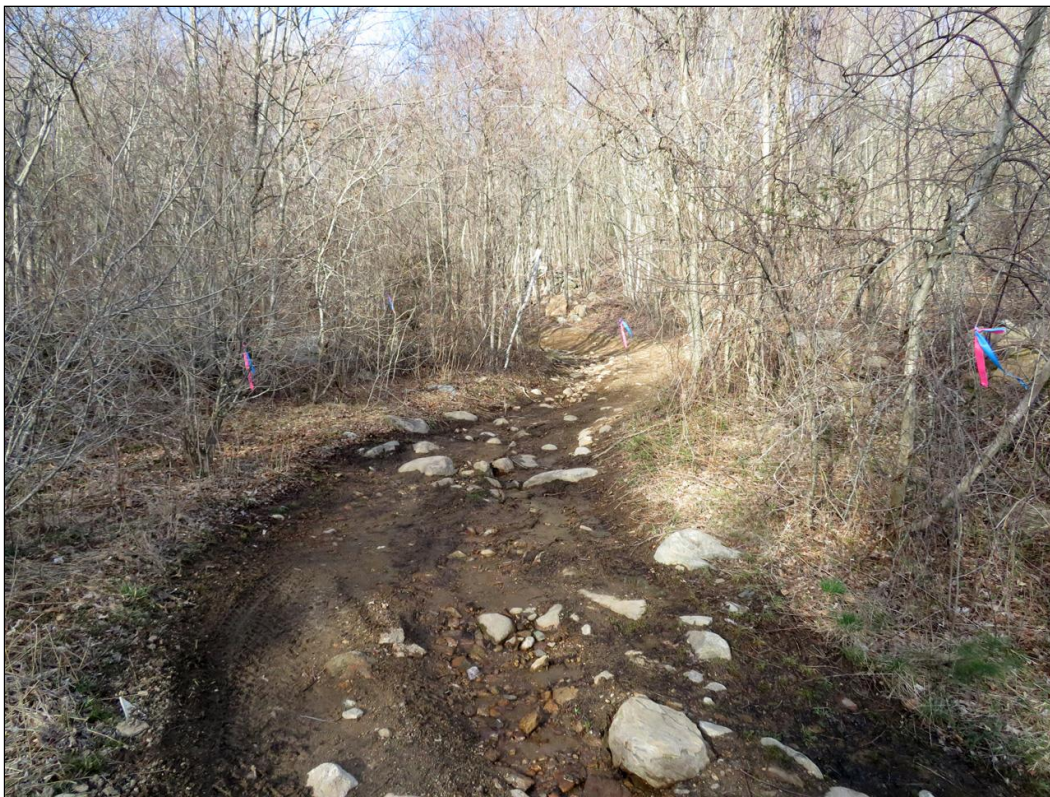
*Photo WH1a:* Wetland H-1; wetland located at the upper (northern) edge of old quarry operation; wetland crosses haul road; facing northerly

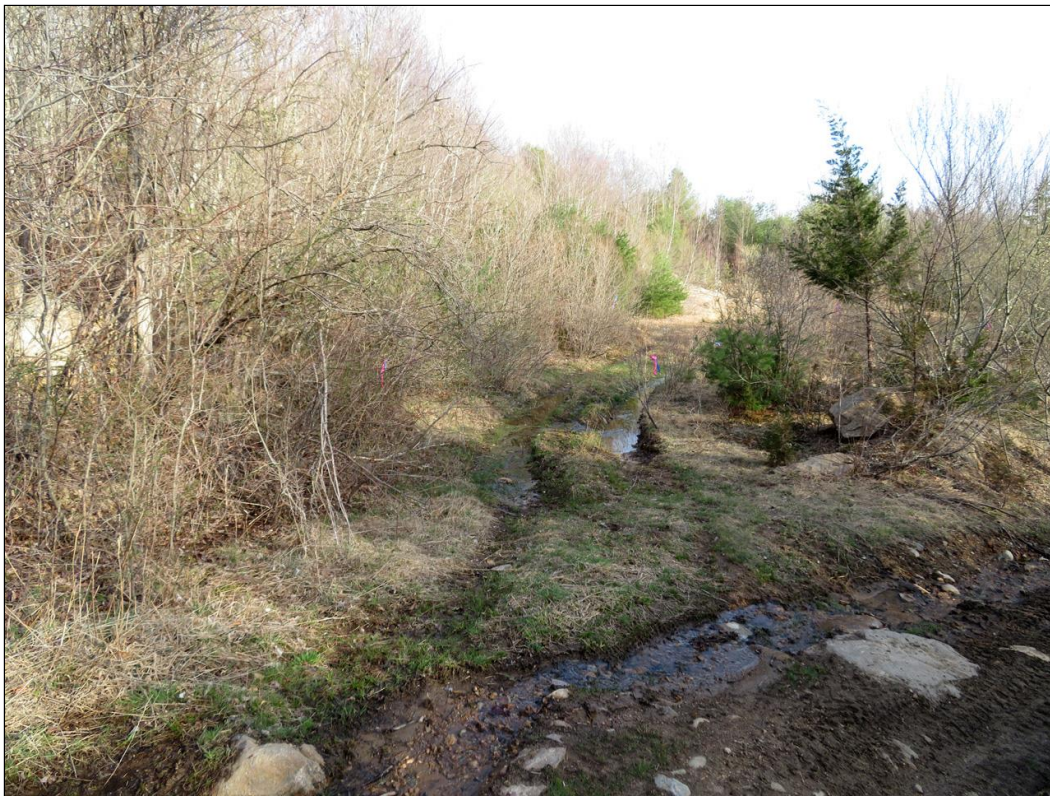
*Photo WH1b:* Wetland H-1; April 2017; facing easterly

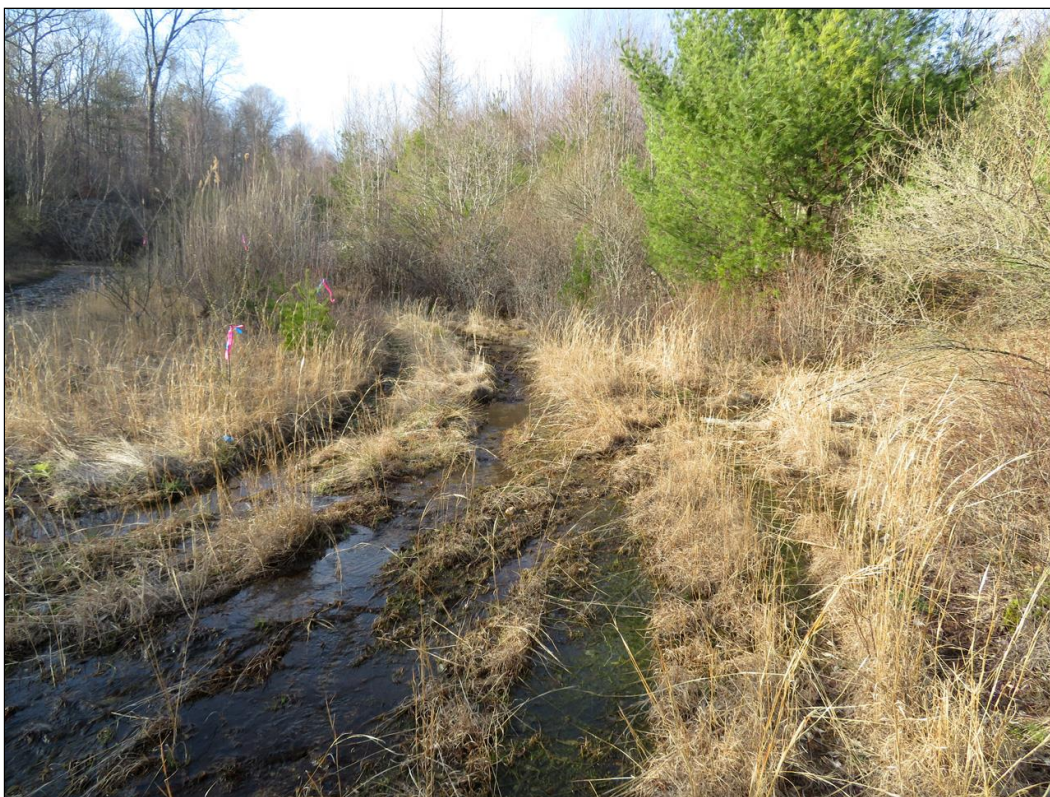
*Photo W1a:* Wetland I; lower portion south of Vernal Pool I; facing northerly

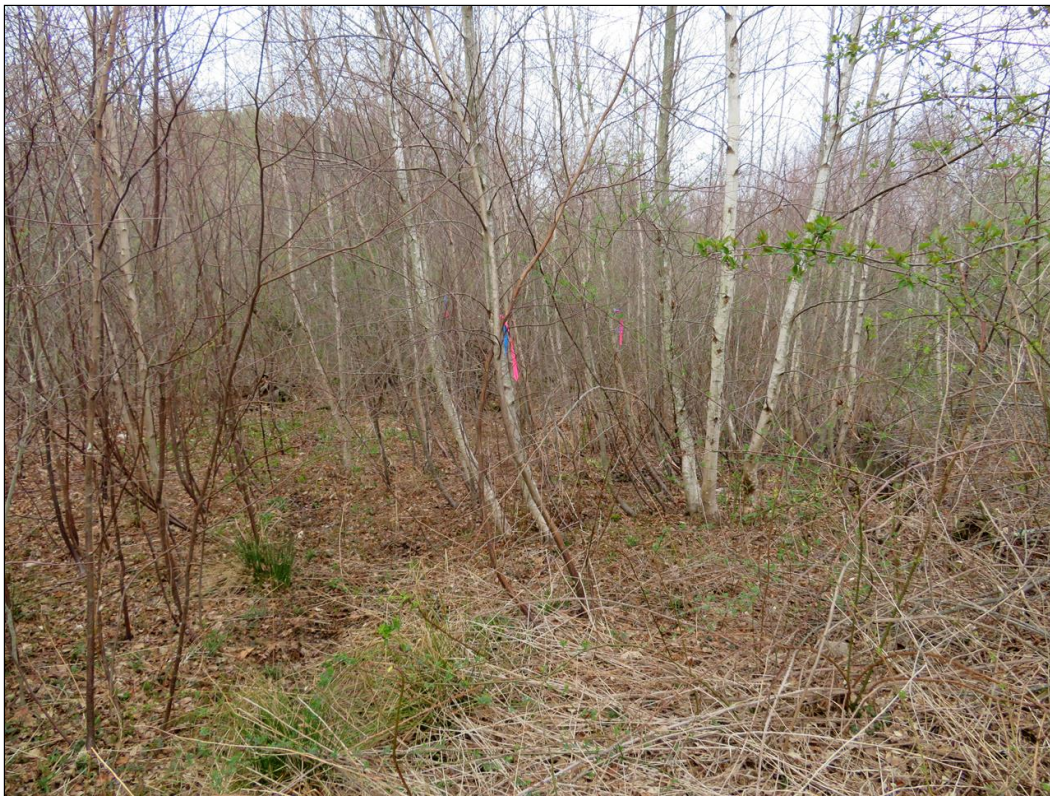
*Photo WKa:* Wetland K; April 2017; scrub shrub wetland (sapling); facing northwesterly

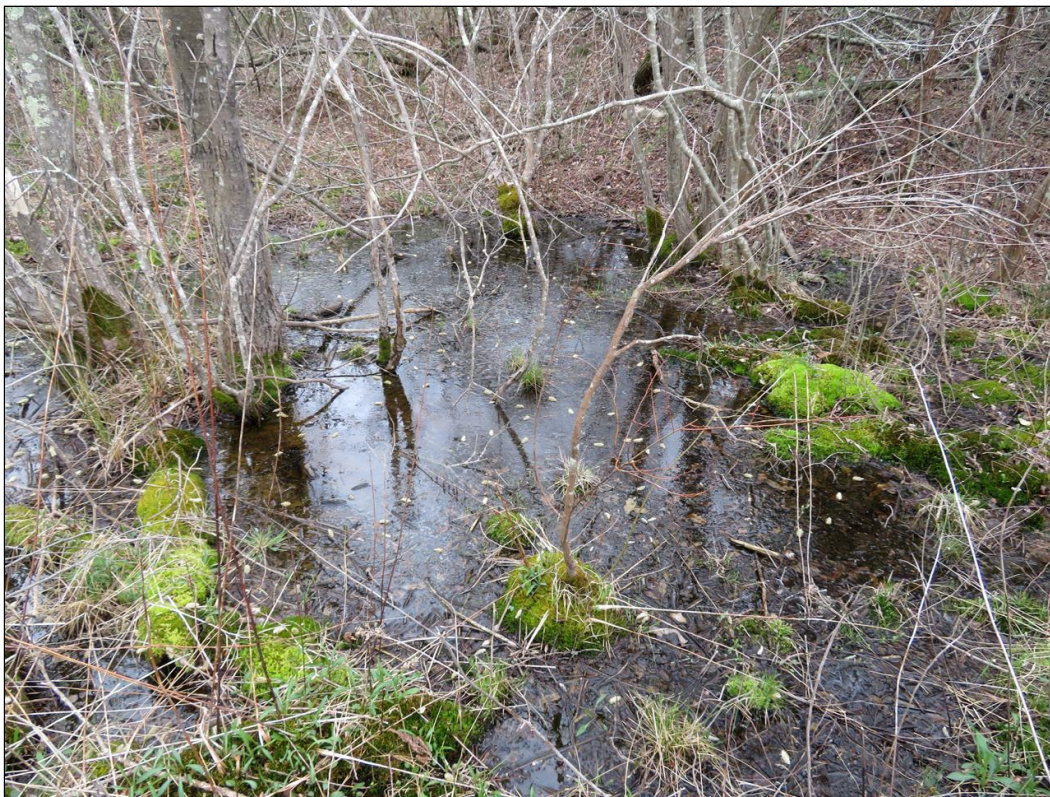
*Photo WKb:* Wetland K; upper seasonally flooded section; facing northerly

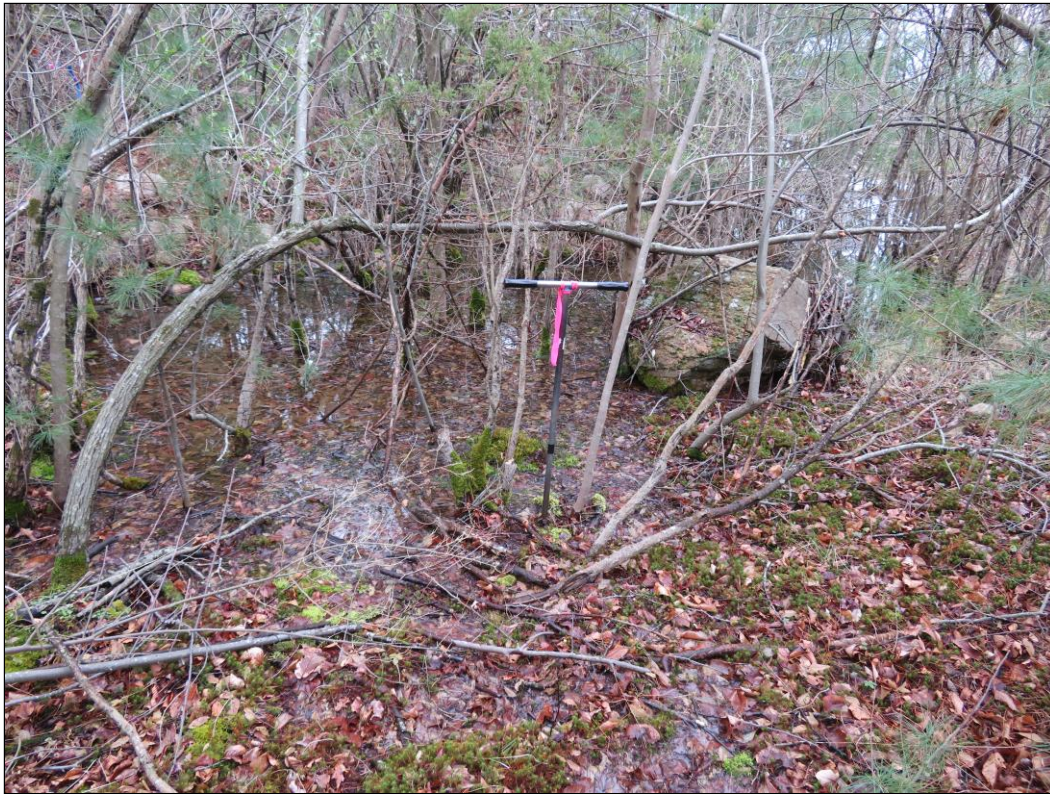
*Photo WMa:* Wetland M; April 2017; scrub shrub wetland (sapling); facing southwesterly

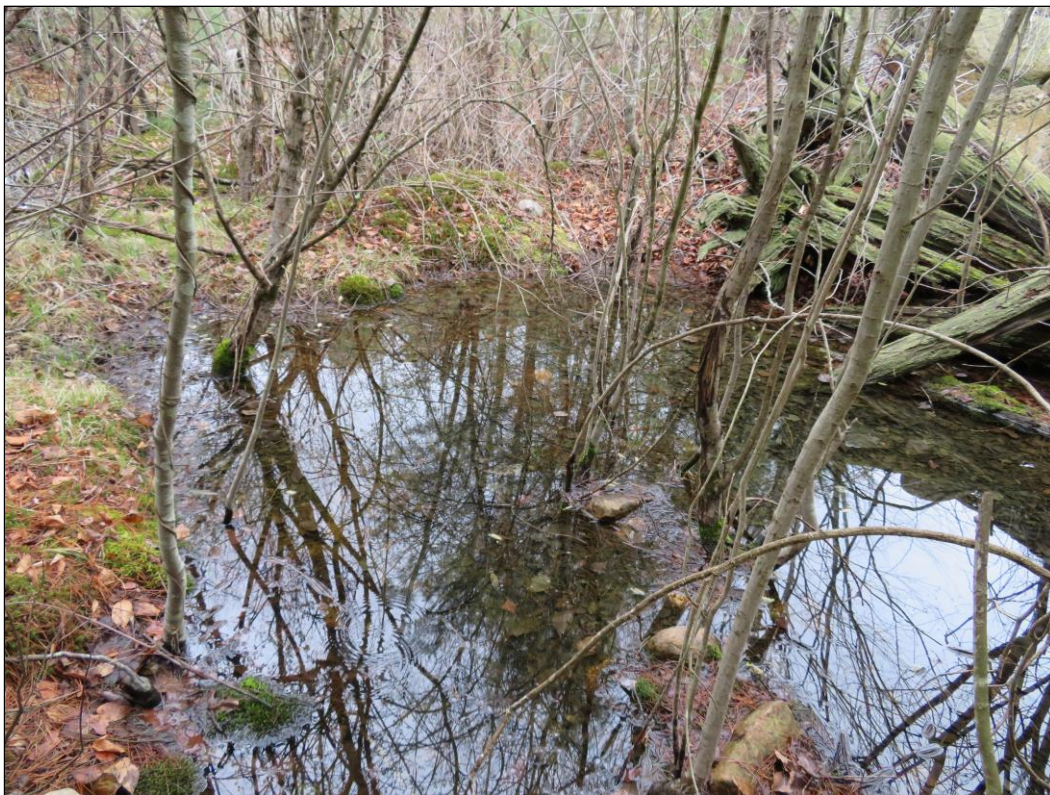
*Photo WMb:* Wetland M; upper seasonally flooded section; facing easterly

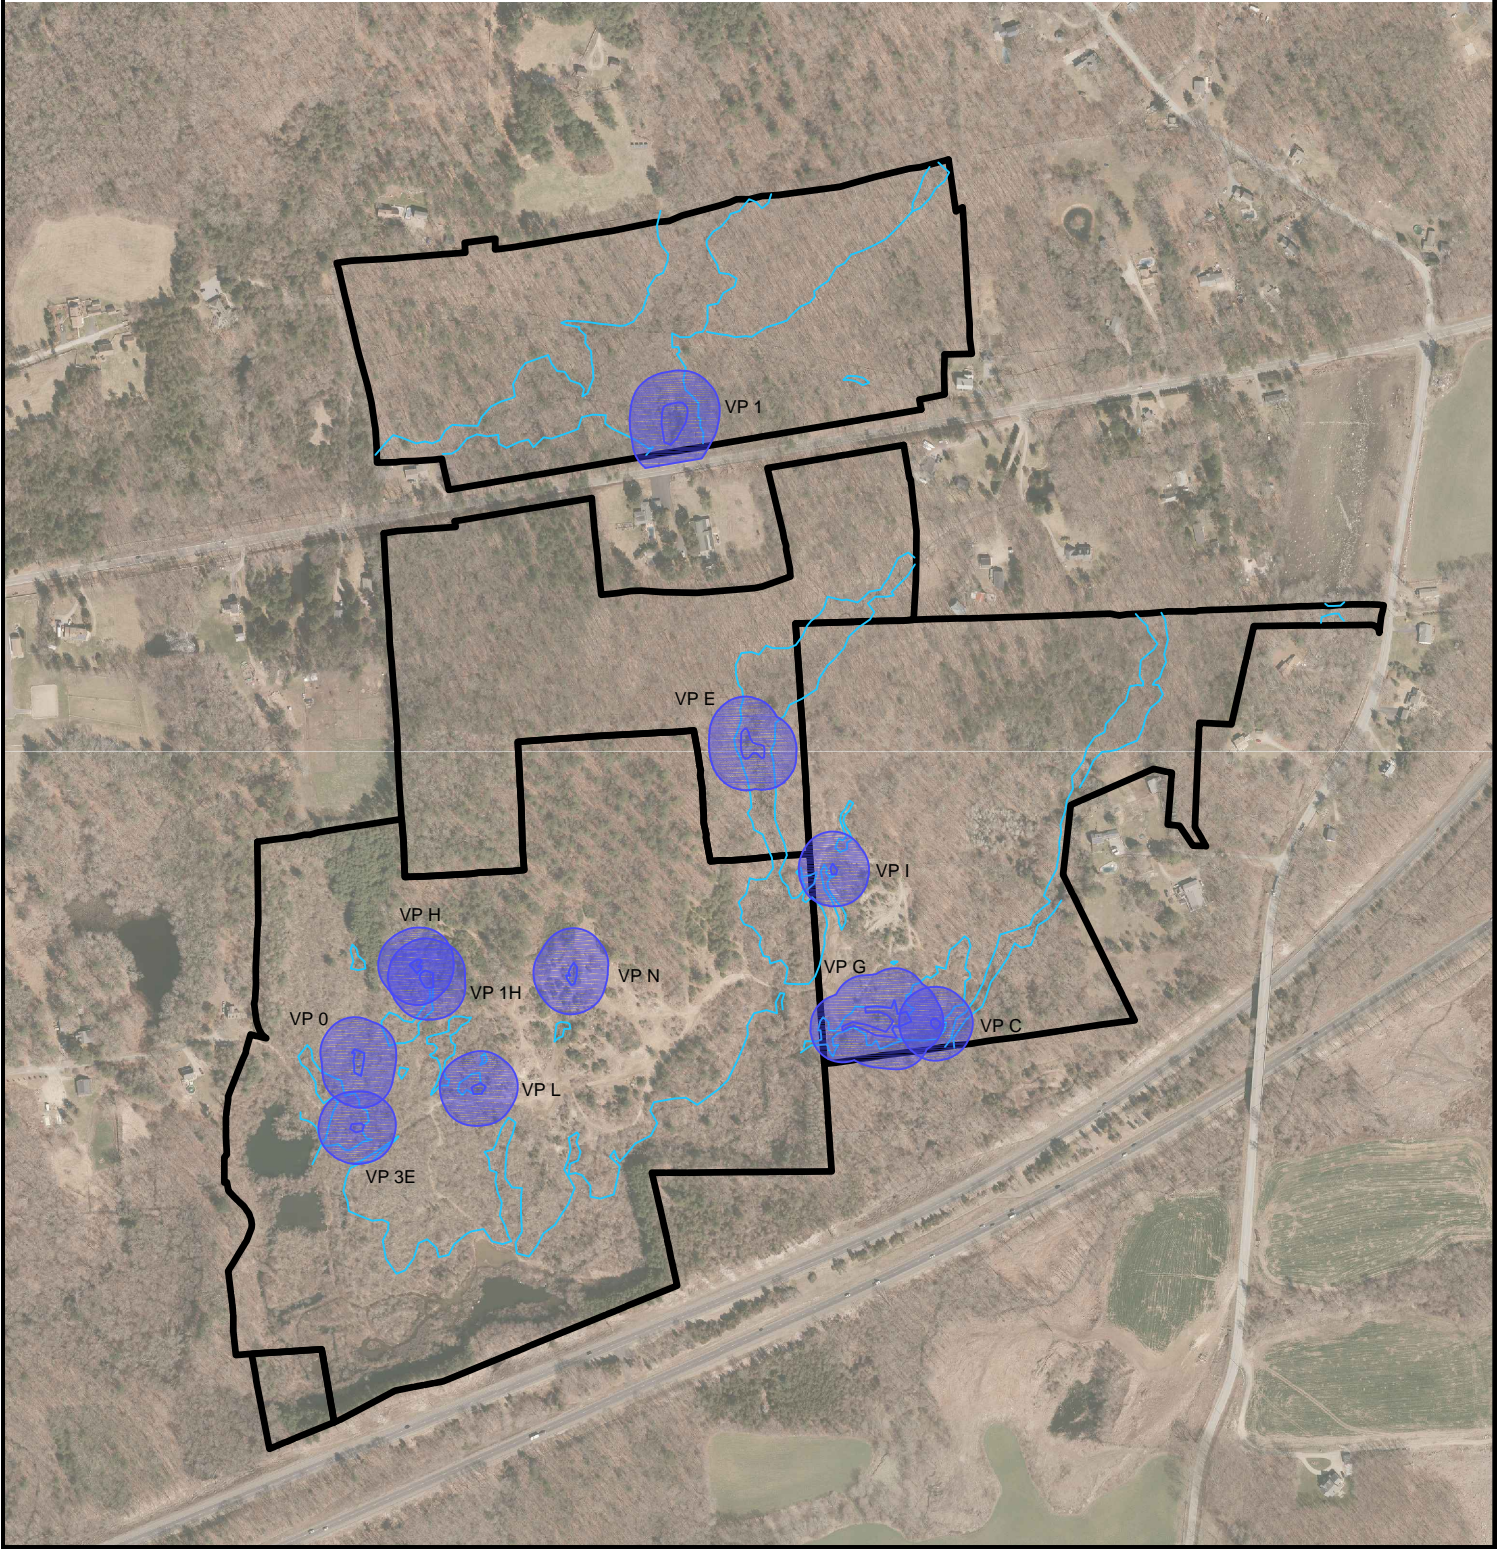
**FIGURE 5:**

VERNAL POOL 1  
EXISTING CONDITIONS  
North Stonington Solar Facility
