## **Attachment C**

Soil Investigations/Mapping  
(Upland – Solar Array Fields)

To: George T. Logan, Rema Ecological Services, LLC  
From: Bill Jackson  
Date: August 15, 2020 [February 15, 2021 – Revised]  
Subject: Spade & Auger Test Holes to Determine Soil Drainage Class  
North Stonington, CT Solar Project

Table A: Vernal Pool Surveys (2017 to 2020); Figures 4 to 26; Annotated Photographs (1 – 47)

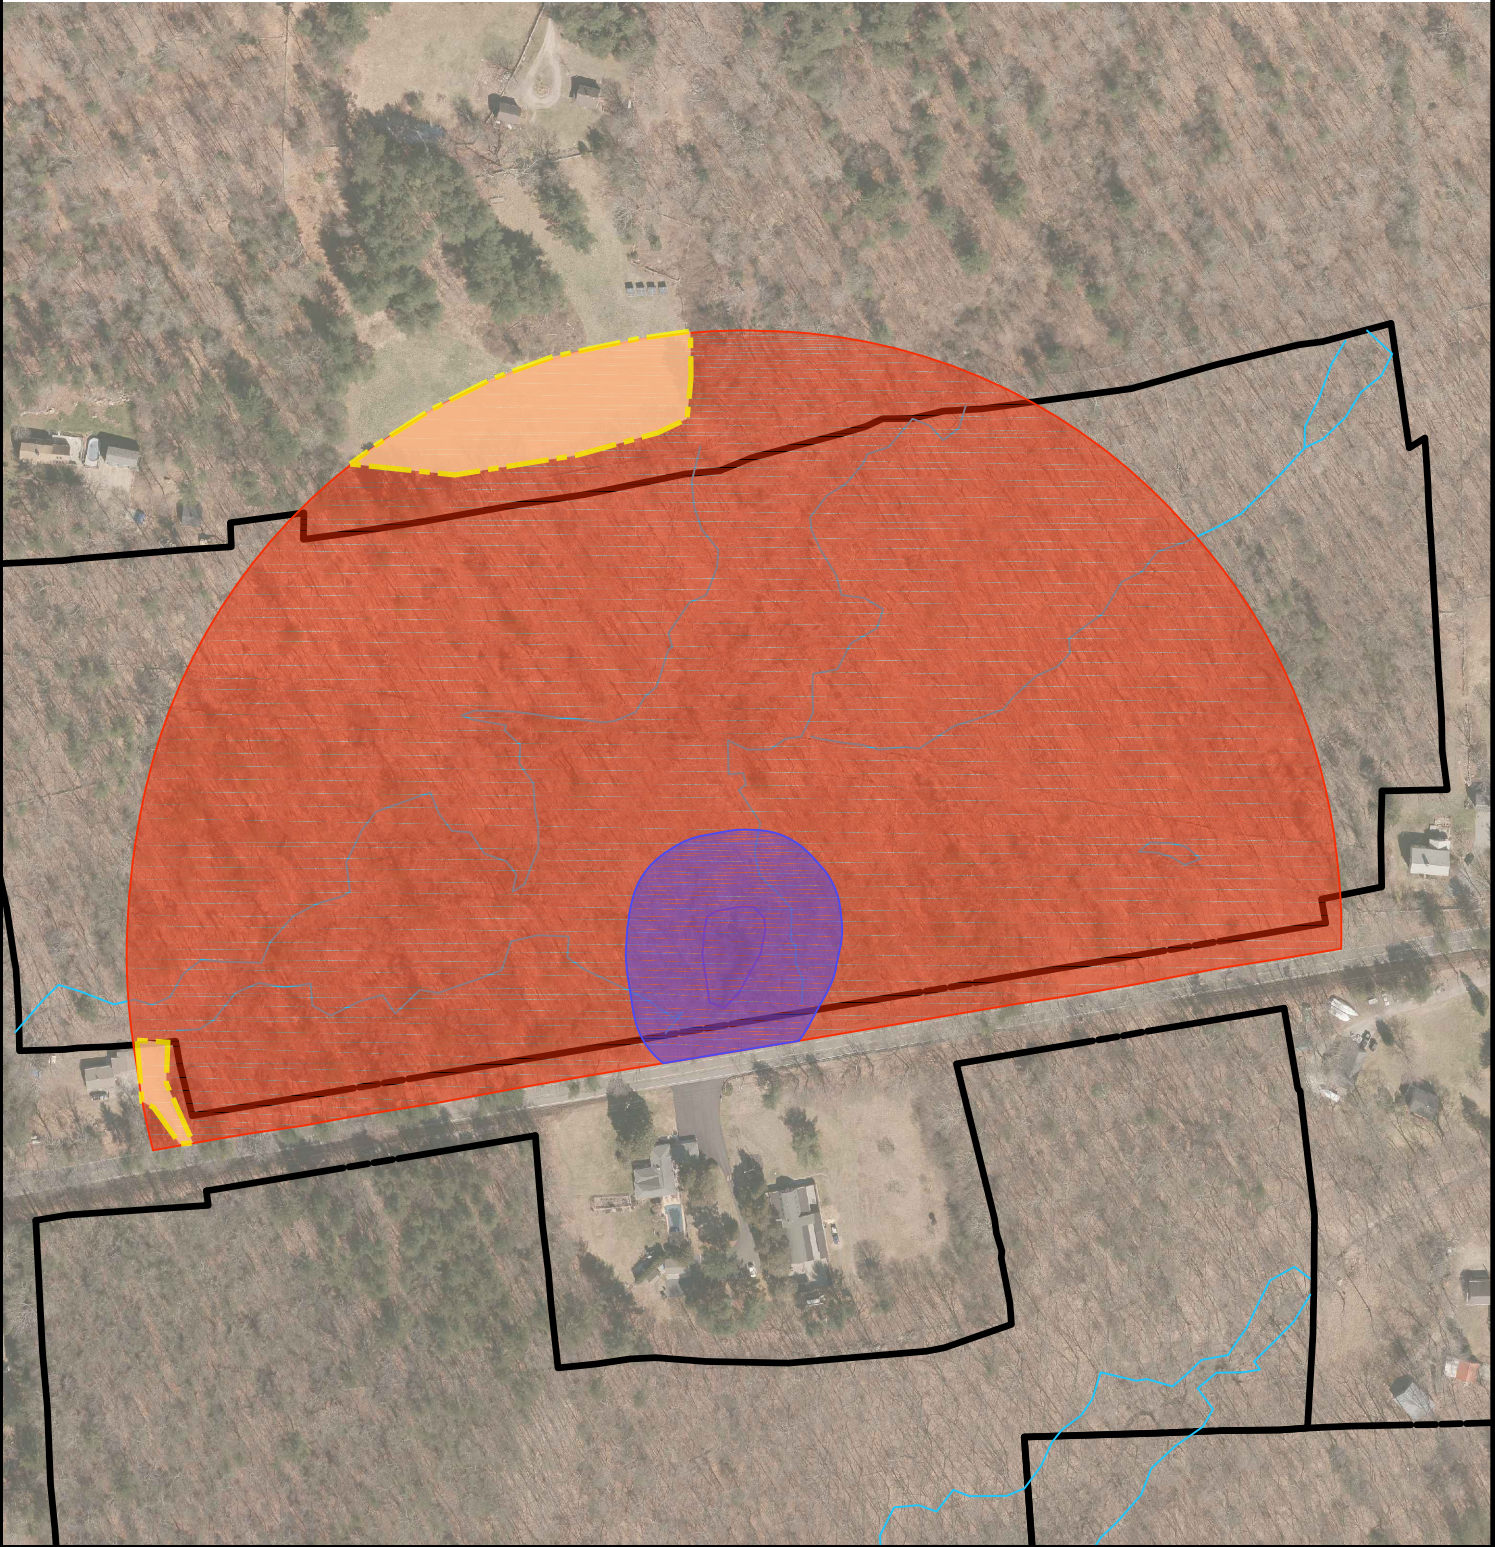
**FIGURE 6:**

VERNAL POOL 1  
PROPOSED CONDITIONS  
North Stonington Solar Facility

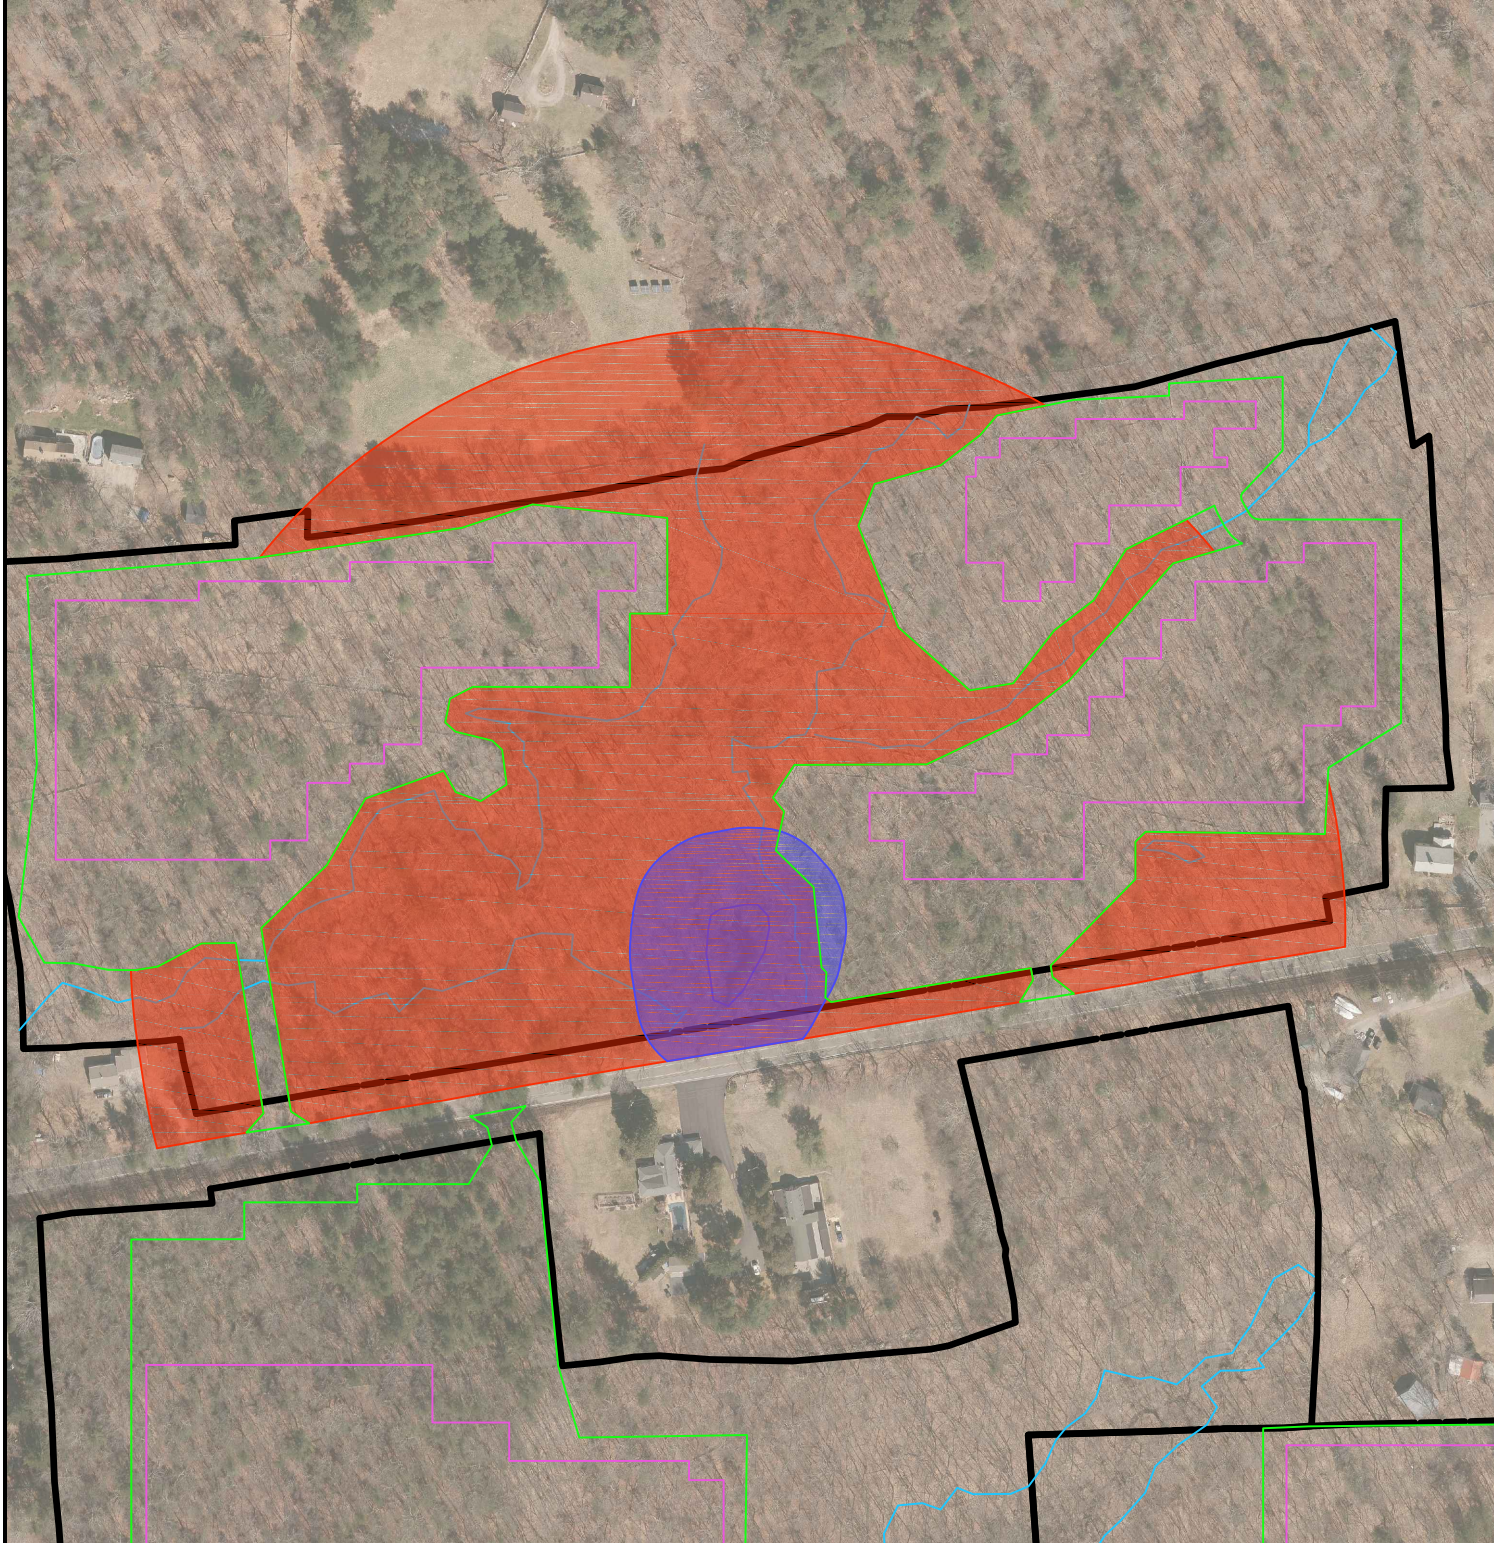
FIGURE 7:

VERNAL POOL C  
EXISTING CONDITIONS  
North Stonington Solar Facility

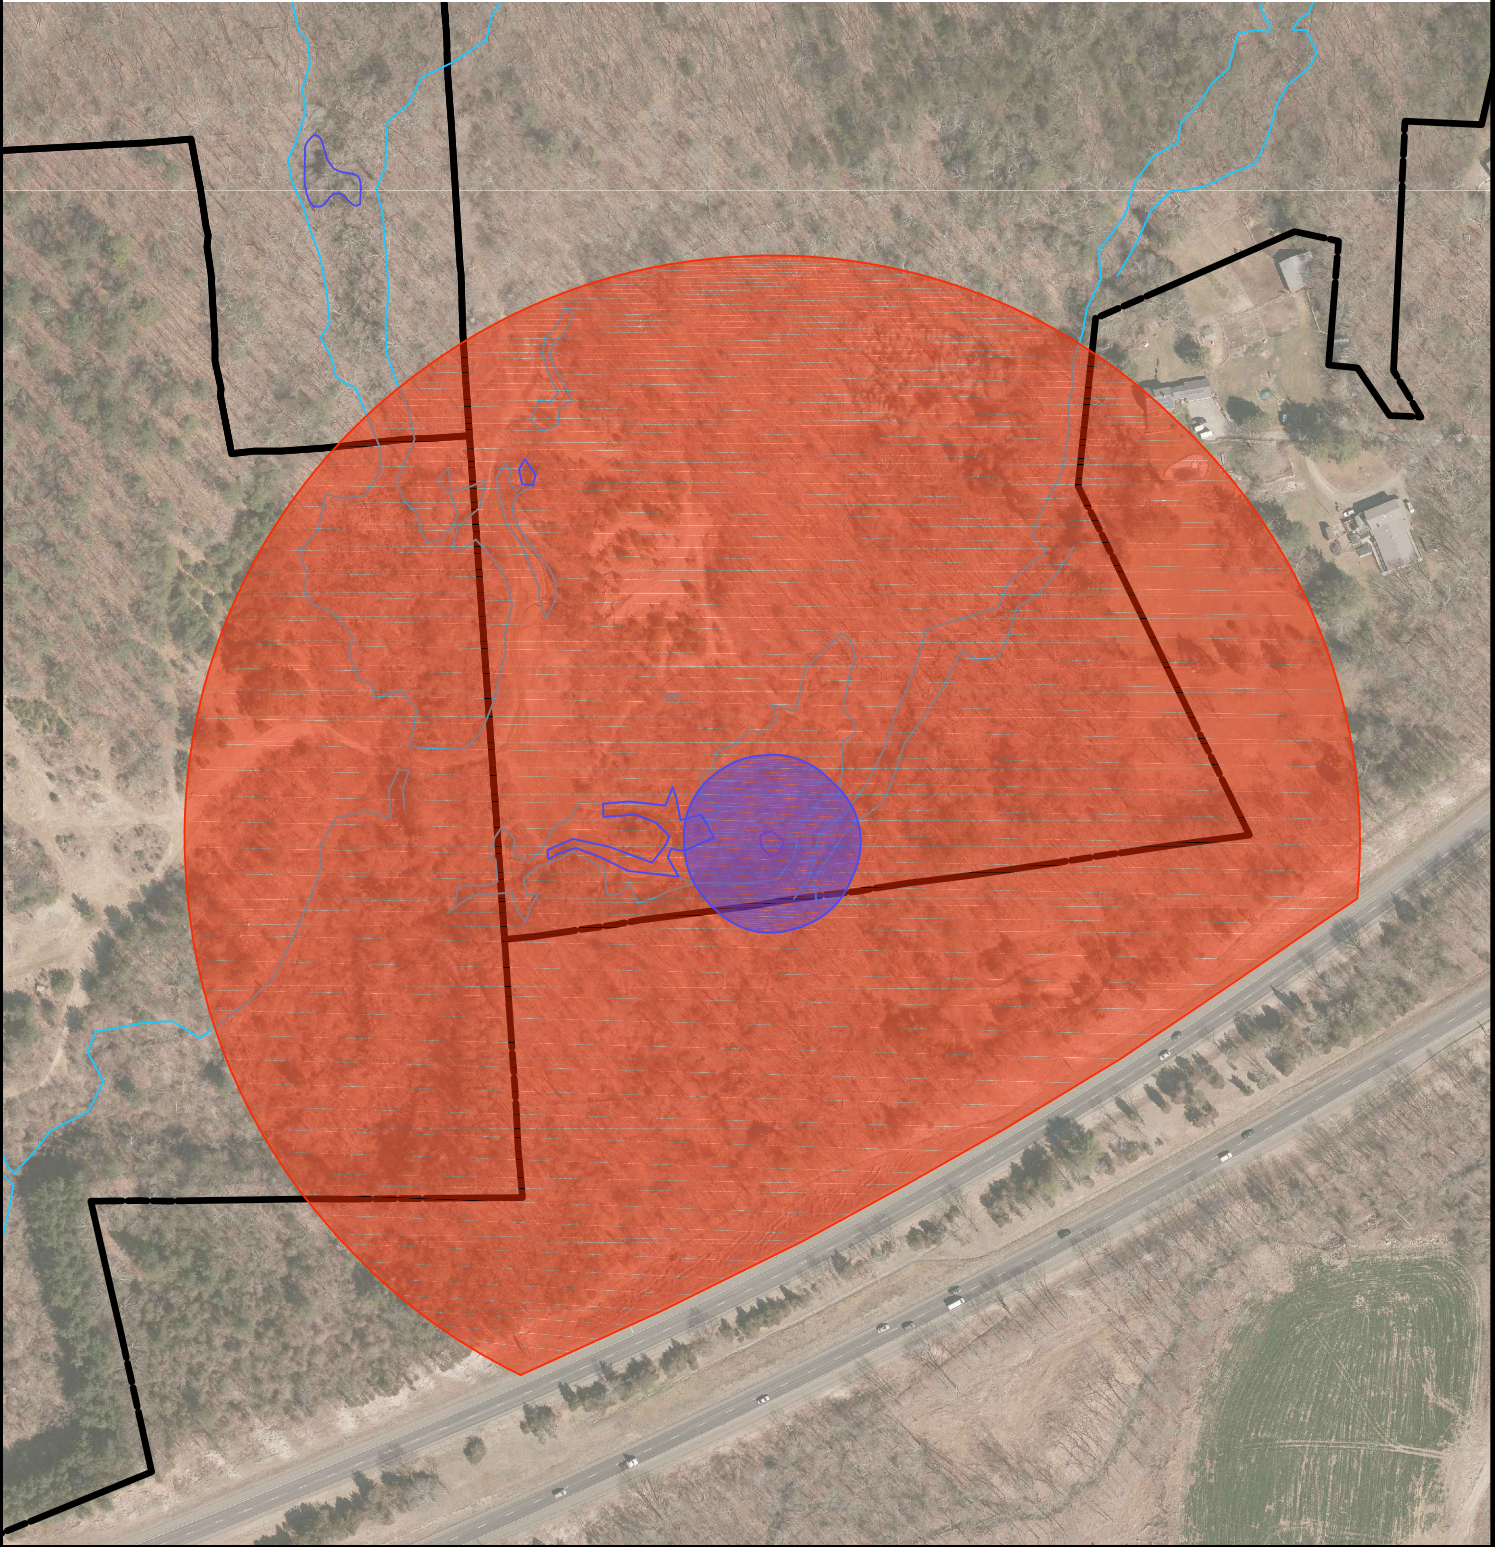
FIGURE 8:

VERNAL POOL C  
PROPOSED CONDITIONS  
North Stonington Solar Facility

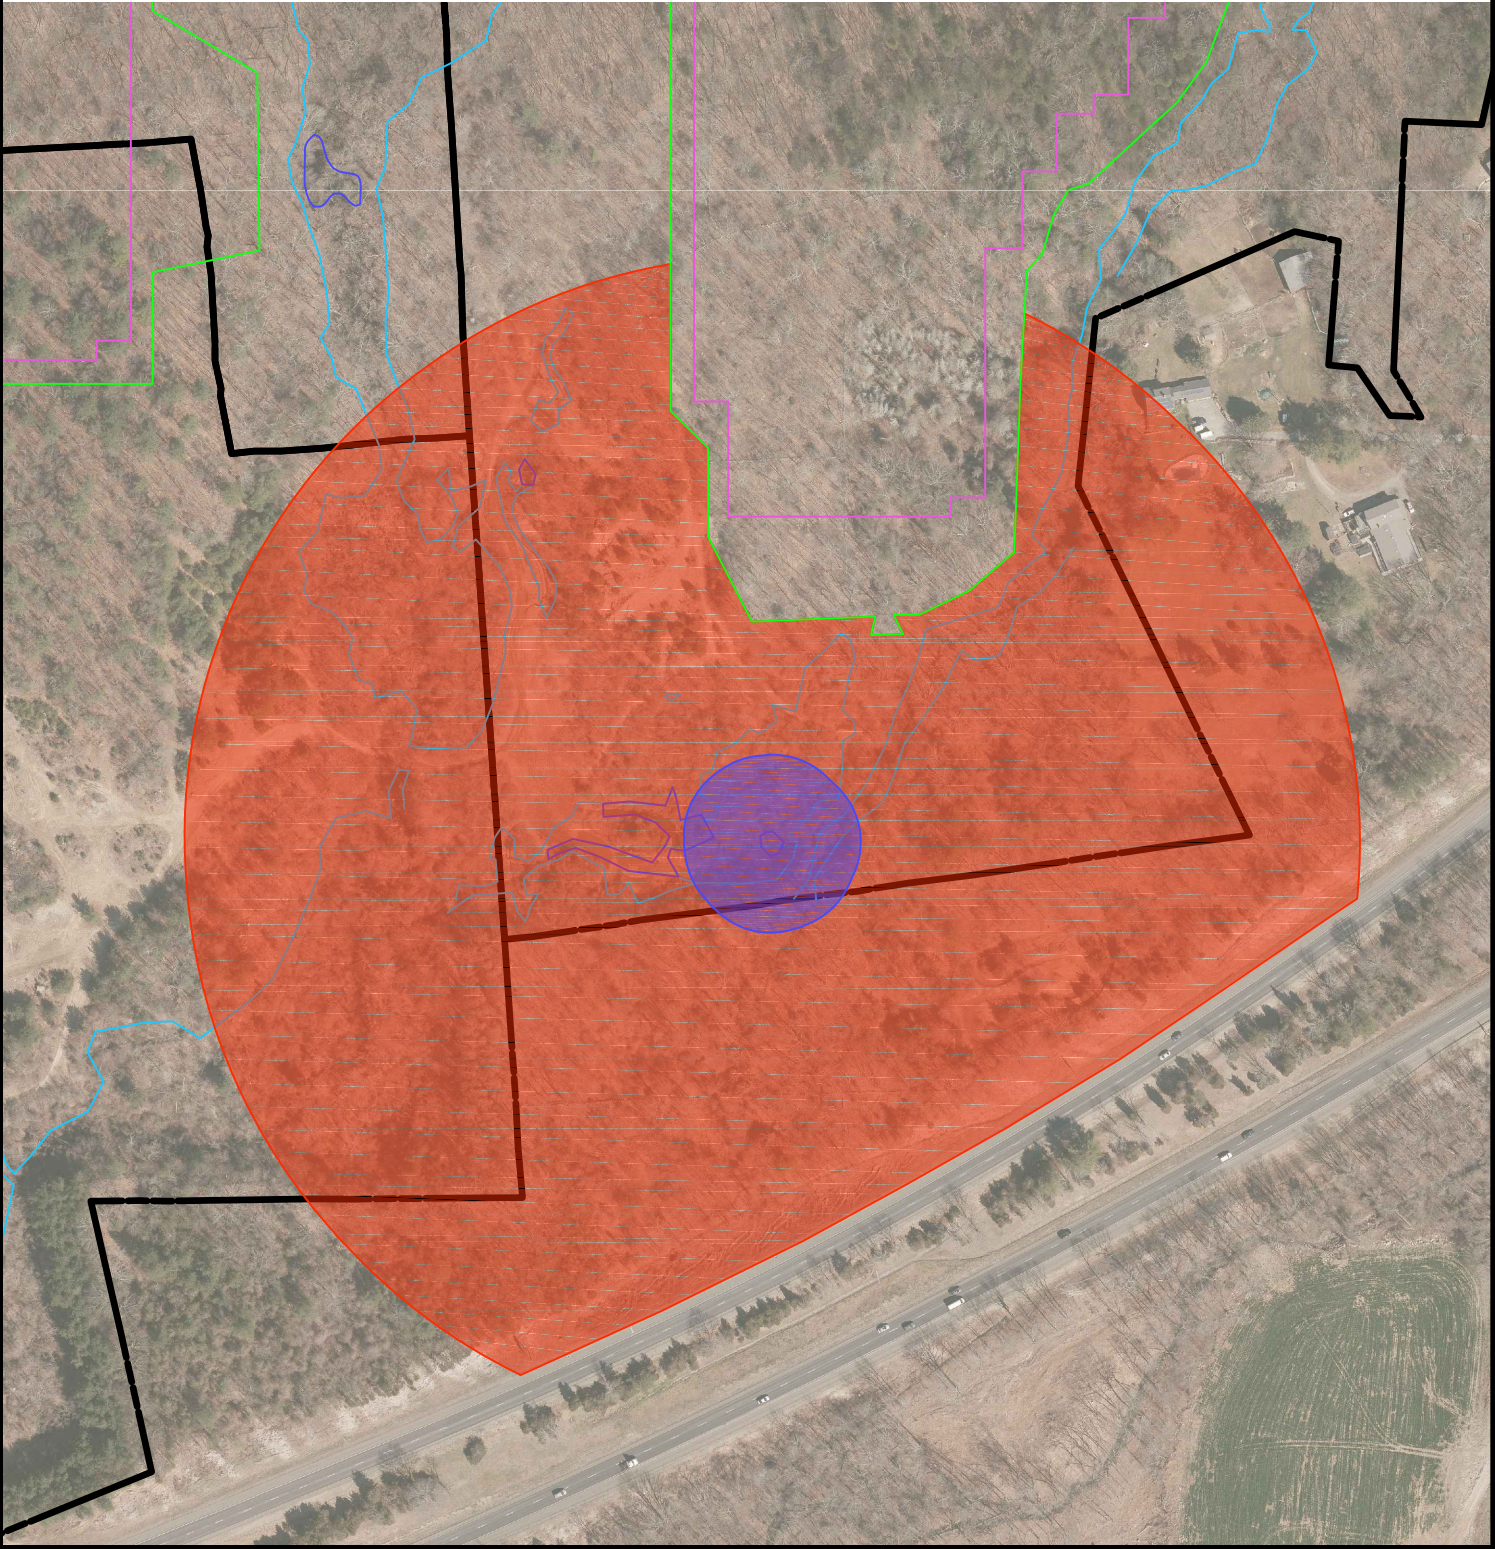
**FIGURE 9:**

VERNAL POOL E  
EXISTING CONDITIONS  
North Stonington Solar Facility

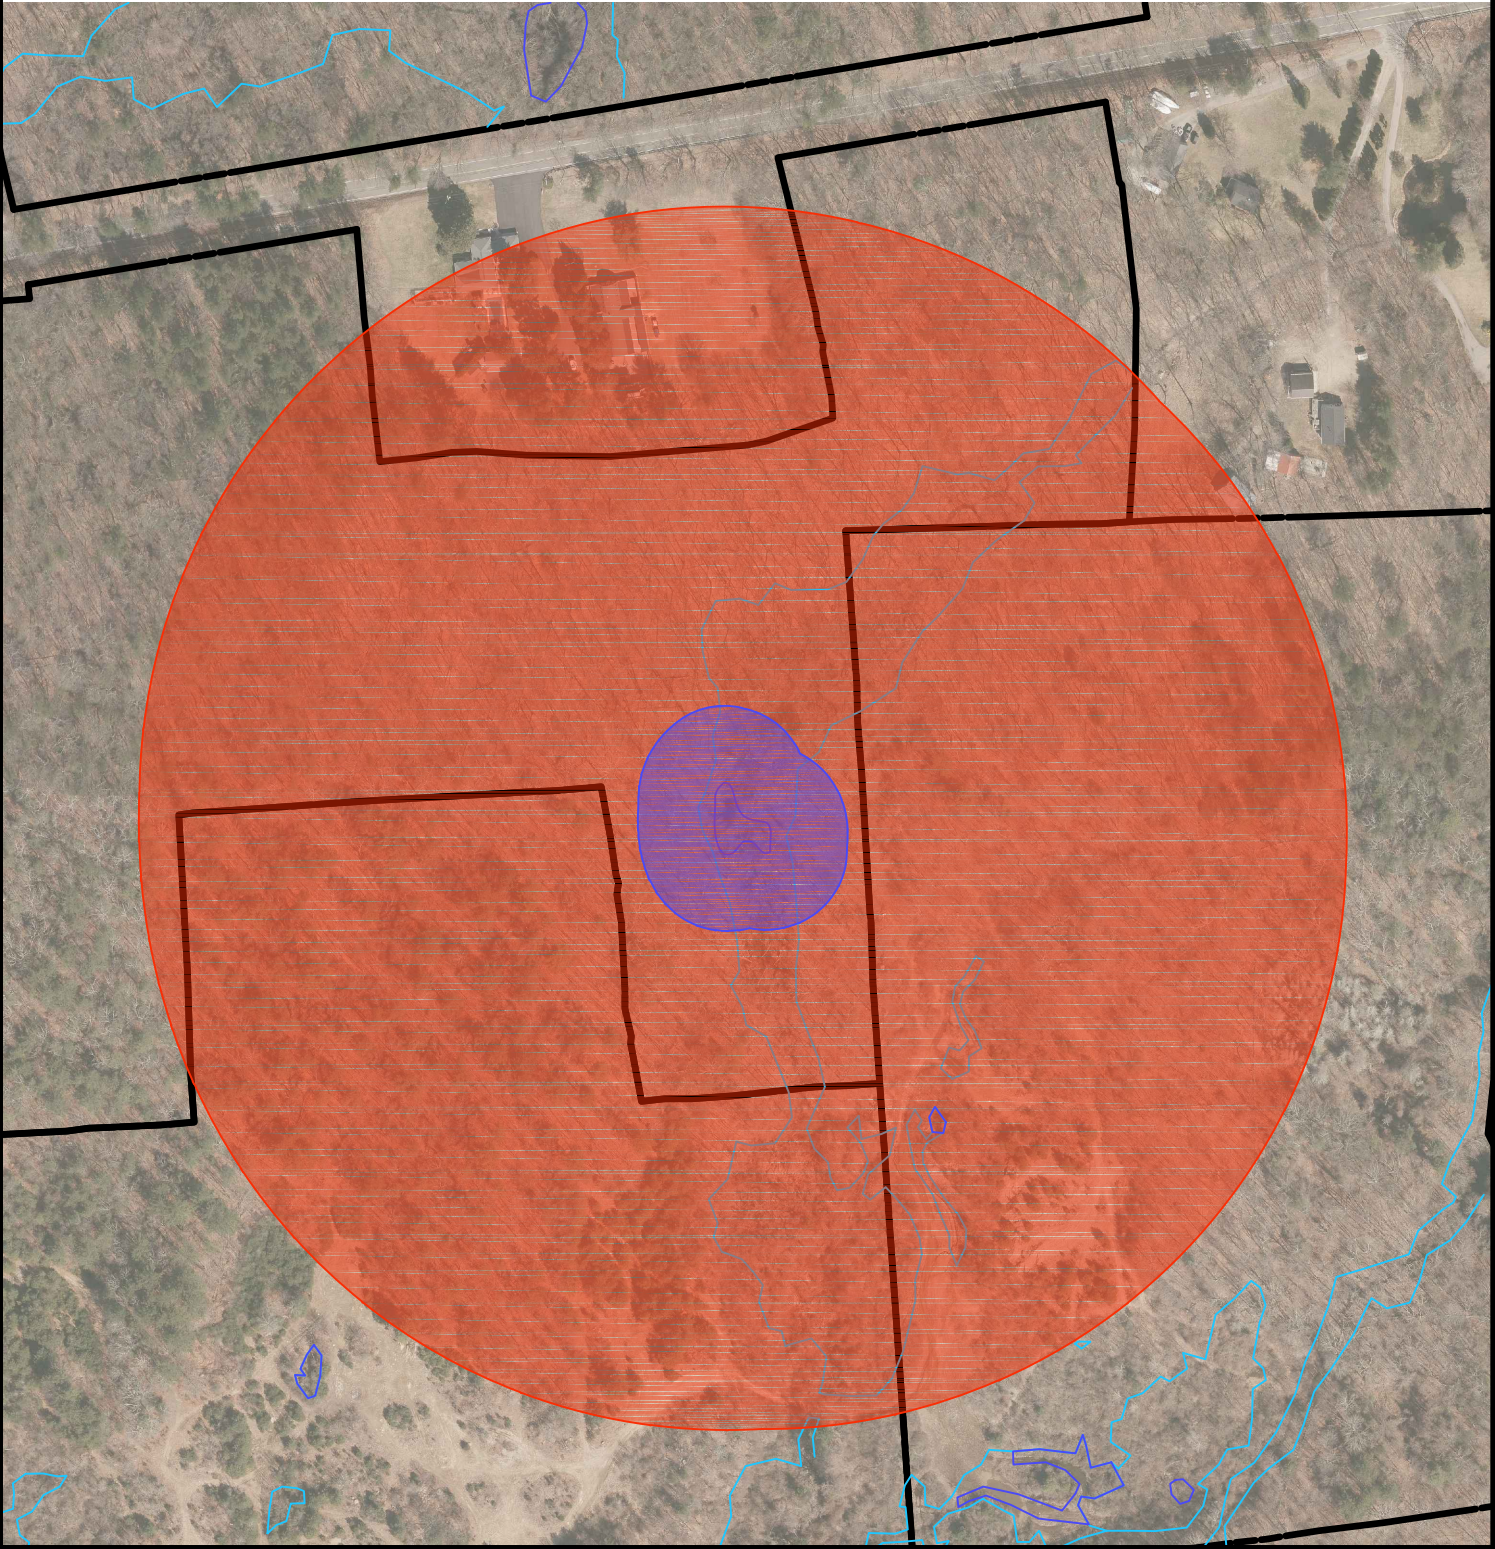
**FIGURE 10:**

VERNAL POOL E  
PROPOSED CONDITIONS  
North Stonington Solar Facility

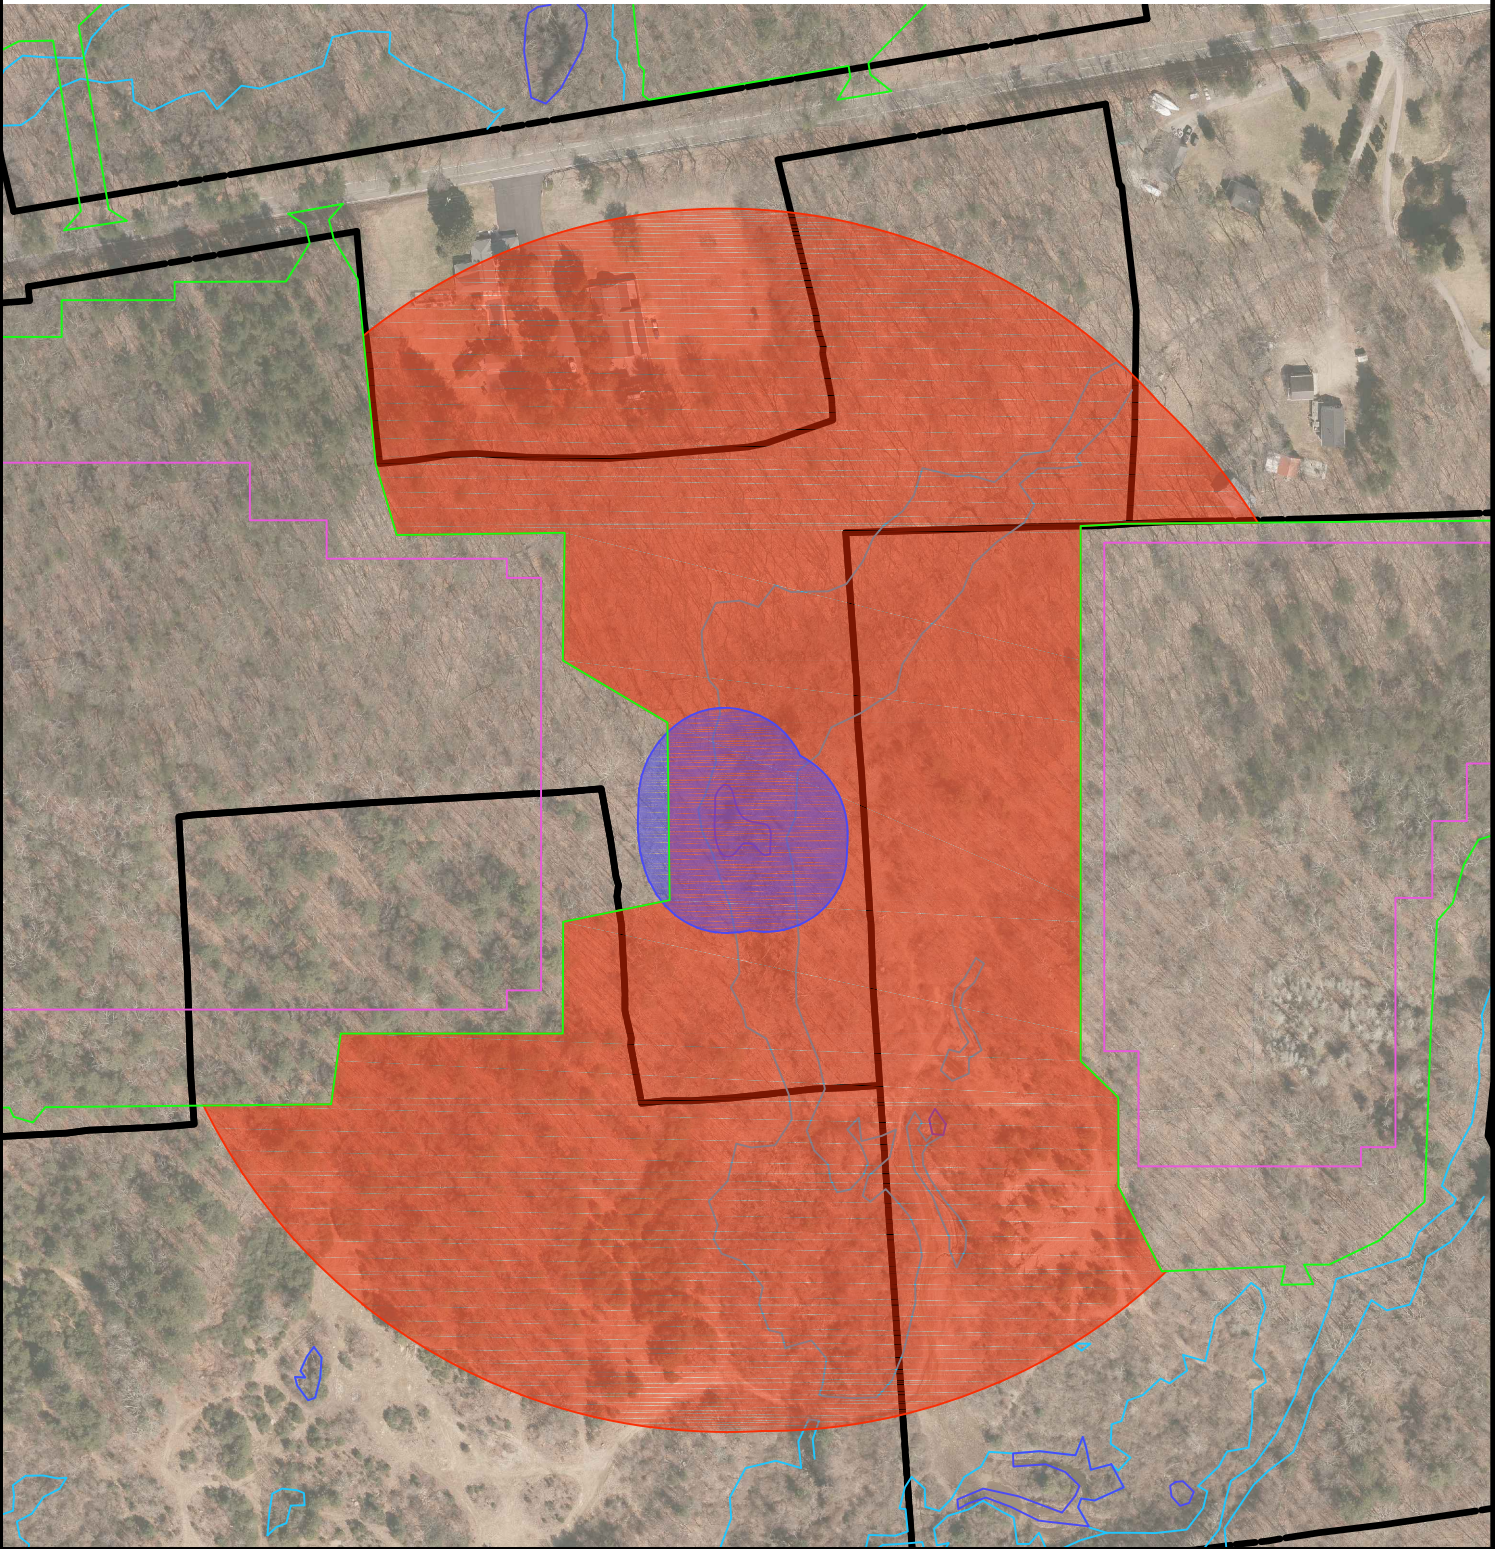
**FIGURE 11:**

VERNAL POOL G  
EXISTING CONDITIONS  
North Stonington Solar Facility

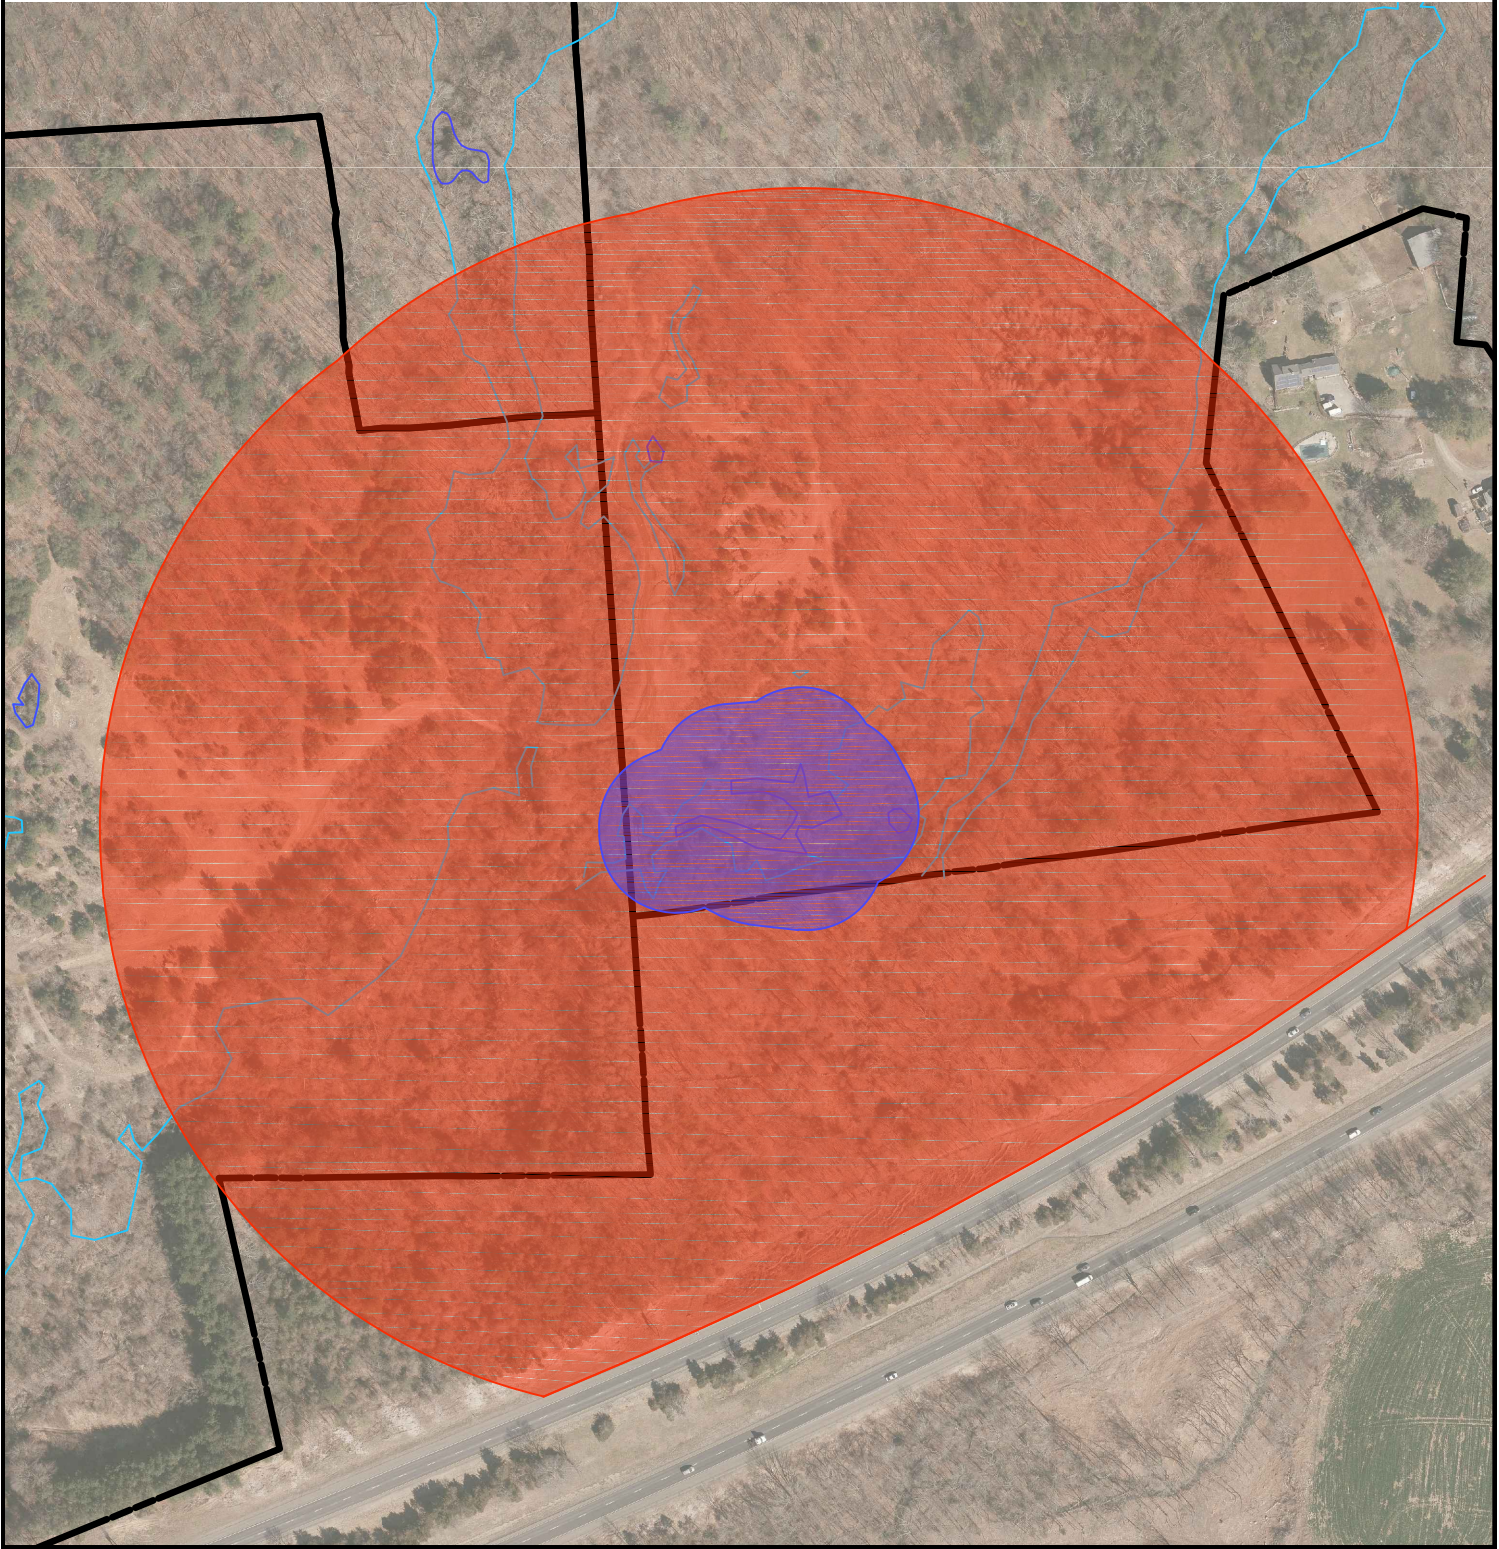
**FIGURE 12:**

VERNAL POOL G  
PROPOSED CONDITIONS  
North Stonington Solar Facility

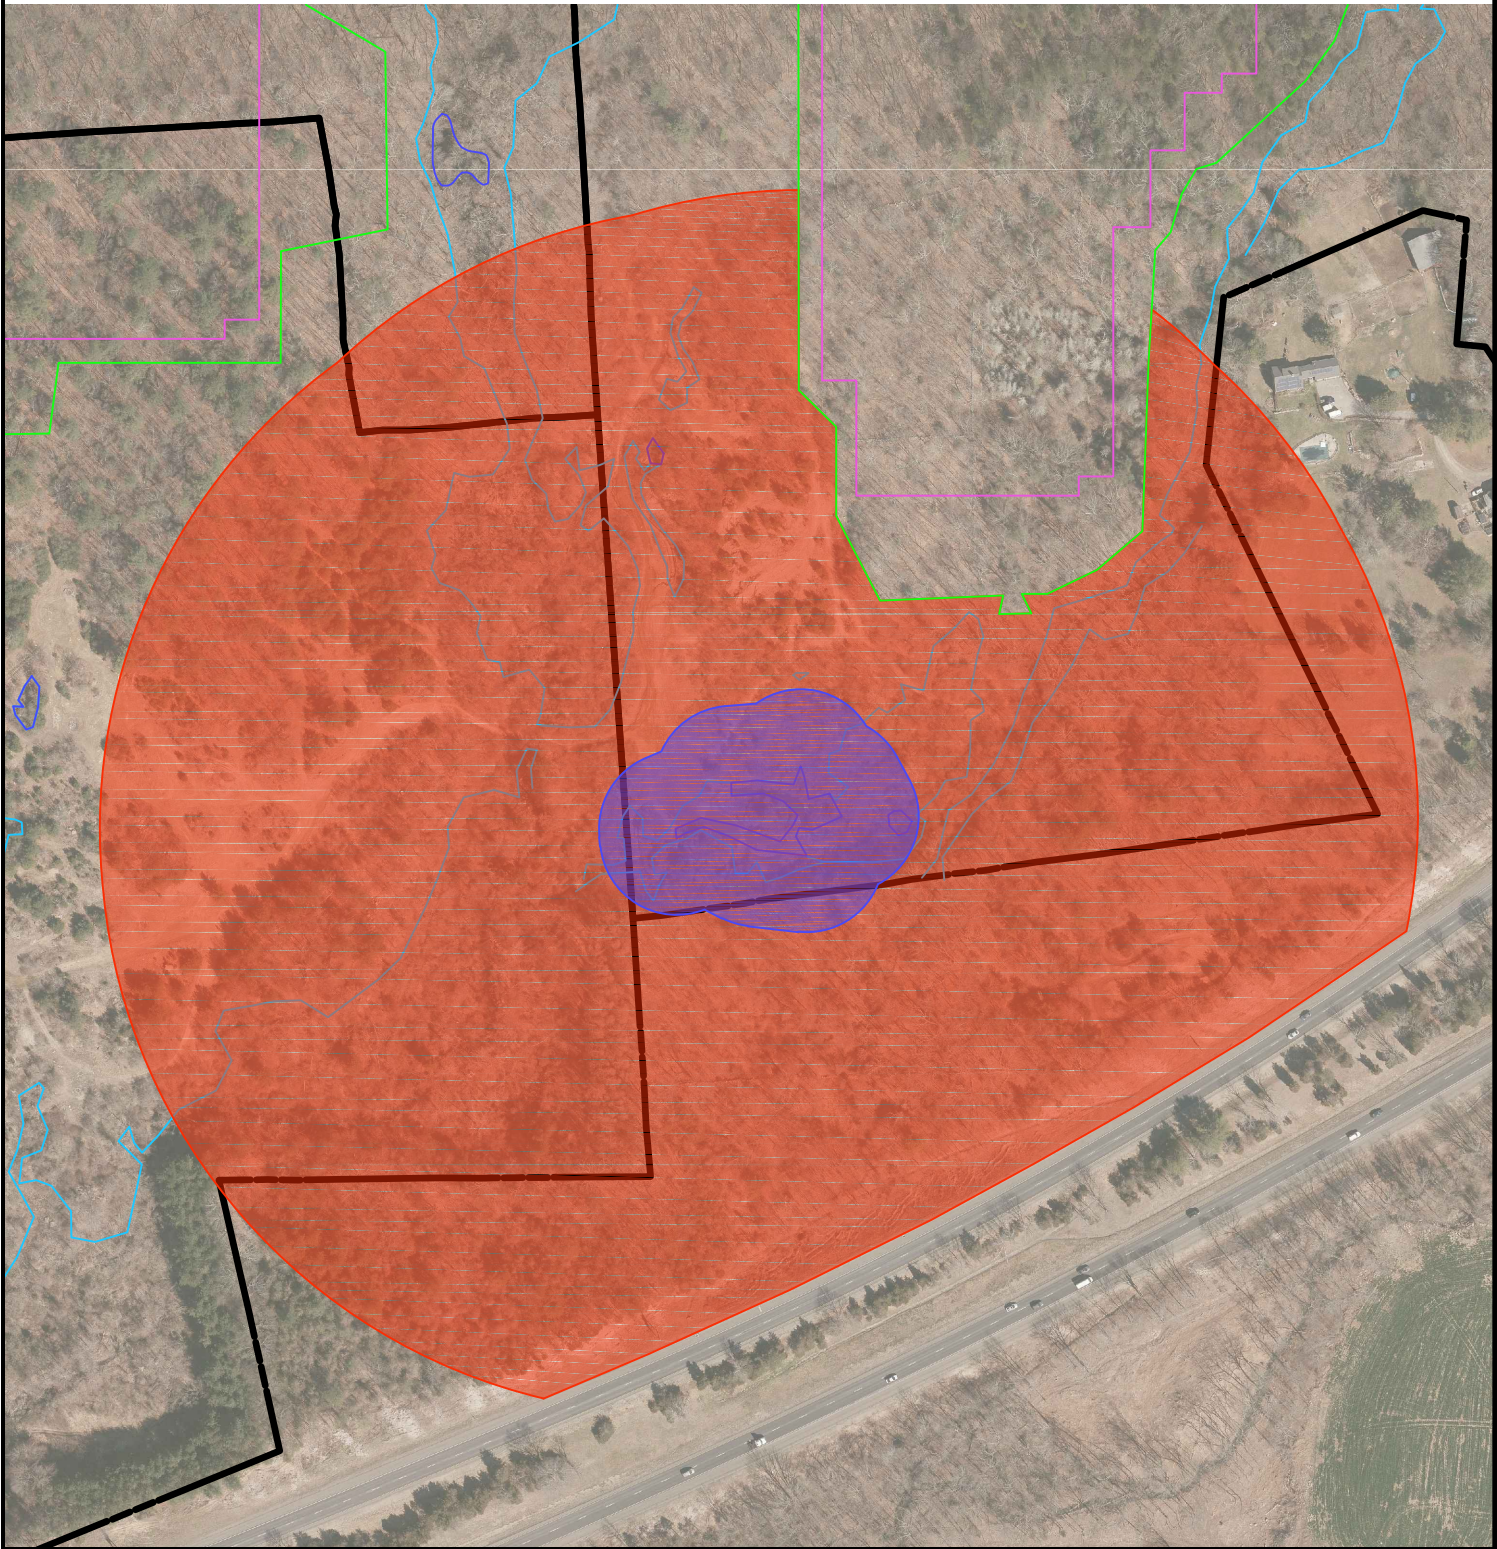
**FIGURE 13:**

VERNAL POOL H  
EXISTING CONDITIONS  
North Stonington Solar Facility

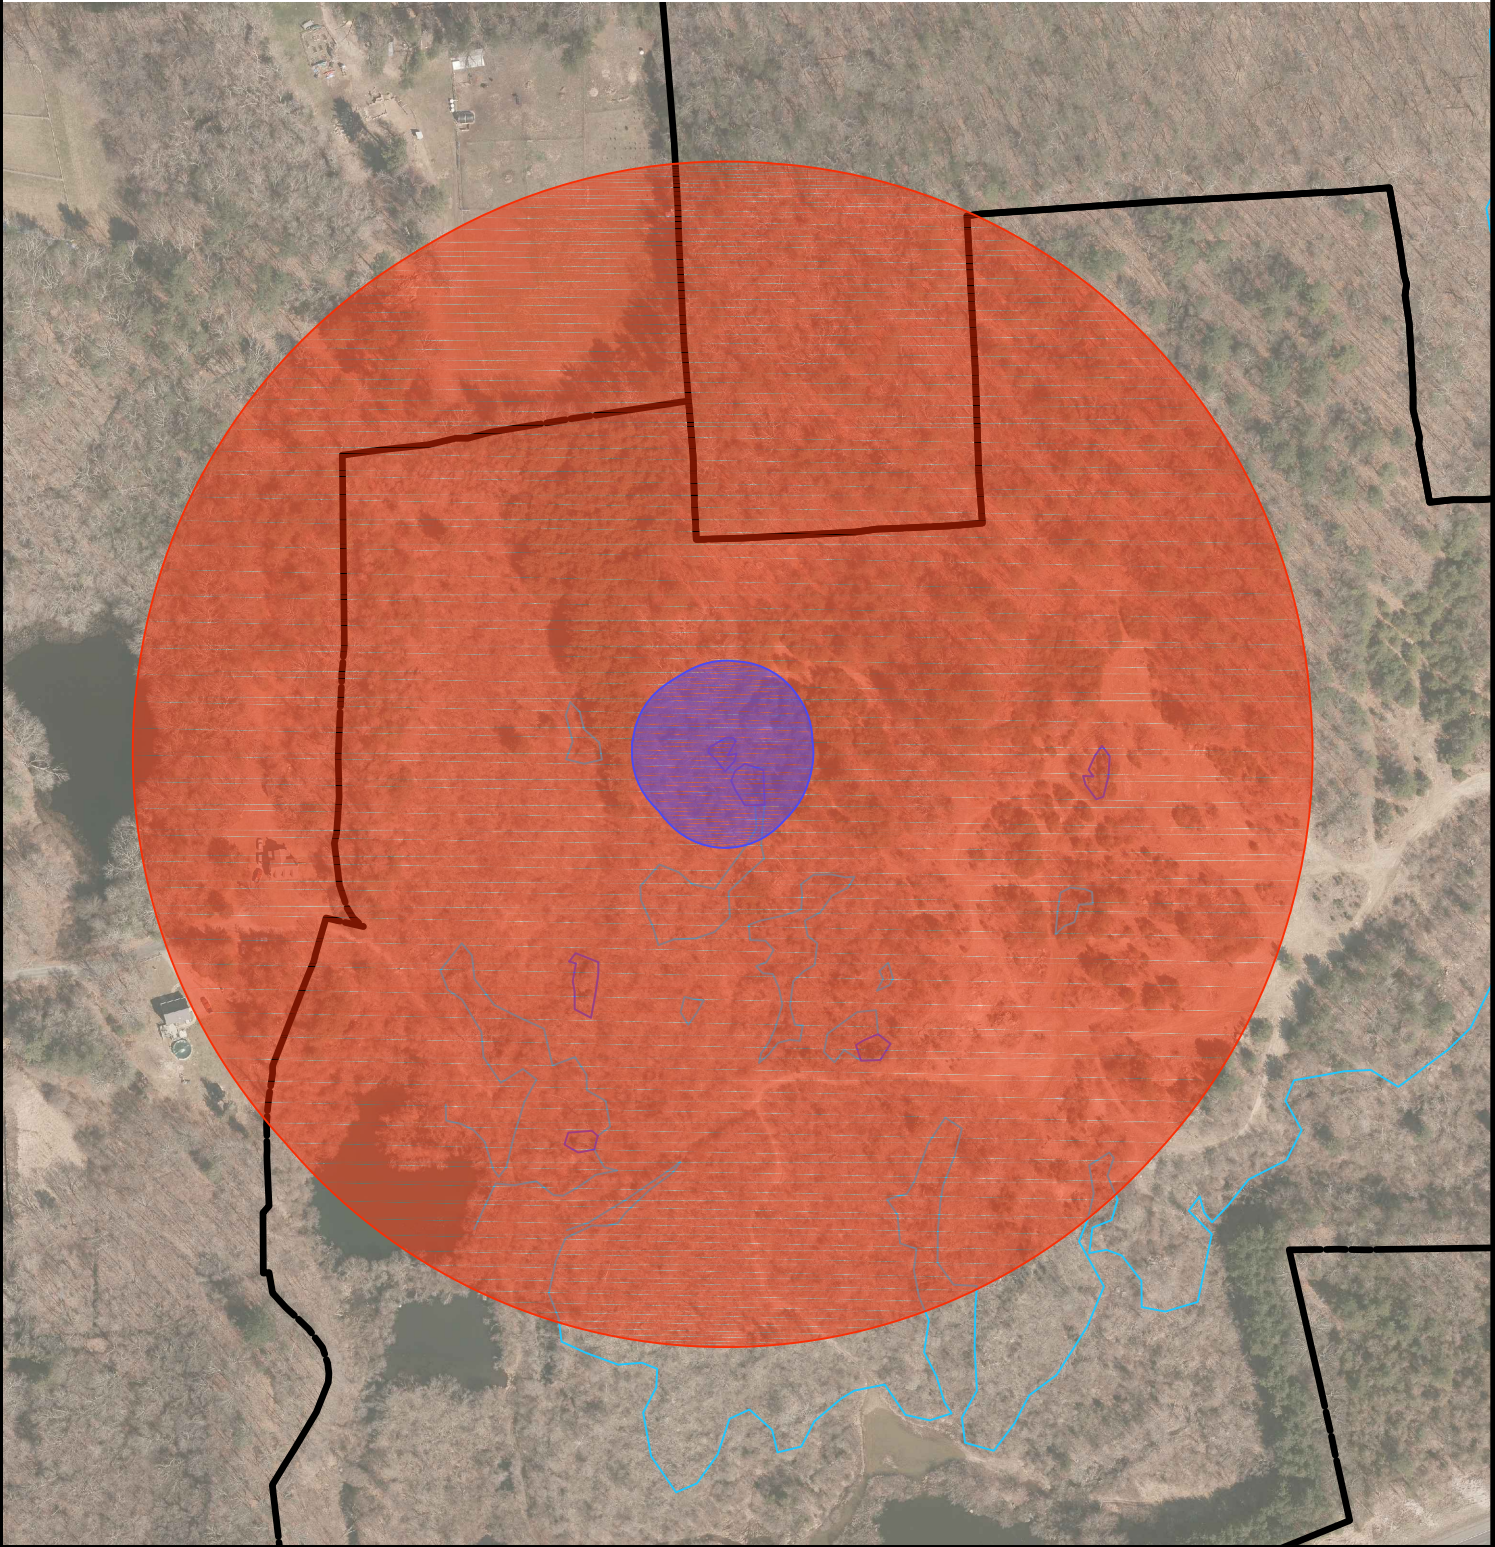
**FIGURE 14:**

VERNAL POOL H  
PROPOSED CONDITIONS  
North Stonington Solar Facility
