## **Attachment C**

Soil Investigations/Mapping  
(Upland – Solar Array Fields)

To: George T. Logan, Rema Ecological Services, LLC  
From: Bill Jackson  
Date: August 15, 2020 [February 15, 2021 – Revised]  
Subject: Spade & Auger Test Holes to Determine Soil Drainage Class  
North Stonington, CT Solar Project

Table A: Vernal Pool Surveys (2017 to 2020); Figures 4 to 26; Annotated Photographs (1 – 47)

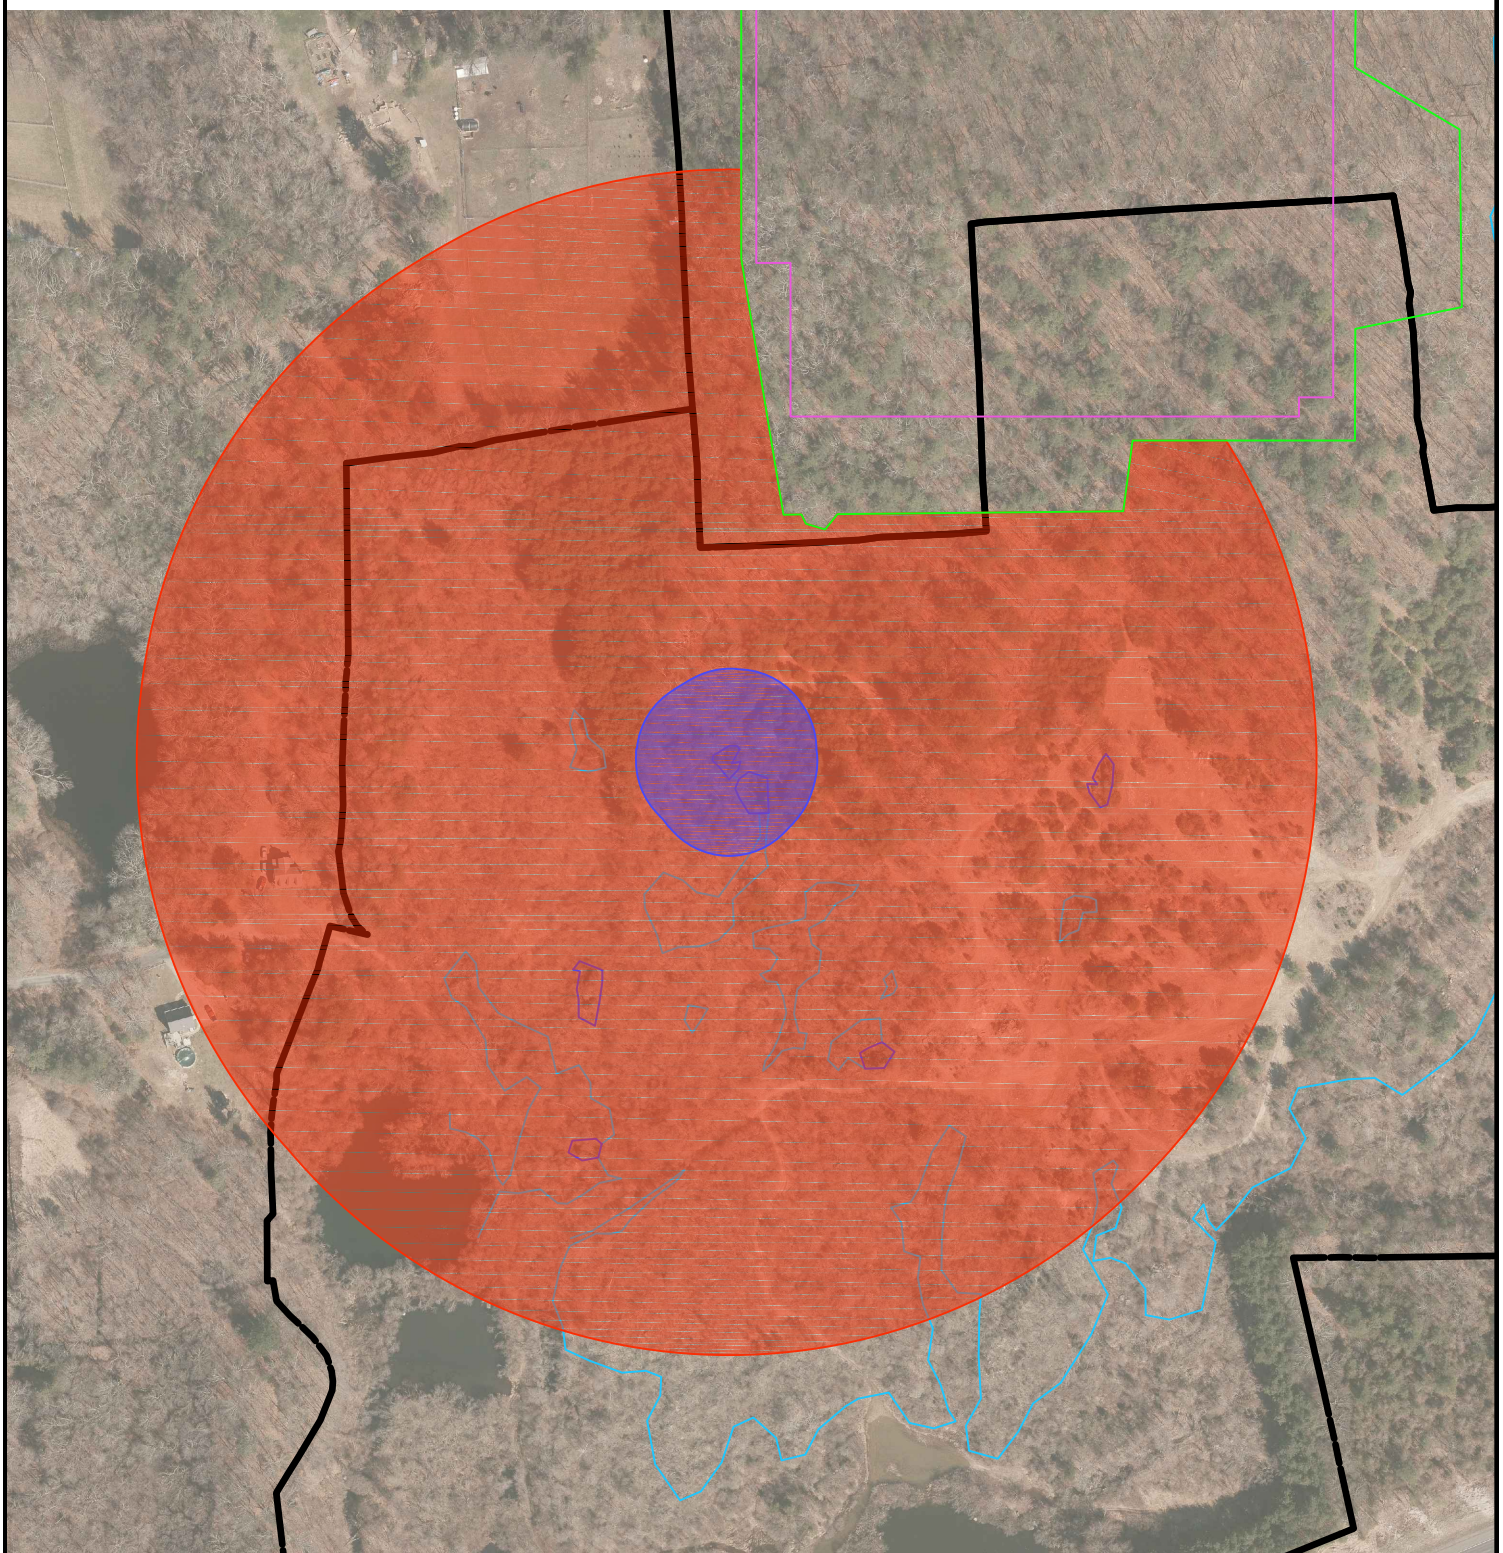
**FIGURE 15:**

VERNAL POOL I  
EXISTING CONDITIONS  
North Stonington Solar Facility

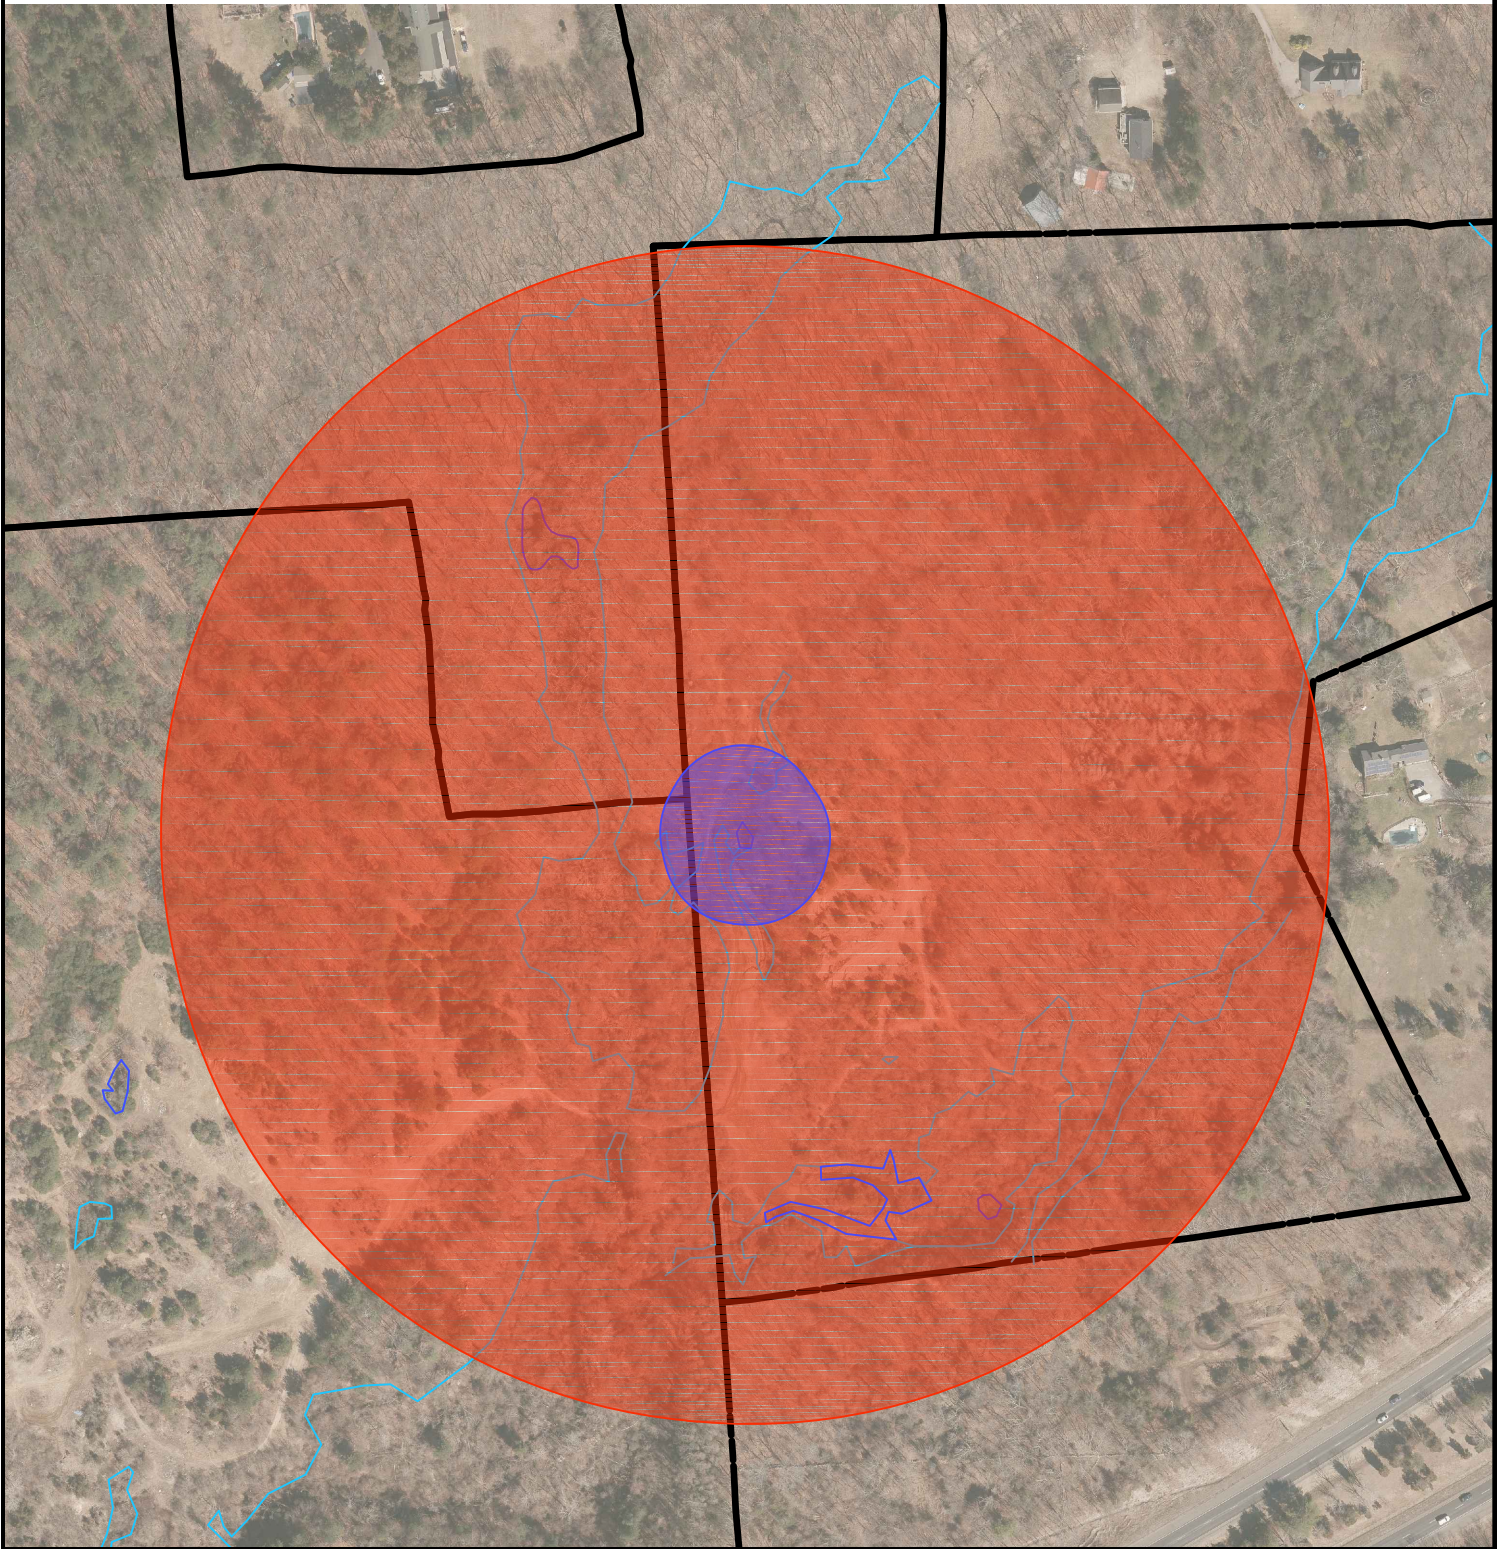
**FIGURE 16:**

VERNAL POOL I  
PROPOSED CONDITIONS  
North Stonington Solar Facility

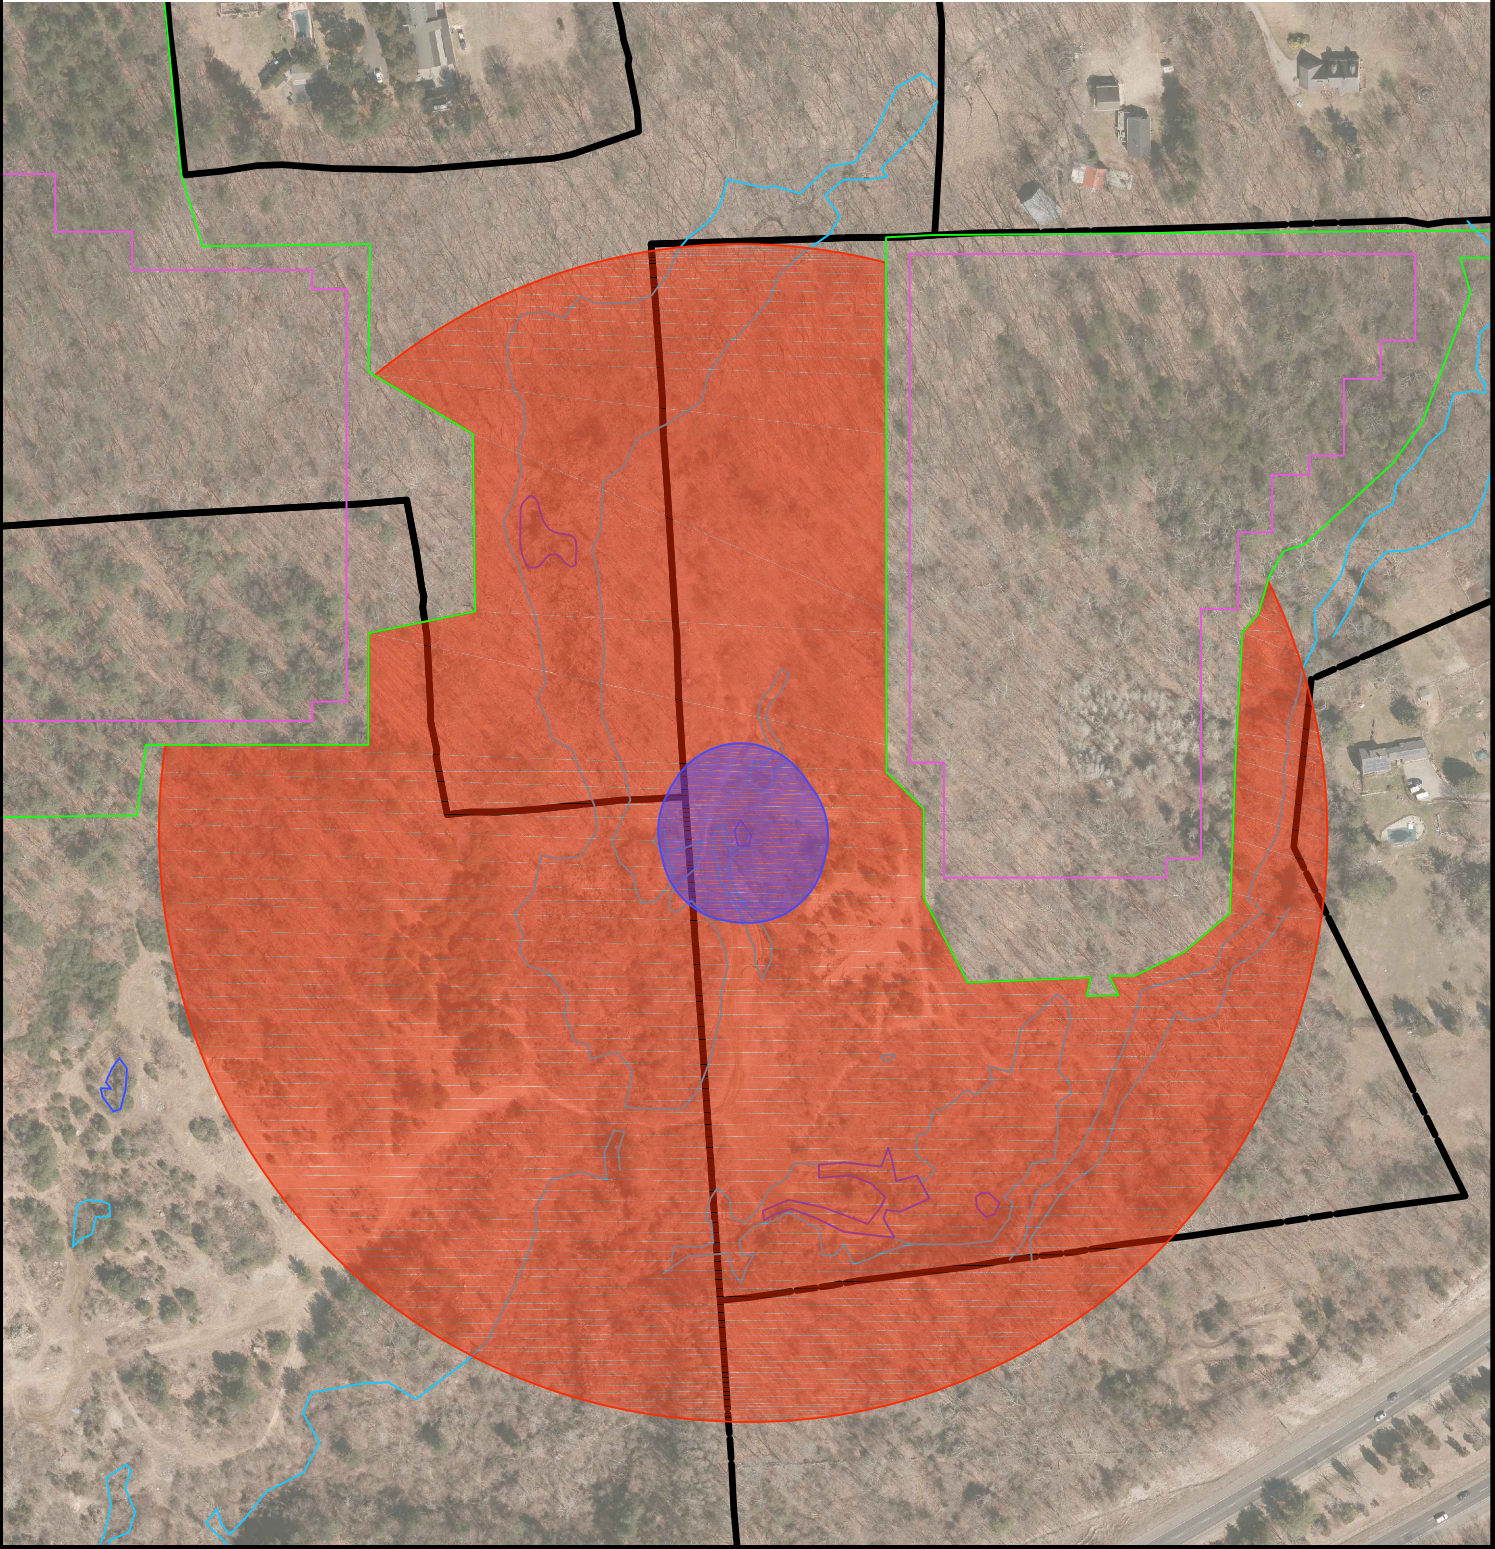
**FIGURE 17:**

VERNAL POOL L  
EXISTING CONDITIONS  
North Stonington Solar Facility
