VERNAL POOL L
PROPOSED CONDITIONS
North Stonington Solar Facility

Attachment E

Annotated Photos of Wildlife including Listed Species

Annotated Photos of Wetland/Watercourse Impact Areas
(IA-1 to IA-4)

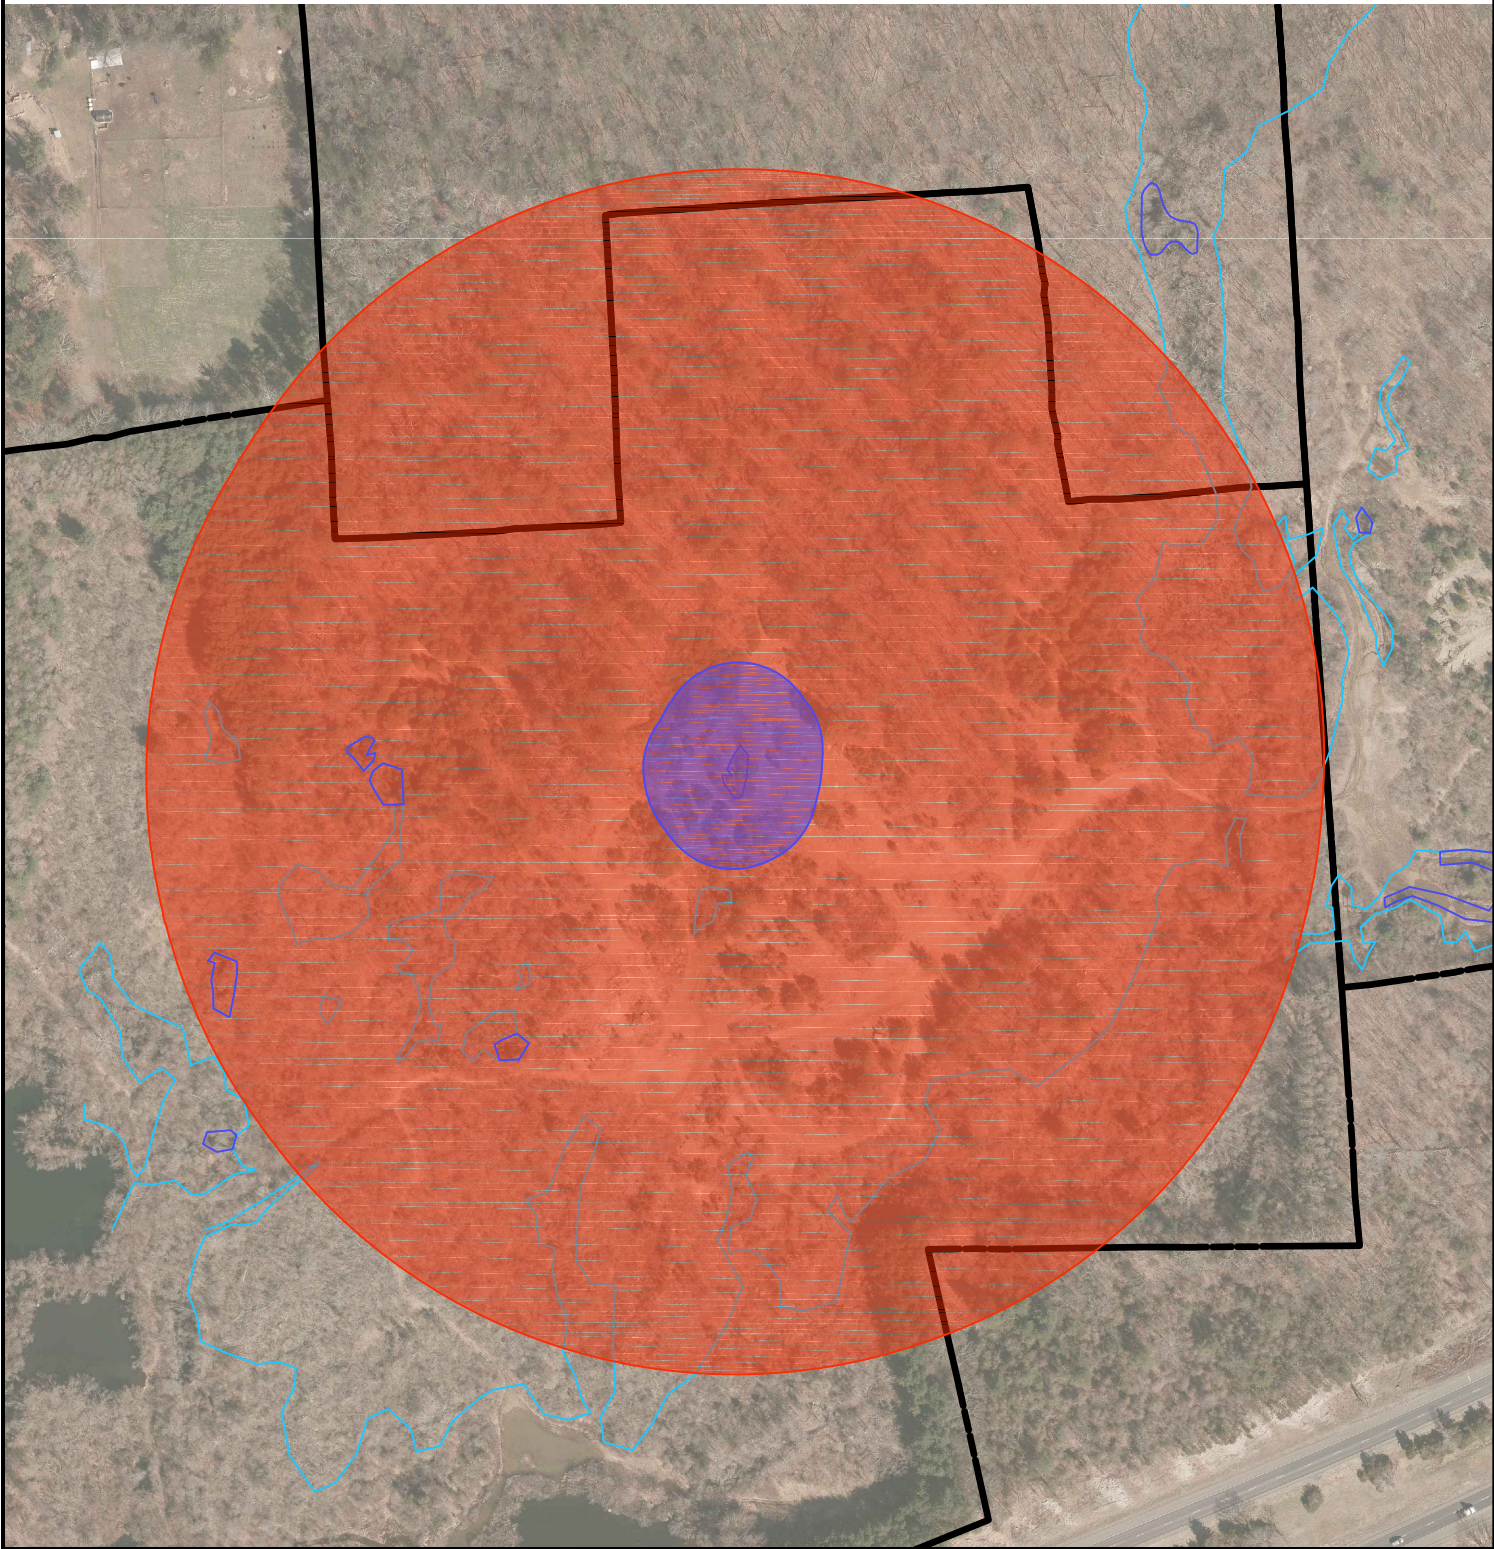
FIGURE 19:

VERNAL POOL N
EXISTING CONDITIONS
North Stonington Solar Facility

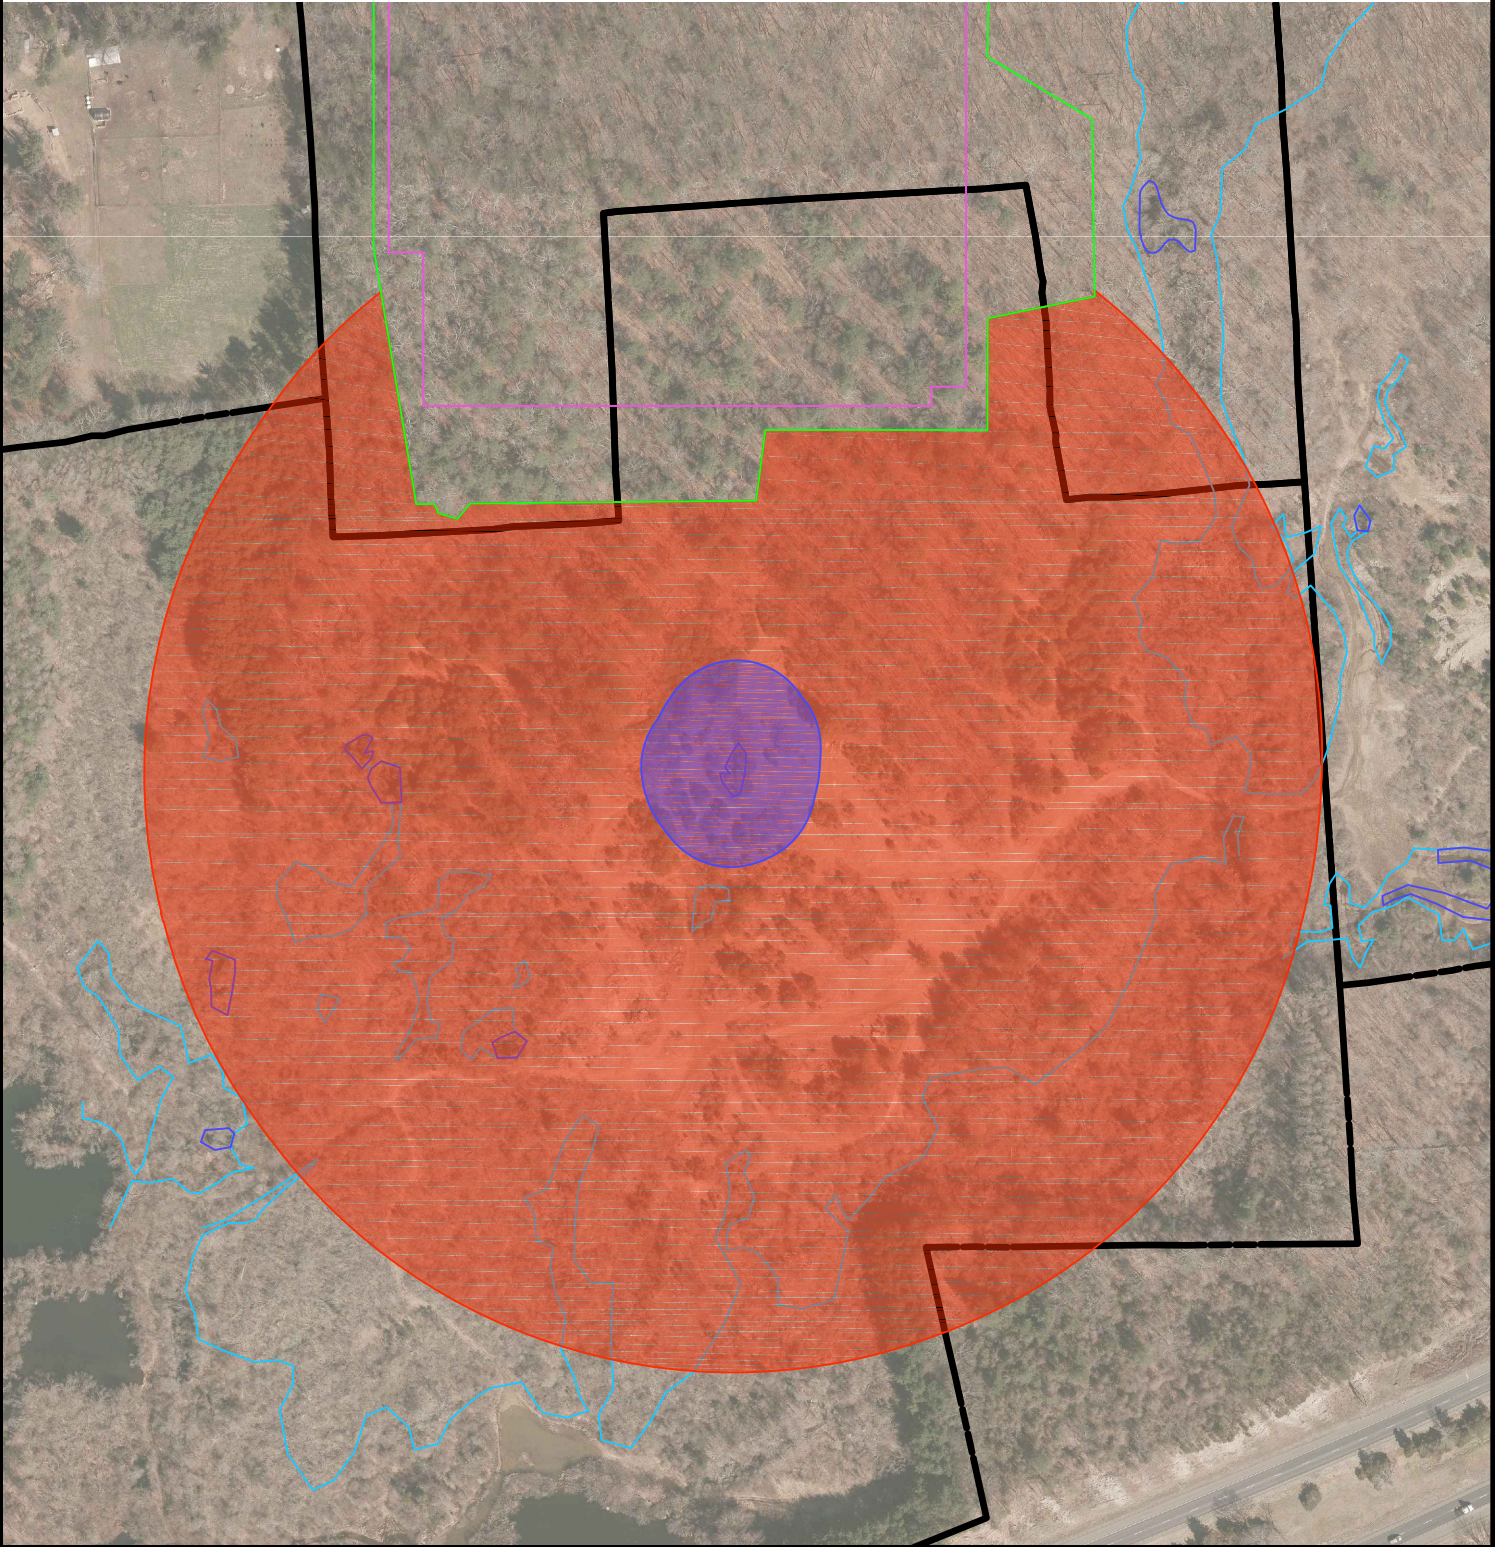
FIGURE 20:

VERNAL POOL N
PROPOSED CONDITIONS
North Stonington Solar Facility

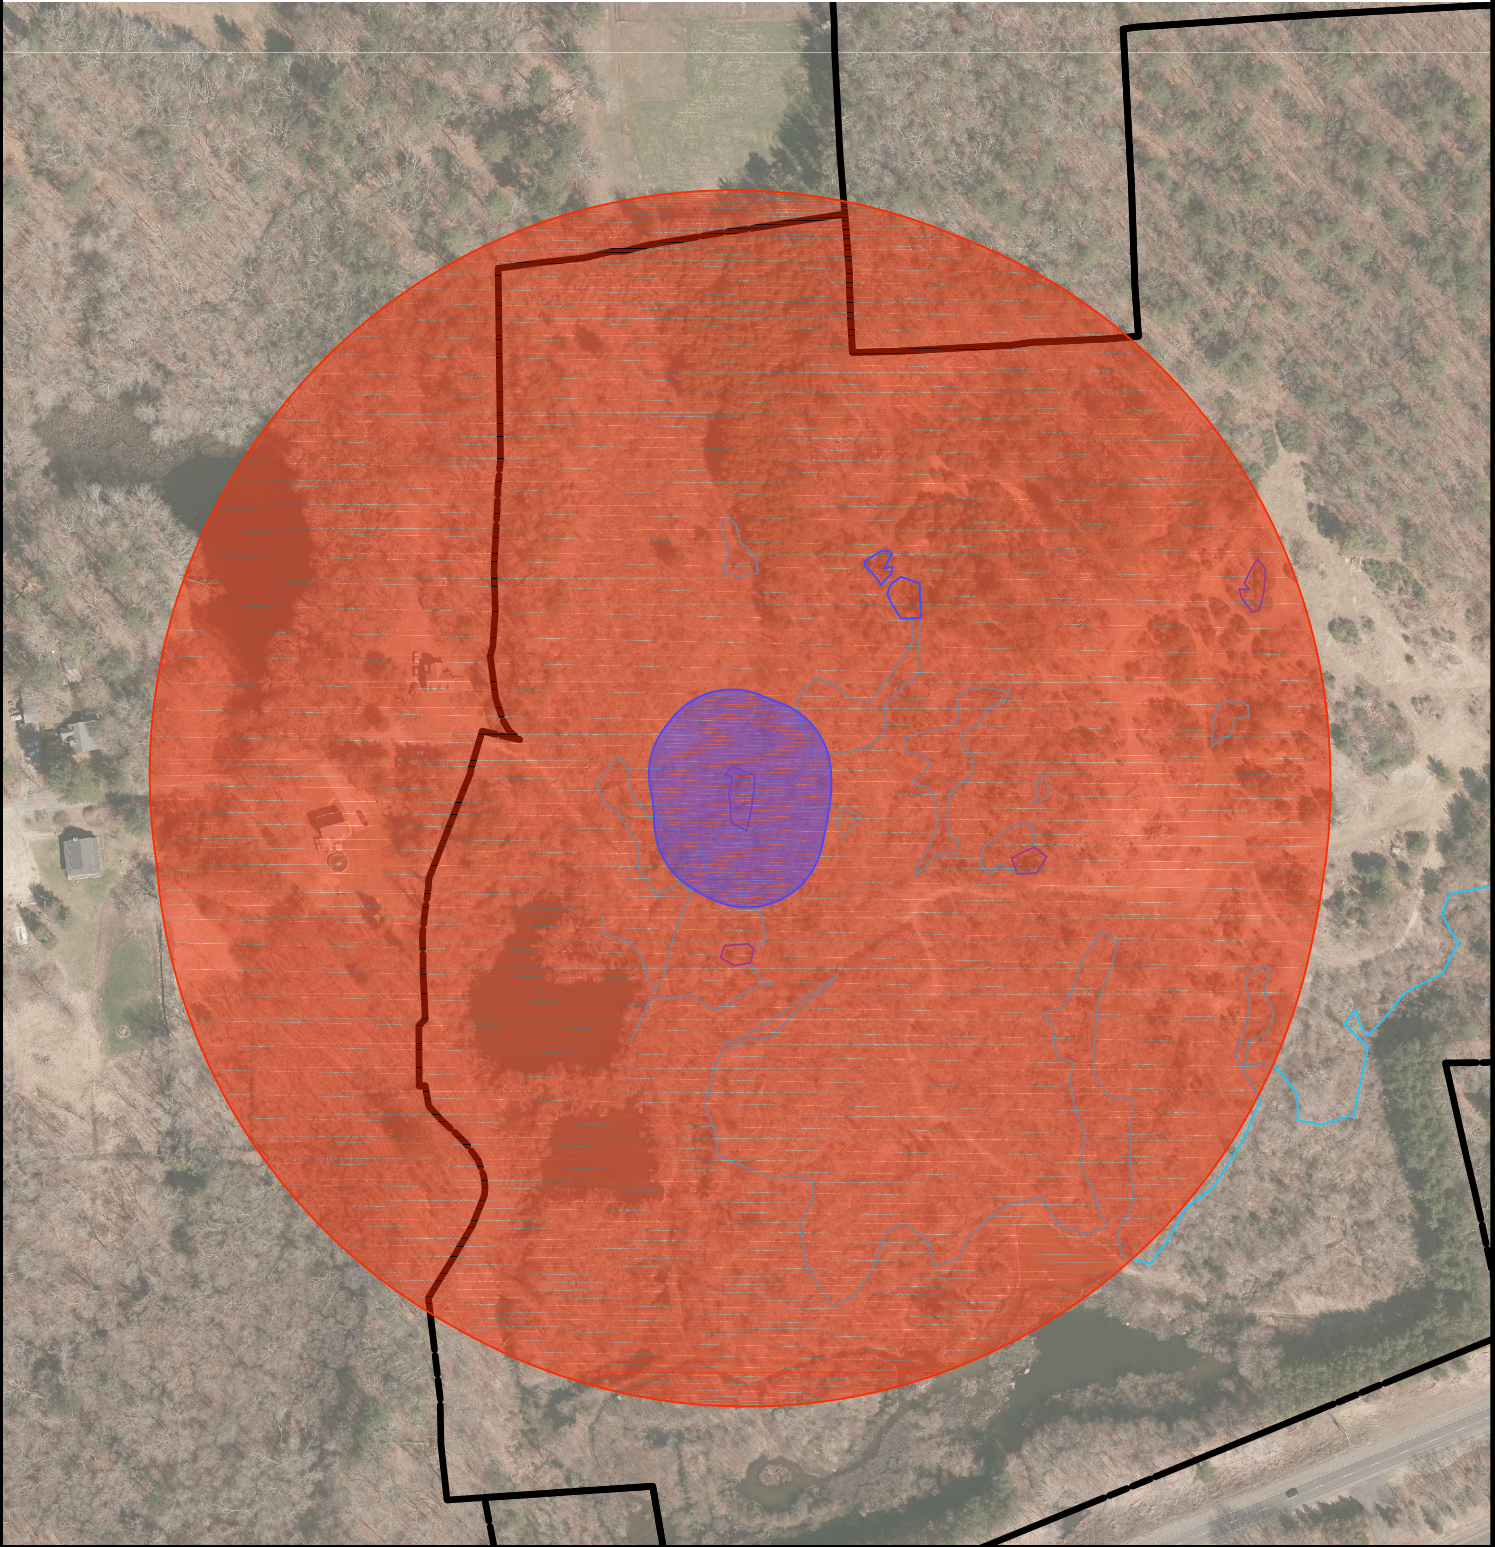
FIGURE 21:

VERNAL POOL O
EXISTING CONDITIONS
North Stonington Solar Facility

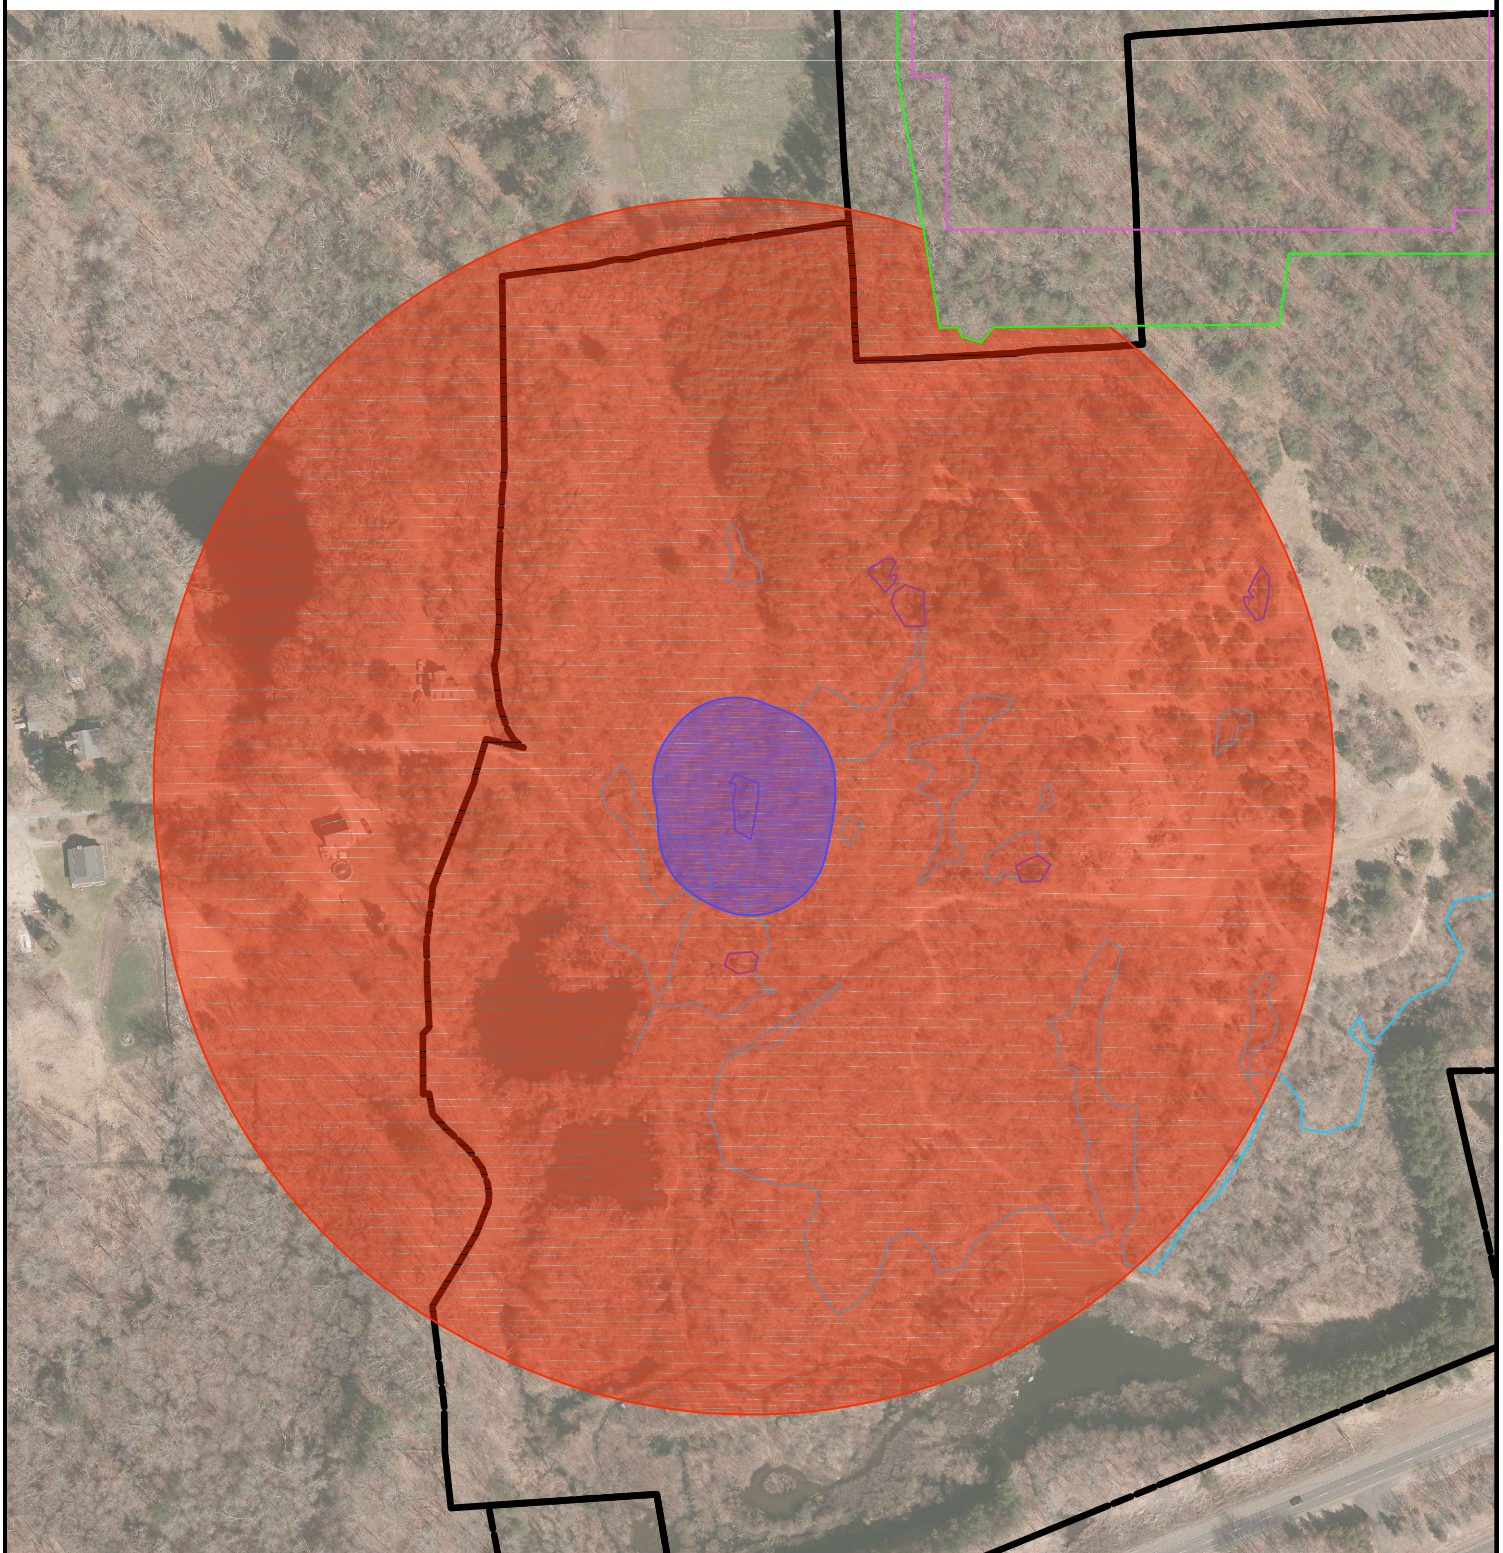
FIGURE 22:

VERNAL POOL O
PROPOSED CONDITIONS
North Stonington Solar Facility

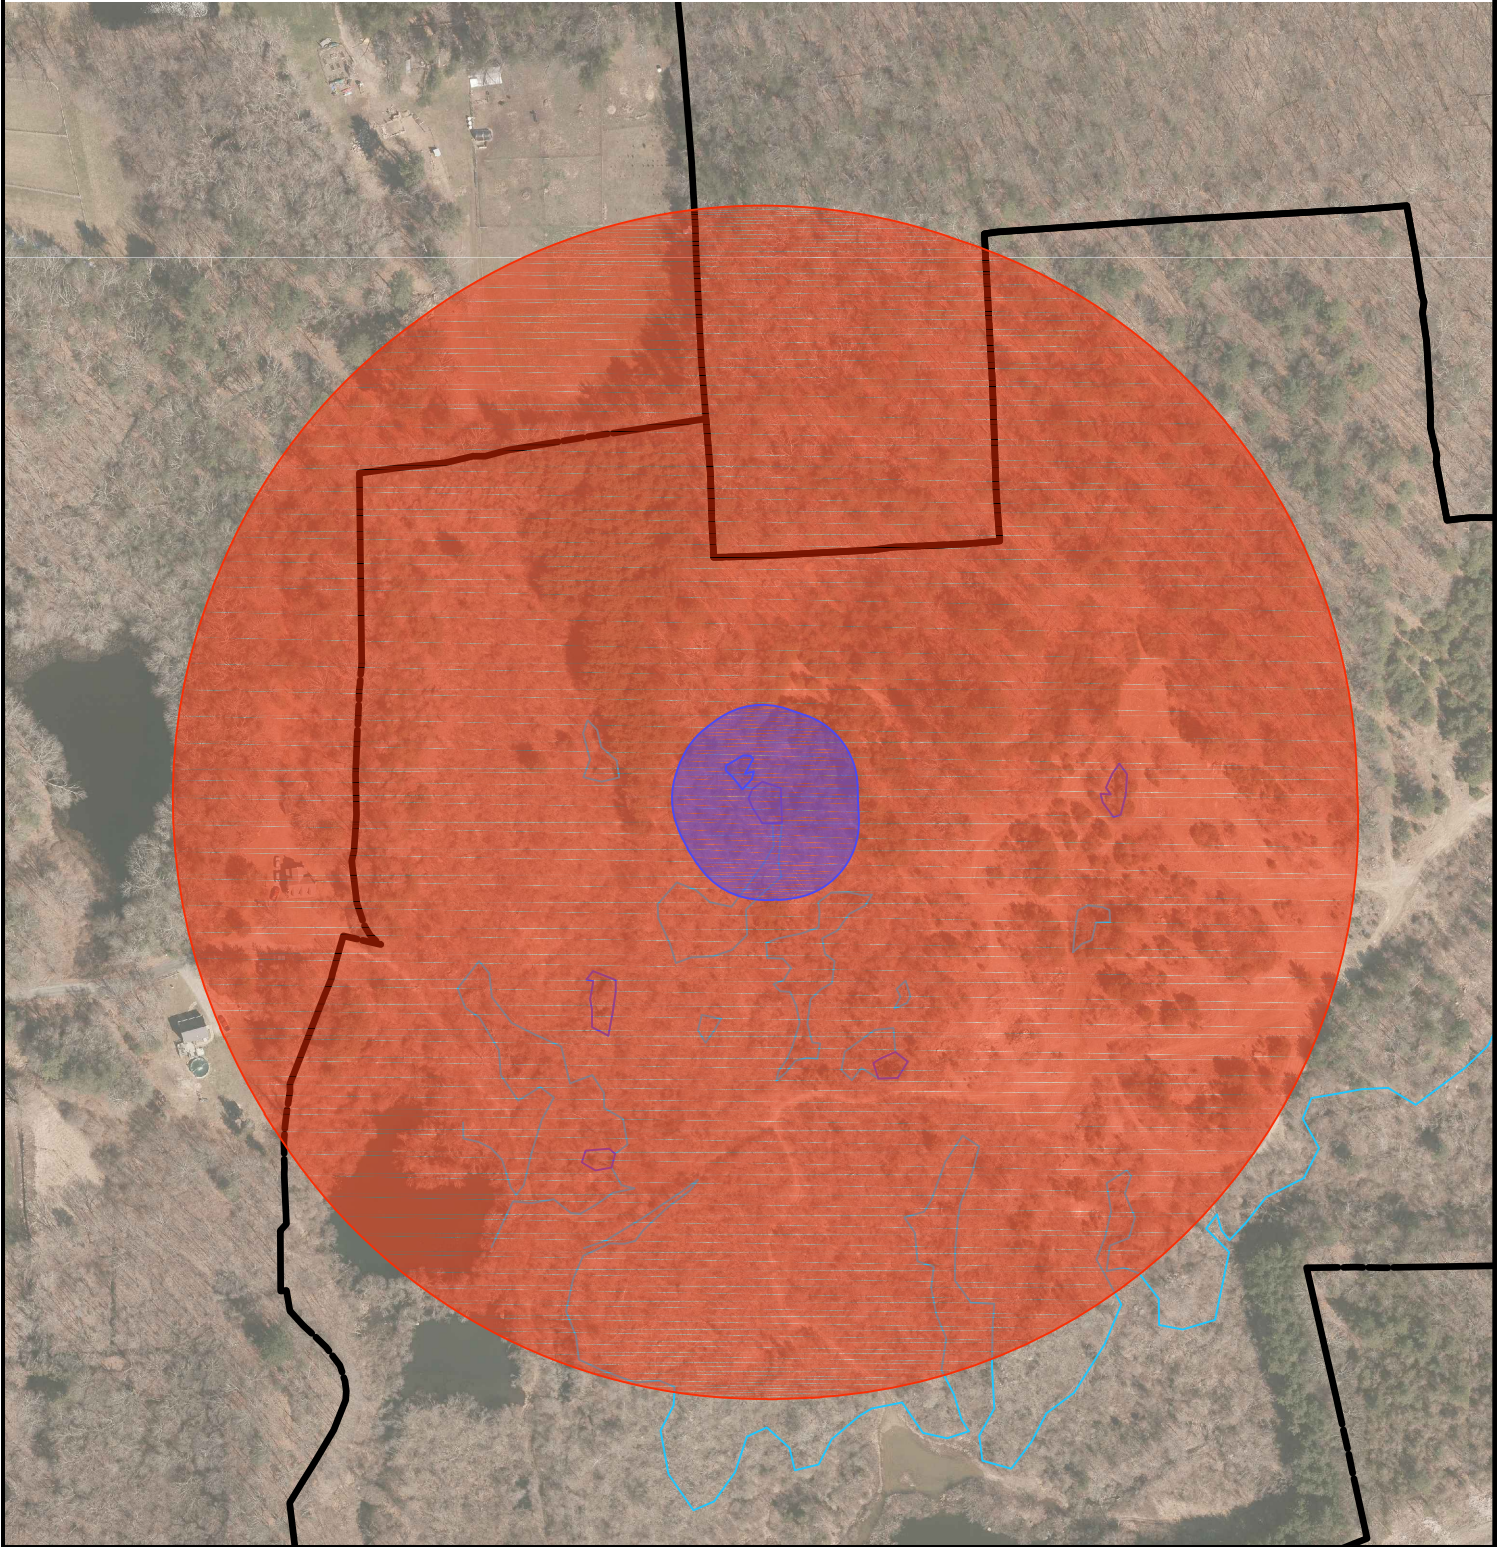
FIGURE 23:

VERNAL POOL 1H
EXISTING CONDITIONS
North Stonington Solar Facility

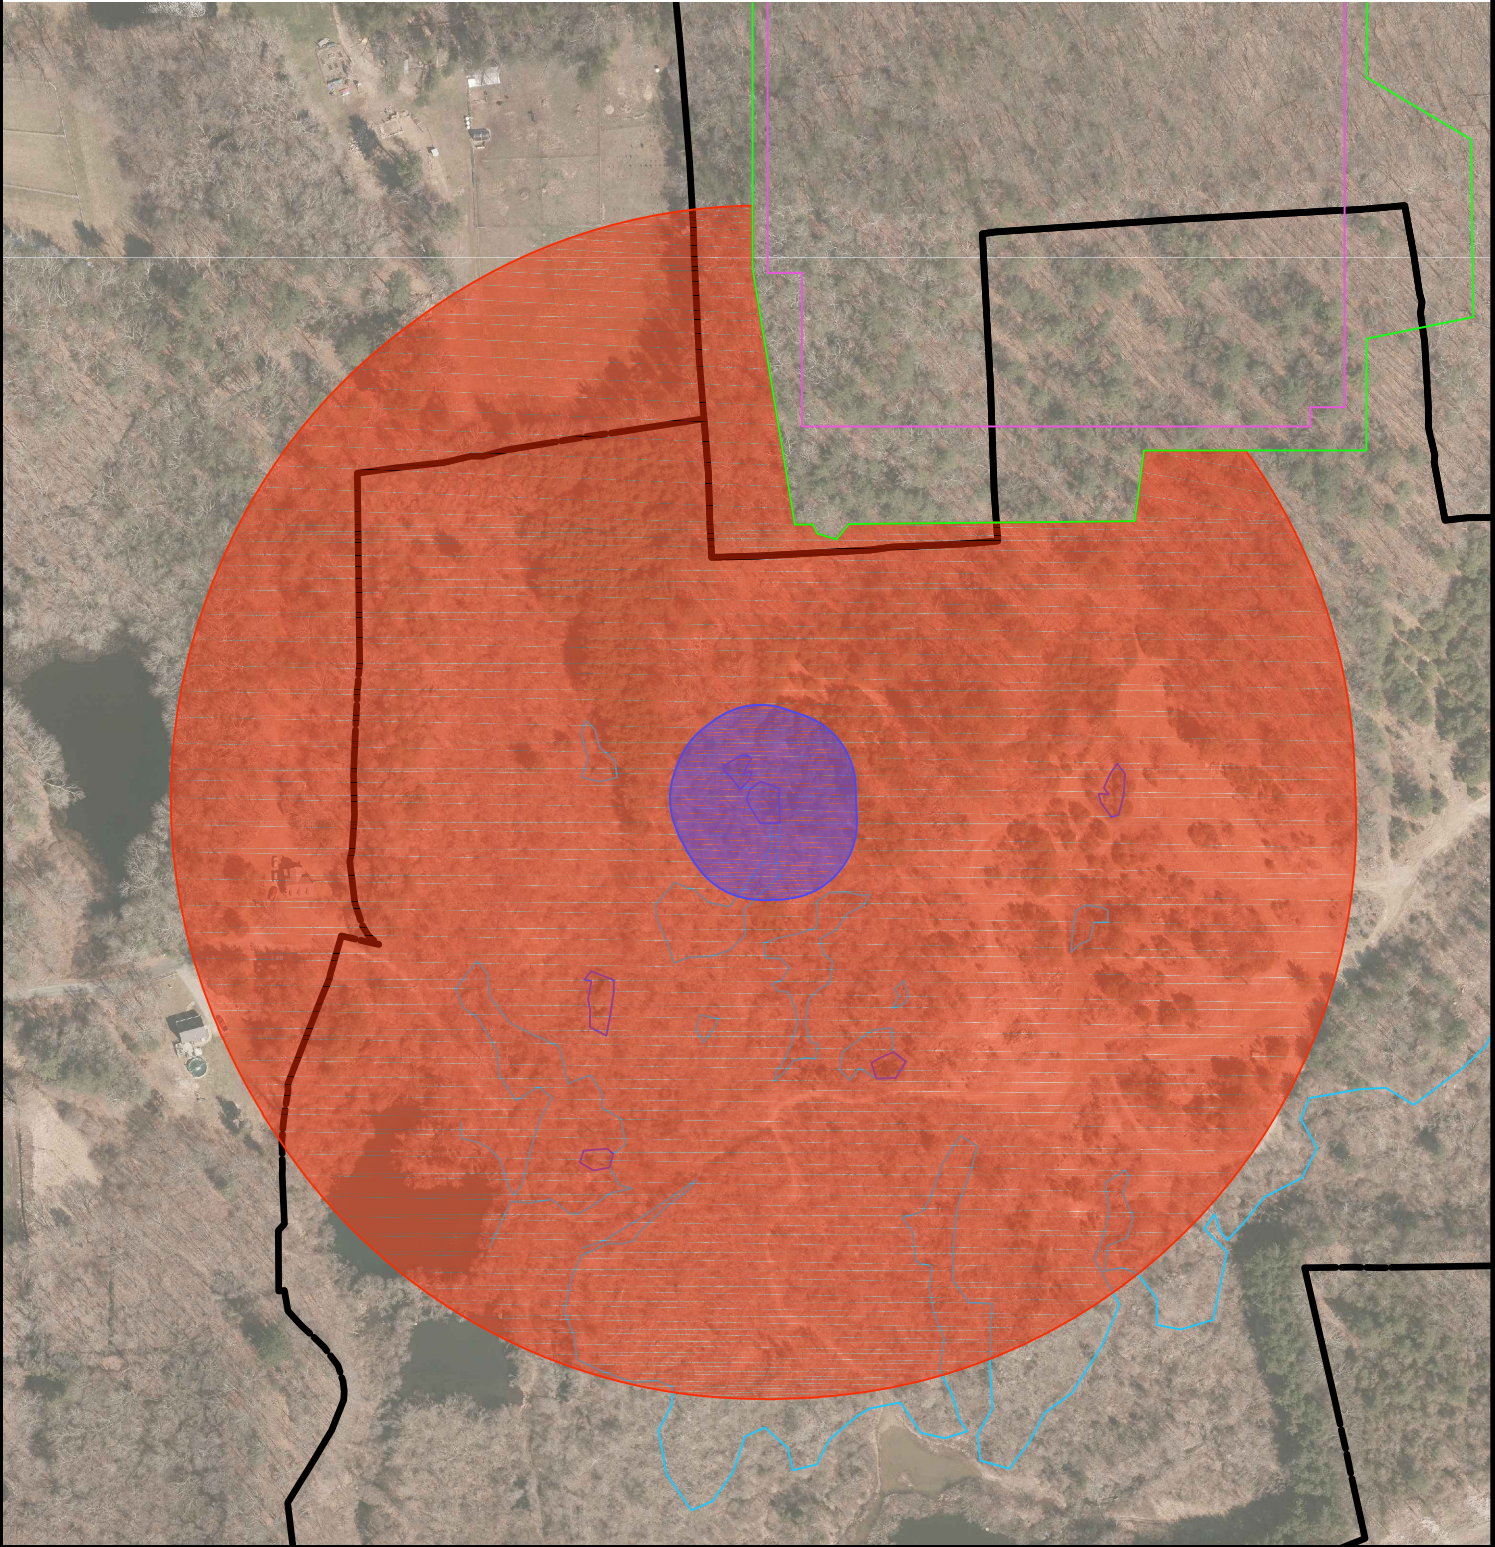
FIGURE 24:

VERNAL POOL 1H
PROPOSED CONDITIONS
North Stonington Solar Facility

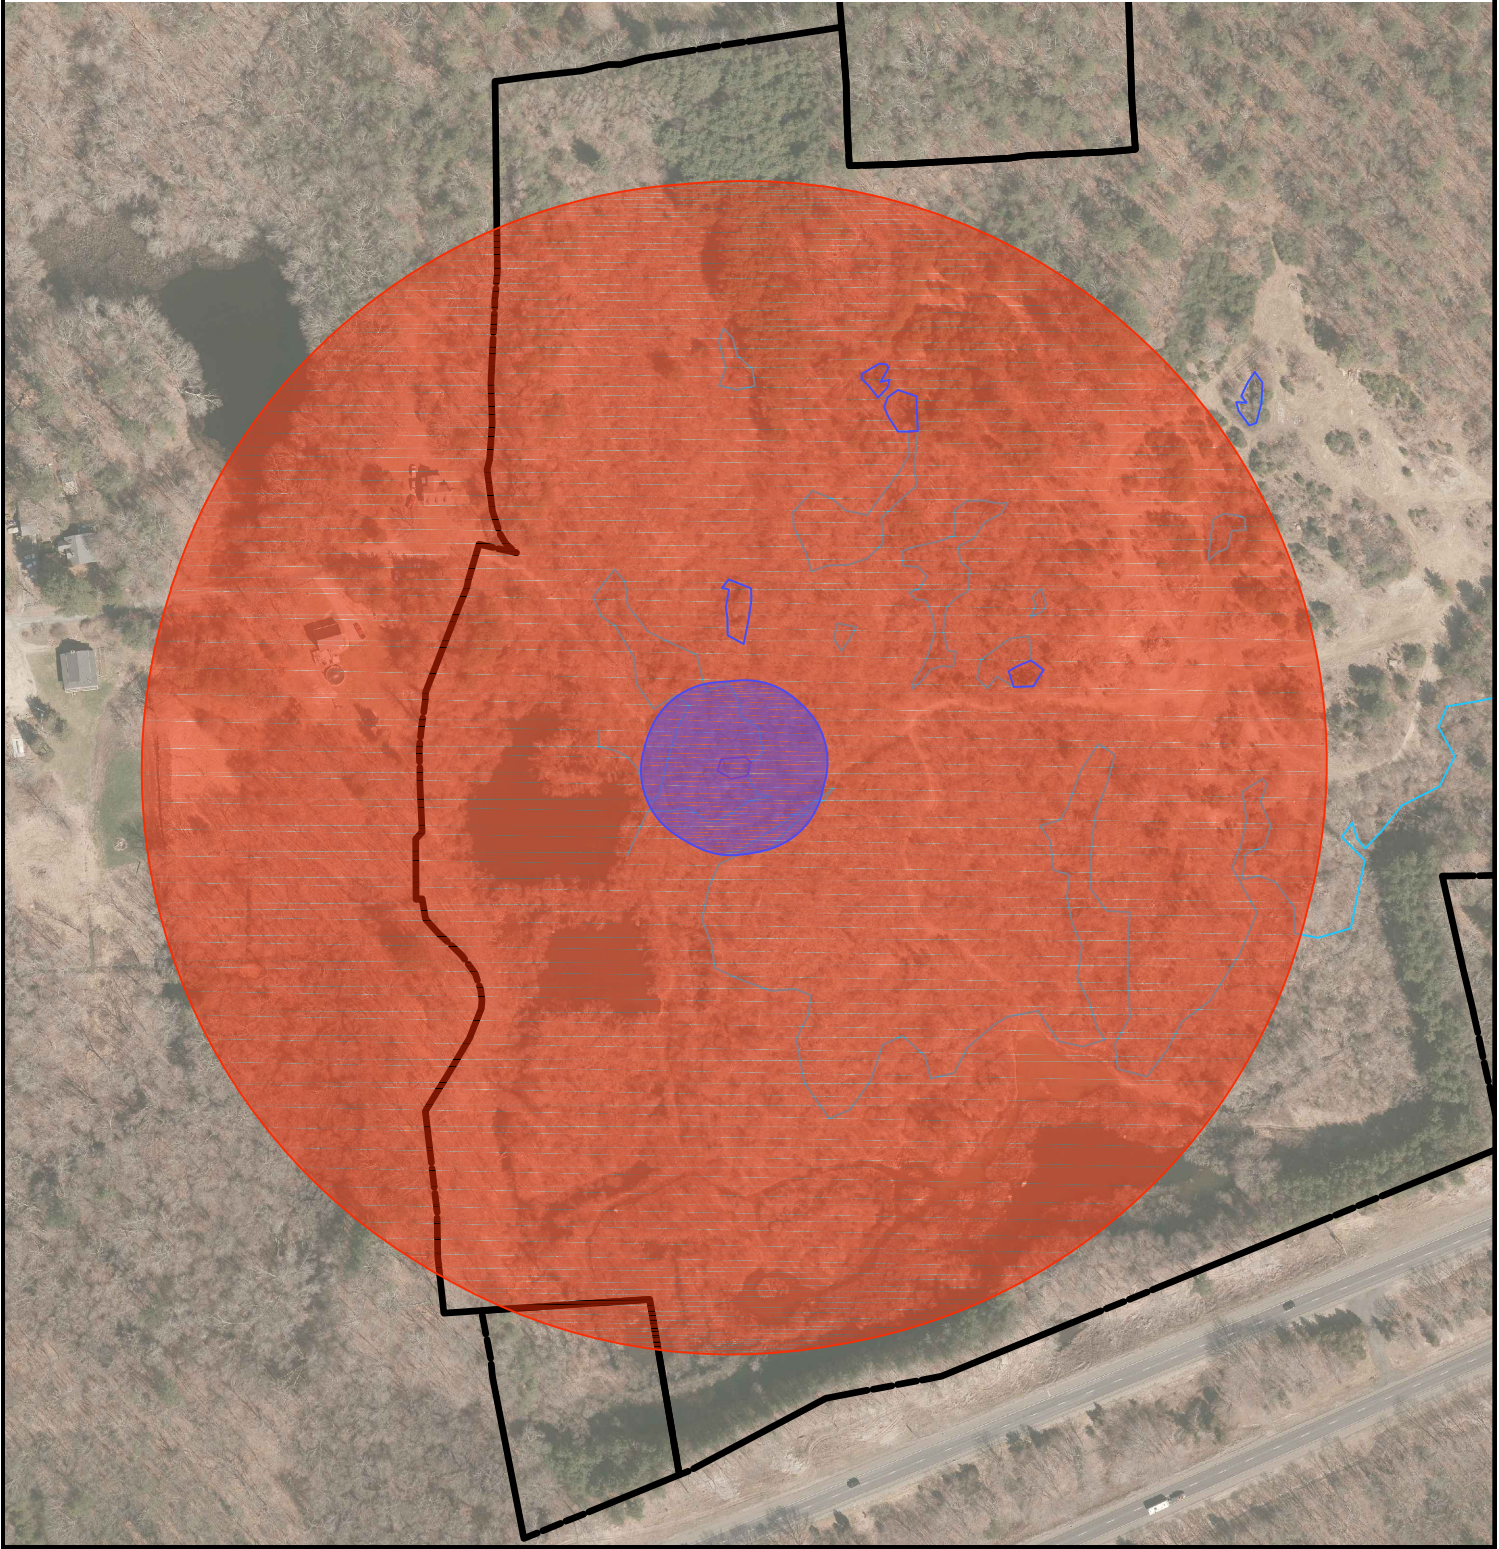
FIGURE 25:

VERNAL POOL 3E
EXISTING CONDITIONS
North Stonington Solar Facility

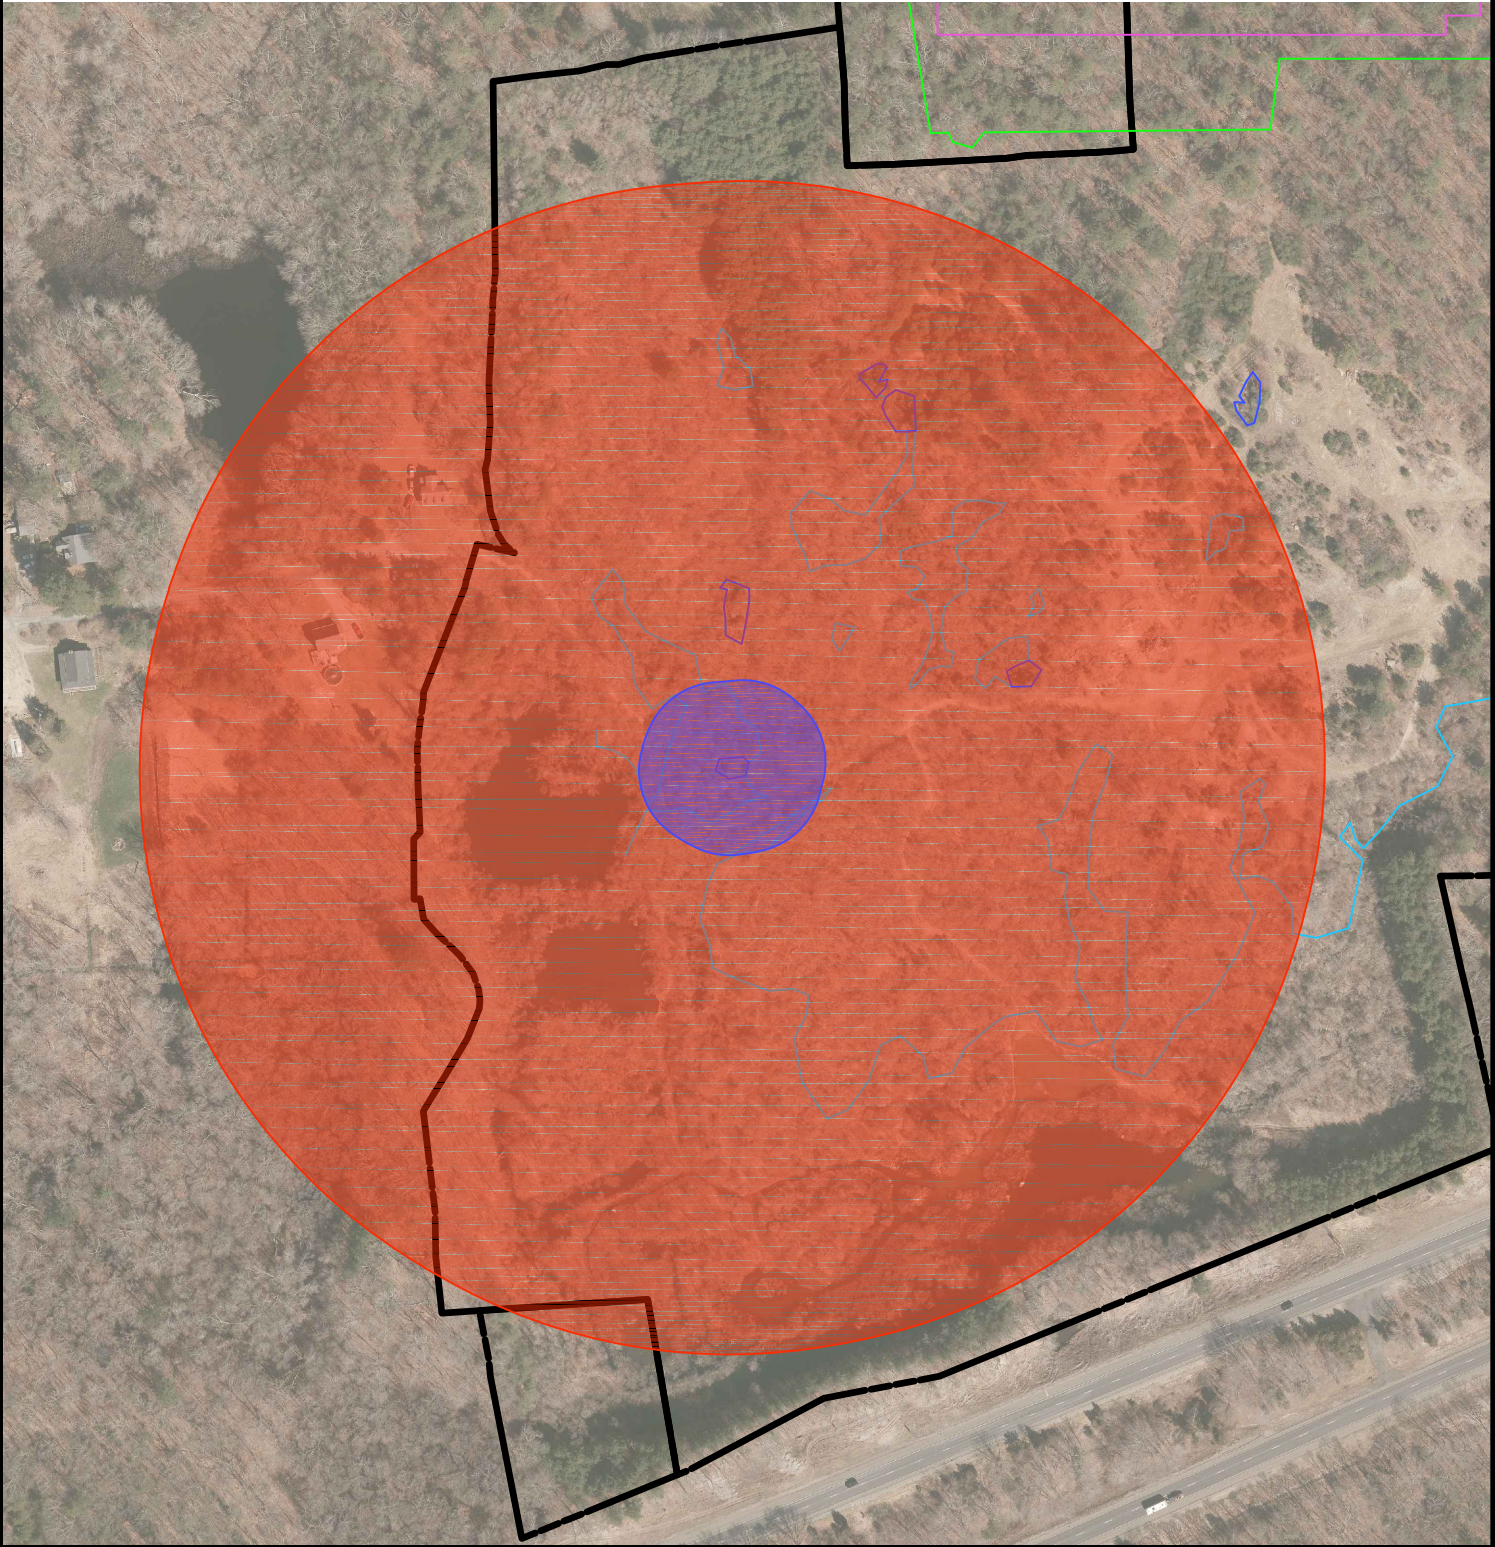
FIGURE 26:

VERNAL POOL 3E
PROPOSED CONDITIONS
North Stonington Solar Facility

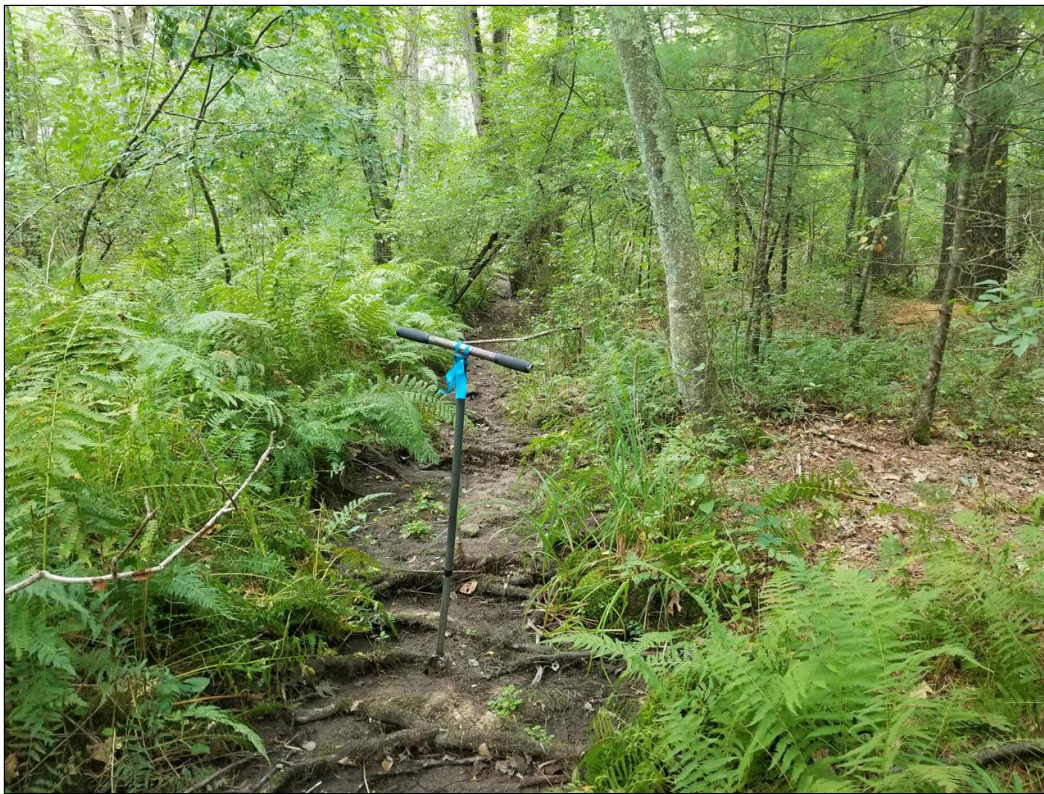
Photo IA-1a: Impact Area 1 (Culvert C-1); man-made outlet ditch to Wetland A-2; facing westerly

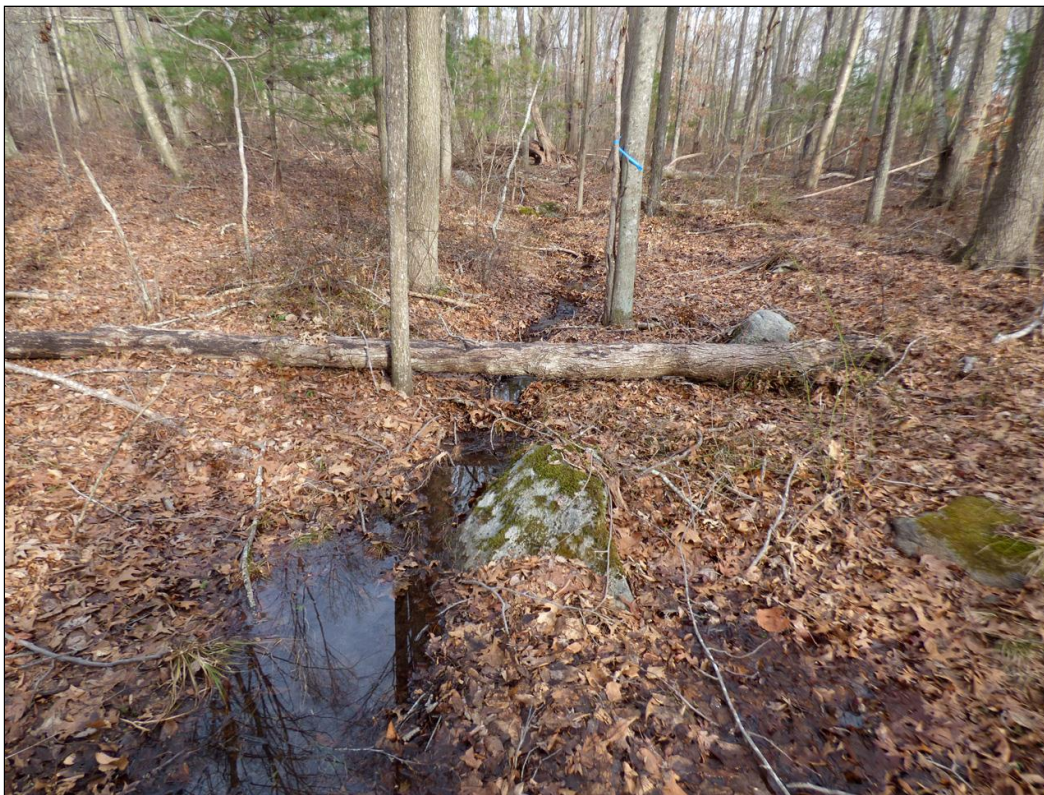
Photo IA-2a: Impact Area 2 (Culvert C-2); intermittent watercourse; facing northeasterly

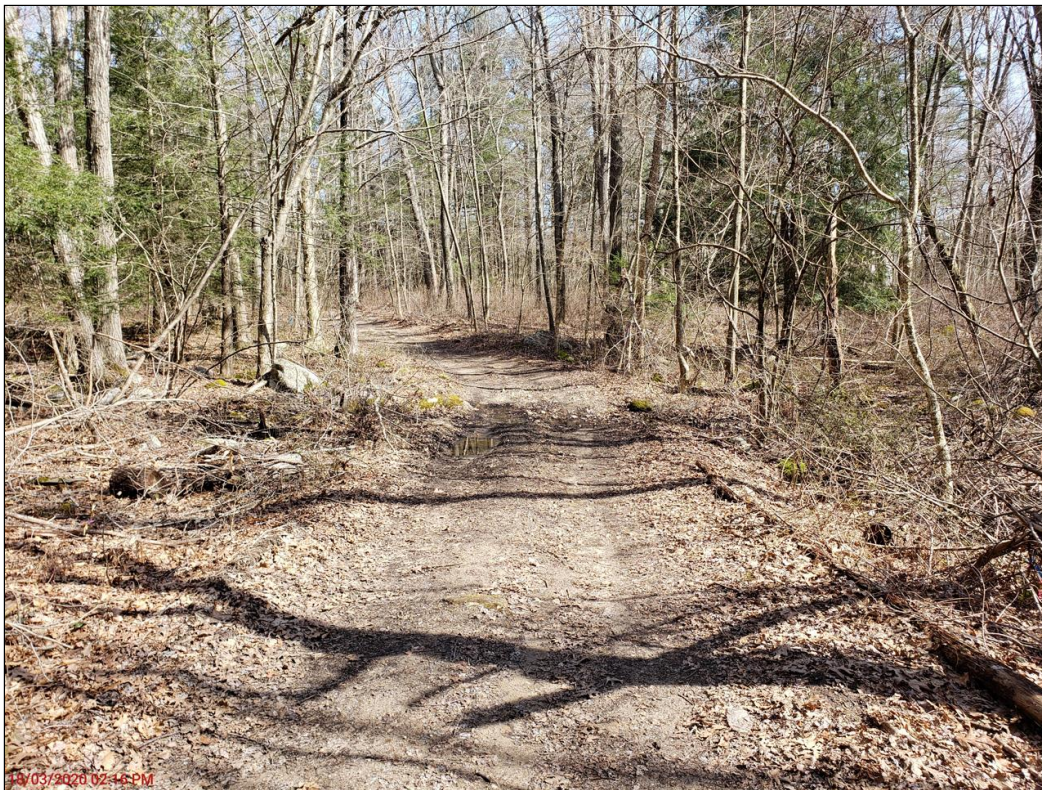
Photo IA-3a: Impact Area 3 (Culvert C-3); aligned with woods road with damaged culvert; facing easterly

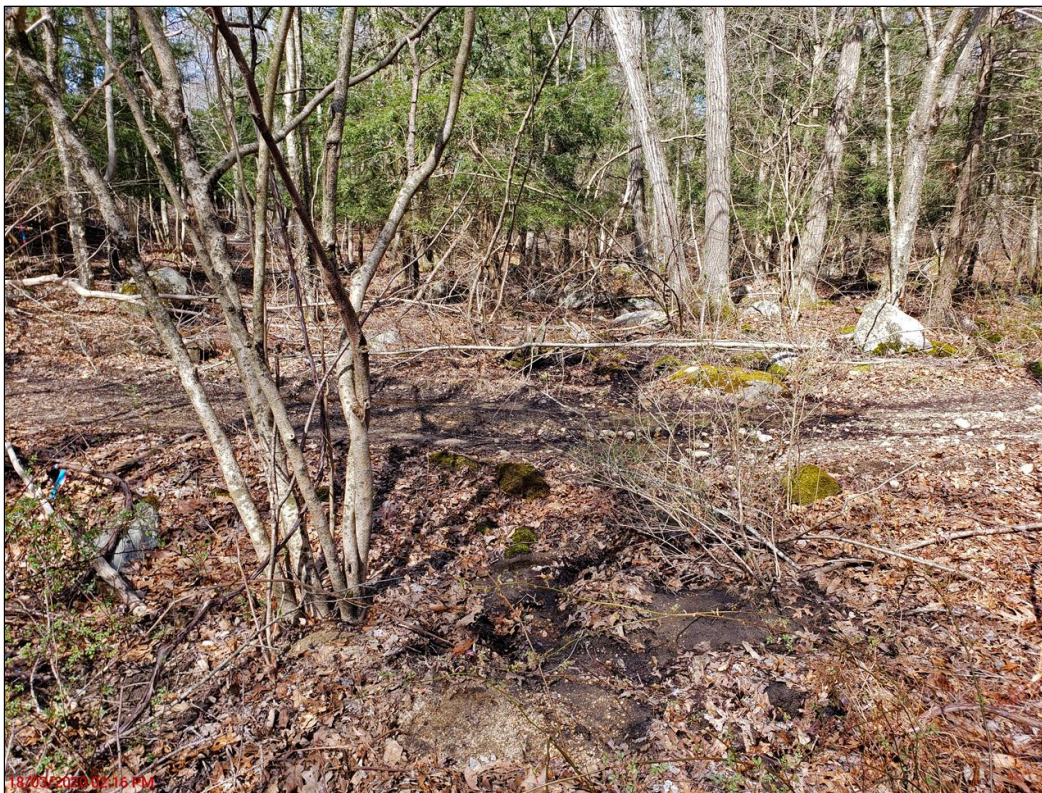
Photo IA-3b: Impact Area 3 (Culvert C-3); intermittent watercourse associated with crossing; facing northerly (upstream)

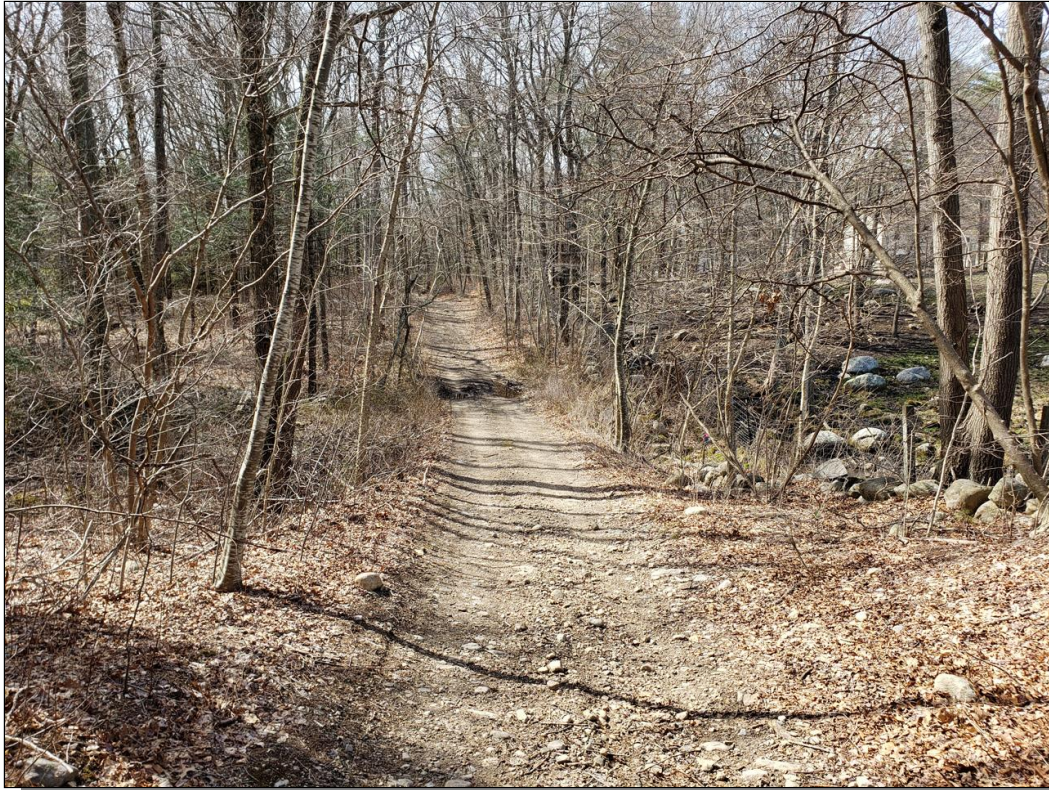
Photo IA-4a: Impact Area 4 (Culvert C-4); aligned with woods road; culvert upgraded/improved with bottomless arch; facing westerly
