VERNAL POOL L
PROPOSED CONDITIONS
North Stonington Solar Facility

Attachment E

Annotated Photos of Wildlife including Listed Species

Annotated Photos of Wetland/Watercourse Impact Areas
(IA-1 to IA-4)

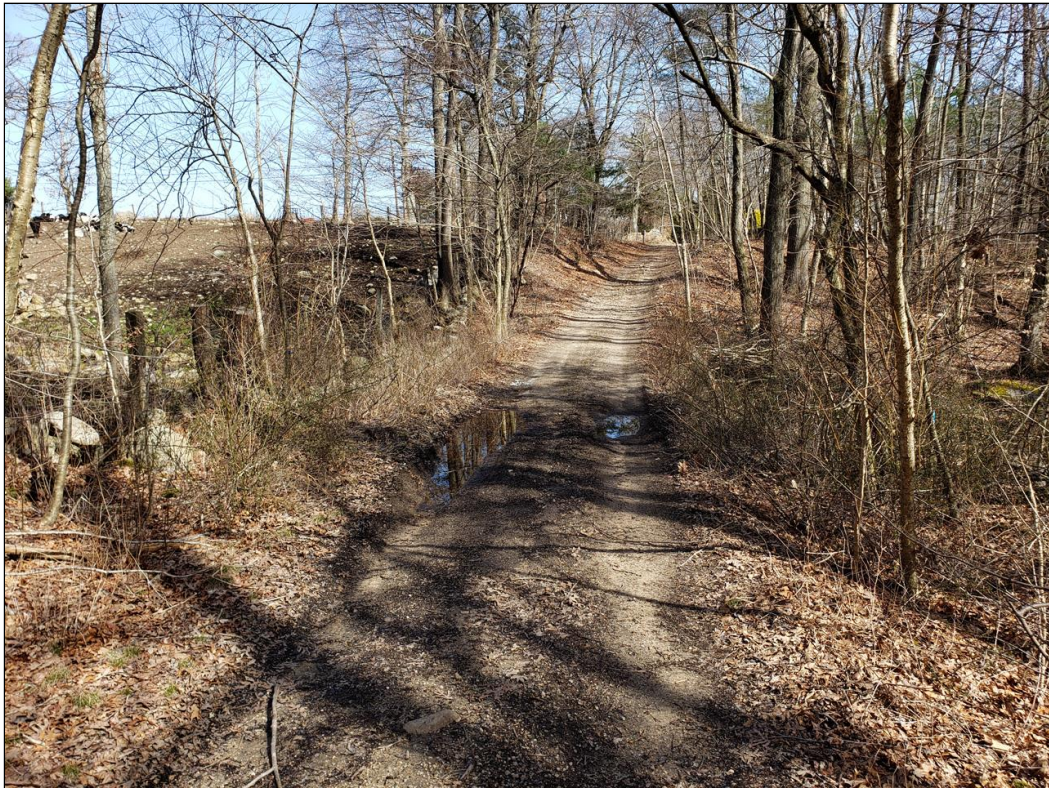
Photo IA-4b: Impact Area 4 (Culvert C-4); facing easterly
