Re: Card to Willimantic Upgrade Project

PETITION TO THE CONNECTICUT SITING COUNCIL
FOR A DECLARATORY RULING OF
NO SUBSTANTIAL ADVERSE ENVIRONMENTAL EFFECT
FOR THE PROPOSED MODIFICATIONS TO THE EXISTING
1210 and 1220 LINES IN THE TOWNS OF WINDHAM AND LEBANON, CONNECTICUT

CARD TO WILLIMANTIC UPGRADE PROJECT

Windham & Lebanon, CT
June 11, 2021

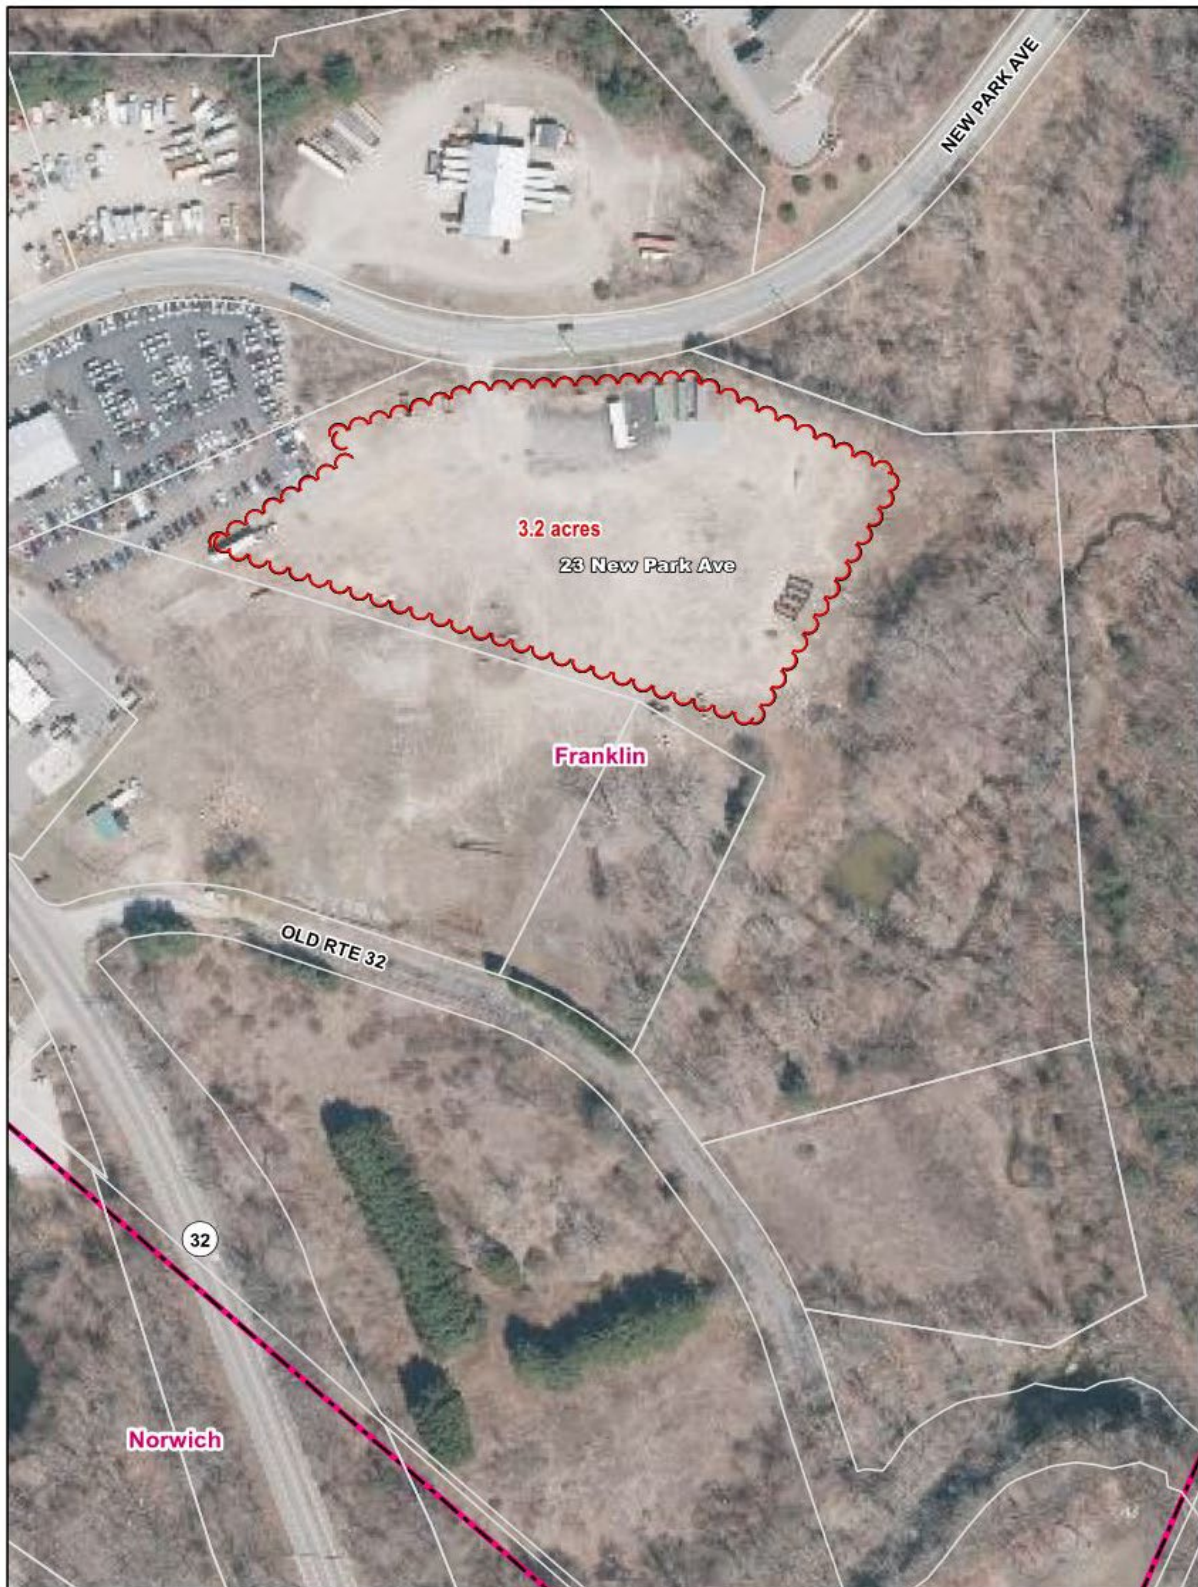
Figure 2: Proposed Staging and Laydown Area at 23 New Park Avenue, Franklin, CT (area defined by red cloud-like line)

prior to removal off-site for salvage and/or disposal. The staging area may also be used by construction crews for parking personal vehicles as well as for construction vehicles and equipment storage, and for performing minor maintenance, when needed, on construction equipment. Appropriate erosion and sedimentation (“E&S”) controls would be installed and maintained until completion of the work in accordance with Project permits and the BMPs.

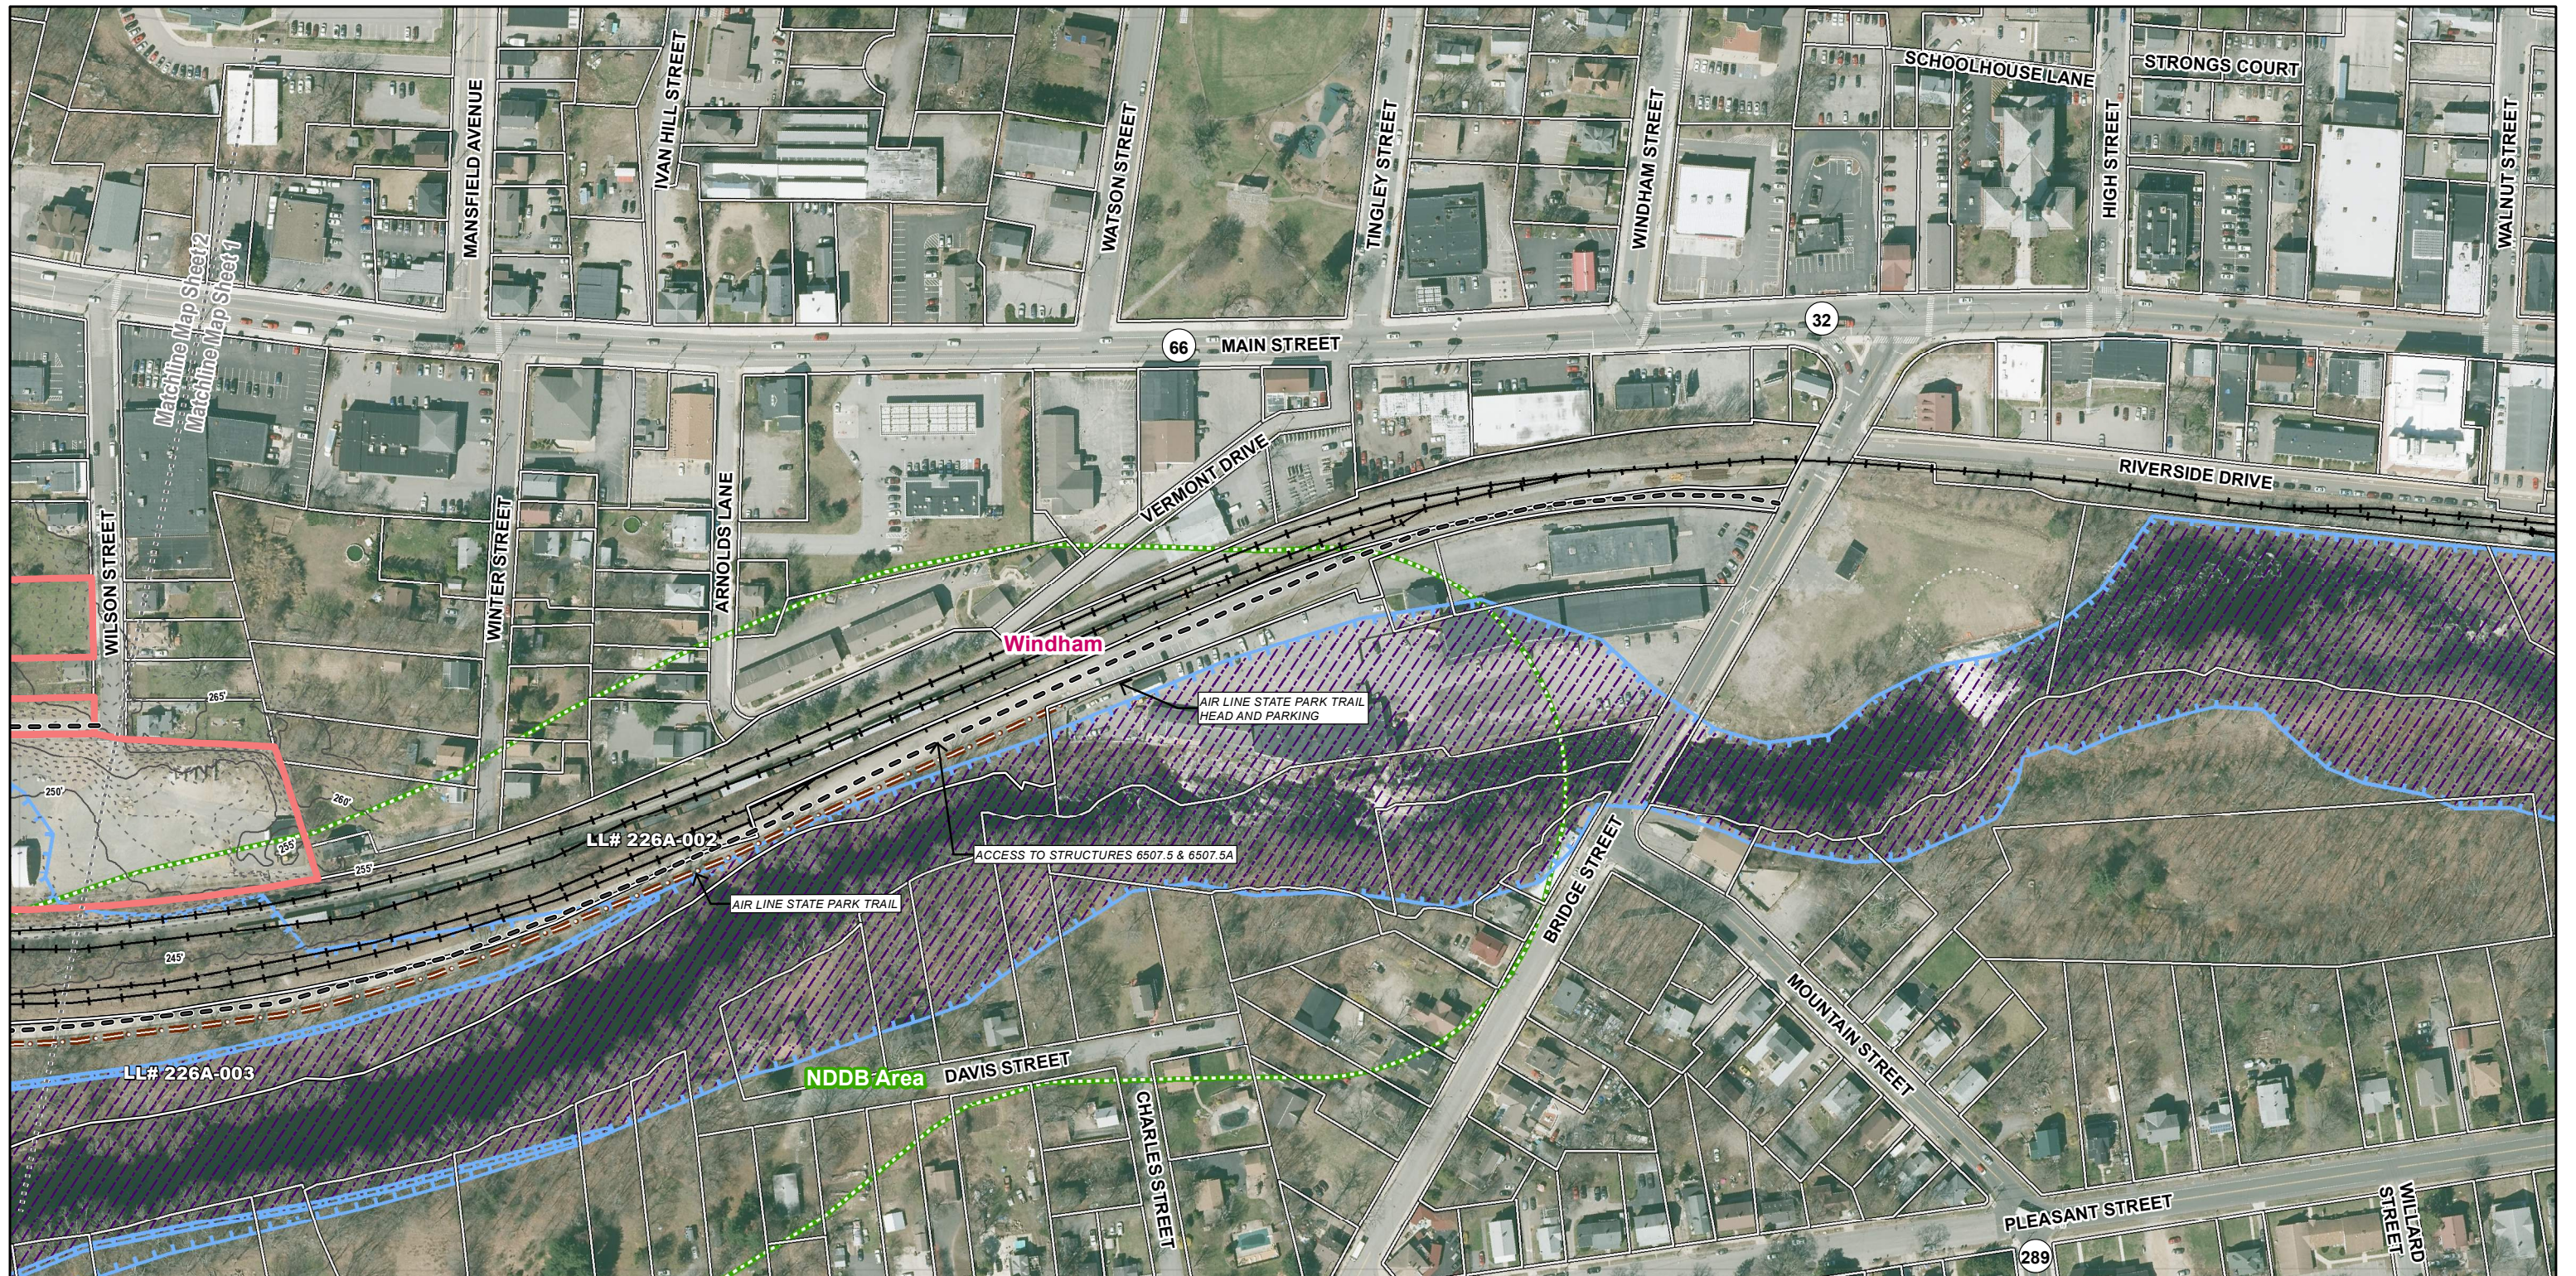
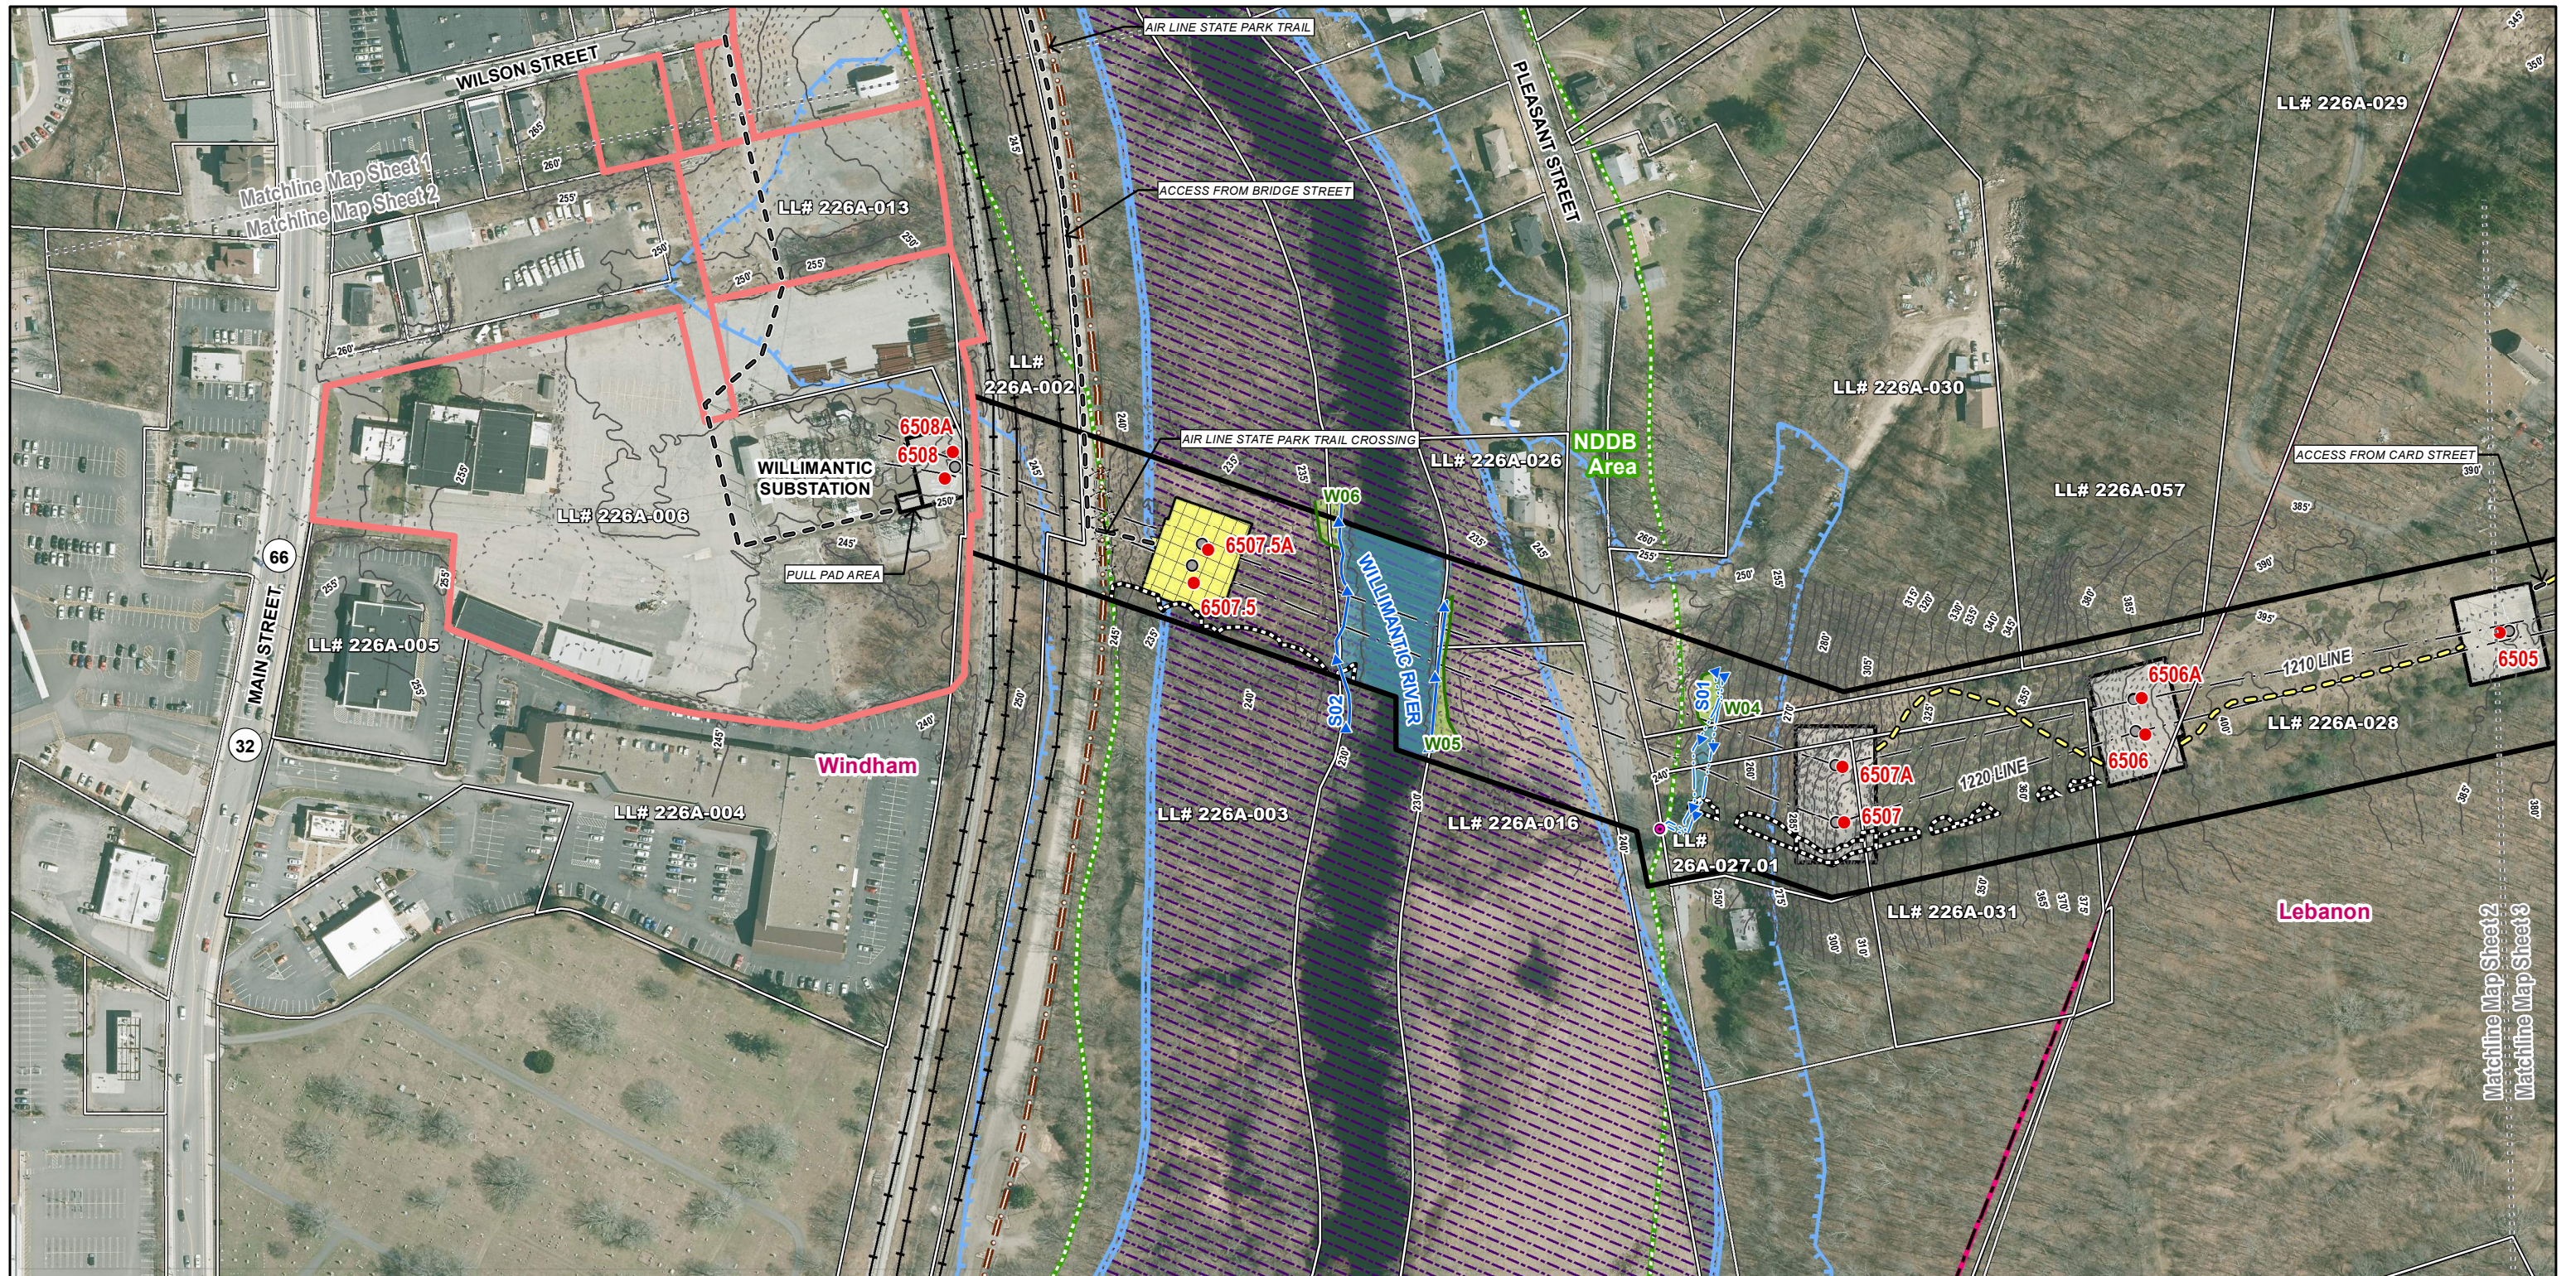
The mapsheets in Attachment A: “Card to Willimantic Upgrade Project”, dated May 13, 2021, depict the locations of existing and proposed structures, existing and proposed access roads, and work pads to be used for the Project, wetland areas and other ROW features and Project elements.

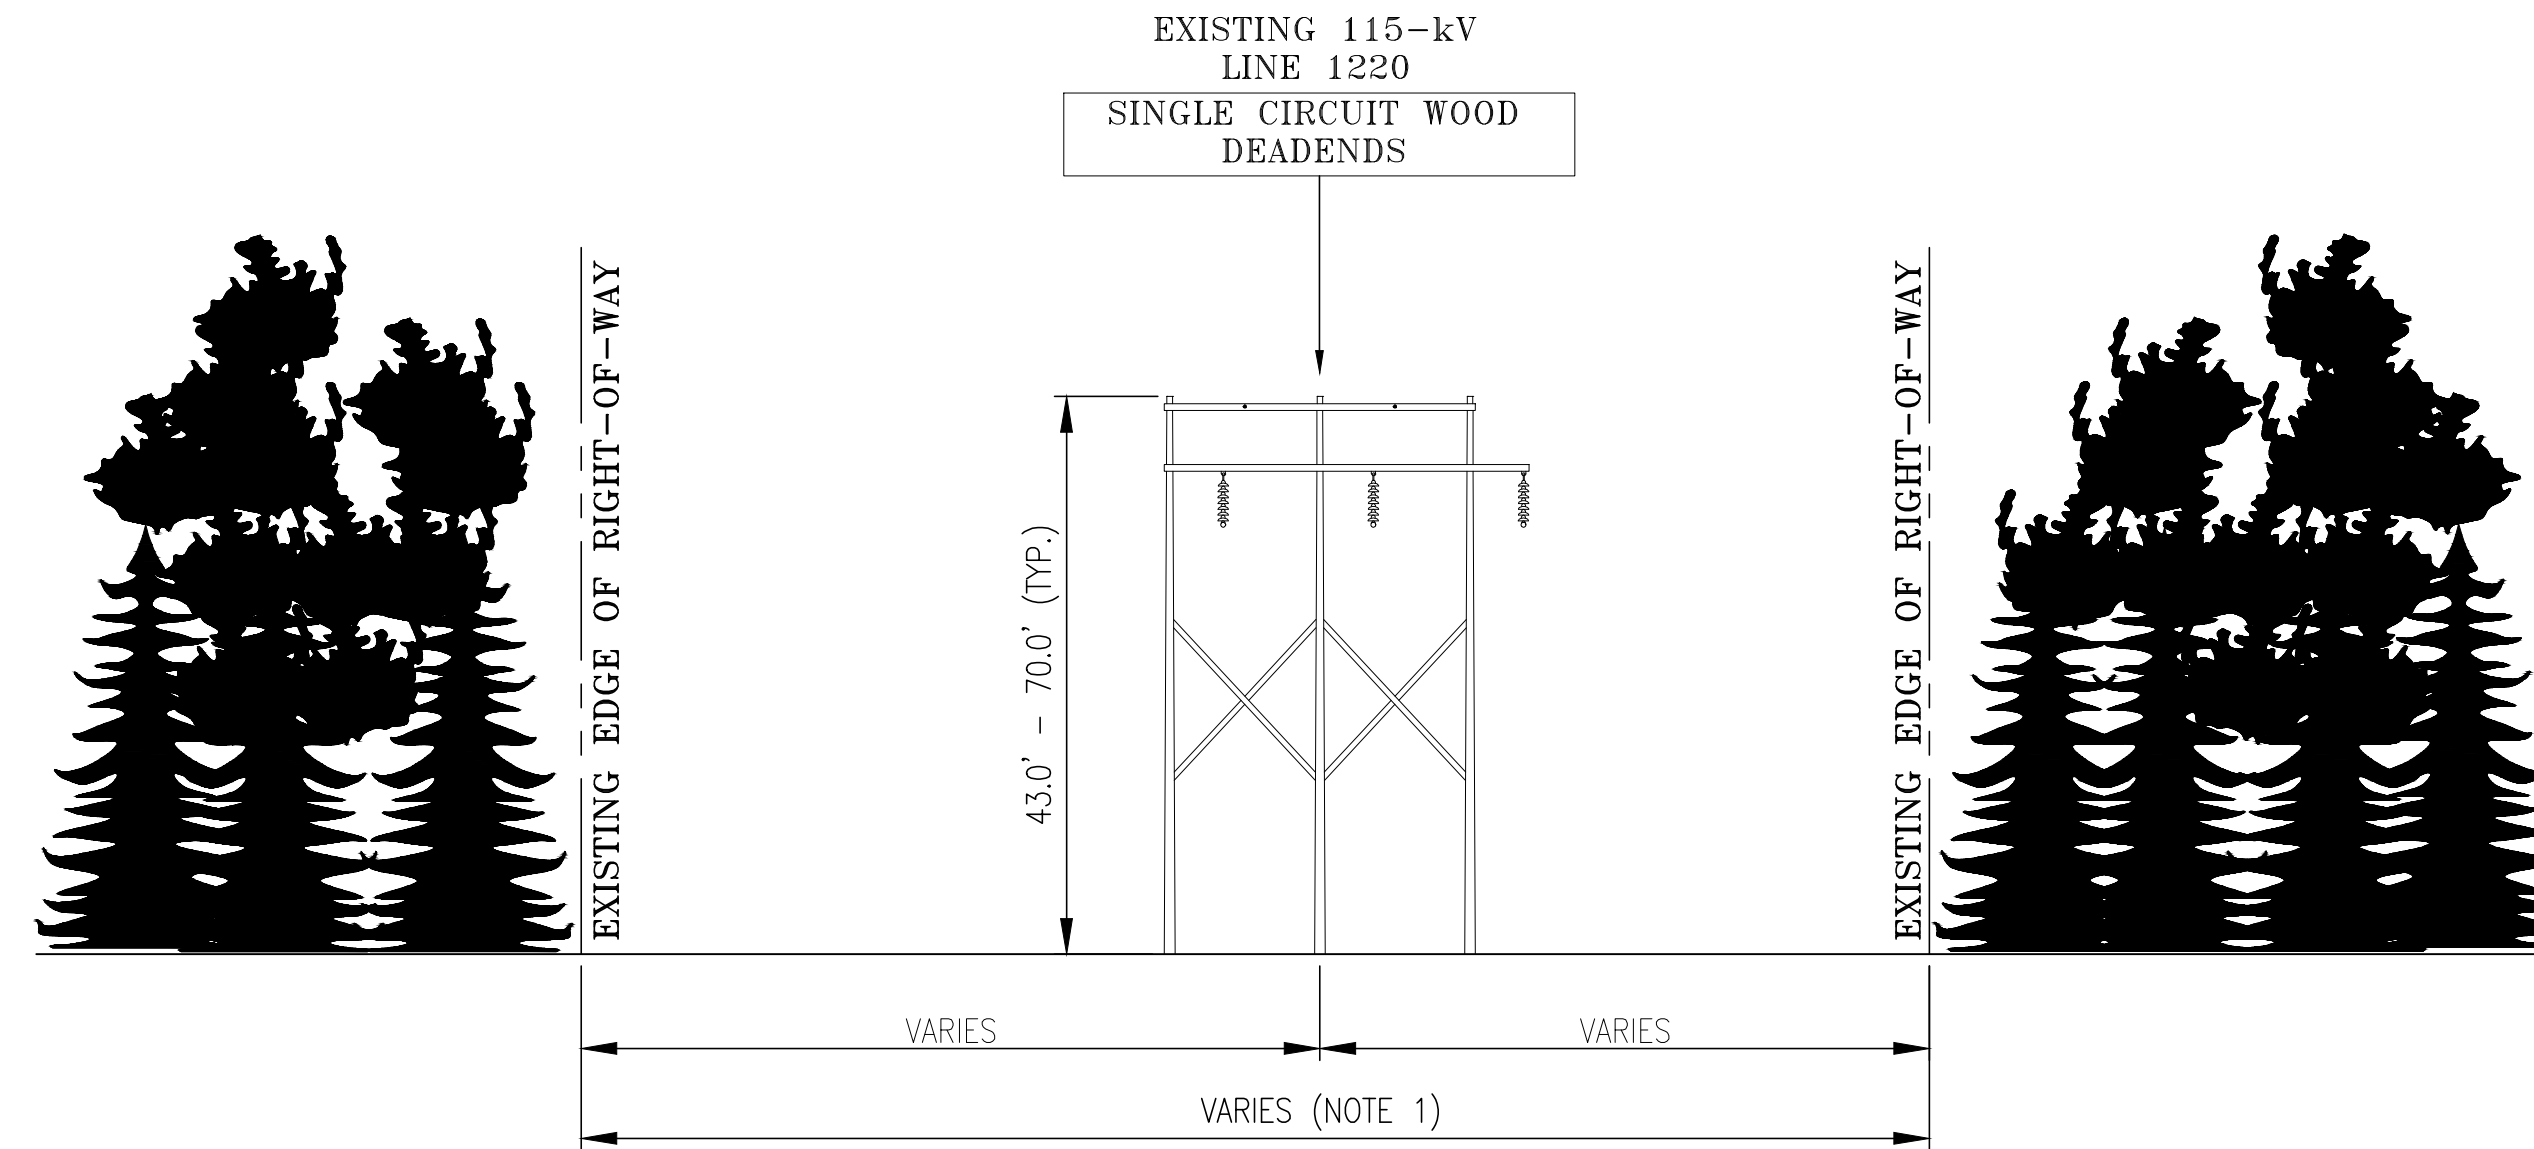
**EXISTING R.O.W. CONFIGURATION
SINGLE CIRCUIT WOOD DEADENDS
LOOKING TOWARD WILLIMANTIC SUBSTATION,
TOWN OF LEBANON, CONNECTICUT
0.1 MILES BETWEEN CARD S/S - STR. #6502**

The cross-section drawings in Attachment B – “Card SS to Willimantic SS Right of Way Cross Sections” depict typical views along the ROW of the existing and proposed structures and the existing limits of the ROW areas. Attachment C – “List of Structure Replacements” provides information on structure heights and the type of configuration for the existing and replacement structures. The heights of the existing structures range from 47.5 to 80 feet above ground level and many of the replacement structures must be taller to meet current NESC clearance requirements. The replacement structures will range in height from 61 feet to 100 feet above

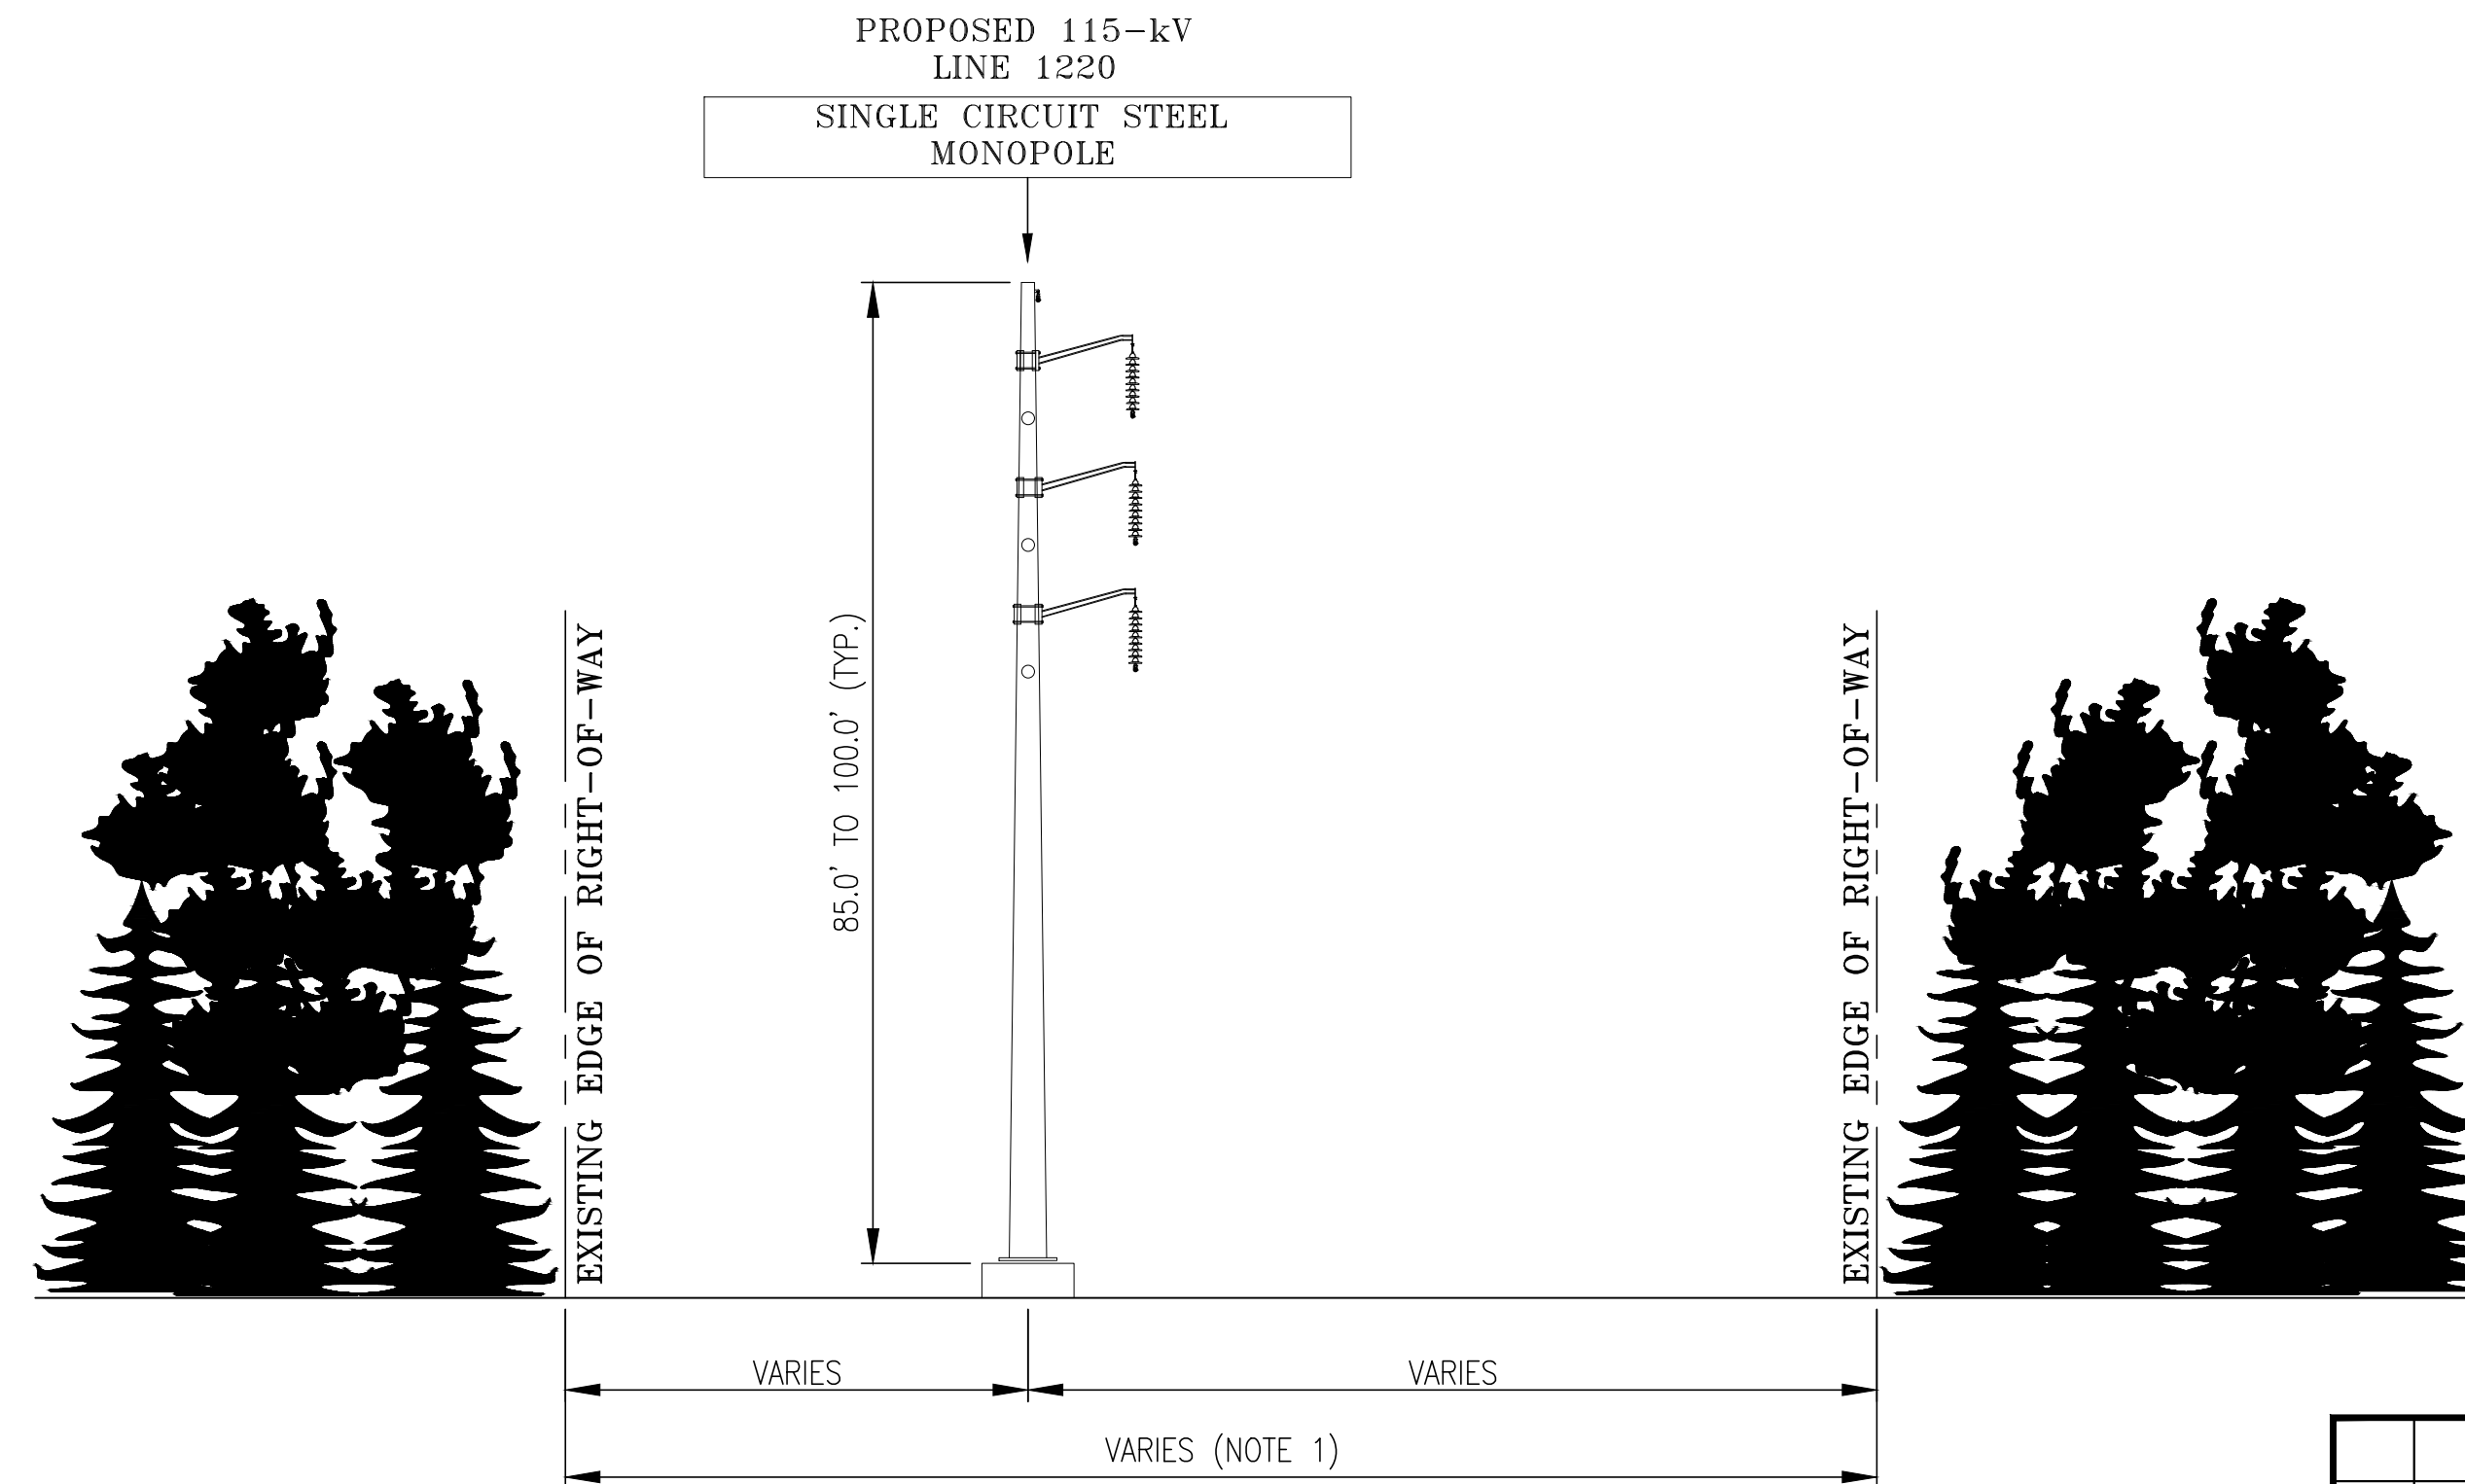
**PROPOSED R.O.W. CONFIGURATION
SINGLE CIRCUIT STEEL MONOPOLES
LOOKING TOWARD WILLIMANTIC SUBSTATION,
TOWN OF LEBANON, CONNECTICUT
0.1 MILES BETWEEN CARD S/S - STR. #6502**

Two of the total fourteen replacement structures (structures 6500 and 6501) located outside of Card Substation will be significantly higher than the structures they are replacing (42.5 feet and 39 feet, respectively), but at a total AGL elevation of 90 feet and 100 feet respectively, the two replacement structures will not be as high as existing structures also located outside of Card Substation.⁷ Visual effects would be further mitigated by utilizing weathering steel for the new structures allowing them to be consistent in appearance with the existing H-frame wood structures. As a result, the Project would not result in a detrimental change to the existing visual character of the line in this area, from nearby residential developments and publicly accessible land.
