Re: Card to Willimantic Upgrade Project

PETITION TO THE CONNECTICUT SITING COUNCIL
FOR A DECLARATORY RULING OF
NO SUBSTANTIAL ADVERSE ENVIRONMENTAL EFFECT
FOR THE PROPOSED MODIFICATIONS TO THE EXISTING
1210 and 1220 LINES IN THE TOWNS OF WINDHAM AND LEBANON, CONNECTICUT

CARD TO WILLIMANTIC UPGRADE PROJECT

Windham & Lebanon, CT
June 11, 2021

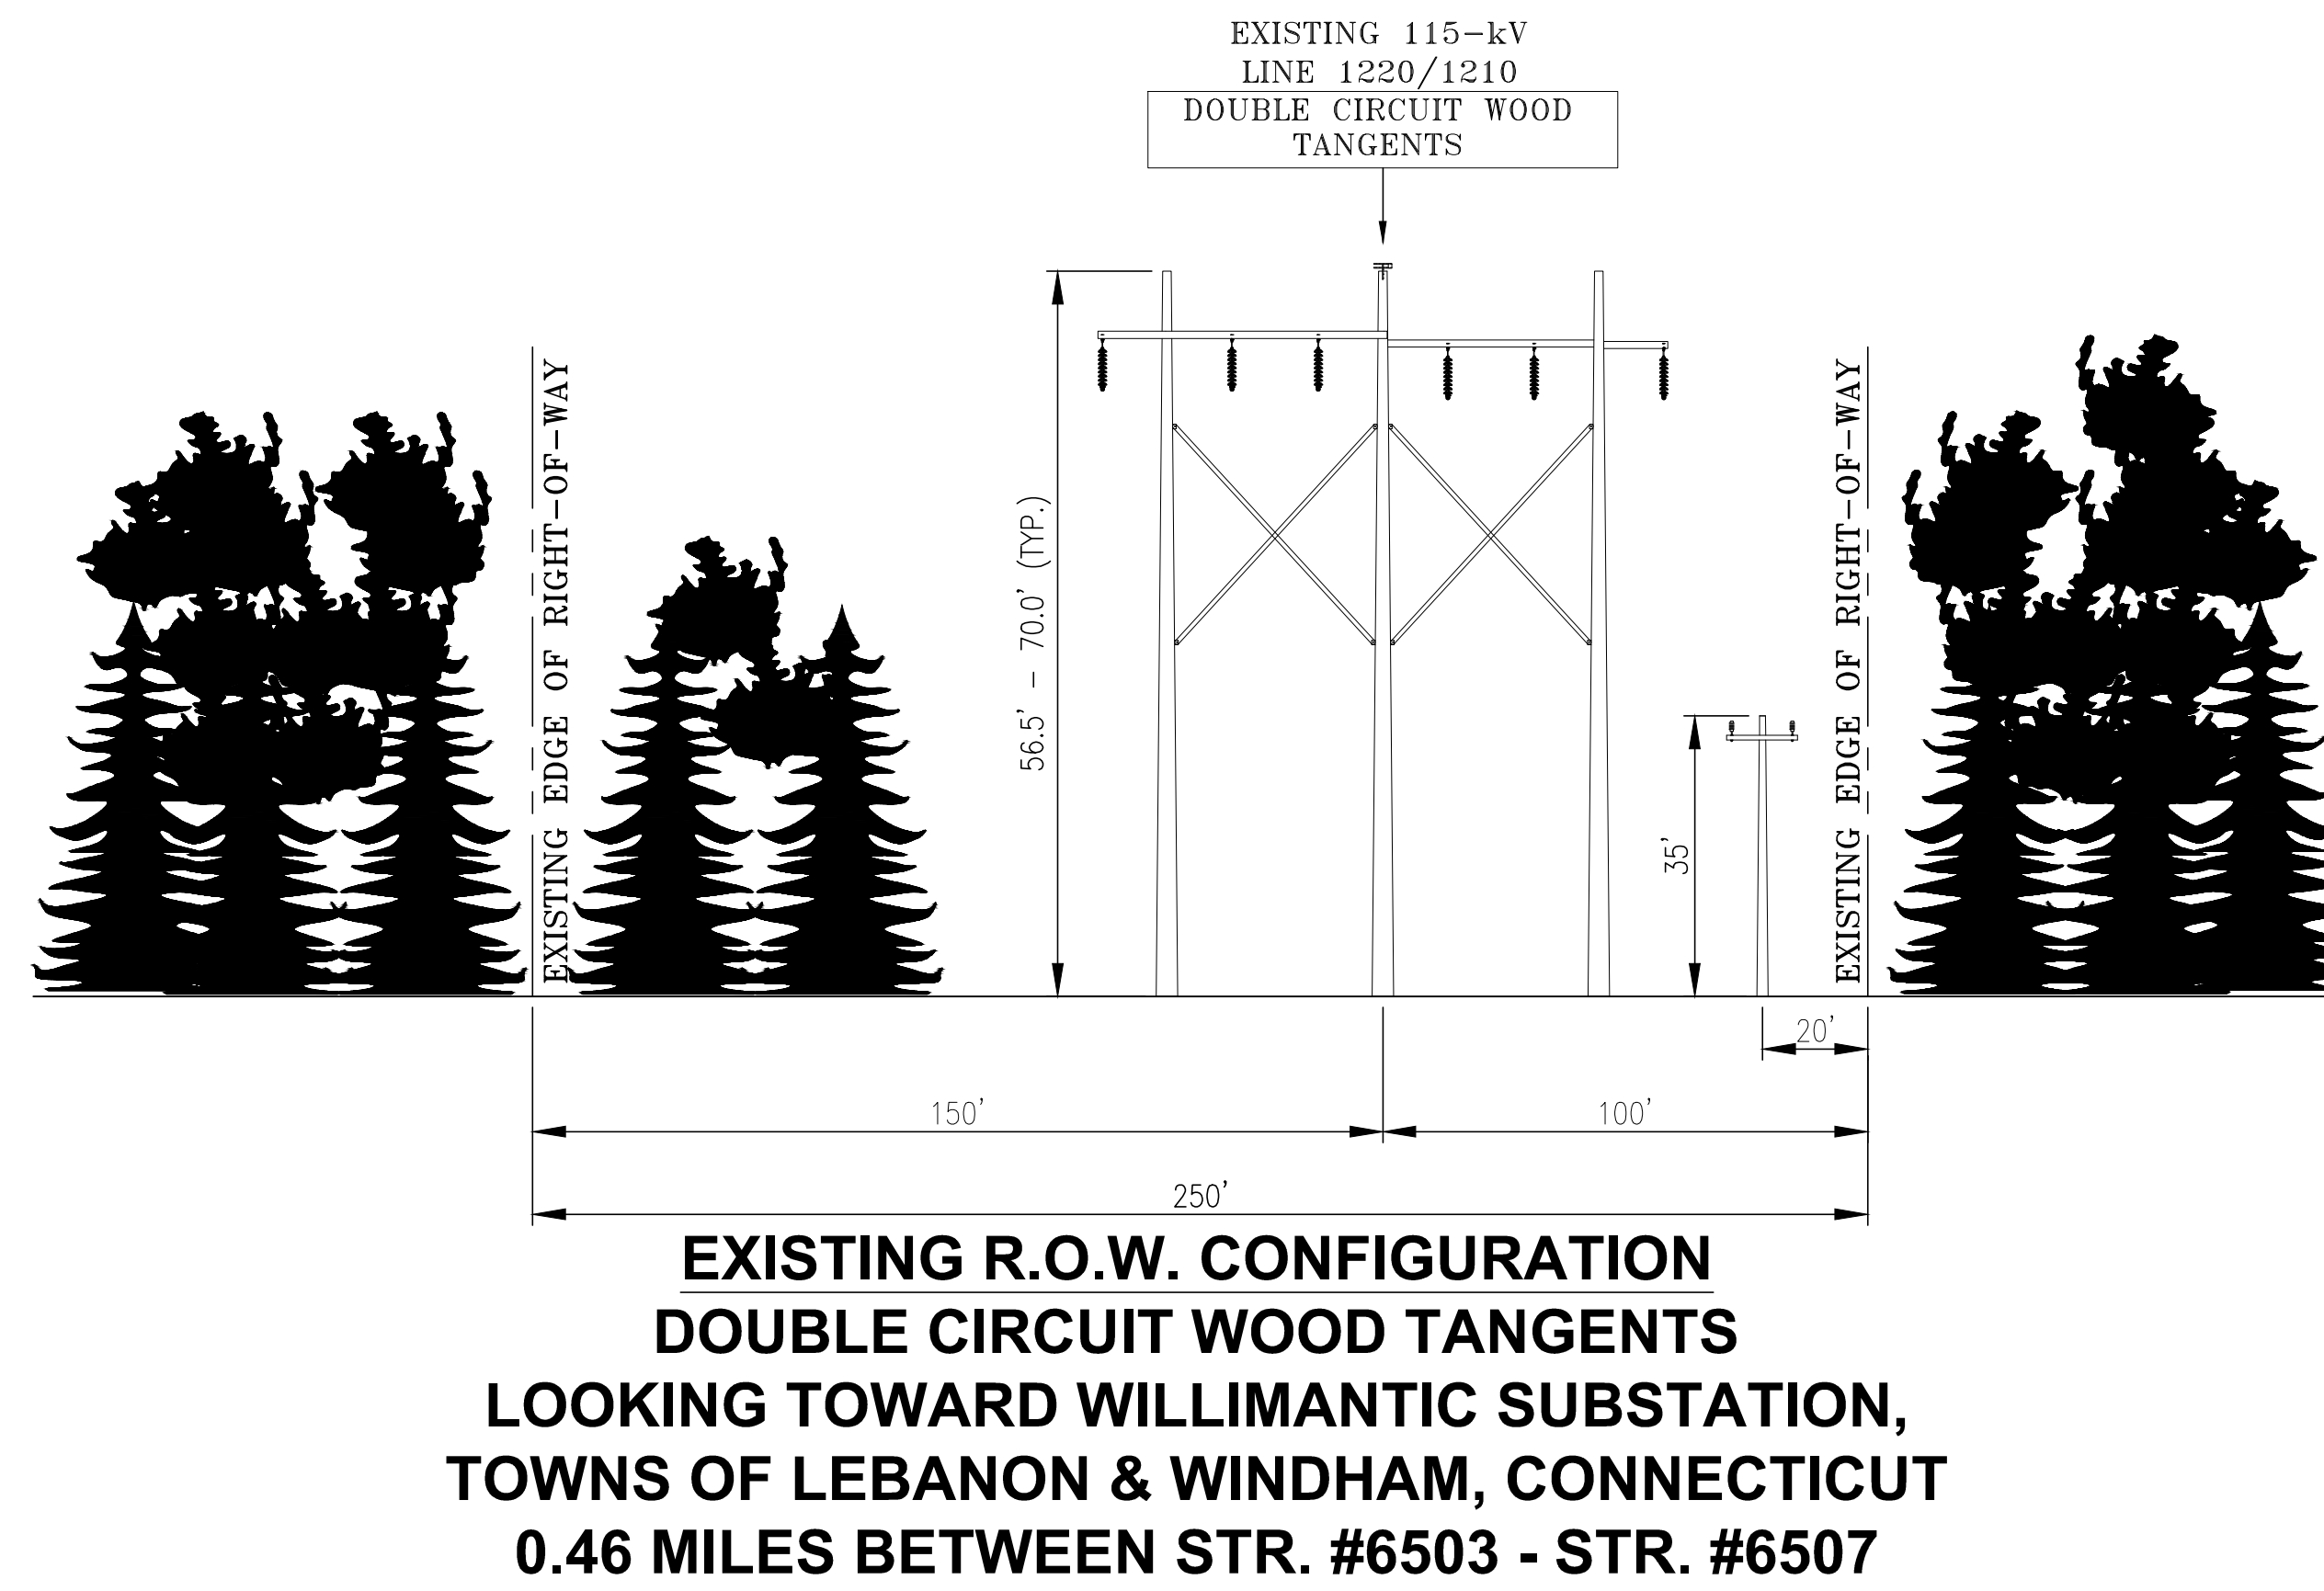
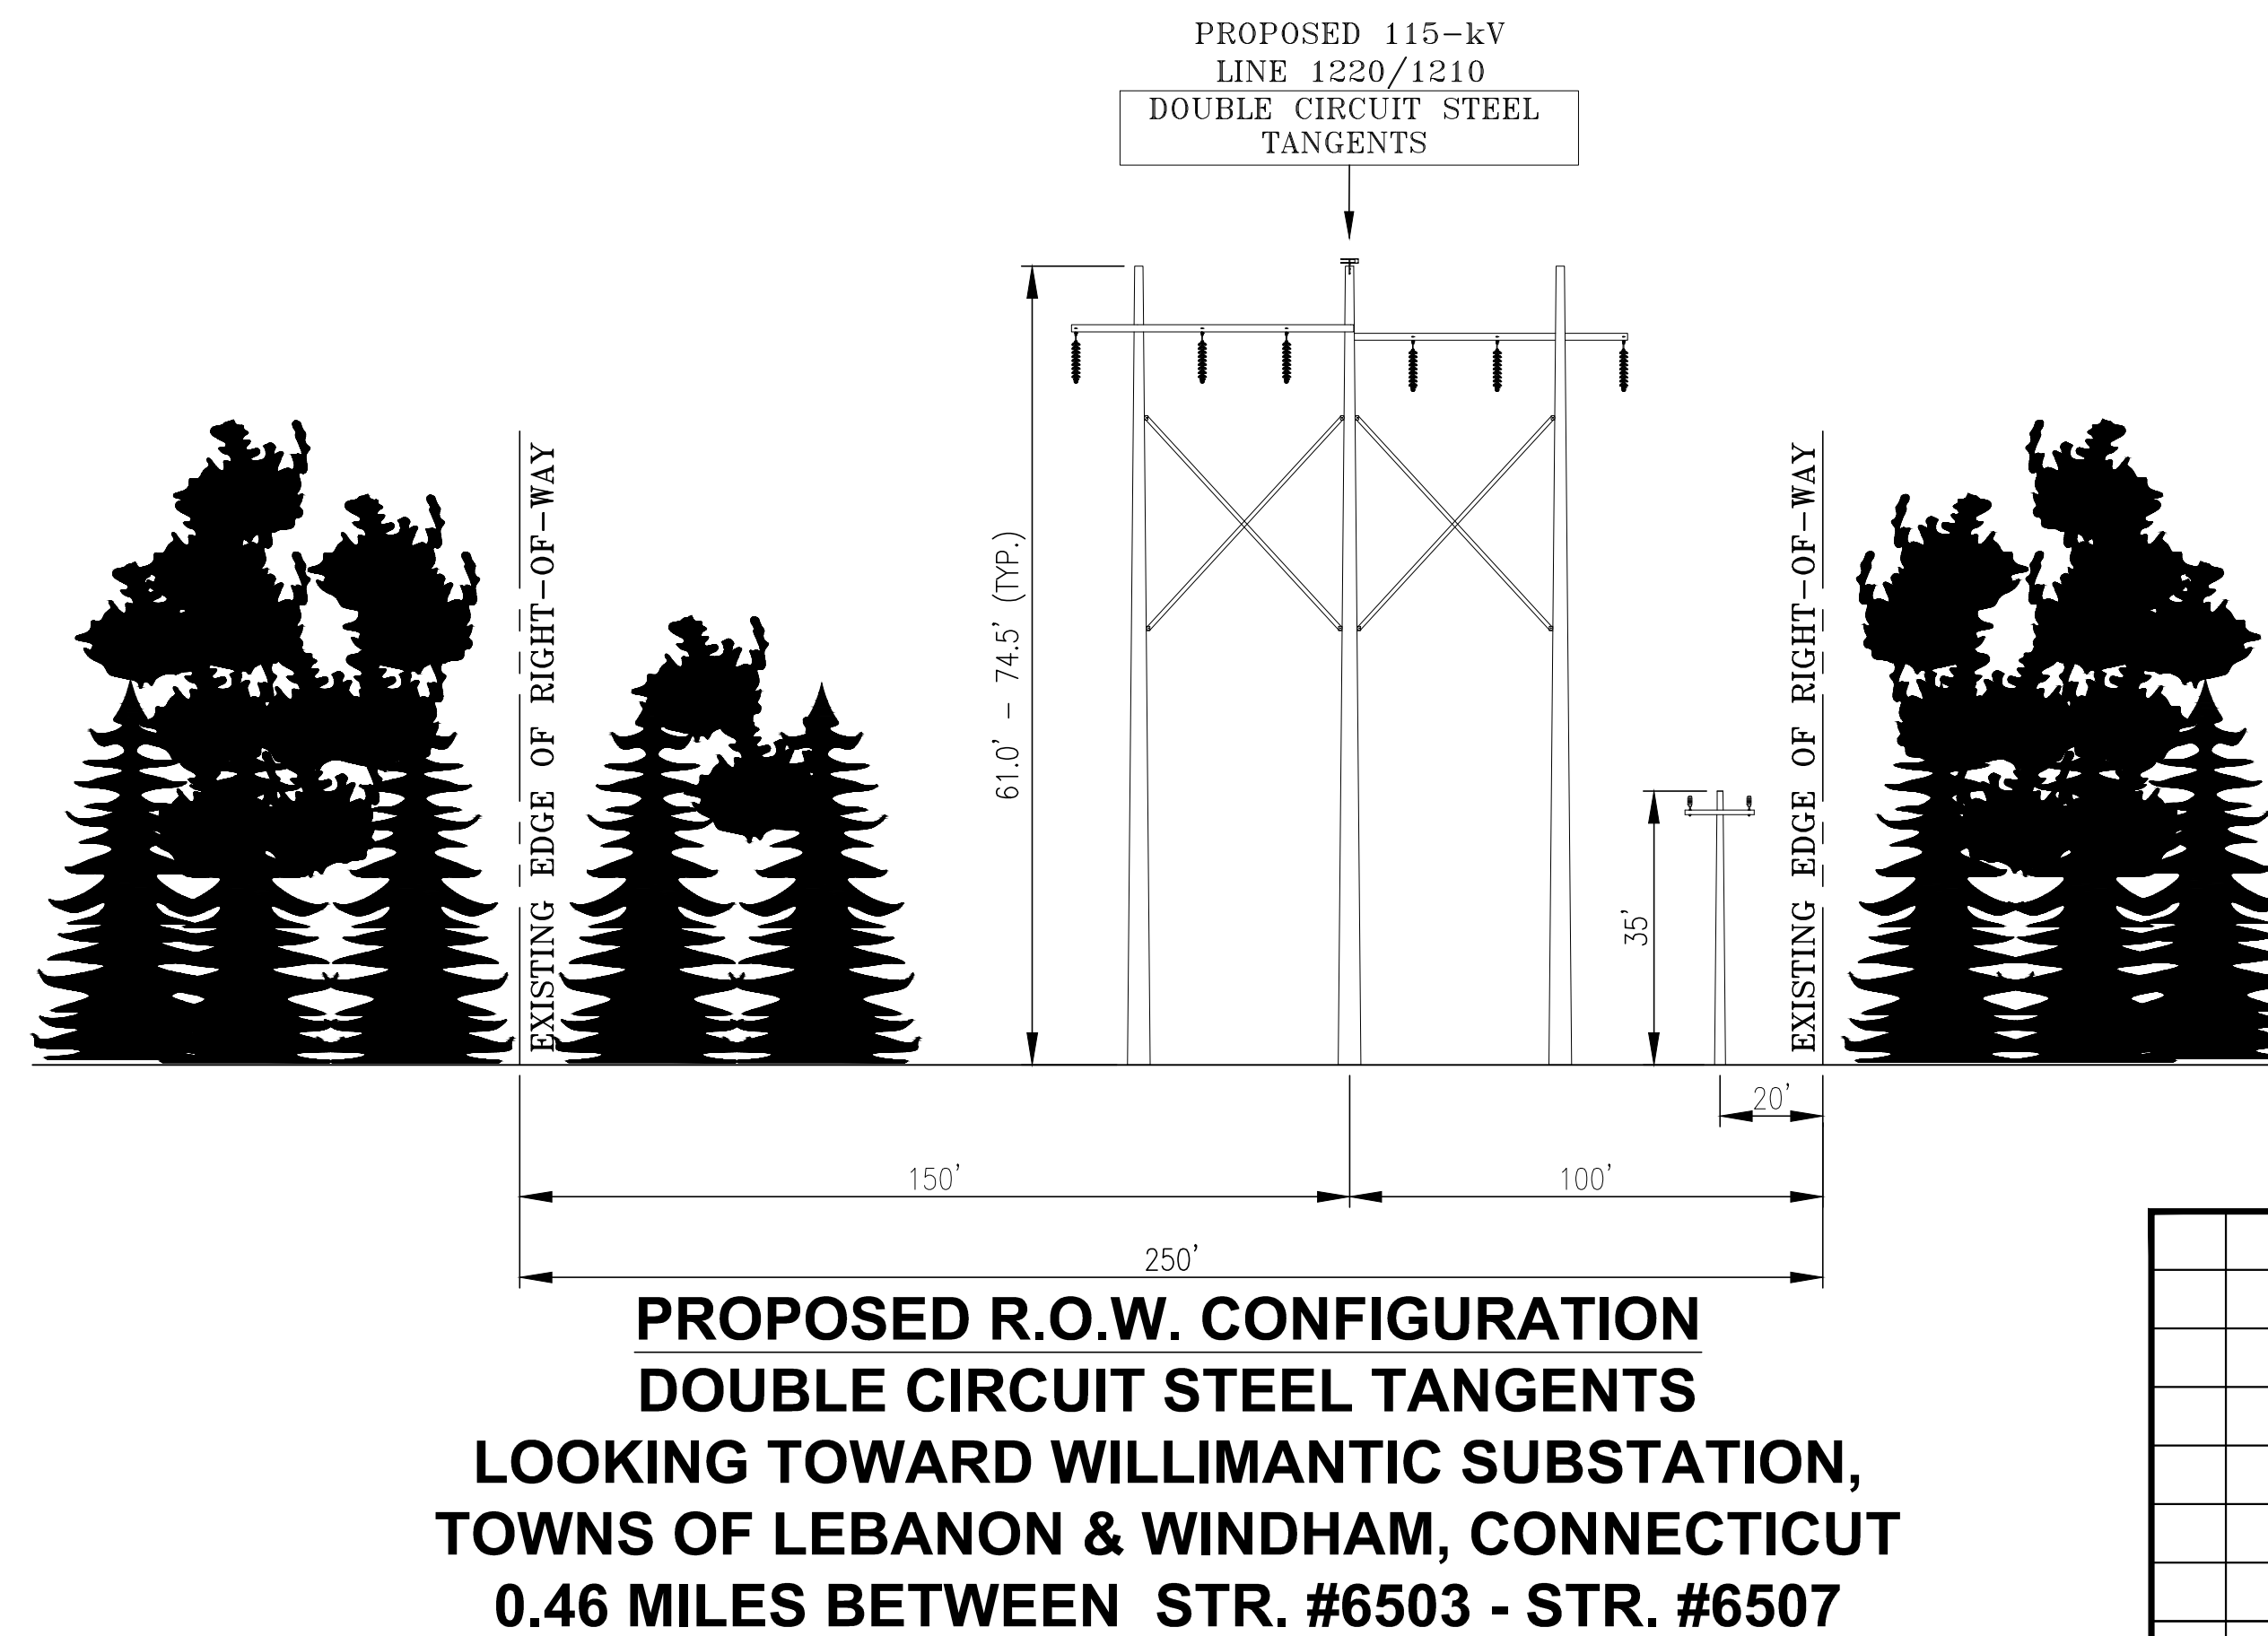
**CARD S/S TO WILLIMANTIC S/S
115-kV TRANSMISSION LINE 1210/1220
RIGHT OF WAY CROSS SECTION
LEBANON AND WINDHAM, CONNECTICUT**

The cross-section drawings in Attachment B – “Card SS to Willimantic SS Right of Way Cross Sections” depict typical views along the ROW of the existing and proposed structures and the existing limits of the ROW areas. Attachment C – “List of Structure Replacements” provides information on structure heights and the type of configuration for the existing and replacement structures. The heights of the existing structures range from 47.5 to 80 feet above ground level and many of the replacement structures must be taller to meet current NESC clearance requirements. The replacement structures will range in height from 61 feet to 100 feet above

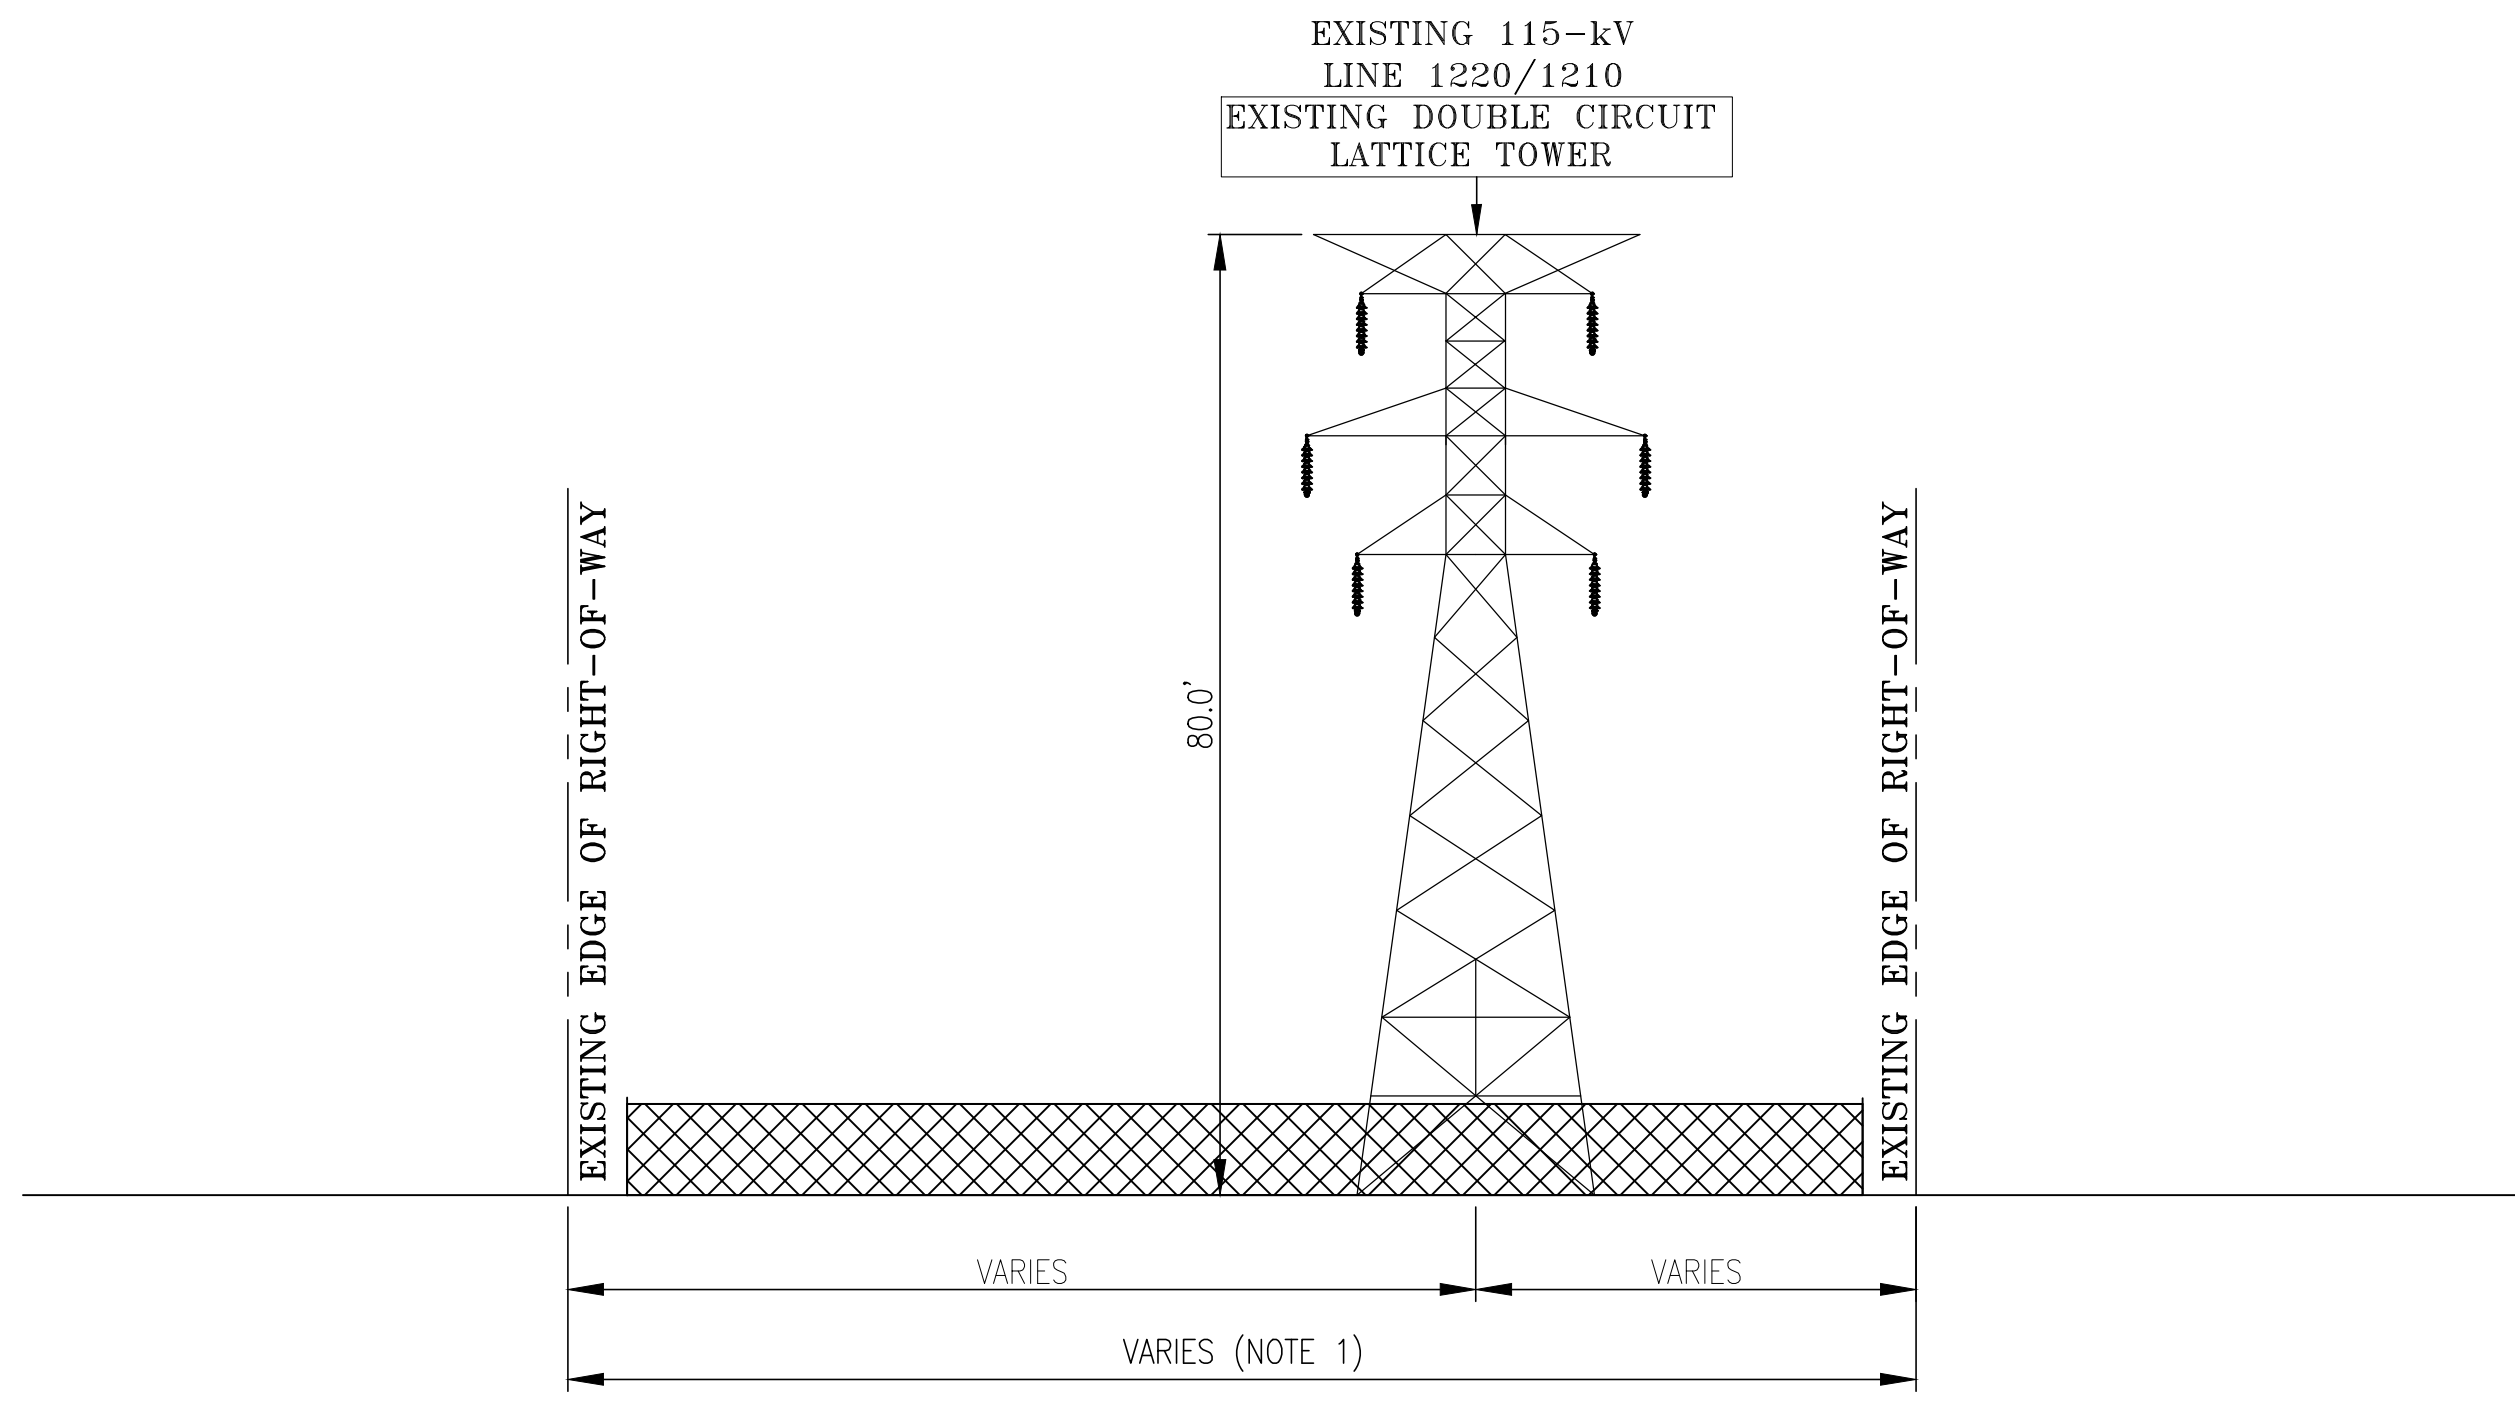
**EXISTING SUBSTATION CONFIGURATION
DOUBLE CIRCUIT LATTICE TOWER
LOOKING TOWARD WILLIMANTIC SUBSTATION,
TOWN OF WINDHAM, CONNECTICUT
STR. #6508**

Replacing the existing lattice tower within the Willimantic Substation with two monopoles will not impact the visual character of the line as they will be located within the Substation. Similarly, the replacement monopoles are not anticipated to appreciably impact the visual character of the Substation.

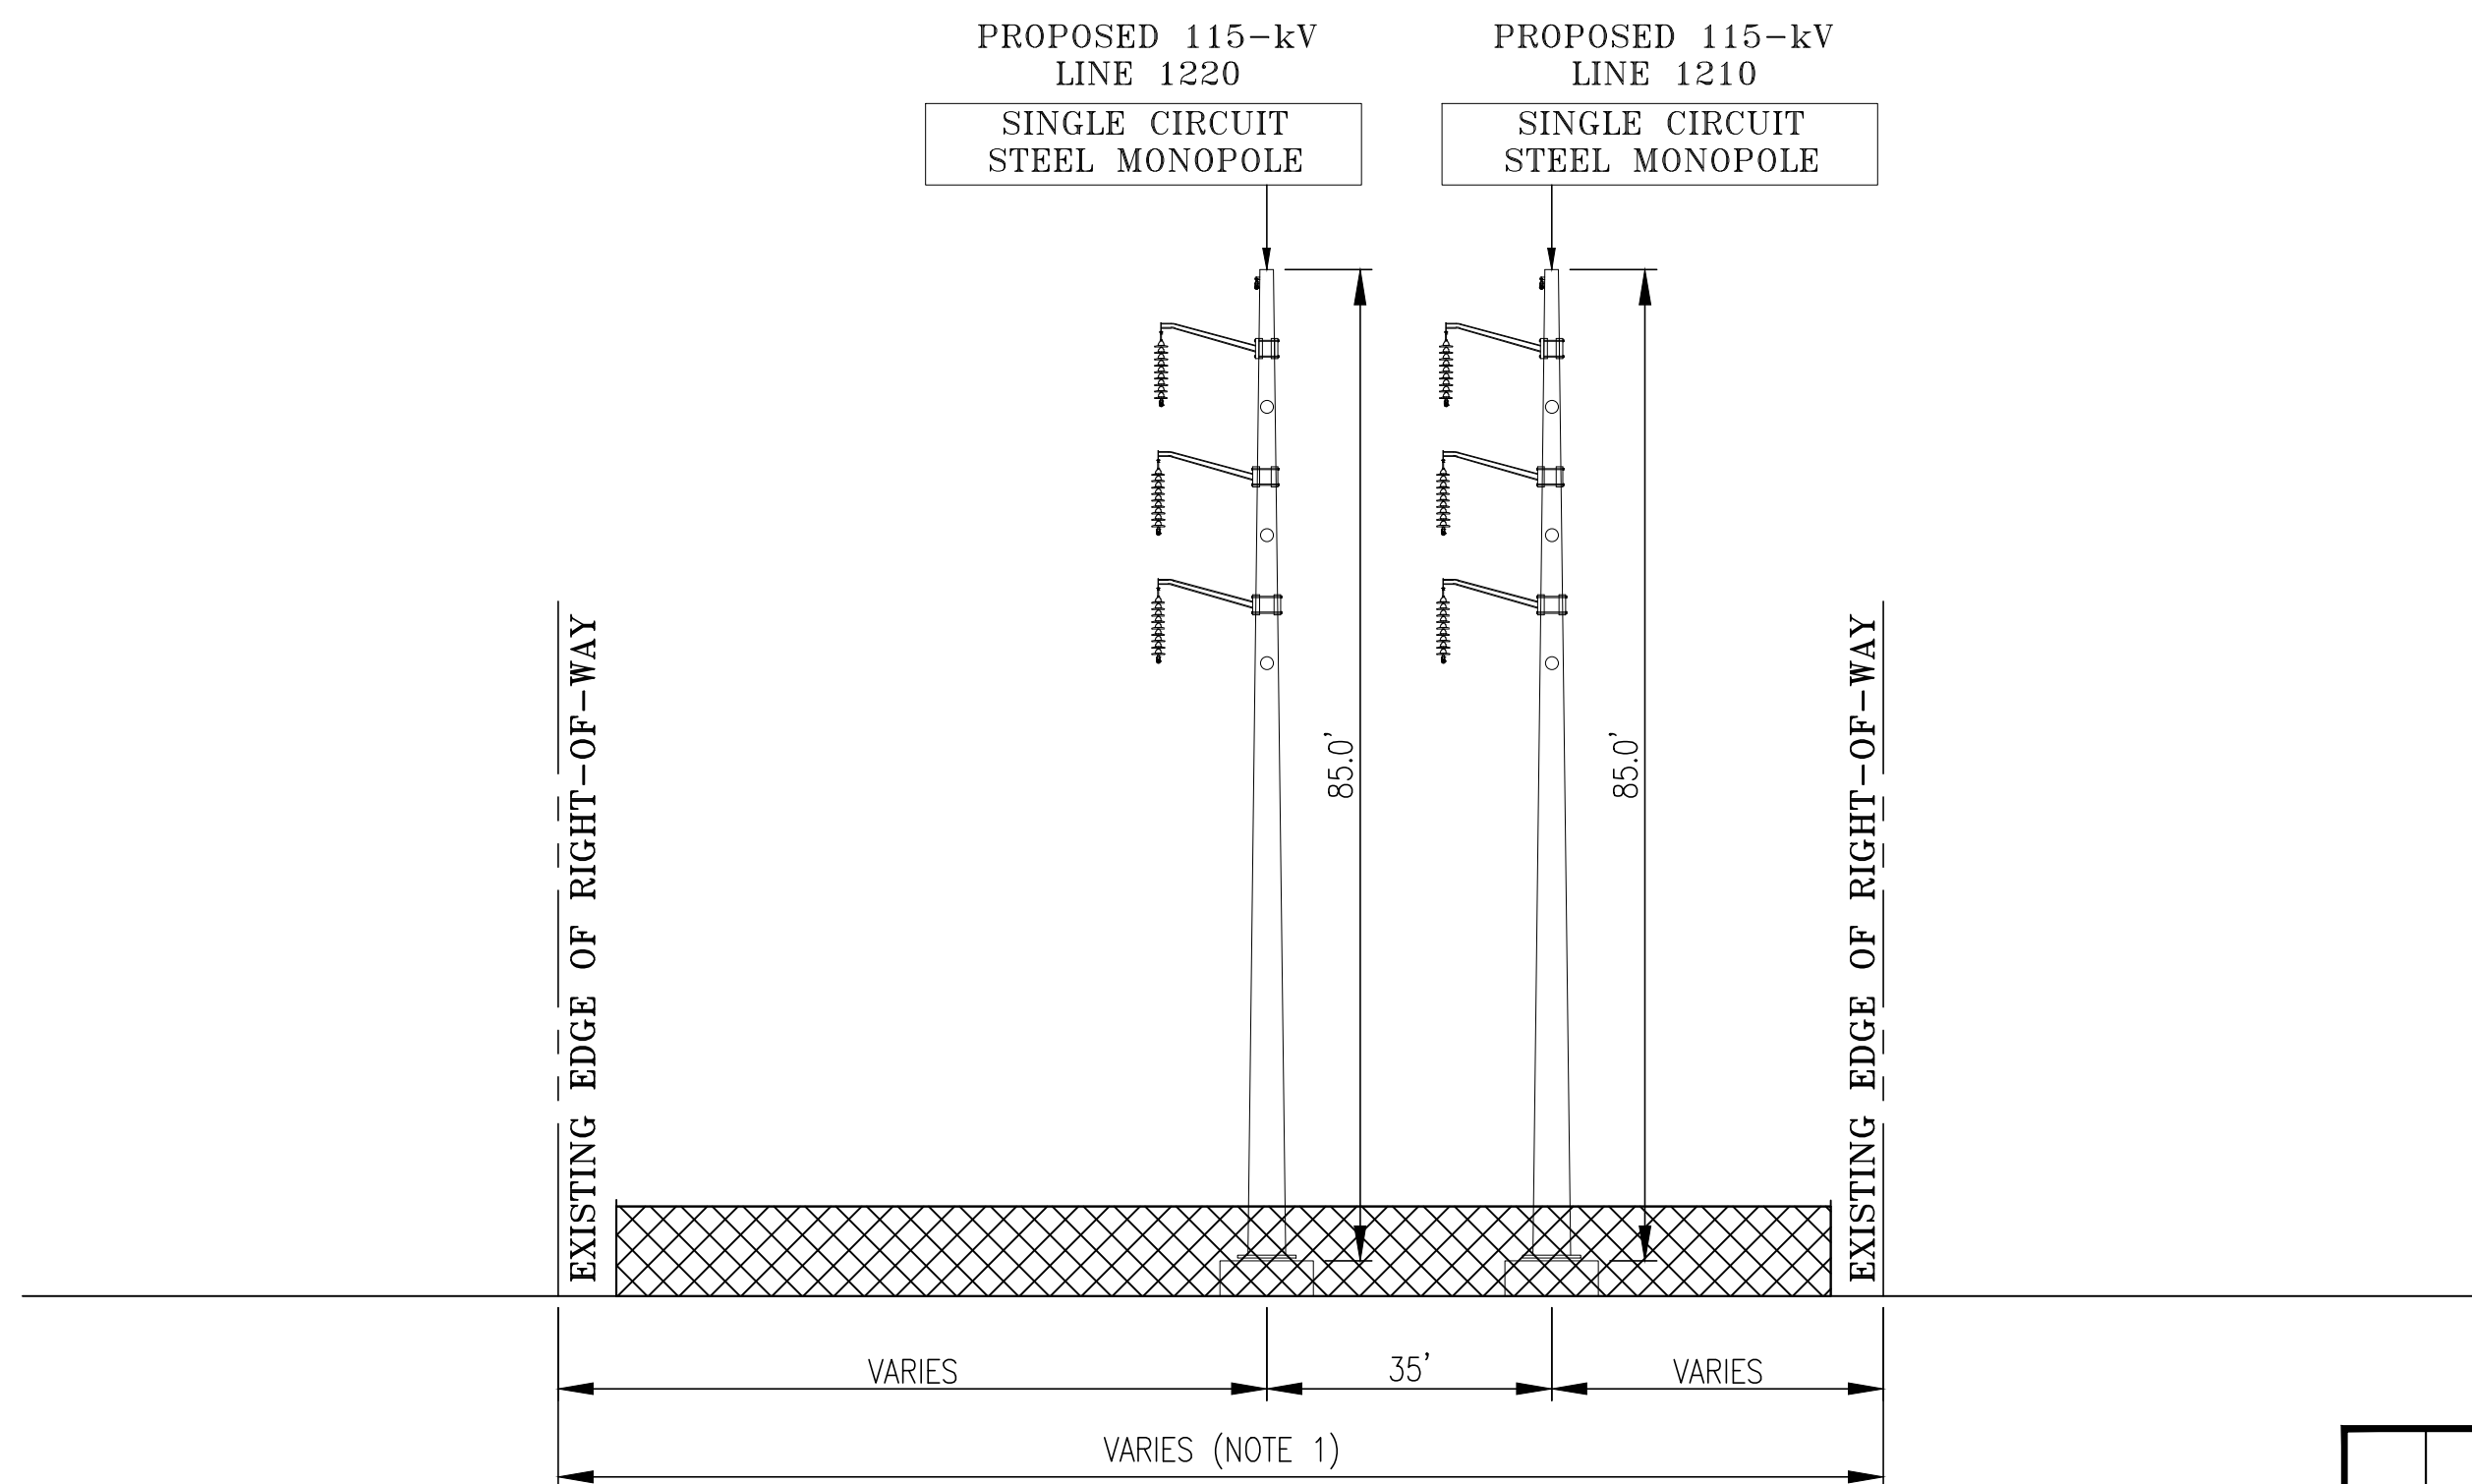
**PROPOSED SUBSTATION CONFIGURATION
SINGLE CIRCUIT STEEL MONOPOLES
LOOKING TOWARD WILLIMANTIC SUBSTATION,
TOWN OF WINDHAM, CONNECTICUT
STR. 6508 & 6508A**

- Replace 1 double circuit steel lattice structure within Willimantic Substation with 2 weathering steel monopole structures. The proposed poles would be constructed in a vertical configuration adjacent to the existing lattice structure within the existing Willimantic Substation yard;
- Replace 13 H-frame wood pole structures with 10 H-frame weathering steel pole structures and 3 weathering steel monopole structures. The single and double circuit configuration of the existing H-frame structures will remain the same with the replacement structures;
- Replace the existing 556 and 795 ACSR conductor along the 1220 Line for approximately 0.10 mile from the 1220 Line Card Substation terminal structure to Structure 6502. The proposed new replacement conductor is 795 ACSS;

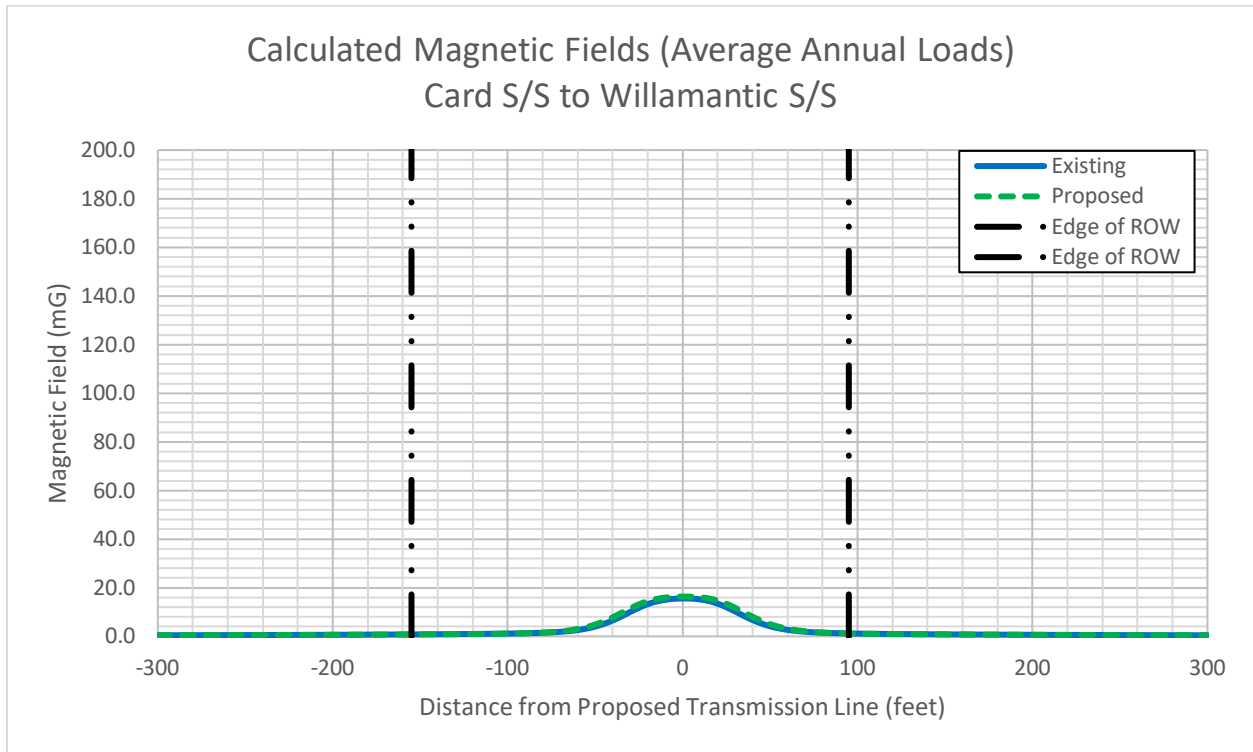
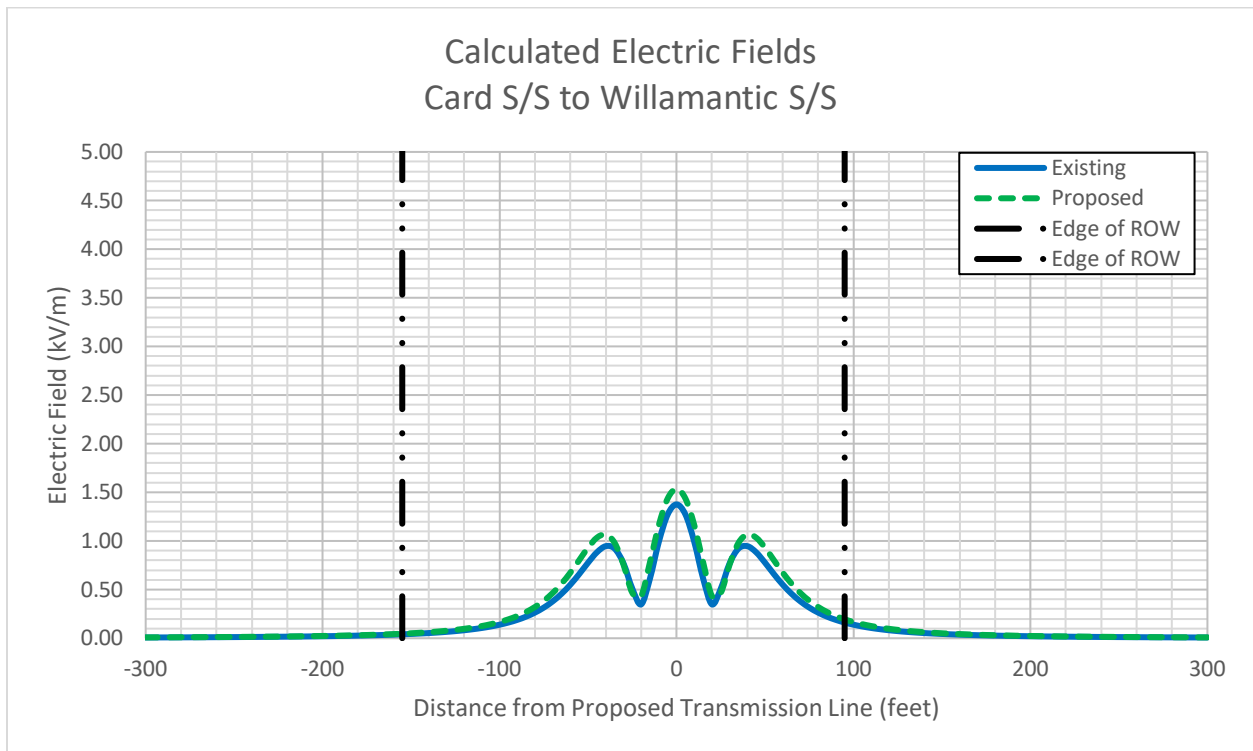
Append E

Distance from Proposed Transmission Line (feet)	Magnetic Fields (mG)		Electric Fields (kV/m)	
	Existing	Proposed	Existing	Proposed
-300	0.5	0.5	0.0	0.0
-275	0.5	0.5	0.0	0.0
-250	0.5	0.5	0.0	0.0
-225	0.6	0.6	0.0	0.0
-200	0.7	0.6	0.0	0.0
-175	0.7	0.7	0.0	0.0
-150	0.8	0.8	0.0	0.1
-125	1.0	0.9	0.1	0.1
-100	1.2	1.1	0.1	0.2
-75	1.6	1.8	0.3	0.4
-50	4.0	4.9	0.8	0.9
-25	11.8	13.2	0.5	0.5
0	15.6	16.3	1.4	1.5
25	12.0	13.4	0.5	0.5
50	4.2	5.0	0.8	0.9
75	1.7	1.8	0.3	0.4
100	1.2	1.1	0.1	0.2
125	1.0	0.9	0.1	0.1
150	0.8	0.8	0.0	0.1
175	0.7	0.7	0.0	0.0
200	0.7	0.6	0.0	0.0
225	0.6	0.6	0.0	0.0
250	0.5	0.5	0.0	0.0
275	0.5	0.5	0.0	0.0
300	0.5	0.4	0.0	0.0

Eversource prepared calculations of the existing and post-Project Electric and Magnetic fields (“EMF”). The calculations were based on average annual loading conditions because these are most representative of typical conditions. The calculations are made relative to the centerline of the proposed, modified transmission lines. The calculations apply at one meter

Eversource's proposes to replace single-circuit and double-circuit wood H-Frame structures with single-circuit and double circuit weathering steel monopoles or weathering steel H-Frame structures and replace the existing double-circuit lattice tower inside Willimantic Substation with two single-circuit weathering steel monopoles.¹⁰ Magnetic field levels will increase by approximately 0.8 mG within the ROW. Magnetic fields at and beyond the edges of the ROW will remain essentially unchanged.
