July 23, 2021

**RE: Wetland Delineation  
Goshen PV Solar Facility  
129 Bartholomew Hill Road  
Goshen, CT  
SLR #145.16763.00011.0011**

USGS LOCUS MAP  
GREENSKIES RENEWABLE ENERGY

## WETLAND DELINEATION

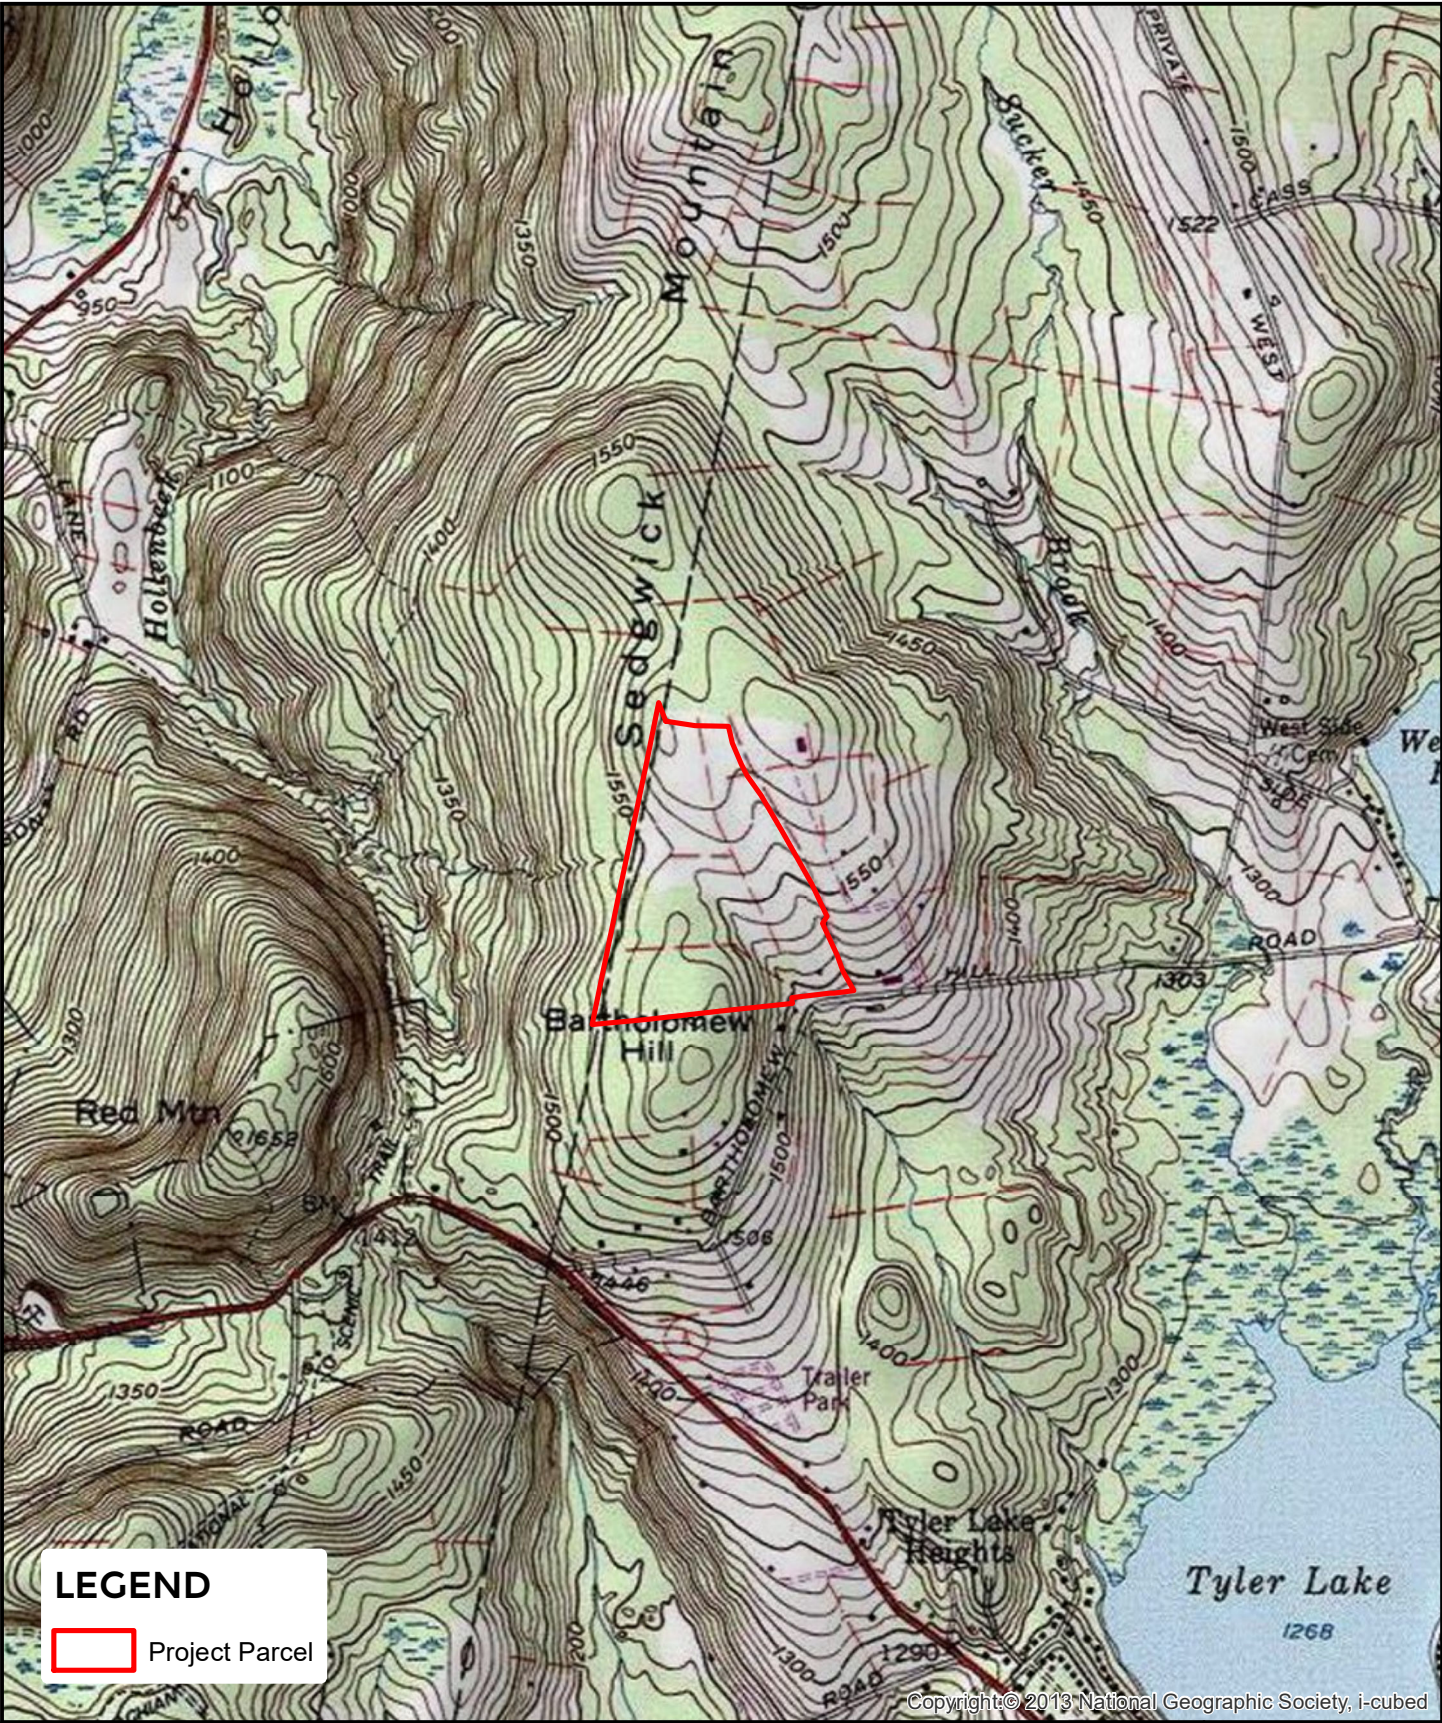
SCALE	1" = 2,000'
DATE	12/21/2020
PROJ. NO.	16763.00011
<b>FIG. 1</b>

The project area is comprised of a 69.1-acre residential property north of Bartholomew Hill Road (Figure 1). The property is accessed to the north from Bartholomew Hill Road and contains a single-family home and associated garage adjacent to the road frontage. The property extends north in a rectangular shape to encompass open fields and forest edge. The land use surrounding the property is comprised of sparsely settled residential homes and agricultural fields. The Wings Ago Airstrip Airport abuts the site to the northeast.

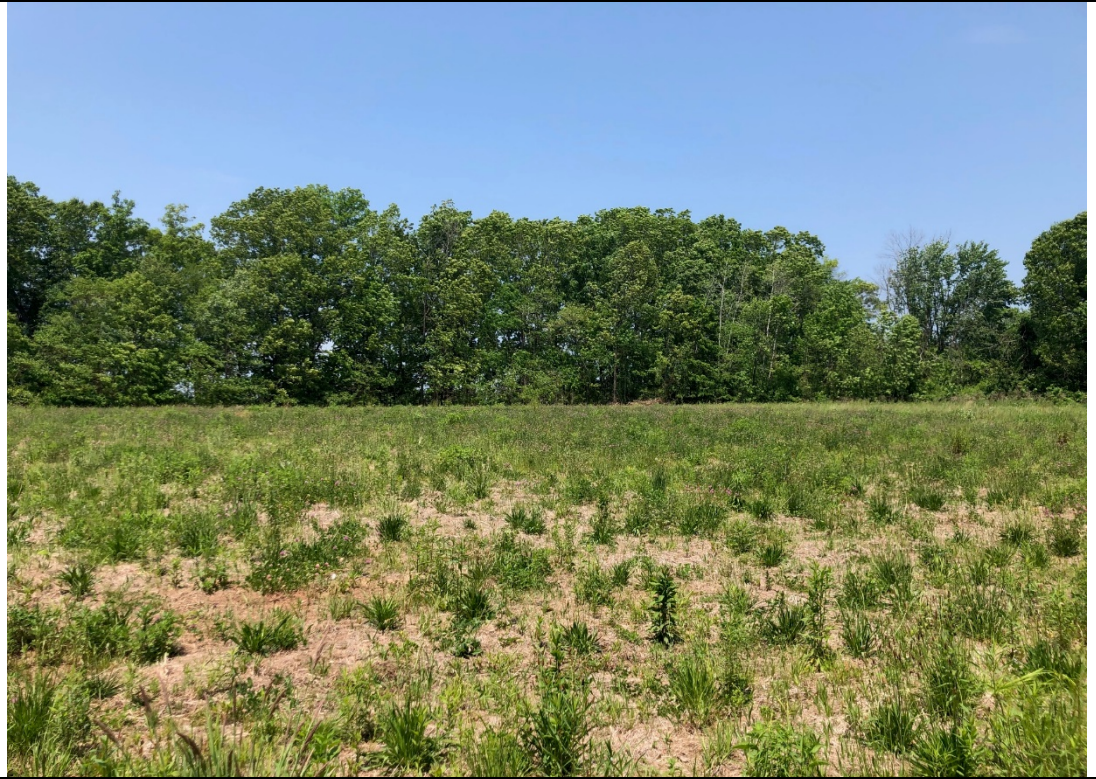
**Photo No.**  
1

**Description:**  
Photo of the upland fields in the northern portion of the property.  
Approximately 20 acres of the property is comprised of agricultural fields.

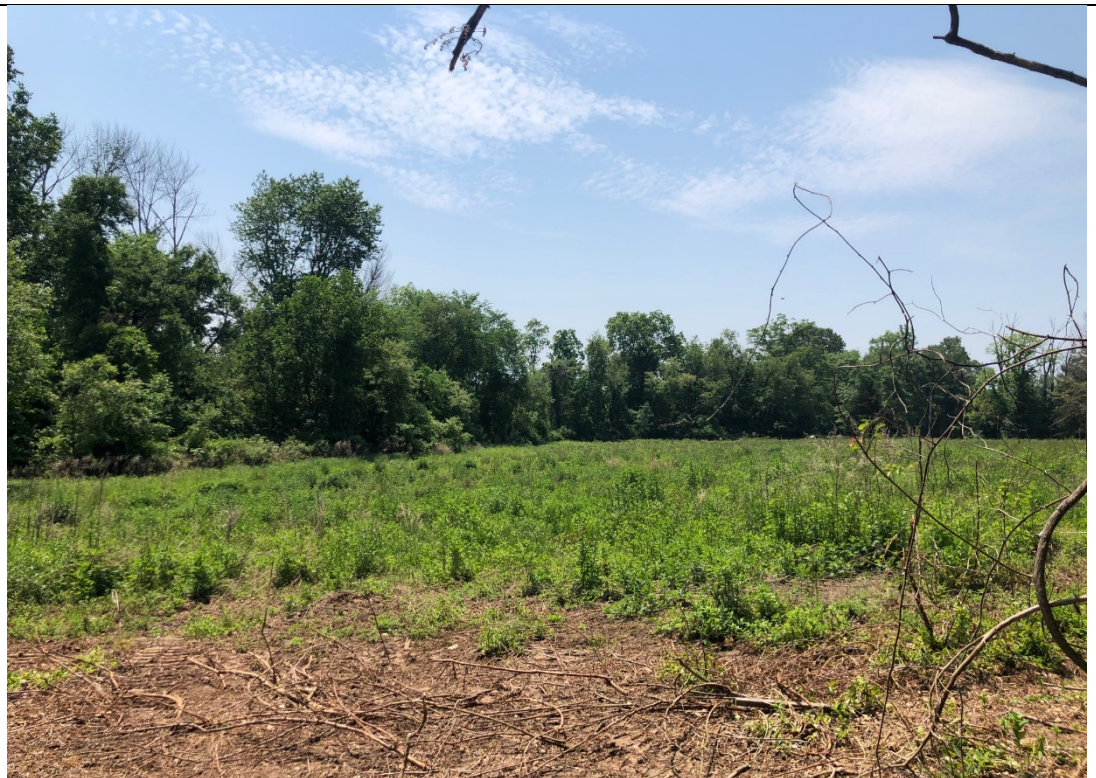
**Photo No.**  
2

**Description:**  
Photo of the upland fields in the northern portion of the property. The fields are bounded by upland forest and forested wetlands.

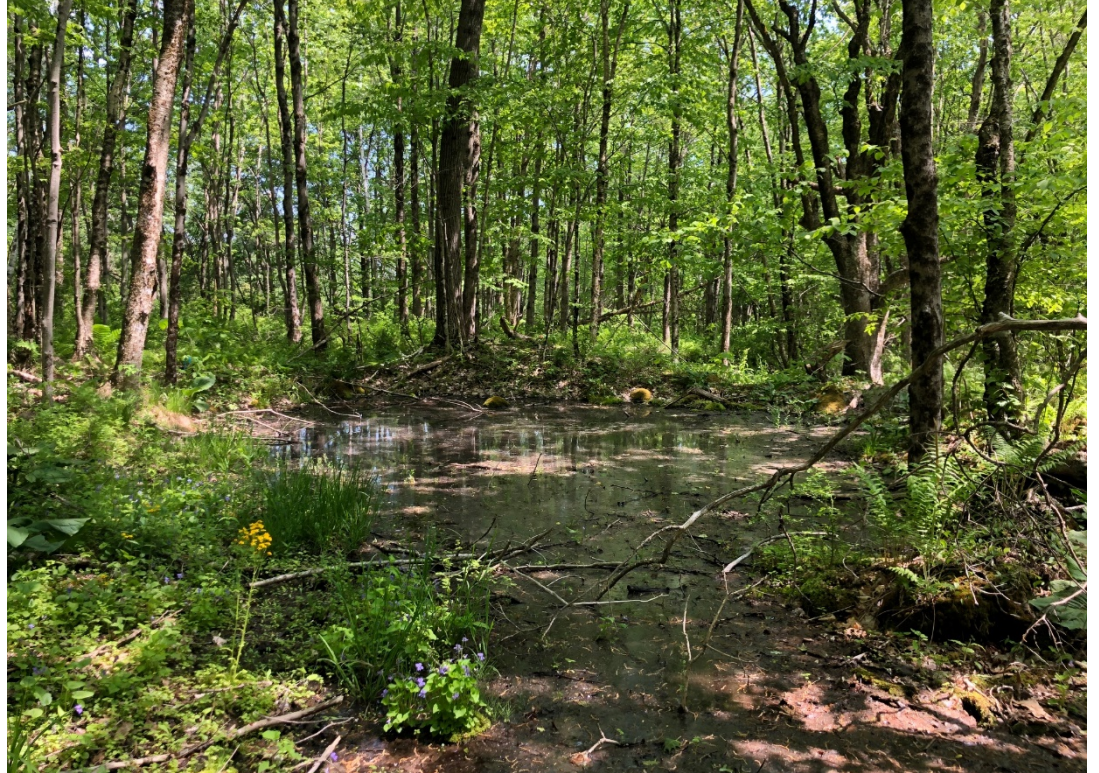
**Photo No.**  
3

**Description:**  
Forested wetland within the property contains a diverse native canopy and understory.

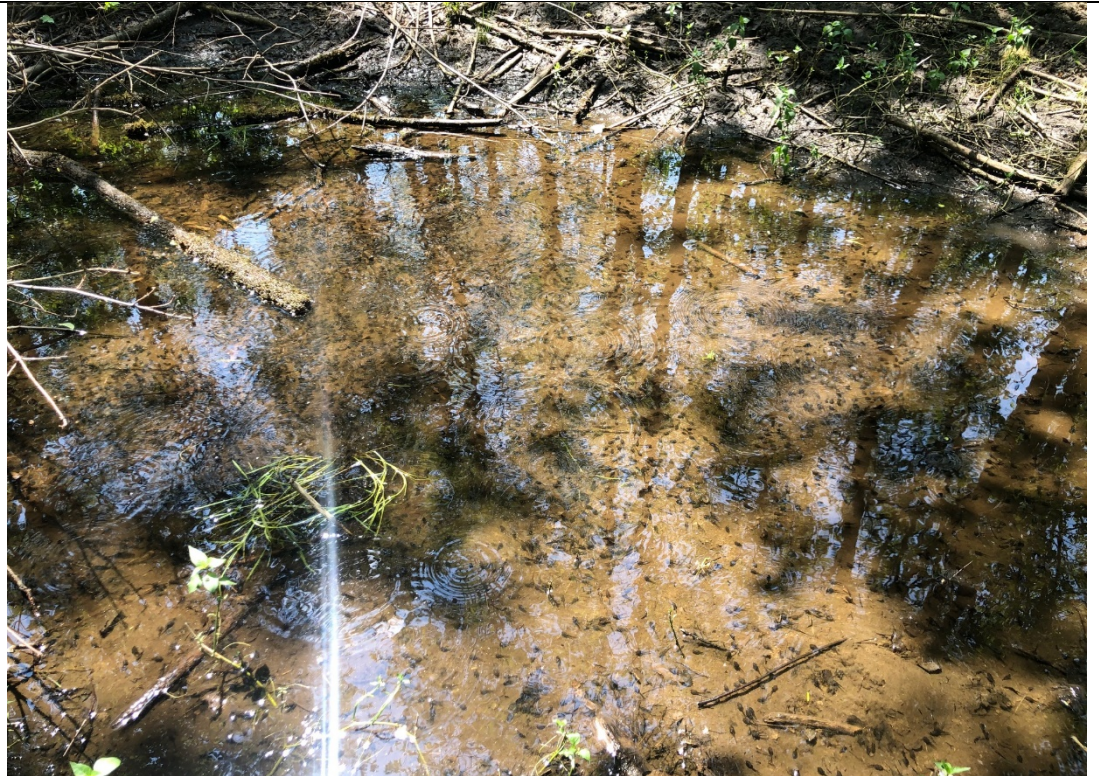
**Photo No.**  
4

The identified pools support breeding and development of wood frog and one vernal pool, vernal pool b, supports spotted salamander egg masses. During the first site evaluation in April, water depths in both wetlands were between 18" and 40". Over 25 wood frog egg masses were observed in each pool and ten spotted salamander egg masses were observed in vernal pool b.

**Description:**  
Vernal pool A located within Wetland 2. Numerous wood frog tadpoles were present in the pool which contained 12" of water.

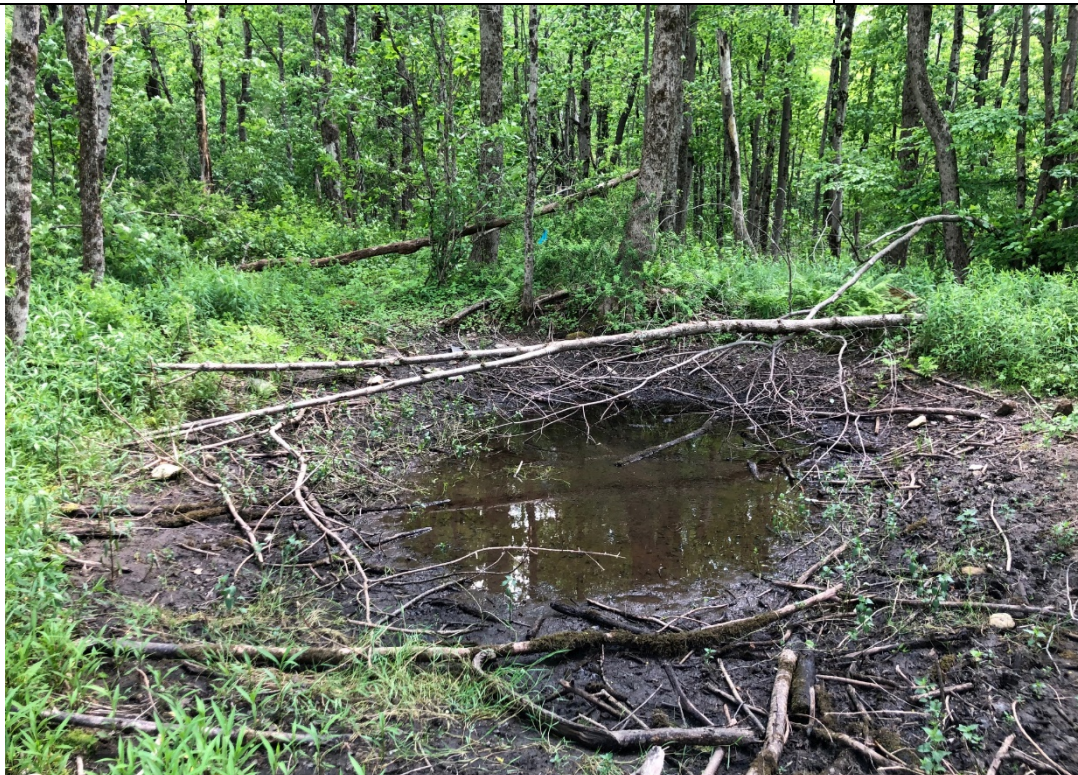
5

The second site evaluation took place on May 26 and all areas were directly evaluated. The water level in vernal pool c had dropped significantly and approximately 3" of water remained in the pool. Hundreds of wood frog tadpoles were observed in the shallow water. The evening of May 26 brought rain and a large storm system occurred over the next several days, refilling the pool and allowing the wood frogs to complete their development cycle. Water levels in vernal pools a and b had only dropped to 12" and the water was cool and clean. Numerous wood frog tadpoles were observed. Mayflies, caddisfly larvae, and mosquito larvae were observed within all three vernal pools.

Vernal pool C within the eastern portion of Wetland 3. Water levels dropped since the April 8, 2021 evaluation and approximately 3" of water was present on May 26, 2021.
