Re: PETITION NO. 1472 – Dynamic Energy Solutions, LLC as agent for Stag Industrial Holdings, LLC petition for a declaratory ruling, pursuant to Connecticut General Statutes §4-176 and §16-50k, for the proposed construction, maintenance and operation of a 1.5 megawatt AC solar photovoltaic electric generating facility located at 40 Pepes Farm Road, Milford, Connecticut, and associated electrical interconnection.

Petition No. 1472
Dynamic Energy Solutions, LLC
Milford Connecticut

Interrogatories

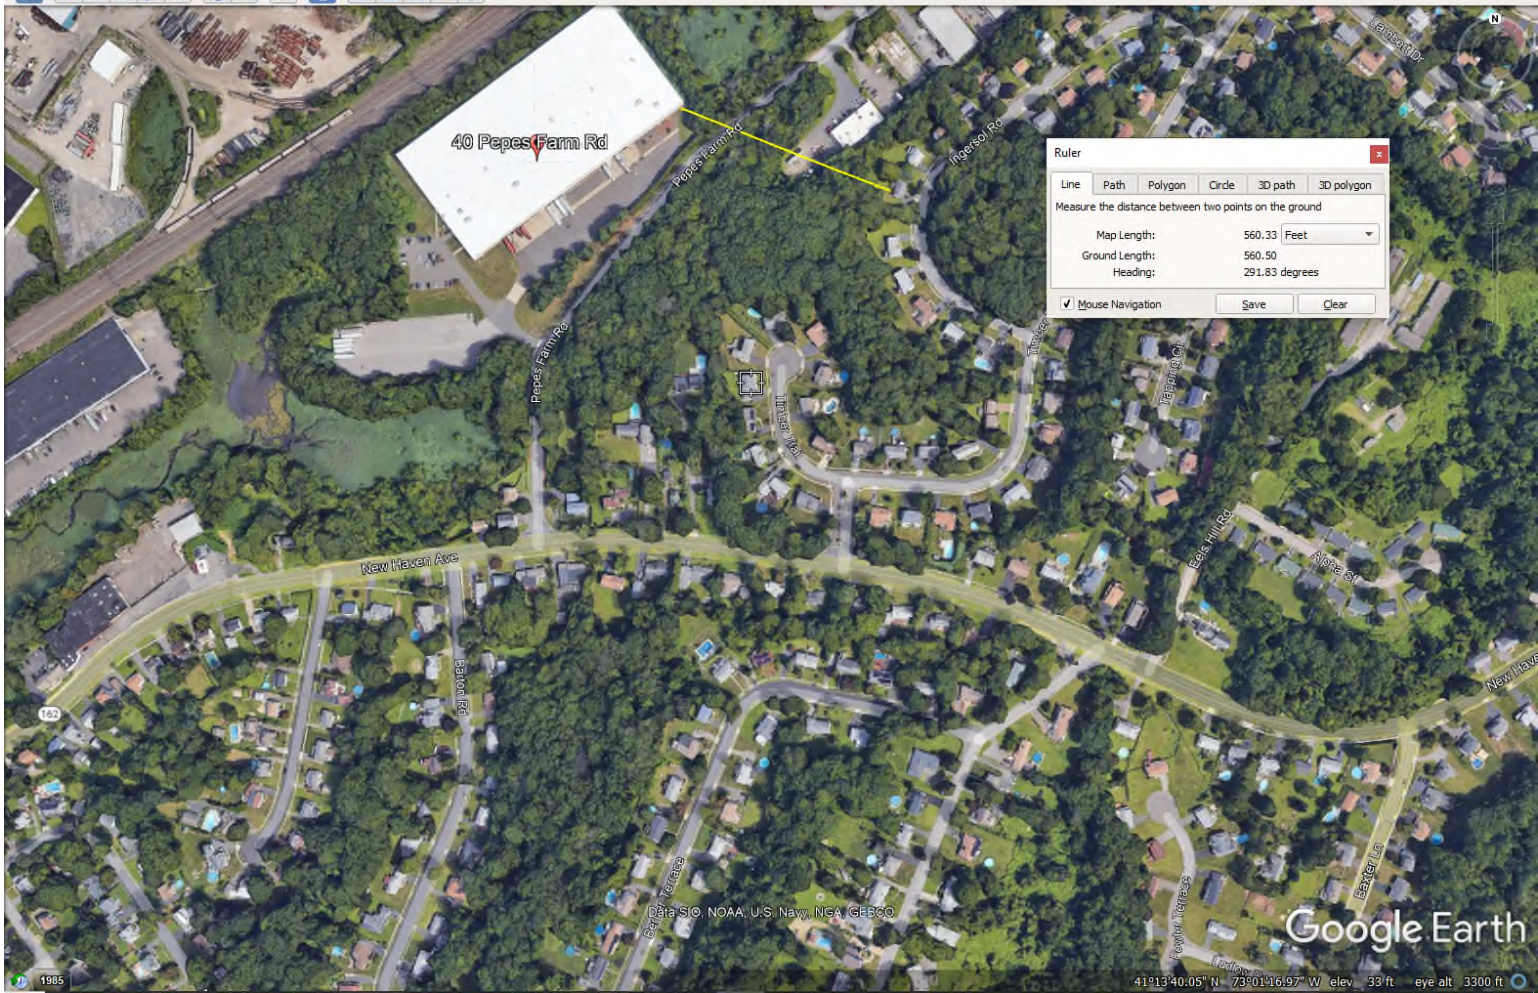
Line	Path	Polygon	Circle	3D path	3D polygon
Measure the distance between two points on the ground					
Map Length:		560.33 Feet			
Ground Length:		560.50			
Heading:		291.83 degrees

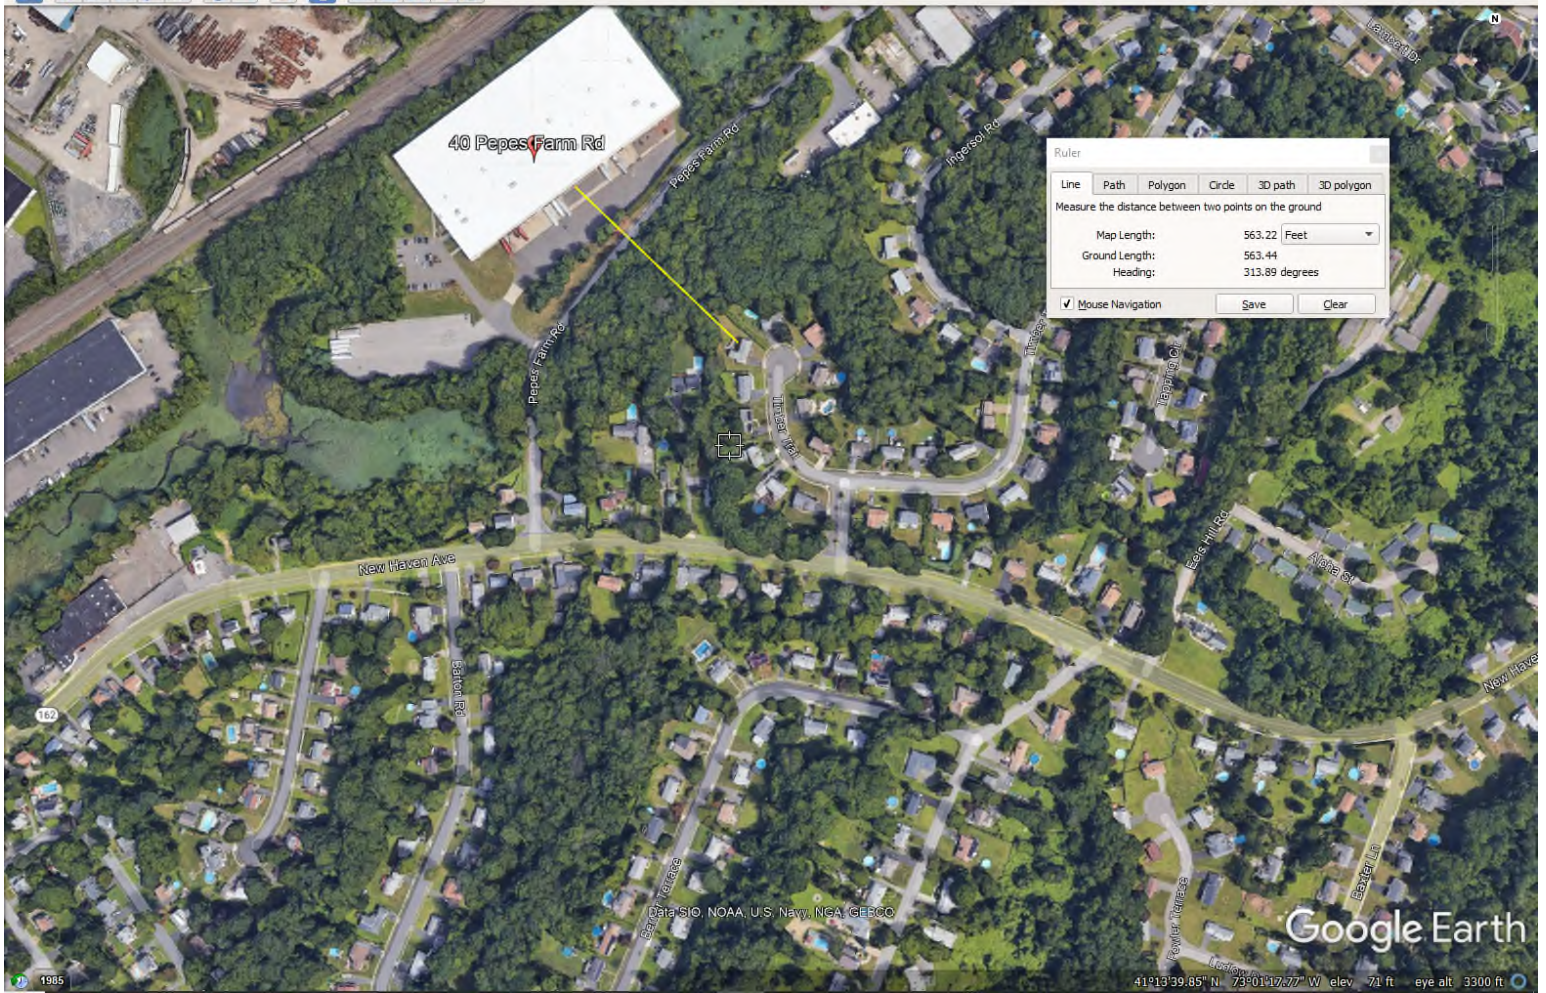
Line	Path	Polygon	Circle	3D path	3D polygon
Measure the distance between two points on the ground					
Map Length:		563.22 Feet			
Ground Length:		563.44			
Heading:		313.89 degrees
