Re: Dooley Substation to Scoville Rock Substation and Middletown Substation Structure Replacement Project

PETITION TO THE CONNECTICUT SITING COUNCIL
FOR A DECLARATORY RULING OF
NO SUBSTANTIAL ADVERSE ENVIRONMENTAL EFFECT
FOR THE PROPOSED MODIFICATIONS TO THE EXISTING
387, 3041 and 1050 LINES IN THE CITY OF MIDDLETOWN, CONNECTICUT

387/3041/1050 Lines Structure Replacement and OPGW Project

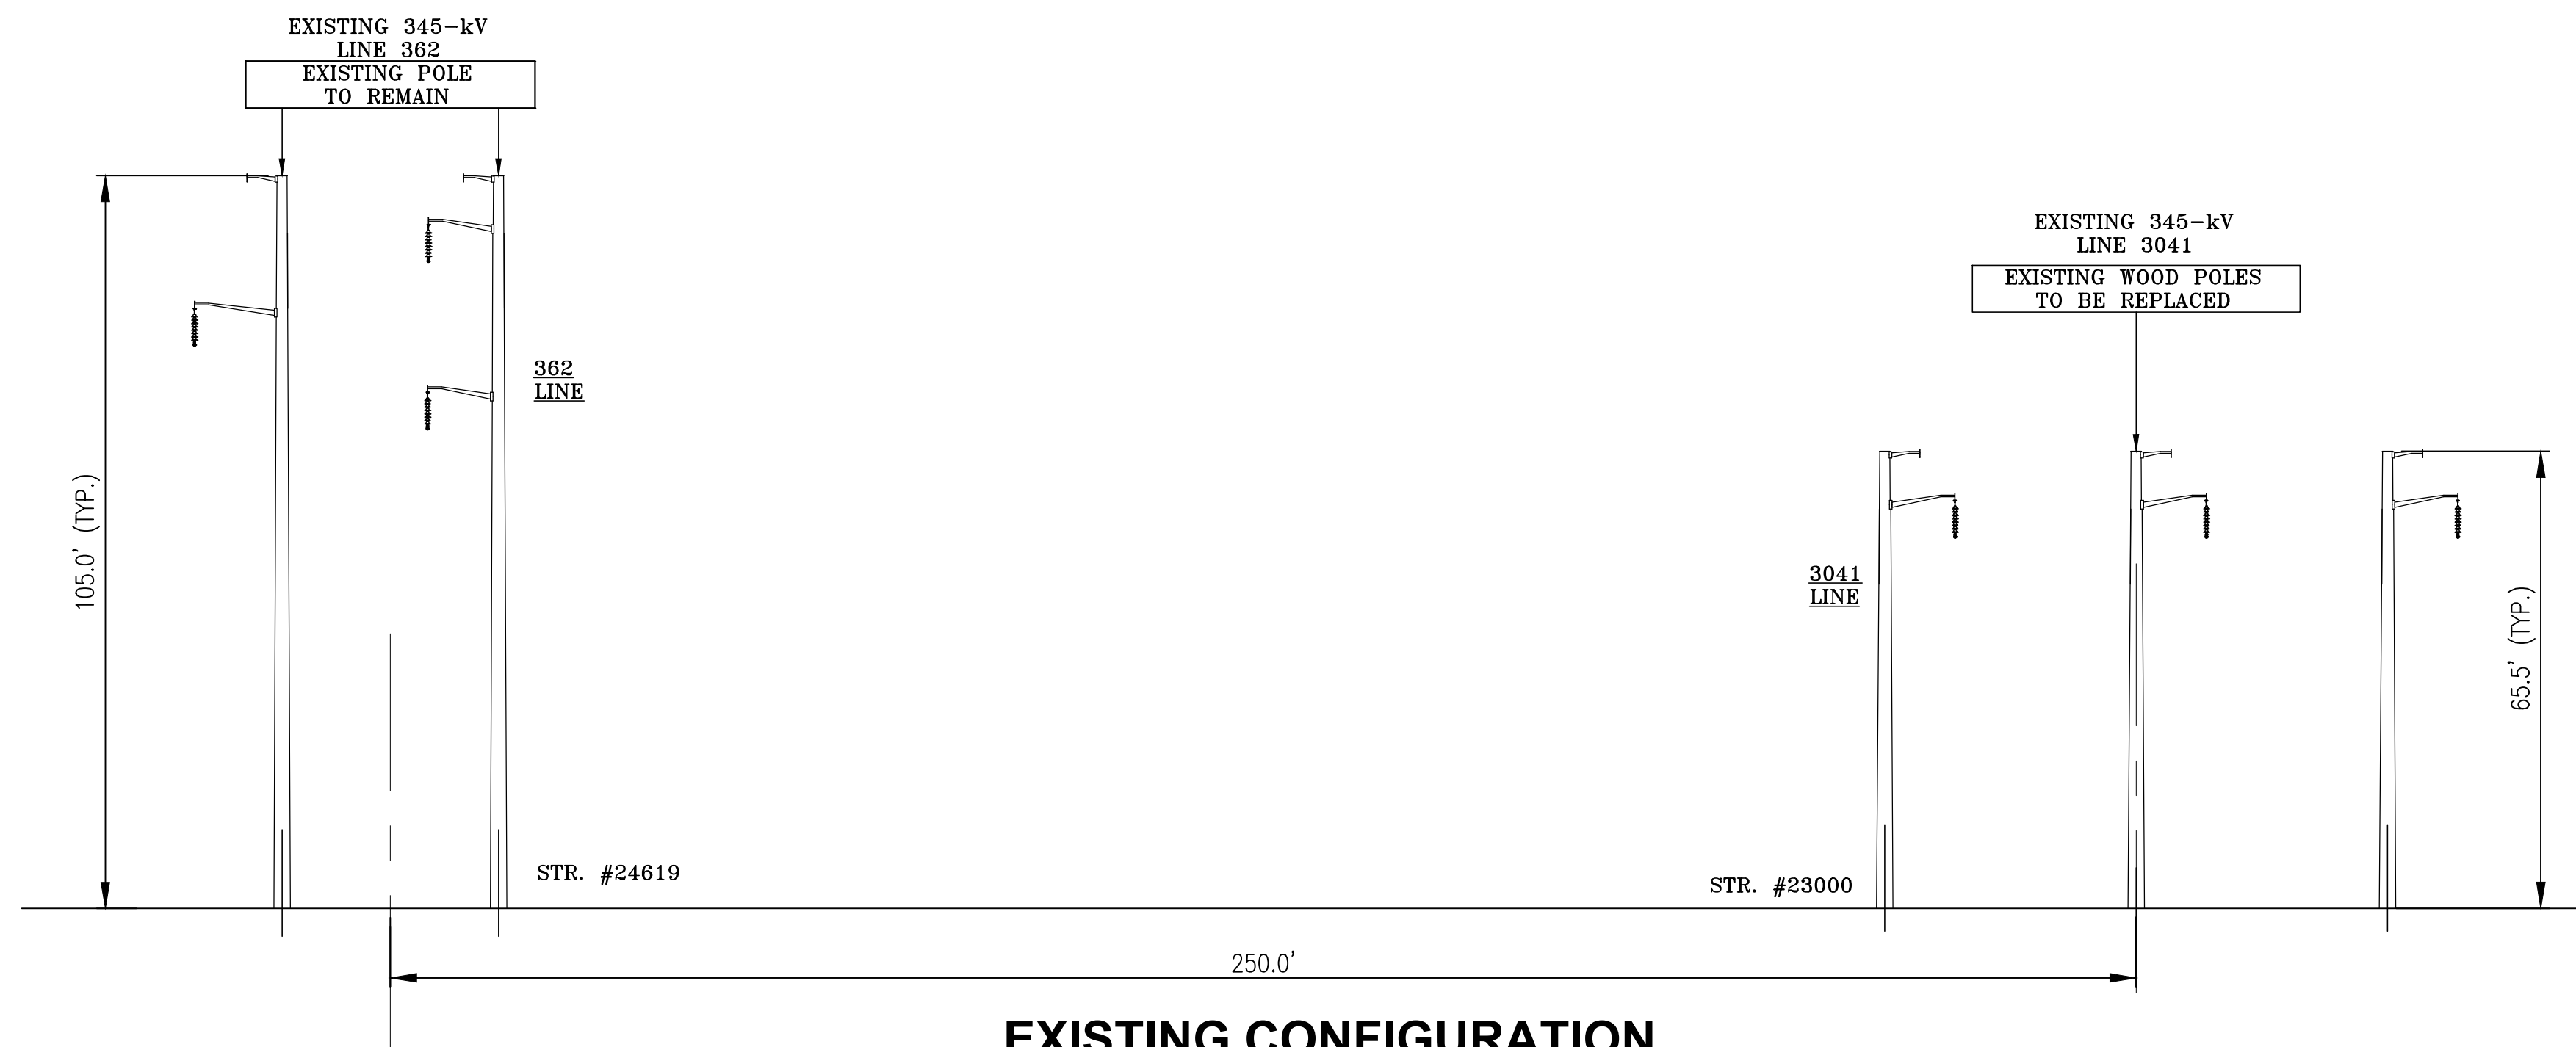
**EXISTING CONFIGURATION
SINGLE CIRCUIT THREE POLE DESIGN
LOOKING WEST FROM SCOVILLE ROCK SUBSTATION TO CHESTNUT JUNCTION
IN THE CITY OF MIDDLETOWN, CT
STR. #23000**

- Replace two single circuit wood H-frames structures (Structures 30021 and 30013), due to asset condition, with single circuit weathering steel H-frame structures;
- Replace one single circuit wood three pole structure (Structure 23000) with a single circuit weathering steel three pole structure; and,

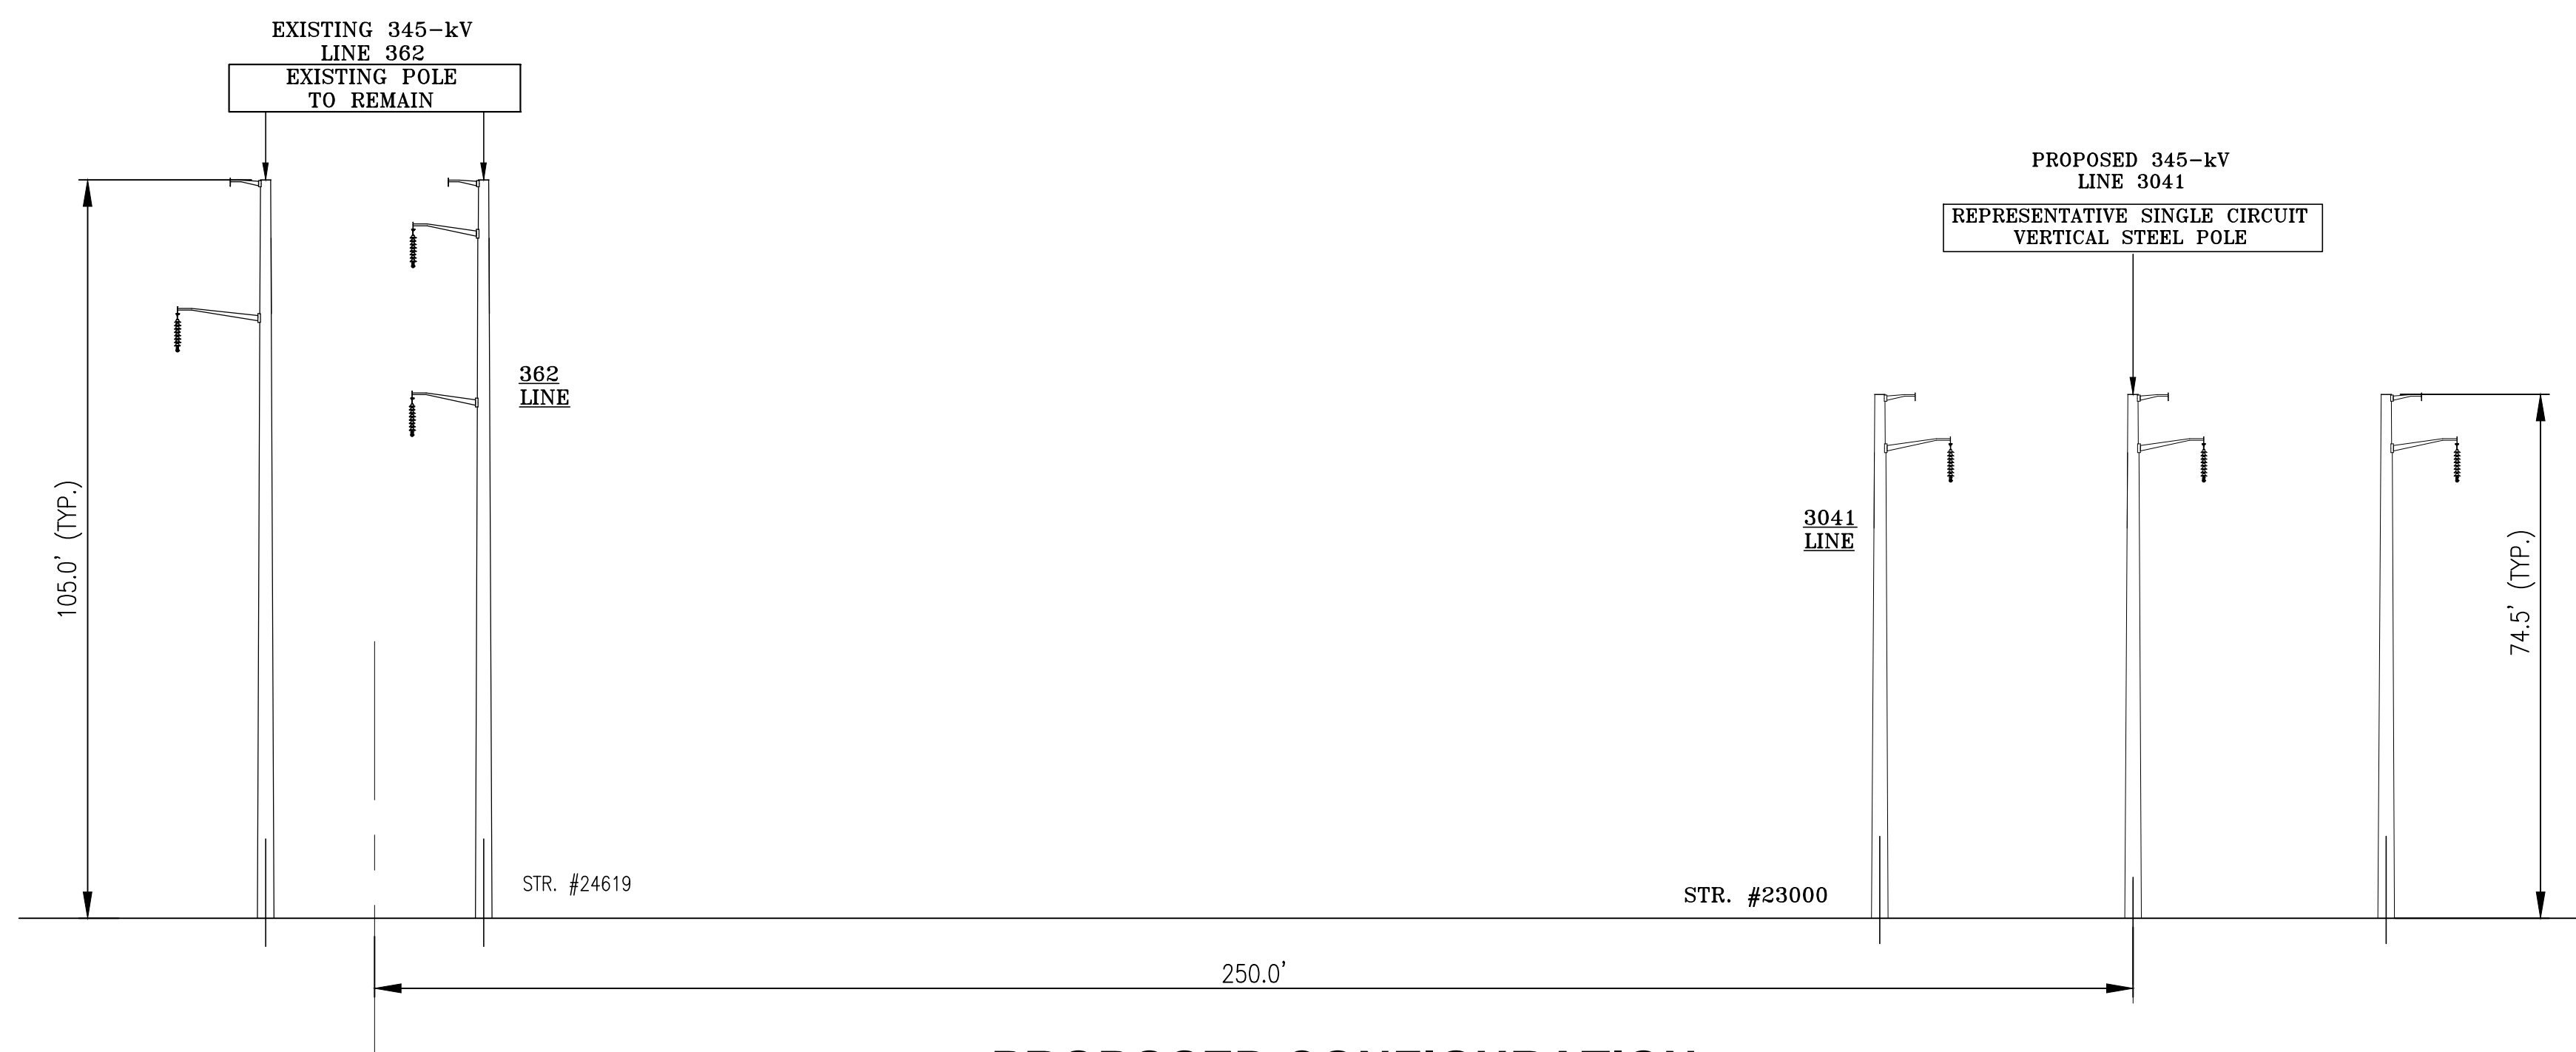
XS-1

**PROPOSED CONFIGURATION
NO ADDITIONAL RIGHT-OF-WAY REQUIRED
SINGLE CIRCUIT THREE POLE DESIGN
LOOKING WEST FROM SCOVILLE ROCK SUBSTATION TO CHESTNUT JUNCTION
IN THE CITY OF MIDDLETOWN, CT
STR. #23000**

NOTE:
LINE ARRESTERS TO BE
ADDED AS REQUIRED

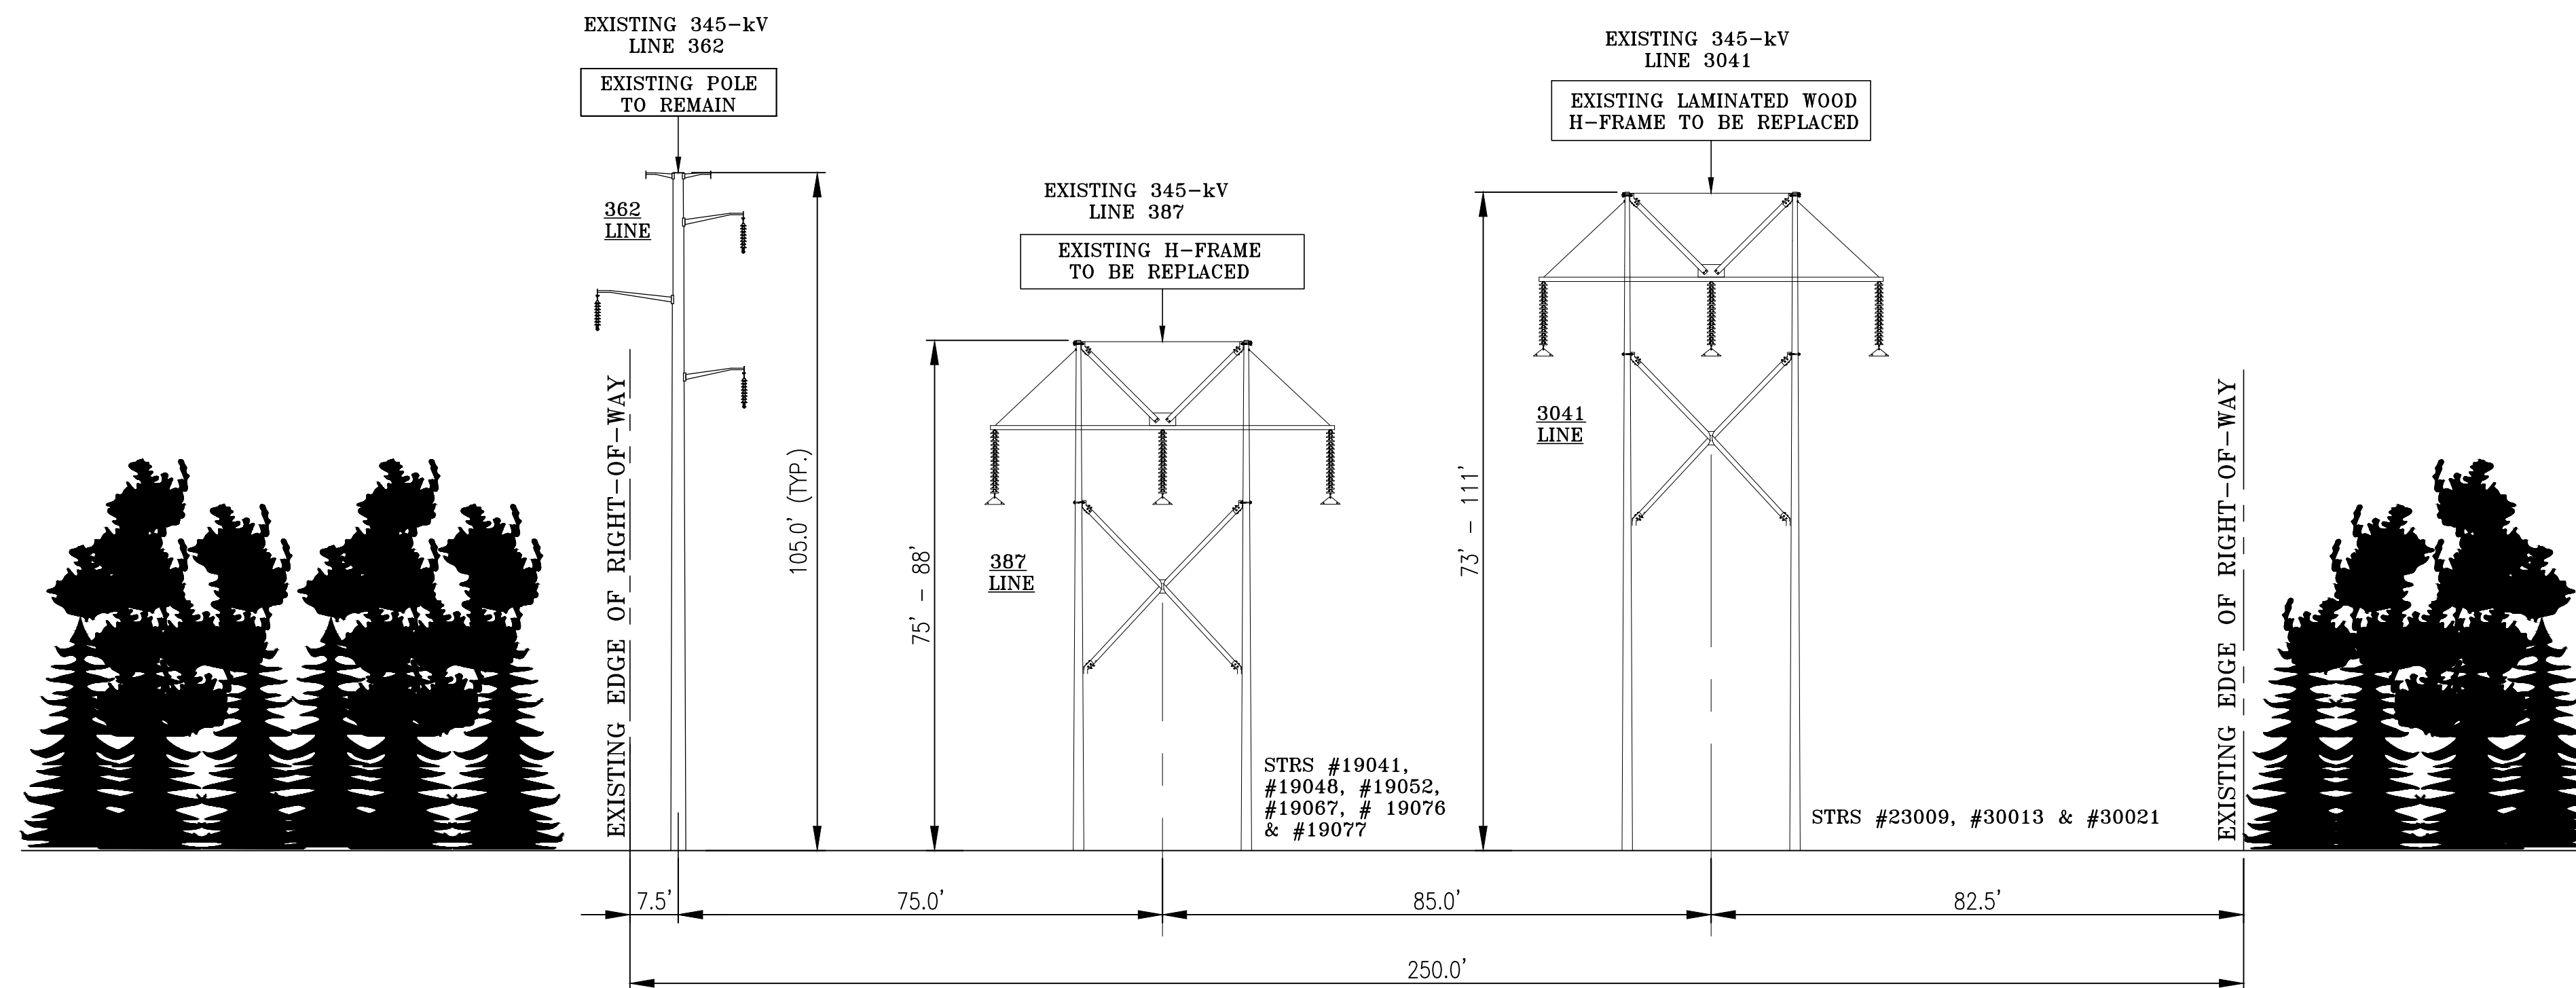
EXISTING R.O.W. CONFIGURATION
SINGLE CIRCUIT STEEL H-FRAME DESIGN
LOOKING WEST FROM SCOVILLE ROCK SUBSTATION TO CHESTNUT JUNCTION
IN THE CITY OF MIDDLETOWN, CT
STRS. #19041, #19048, #19052, #19067, # 19076 & #19077 FOR LINE 387
STRS. #23009, #30013 & #30021 FOR LINE 3041

- Replace 6 single circuit wood H-frame structures (Structures: 19041, 19048, 19052, 19067, 19076 and 19077), due to asset condition, with single circuit weathering steel H-frame structures;

- Replace one single circuit laminated wood H-frame structure (Structure 23009), due to asset condition, with a single circuit weathering steel H-frame structure.

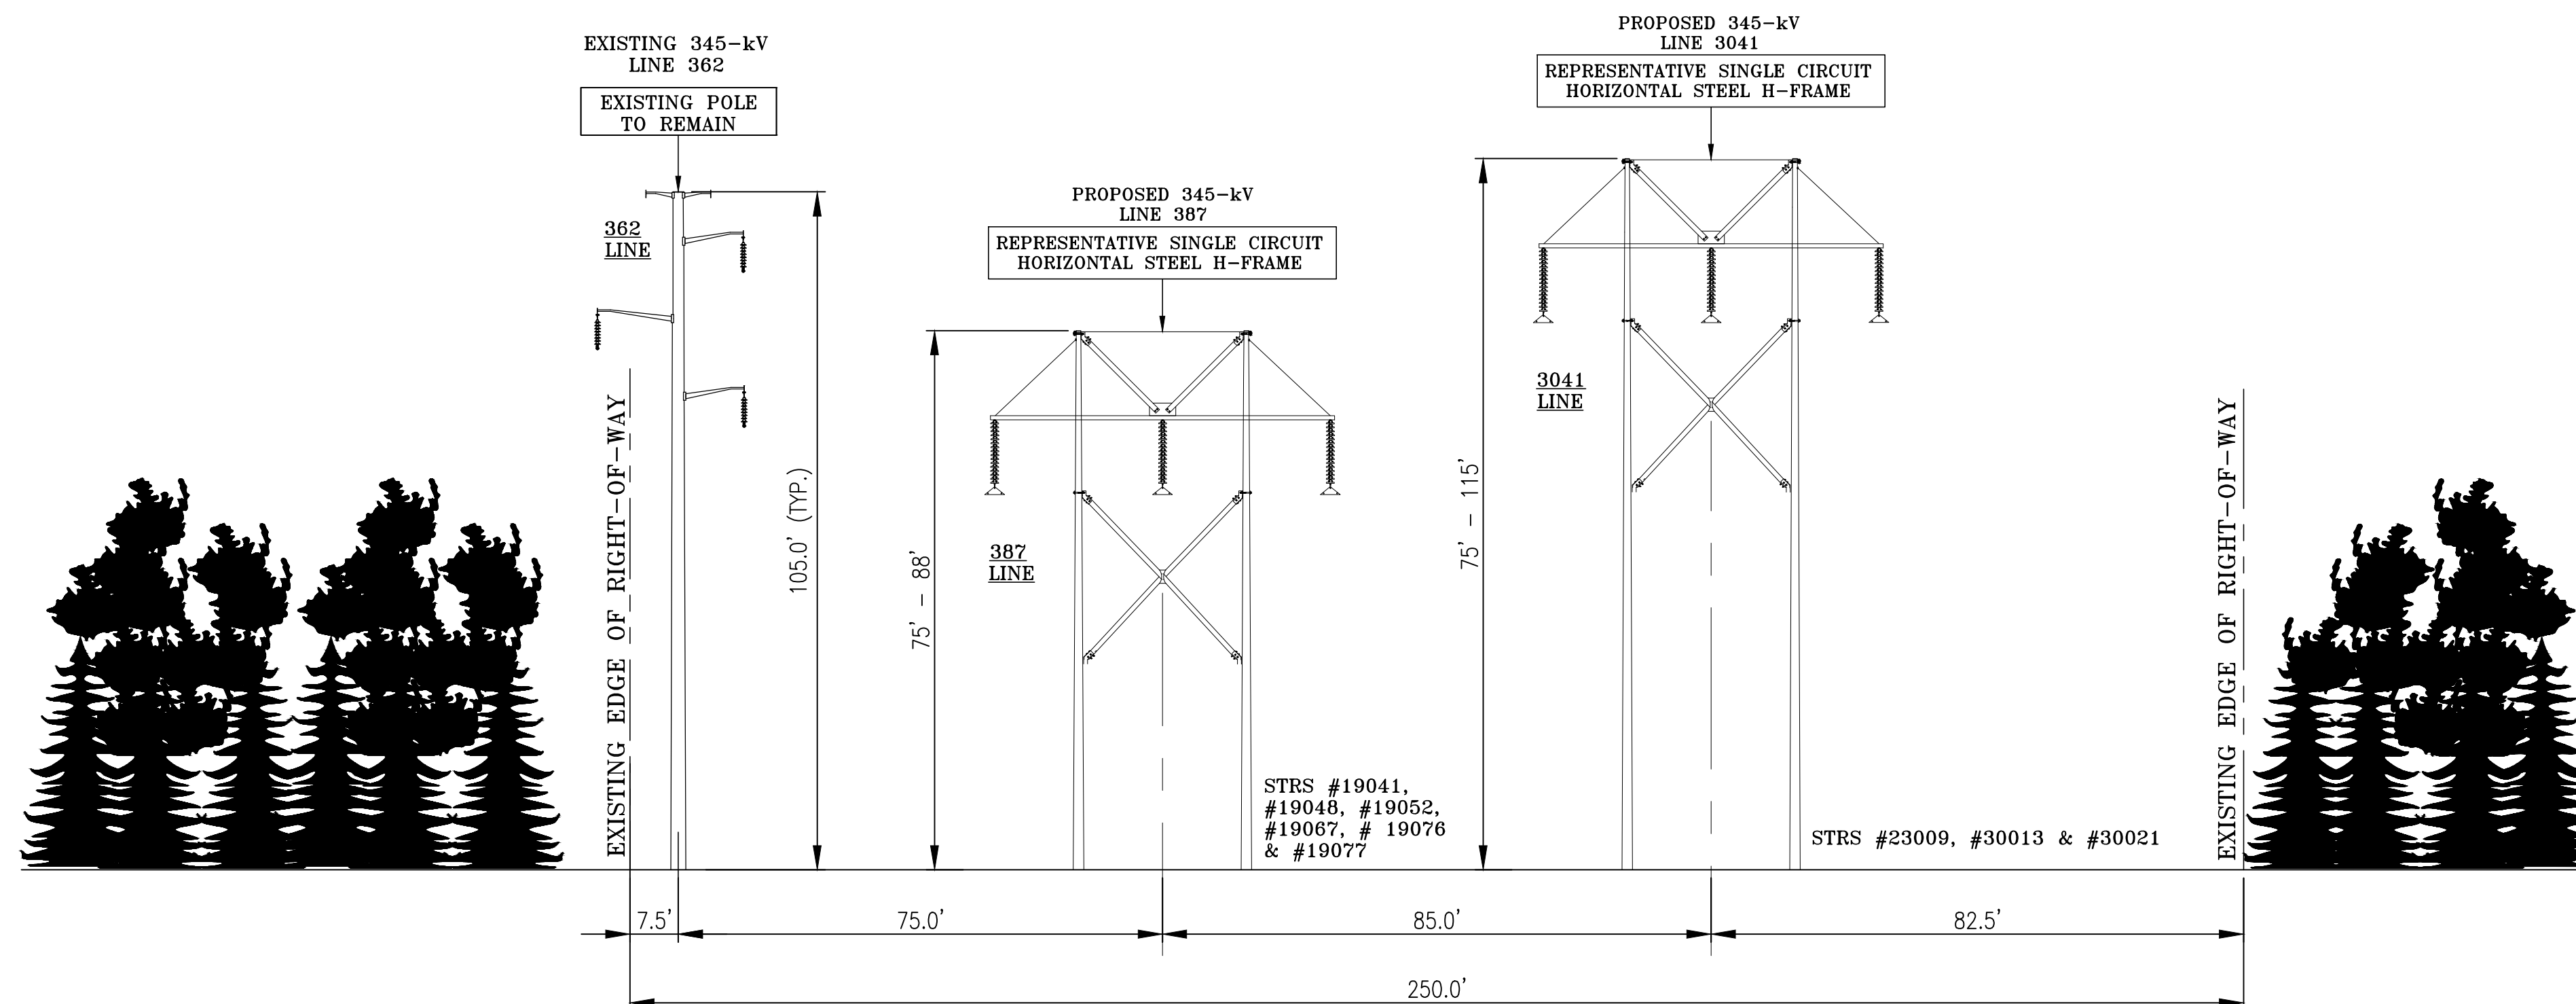
PROPOSED R.O.W. CONFIGURATION
NO ADDITIONAL RIGHT-OF-WAY REQUIRED
SINGLE CIRCUIT STEEL H-FRAME DESIGN
LOOKING WEST FROM SCOVILLE ROCK SUBSTATION TO CHESTNUT JUNCTION
IN THE CITY OF MIDDLETOWN, CT
STRS. #19041, #19048, #19052, #19067, # 19076 & #19077 FOR LINE 387
STRS. #23009, #30013 & #30021 FOR LINE 3041

NOTE:
 LINE ARRESTERS TO BE
 ADDED AS REQUIRED

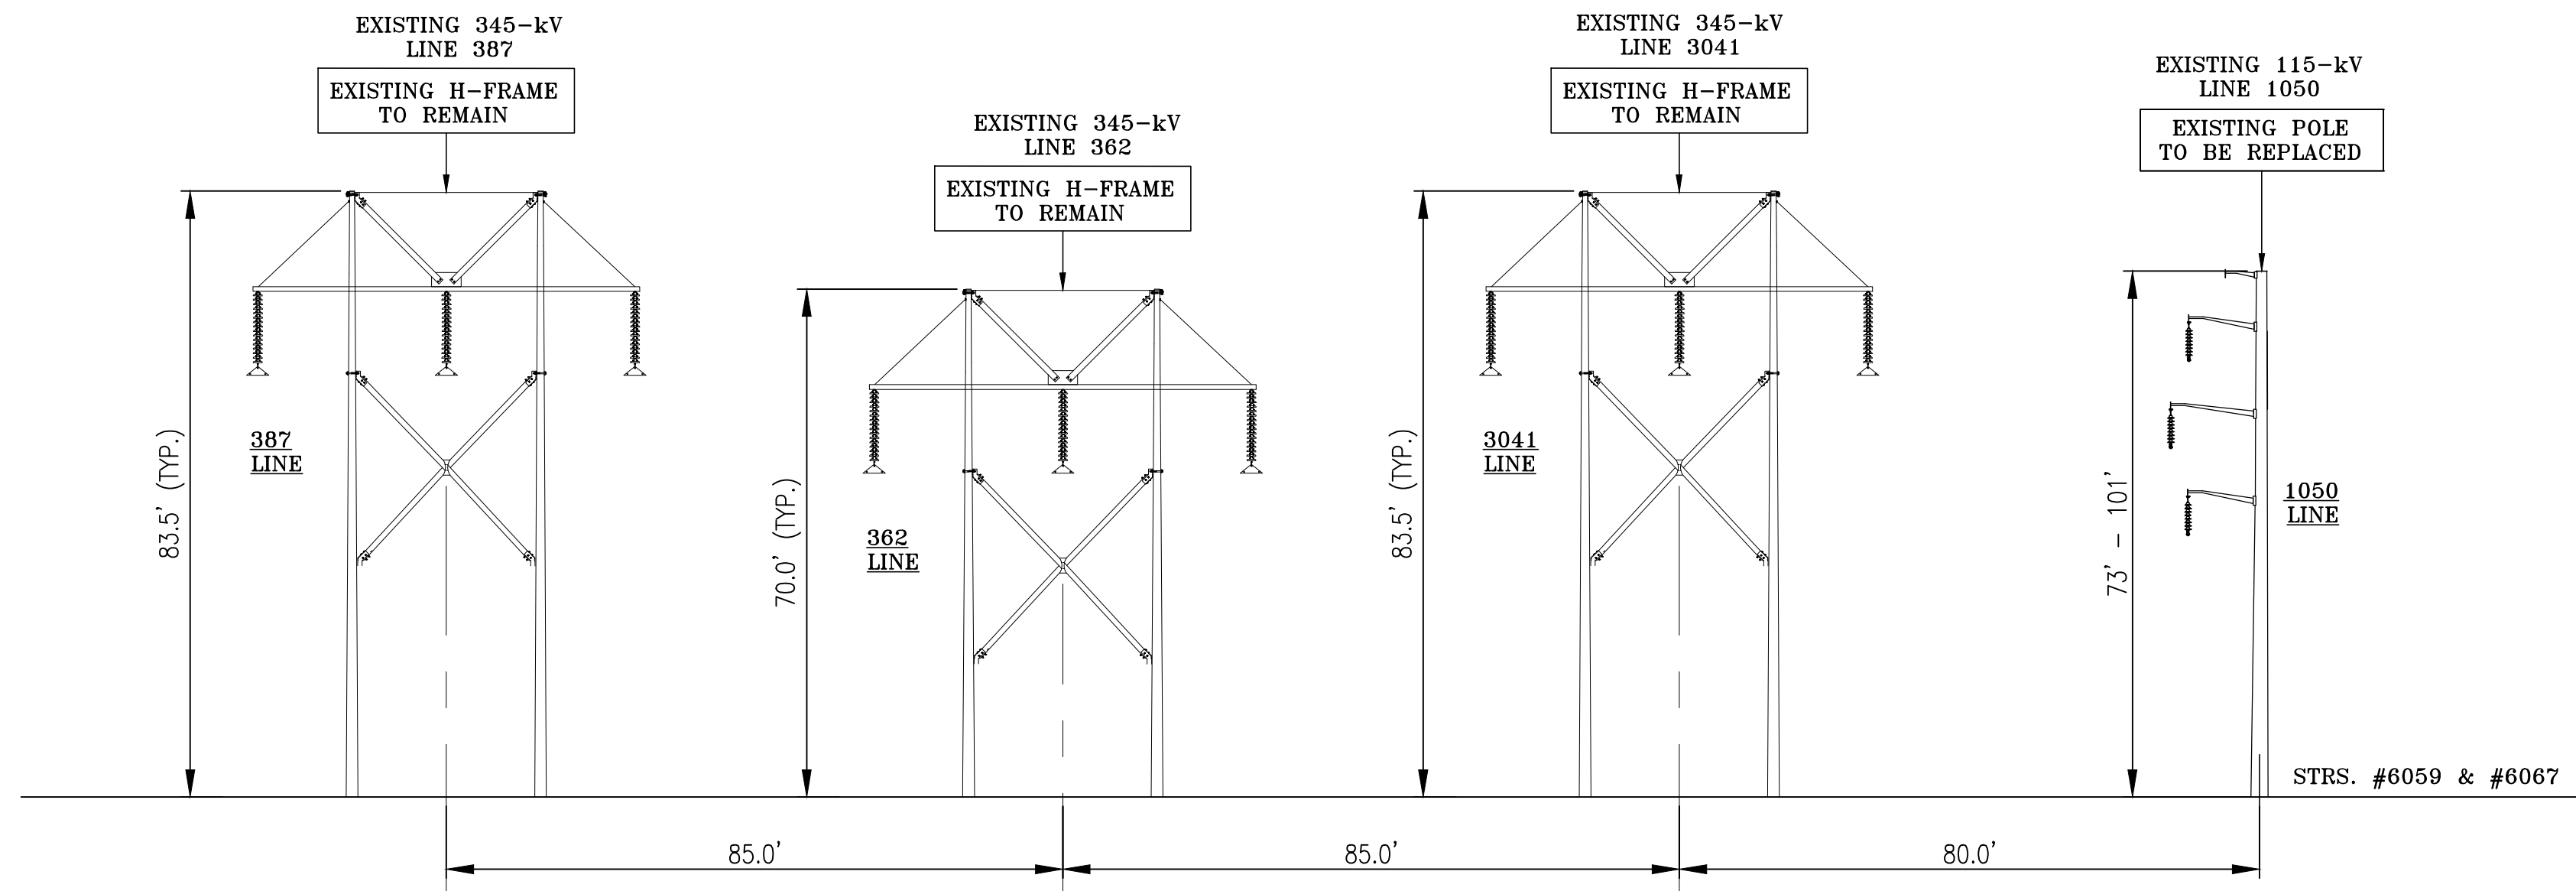
**EXISTING CONFIGURATION
SINGLE CIRCUIT STEEL MONOPOLE DESIGN
LOOKING FROM CHESTNUT JUNCTION TO HANS BROOK JUNCTION
IN THE CITY OF MIDDLETOWN, CT
STRS. #6059 & #6067**

- Replace one single-circuit steel lattice structure (Structure 6001) with a weathering steel single-circuit monopole structure inside Middletown Substation, and,
- Replace two steel single-circuit monopole structures (Structures 6067 and 6059), with single circuit weathering steel monopole structures.

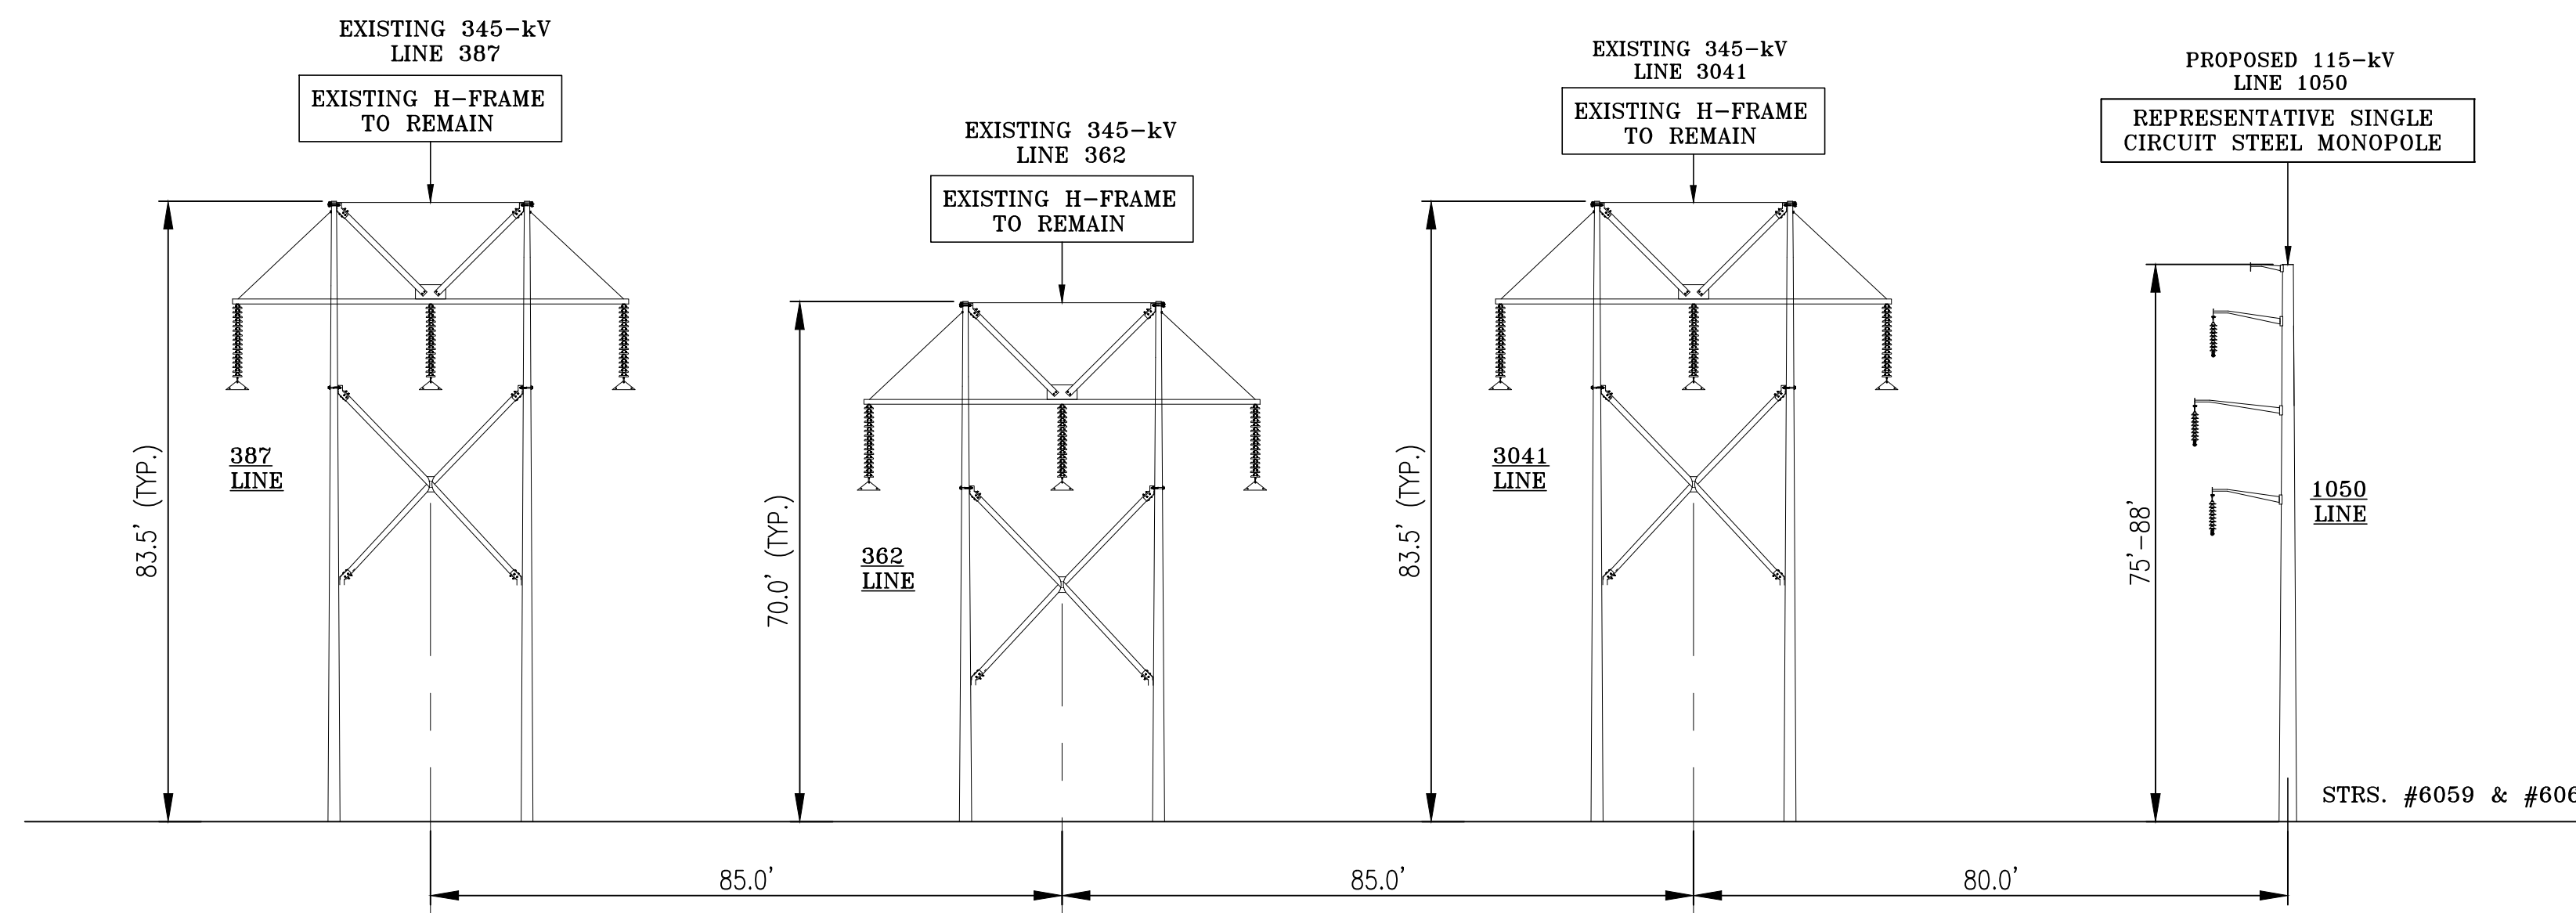
**PROPOSED CONFIGURATION
NO ADDITIONAL RIGHT-OF-WAY REQUIRED
SINGLE CIRCUIT STEEL MONOPOLE DESIGN
LOOKING FROM CHESTNUT JUNCTION TO HANS BROOK JUNCTION
IN THE CITY OF MIDDLETOWN, CT
STRS. #6059 & #6067**

NOTE:
LINE ARRESTERS TO BE
ADDED AS REQUIRED

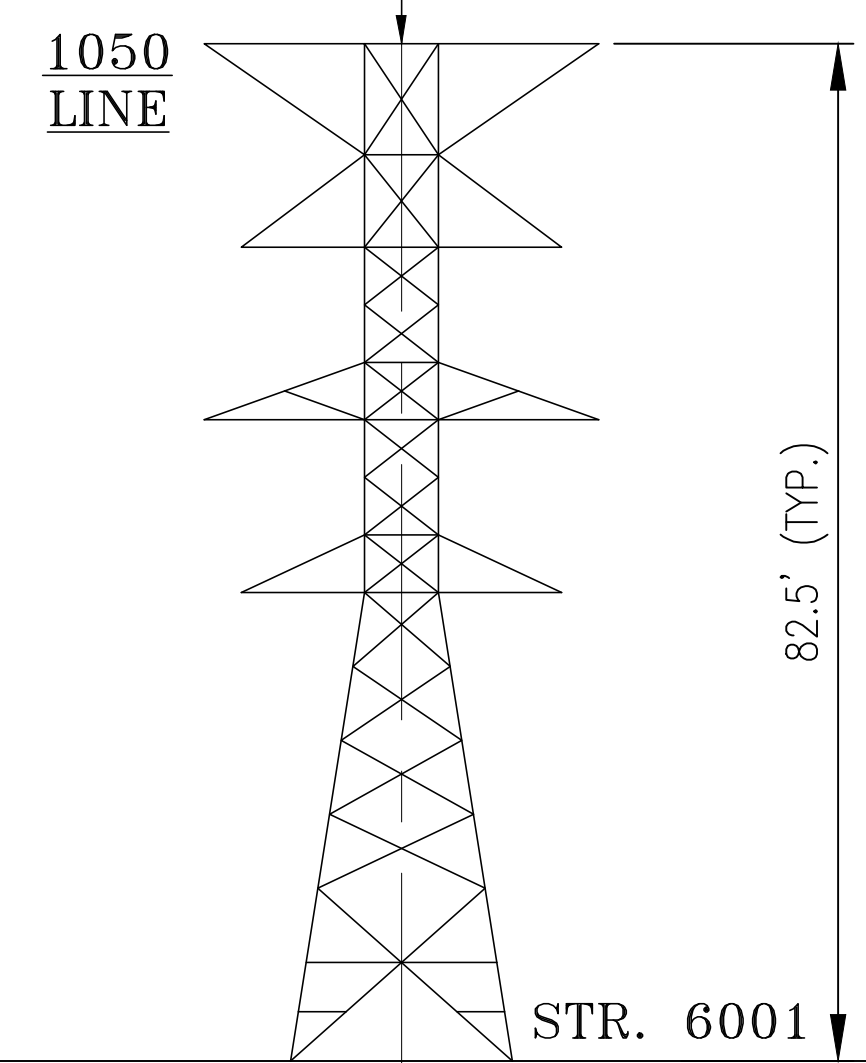
EXISTING 115-kV
LINE 1050
EXISTING LATTICE
TOWER TO BE REPLACED

**EXISTING CONFIGURATION
DOUBLE CIRCUIT LATTICE TOWER
MIDDLETOWN SUBSTATION LOOKING EAST
IN THE CITY OF MIDDLETOWN, CT**

The remaining three replacement structures are on the 1050 Line and require replacement due to structural loading issues associated with the planned installation of the OPGW and, specific to the lattice tower in Middletown Substation, additional signs of degradation with bent and/or deteriorated members.

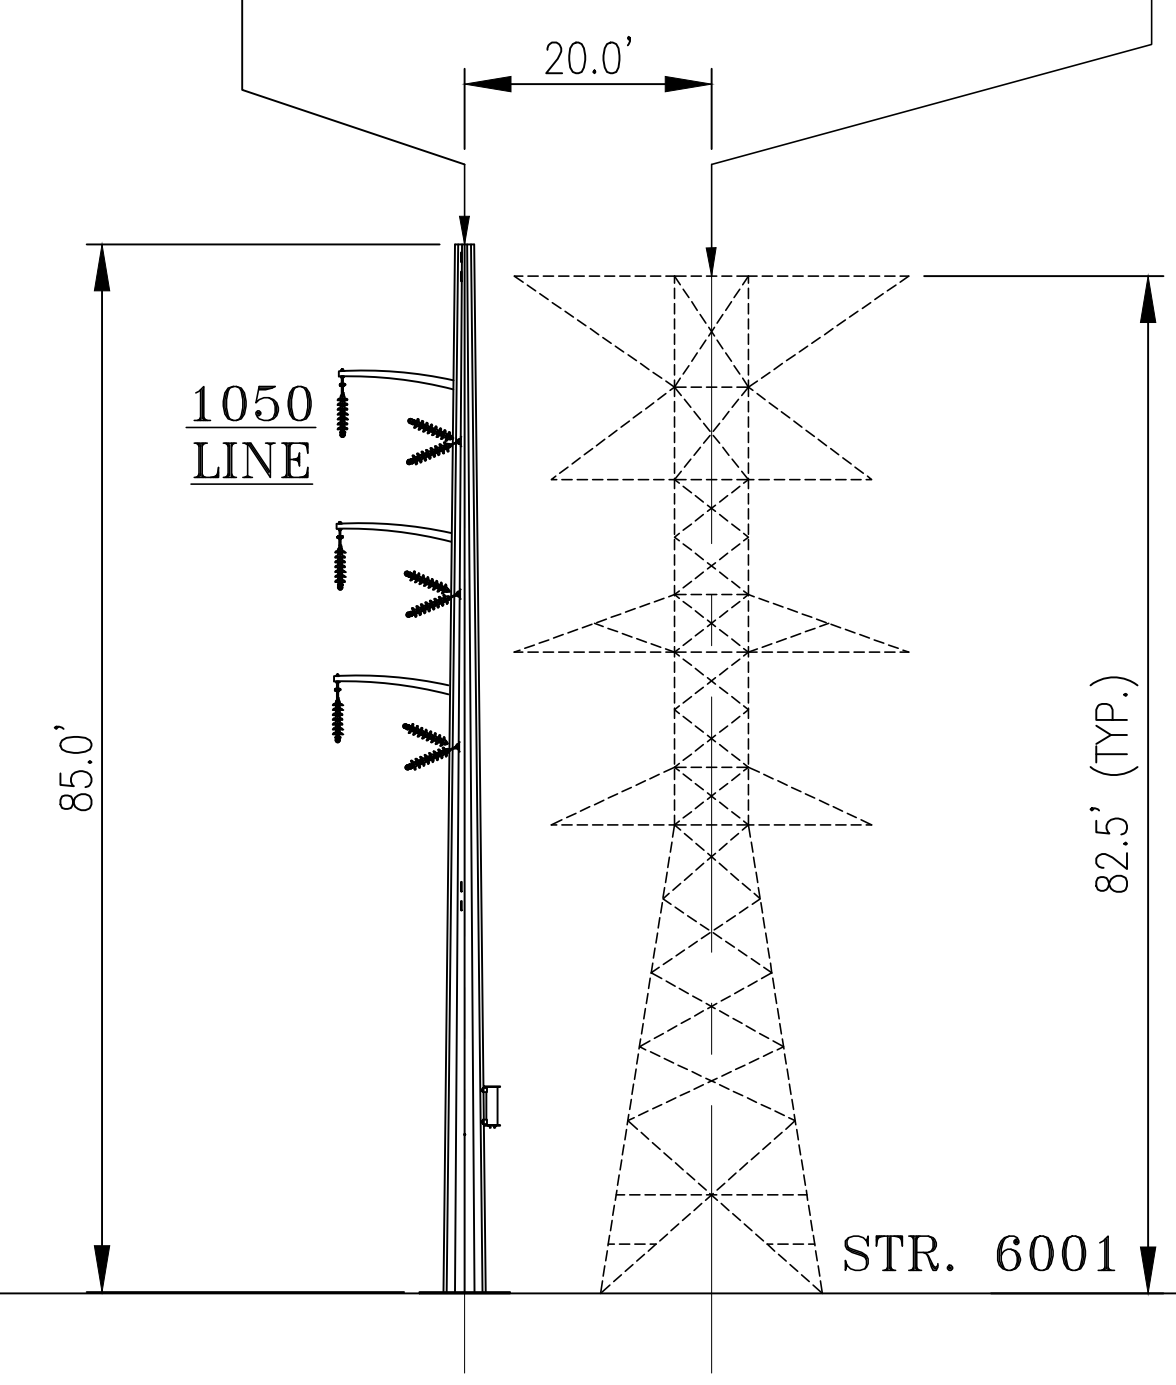
XS-1

PROPOSED 115-kV
LINE 1050
PROPOSED SINGLE CIRCUIT
VERTICAL STEEL POLE

EXISTING 115-kV
LINE 1050
EXISTING LATTICE
TOWER TO BE REPLACED

**PROPOSED CONFIGURATION
SINGLE CIRCUIT STEEL POLE VERTICAL DESIGN
MIDDLETOWN SUBSTATION LOOKING EAST
IN THE CITY OF MIDDLETOWN, CT**
