Re: Eastern Connecticut Reliability Project – 400/500 Lines Rebuild Project

PETITION TO THE CONNECTICUT SITING COUNCIL
FOR A DECLARATORY RULING OF
NO SUBSTANTIAL ADVERSE ENVIRONMENTAL EFFECT
FOR THE PROPOSED MODIFICATIONS TO THE EXISTING
400 and 500 LINES IN THE TOWNS OF LEDYARD AND PRESTON, CONNECTICUT

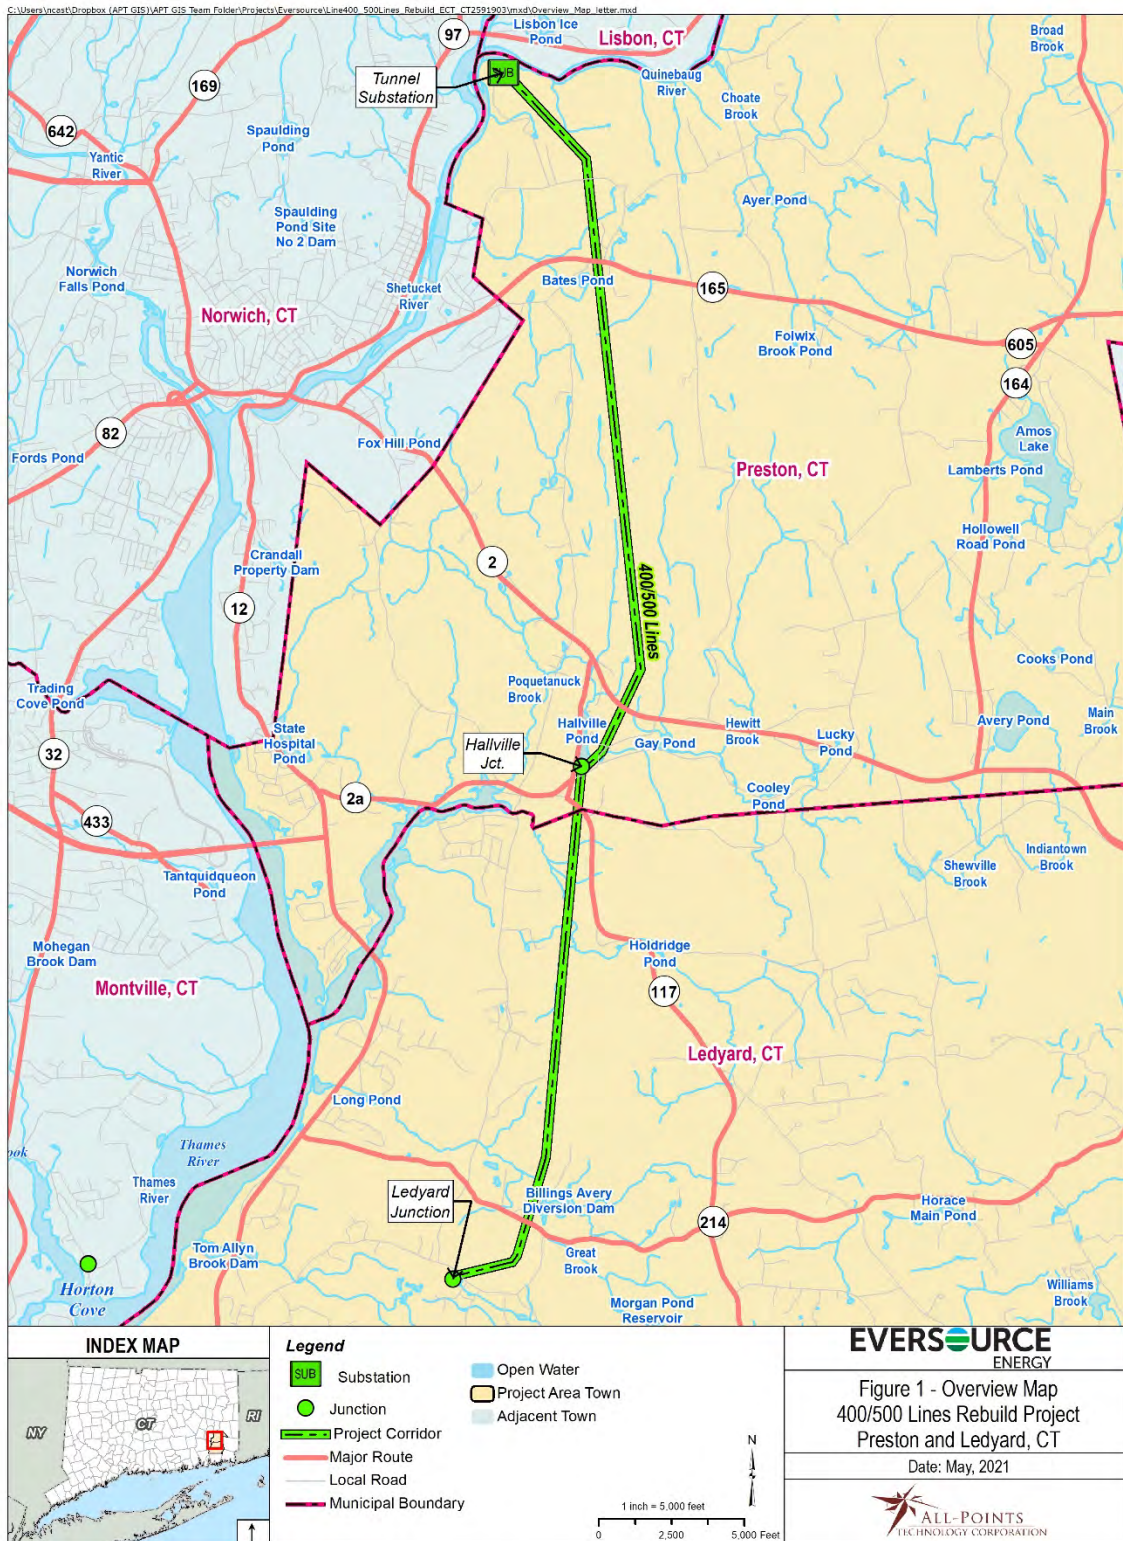
Figure 1: Project Overview Map

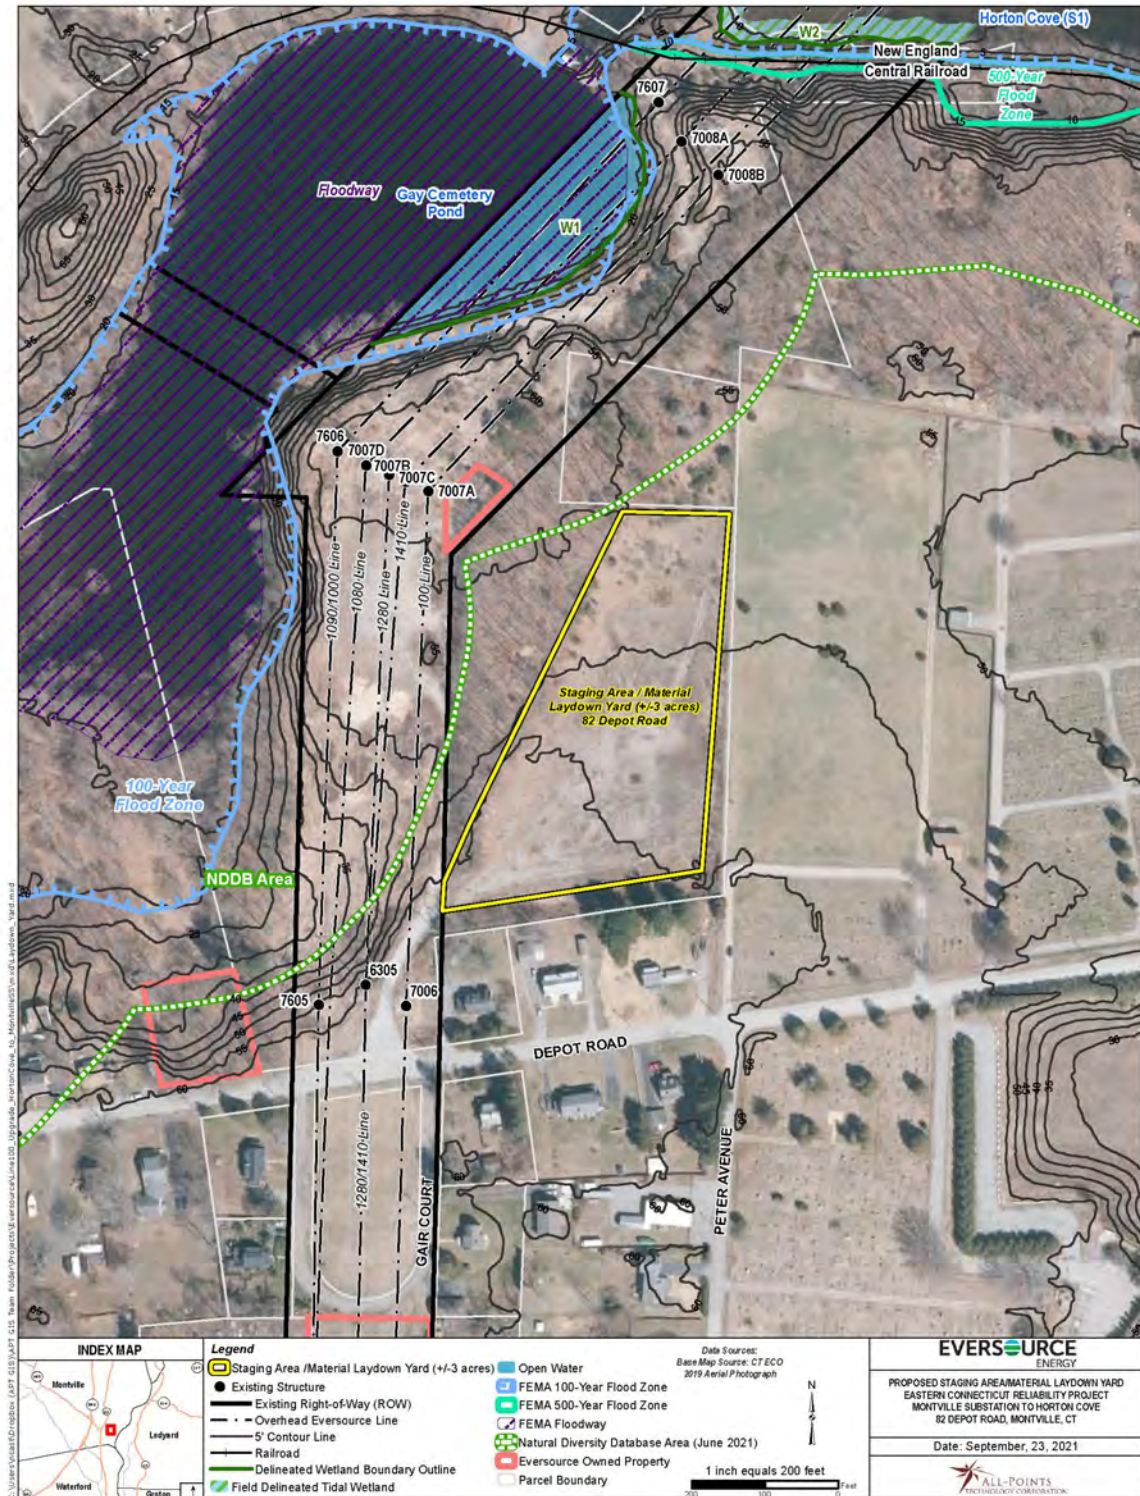
Figure 2: Staging and Laydown Area at 82 Depot Road Uncasville, CT

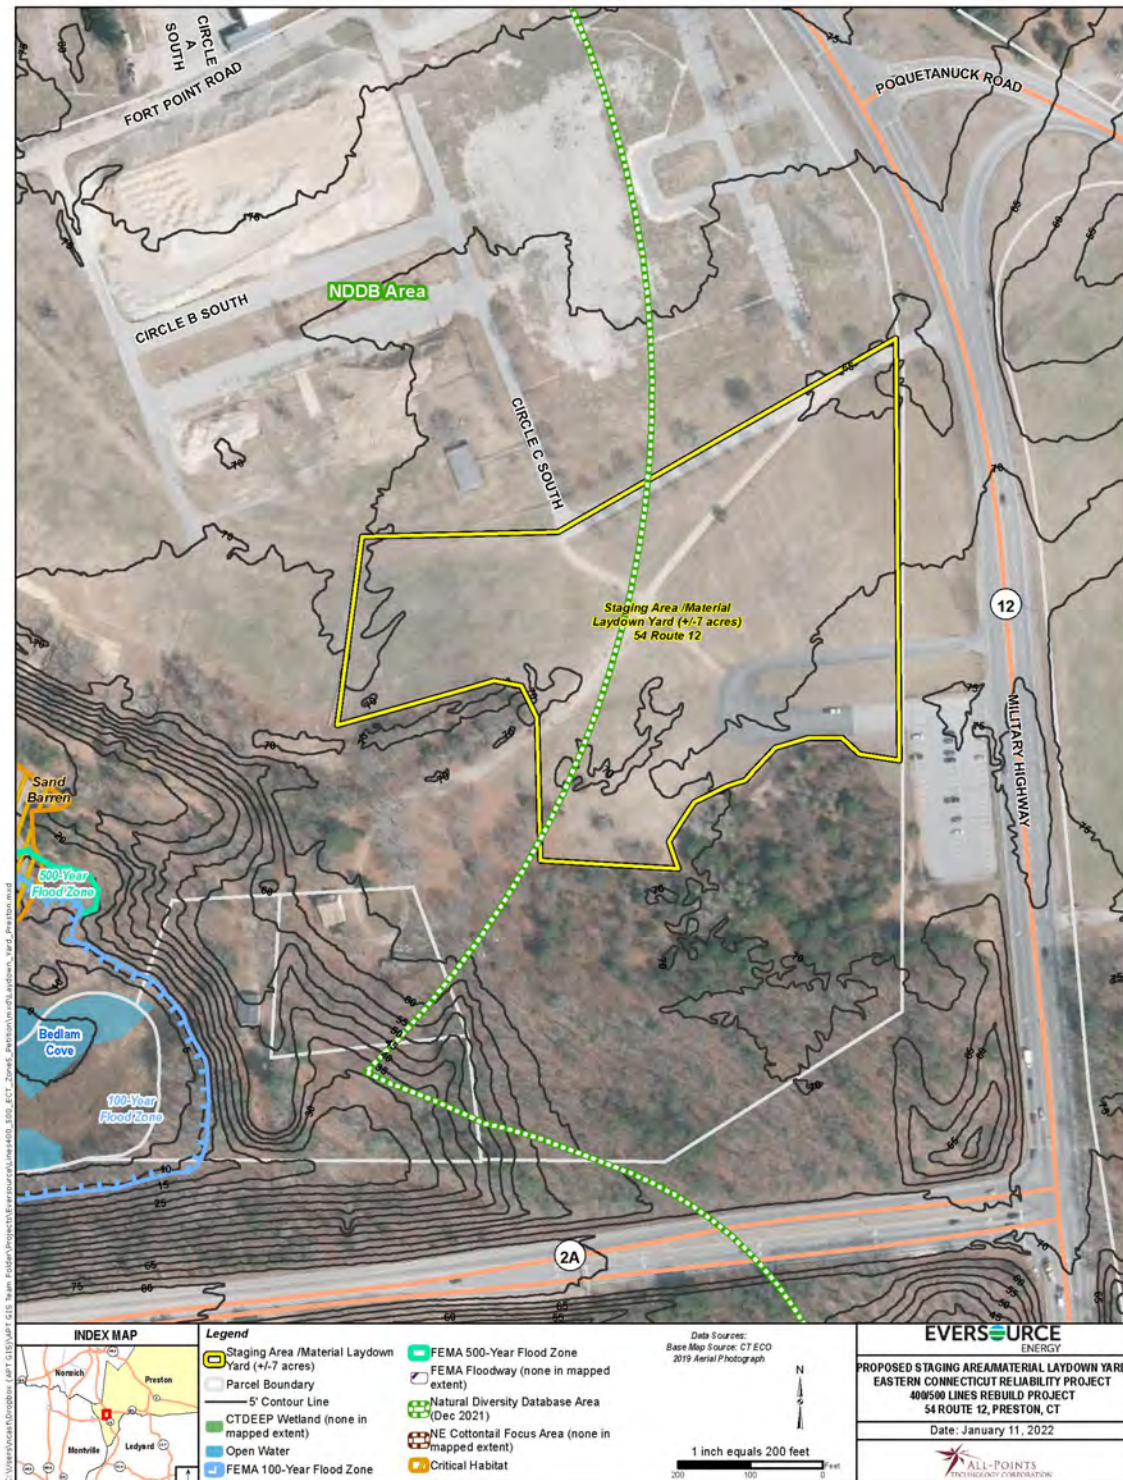
Figure 3: Staging and Laydown Area at 54 Route 12, Preston, CT

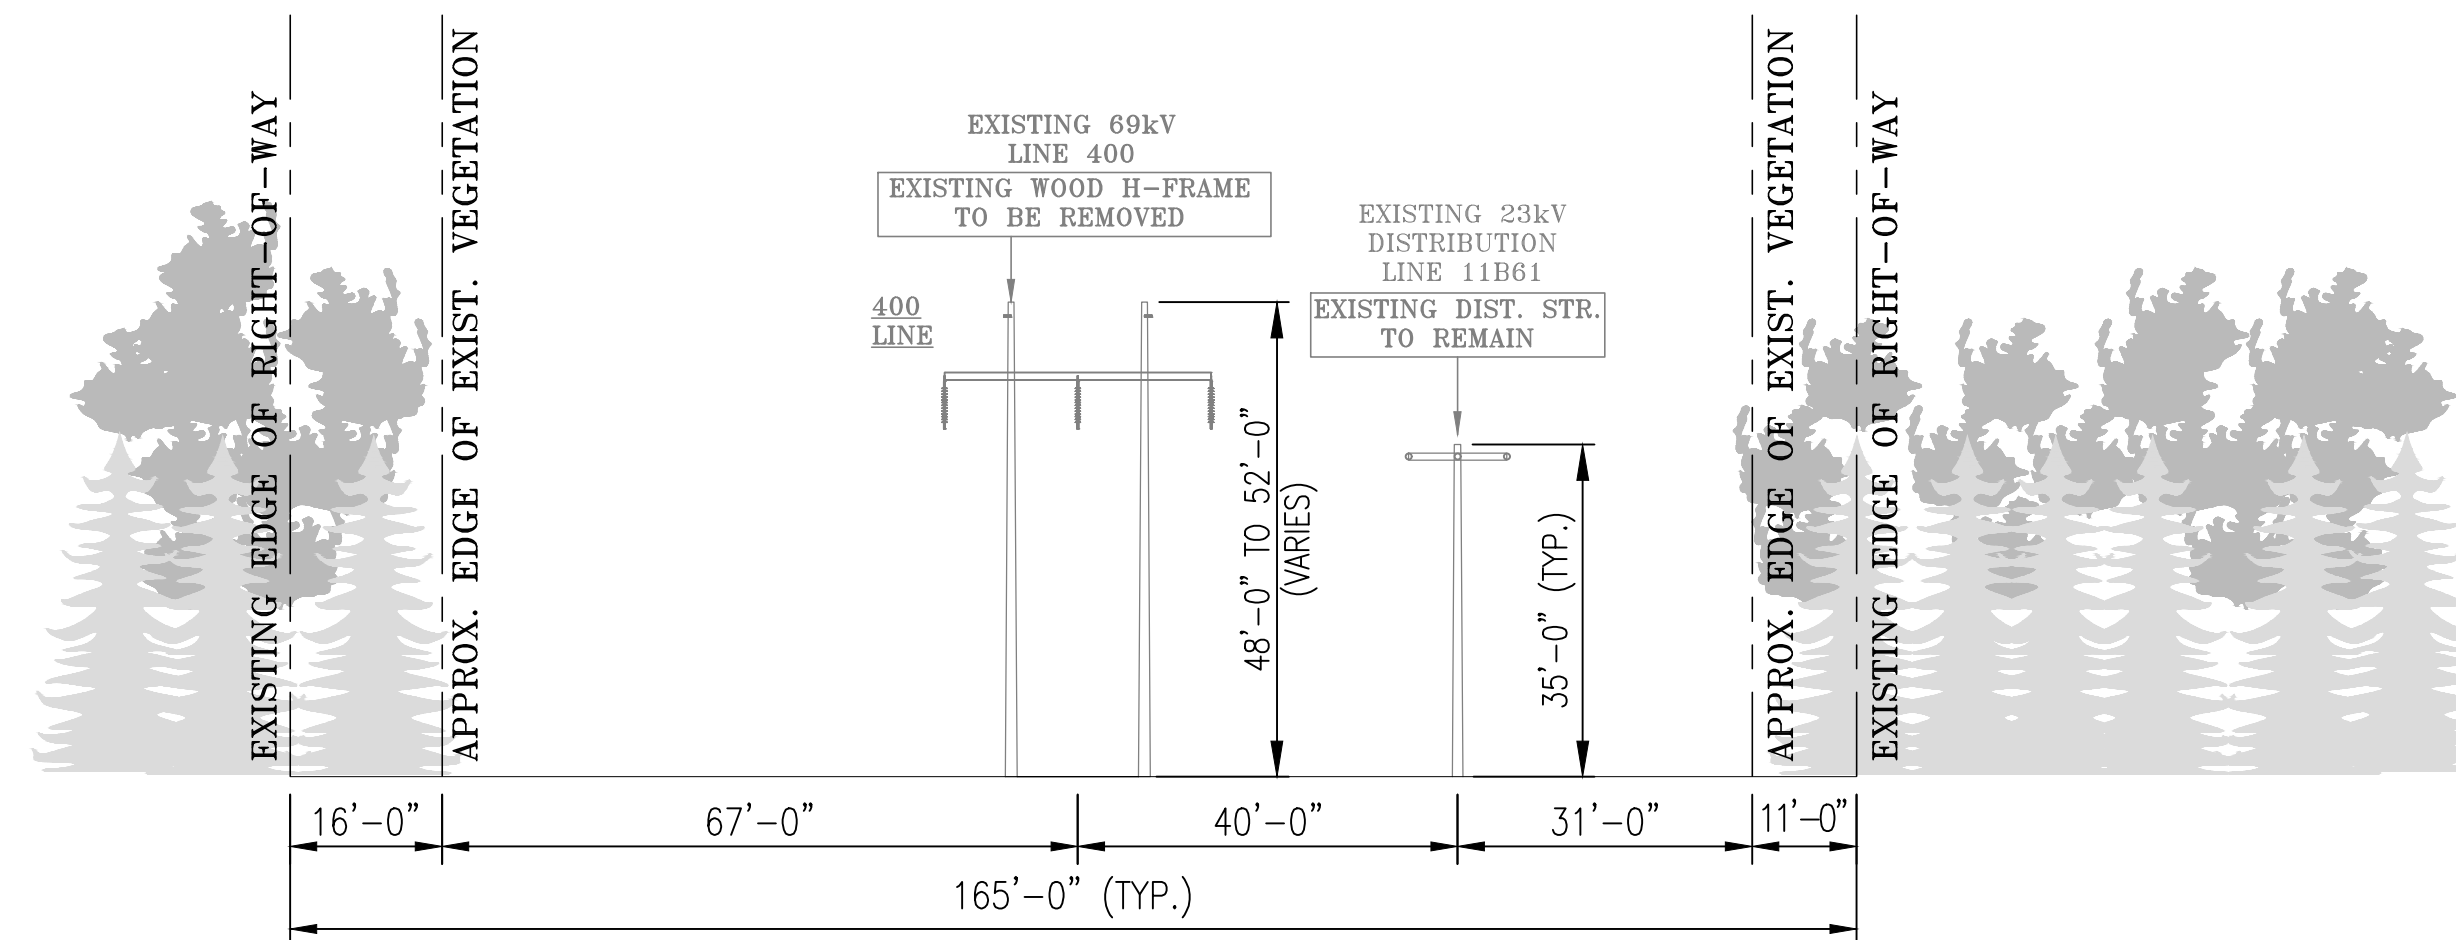
**EXISTING R.O.W. CONFIGURATION
SINGLE CIRCUIT HORIZONTAL DESIGN
LOOKING FROM LEDYARD JUNCTION TO TUNNEL SUBSTATION
IN THE TOWN OF LEDYARD, CT
0.29 MILES, STR. #7037 - STR. #7039**

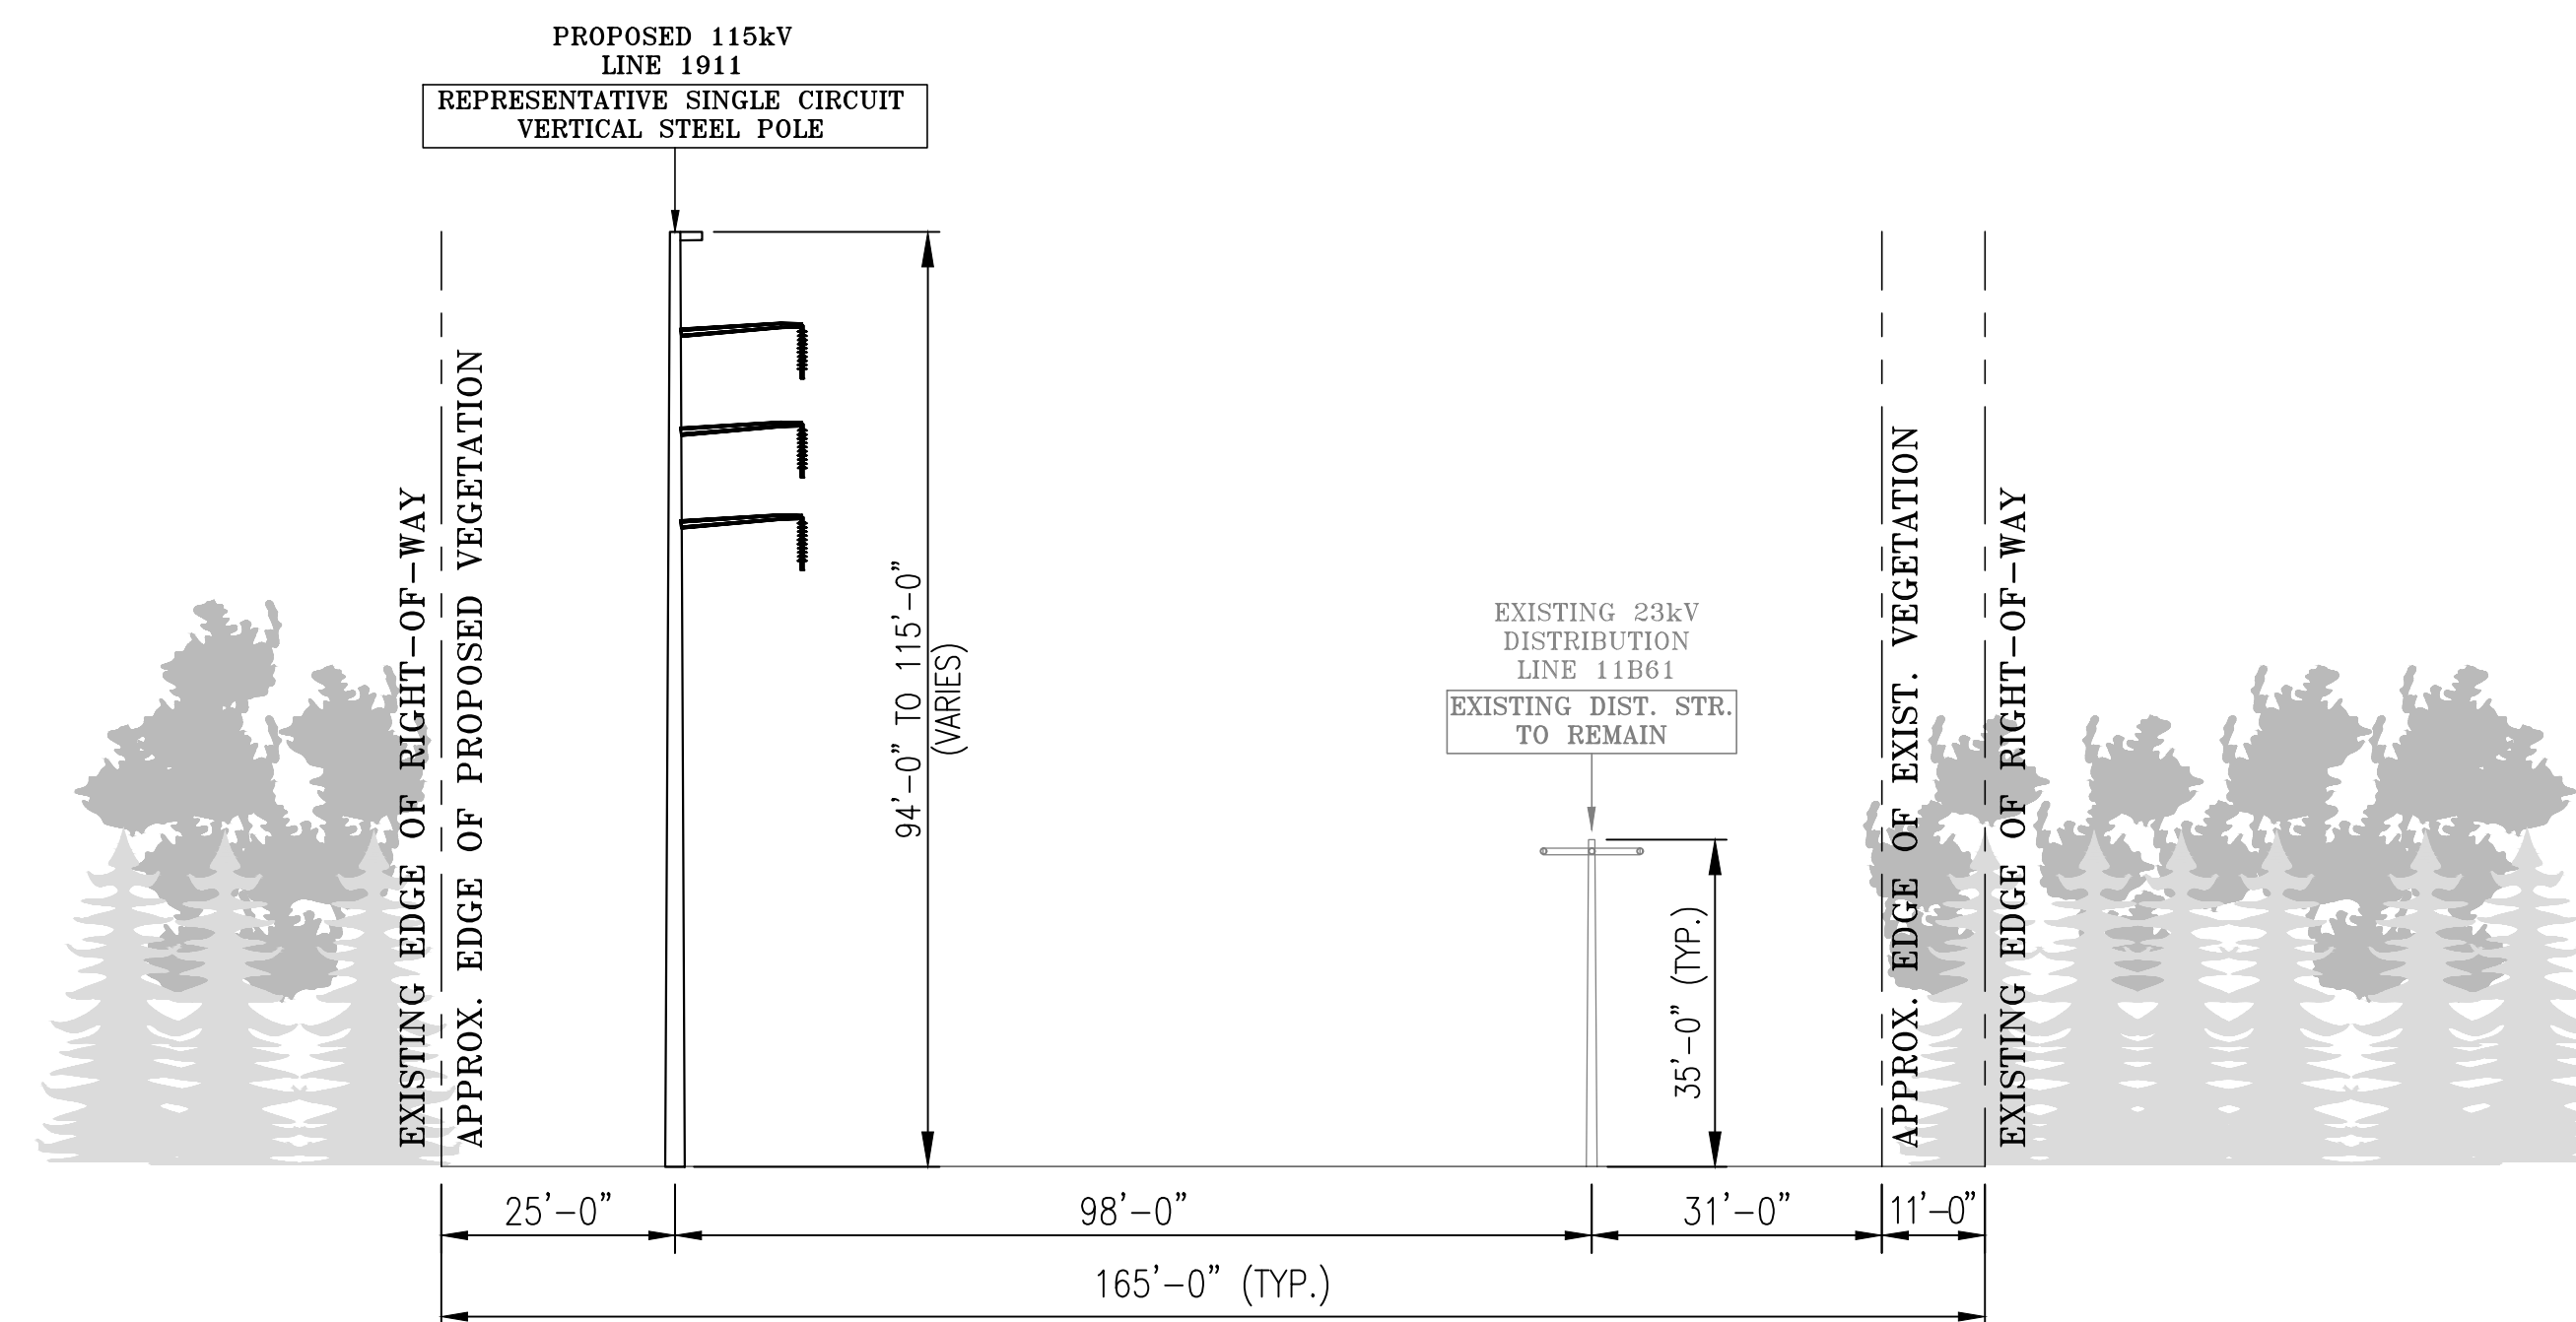
XS-1

**PROPOSED R.O.W. CONFIGURATION
NO ADDITIONAL RIGHT-OF-WAY REQUIRED
SINGLE CIRCUIT VERTICAL DESIGN
LOOKING FROM LEDYARD JUNCTION TO TUNNEL SUBSTATION
IN THE TOWN OF LEDYARD, CT
0.29 MILES, STR. #7037 - STR. #7039**

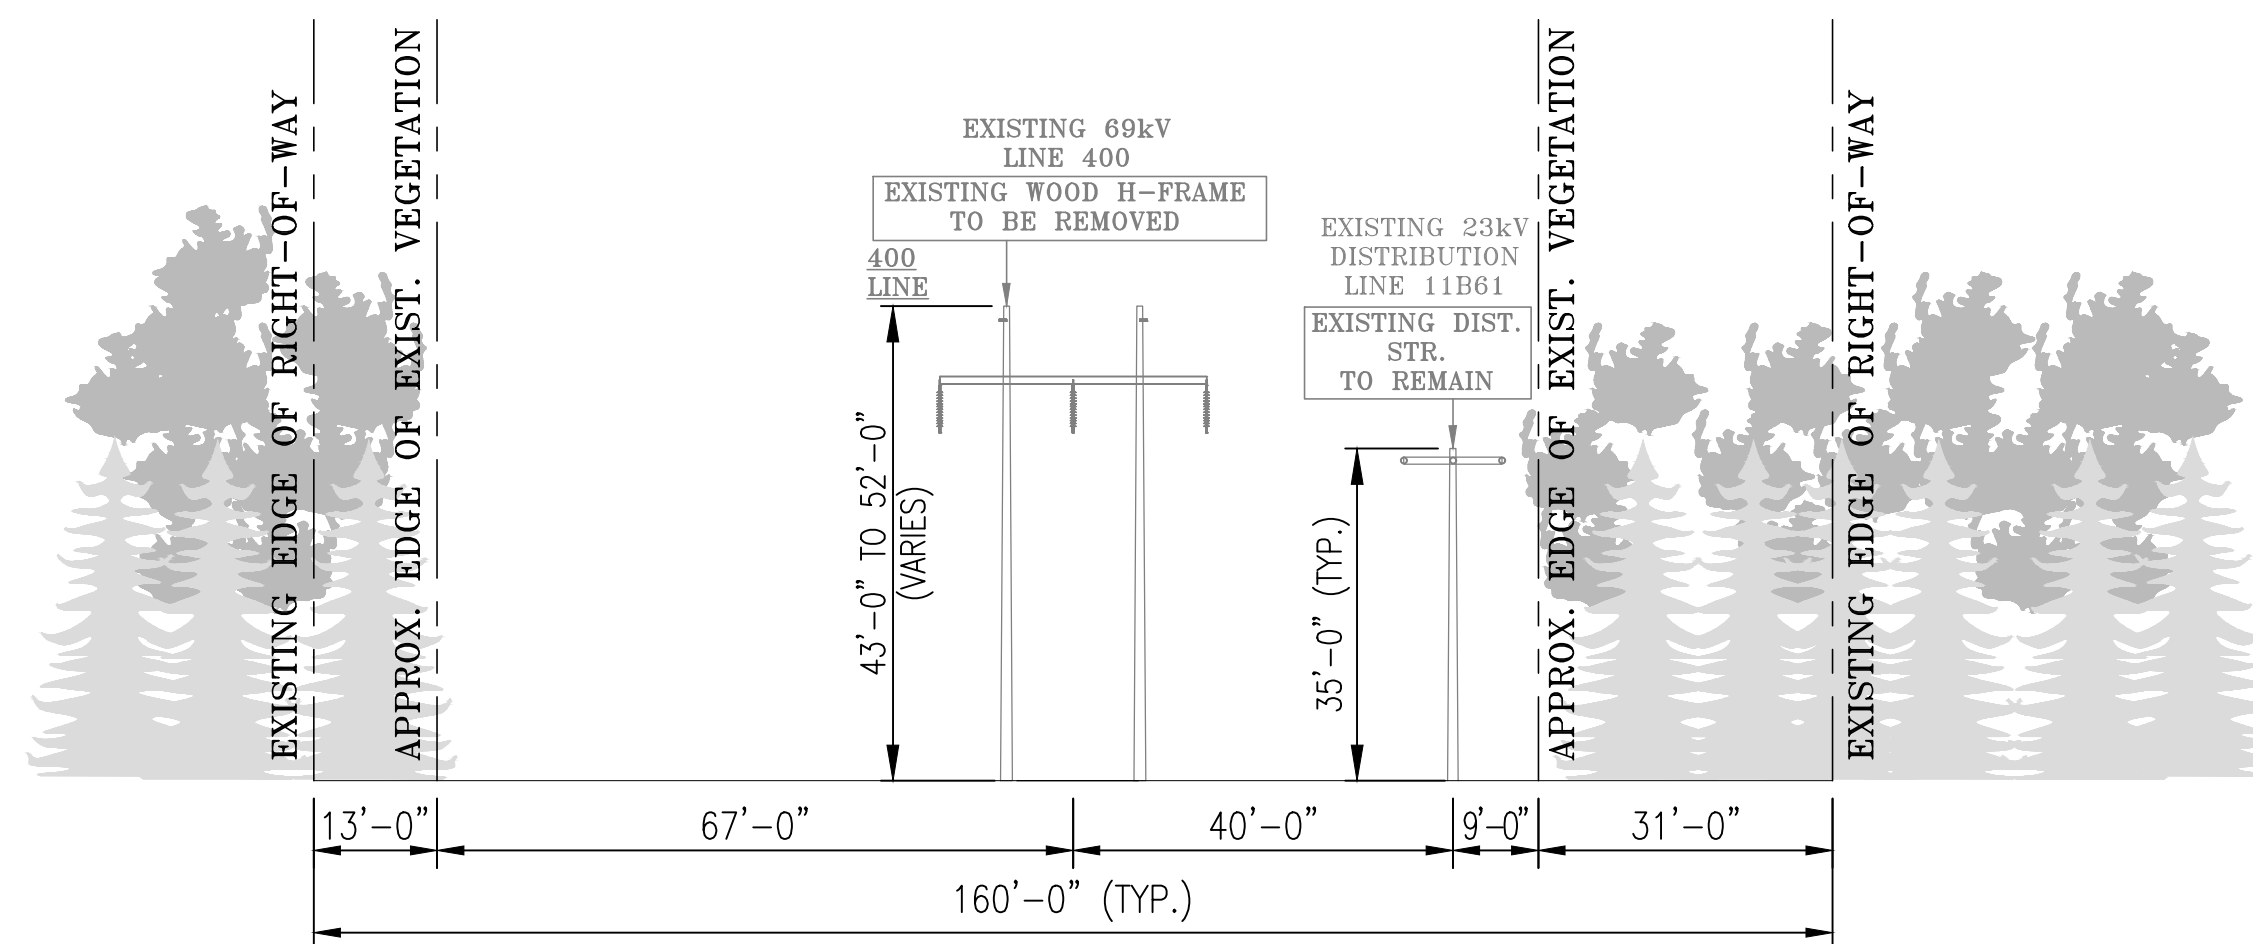
**EXISTING R.O.W. CONFIGURATION
SINGLE CIRCUIT HORIZONTAL DESIGN
LOOKING FROM LEDYARD JUNCTION TO TUNNEL SUBSTATION
IN THE TOWN OF LEDYARD, CT
0.33 MILES, STR. #7040 - STR. #7042**

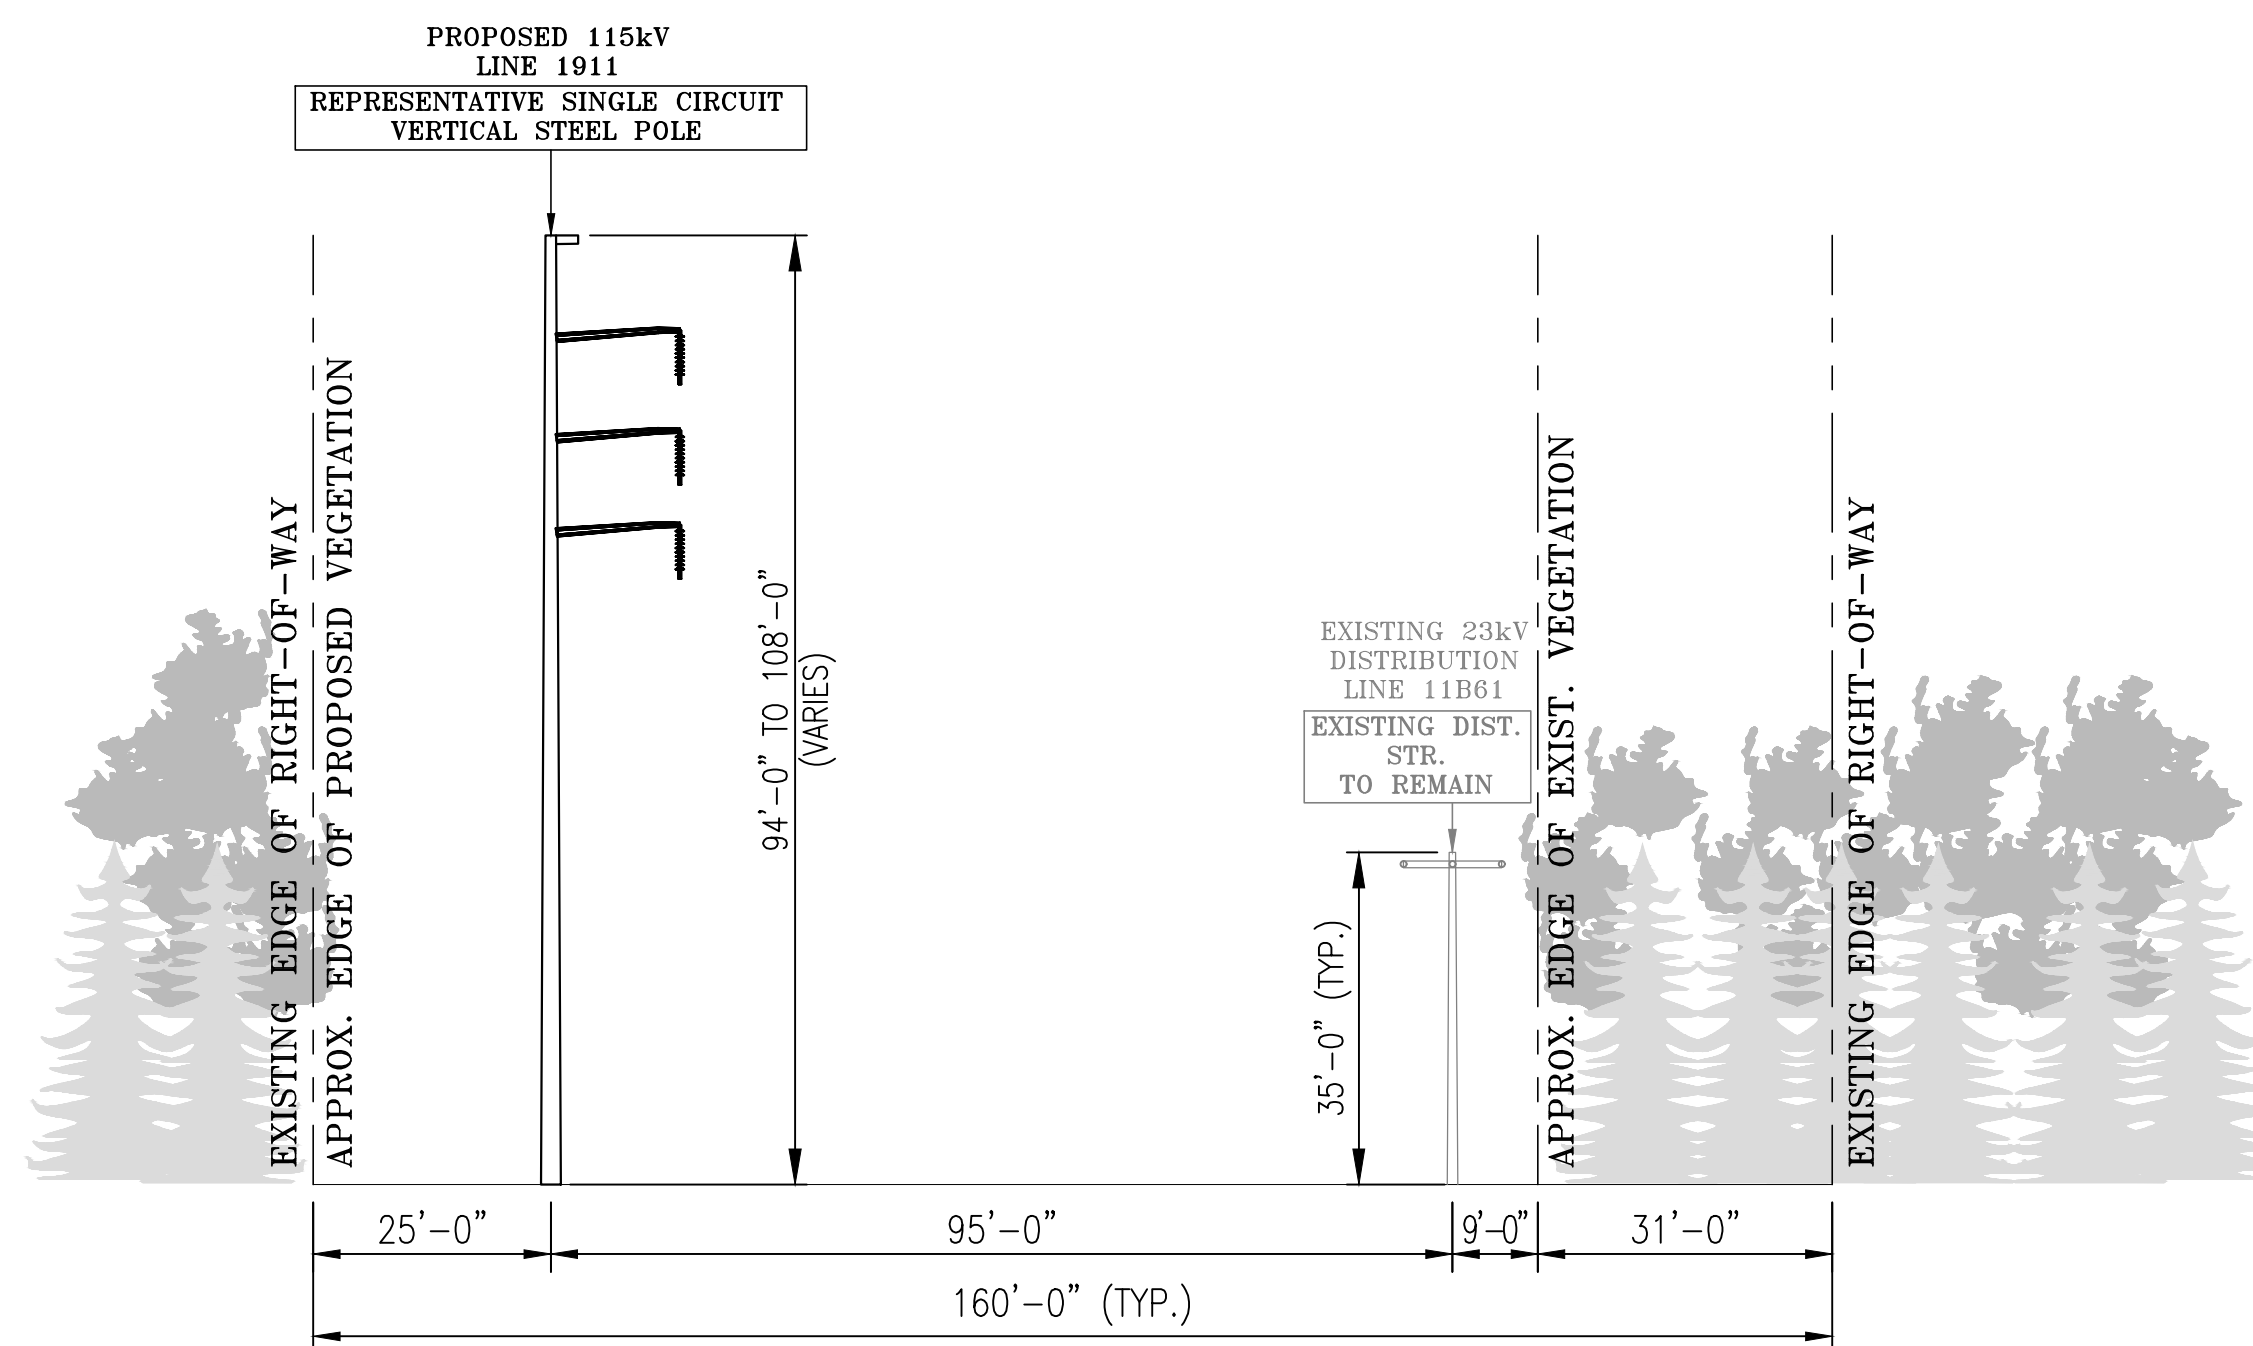
**PROPOSED R.O.W. CONFIGURATION
NO ADDITIONAL RIGHT-OF-WAY REQUIRED
SINGLE CIRCUIT VERTICAL DESIGN
LOOKING FROM LEDYARD JUNCTION TO TUNNEL SUBSTATION
IN THE TOWN OF LEDYARD, CT
0.33 MILES, STR. #7040 - STR. #7042**

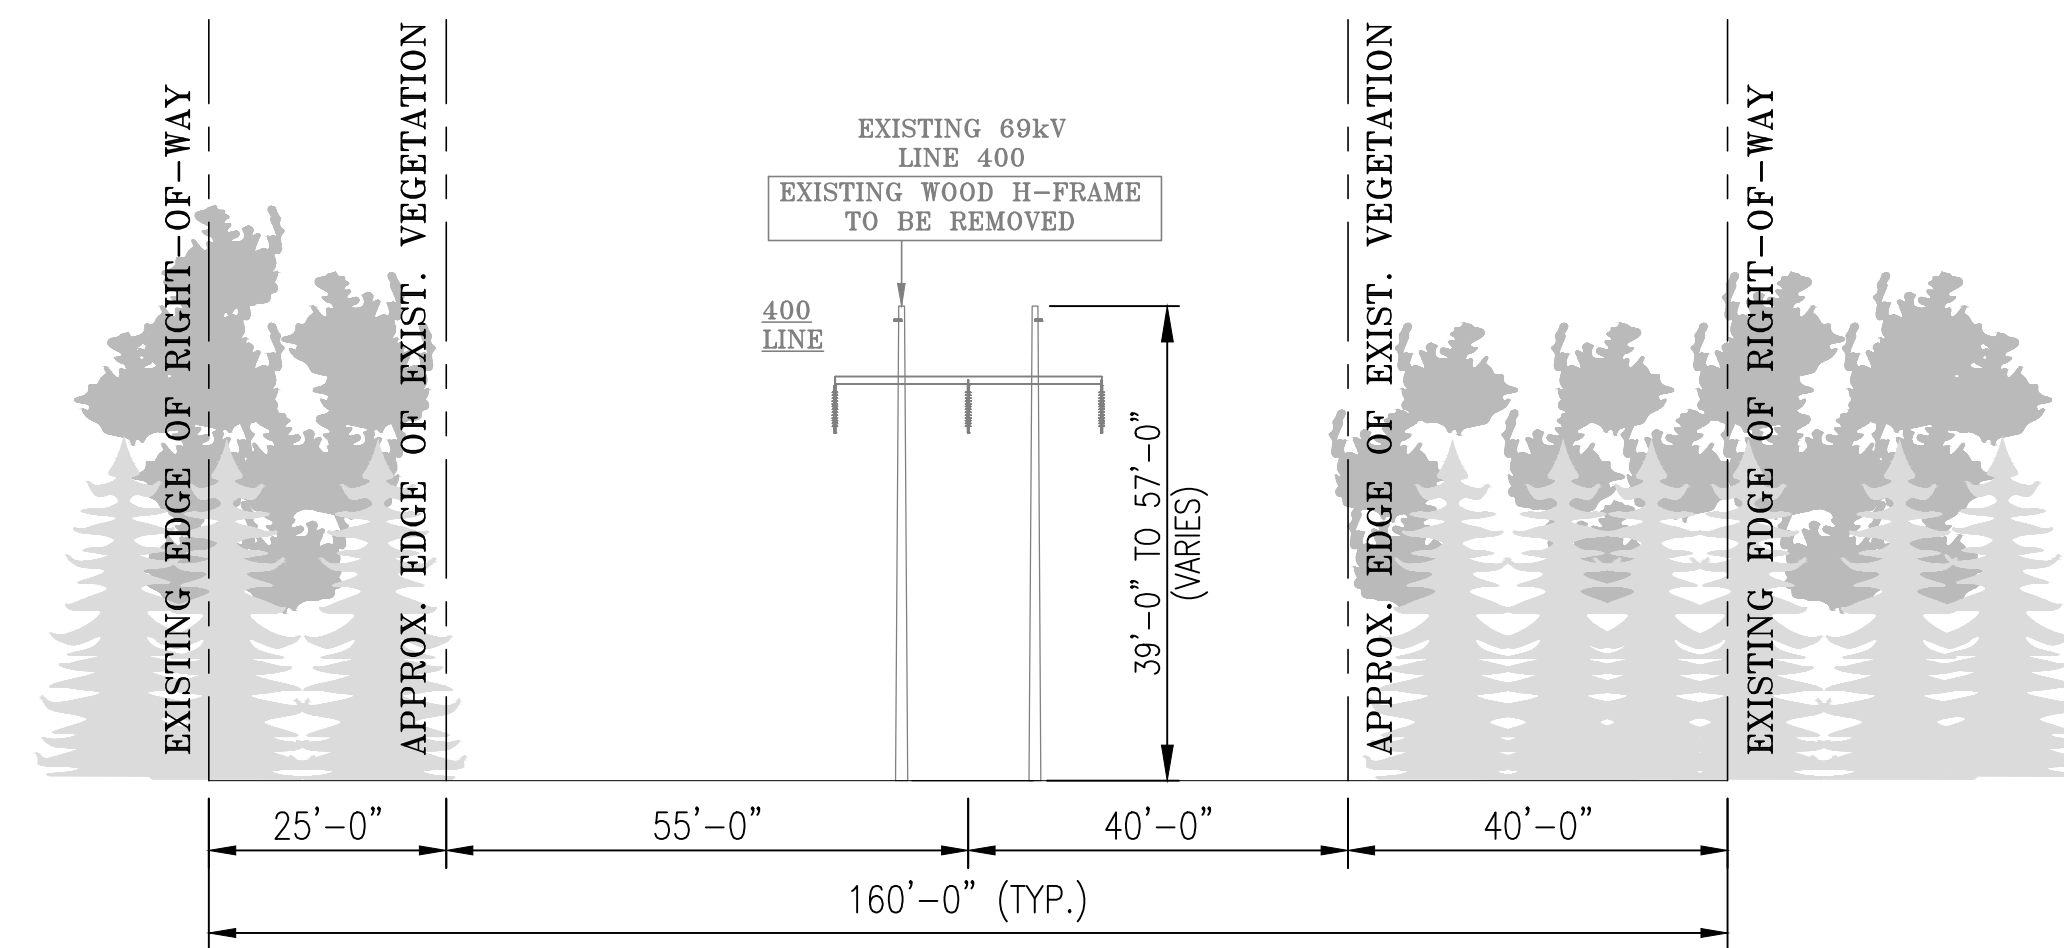
**EXISTING R.O.W. CONFIGURATION
SINGLE CIRCUIT HORIZONTAL DESIGN
LOOKING FROM LEDYARD JUNCTION TO TUNNEL SUBSTATION
IN THE TOWN OF LEDYARD, CT
1.05 MILES, STR. #7043 - STR. #7053**

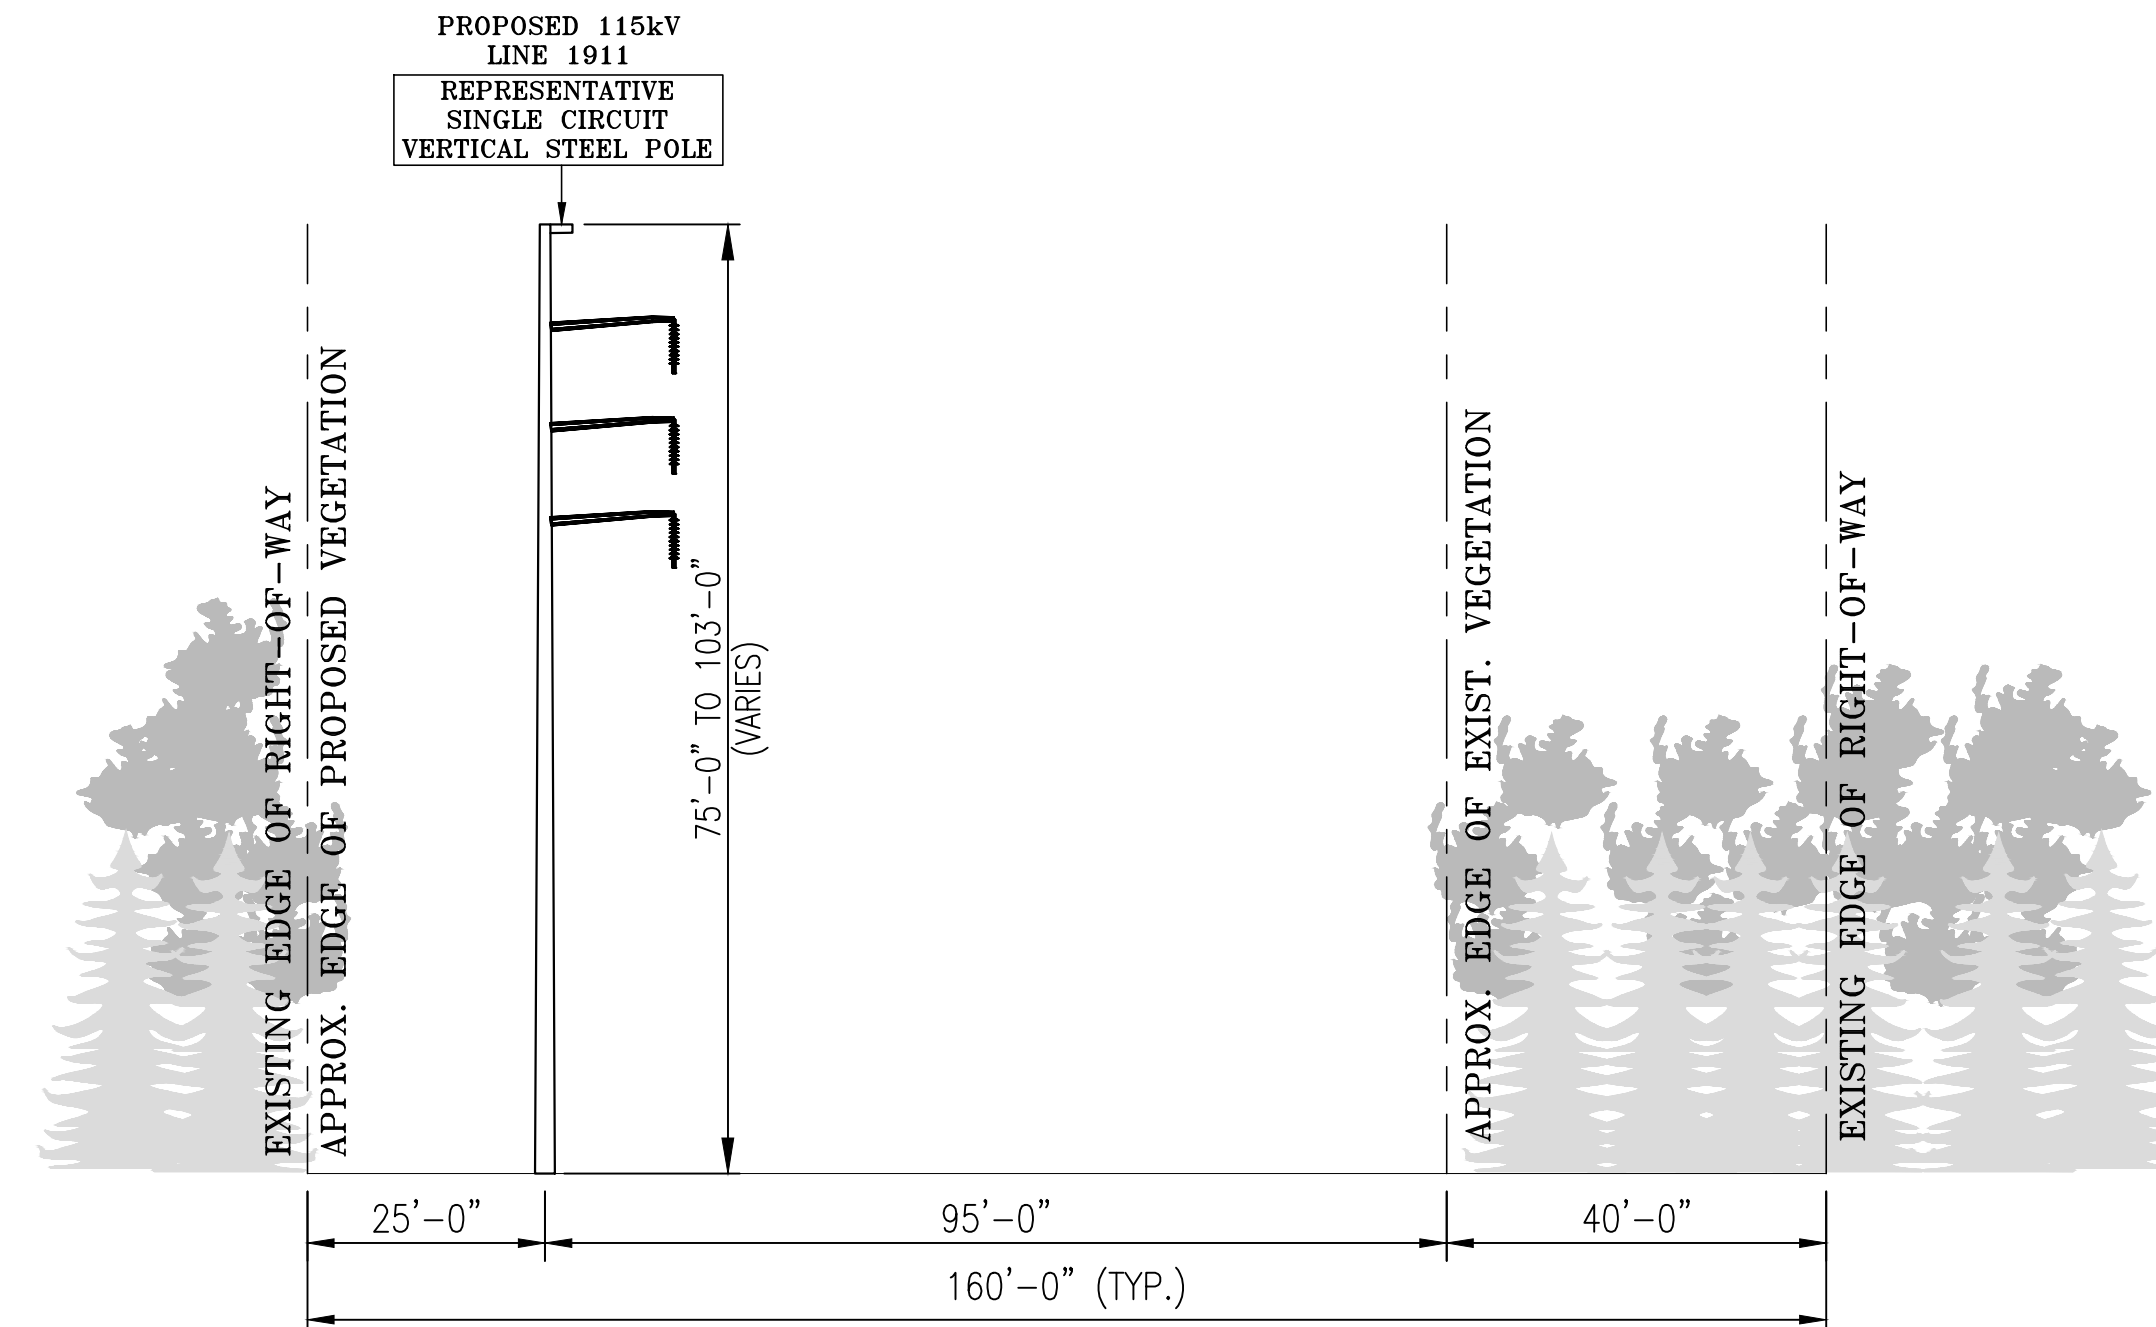
**PROPOSED R.O.W. CONFIGURATION
NO ADDITIONAL RIGHT-OF-WAY REQUIRED
SINGLE CIRCUIT VERTICAL DESIGN
LOOKING FROM LEDYARD JUNCTION TO TUNNEL SUBSTATION
IN THE TOWN OF LEDYARD, CT
1.05 MILES, STR. #7043 - STR. #7053**

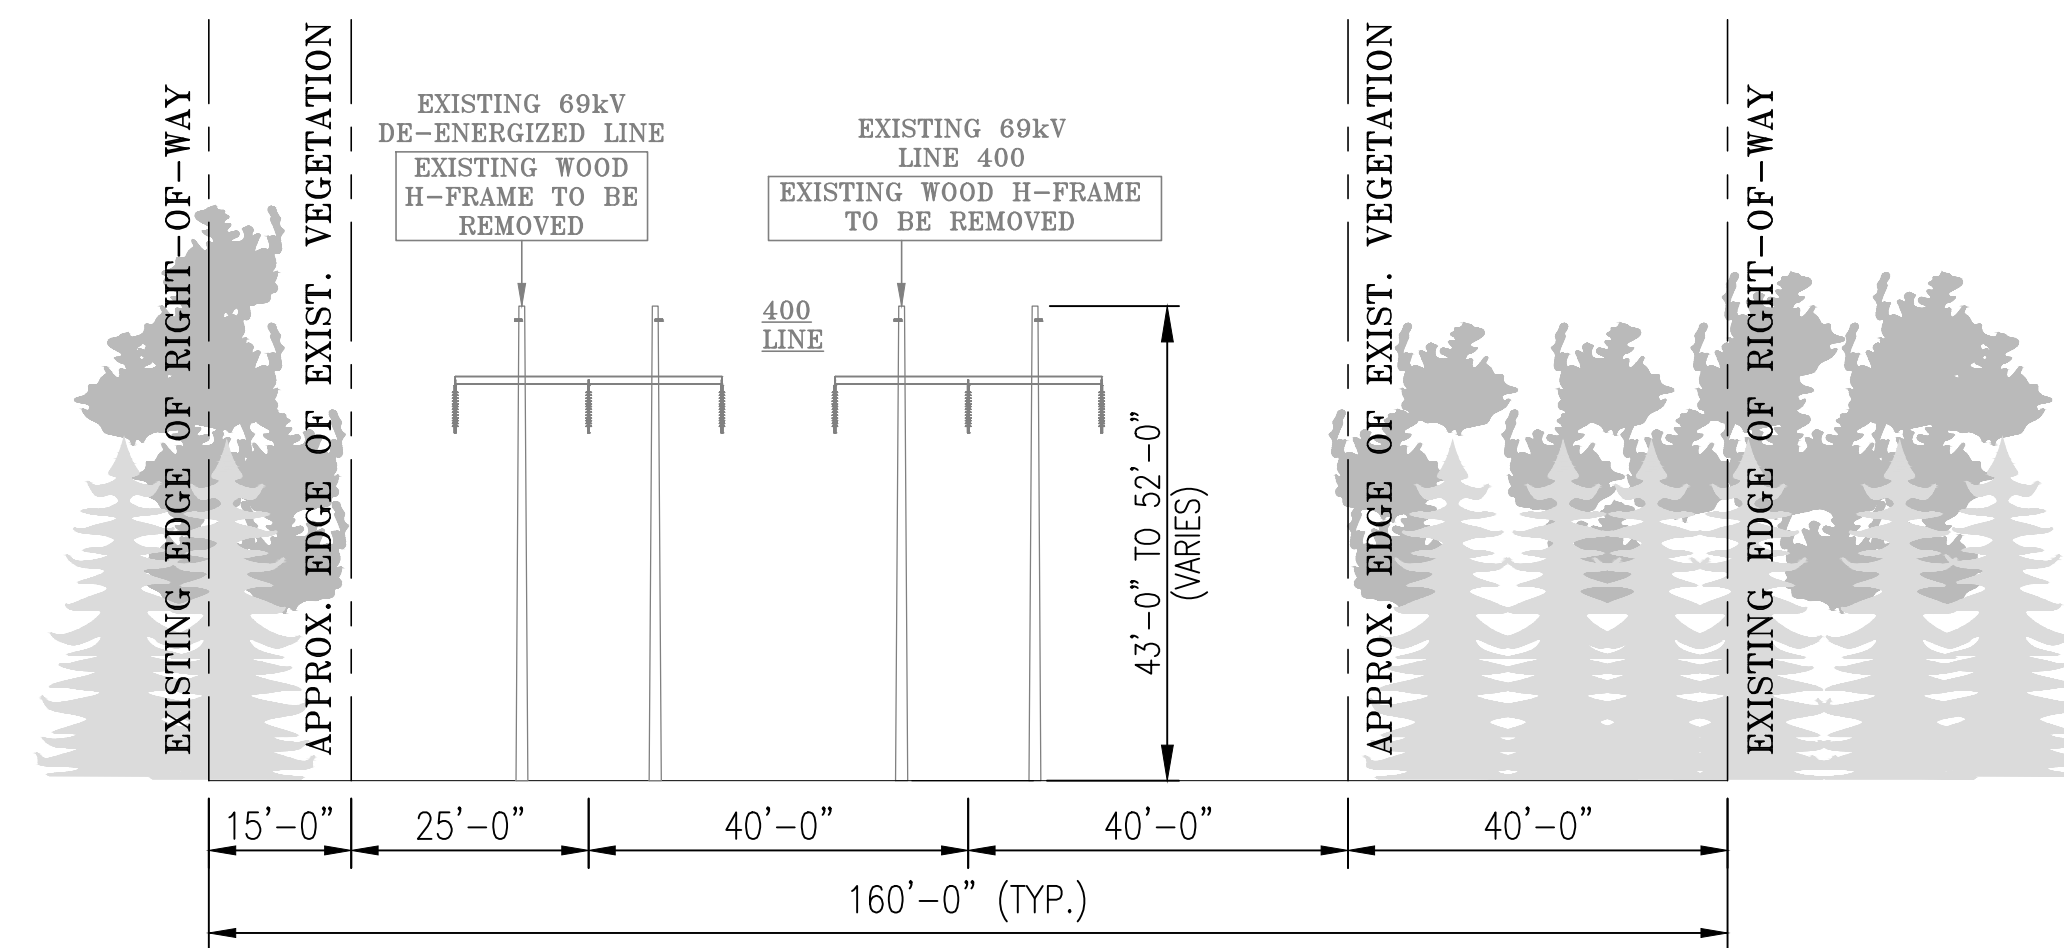
**EXISTING R.O.W. CONFIGURATION
SINGLE CIRCUIT HORIZONTAL DESIGN
LOOKING FROM LEDYARD JUNCTION TO TUNNEL SUBSTATION
IN THE TOWN OF LEDYARD, CT
1.81 MILES, STR. #7054 - STR. #7070**
