Re: Eastern Connecticut Reliability Project – 400/500 Lines Rebuild Project

PETITION TO THE CONNECTICUT SITING COUNCIL
FOR A DECLARATORY RULING OF
NO SUBSTANTIAL ADVERSE ENVIRONMENTAL EFFECT
FOR THE PROPOSED MODIFICATIONS TO THE EXISTING
400 and 500 LINES IN THE TOWNS OF LEDYARD AND PRESTON, CONNECTICUT

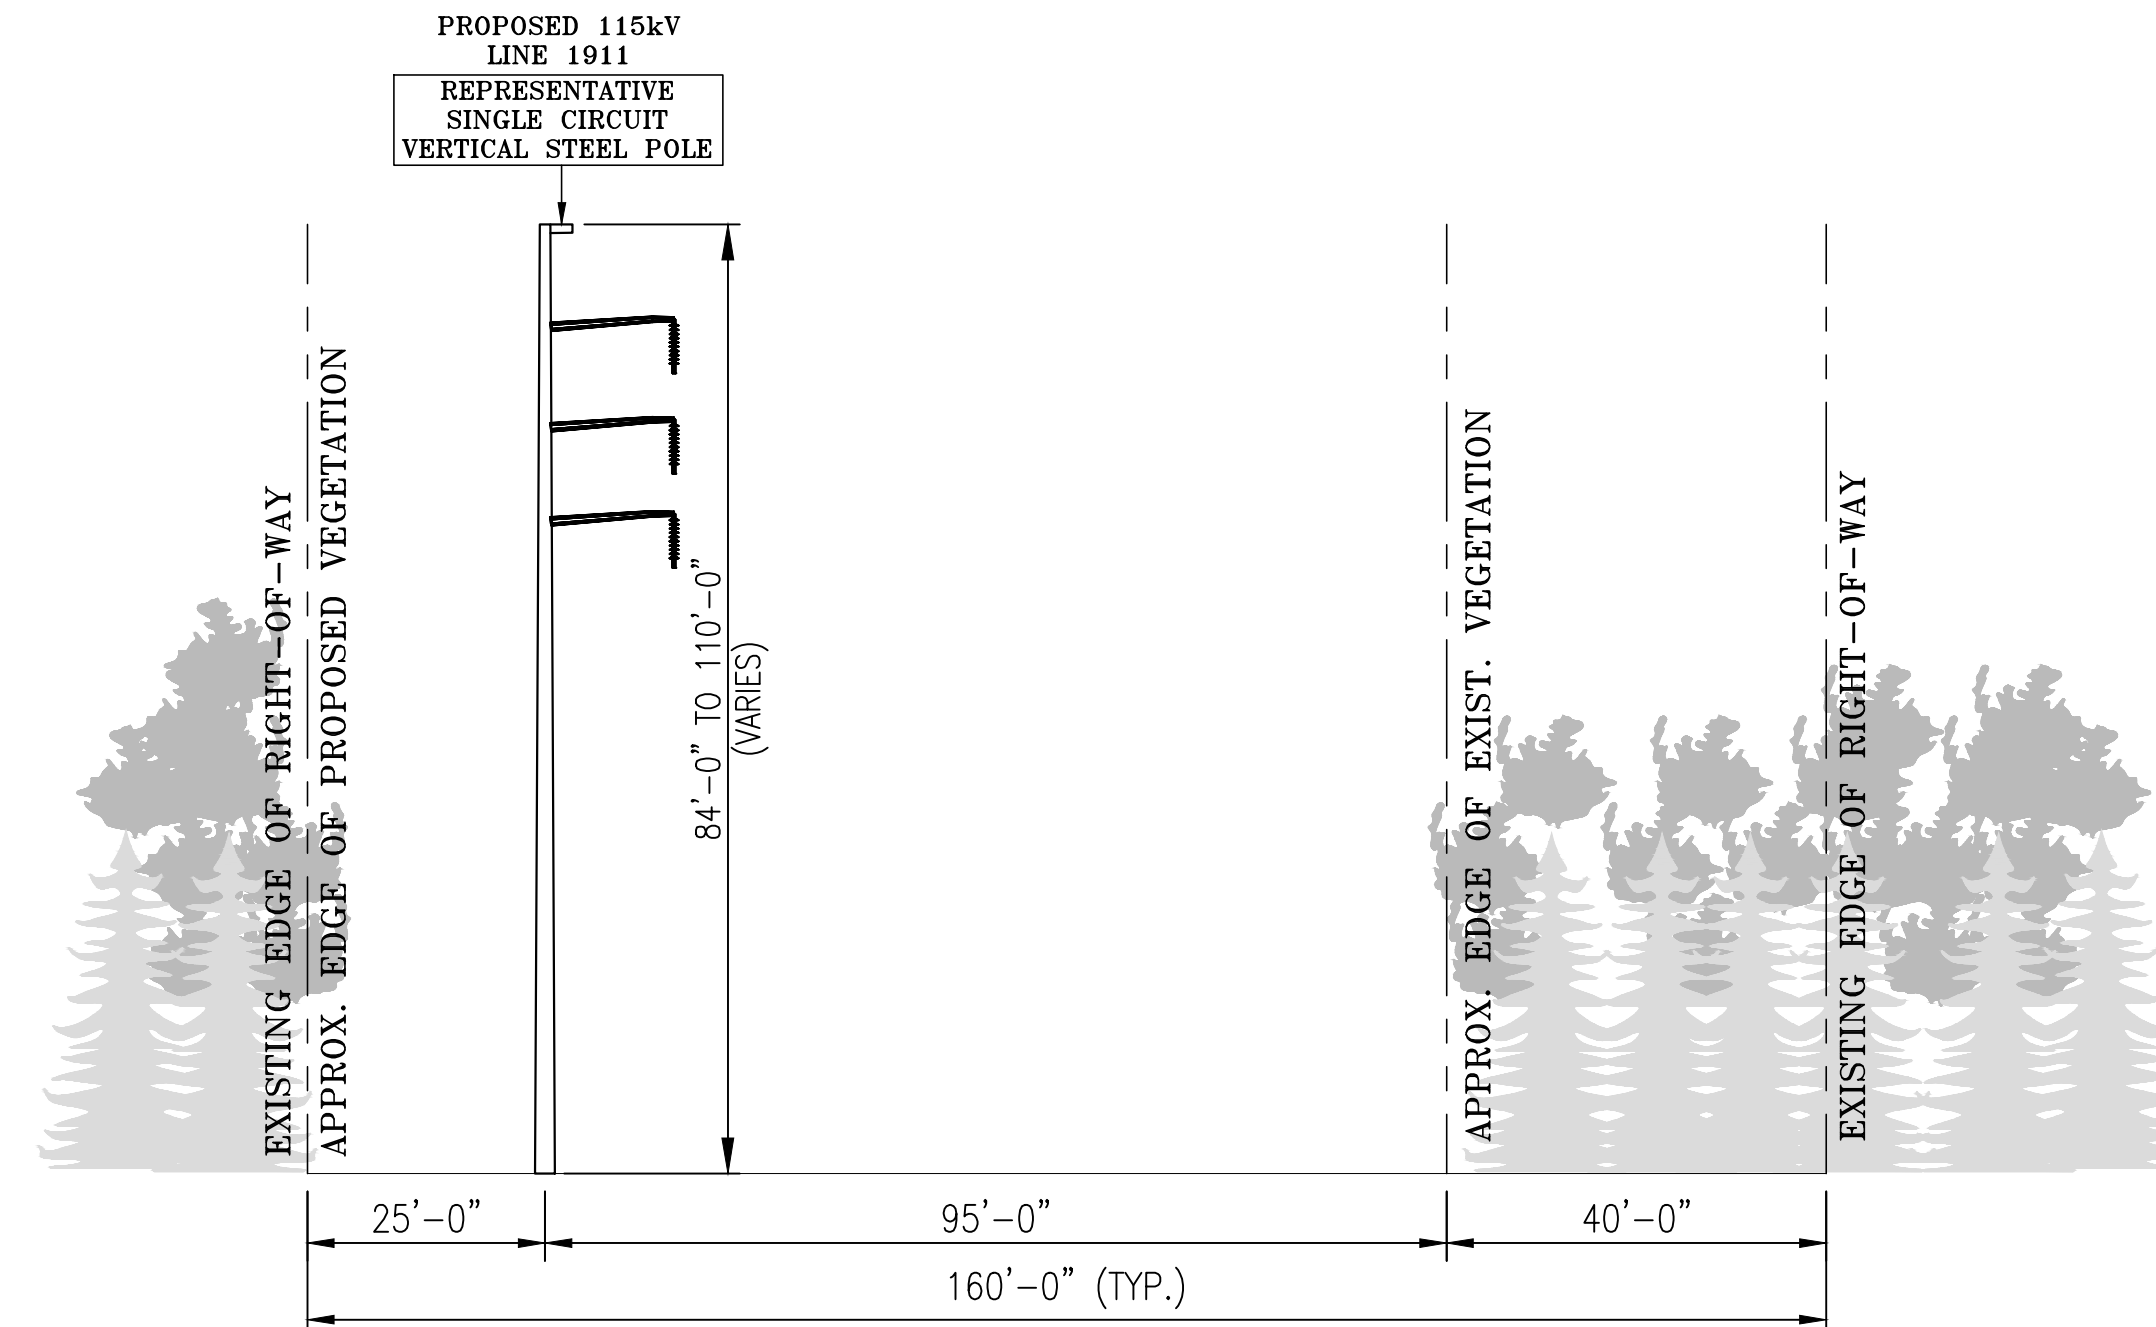
**PROPOSED R.O.W. CONFIGURATION
NO ADDITIONAL RIGHT-OF-WAY REQUIRED
SINGLE CIRCUIT VERTICAL DESIGN
LOOKING FROM LEDYARD JUNCTION TO TUNNEL SUBSTATION
IN THE TOWN OF LEDYARD, CT
1.81 MILES, STR. #7054 - STR. #7070**

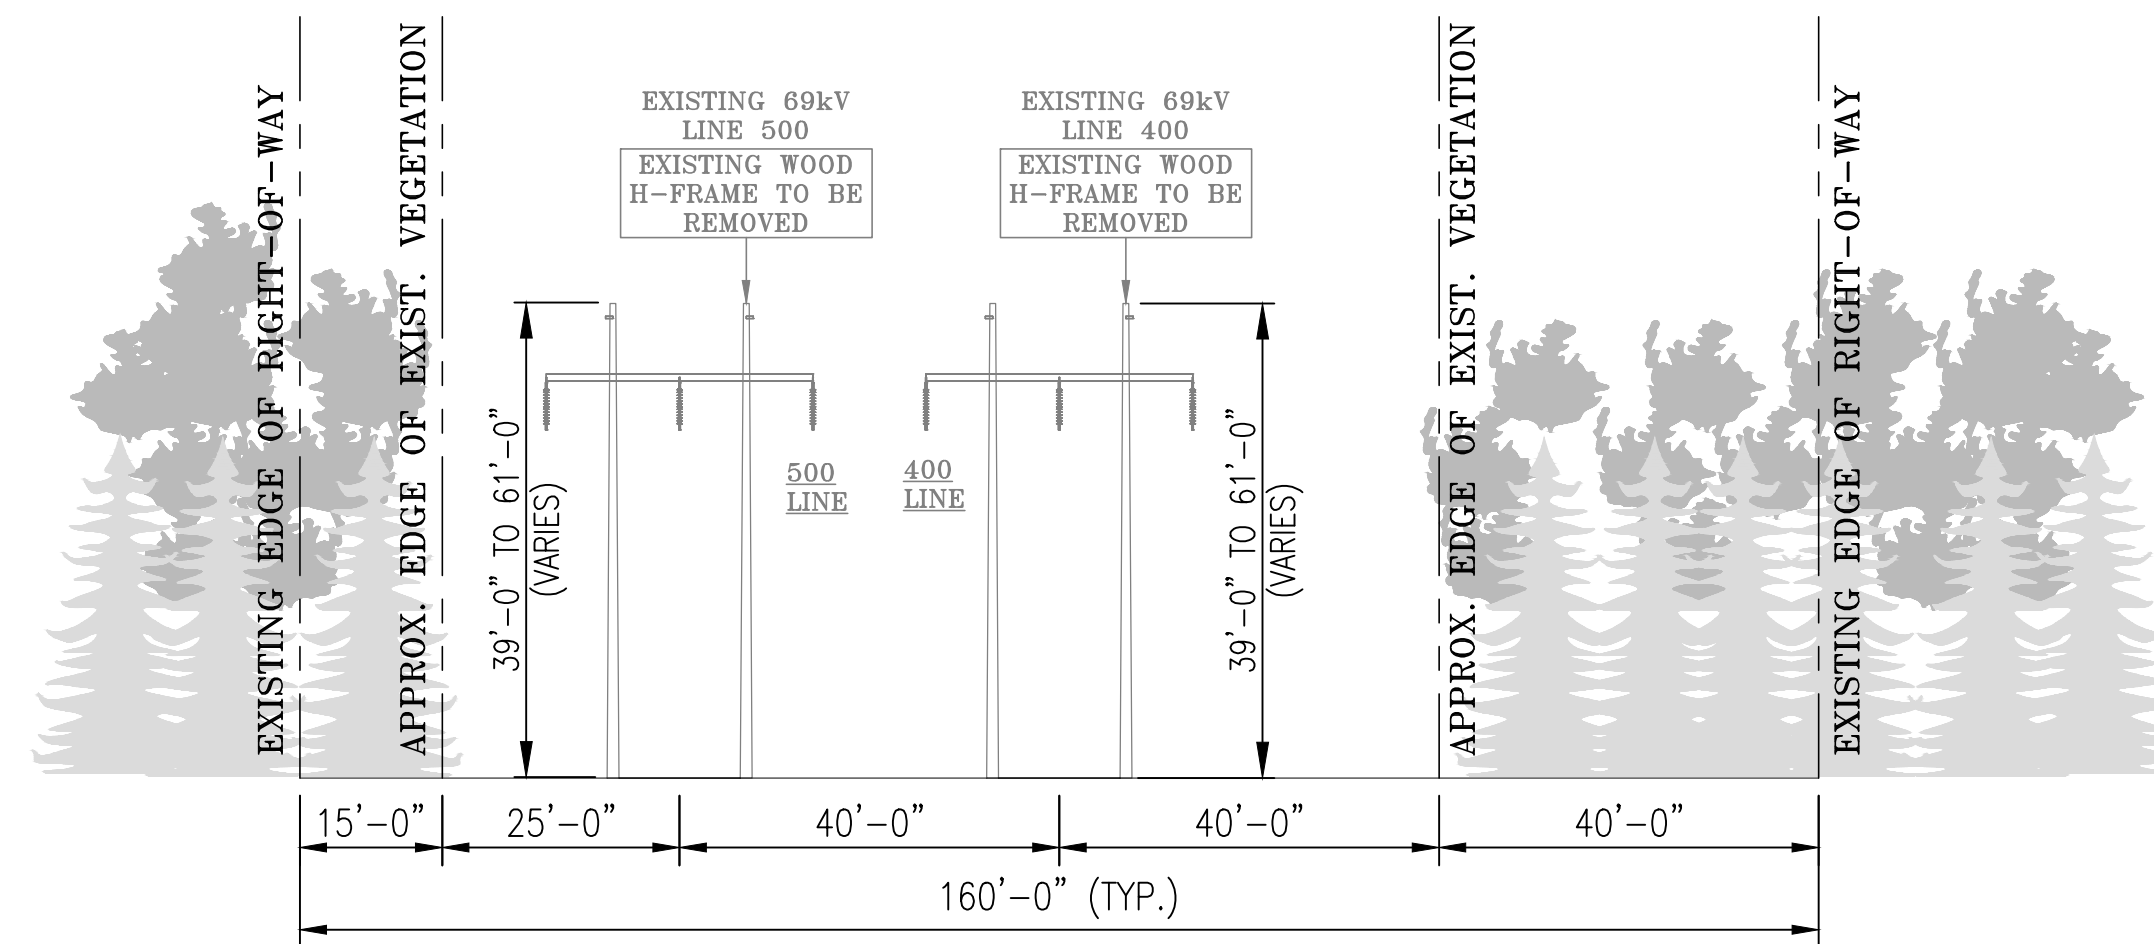
**EXISTING R.O.W. CONFIGURATION
SINGLE CIRCUIT HORIZONTAL DESIGN
LOOKING FROM LEDYARD JUNCTION TO TUNNEL SUBSTATION
IN THE TOWN OF PRESTON, CT
3.57 MILES, STR. #7071 - STR. #7105**

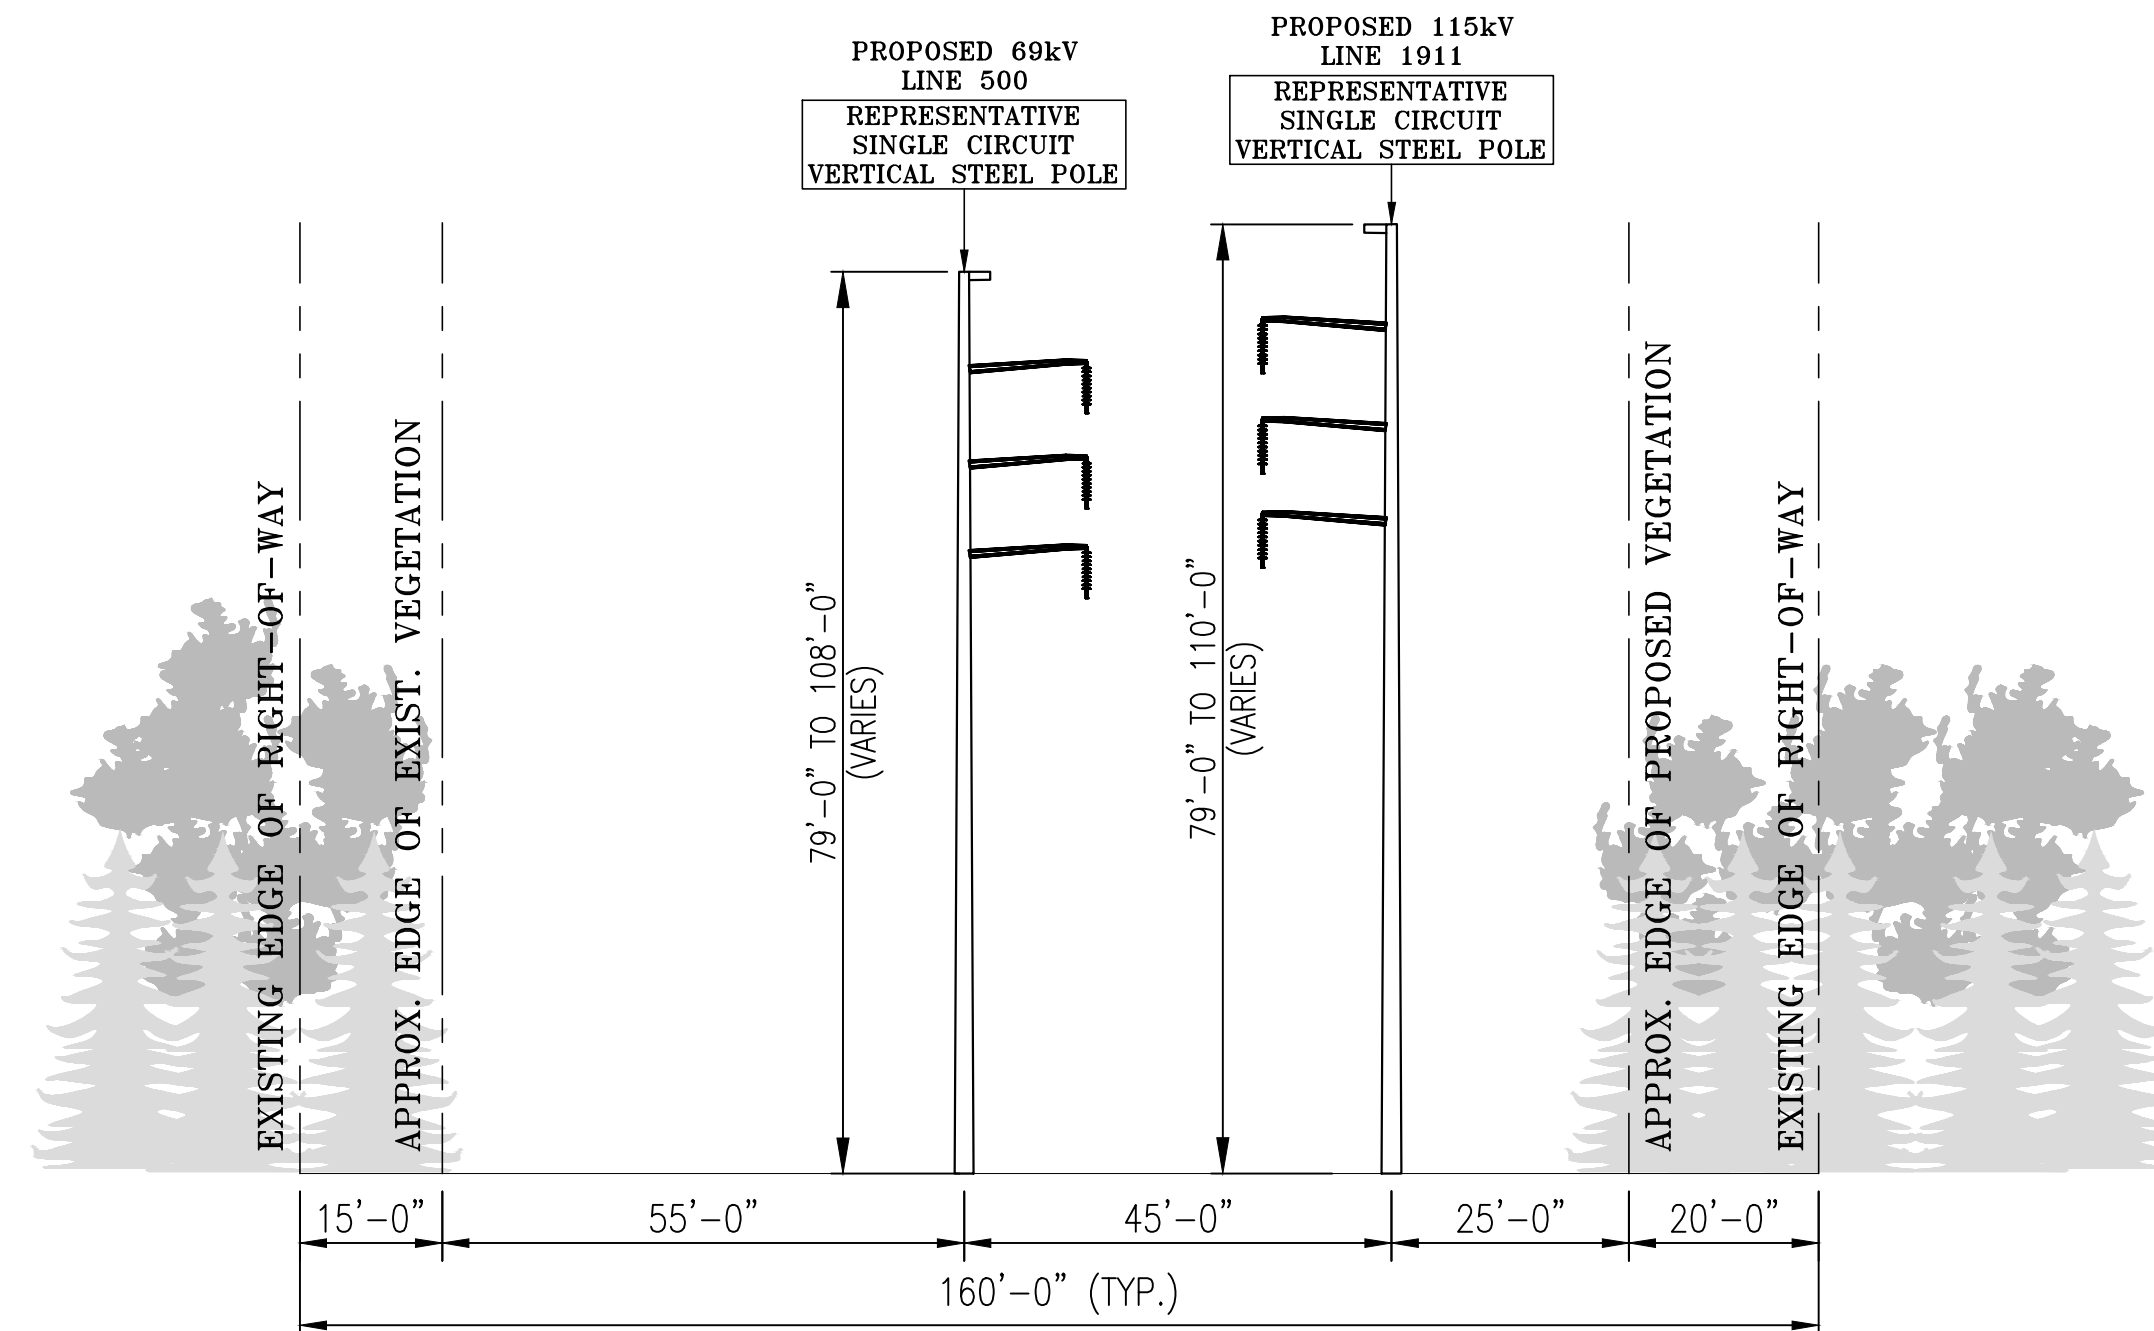
**PROPOSED R.O.W. CONFIGURATION
NO ADDITIONAL RIGHT-OF-WAY REQUIRED
SINGLE CIRCUIT VERTICAL DESIGN
LOOKING FROM LEDYARD JUNCTION TO TUNNEL SUBSTATION
IN THE TOWN OF PRESTON, CT
3.57 MILES, STR. #7071 - STR. #7105**

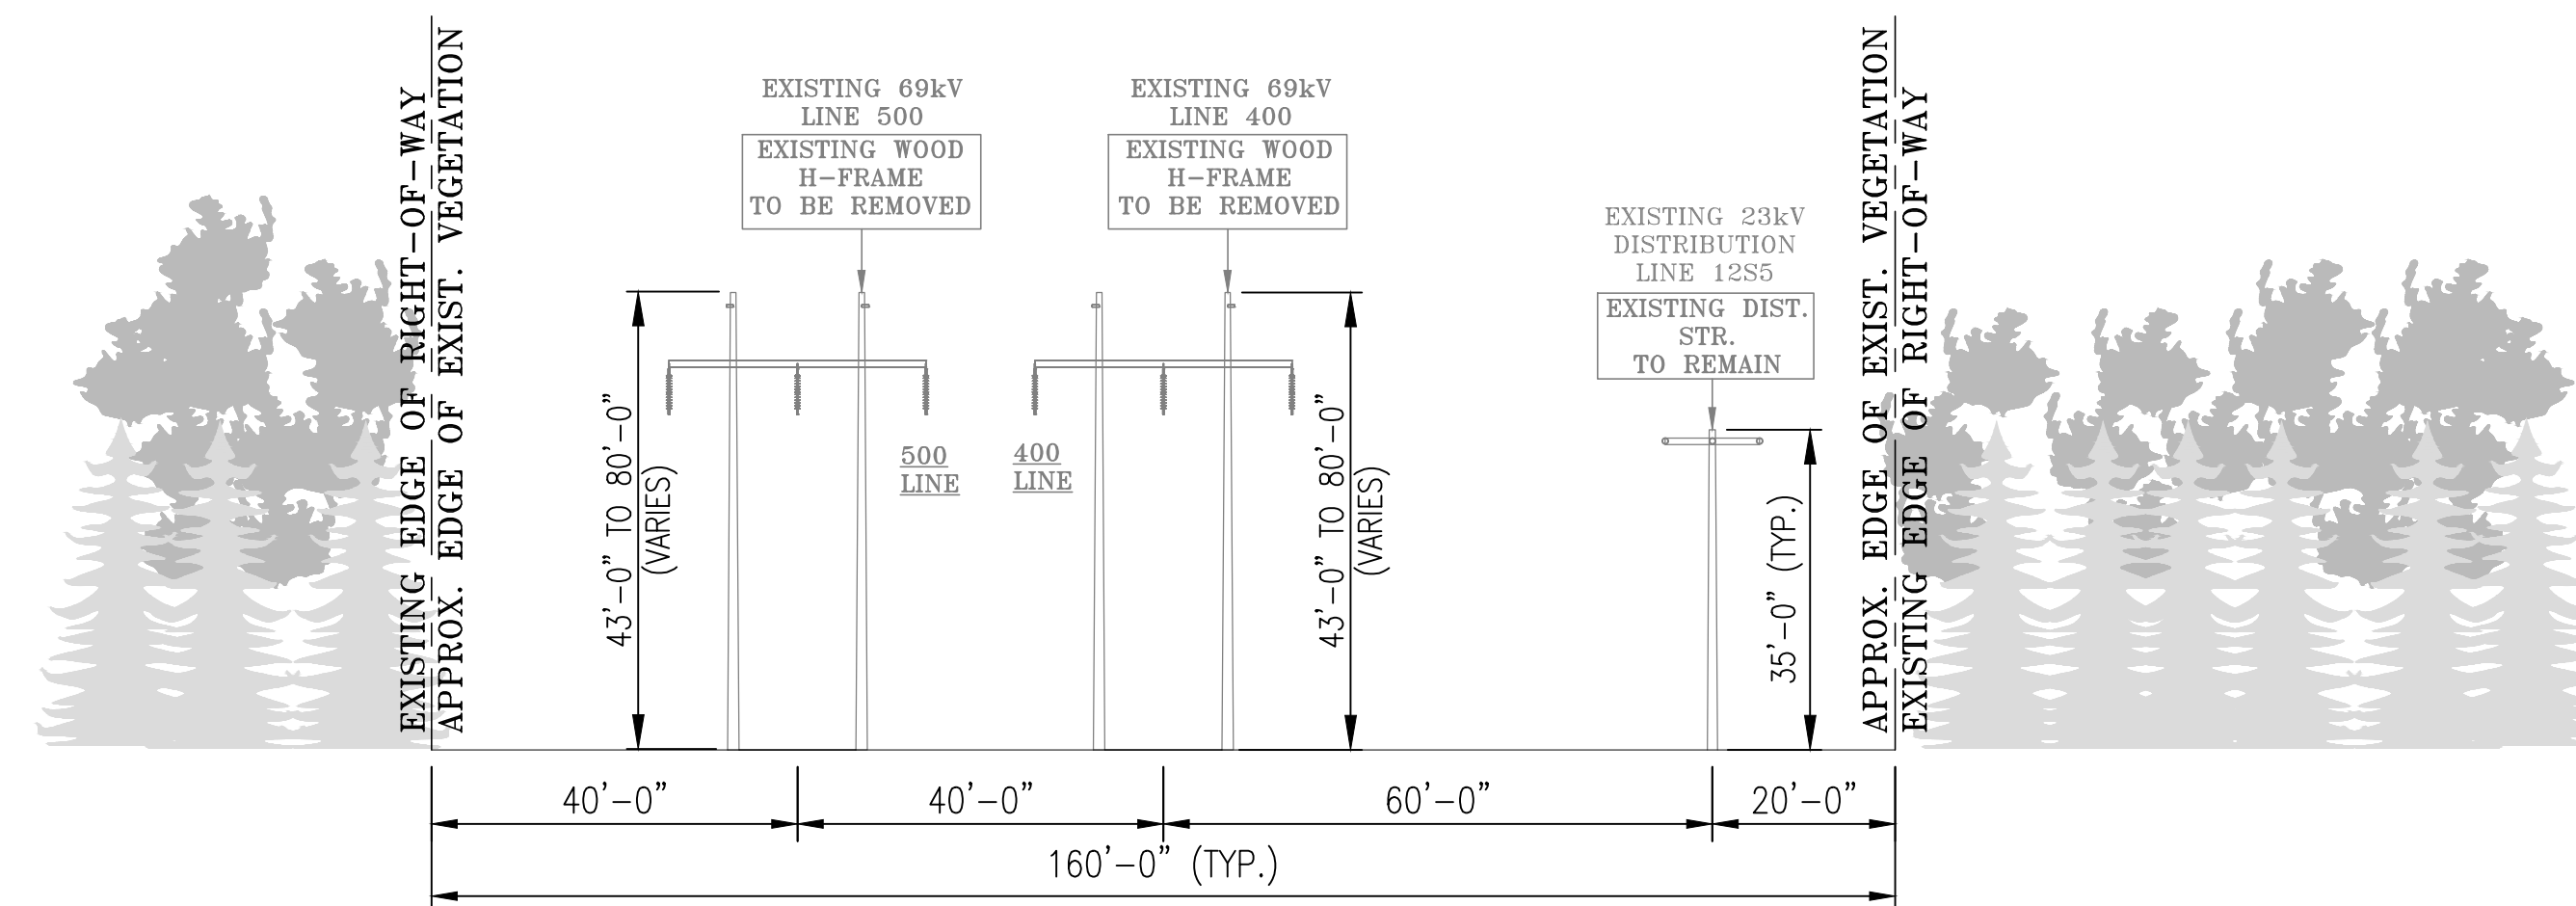
**EXISTING R.O.W. CONFIGURATION
SINGLE CIRCUIT HORIZONTAL DESIGN
LOOKING FROM LEDYARD JUNCTION TO TUNNEL SUBSTATION
IN THE TOWN OF PRESTON, CT
1.33 MILES, STR. #7106 - STR. #7119**

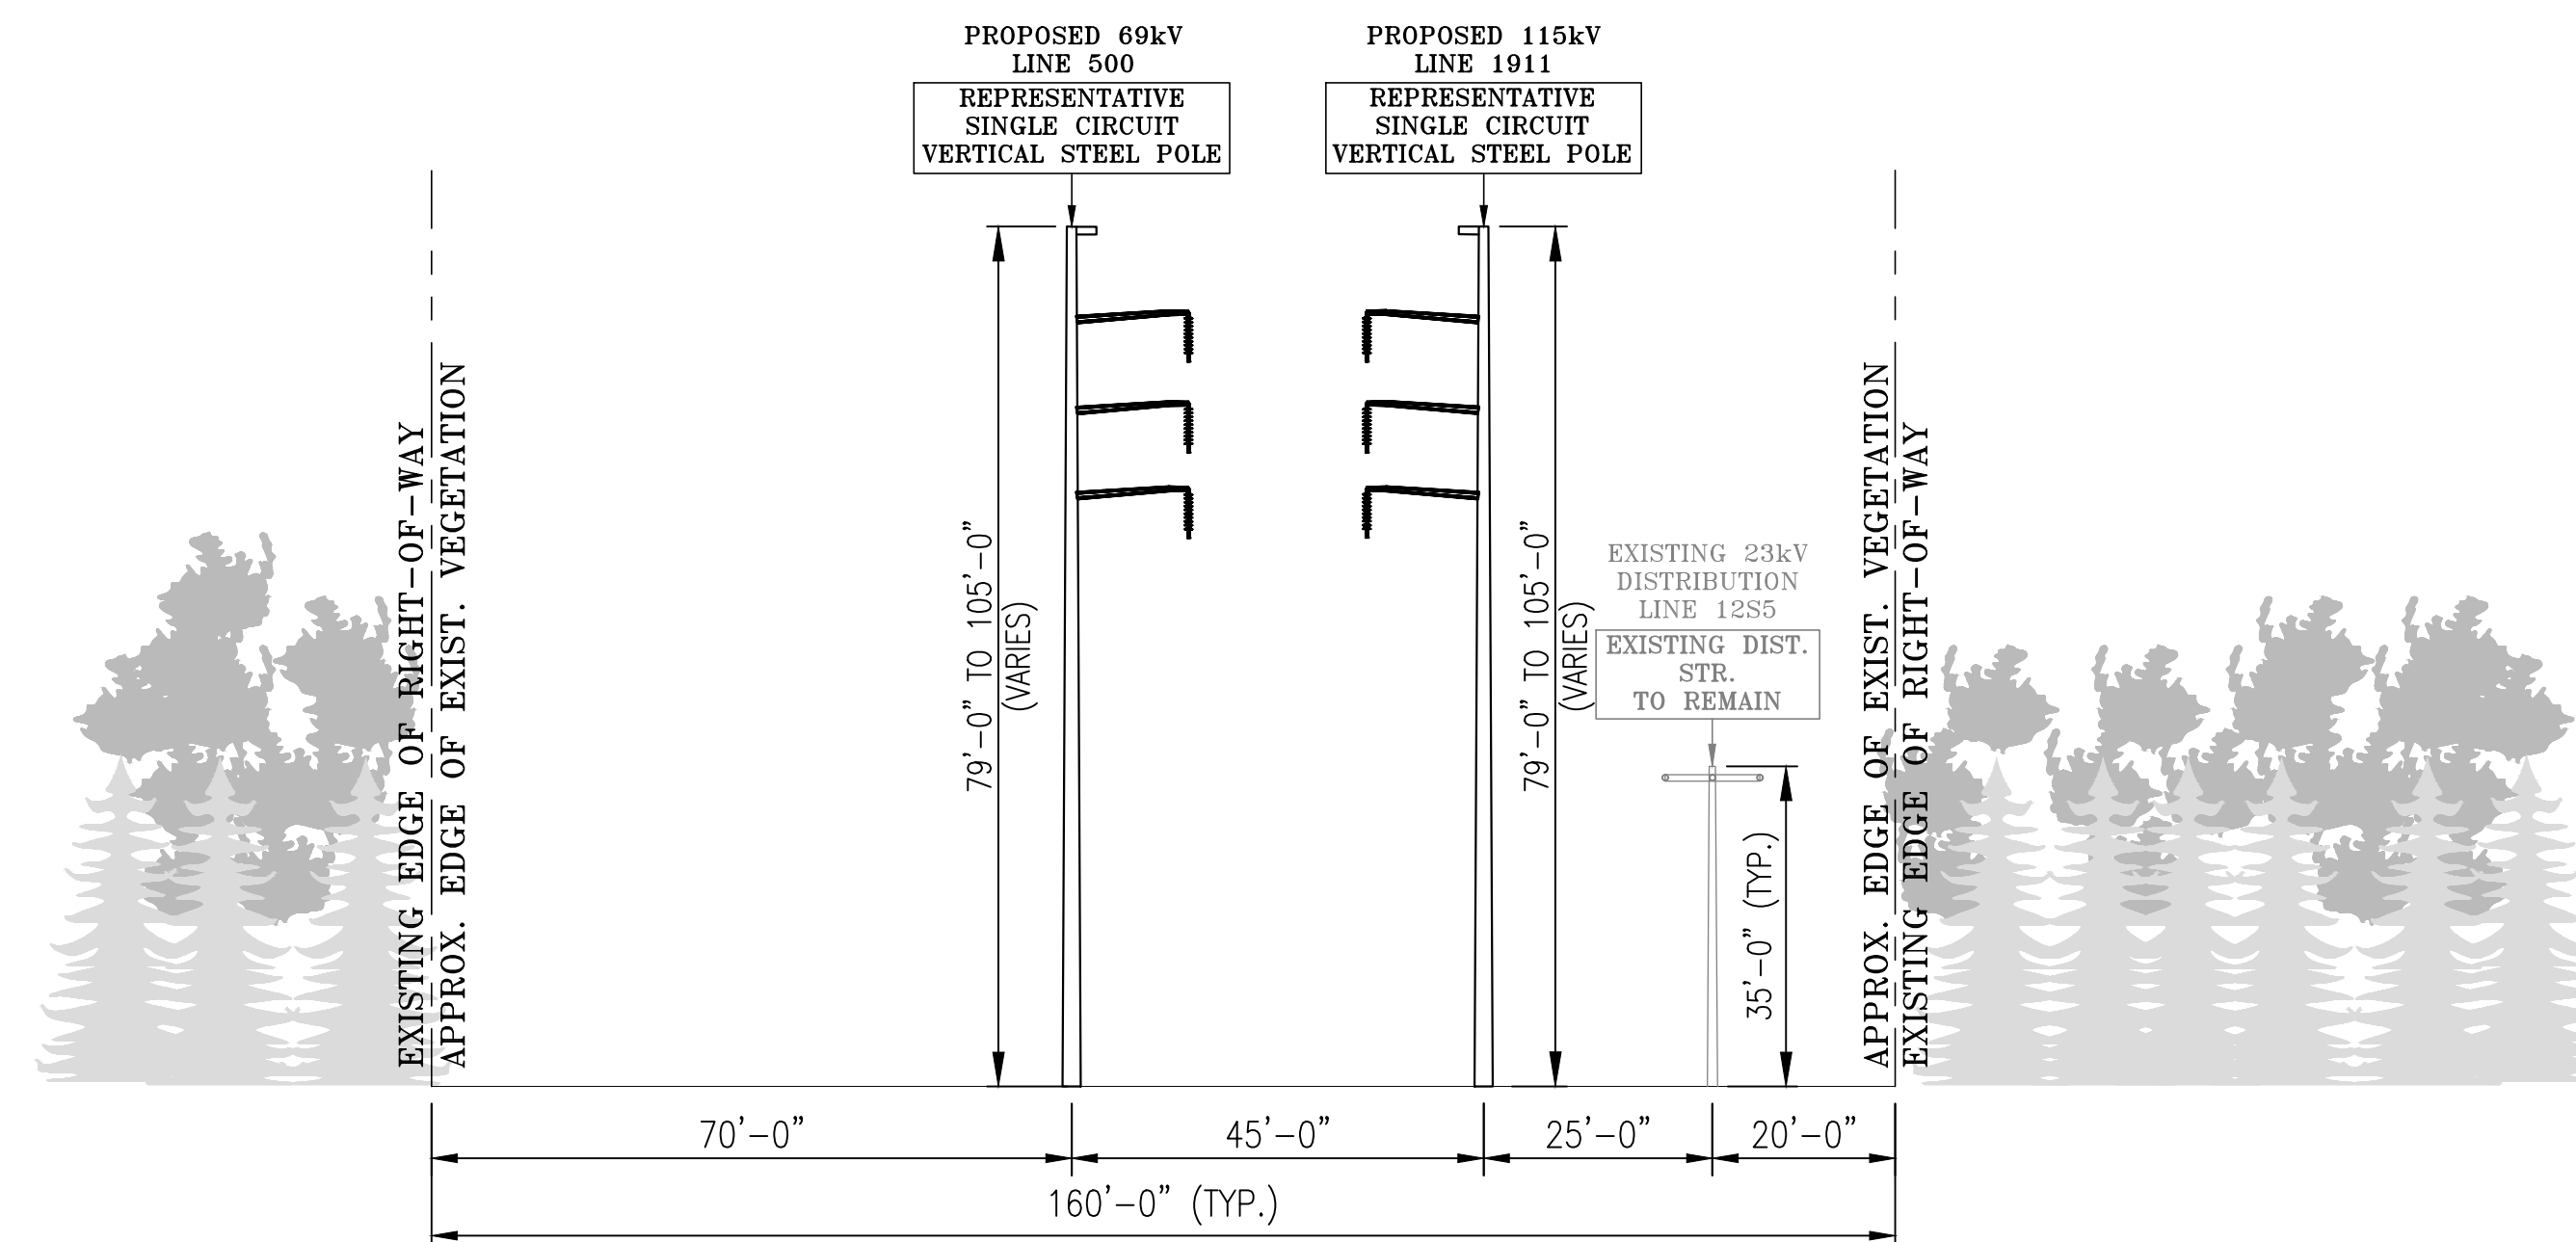
**PROPOSED R.O.W. CONFIGURATION
NO ADDITIONAL RIGHT-OF-WAY REQUIRED
SINGLE CIRCUIT VERTICAL DESIGN
LOOKING FROM LEDYARD JUNCTION TO TUNNEL SUBSTATION
IN THE TOWN OF PRESTON, CT
1.33 MILES, STR. #7106 - STR. #7119**

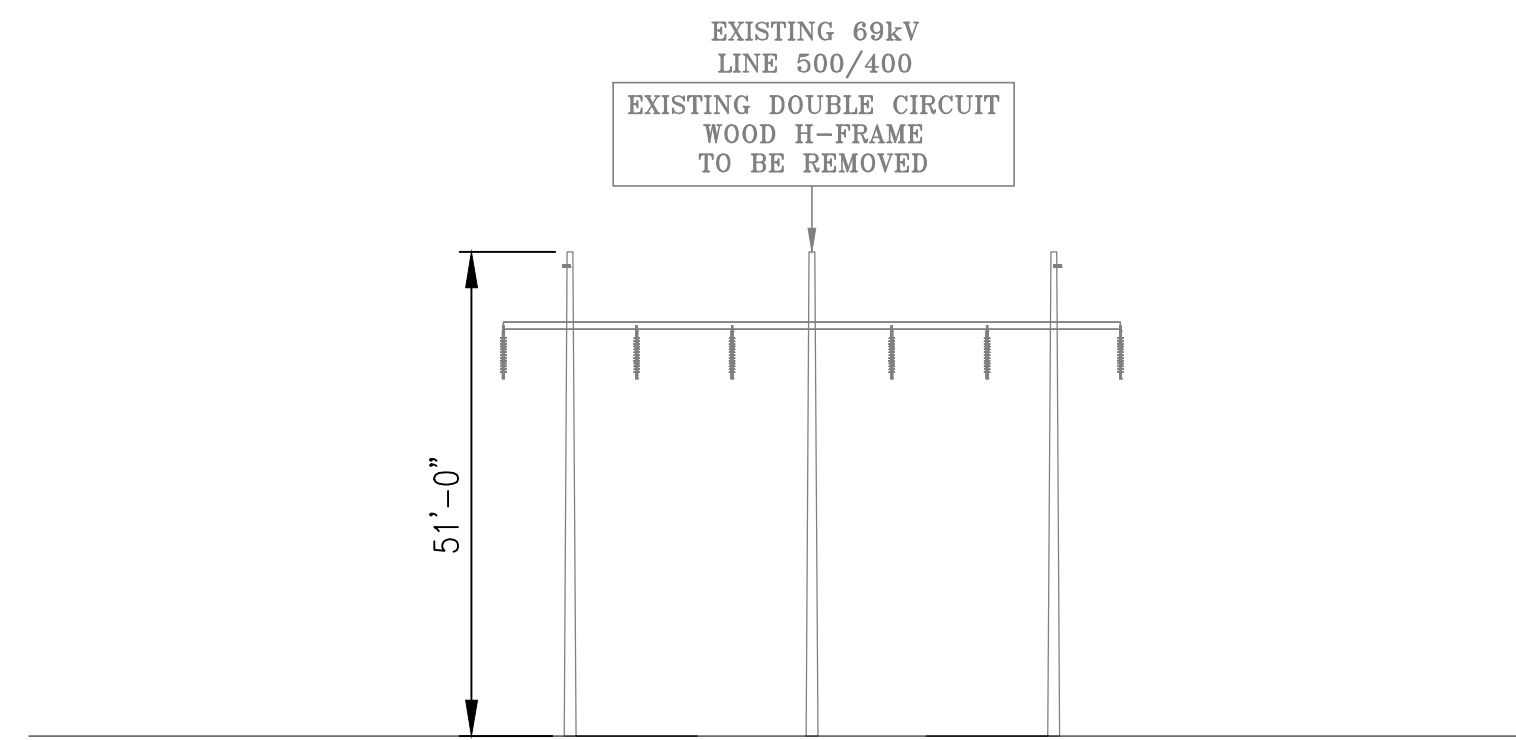
**EXISTING CONFIGURATION
DOUBLE CIRCUIT HORIZONTAL DESIGN
LOOKING FROM LEDYARD JUNCTION TO TUNNEL SUBSTATION
IN THE TOWN OF PRESTON, CT
STR. #7119.5**

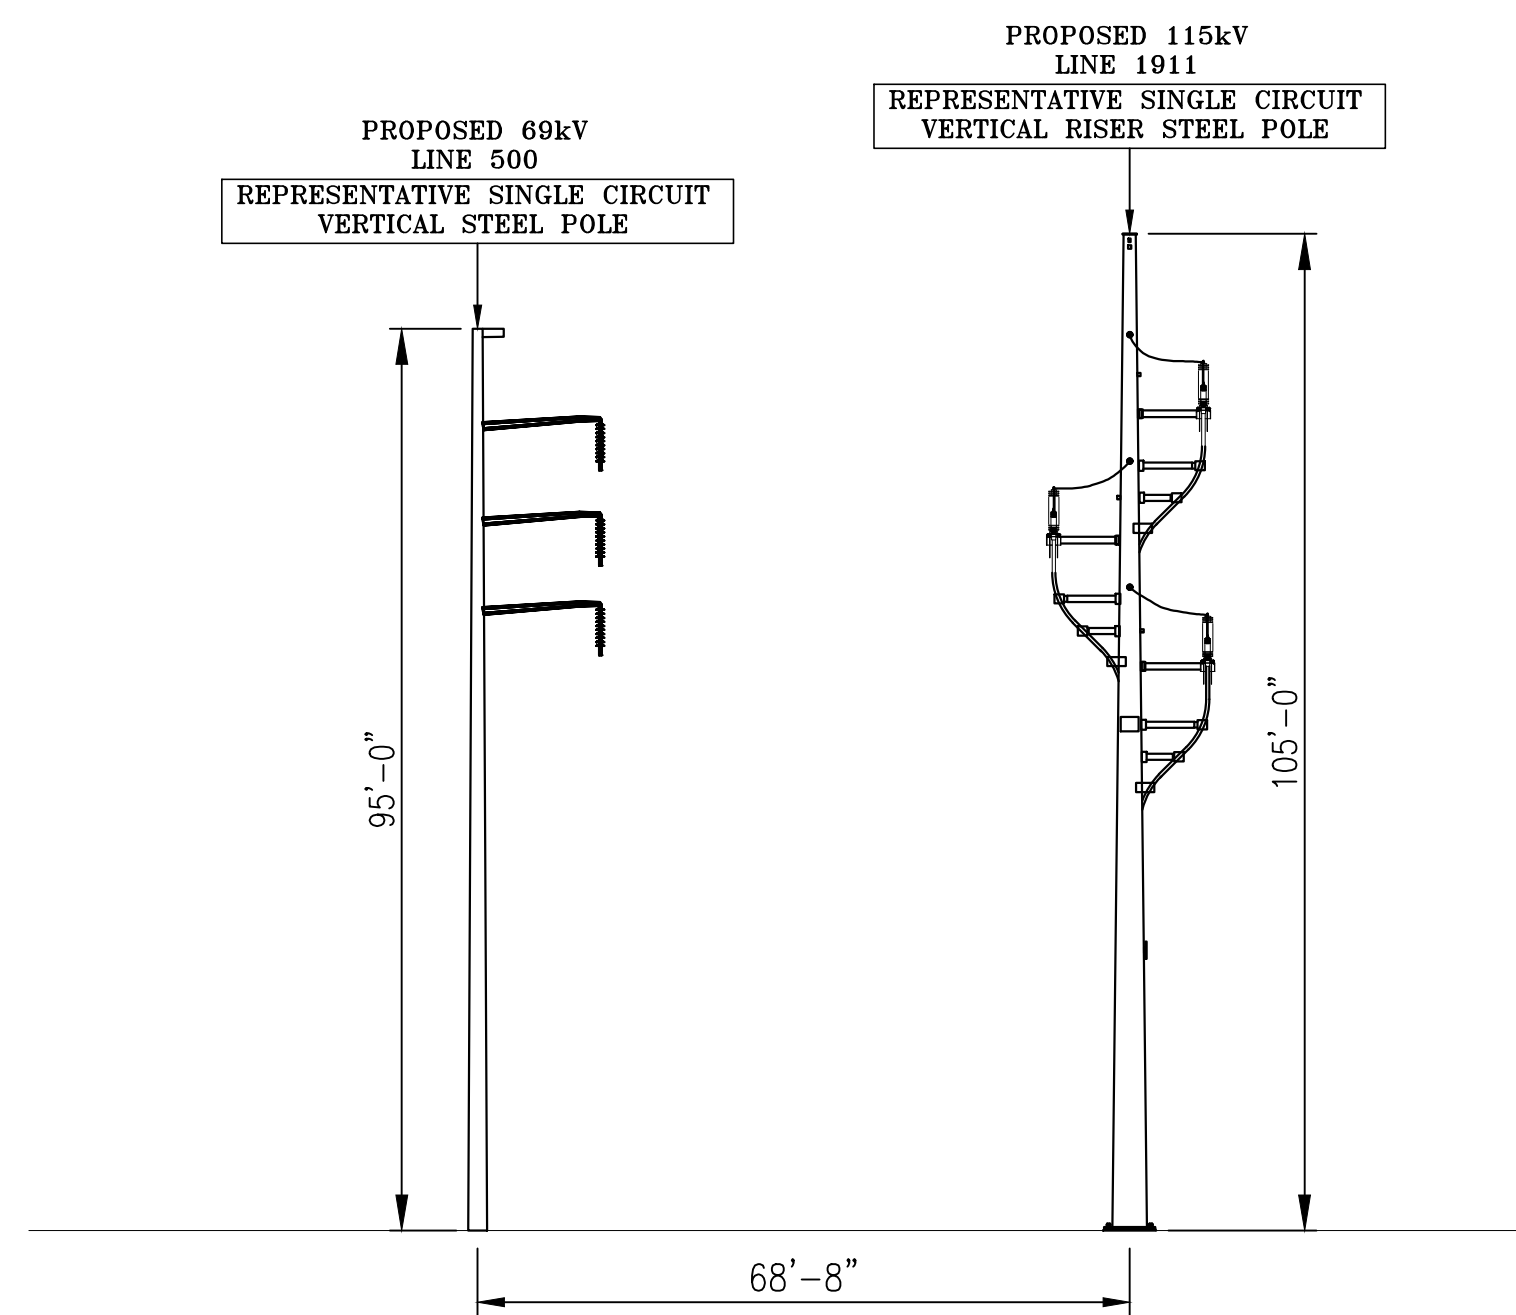
**PROPOSED CONFIGURATION
SINGLE CIRCUIT VERTICAL DESIGN
LOOKING FROM LEDYARD JUNCTION TO TUNNEL SUBSTATION
IN THE TOWN OF PRESTON, CT
STR. #7119.5 & STR. #7119.5A**
