Re: Stevenson to Pootatuck Rebuild Project

PETITION TO THE CONNECTICUT SITING COUNCIL
FOR A DECLARATORY RULING OF
NO SUBSTANTIAL ADVERSE ENVIRONMENTAL EFFECT
FOR THE PROPOSED MODIFICATIONS TO THE EXISTING
1560, 1808 AND 1580 LINES IN THE TOWN OF MONROE AND CITY OF SHELTON,
CONNECTICUT

Attachment B: Stevenson to Pootatuck Rebuild Project – Right-of-Way Cross Section

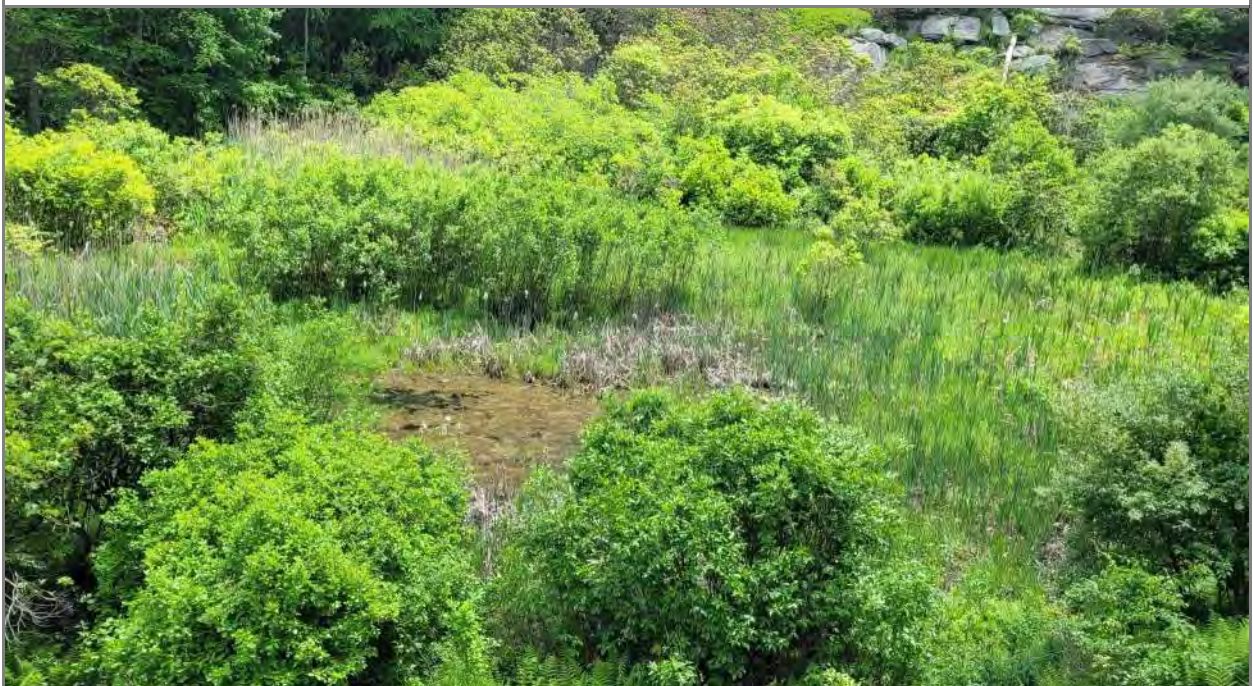
Photograph No.: 10	Date: 5/27/2021	Direction Taken: South
Description: The growth of emergent wetland vegetation reduced the open water area over the course of the spring 2021 observations.
