Re: Vernal Pool Investigation
Verogy
North Haven Solar One Project
700 Middletown Avenue
North Haven, Connecticut

2022 Vernal Pool Investigation
700 Middletown Avenue, North Haven, CT

Vernal Pool Evaluation Photographs

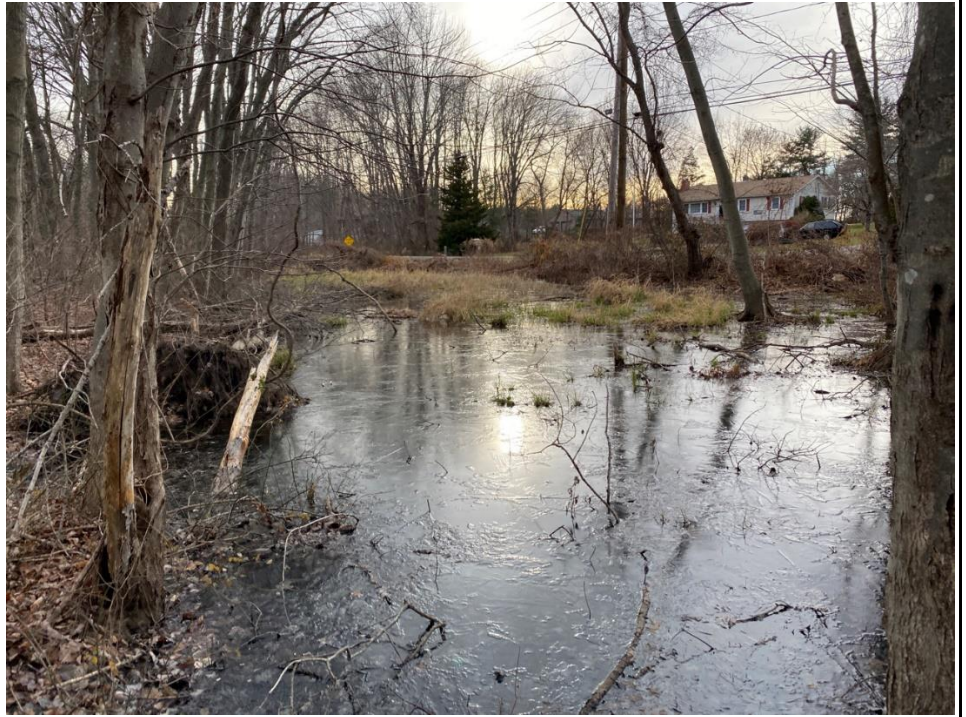
Photo No.: 1

View facing southwest of PVP-1, located within Wetland 1. Mill Road and residential properties in background of photo, located within the 100-foot vernal pool envelope (100-ft. VPE) and 750-foot critical terrestrial habitat zone (750-ft. CTHZ).

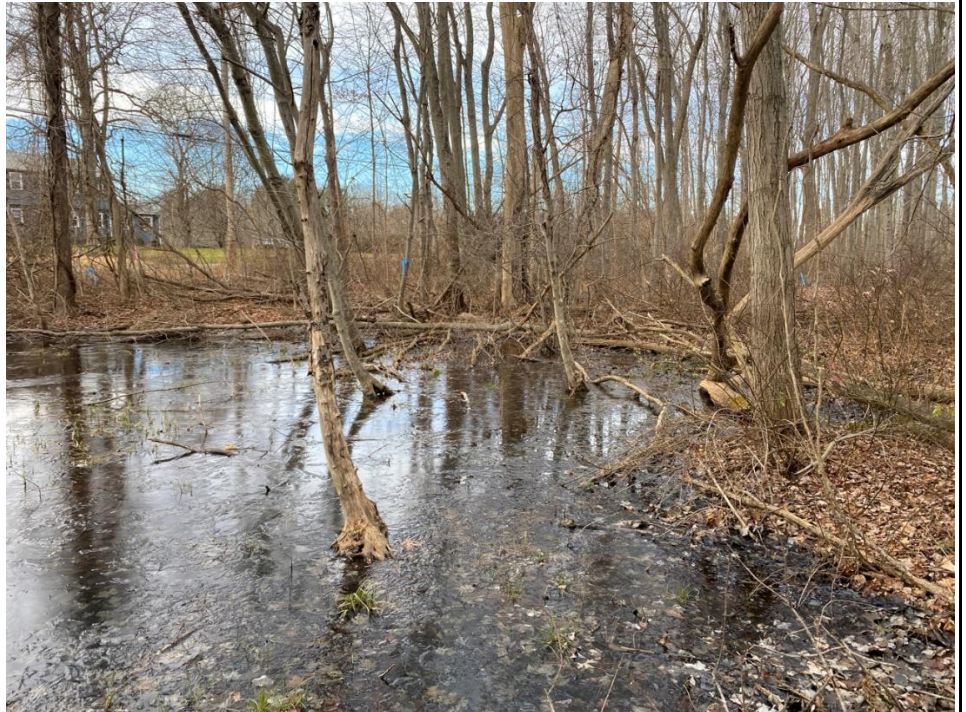
Photo No.: 2

View facing northwest of PVP-1, located within Wetland 1. Mill Road and residential properties in the background, located within the 100-ft. VPE/750-ft. CTHZ.

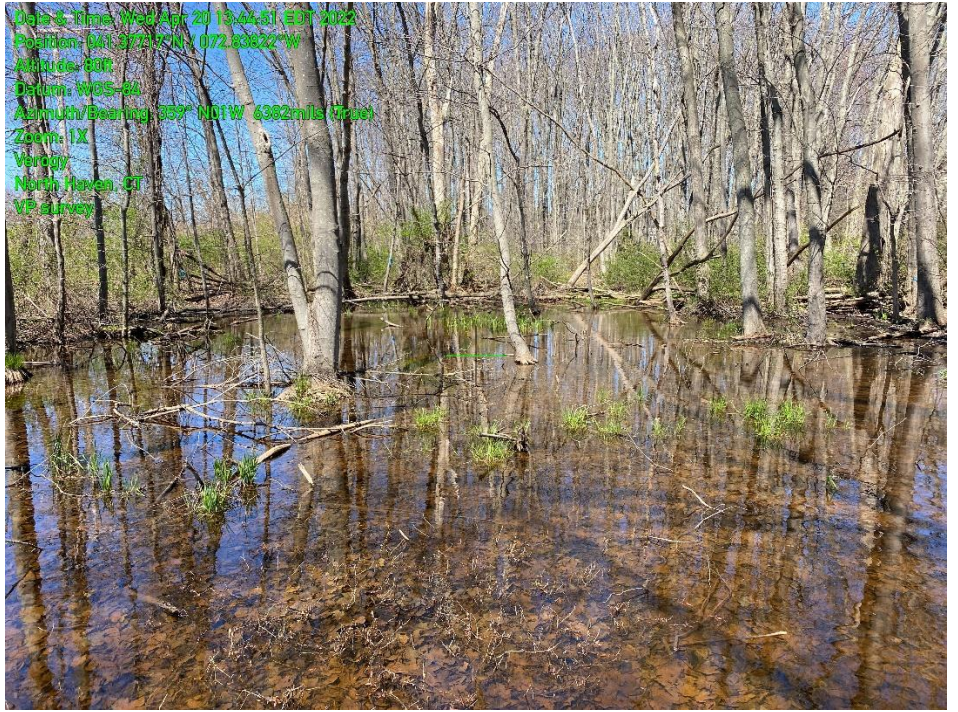
Client Name: North Haven Solar One		Site Location: 700 Middletown Avenue, North Haven, CT		Project No.: 42889.00
Photo No.: 3	Date: 04/20/22	<p>Description: View facing north from within VP-1.</p>		
<p>Date & Time: Wed Apr 20 13:44:51 EDT 2022 Position: 44° 37'21" N, 072° 33'22" W Altitude: 82ft Datum: WGS-84 Azimuth/Bearing: 357° NR1W 6382mils (True) Zoom: 1X Verogy North Haven, CT VP survey</p>

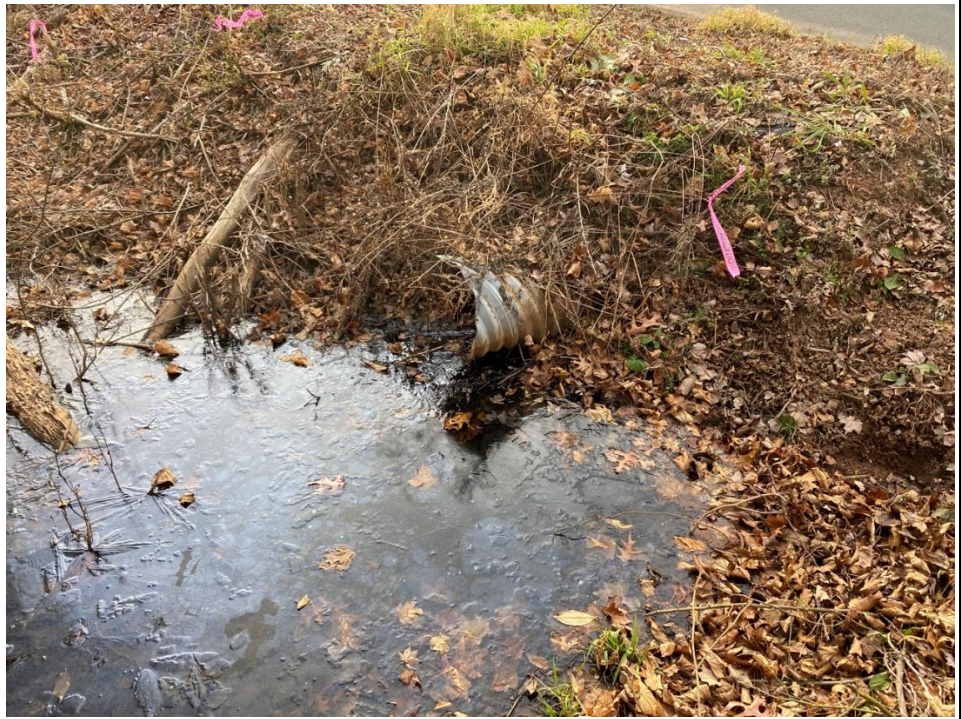
Photo No.: 5

While VP-1 does contain a permanent culverted outlet, it is a restricted outlet in that the culvert is perched above the ground by approximately 12-inches, which allows for the presence of standing water. Based on the depth of the pool, and the presence of a mix of OBL and FACW species, it is not clear if the pool completely dries out on an annual basis. Given the strong presence of OBL plant species, it appears likely that the pool may occasionally dry down completely, but likely experiences only partial drying during most years (i.e., semi-permanent).

* There is a permanent 12-inch culvert located at the southern end of the vernal pool, however, it is perched about 12-inches above the ground level, which allows for the continued presence of standing water.

View facing southwest of the restricted permanent outlet located at the far southwestern corner of Wetland 1 and VP-1, which flows under Mill Road to the west.

The corrugated metal outlet pipe is perched above the current water level.

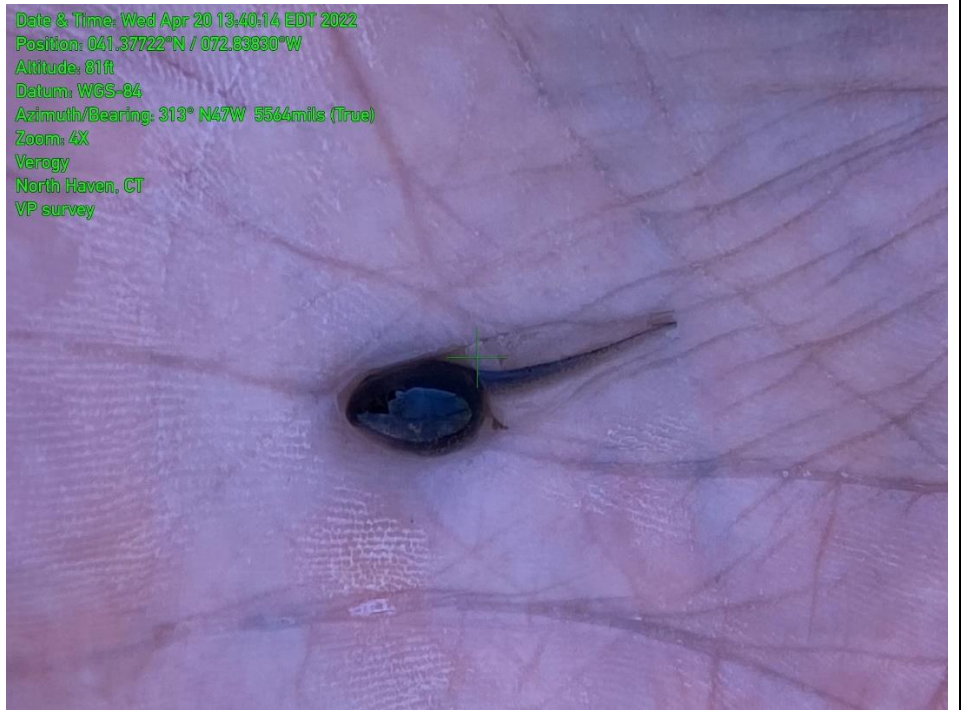
Photo No.: 6

Wetland 1 was found to contain one (1) cryptic vernal pool breeding area (see Figure 2), which was delineated in the field with blue flagging labeled PVP-1-100 to PVP-1-120. Observed obligate vernal pool species included wood frog tadpoles (see Photo 6). No fairy shrimp, marbled salamander, or state-listed vernal pool breeding amphibians were observed. The vernal pool area exhibits a soft, leafy, silty bottom and flood depths within the breeding area at approximately 10-12 inches. The vernal pool (VP) 1 breeding area was a long and broad pool located within the southern portion of Wetland 1 (see Photos 1 through 4). The pool is approximately 230 long and 80-feet wide at the northern extent, tapering down to approximately 40 feet wide at the southern extent.

Wood frog tadpole found in VP-1, which is an obligate vernal pool species.

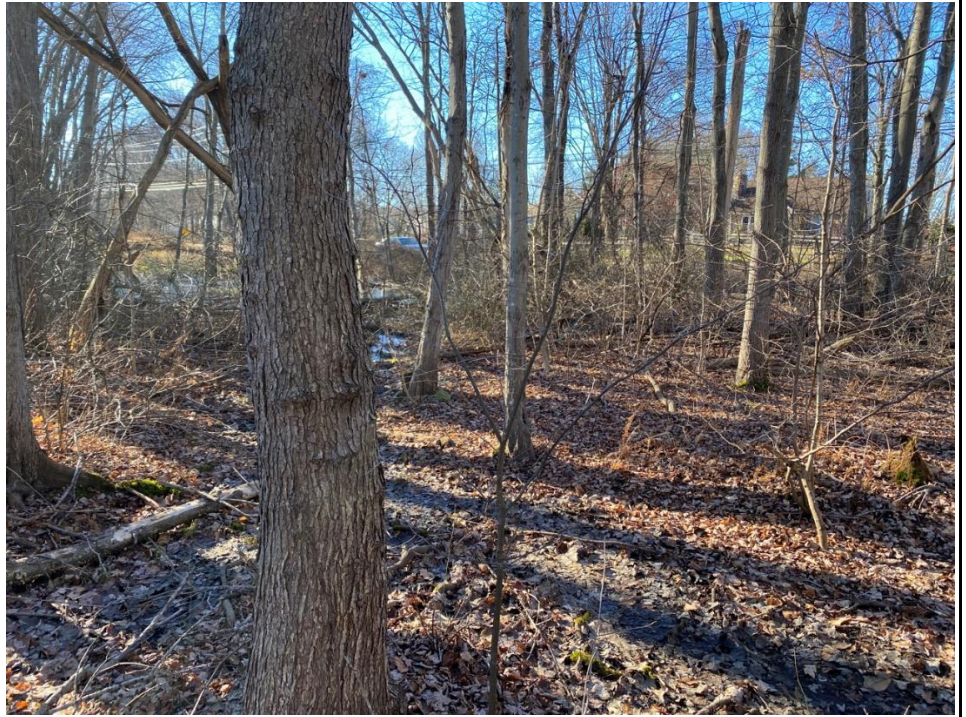
Photo No.: 7

View facing southwest from within Wetland 1 inside the 100-ft. VPE, located north of VP-1.

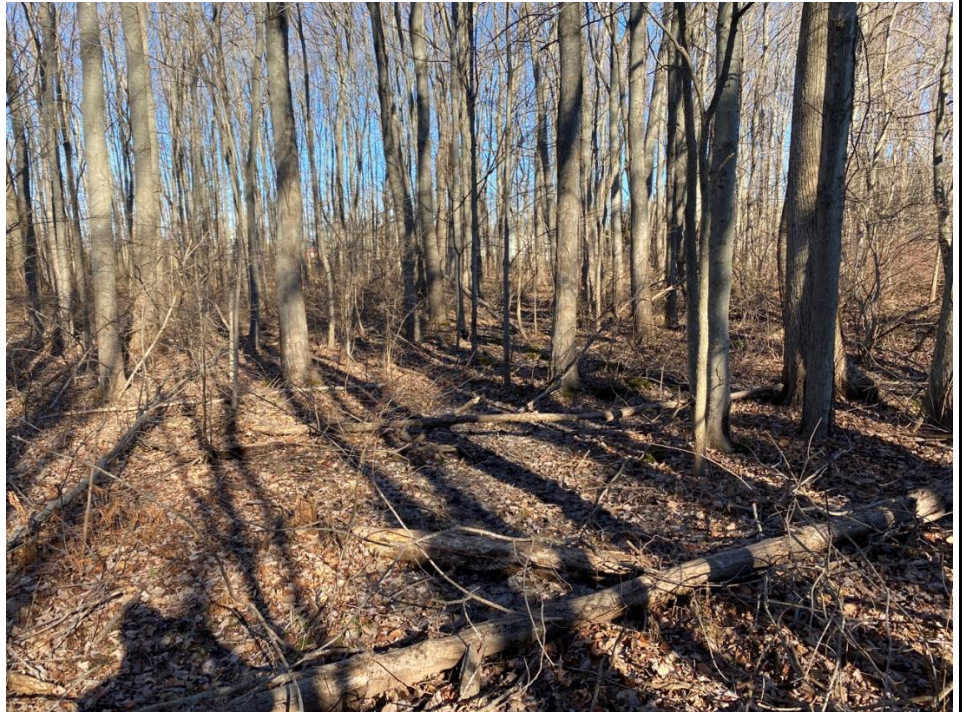
Photo No.: 8

View facing north from within Wetland 1 at the approximately boundary of the 100-ft. VPE. The 750-ft. CTHZ is in the background.

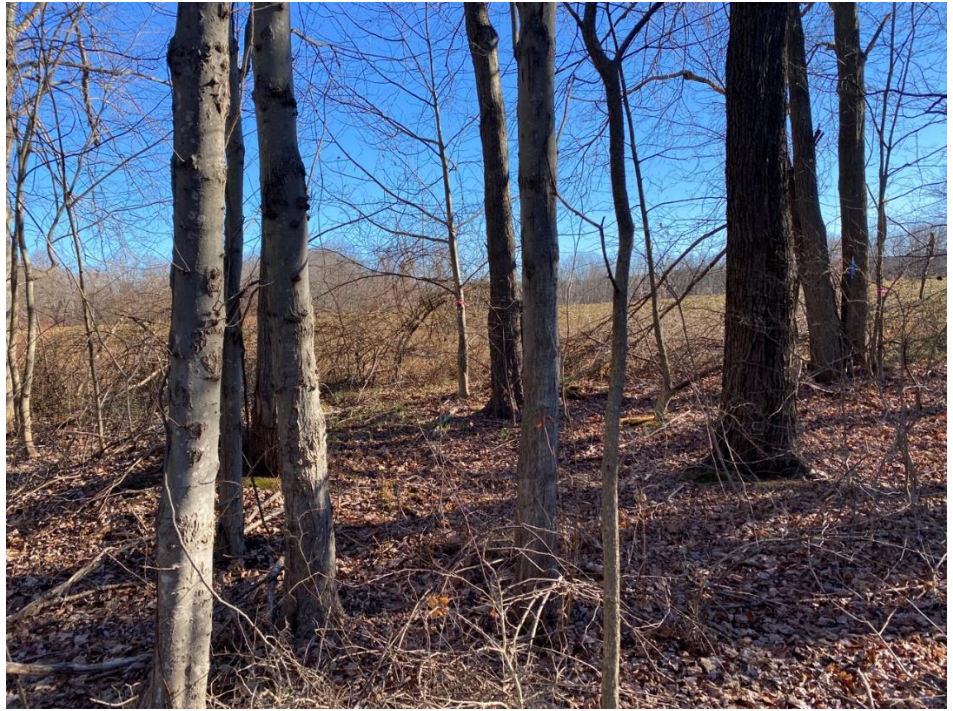
Photo No.: 9 **Date:** 12/23/21

View facing east from within Wetland 1, located within the 100-ft. VPE north of VP-1. Agricultural field in background.

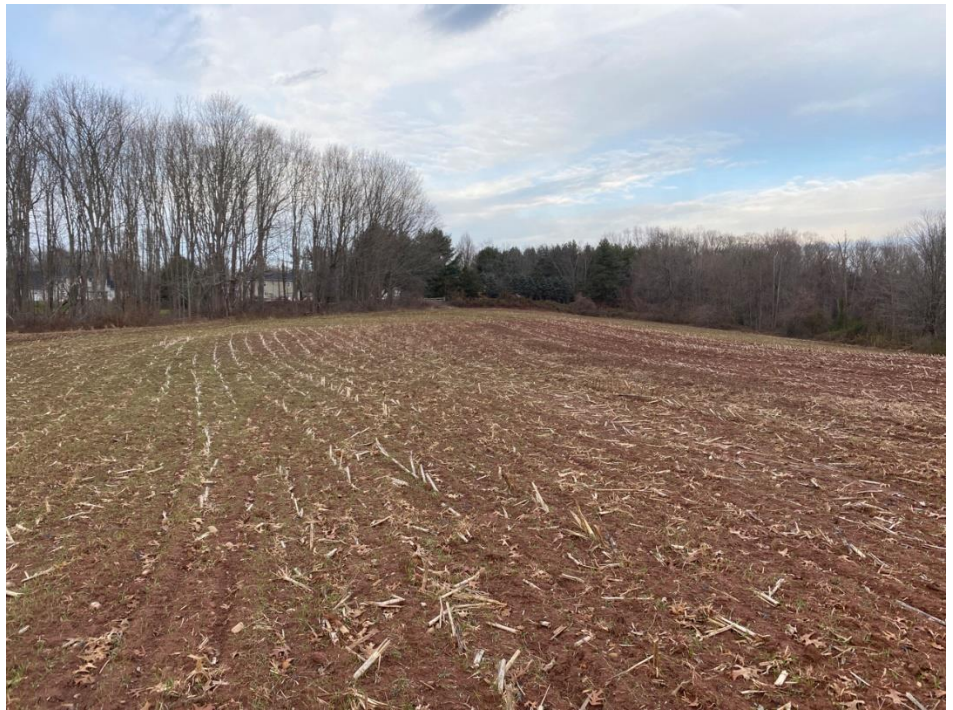
Photo No.: 10 **Date:** 12/23/21

As noted above, the northcentral portion of the Site contains agricultural fields with fingers extending to both the southeast and southwest. While no direct activity was observed within the field during the December 2021 delineation or the Spring 2022 vernal pool investigation, evidence of corn crop harvesting from the 2021 season were visible via cut corn stalks (see Photo 10).

View facing north from within the agricultural field located east of VP-1, which is within the 750-ft. CTHZ.
