New Britain Landfill Solar Development  
CTEC Solar, LLC  
Weston & Sampson Project No. ENG22-1107

November 2, 2022

RE: **Geotechnical Engineering Report**  
**New Britain Landfill Solar**  
**Berlin, Connecticut**

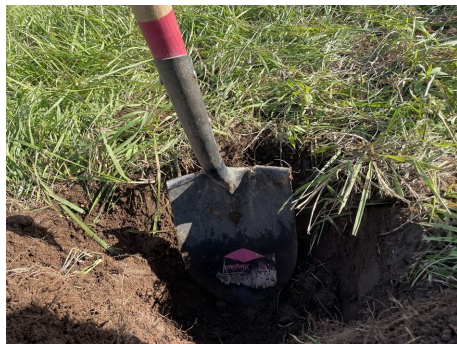
TP-1

<b>Silty sand (SM)</b> - Brown; moist; mostly fine to medium SAND, some non plastic fines, trace gravel; occasional roots; <b>[VEGETATIVE SUPPORT LAYER] 11 inches thick.</b> <i>Change to low plasticity fines at 4 inches.</i>		
5				92	[0.9] Additional higher plasticity cover soils encountered at 11 inches. <b>Exploration ended at 0.9 ft.</b>

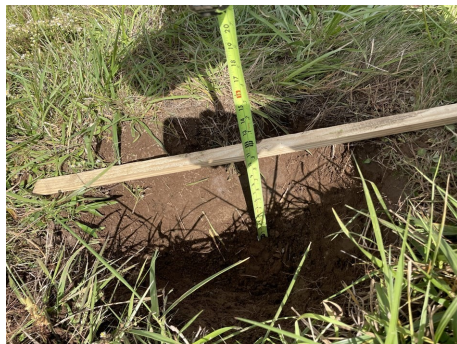
TP-3

DEPTH BELOW GROUND SURFACE [VERTICAL FT.]	SAMPLE TYPE GRAPHIC	STRATIGRAPHY LOG	STRATUM IDENTIFICATION AND DESCRIPTION	ELEVATION SCALE SHOWN TO NEAREST FT.	REMARKS, OTHER TESTS, AND INSTALLATIONS
			Surface: Grass area.		Note: Values in brackets preceding a remark indicate depth below ground surface (in feet) corresponding to the remark.
			<b>Silty sand (SM)</b> - Brown; moist; mostly fine to medium SAND, some low plasticity fines, trace fine to coarse gravel; occasional roots; <b>[VEGETATIVE SUPPORT] 11 inches thick.</b>		
5				96	[0.9] Additional higher plasticity cover soils encountered at 11 inches. <b>Exploration ended at 0.9 ft.</b>

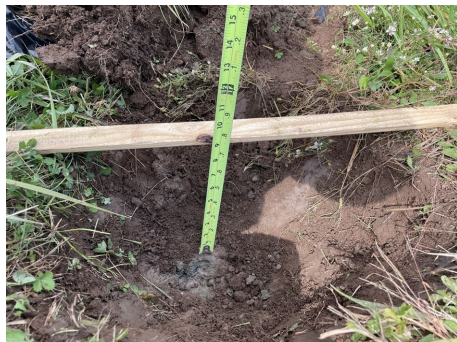
TP-4

DEPTH BELOW GROUND SURFACE [VERTICAL FT.]	SAMPLE TYPE GRAPHIC	STRATIGRAPHY LOG	STRATUM IDENTIFICATION AND DESCRIPTION	ELEVATION SCALE SHOWN TO NEAREST FT.	REMARKS, OTHER TESTS, AND INSTALLATIONS
			Surface: Grass area.		Note: Values in brackets preceding a remark indicate depth below ground surface (in feet) corresponding to the remark.
			<b>Silty sand (SM)</b> - Brown; moist; mostly fine to medium SAND, some low plasticity fines, trace fine to coarse gravel; occasional roots; <b>[VEGETATIVE SUPPORT] 9 inches thick.</b>		
5				96	[0.8] Additional higher plasticity cover soils encountered at 9 inches. <b>Exploration ended at 0.8 ft.</b>
				91

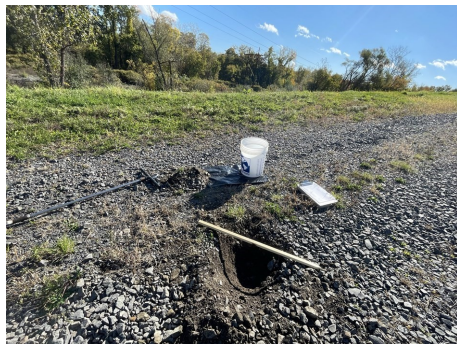
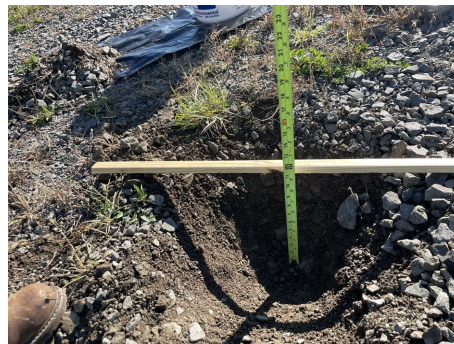
TP-12

DEPTH BELOW GROUND SURFACE [VERTICAL FT.]	SAMPLE TYPE GRAPHIC	STRATIGRAPHY LOG	STRATUM IDENTIFICATION AND DESCRIPTION	ELEVATION SCALE SHOWN TO NEAREST FT.	REMARKS, OTHER TESTS, AND INSTALLATIONS
			Surface: Gravel area.		Note: Values in brackets preceding a remark indicate depth below ground surface (in feet) corresponding to the remark.
			<b>Well graded gravel with sand (GW)</b> - Gray and brown; moist; mostly fine to coarse GRAVEL, some fine to coarse sand; trace roots.		
5				58	[0.9] Additional higher plasticity cover soils encountered at 11 inches. <b>Exploration ended at 0.9 ft.</b>
