Martin Brogie, Inc.
ENVIRONMENTAL SERVICES

RE: Wetland Delineation Report
24 Middle Road
Ellington, CT

Figure 1
Site Locus Map

Figure 2 - Aerial Site Plan

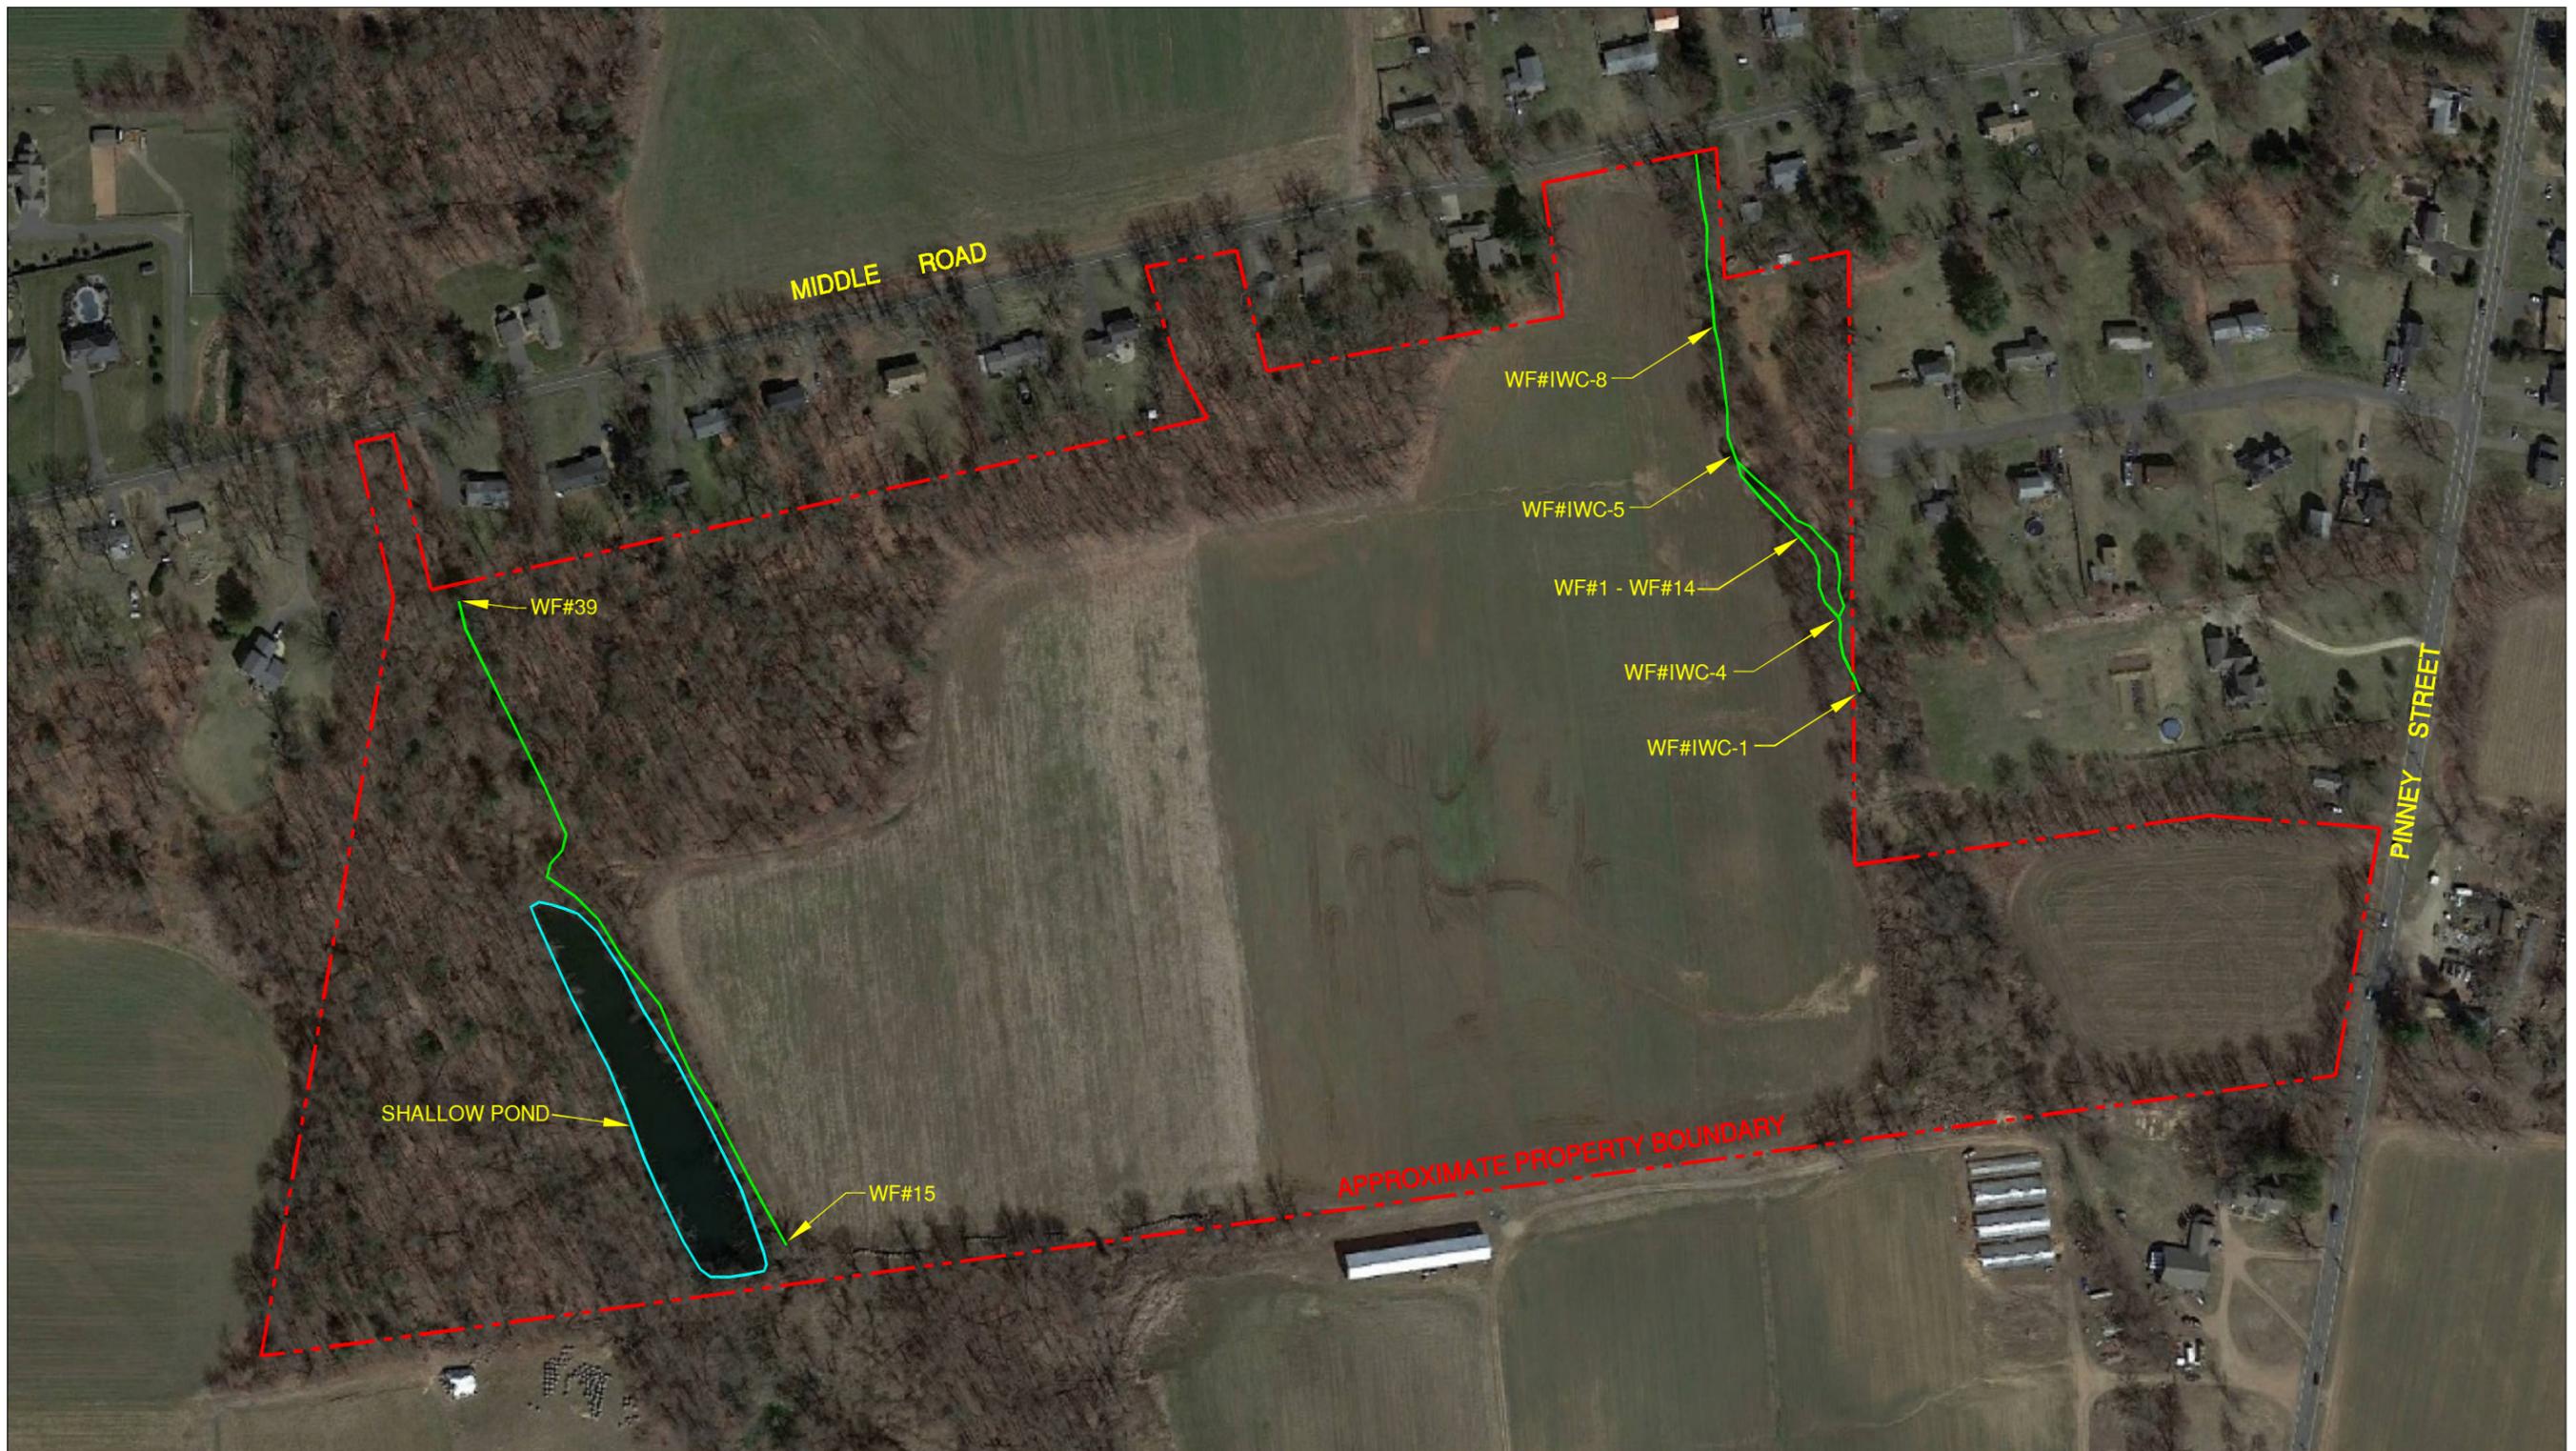
An intermittent watercourse (IWC) was identified north of the open meadow. It exhibited a defined channel and bank, evidence of scour and deposition and wetland vegetation including Jewelweed, Soft Rush (*Juncus effusus*) and Beggars Tick (*Bidens frondosa*). The IWC consisted of a narrow channel from IWC#1 to IWC#5 and then broadened as captured by wetland flags WF#1 through WF#14 and was then picked up again as a narrow, linear channel north of the broad area with flags IWC# 5 through IWC #8. Although the IWC feature extended up to Middle Road, wetland flags were not hung as it appeared the area was off site based on lawn mowing and maintenance that was associated with the adjacent residence to the northeast. After reviewing survey plans, it became evident that the remainder of the IWC was onsite. Since the remainder of the IWC consists of a narrow, linear channel picked up on the site topographic survey, additional flags did not appear warranted. The extent of the IWC is shown on Figure 2.

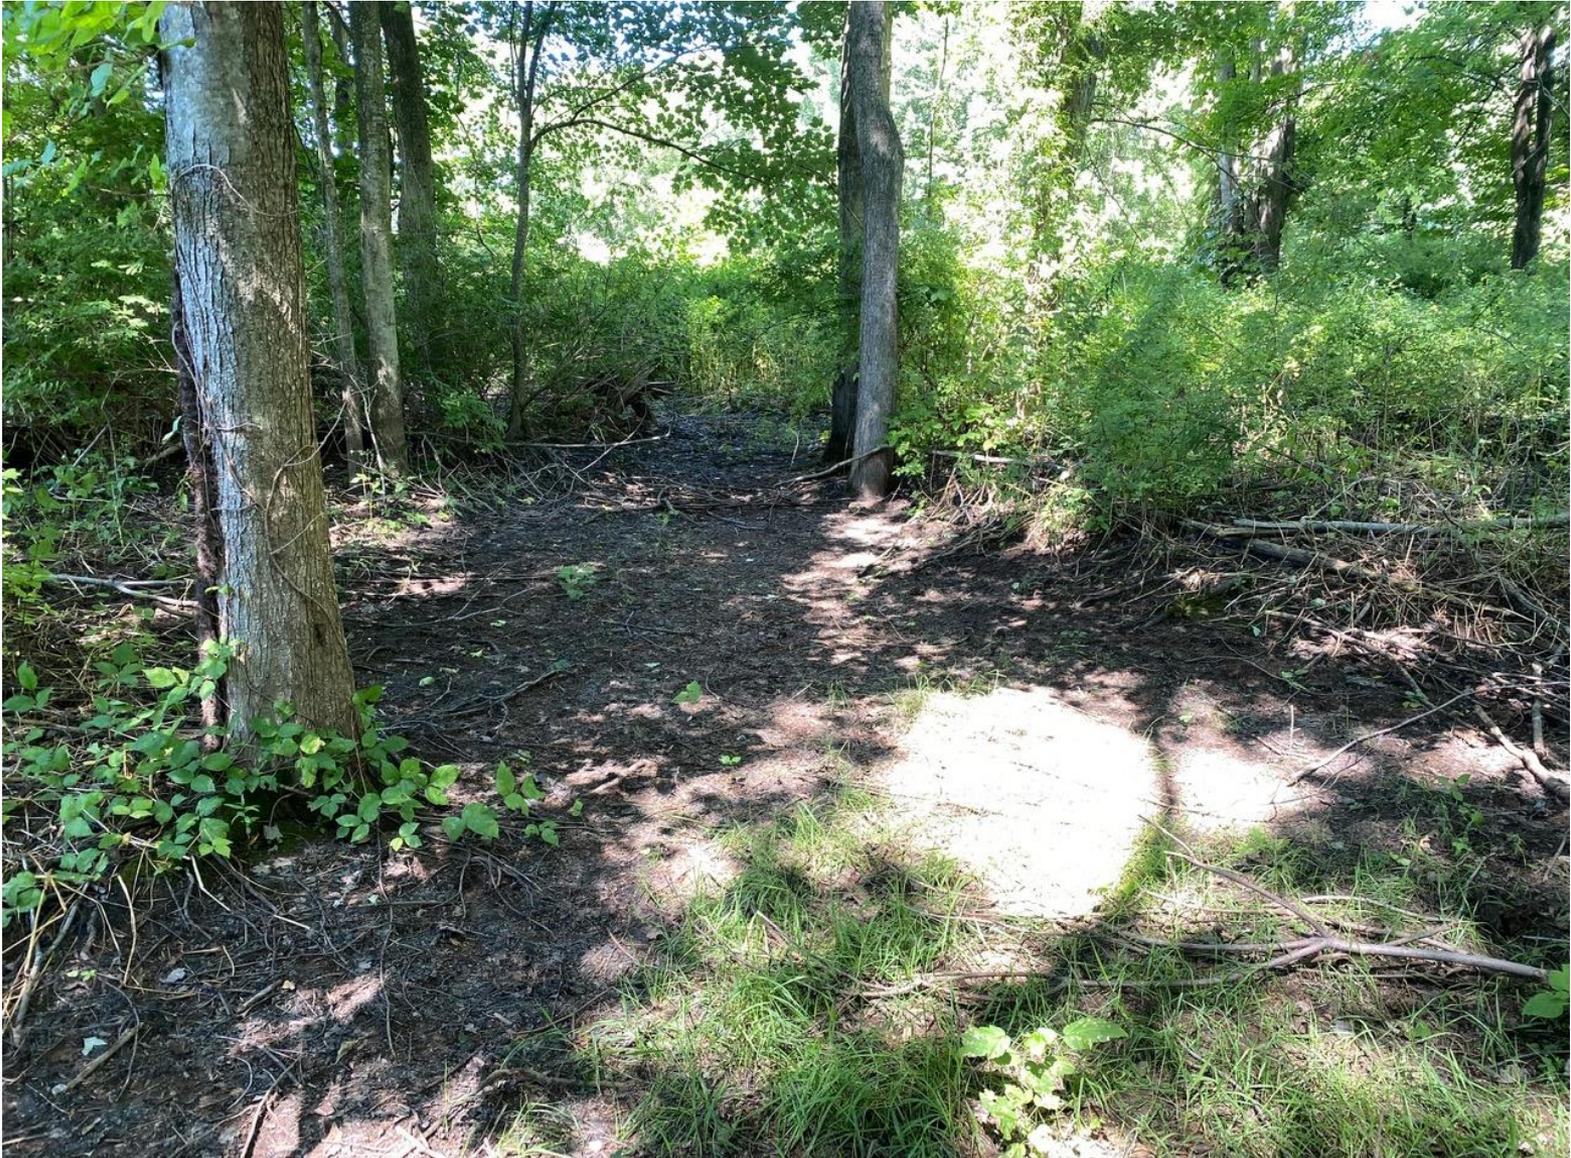
understory. In this wooded area MBI observed evidence of generally north to south, intermittent surface flows including small rack lines and some small areas of sediment accumulation. No defined channel or bank were noted and no wetland soils were identified in the area. Jewelweed (*Impatiens capensis*) and Pennsylvania Smartweed (*Persicaria pensylvanica*) were noted in the areas of apparent surface flow-through.

Area south of Eastern Wetland IWC (between the two cornfields) where evidence of surficial flows were noted, but the area did not meet wetland definitions.

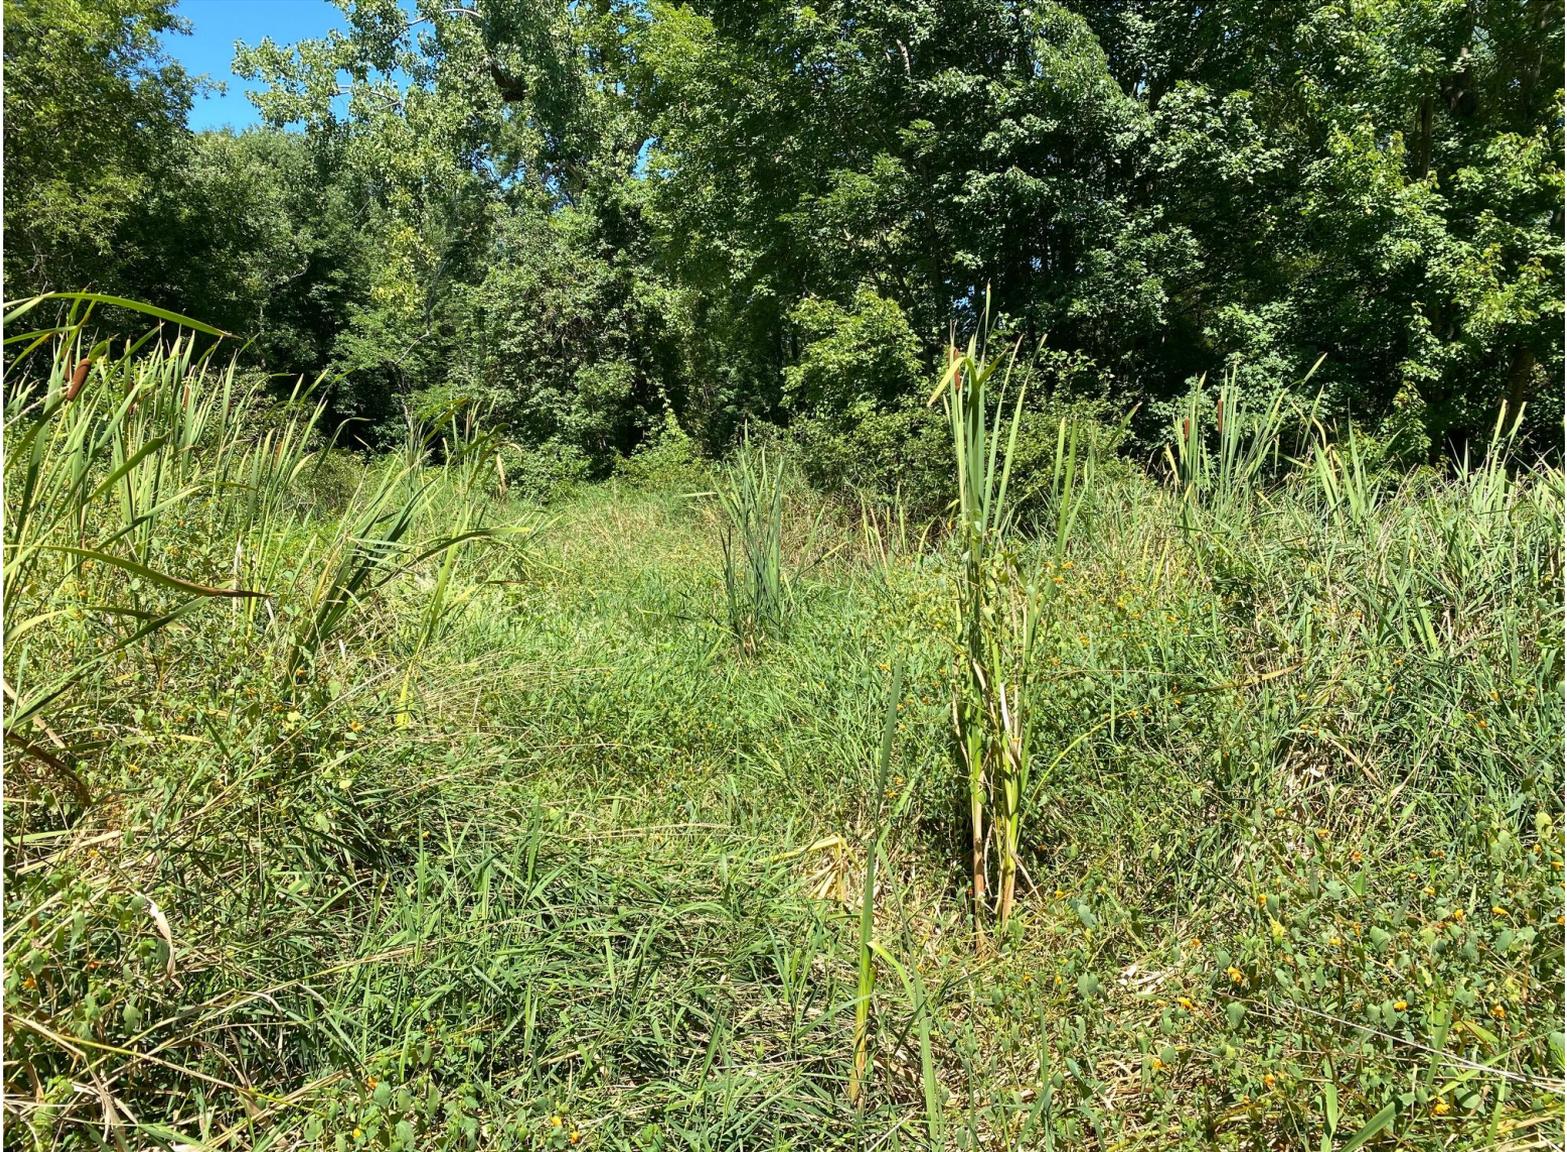
Further to the north and just offsite to the east was an open area dominated by a thick stand of Reed Canary Grass (*Phalaris arundinacea*) and included Tearthumb (*Persicaria sagittate*), Smartweed, and Elderberry (*Sambucus canadensis*) along with several Narrow-leaved Cattails (*Typha angustifolia*). Silky Dogwood (*Cornus Amomum*) and Cottonwoods (*Populus deltoides*) were located along the northern border. No wetland soils were noted and no defined channel or other evidence of surface flows were evident. The soil consisted of a generally dark brown silt loam. It appears the silty soil conditions and thick grass cover capture and hold run-off entering the area from the north. The moist soil conditions are adequate for supporting the noted hydrophytic vegetation.

Area directly below Eastern IWC containing hydrophytic vegetation but no wetland soil or channelized areas.

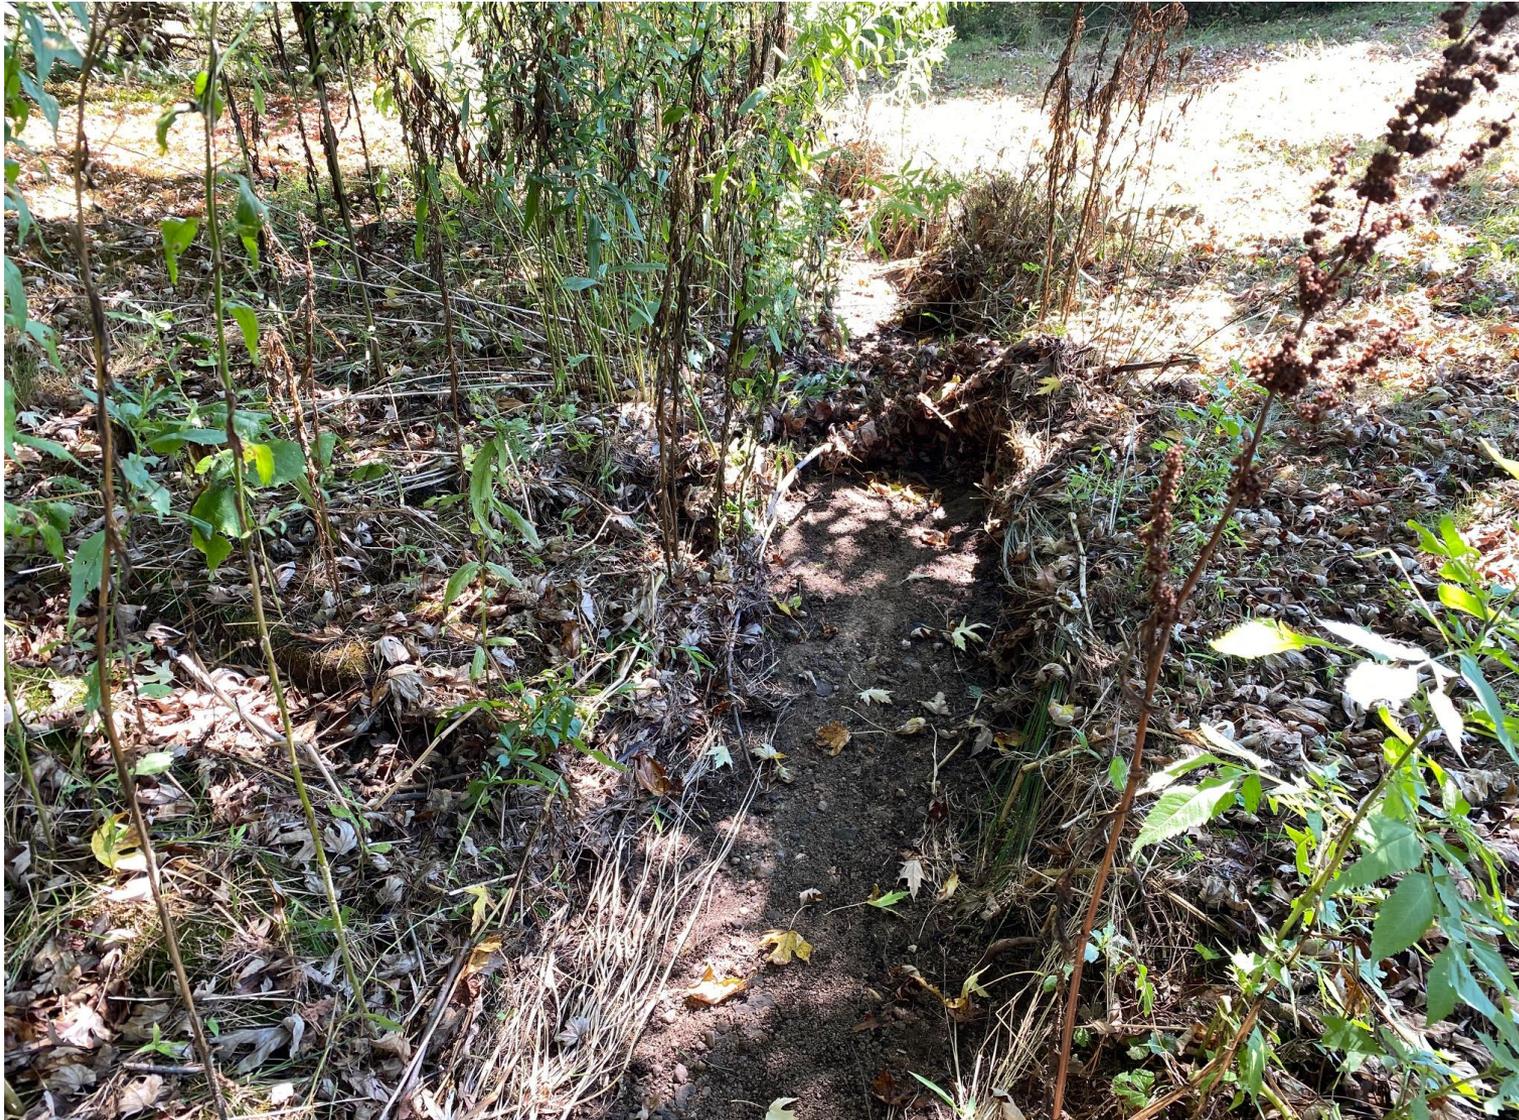
Eastern IWC – area of narrow channel near IWC#7.

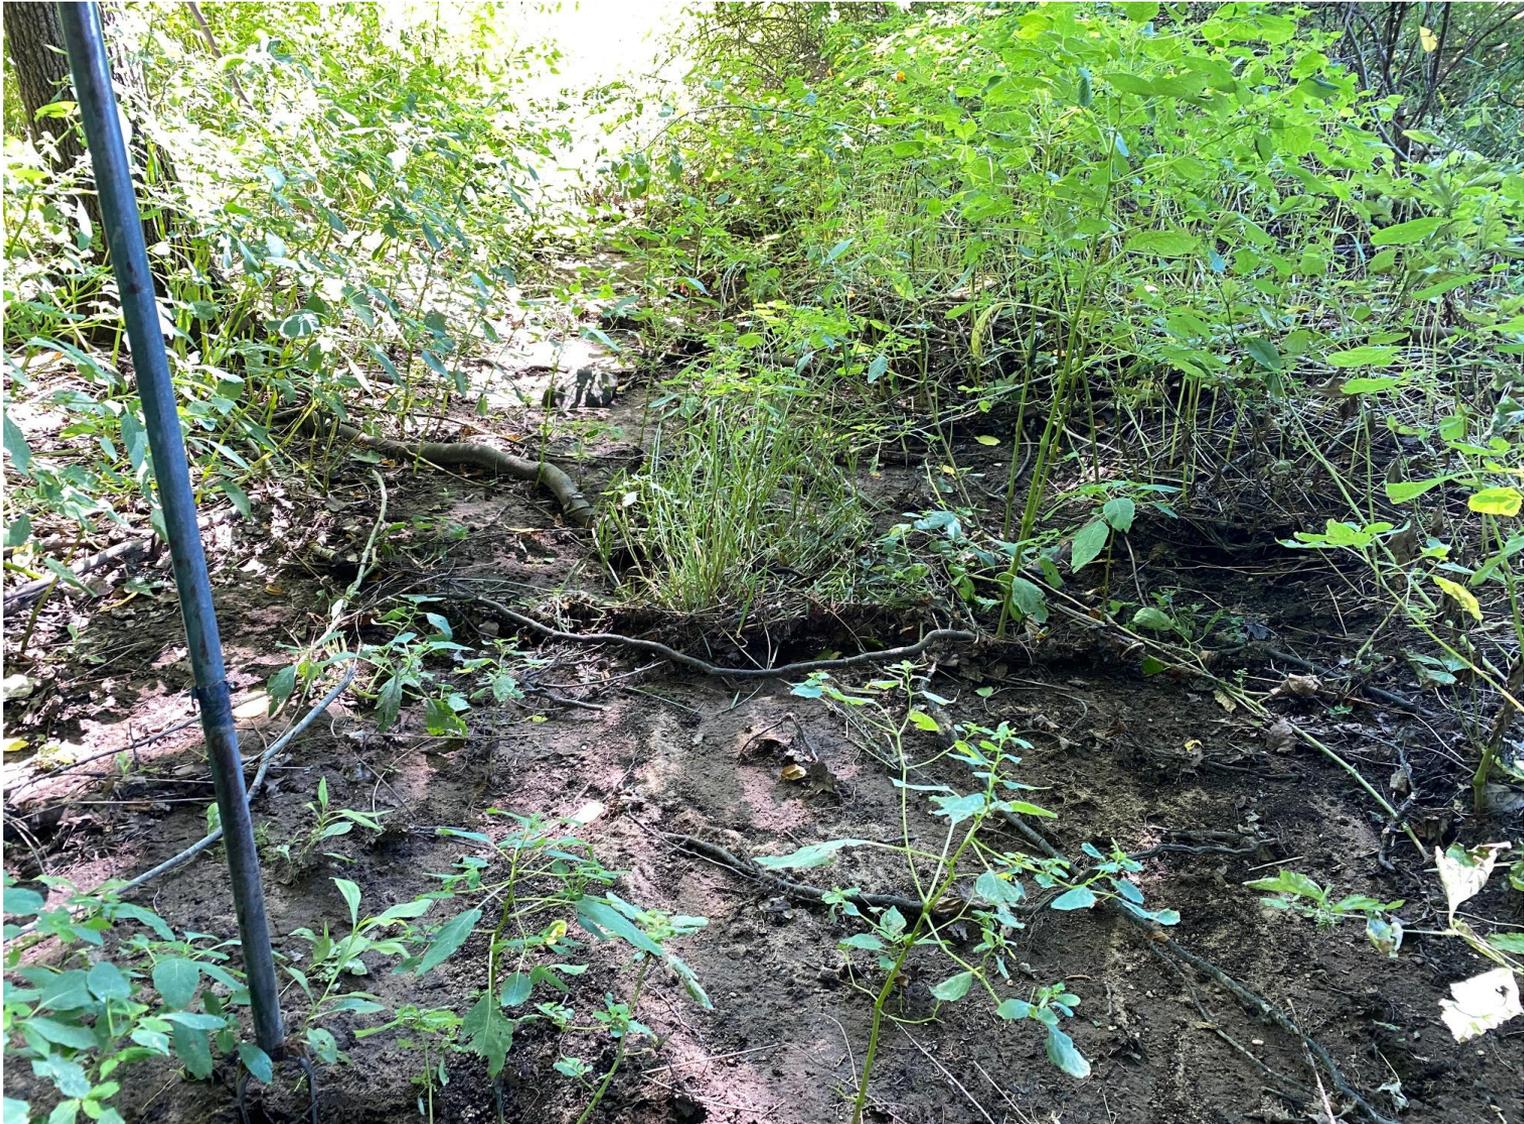
Eastern IWC – area of broad channel within WF#1-14.

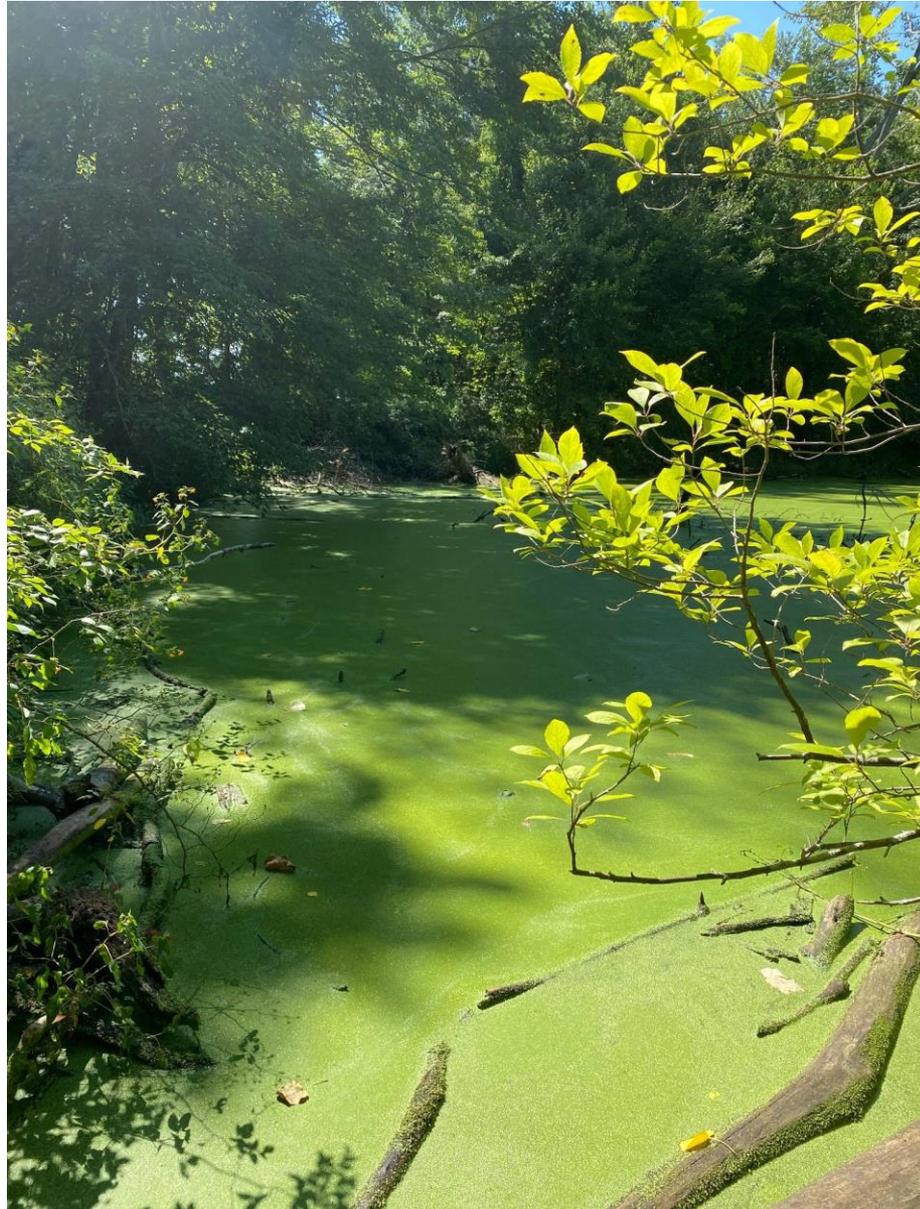
This line along the pond was heavily overgrown with Multi-Flora Rose and included Jewelweed along the water line. The pond occupies approximately one acre and appears to be shallow (2-4 feet deep). It was covered with Duckweed (*Lemna minor*) and likely provides some function as amphibian breeding habitat.

Shallow pond in southwestern portion of site/southern end of western wetlands

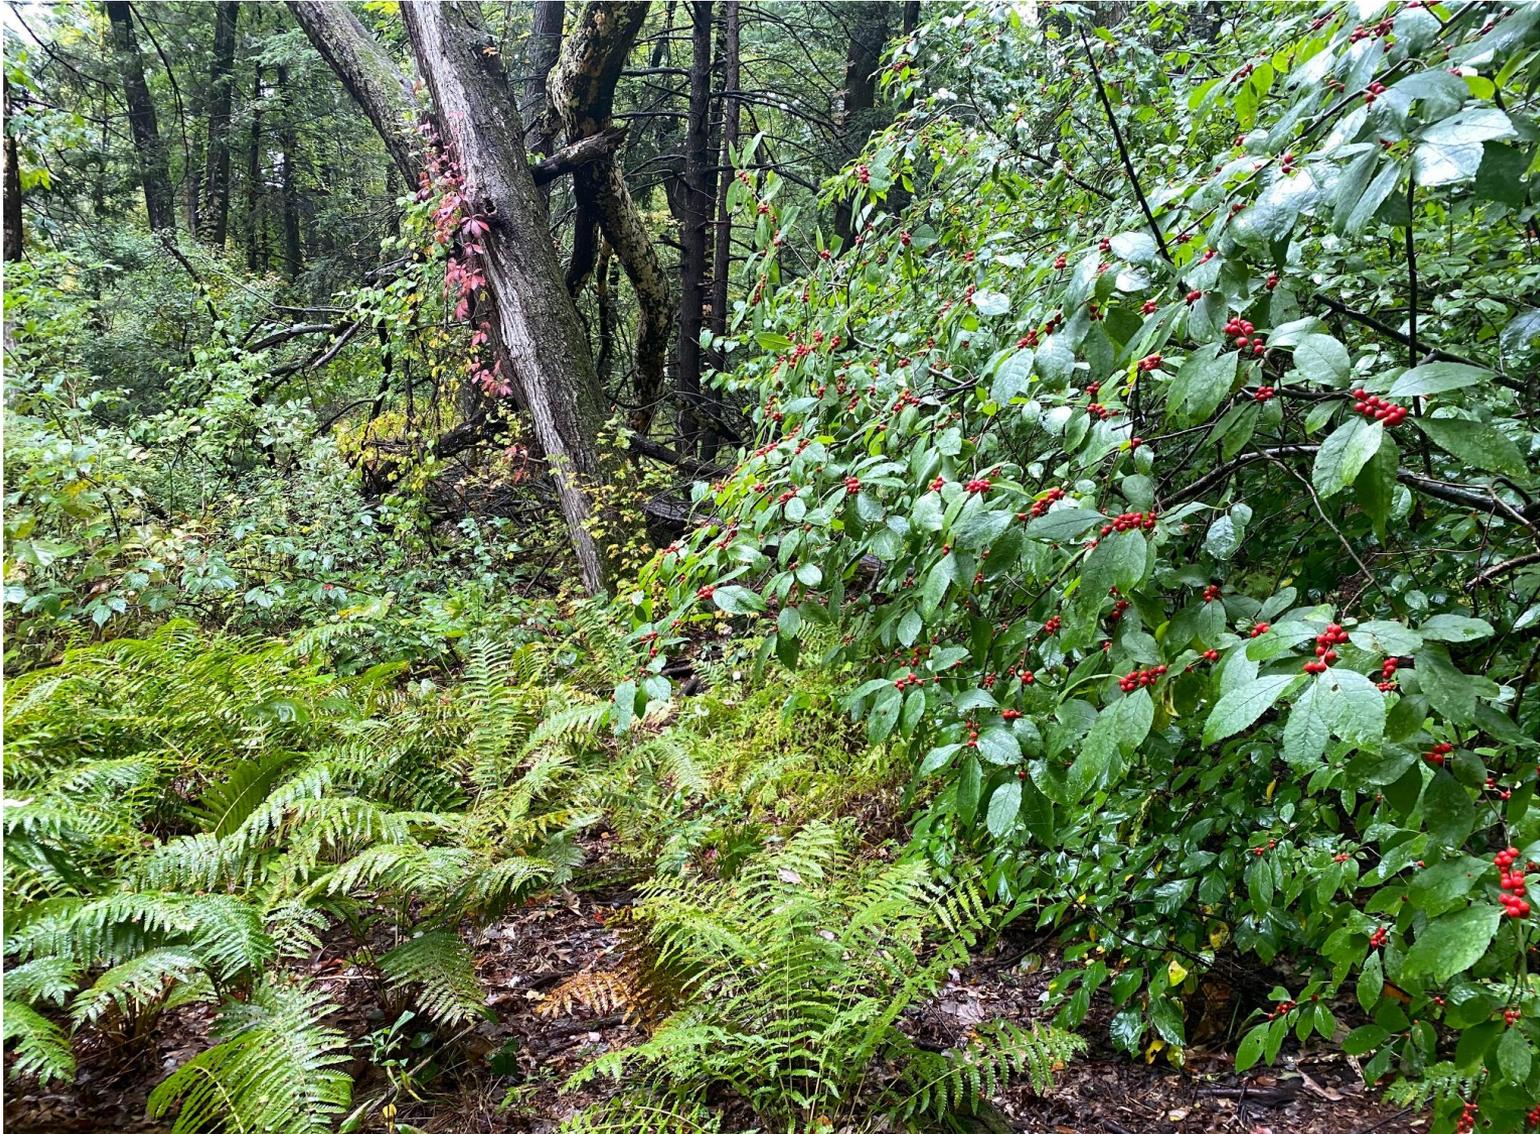
The wetland area north of the pond exhibited poorly-drained wetland soils along with Red Maple, Silky Dogwood, Grape Vine (*vitus spp.*), Multi-flora Rose, and Jewelweed. Further north vegetation along the eastern wetland border included Eastern Hemlock (*Tsuga canadensis*), Red Maple, Winterberry (*Ilex verticillata*), Cinnamon Fern (*Osmunda cinnamomea*) and Jewelweed. This wetland line included flags WF#28 through WF# 39 terminating southwest of the residential property abutting the northwestern portion of the site .

View looking north along northern portion of western wetland boundary near flag WF#35

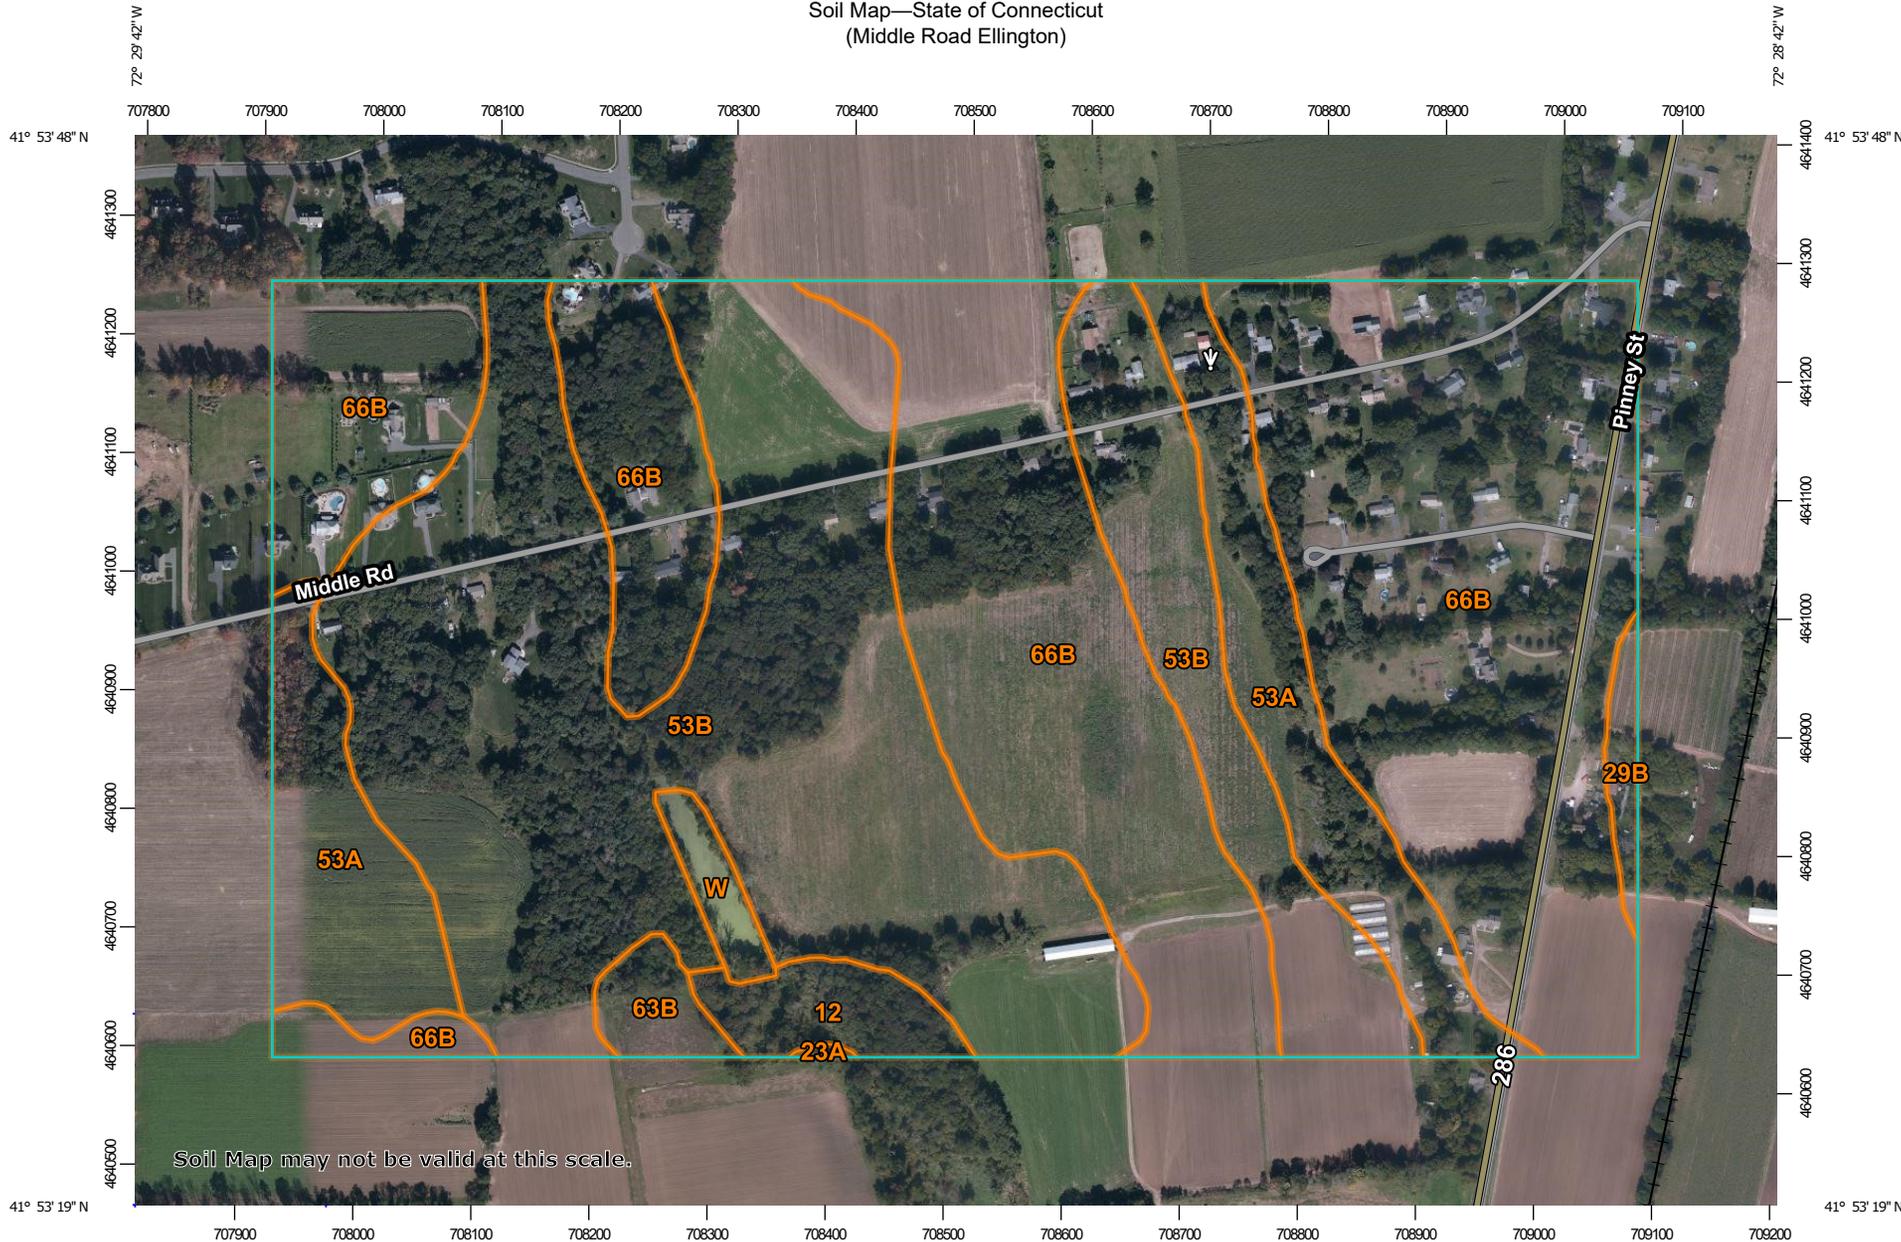
Soil Map—State of Connecticut
(Middle Road Ellington)

The area of the smaller eastern cornfield and the central portion of the large onsite cornfield are mapped as Narragansett Silt Loam, which is a very deep, well drained loamy soil formed in medium-textured deposits overlying till. The majority of the remainder of the site is mapped as Wapping Very Fine Sandy Loam, which is a very deep, moderately well drained loamy soil formed in a silty-mantled friable or firm till on uplands. The Soil survey identifies the pond in the southwestern portion of the site. No wetland soils or other wetland features are mapped.
