Re: 1637/1720 Lines Rebuild Project

PETITION TO THE CONNECTICUT SITING COUNCIL
FOR A DECLARATORY RULING OF
NO SUBSTANTIAL ADVERSE ENVIRONMENTAL EFFECT
FOR THE PROPOSED MODIFICATIONS TO THE EXISTING
1637 and 1720 LINES IN THE MUNICIPALITIES OF
NORWALK, WILTON AND WESTON, CONNECTICUT

The purpose of the proposed Project is to reduce the risk of age-related failures of deteriorating lattice tower structures and to replace conductor across approximately 4.0 miles of both the 1637 and 1720 115-kV transmission lines (“1637/1720 Lines”). The Project will include replacement of

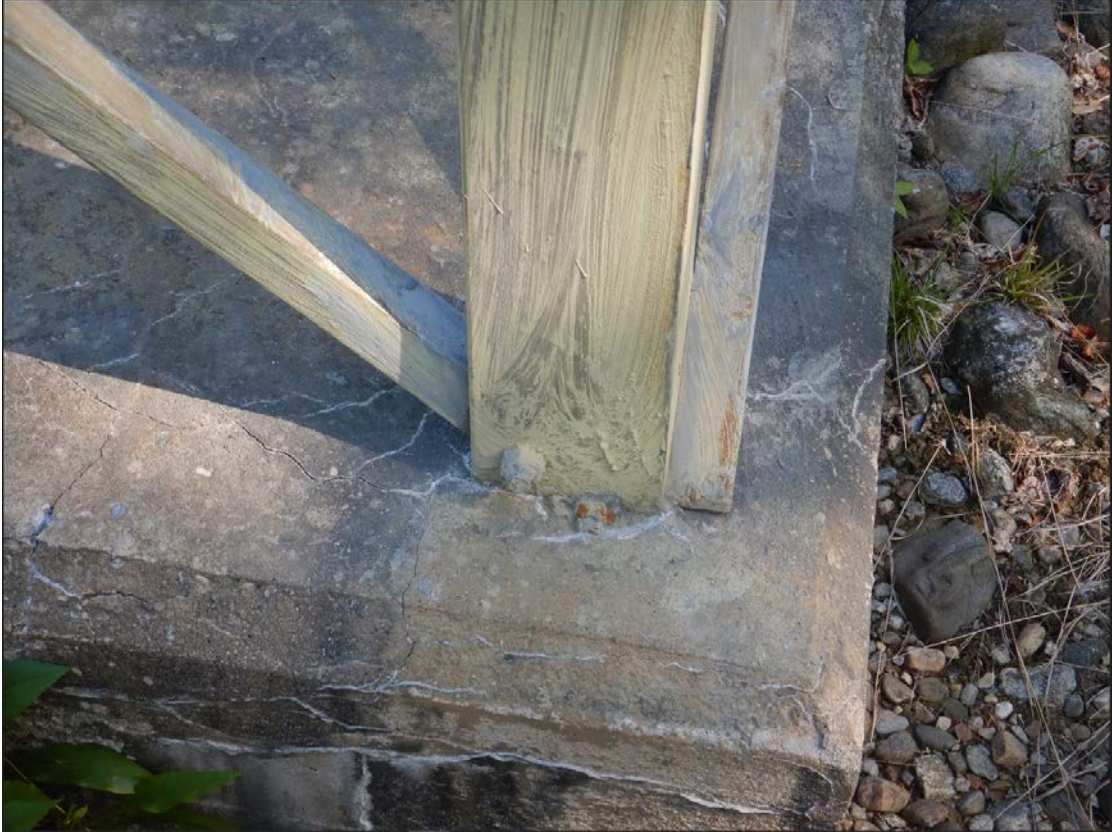
Structure 953 – Foundation Cracks

Within the Project area, the 1637/1720 Lines are supported on a total of 40 structures (32 double-circuit lattice towers and eight single-circuit steel monopoles). During recent inspection, some lattice towers, most of which are approximately 74 years old, displayed signs of aging and significant deterioration, as shown in the photographs in Attachment A. Structure modelling has been completed showed that other lattice structures have a significant risk of failure during extreme weather events. As a result, 32 of the double-circuit lattice structures will be replaced.

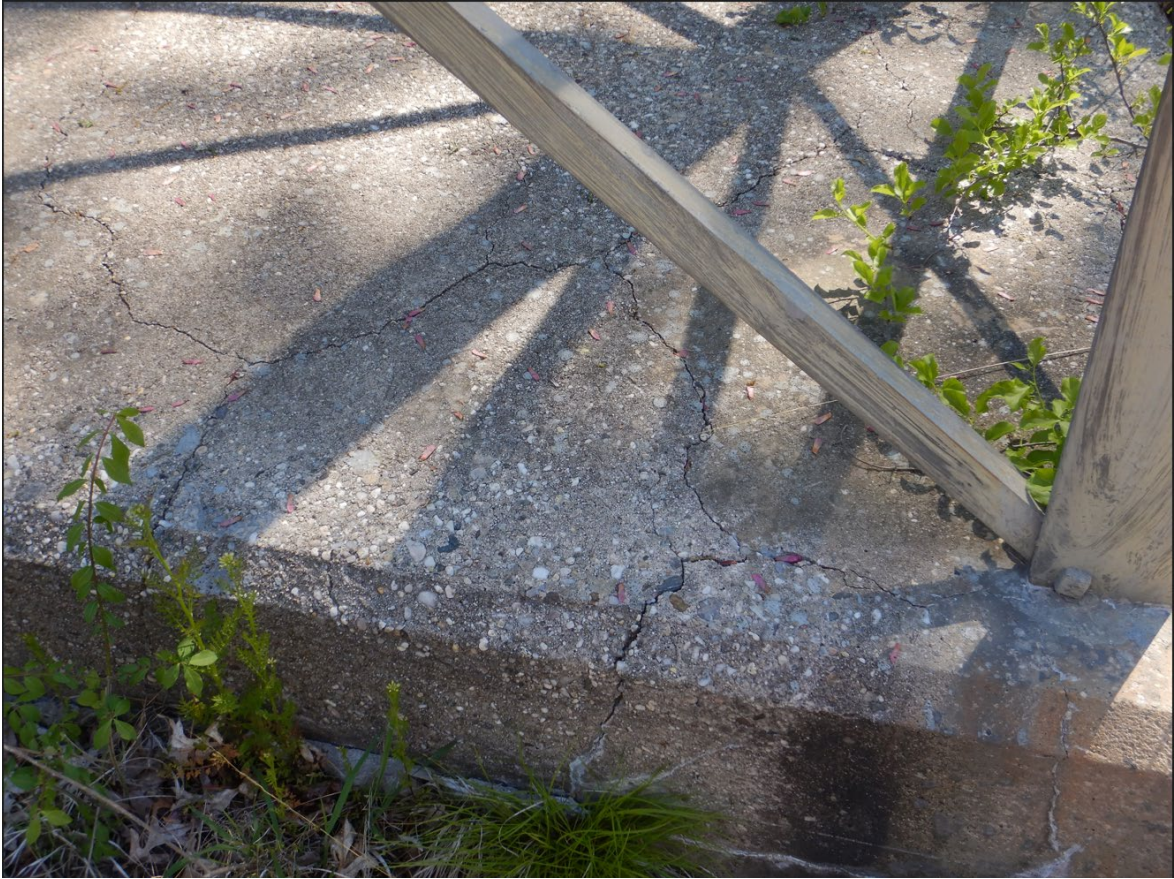
Structure 955 – Foundation Cracks

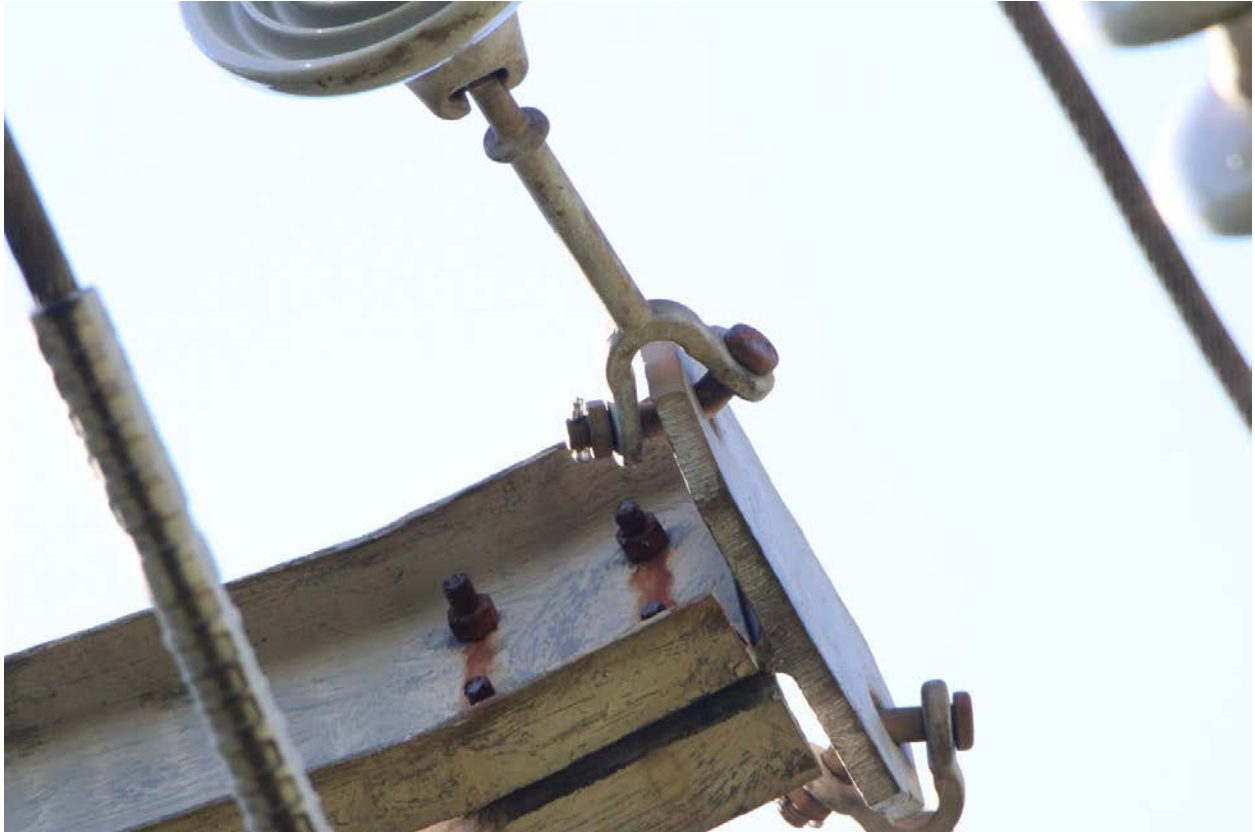
Structure 954 – Rust on Tower Hardware

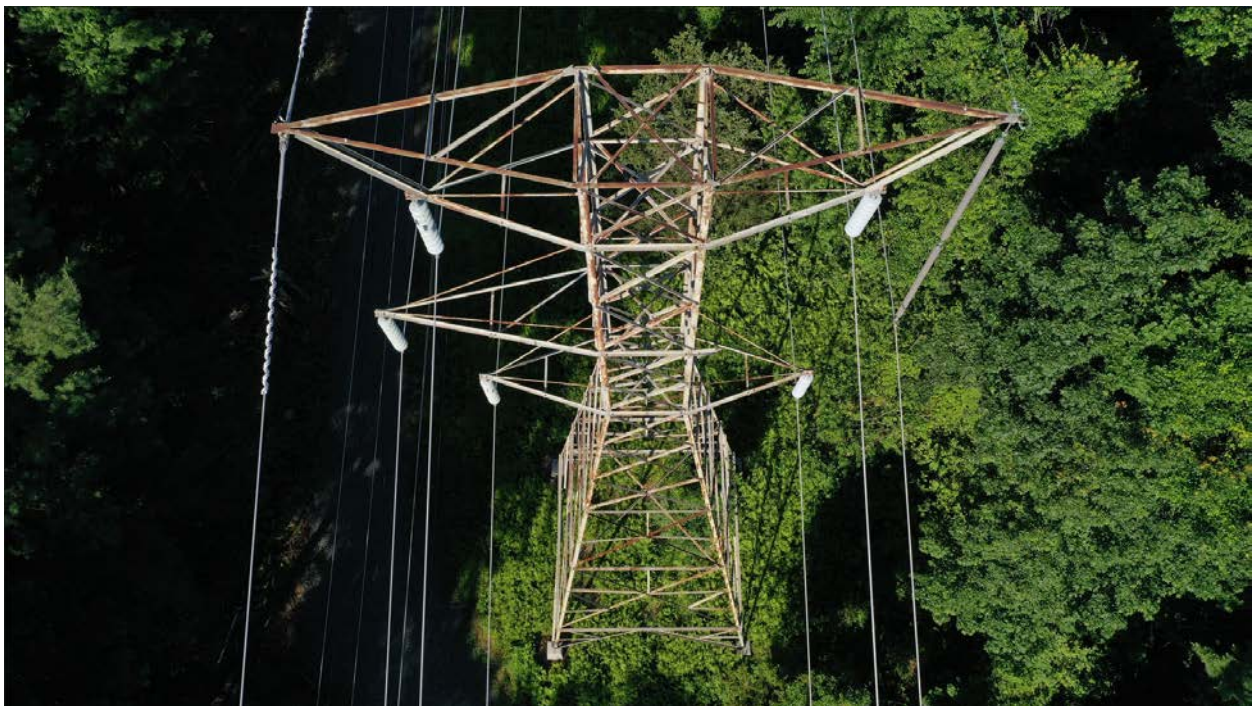
Structure 927 – Arm Damage due to Vegetation/Storm. (Arm damage has been repaired). Rust on tower members

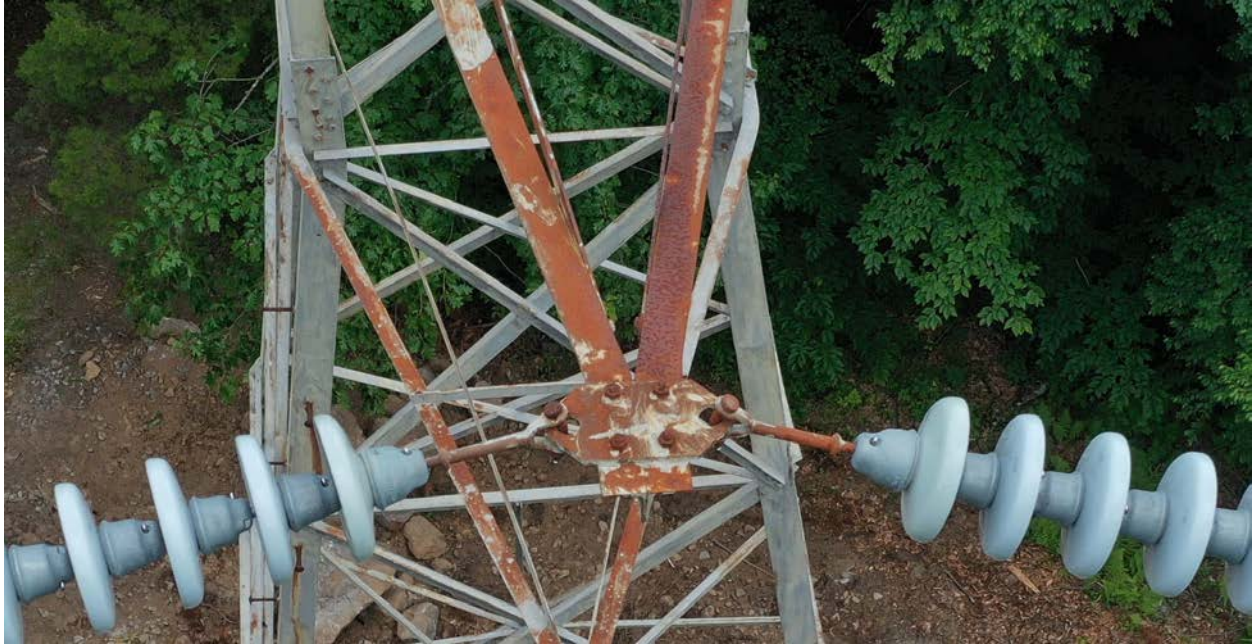
Structure 931 – Corrosion – pitting of tower arm members

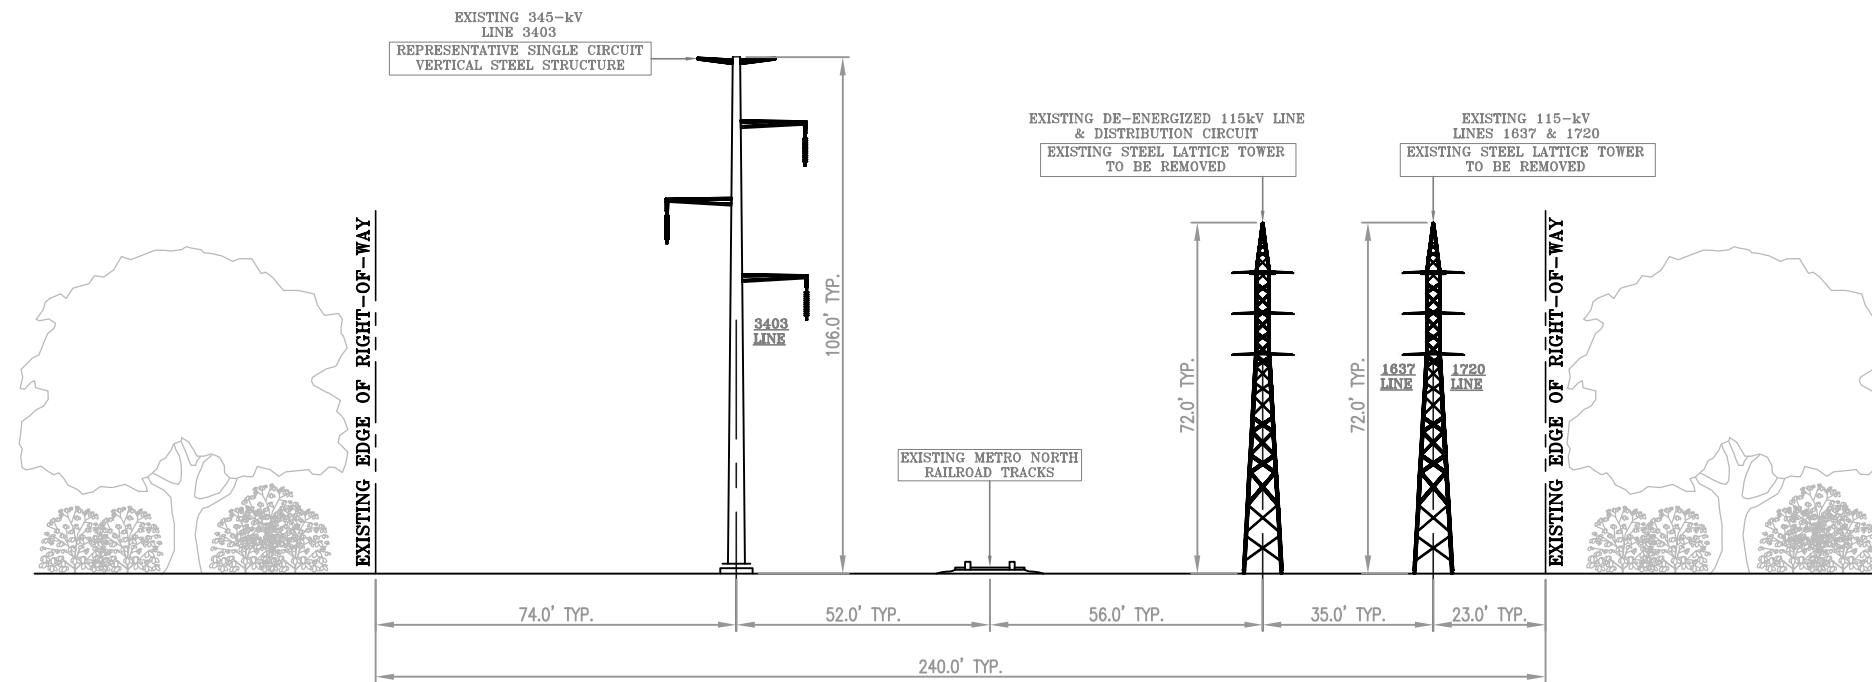
EXISTING R.O.W. CONFIGURATION
TYPICAL DOUBLE CIRCUIT STEEL LATTICE TOWER DESIGN
LOOKING FROM GRIST MILL RD. TO NORWALK JCT.
IN THE TOWNS OF NORWALK & WILTON, CT

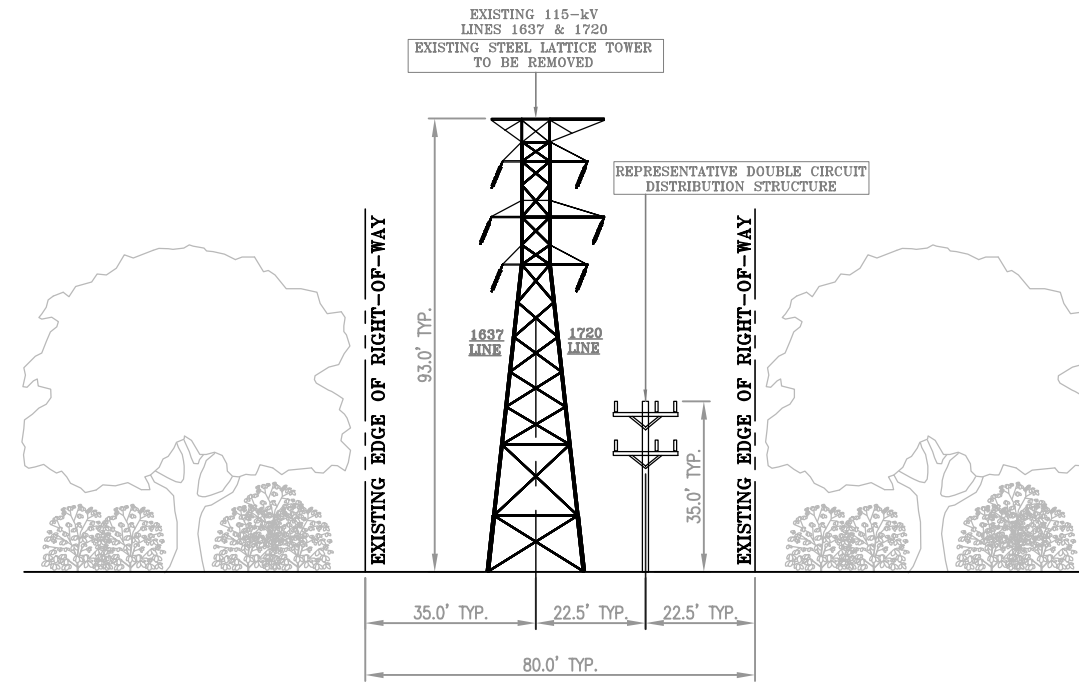
**EXISTING R.O.W. CONFIGURATION
TYPICAL DOUBLE CIRCUIT STEEL LATTICE TOWER DESIGN
LOOKING FROM NORWALK JCT. TO WESTON S/S.
IN THE TOWNS OF WILTON & WESTON, CT**

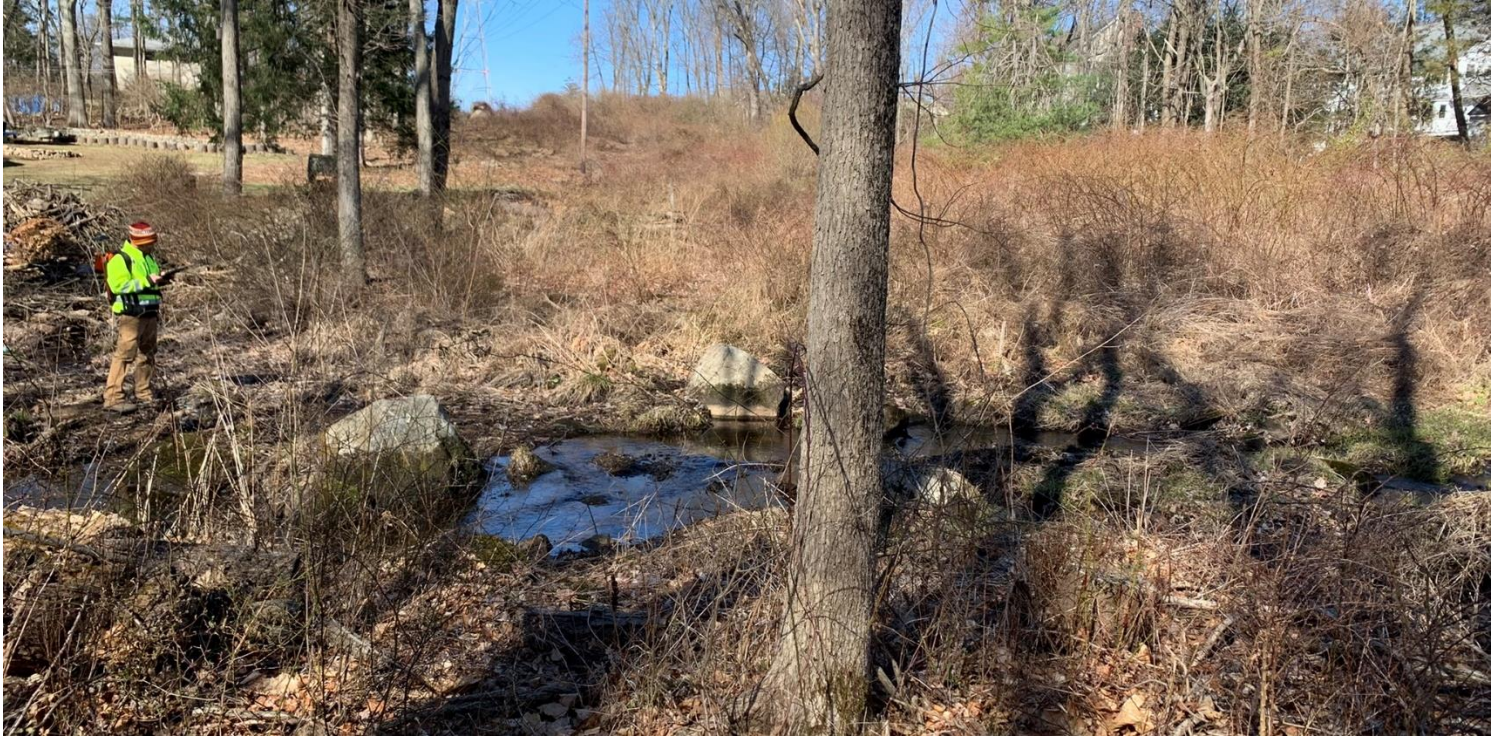
Photo #1: View of a cryptic vernal pool embedded within wetland W16.

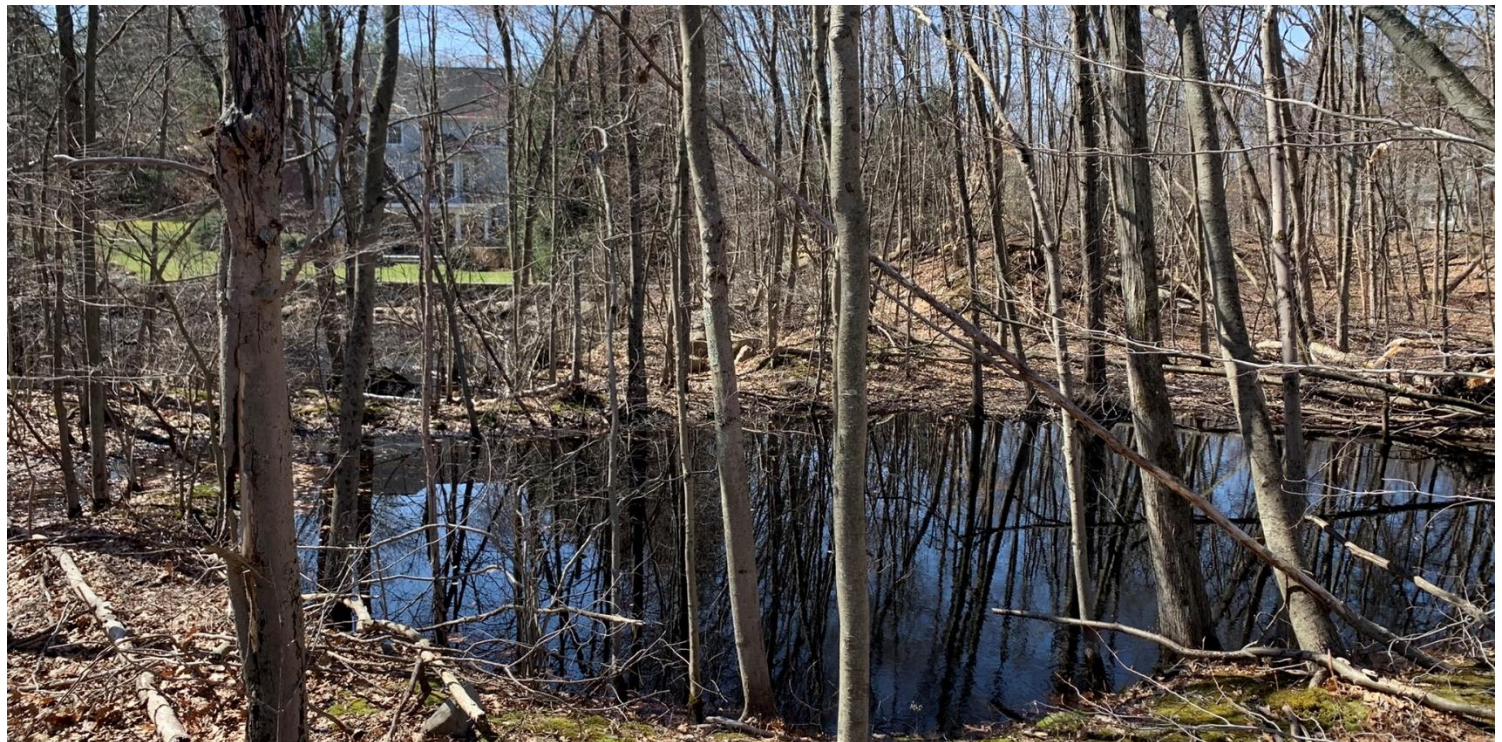
Photo #2: View of a cryptic vernal pool embedded within wetland W17 off-ROW.

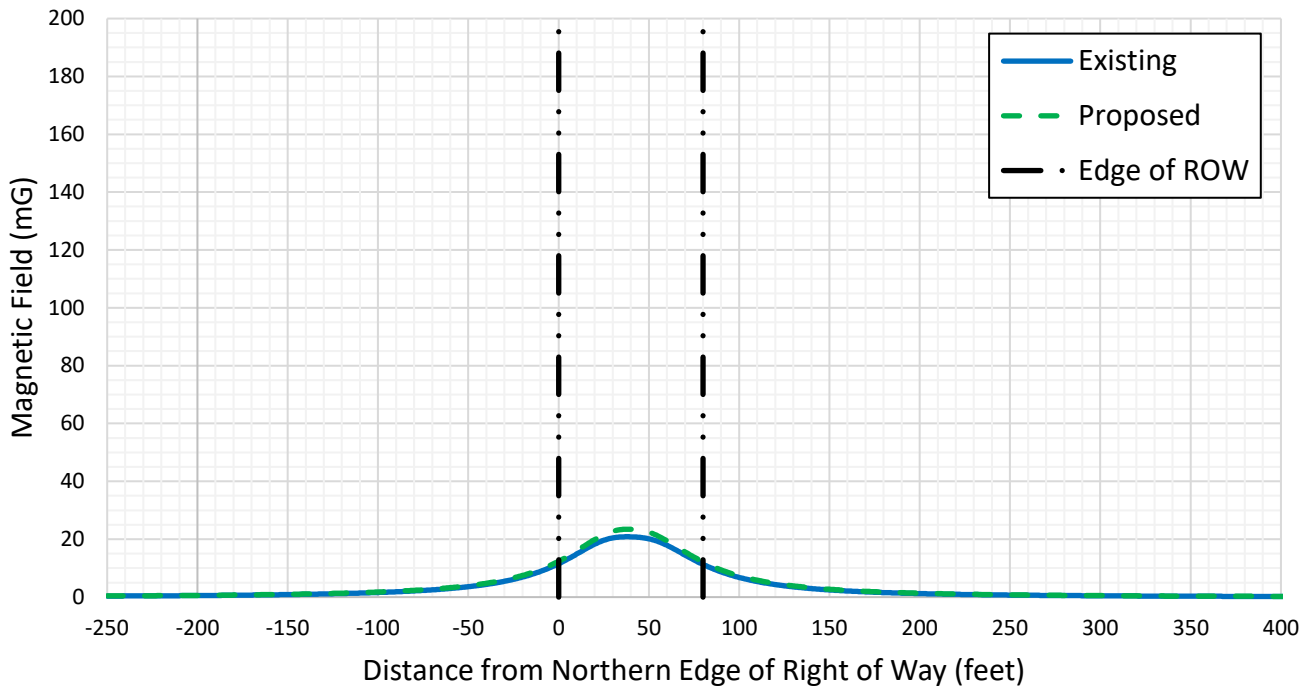
Calculated Magnetic Fields (Annual Average Loads) Norwalk Junction - Weston S/S

Eversource prepared calculations of the existing and post-Project Electric and Magnetic fields (“EMF”). The calculations were based on average annual loading conditions because these are most representative of typical conditions. The calculations are made relative to the centerline of the proposed, modified transmission lines. The calculations apply at one meter (3.28 feet) above grade and assume that the lowest point of the lowest conductor for each 115-kV circuit is 30 feet above grade.

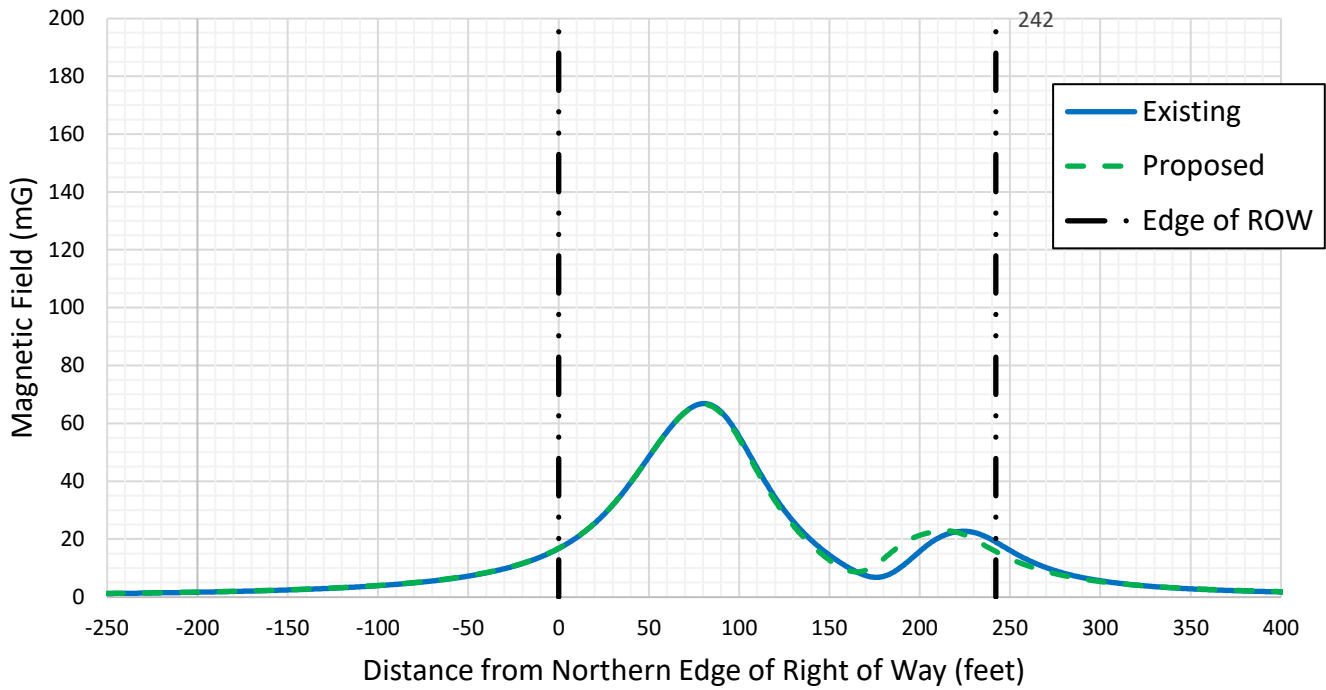
Calculated Magnetic Fields (Annual Average Loads) Kent Road - Norwalk Jct

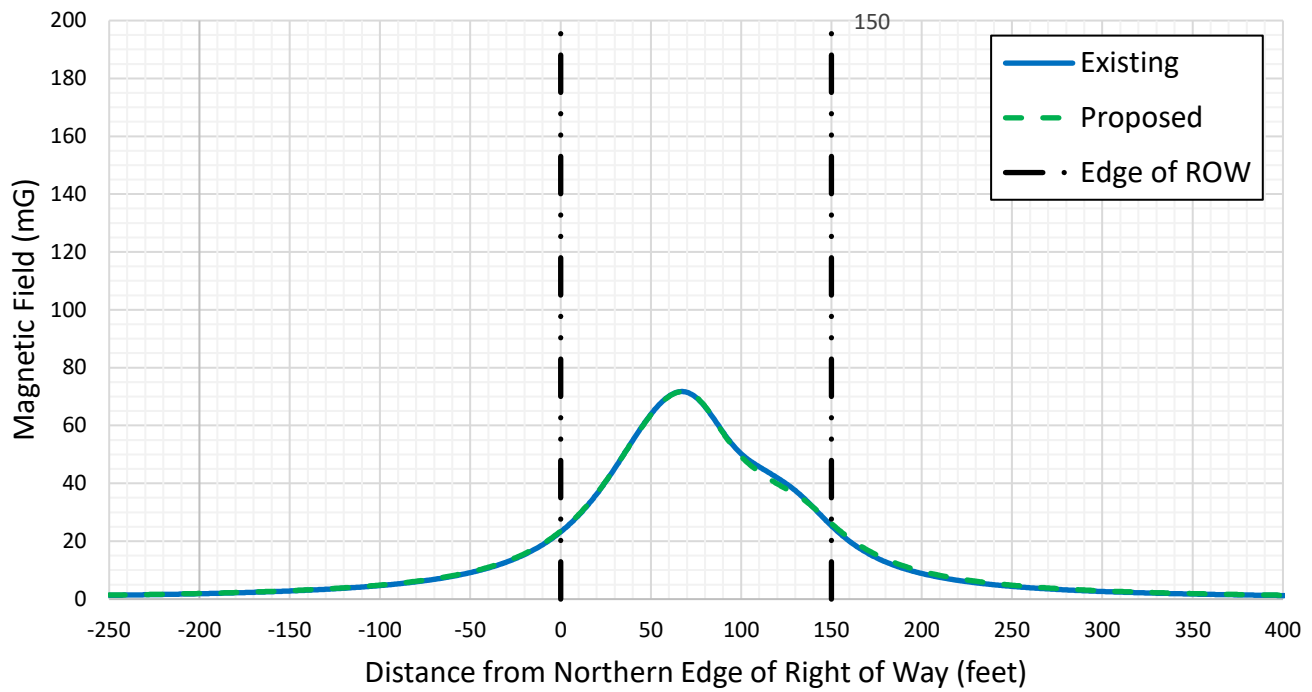
Calculated Magnetic Fields (Annual Average Loads) Structure 962-Kent Road

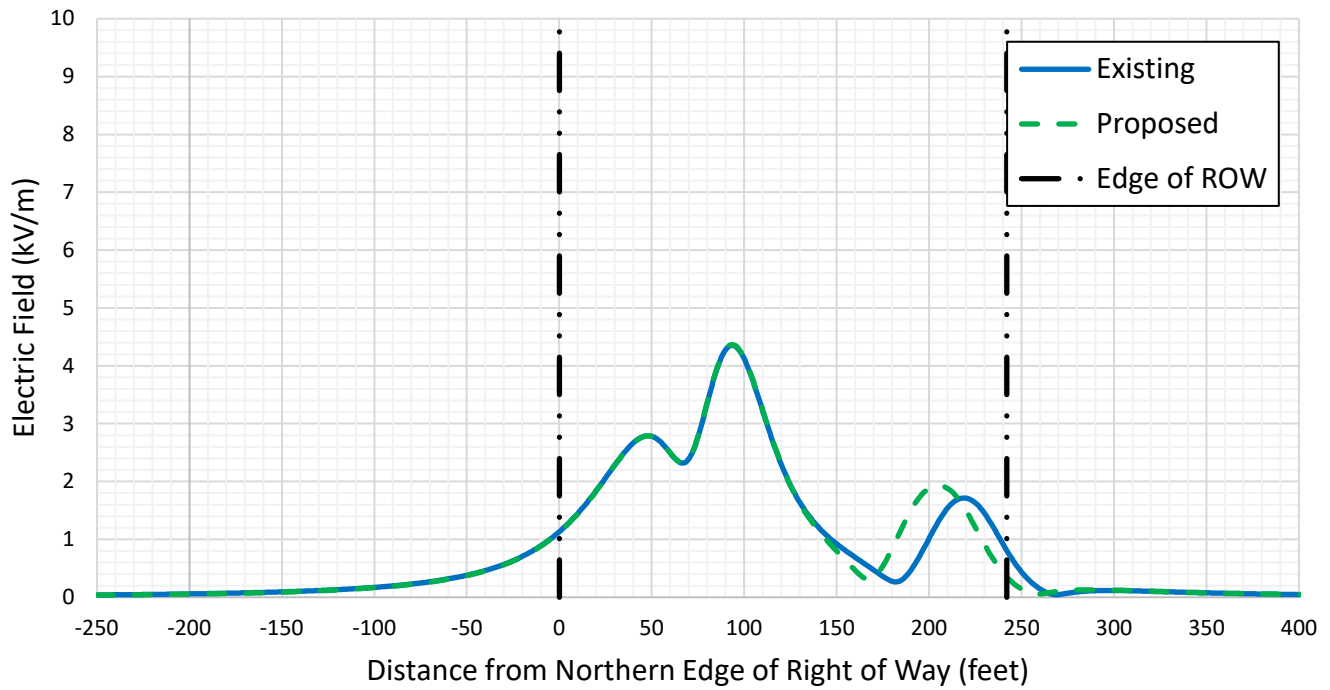
Calculated Electric Fields (Annual Average Loads) Kent Road - Norwalk Junction

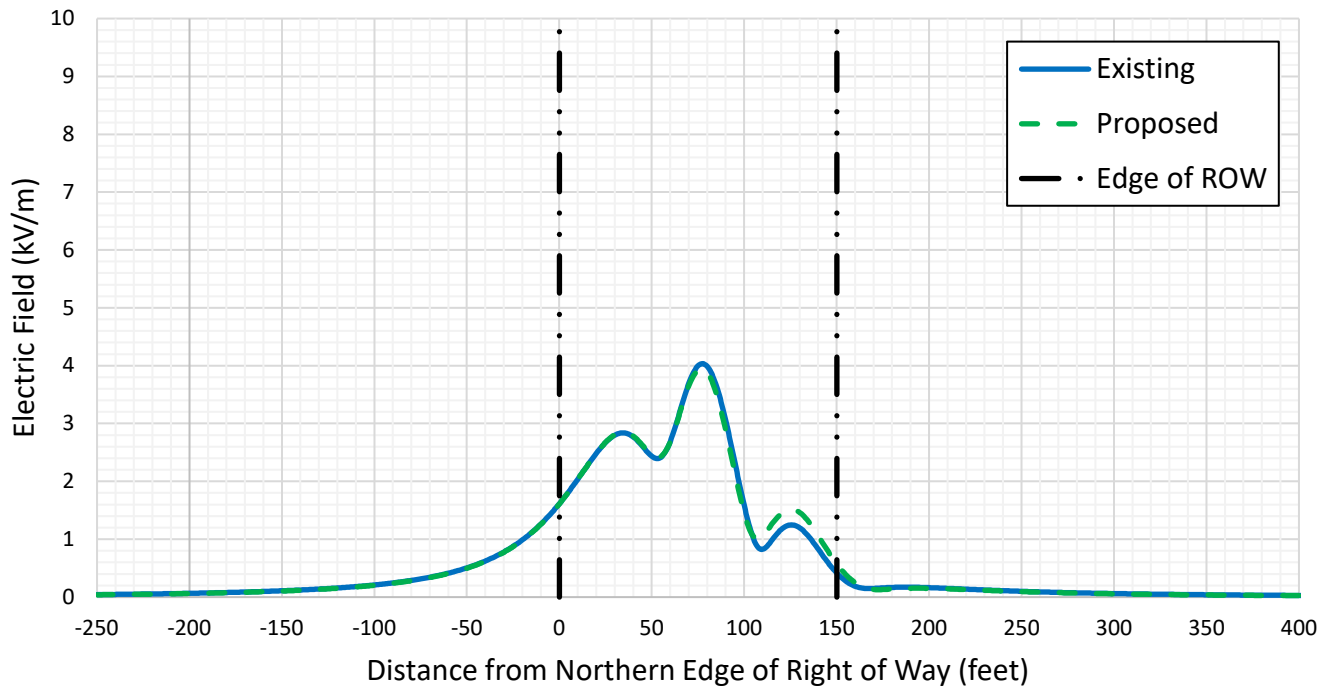
Calculated Electric Fields (Annual Average Loads) Structure 962 - Kent Road

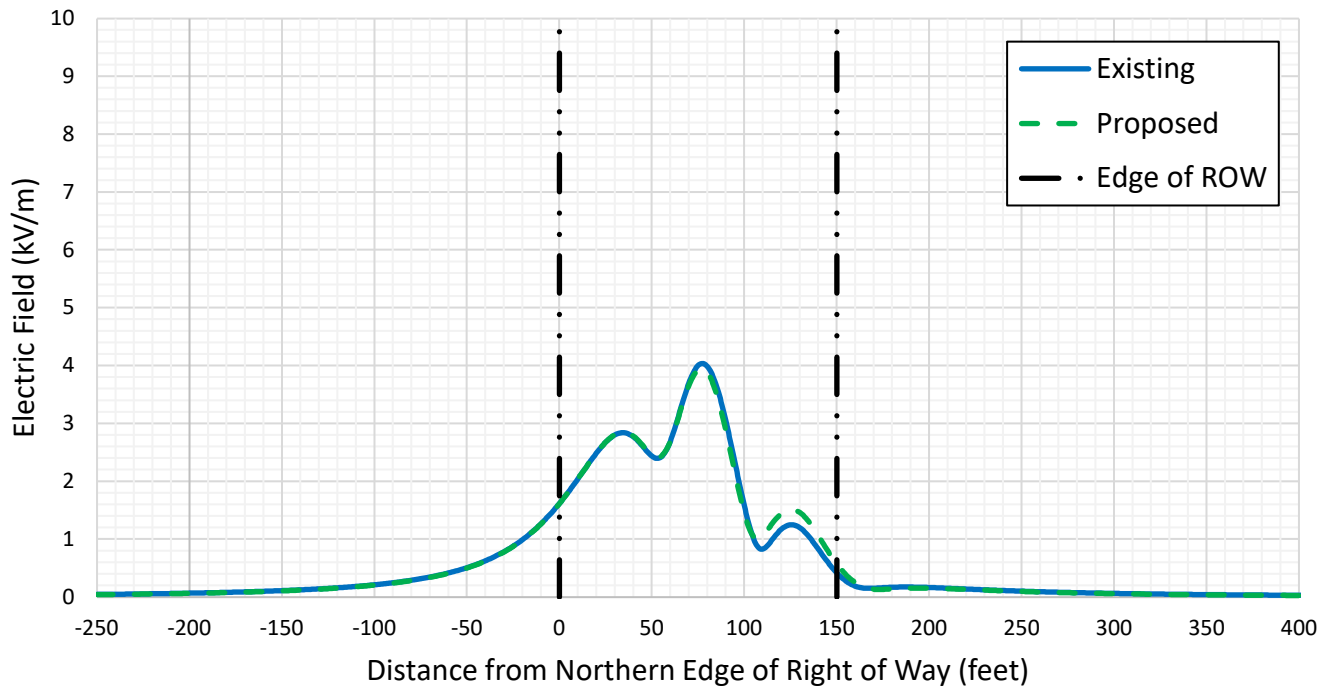
Calculated Electric Fields (Annual Average Loads) Structure 962 - Kent Road
