Re: Southington Substation to Cook Hill Junction Rebuild Project

PETITION TO THE CONNECTICUT SITING COUNCIL
FOR A DECLARATORY RULING OF
NO SUBSTANTIAL ADVERSE ENVIRONMENTAL EFFECT
FOR THE PROPOSED MODIFICATIONS TO THE EXISTING 1355, 1610, 1690 AND 1208
LINES IN THE TOWNS SOUTHINGTON, WALLINGFORD, AND CHESHIRE, AND CITY OF
MERIDEN, CONNECTICUT

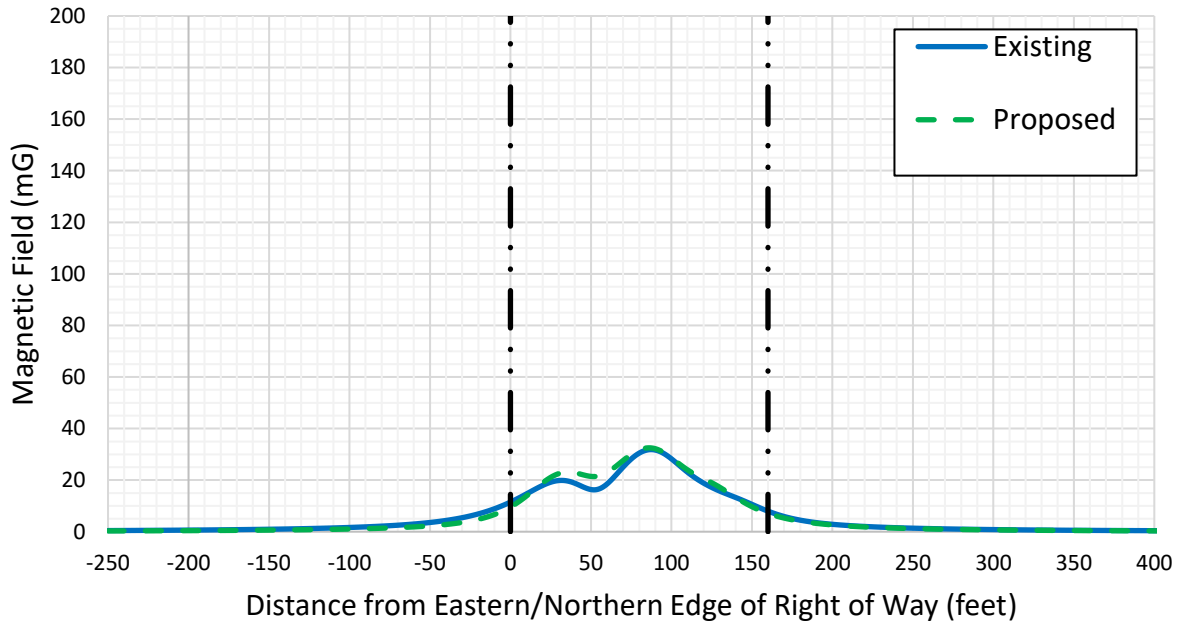
Calculated Magnetic Fields (Annual Average Loads) Southington S/S - Allen Avenue

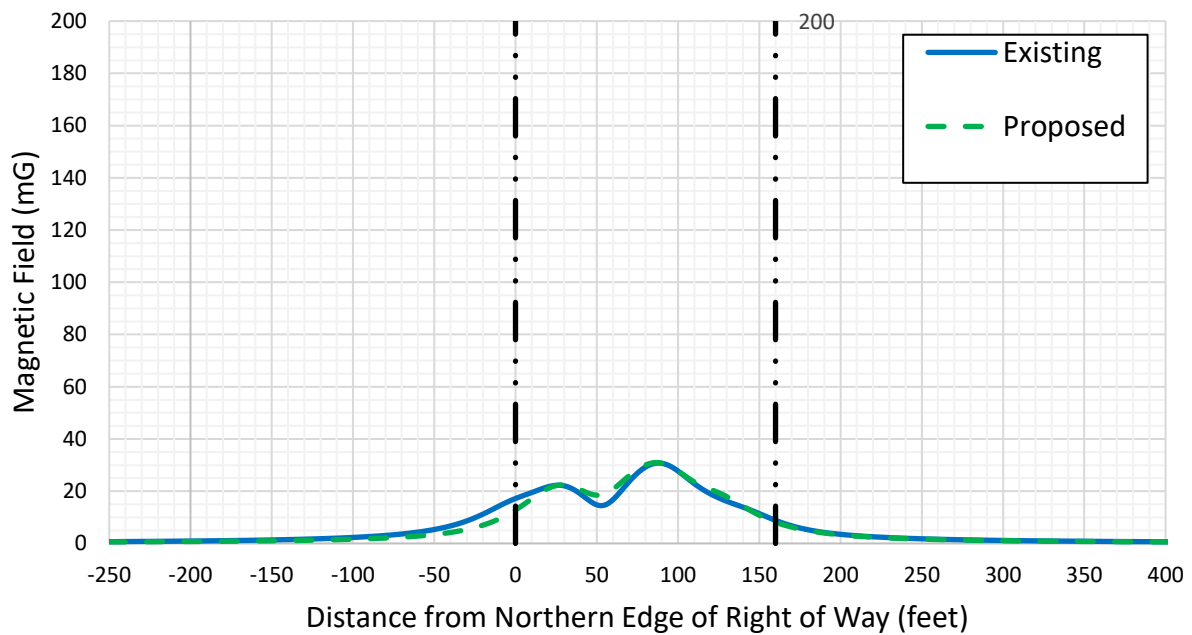
Calculated Magnetic Fields (Annual Average Loads) Allen Avenue - Lucchini Junction

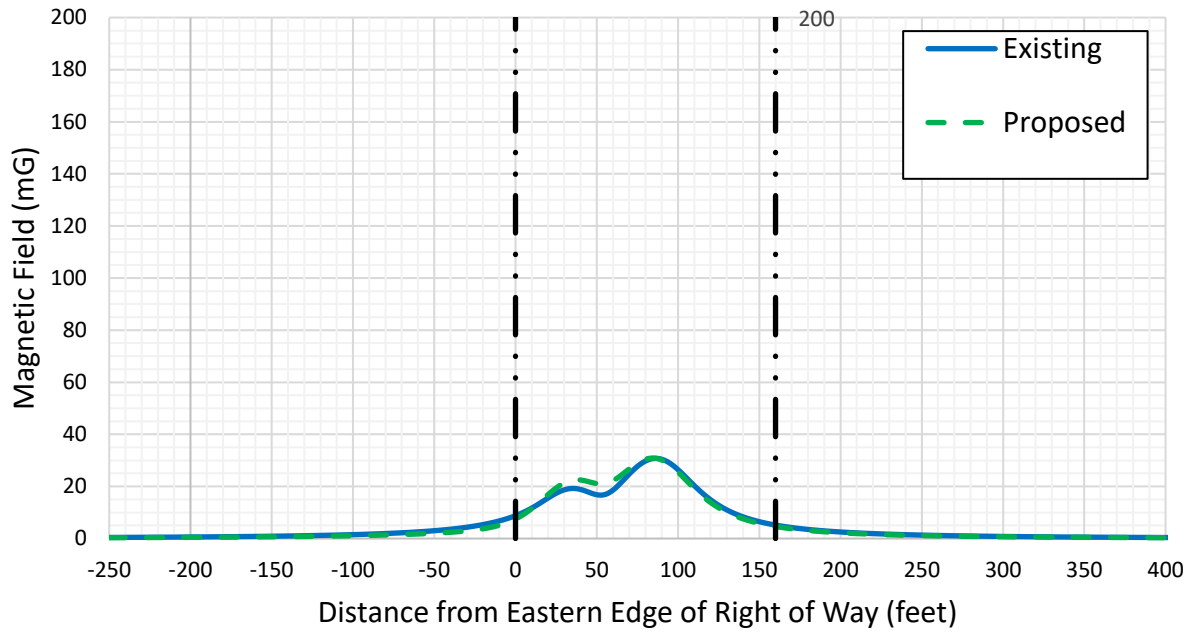
Calculated Magnetic Fields (Annual Average Loads) Lucchini Junction - Schwab Junction

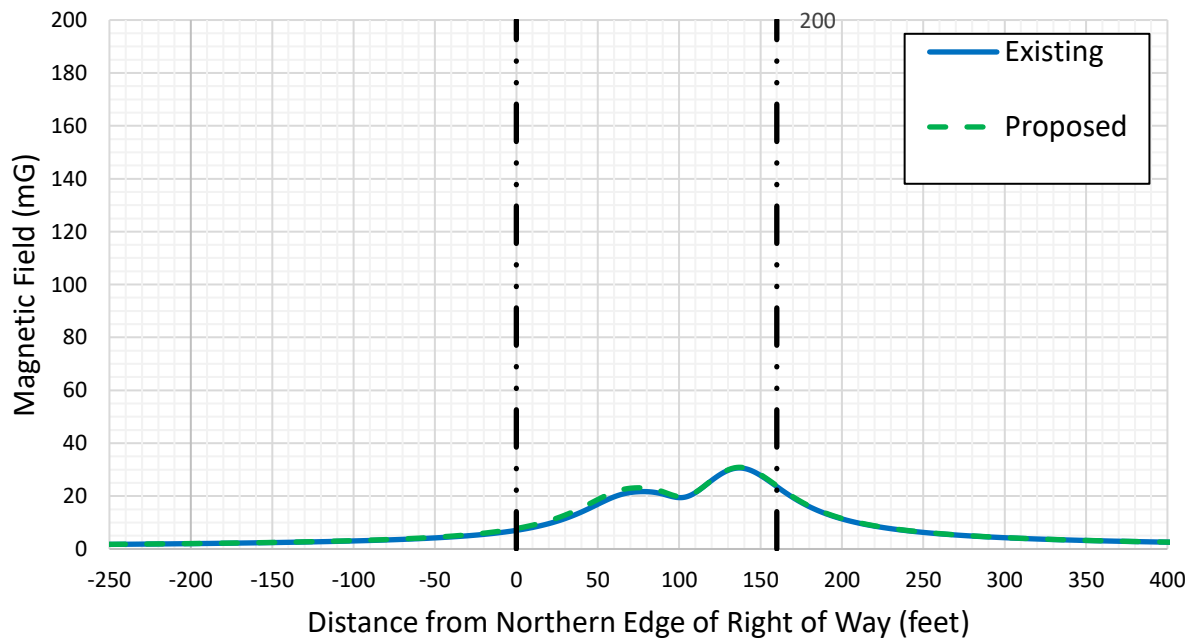
Calculated Magnetic Fields (Annual Average Loads) Lucchini Junction - Hanover S/S

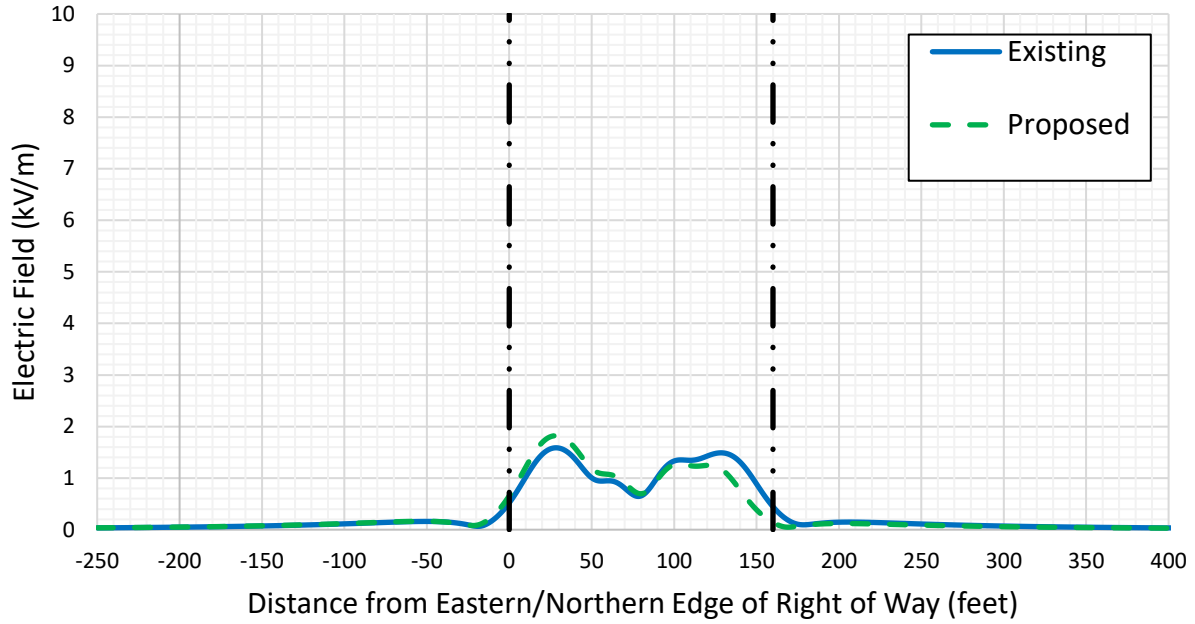
Calculated Electric Fields (Annual Average Loads) Southington S/S - Allen Avenue
