Re: Middletown Substation to Oxbow Junction Upgrade Project

PETITION TO THE CONNECTICUT SITING COUNCIL
FOR A DECLARATORY RULING OF
NO SUBSTANTIAL ADVERSE ENVIRONMENTAL EFFECT
FOR THE PROPOSED MODIFICATIONS TO THE EXISTING
1620 LINE IN THE CITY OF MIDDLETOWN, AND TOWN OF HADDAM, CONNECTICUT

MIDDLETOWN S/S - HADDAM S/S
115-kV TRANSMISSION LINES CROSS SECTION
MIDDLETOWN & HADDAM, CONNECTICUT

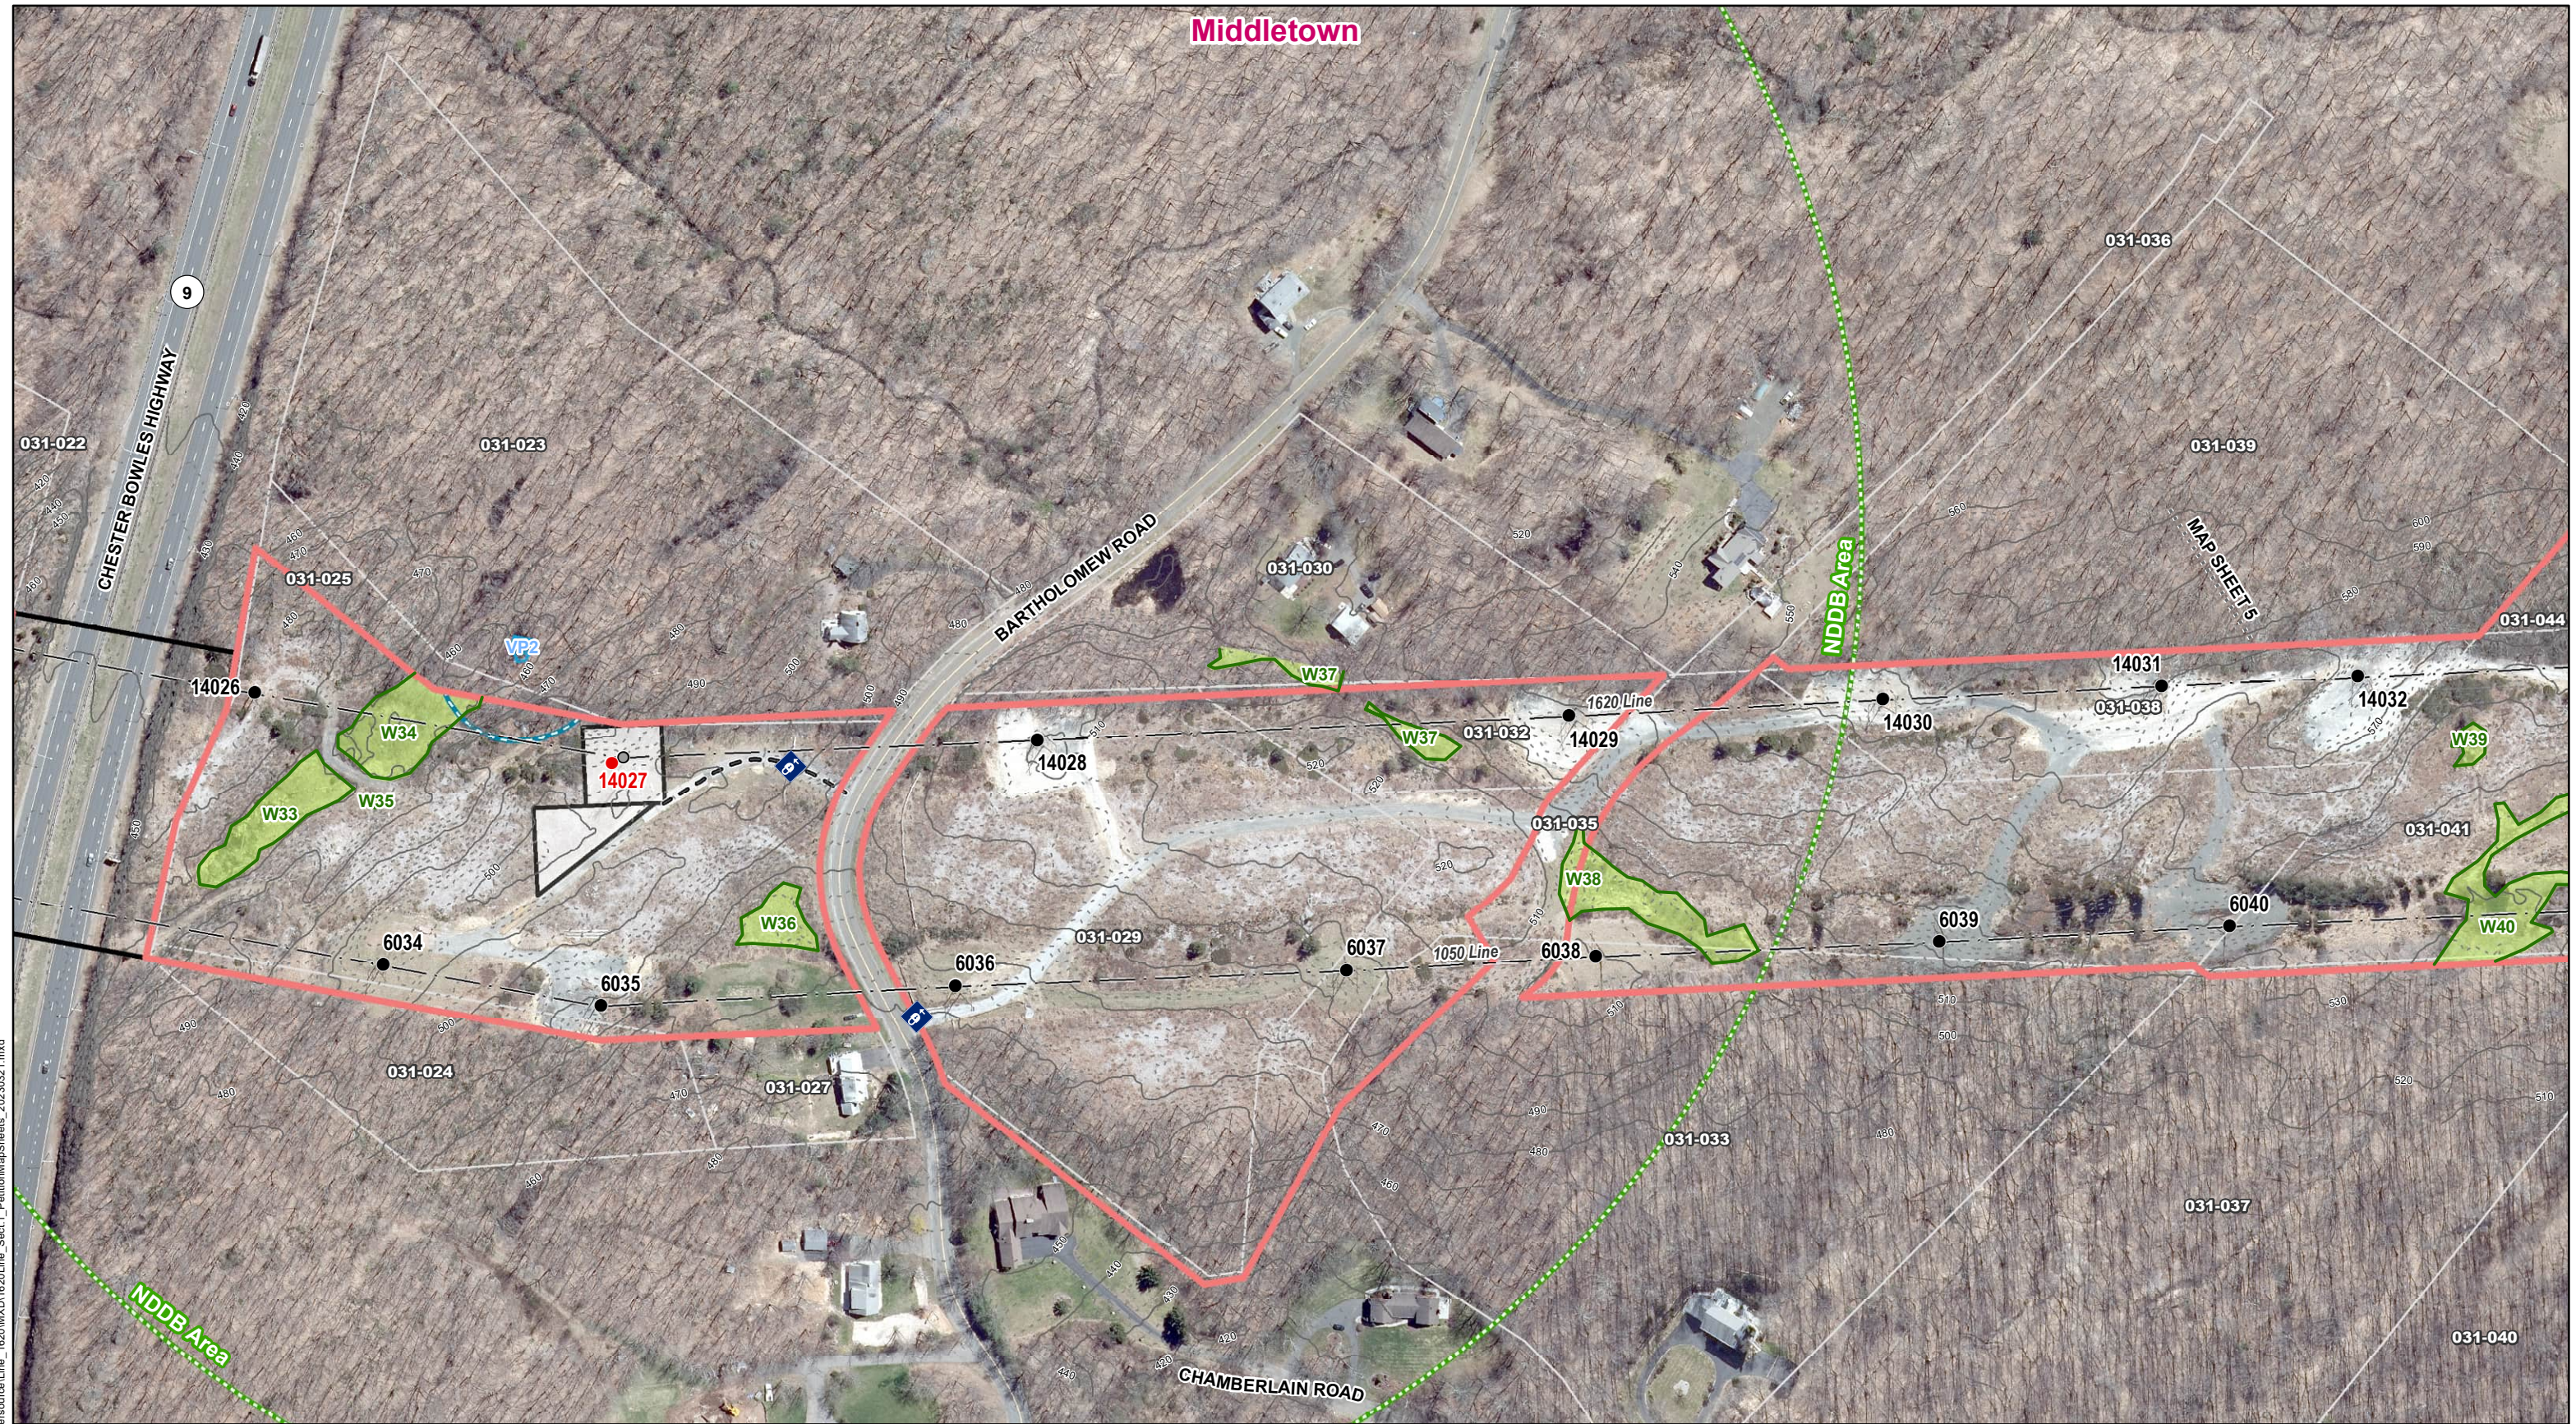
MAPSHEET 4 of 7
1620 Line Middletown Substation to Oxbow Junction Upgrade Project
Structures to be Replaced: 14027
Middletown, CT

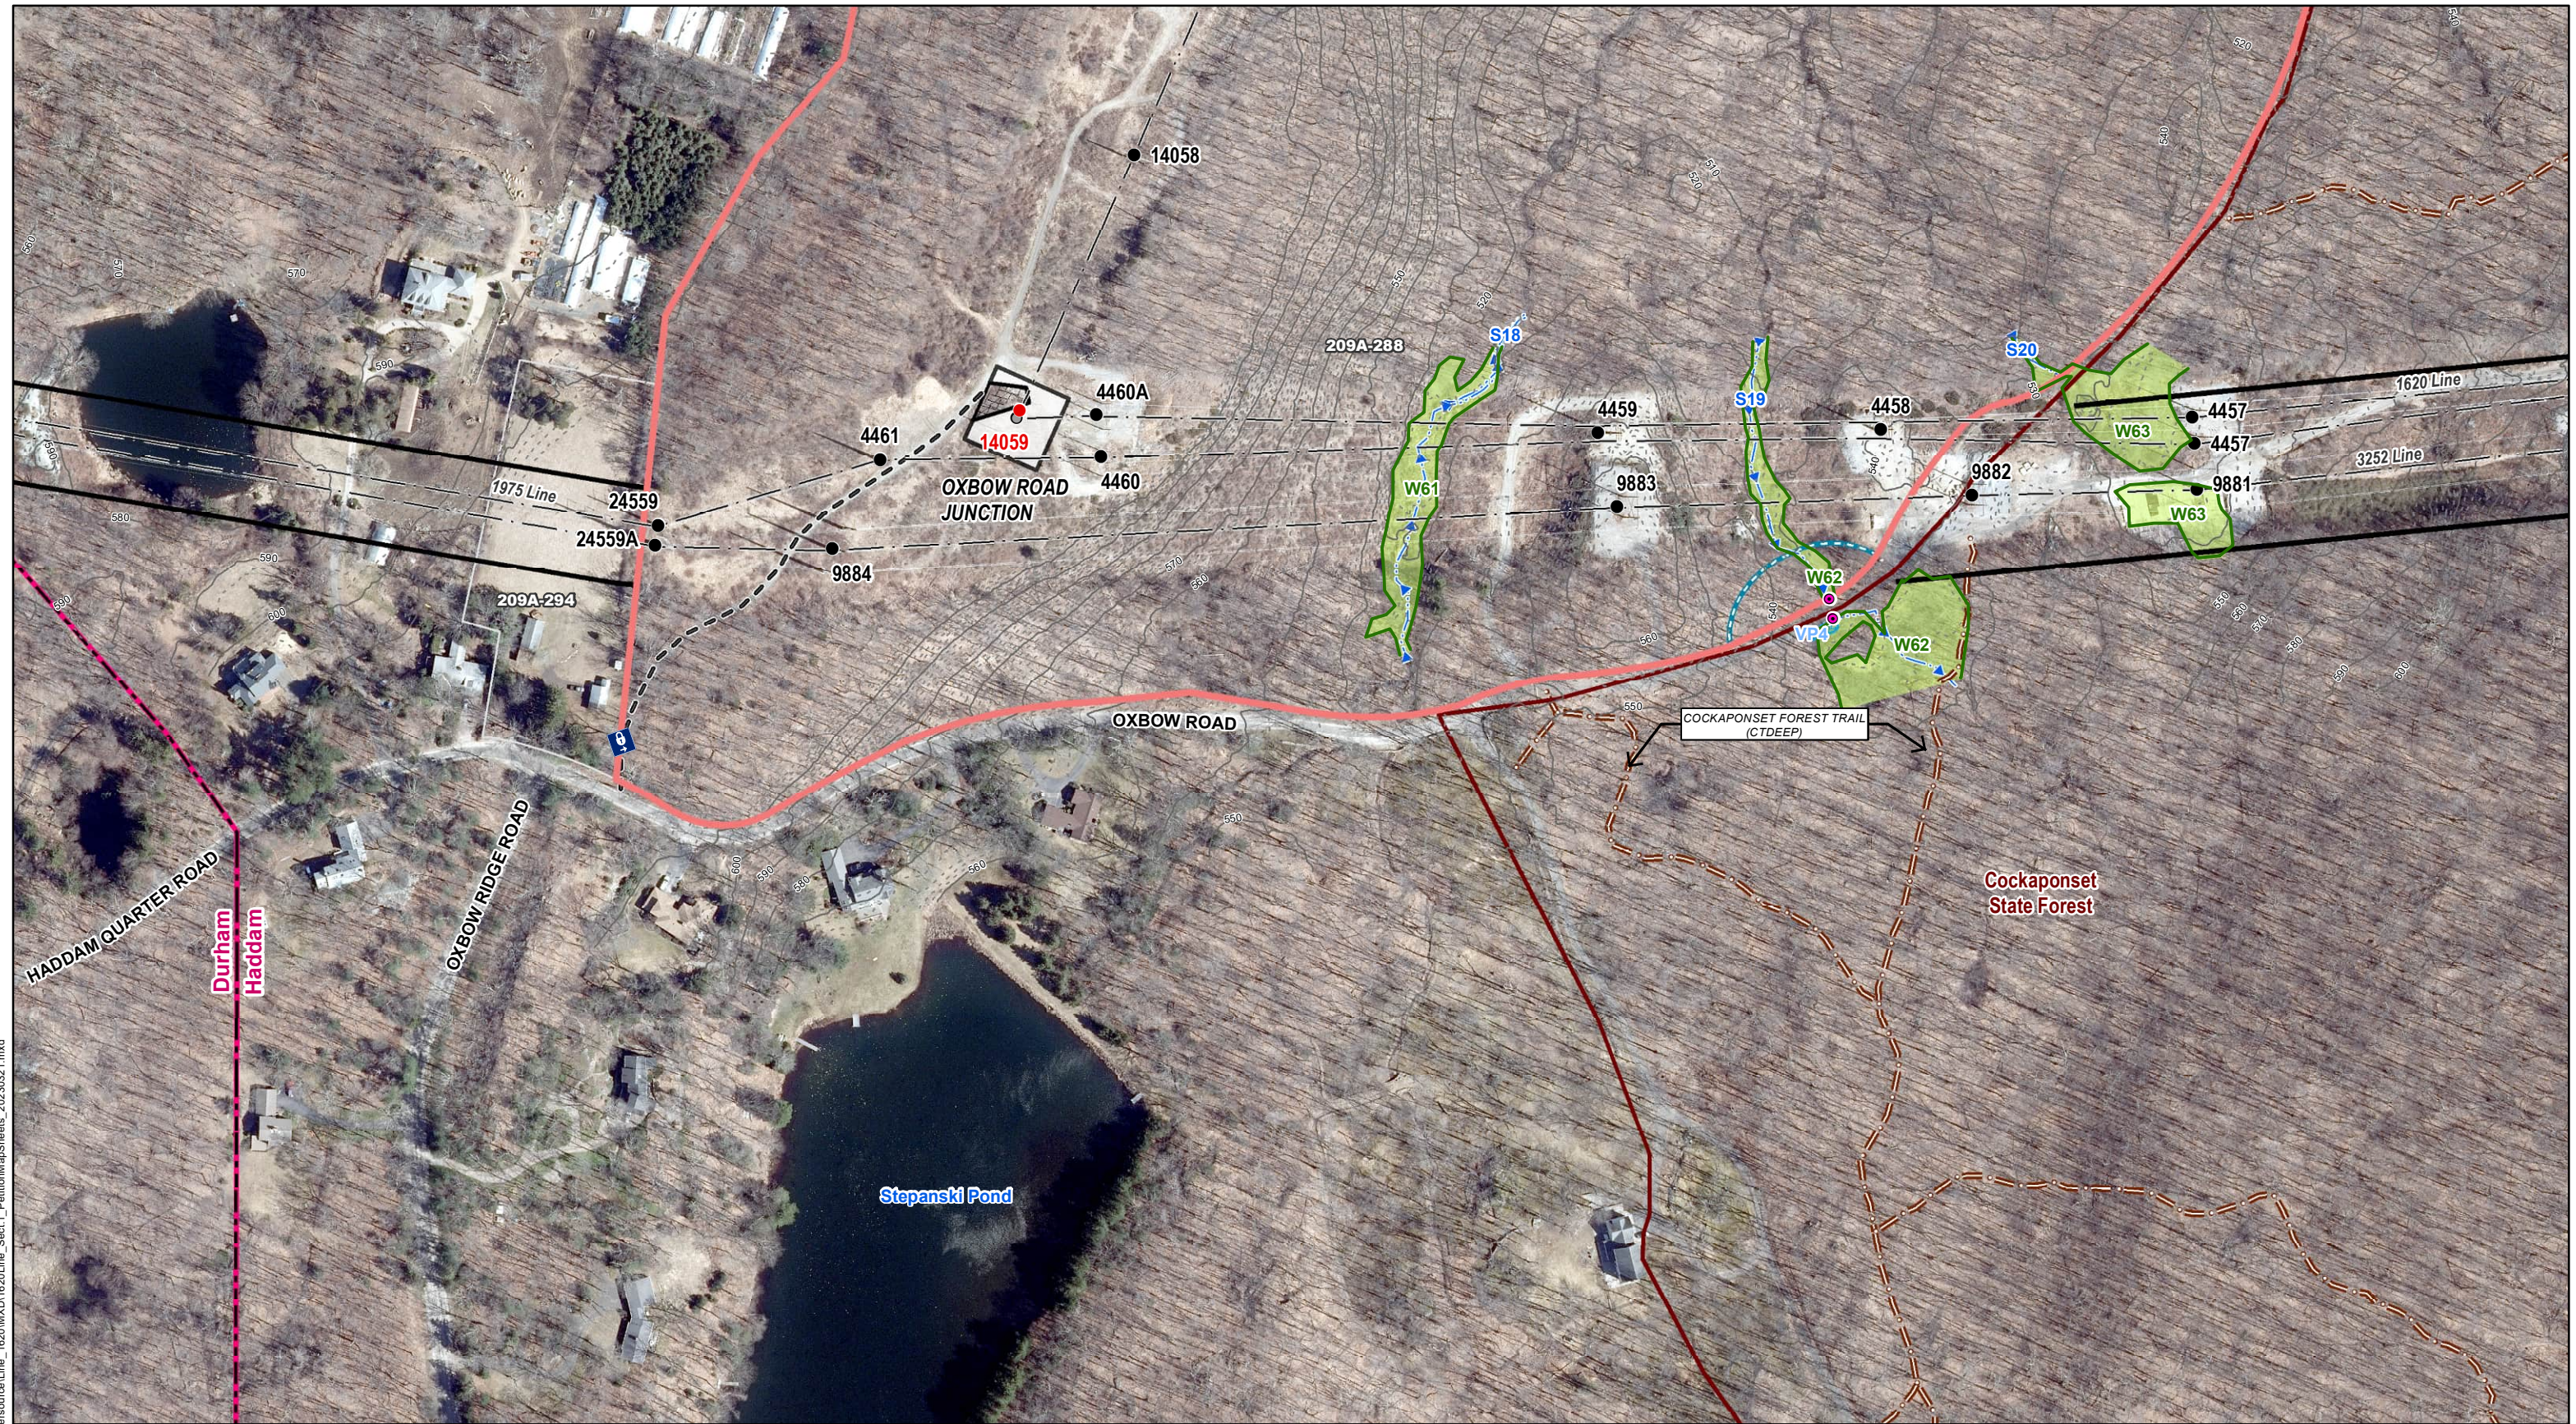
MAPSHEET 7 of 7
1620 Line Middletown Substation to Oxbow Junction Upgrade Project
Structure to be Replaced: 14059
Haddam, CT

Existing Maintained Right-of-Way Width

- 165 feet, variable

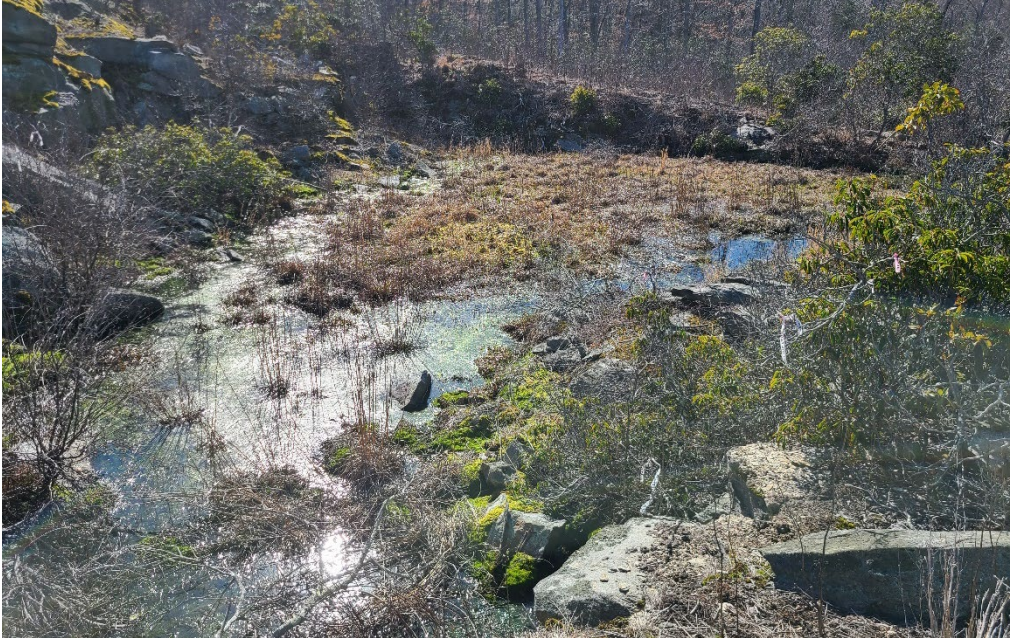
| Photo 1 | |

| <p>Description:</p> <p>Vernal Pool 1A (VP1A).</p> <p>Vernal pool basin.</p> <p>Facing southwest.</p> | |
