Re: Frost Bridge to Noera Rebuild Project

PETITION TO THE CONNECTICUT SITING COUNCIL
FOR A DECLARATORY RULING OF
NO SUBSTANTIAL ADVERSE ENVIRONMENTAL EFFECT
FOR THE PROPOSED MODIFICATIONS TO THE EXISTING
1163 and 1550 LINES IN THE TOWNS OF WATERTOWN, THOMASTON, PLYMOUTH
AND CITY OF WATERBURY, CONNECTICUT

The purpose of the Project is to replace structures and reconductor approximately 5 miles of the 1163 and 1550 lines entirely within the ROW that connects Frost Bridge Substation, located at Frost Bridge Road, Watertown, to Noera Junction in Waterbury and to Noera Substation, located at 1 Foote Street, Waterbury.

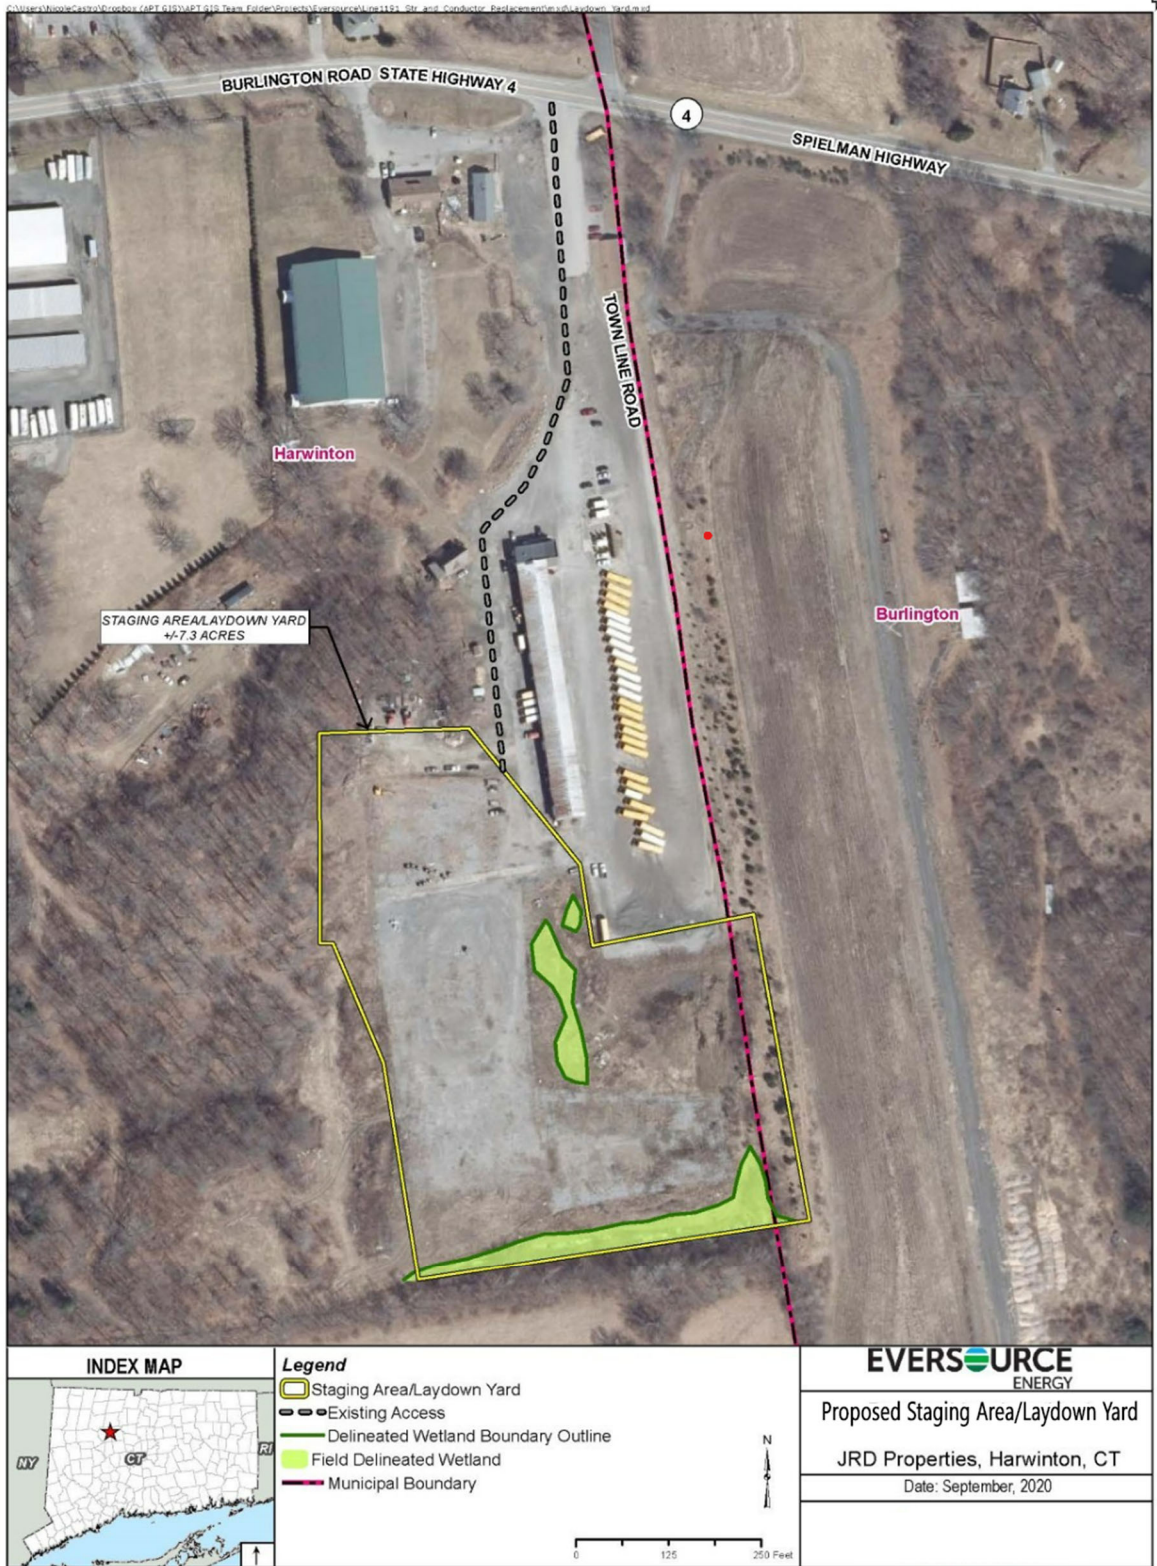
Figure 2: Proposed Staging Area/Laydown Yard

mats, for the Project. Office trailers may also be located at a staging area, and transmission line components removed during the work (structure steel, conductor, hardware and insulators) may be temporarily accumulated and stored at a staging area prior to removal off-site for salvage and/or disposal. The staging areas may also be used by construction crew members for parking personal vehicles as well as for construction vehicles, and for performing minor maintenance, when needed, on construction equipment. An environmental review of each potential staging area location would be completed, and Eversource would consult with the local municipal officials and provide notice to the Council when the staging areas are identified.

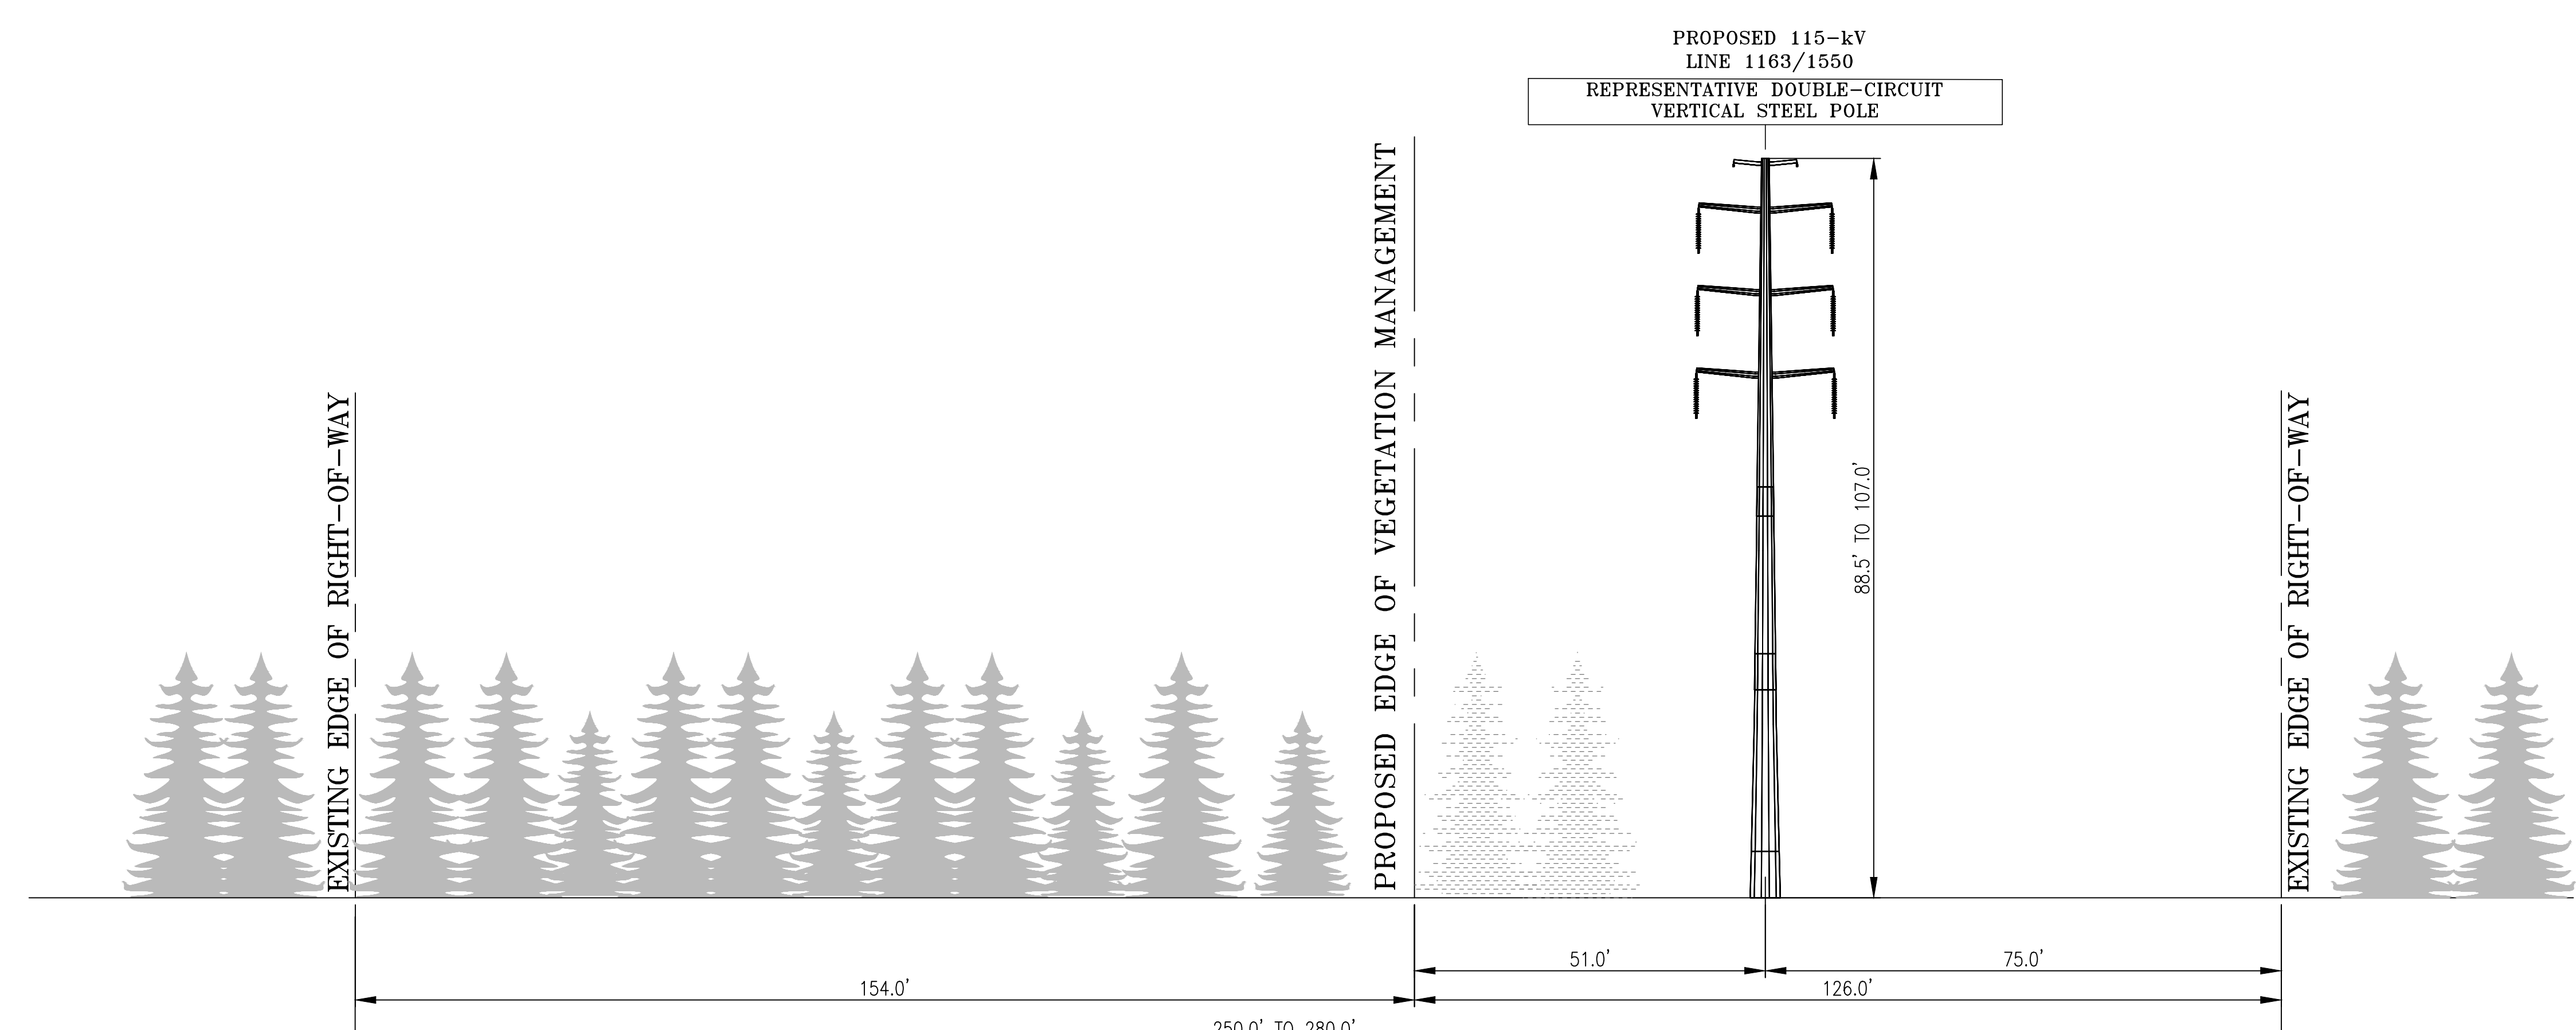
PROPOSED R.O.W. CONFIGURATION
DOUBLE-CIRCUIT STEEL POLE DESIGN
 LOOKING FROM FROST BRIDGE SUBSTATION TO NOERA JUNCTION
 IN THE TOWNS OF WATERTOWN & THOMASTON, CT

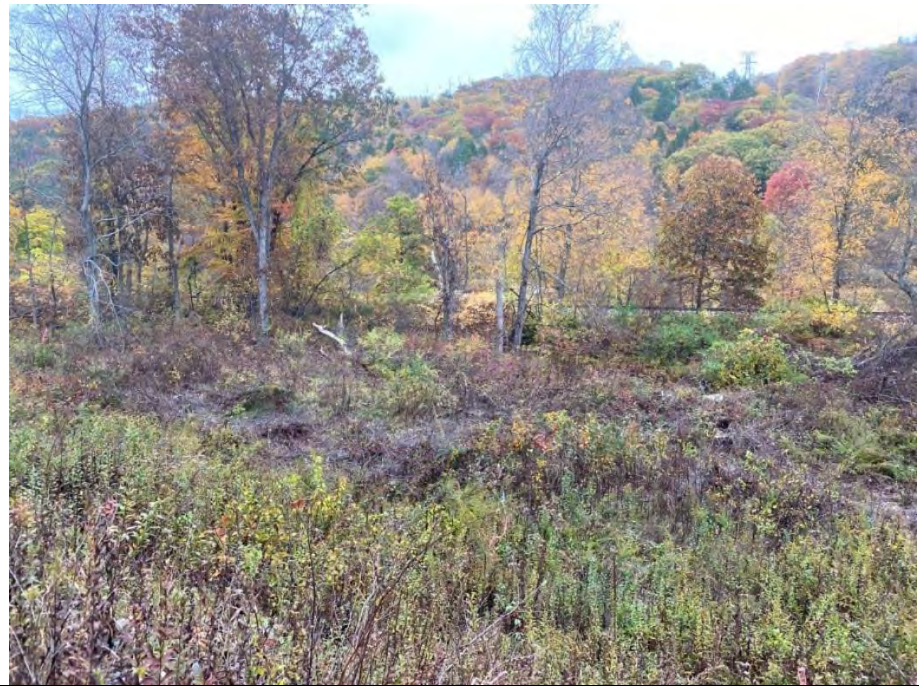
Description: View facing northeast, looking down at Wetland 1, which is a depressional wetland at the base of a hillside slope.

Note the train tracks in the background separating Wetland 1 from Wetland 4, which are connected via culvert under the tracks.

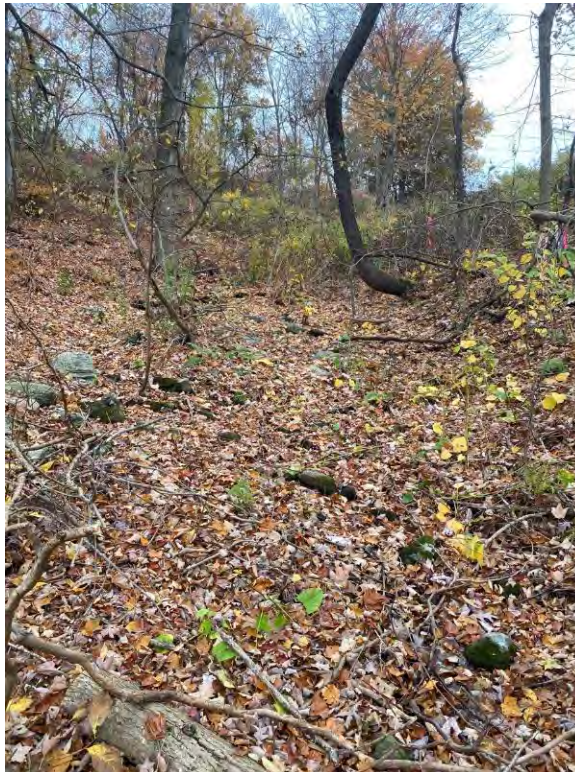
Description: View facing southwest of Wetland 2 located along a steep hillside slope.

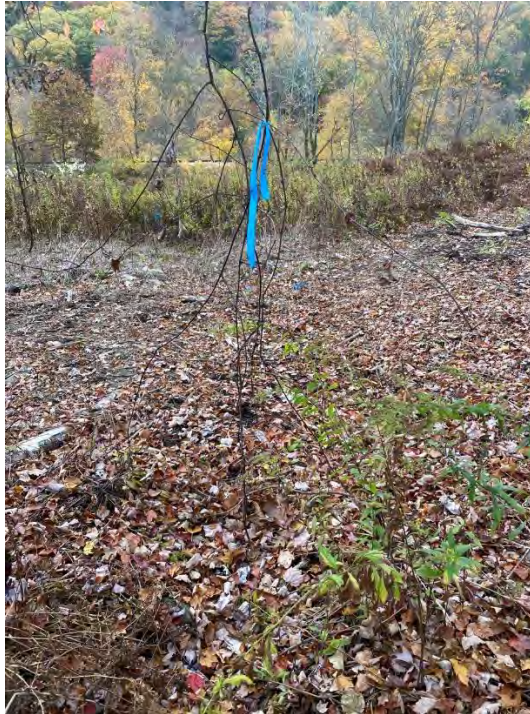
Description: View facing east of Stream 2 where it exits Wetland 2 and flows downhill to Wetland 1 (in background).

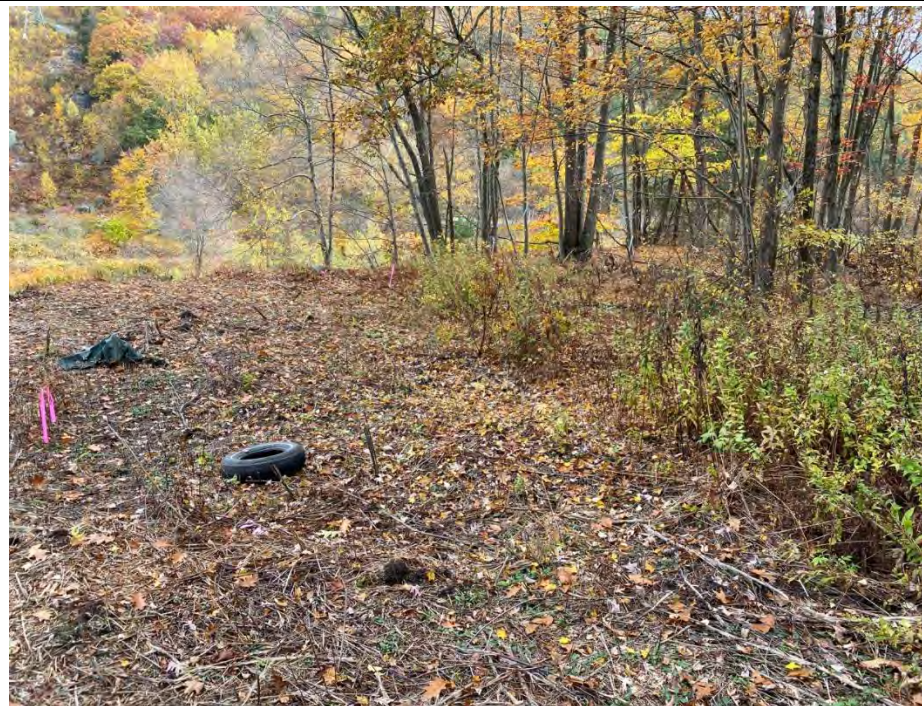
Description: View facing southeast of Wetland 3.

Note that the portion in the ROW had been recently maintained (with PSS cover type) and off-ROW portion is a PFO cover type.

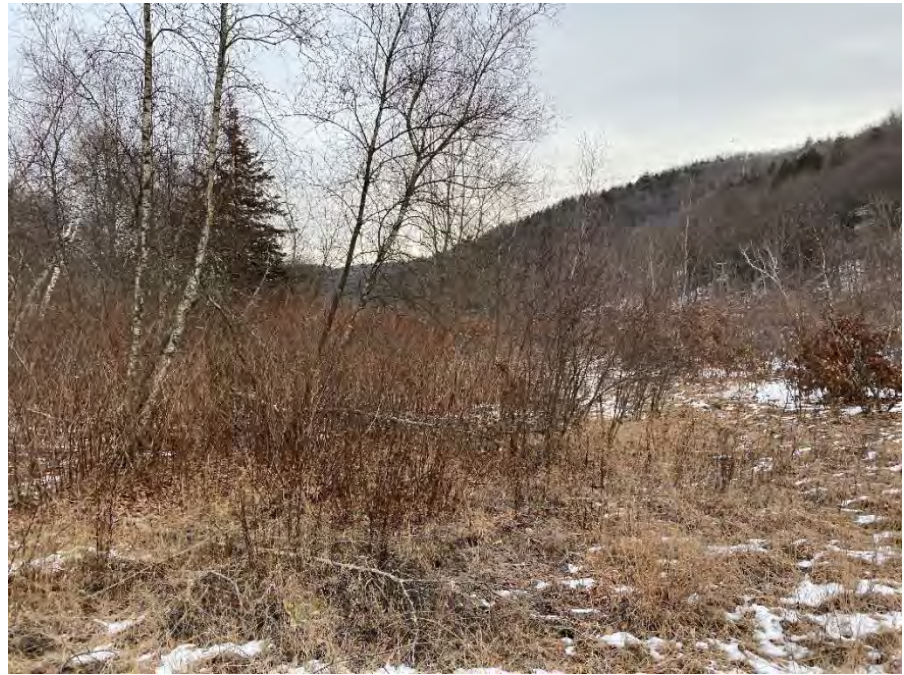
Description: View facing northeast of Wetland 4 located along the western bank of the Naugatuck River (Stream 2) in background.

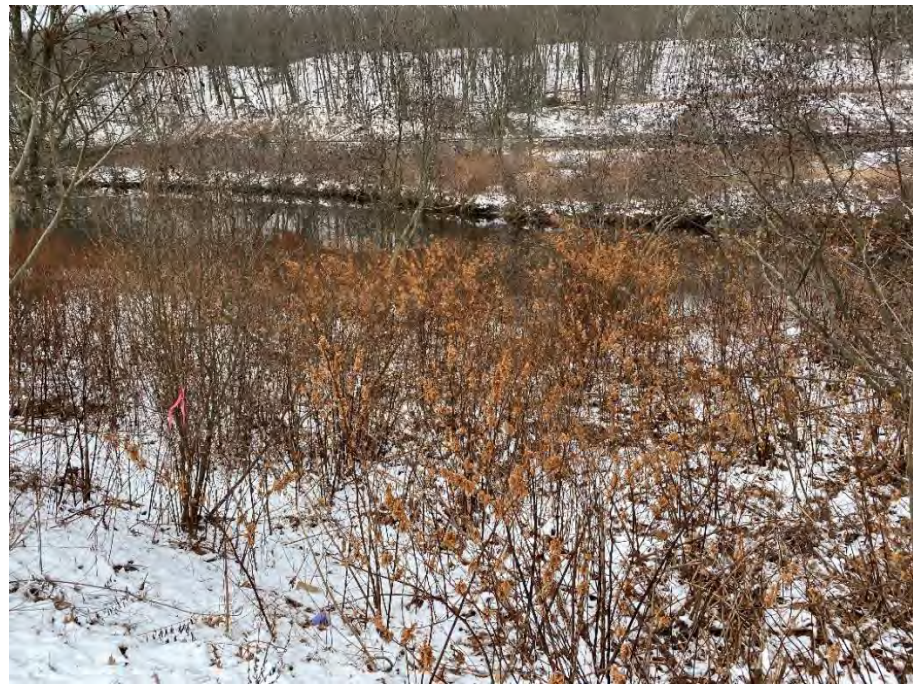
Description: View facing southwest of Wetland 5 located along the eastern bank of the Naugatuck River (Stream 2) in background.

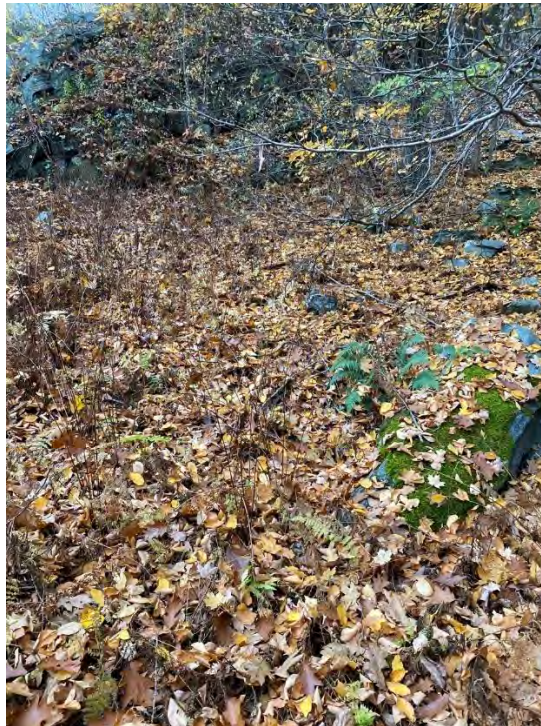
Description: View facing northeast of Wetland 6, which is located on a steep hillside slope.

Note the groundwater seep emanating from the bedrock outcrop in background.

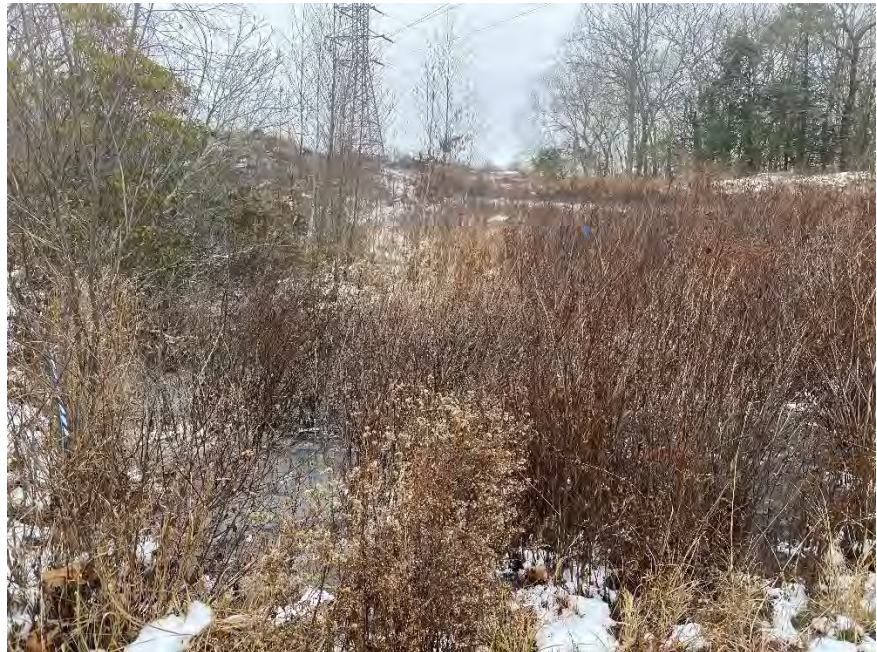
Description: View facing east of Wetland 7 and Vernal Pool 1.

Note lattice Structure 4 in the background.

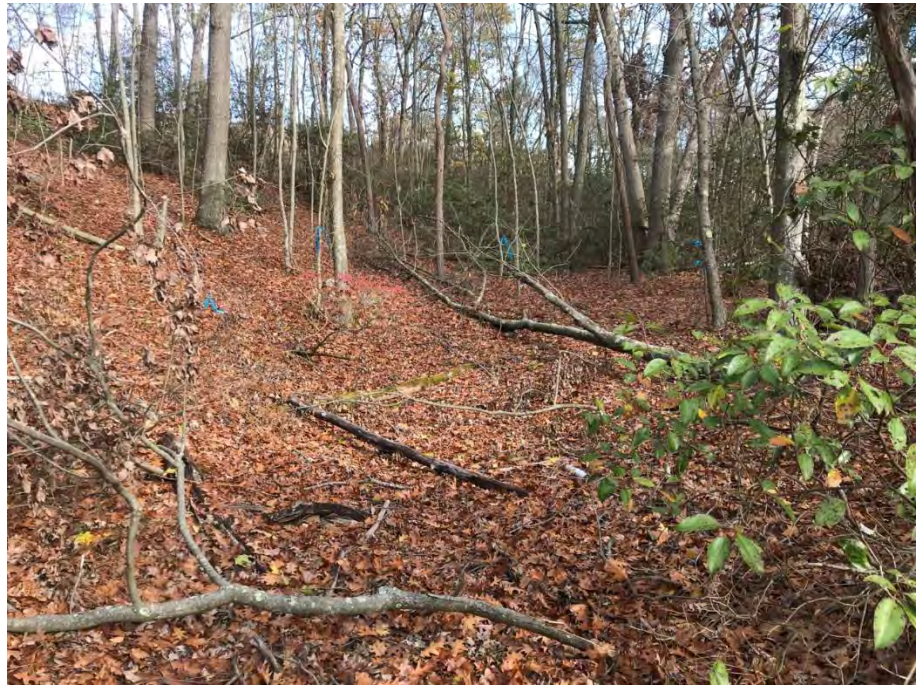
Description: View facing northeast of Wetland 8 and Vernal Pool 2.

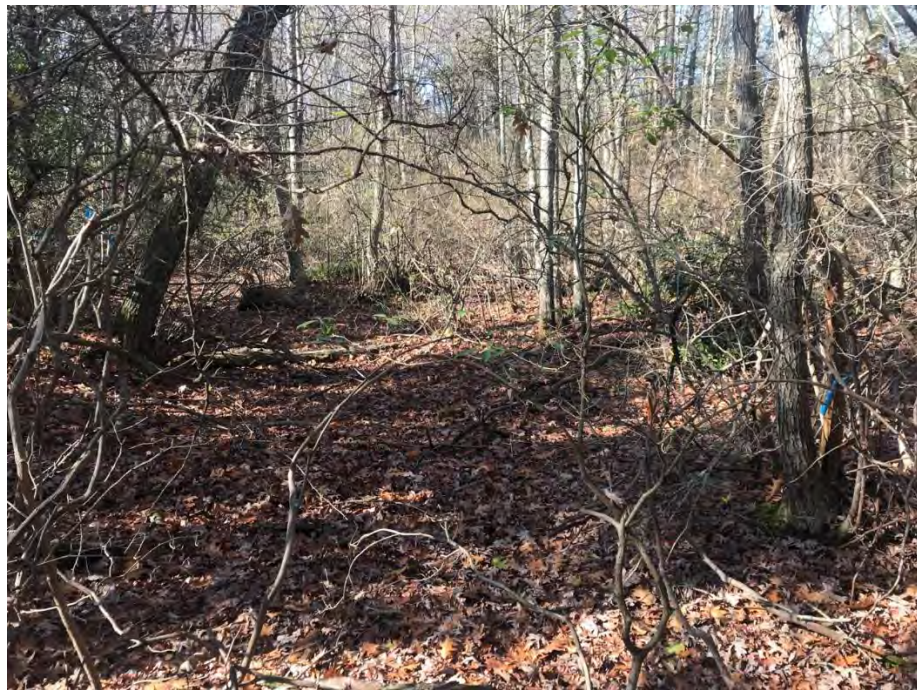
Description: View facing northwest of Wetland 9 and Vernal Pool 3.

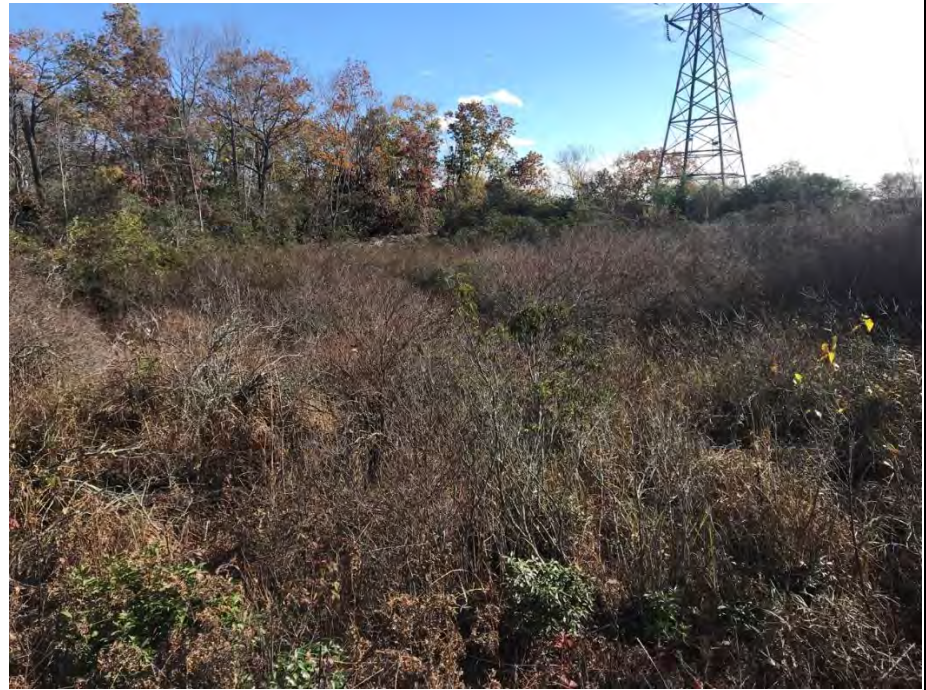
Description: View facing southeast of Wetland 10.

Note lattice Structure 4 in the background.

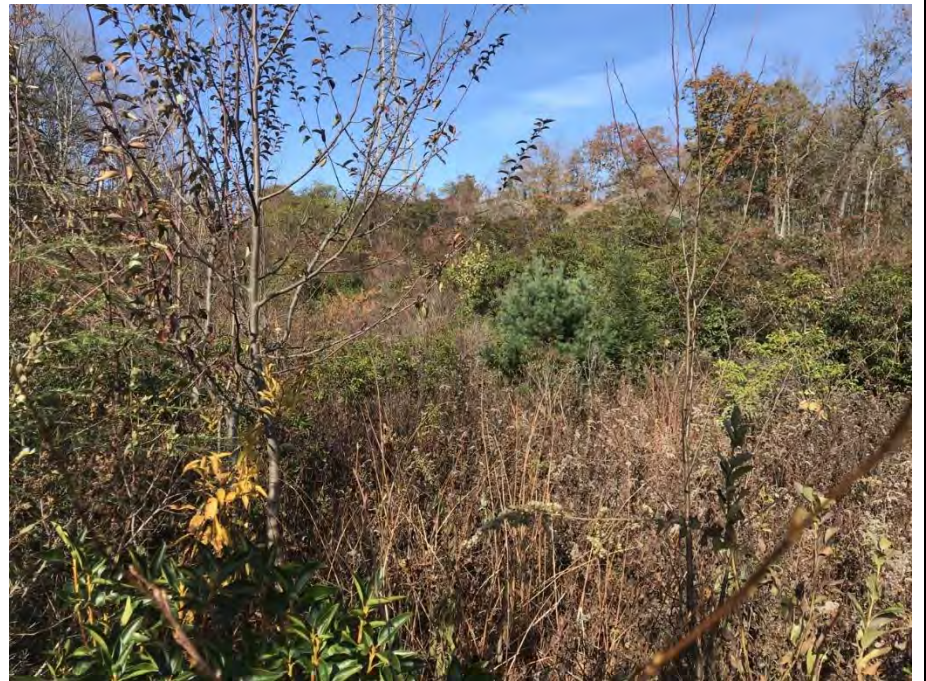
Photo No.: 12 **Date:** 11/03/20

Description: View facing north of Wetland 11.

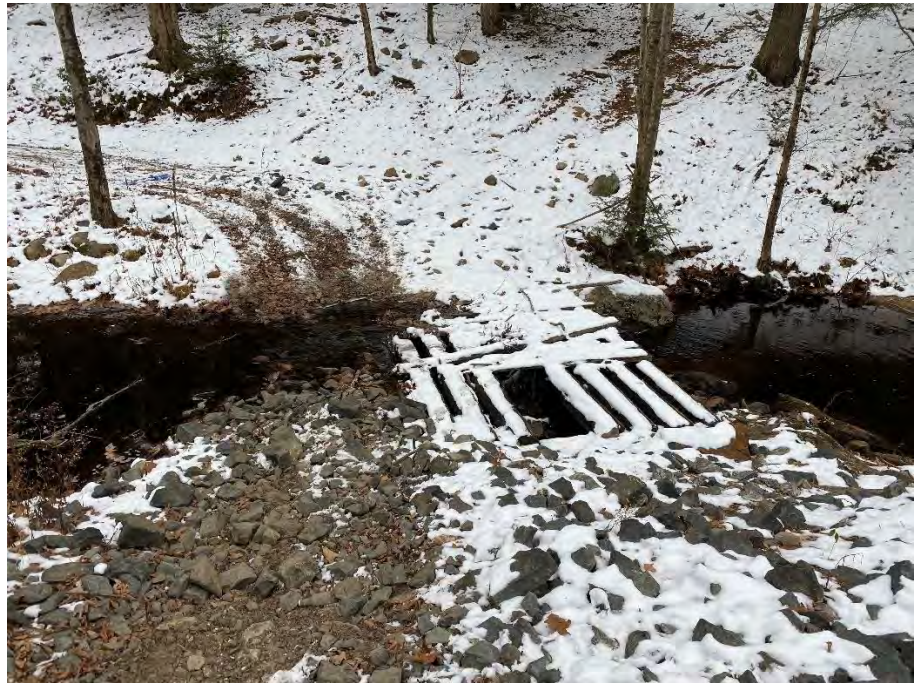
Description: View facing southeast of the existing access road crossing at Stream 3 (Spruce Brook).

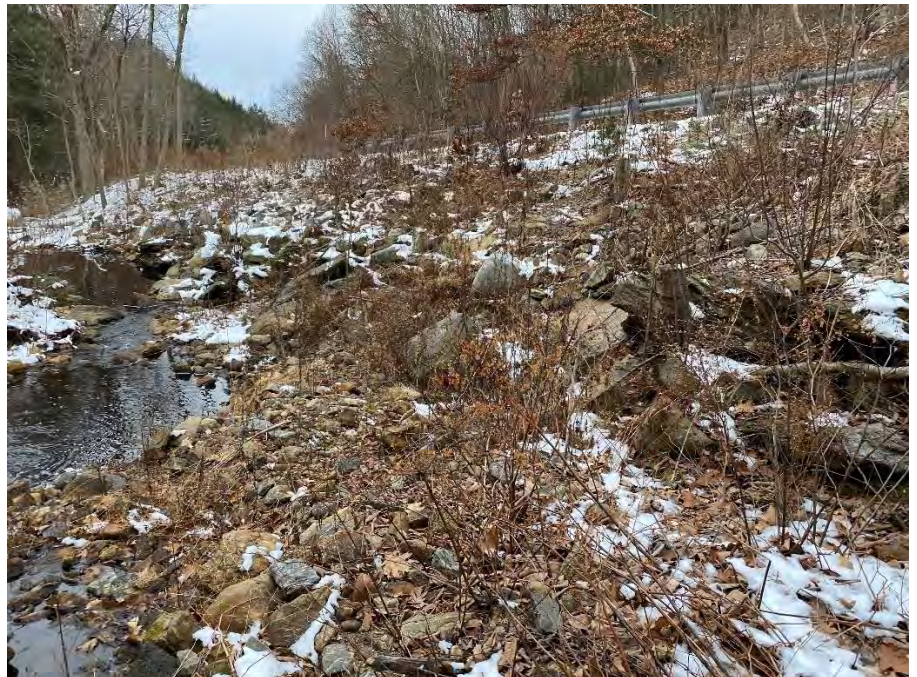
Description: View facing southwest of Wetland 12 along the western bank of Spruce Brook. Spruce Brook Road in background.

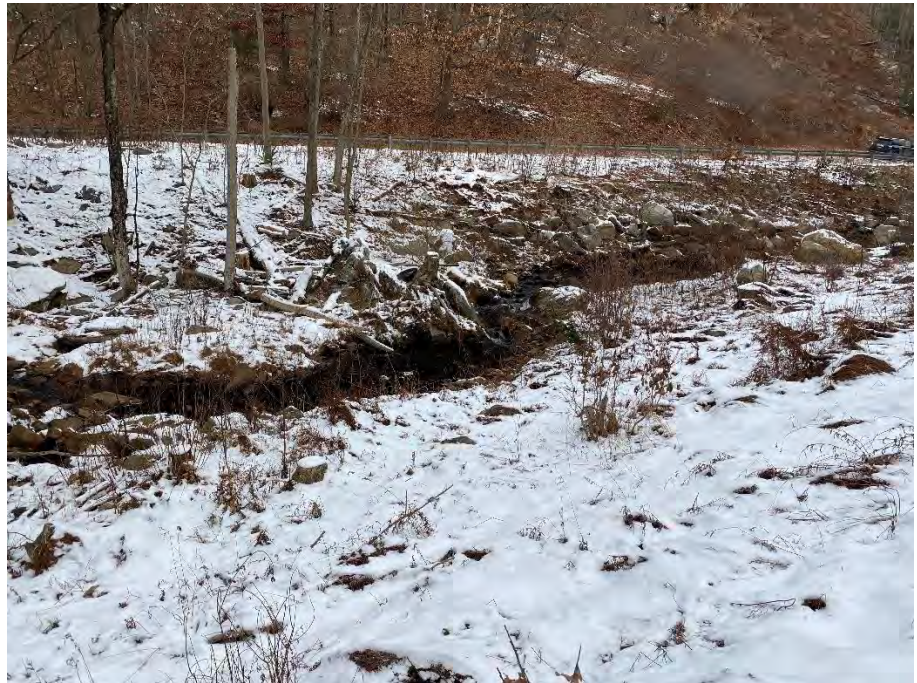
Description: View facing northwest of Wetland 13, located along the eastern banks of Spruce Brook. Spruce Brook Road in background.

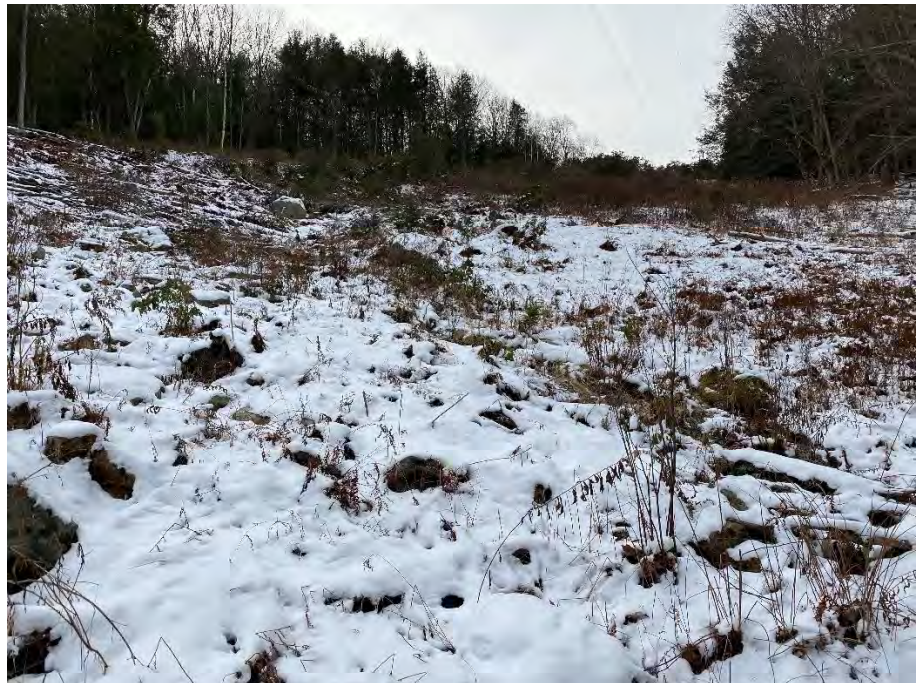
Description: View facing southeast of Wetland 14 and Stream 3A, which are located along a steep hillside slope (Lattice Structure 7 is just out of sight, over the hill in background).

Note that a groundwater seep is emanating from bedrock located just below the top of the slope in background.

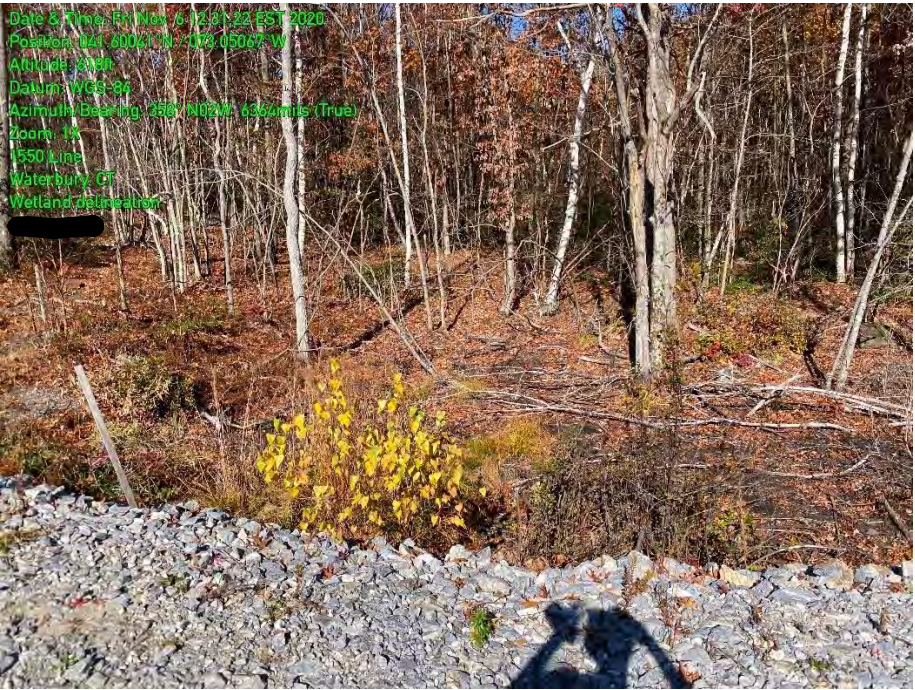
Note that this portion of Wetland 15 is forested and located outside of the cleared portion of right-of-way, to the north of the existing access road.

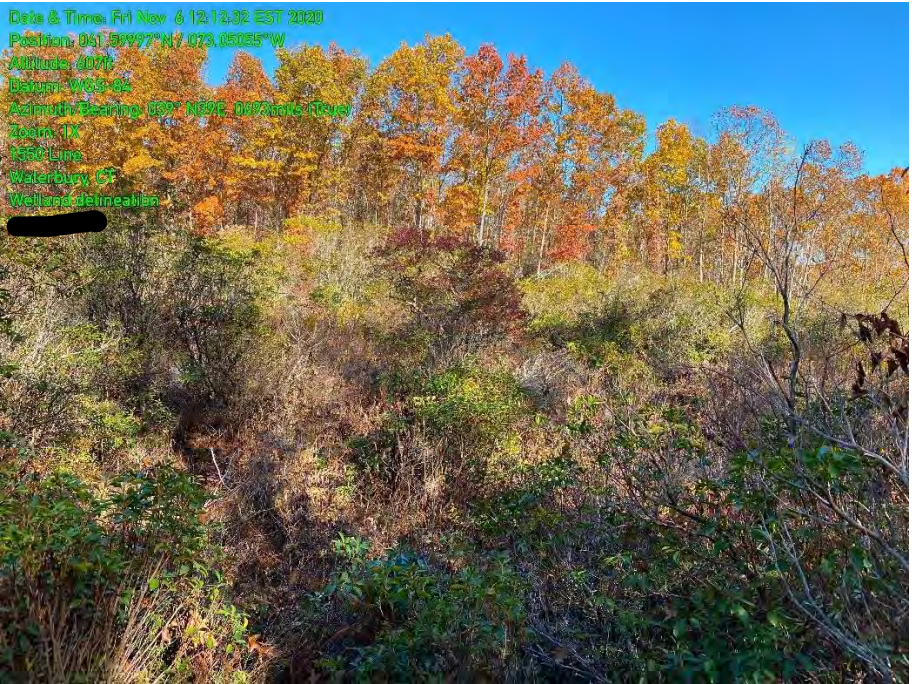
Note that this portion of Wetland 15 is scrub shrub and located within the cleared portion of right-of-way, to the south of the existing access road.

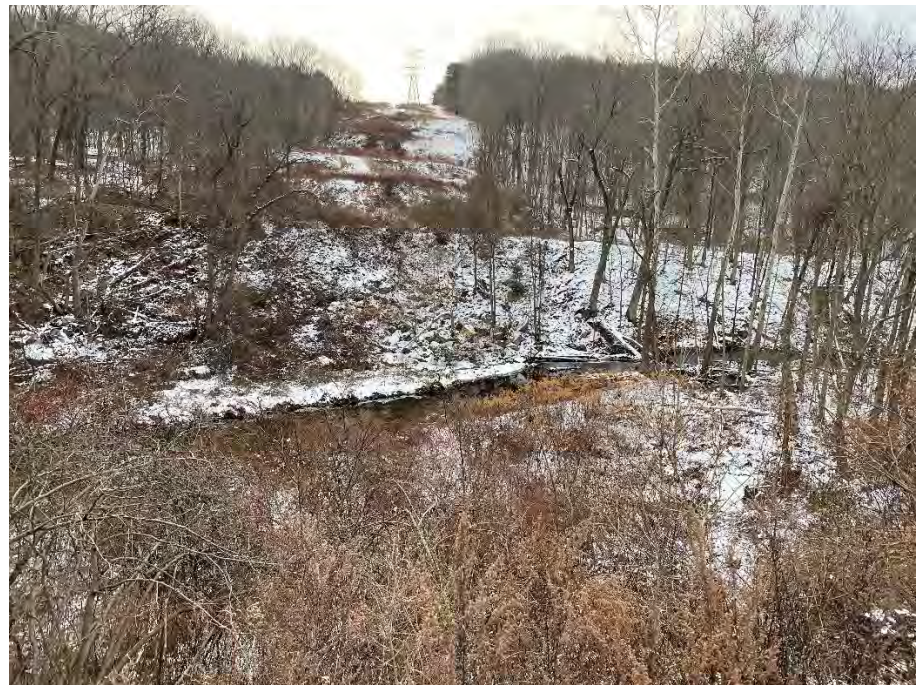
Description: View facing southeast, looking down at Wetland 16 and Stream 4 (Hancock Brook).

Note lattice Structure 13 in the far background.

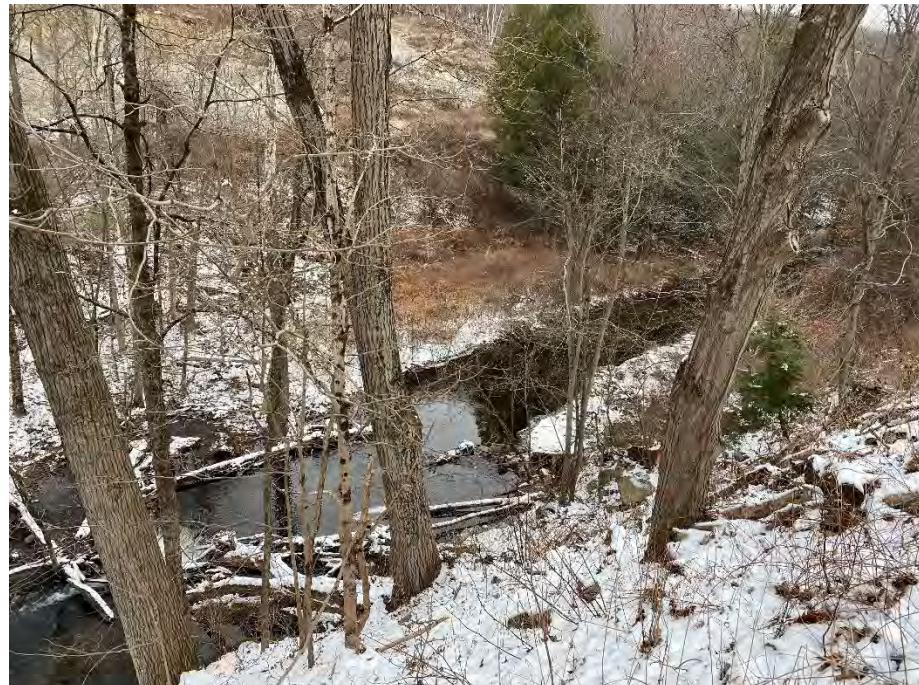
Description: View facing northwest, looking down at Stream 4 (Hancock Brook) and Wetland 16 in background.

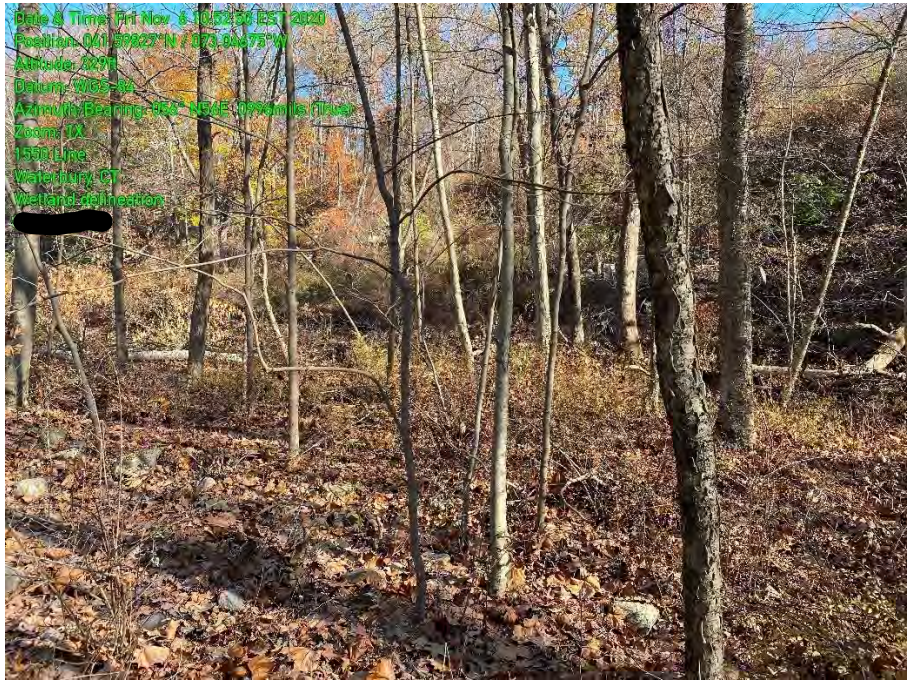
Description: View facing northeast of the forested portion of Wetland 16 and Stream 4 (Hancock Brook in background), located to the south of the cleared right-of-way.

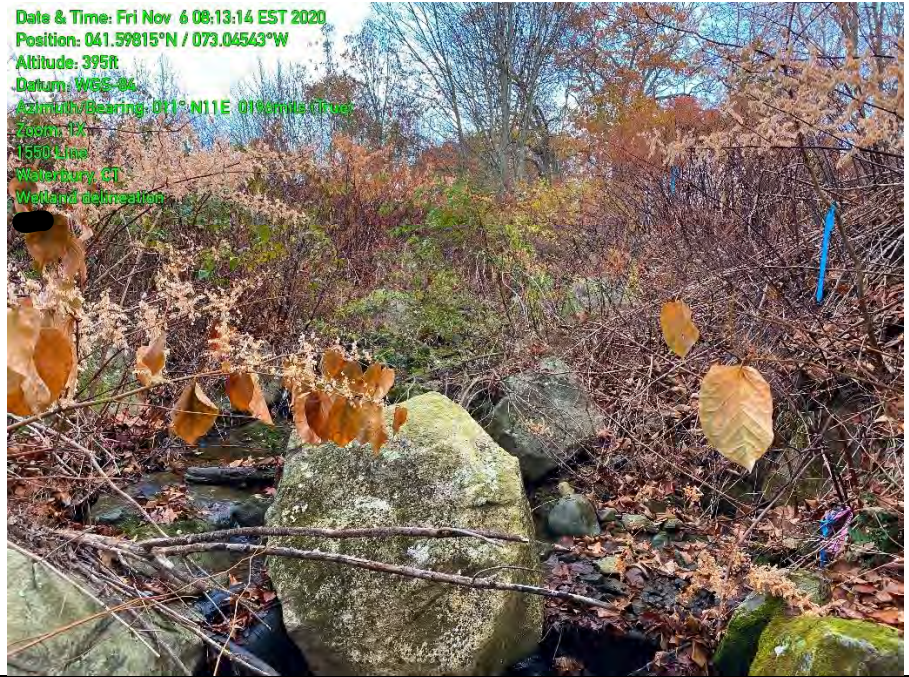
Description: View facing northeast of Wetland 17 and Stream 7 (Unnamed Tributary to Hancock Brook).

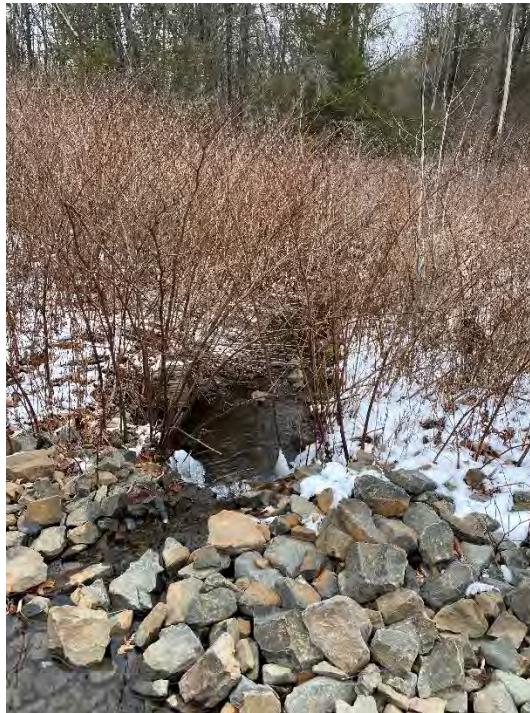
Description: View facing northeast from the access road crossing of Stream 8 located within Wetland 18.

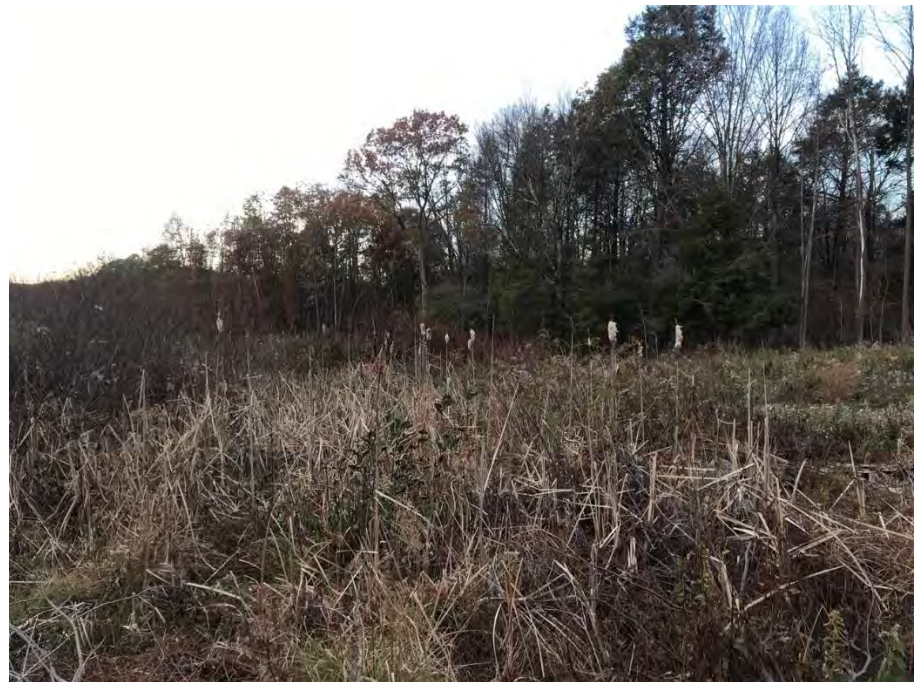
Description: View facing northwest of Wetland 18, south of the existing access road.

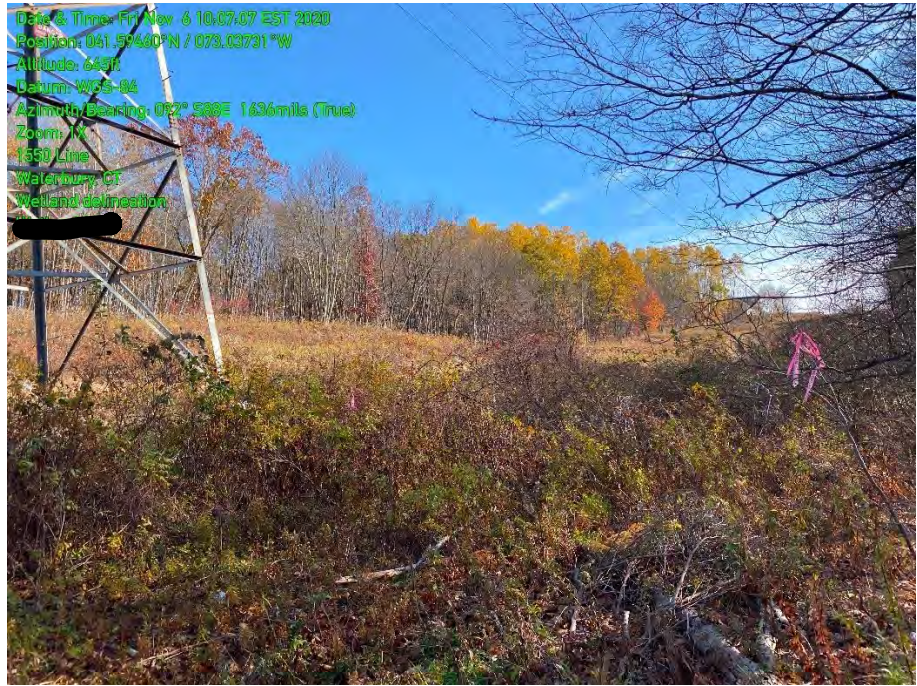
Note lattice Structure 16 on the left.

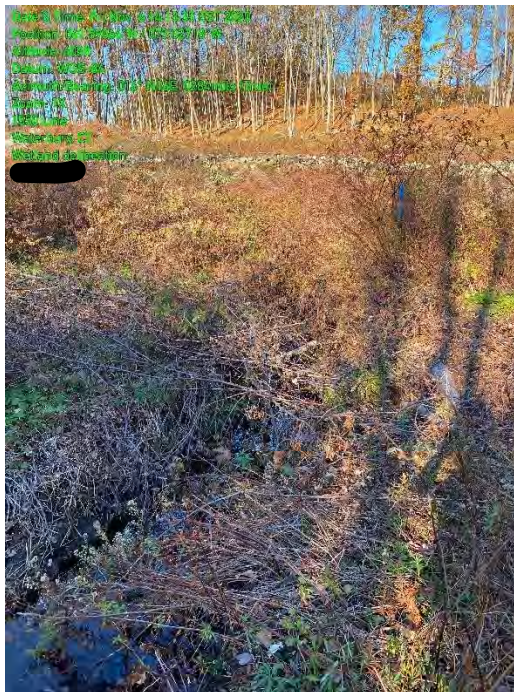
Photo No.: 26 Date: 11/06/20

Description: View facing northeast of Stream 9, and Wetland 20.

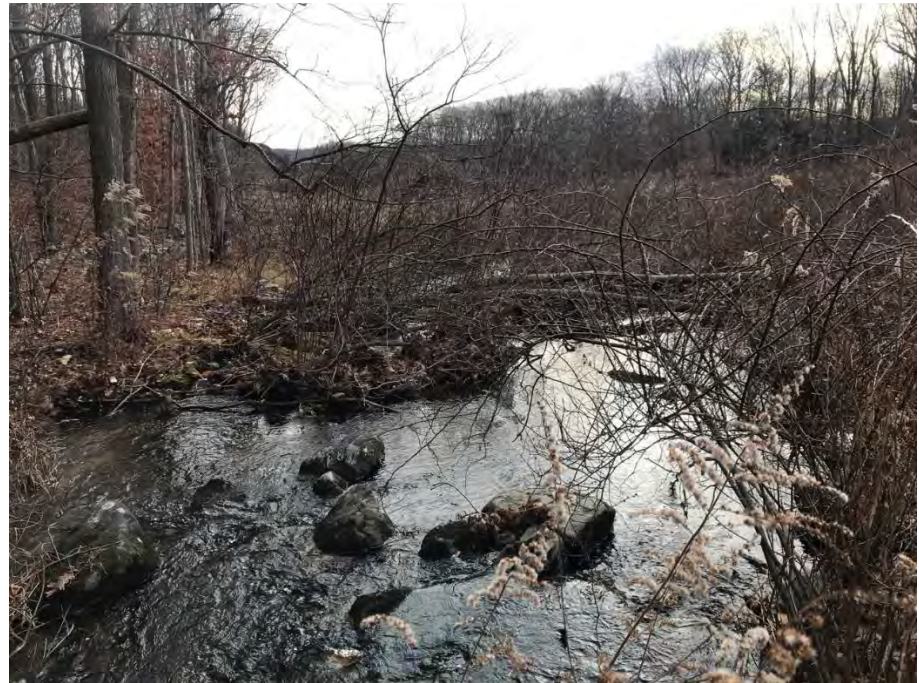
Description: View facing southeast of Stream 10 where it enters into the right-of-way and Wetland 21 in the northwestern corner.

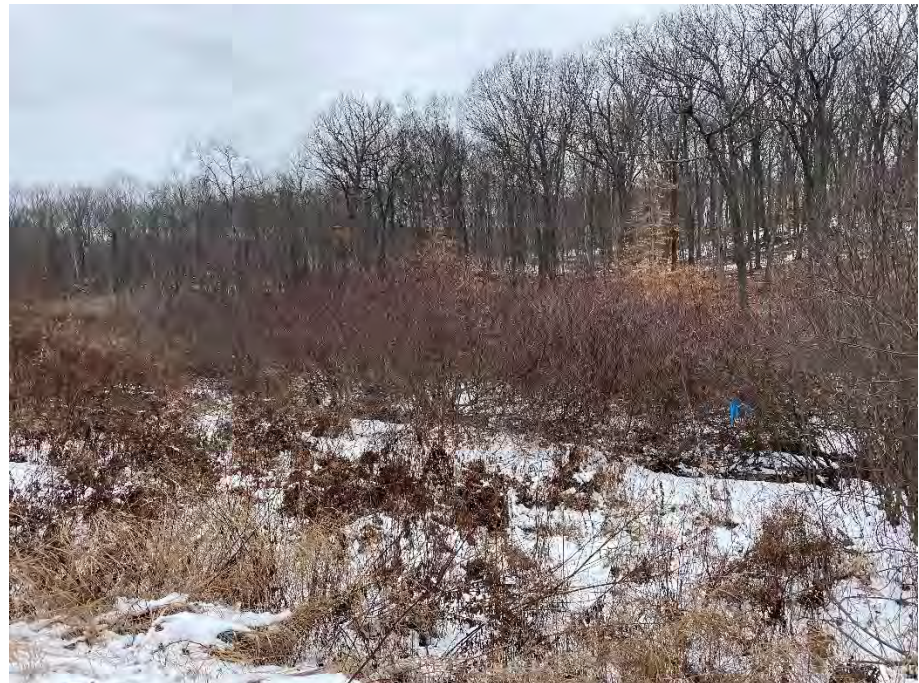
Description: View facing northwest of Wetland 21 and Stream 10.

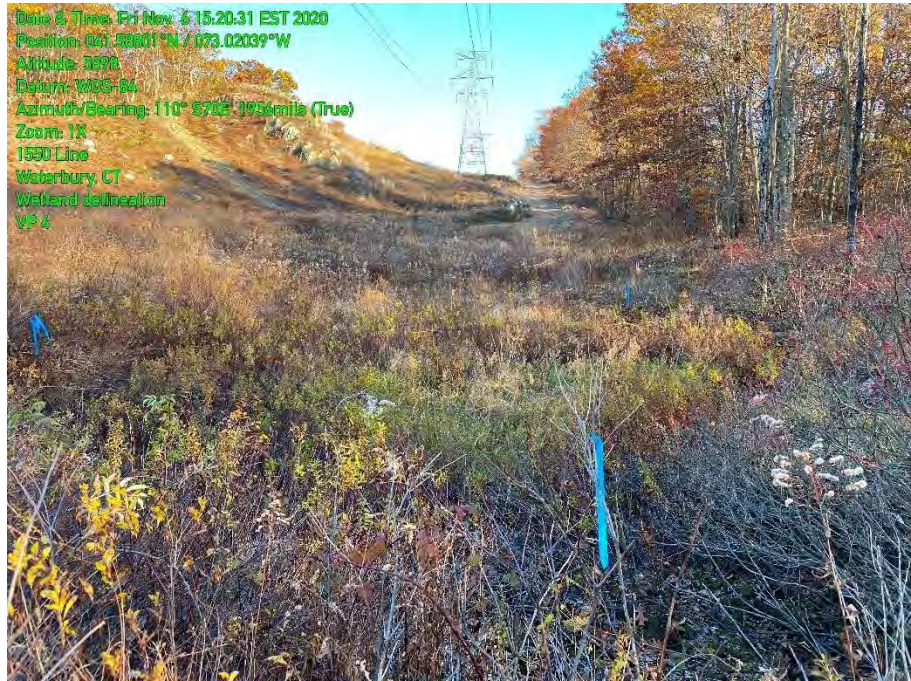
Note lattice Structure 23 in the background.
