Re: Frost Bridge to Noera Rebuild Project

PETITION TO THE CONNECTICUT SITING COUNCIL
FOR A DECLARATORY RULING OF
NO SUBSTANTIAL ADVERSE ENVIRONMENTAL EFFECT
FOR THE PROPOSED MODIFICATIONS TO THE EXISTING
1163 and 1550 LINES IN THE TOWNS OF WATERTOWN, THOMASTON, PLYMOUTH
AND CITY OF WATERBURY, CONNECTICUT

The purpose of the Project is to replace structures and reconductor approximately 5 miles of the 1163 and 1550 lines entirely within the ROW that connects Frost Bridge Substation, located at Frost Bridge Road, Watertown, to Noera Junction in Waterbury and to Noera Substation, located at 1 Foote Street, Waterbury.

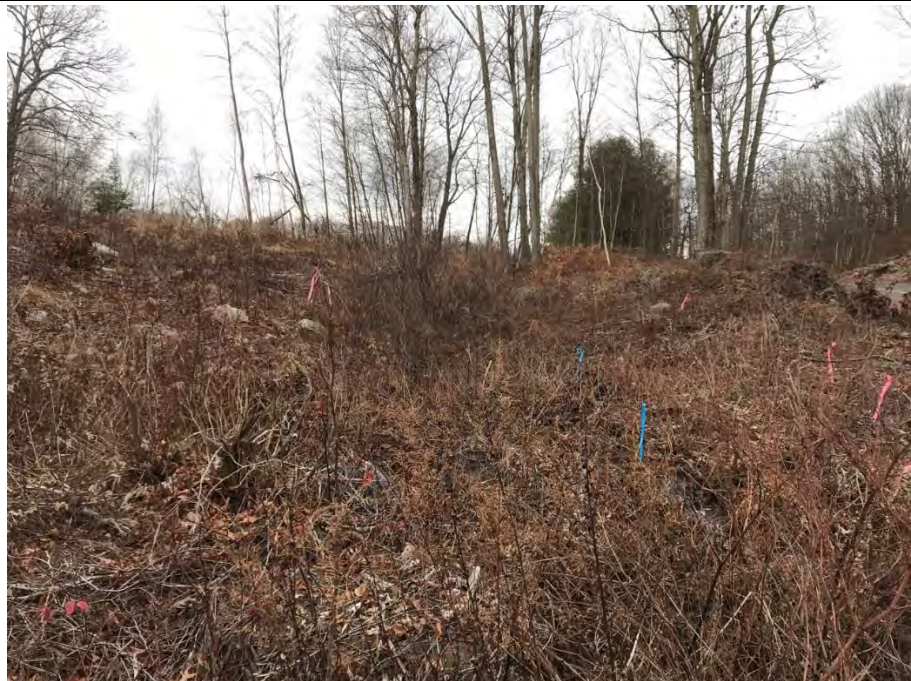
Photo No.: 30 Date: 12/02/20

Description: View facing north of Wetland 21A and Stream 11, which are located on a moderately steep slope before flowing into a culvert under Farm Wood Road (far right of photo) and into Wetland 25.

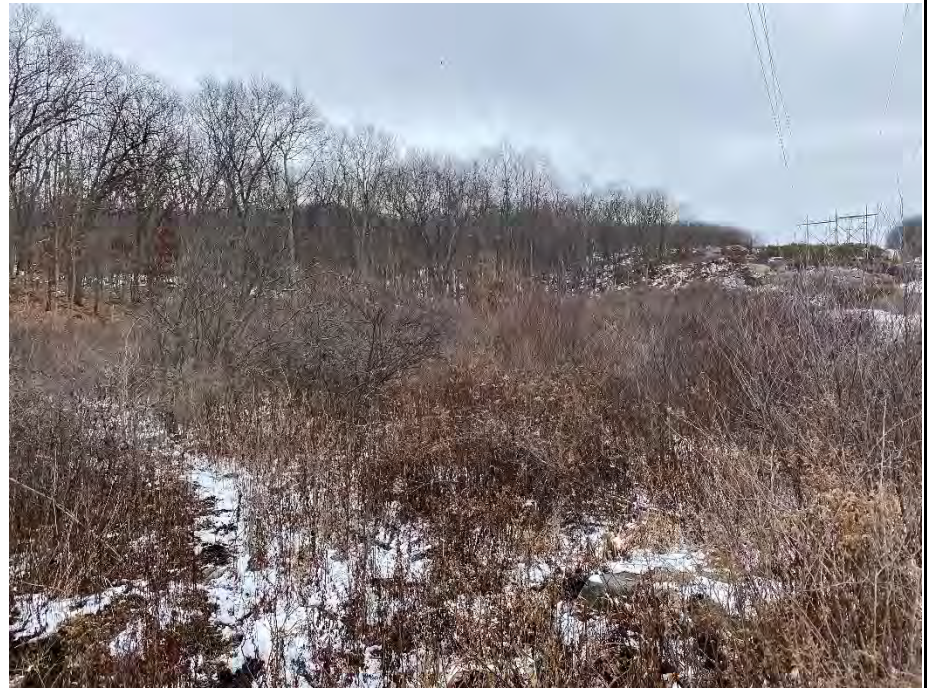
Description: View facing east of Wetland 22A.

Note lattice Structure 26 in the background.

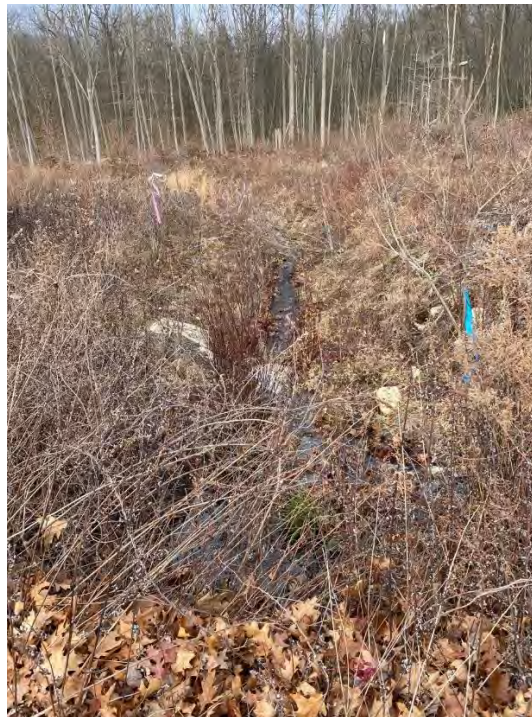
Description: View facing north of Stream 13 inside the eastern side of Wetland 22A.

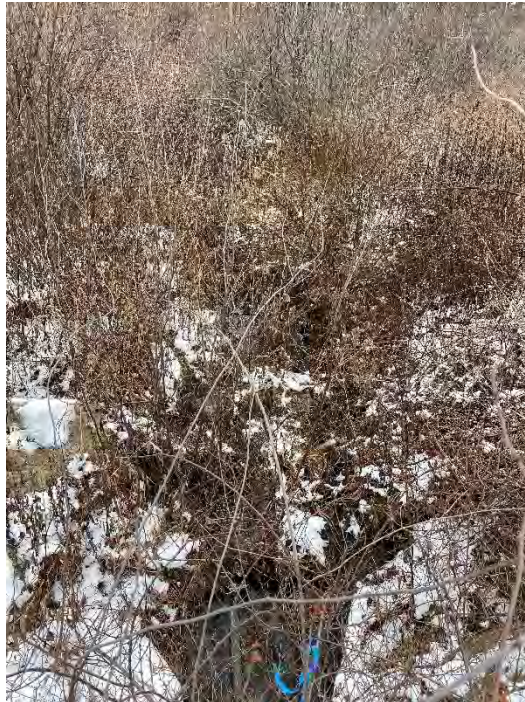
Description: View facing northeast of Stream 12 inside of Wetland 22A in the far southwestern corner where it flows into a culvert under the existing access road and into Wetland 25.

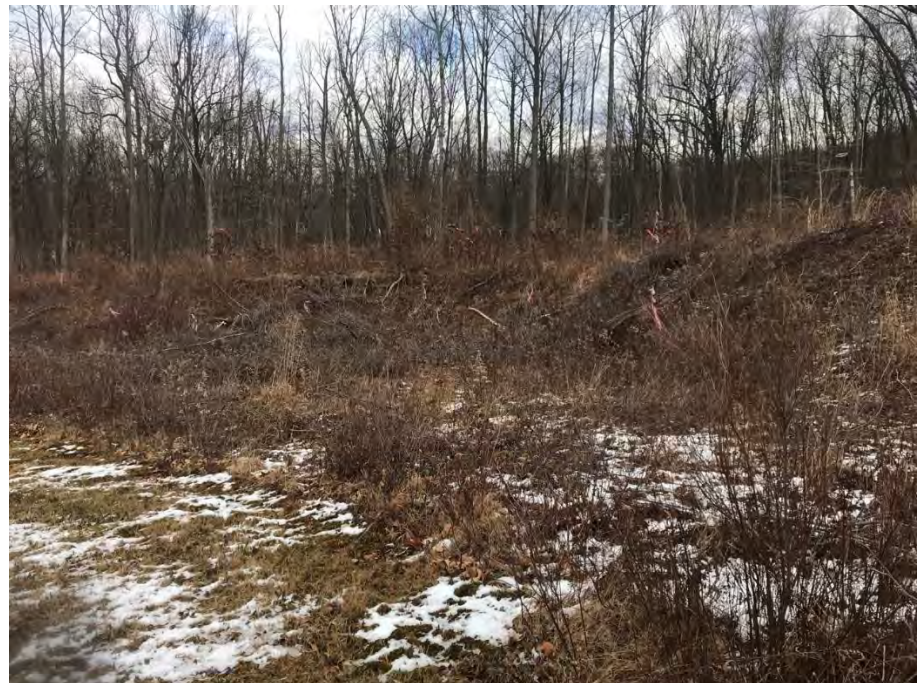
Description: View facing northeast of Wetland 23.

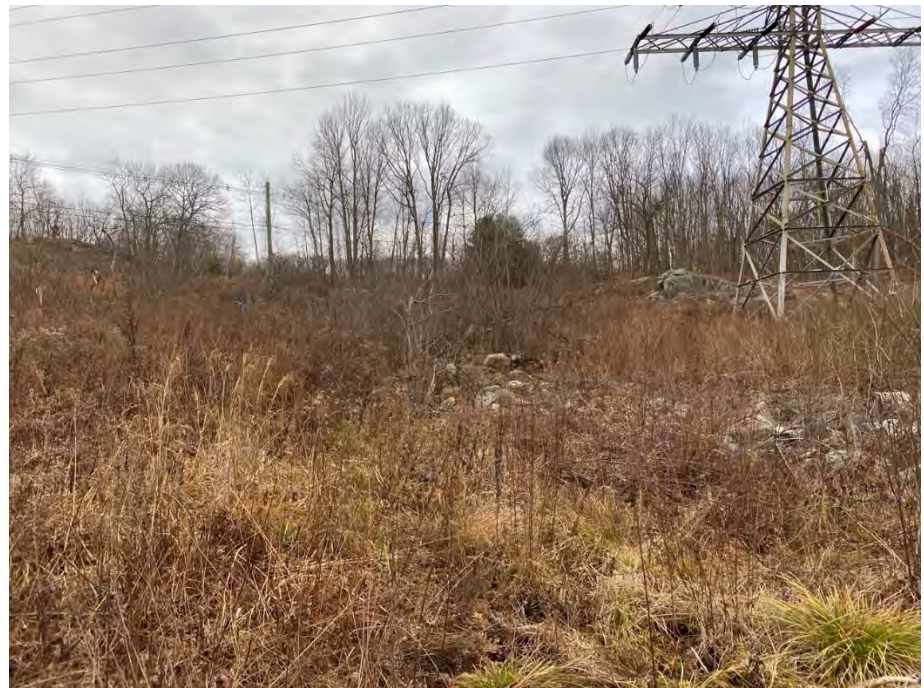
Description: View facing north of Wetland 25.

Note lattice Structure 25 on the right.

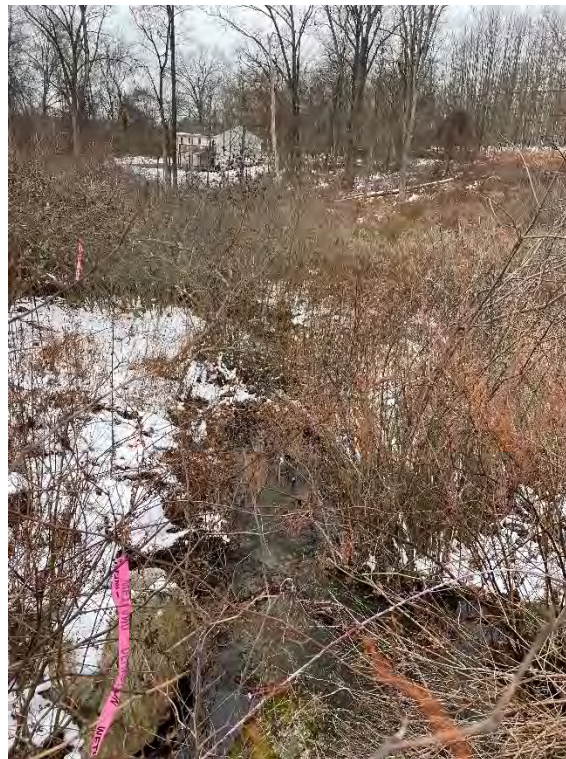
Description: View facing south where Stream 11 (right) converges with Stream 13 (center) inside Wetland 25.

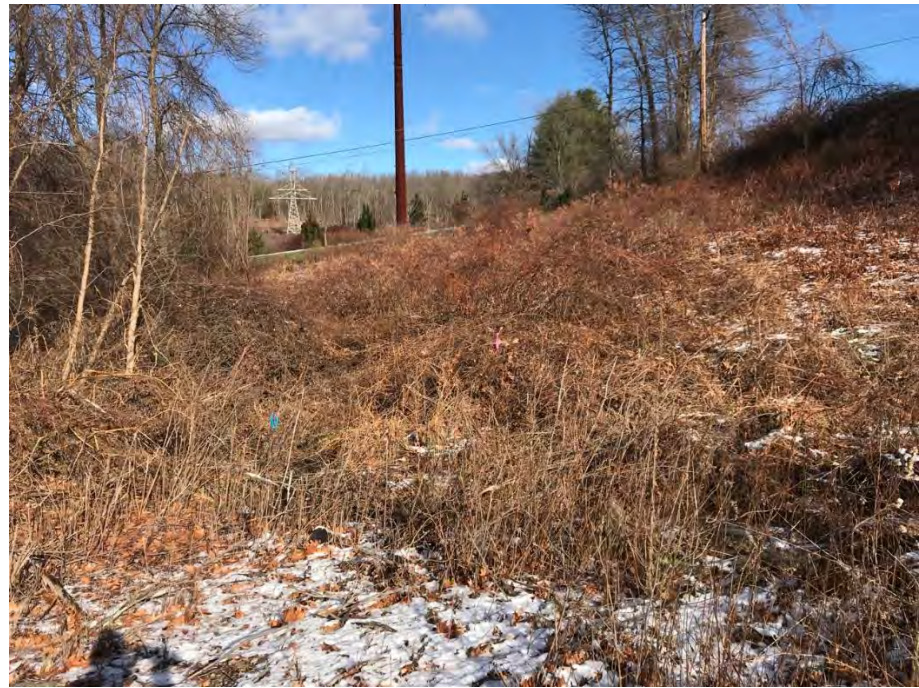
Description: View facing northeast of Wetland 26 and Stream 14.

Note monopole Structure 691 in the background and lattice Structure 25 in far background.

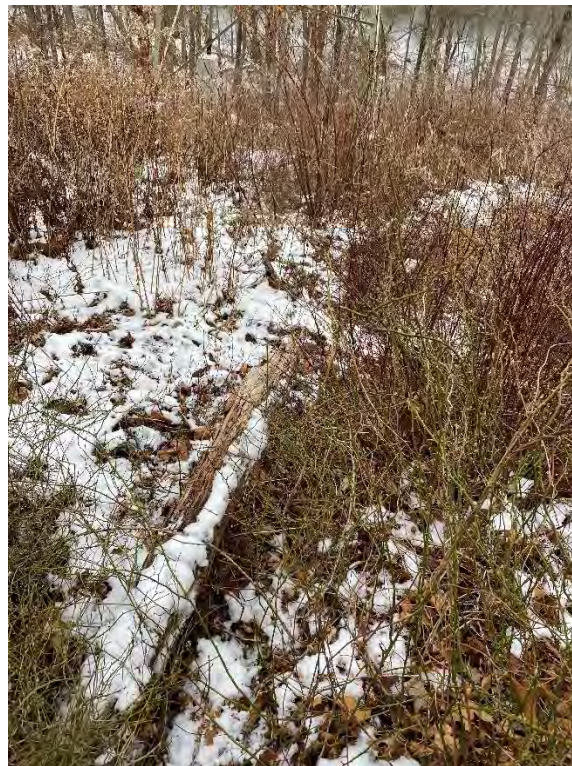
Description: View facing west of Stream 15, which drains an upslope PFO wetland located outside of the right-of-way.

Note the base of lattice Structure 692 in the background and Great Brook Reservoir in far background.

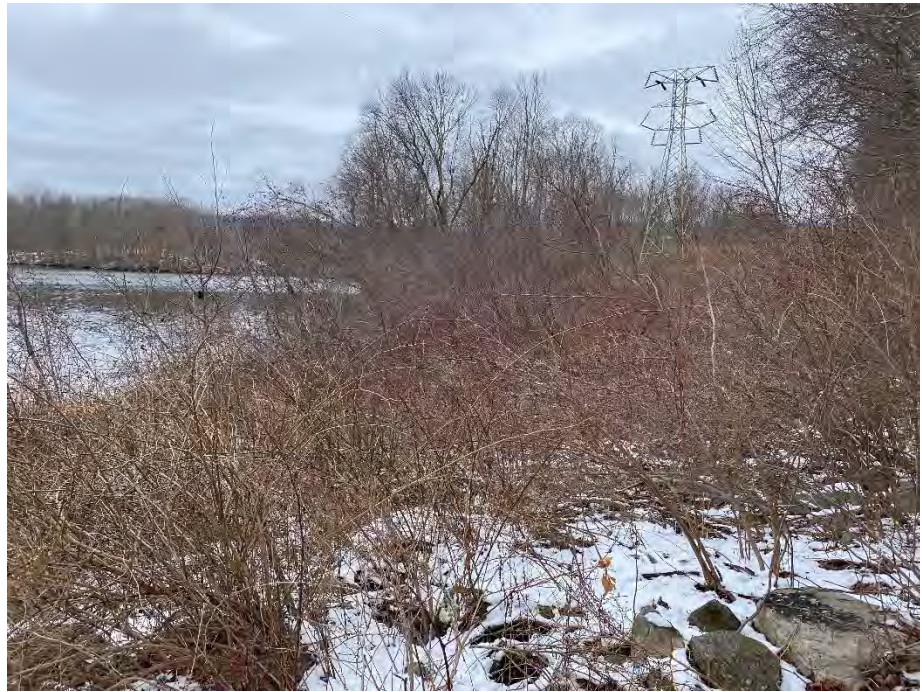
Description: View facing north of Wetland 27. Wetland 27 at this location is part Open Water (Great Brook Reservoir) and PSS cover type.

Note lattice Structure 693 in the background.

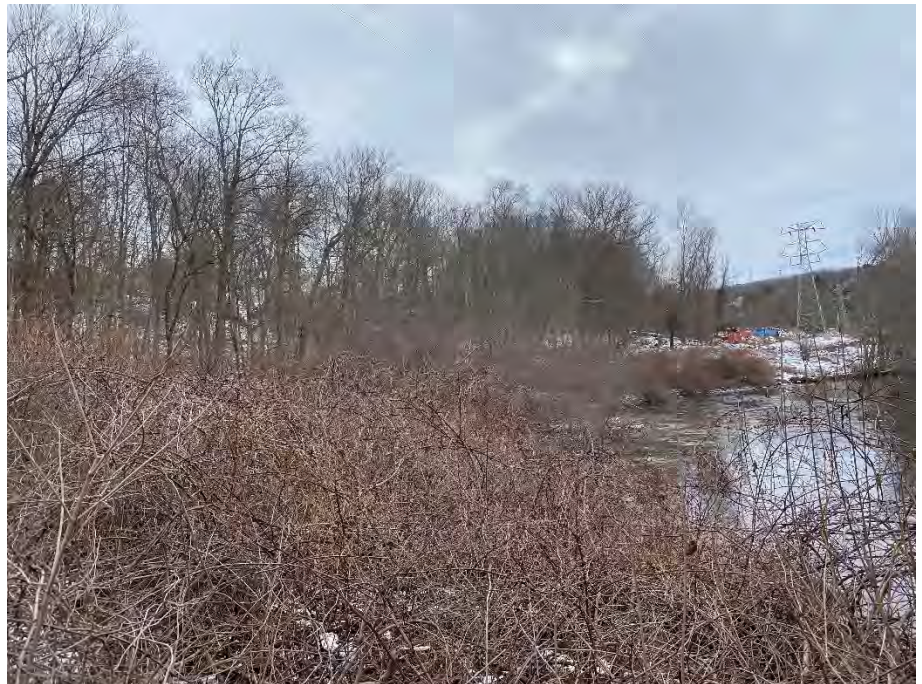
Description: View facing south of Wetland 27. Wetland 27 at this location is part Open Water (Great Brook Reservoir) and PSS cover type.

Note lattice Structure 694 in the background.

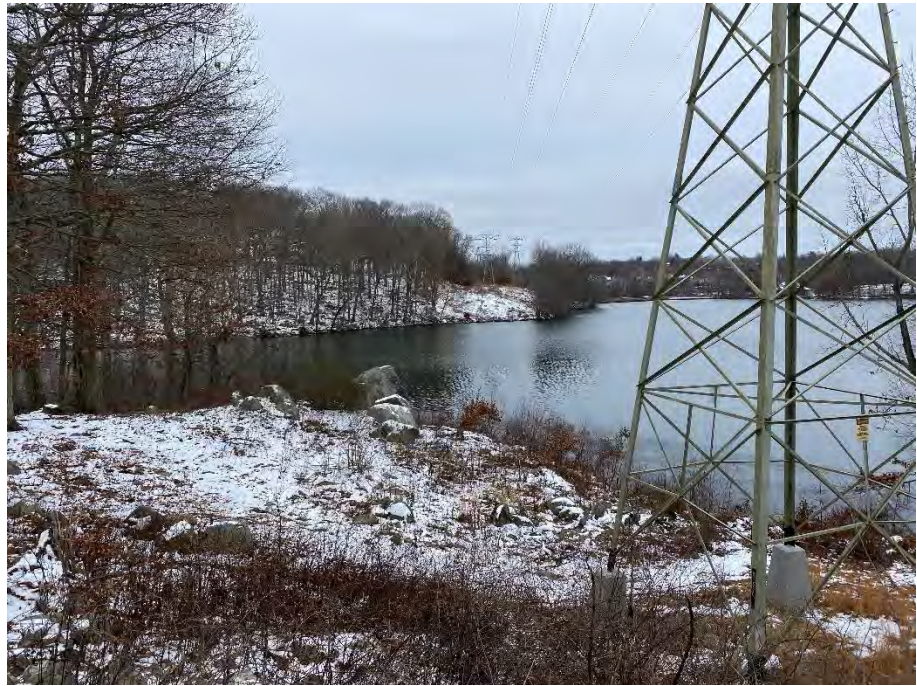
Description: View facing north of second crossing of Wetland 27 (Great Brook Reservoir), all Open Water at this location.

Note lattice Structure 695 in foreground and Structure 696 in background.

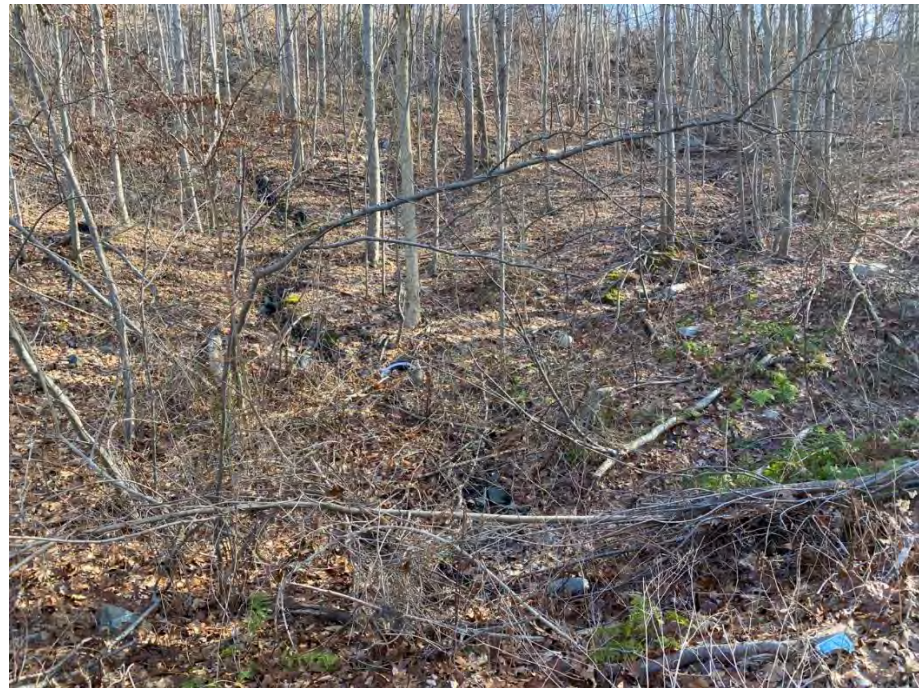
Description: View facing southeast of Wetland 34, located east of the cleared ROW adjacent to unimproved access road.

Note that Wetland 34 is connected to Wetland 30 via culvert under the existing unimproved access road.

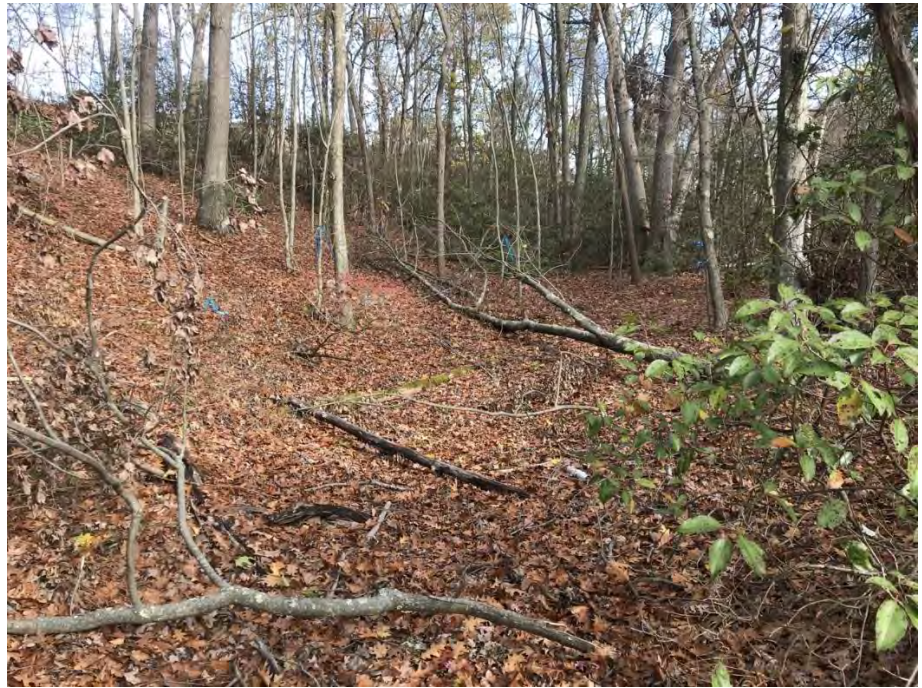
Photo No.: 11 Date: 11/03/20

Description: View facing northeast of Vernal Pool 2, observed to be dried out during the wetland delineation in November 2020.

Wetland 8 is a palustrine forested (PFO) wetland located adjacent to the maintained portion of the ROW and was found to contain one (1) cryptic vernal pool breeding area (see Photos 9-11). Obligate vernal pool species were observed during two breeding seasons (Spring 2021 and Spring 2022) as noted in Table 2, which included wood frog (*Lithobates sylvaticus*) egg masses and larvae (see Photo 13) and spotted salamander (*Ambystoma maculatum*) egg masses (see Photo 12). No fairy shrimp, marbled salamander, or state-listed vernal pool breeding amphibians were observed. The vernal pool area exhibits a soft, leafy, silty bottom and flood depths within the breeding area at approximately 1-2 feet on average. The vernal pool (VP) 2 breeding area is approximately 30-feet long and 15-feet wide and its area accounts for the large majority of Wetland 8.

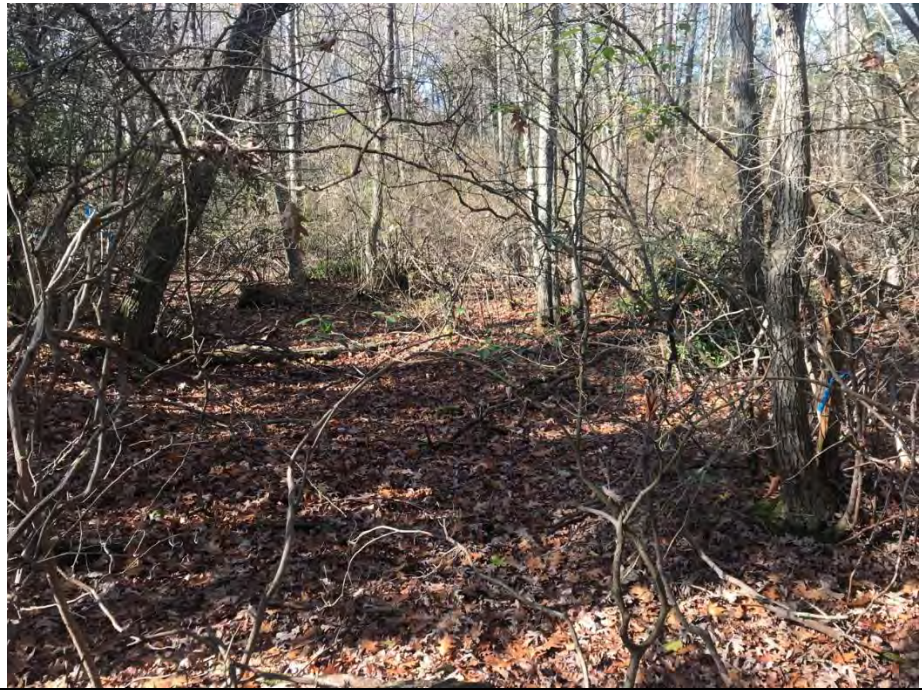
Photo No.: 15 Date: 04/08/21

Description: View facing northwest of Vernal Pool 3, observed to be dried out during the wetland delineation in November 2020.

was observed to be completely dried out (see Photo 15). Based on that observation and the depth of the pool, it is likely that the pool dries out during most years (i.e., temporarily inundated).

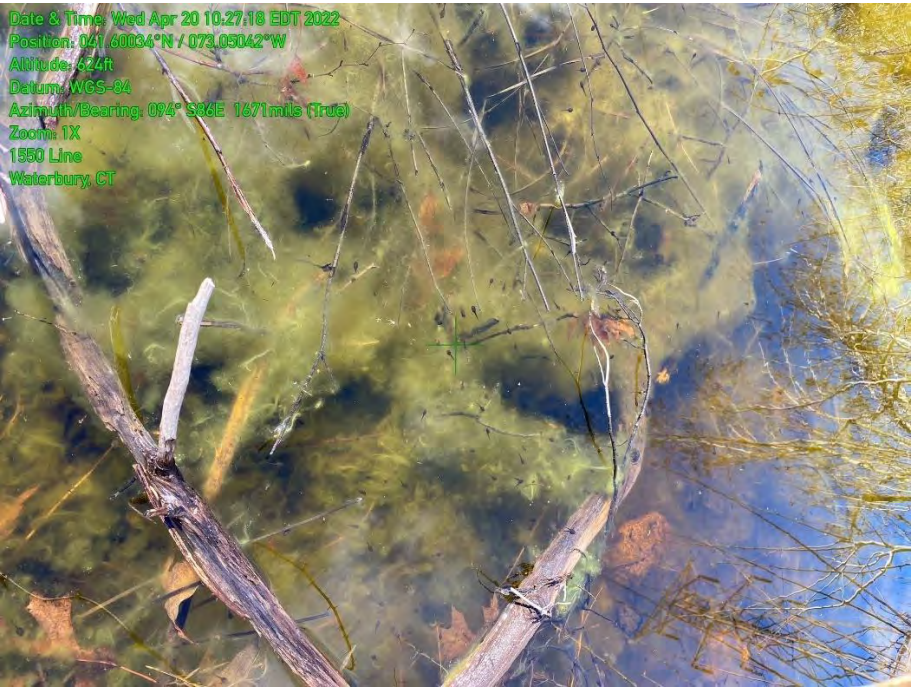
Description: View within Vernal Pool 5 (located within Wetland 15) of spent wood frog (*Lithobates sylvaticus*) egg masses (green) and hatched larvae.

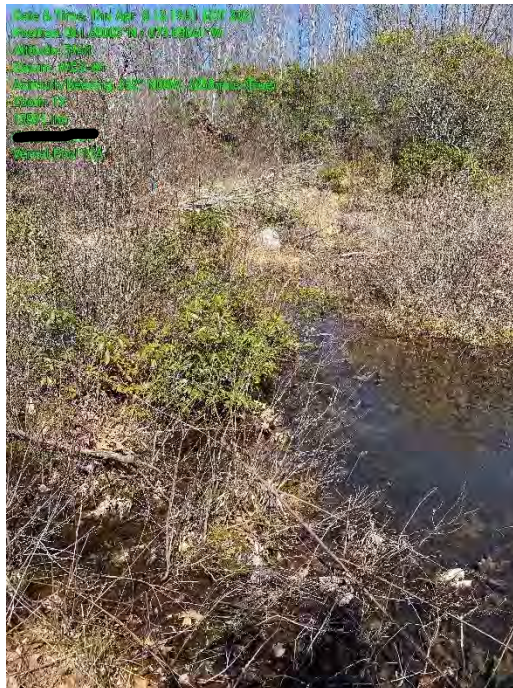
Description: View facing northwest of Vernal Pool 6 located within the PSS portion of Wetland 15, south of the existing access road.

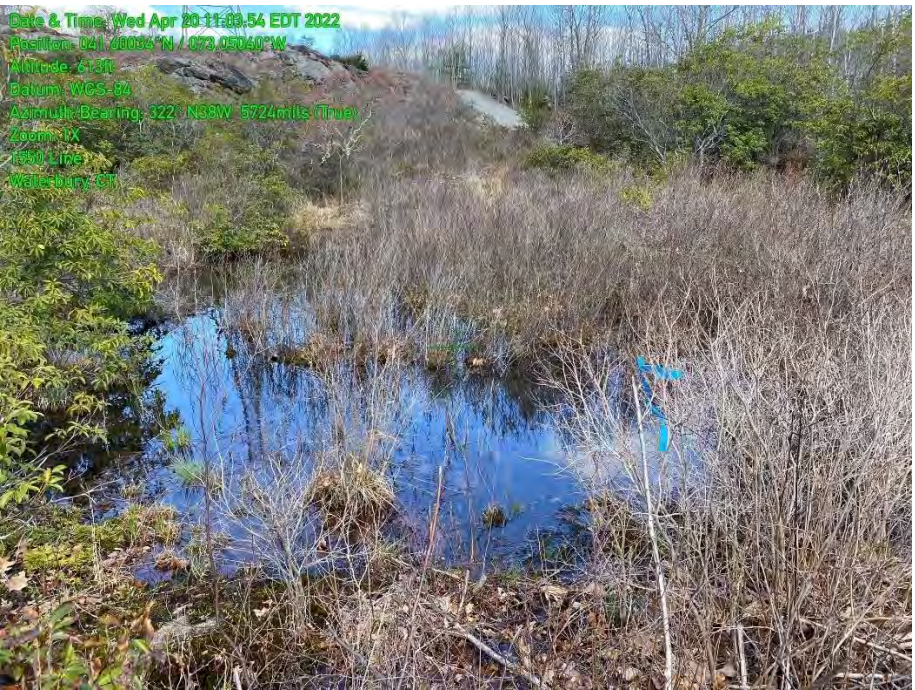
Description: View facing northwest of Vernal Pool 6 located within the PSS portion of Wetland 15, south of the existing access road.

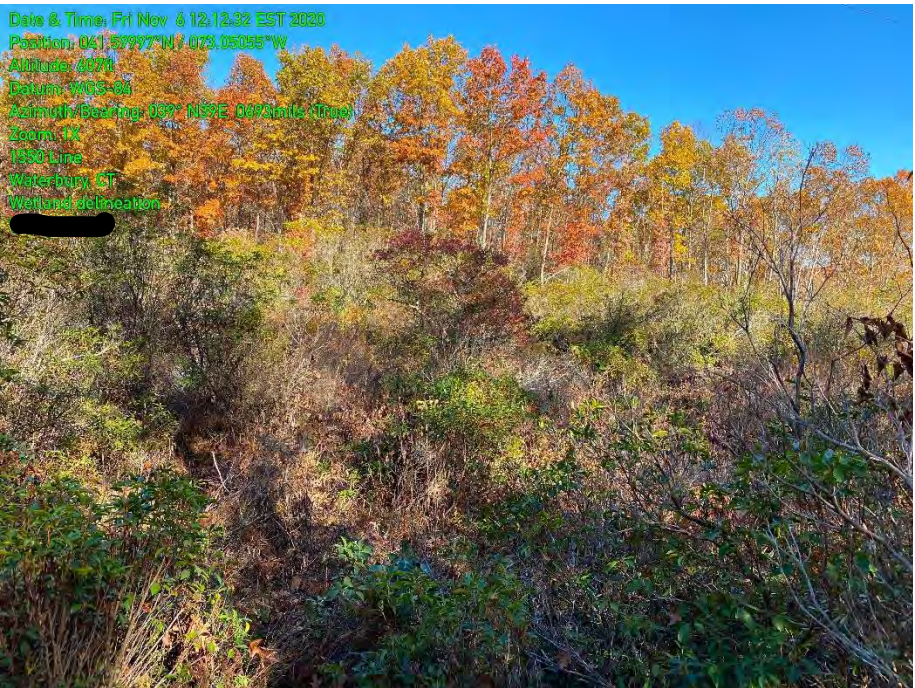
Photo No.: 30 Date: 04/08/21

Description: View facing northeast of Vernal Pool 6, observed to be dried out during the wetland delineation in November 2020.

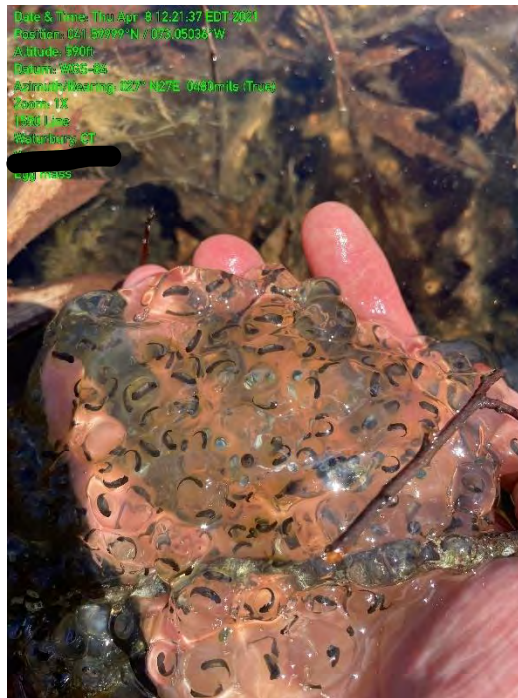
Description: View within Vernal Pool 6 (located within Wetland 15) of wood frog (*Lithobates sylvaticus*) egg masses with developing larvae.

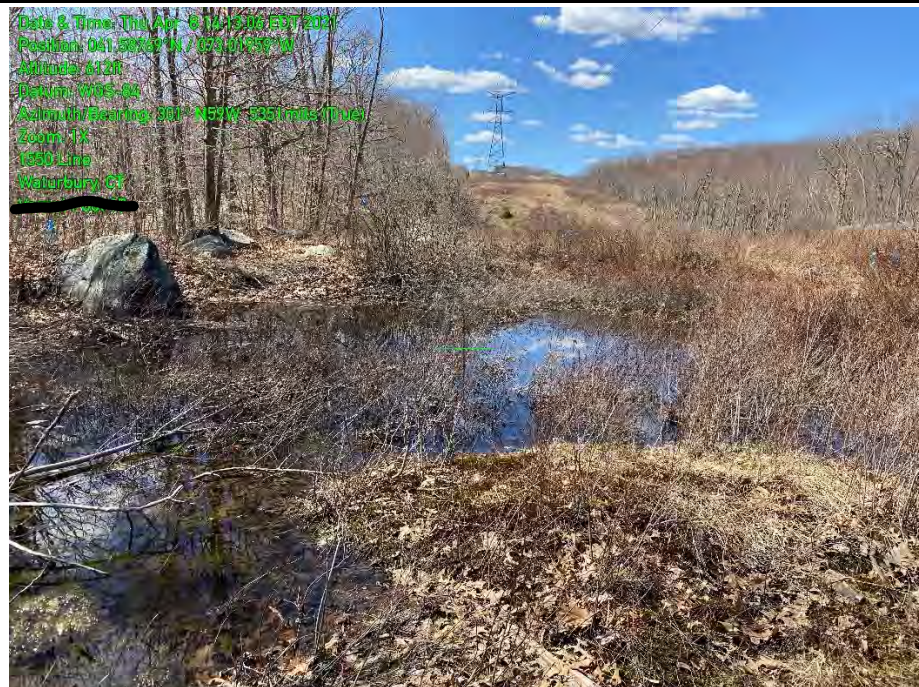
Description: View facing northwest of Vernal Pool 7 located within the Wetland 22. Lattice Structure 22 in background.

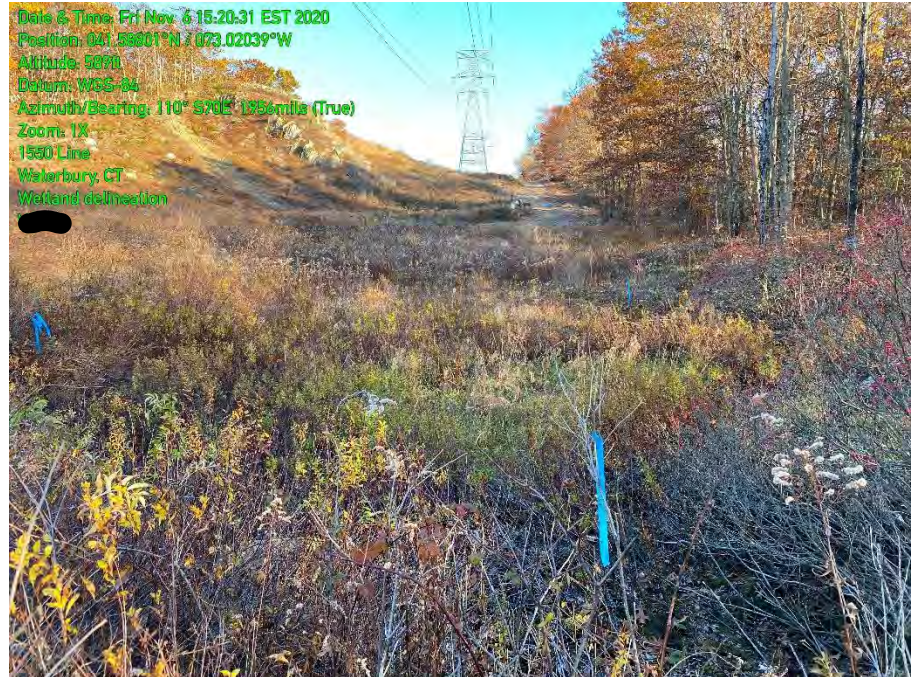
Description: View facing southeast of Vernal Pool 7, observed to be dried out during the wetland delineation in November 2020.

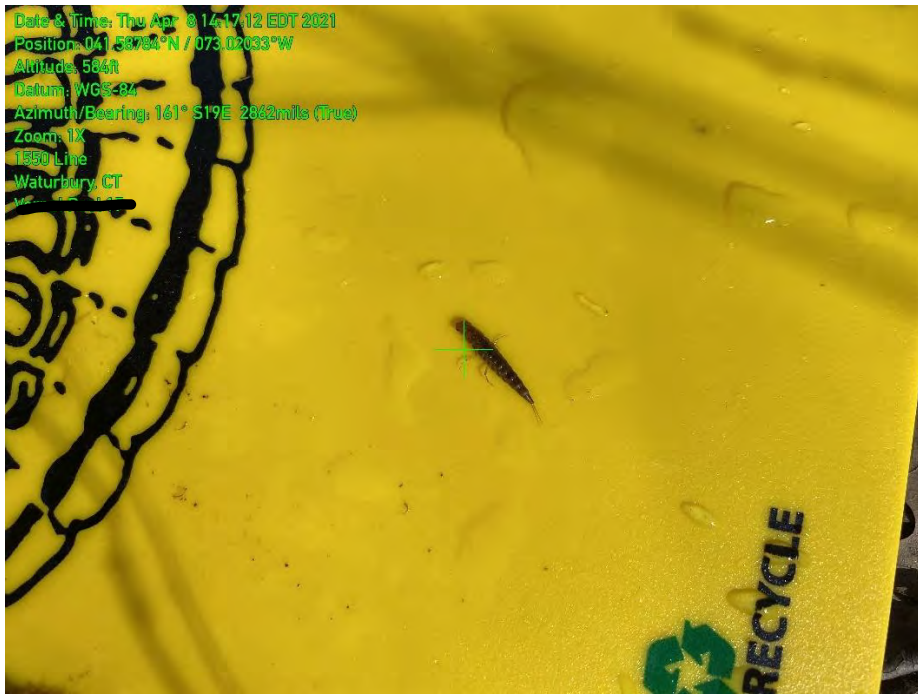
Description: View within Vernal Pool 7 (located in Wetland 22) of a fairy shrimp (*Eubranchipus* sp.).

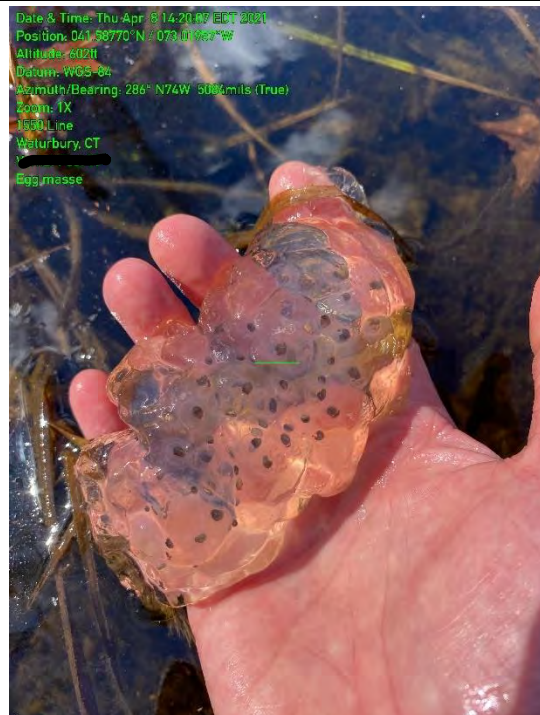
Description: View within Vernal Pool 7 (located in Wetland 22) of a wood frog (*Lithobates sylvaticus*) egg mass.

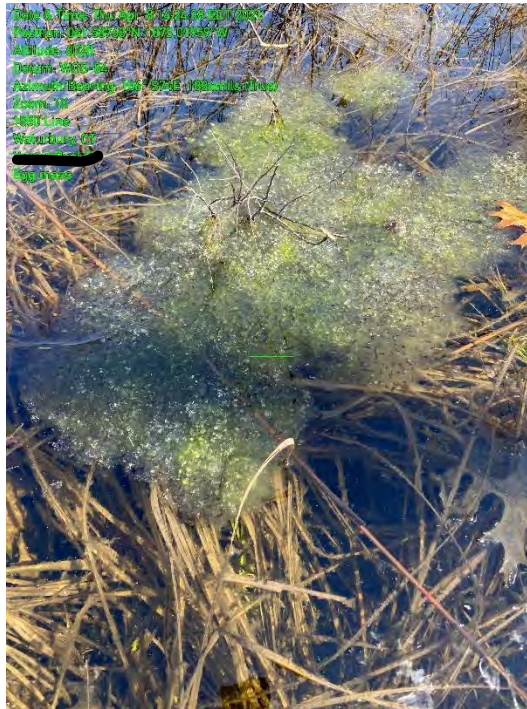
Description: View within Vernal Pool 7 (located in Wetland 22) of wood frog (*Lithobates sylvaticus*) egg masses with developing larvae.

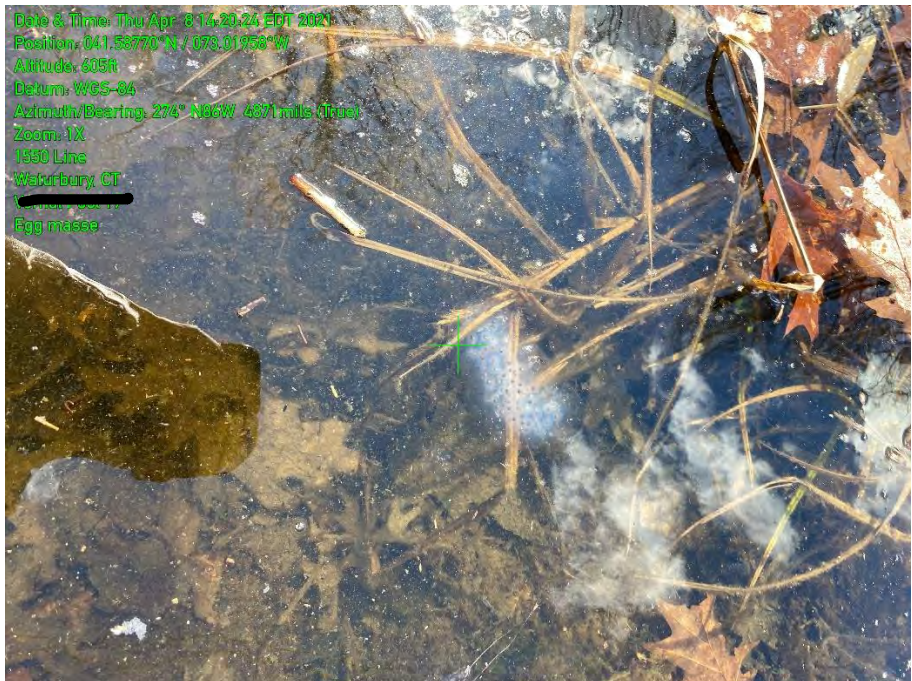
Description: View within Vernal Pool 7 (located in Wetland 22) of a spotted salamander (*Ambystoma maculatum*) egg mass.

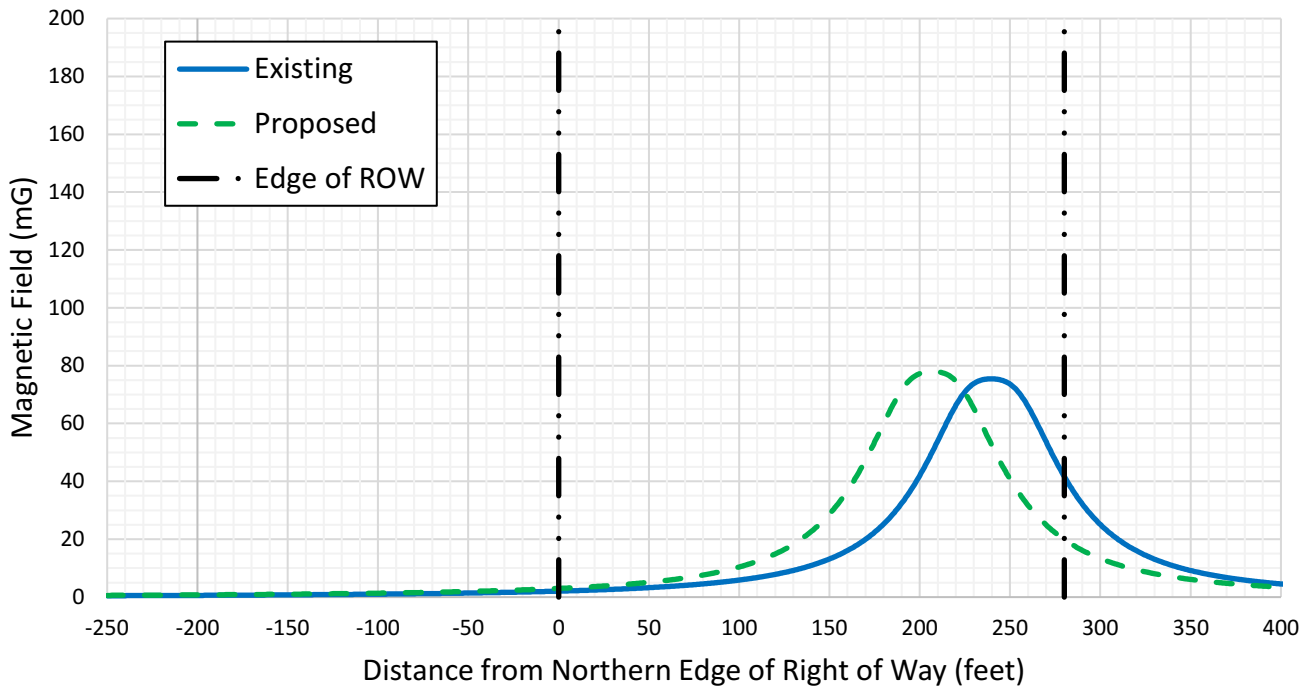
Calculated Magnetic Fields (Annual Average Loads) Frost Bridge - Structure 4

The results of the calculations show that the proposed modifications would not substantially increase electric or magnetic fields. In locations between Frost Bridge and Noera Junction, magnetic fields at the southern/western edges of the ROW will significantly decrease. Electric fields are expected to increase slightly throughout the ROW, due to the increased conductor diameter. See Attachment F: EMF Graphs.

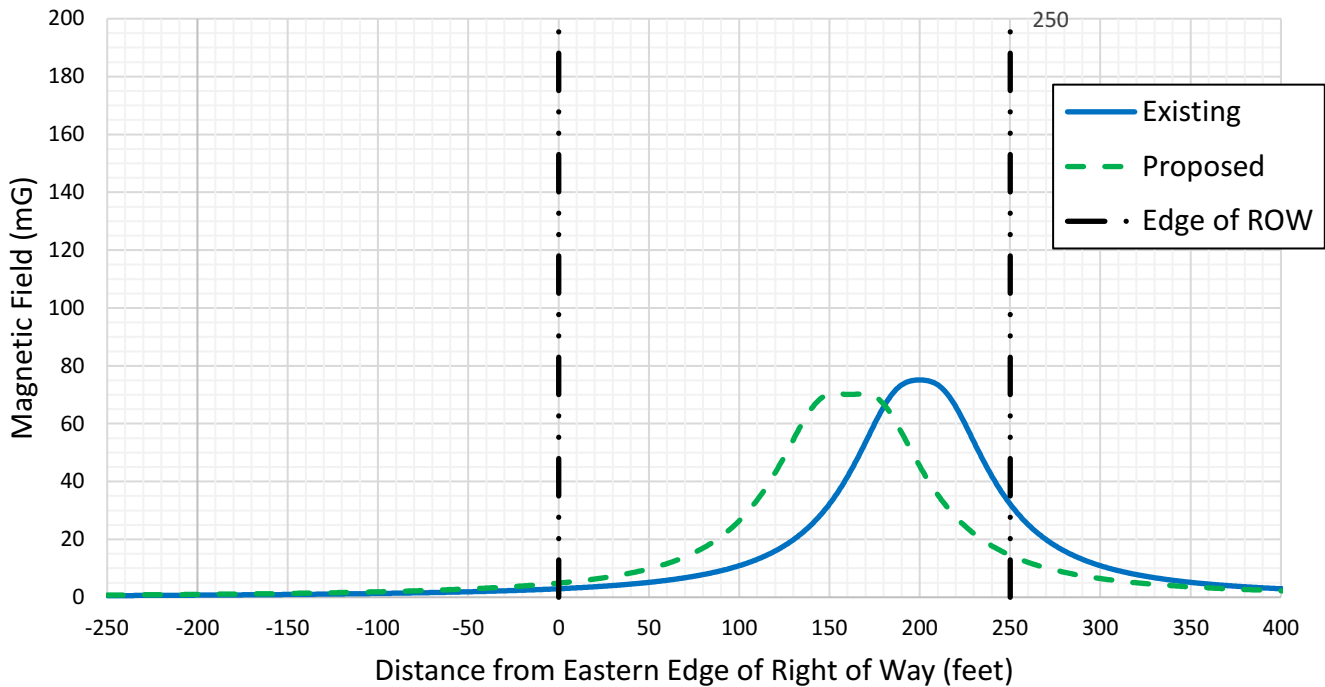
Calculated Magnetic Fields (Annual Average Loads) Structure 4-Structure 9

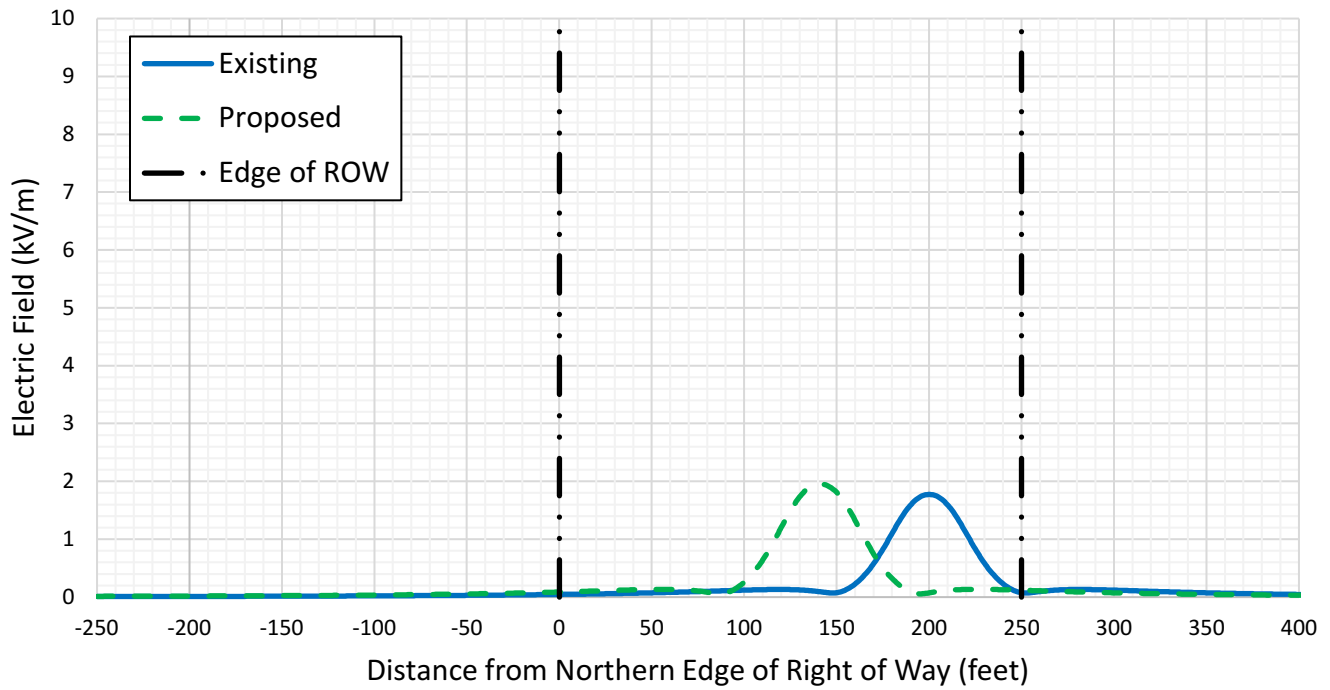
Calculated Electric Fields (Annual Average Loads) Structure 9 - Structure 16

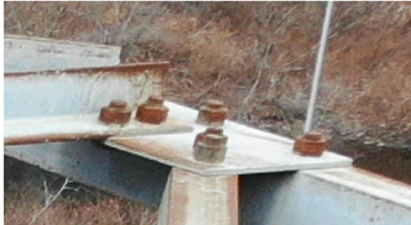
- Rusted/pitted attachment plates
- Rusted bolts
- Bent and Rusted structure members

The 1163 and 1550 lines within the Project area are primarily supported on double-circuit lattice tower transmission structures, most of which are between 65 to 74 years old. Eversource has identified the existing copper conductor and copperweld shield wire as obsolete and susceptible to failure due to thermal rating and environmental degradation and need to be replaced. Eversource has determined that the existing lattice tower structures require replacement due to their inability to physically support the new conductor. In addition, many of the existing lattice structures are also displaying age-related degradation (corrosion, bent and deteriorated frame members, rusted critical structure members and attachment plates). See attachment H: Photographs.

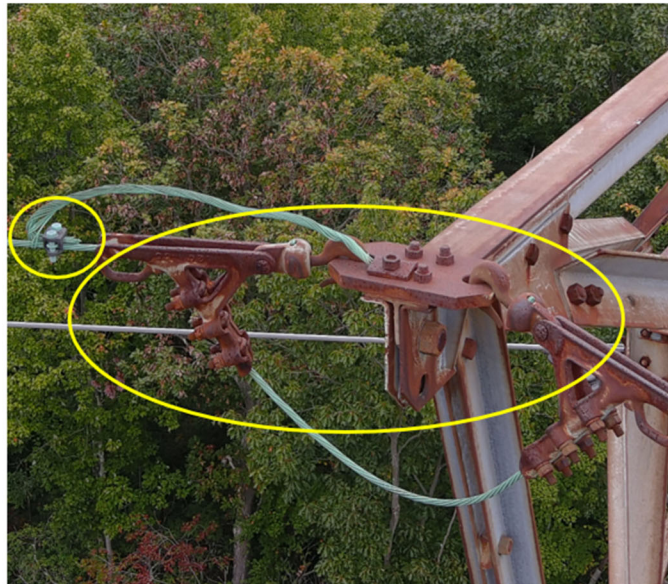
Structure 05

- Corrosion on attachment plate and hardware

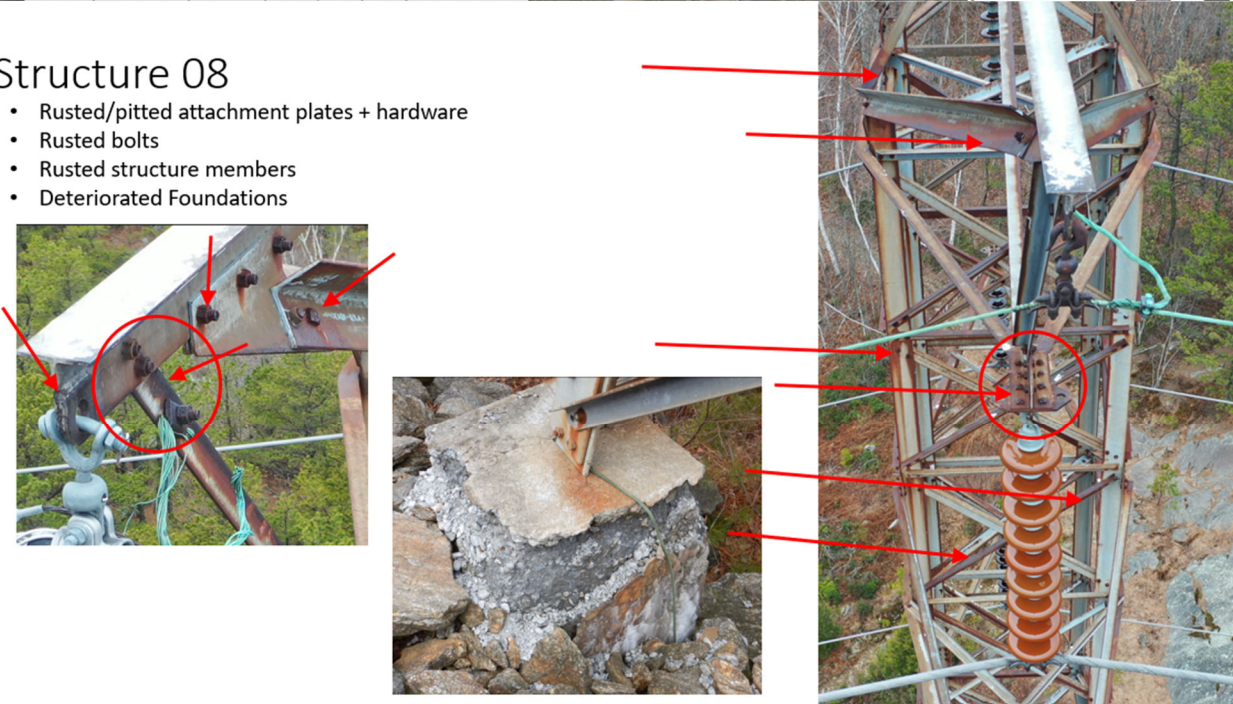
Structure 08

- Rusted/pitted attachment plates + hardware
- Rusted bolts
- Rusted structure members
- Deteriorated Foundations
