Re: Pootatuck to West Devon Rebuild Project

PETITION TO THE CONNECTICUT SITING COUNCIL
FOR A DECLARATORY RULING OF
NO SUBSTANTIAL ADVERSE ENVIRONMENTAL EFFECT
FOR THE PROPOSED MODIFICATIONS TO THE EXISTING
1580, 1241, 1483, AND 1545 LINES IN THE CITY OF SHELTON
AND TOWN OF STRATFORD, CONNECTICUT

The purpose of the Project is to replace structures and reconductor along approximately 3.3 miles of the 1580, 1241, 1483 and 1545 lines within the existing ROW that connects United Illuminating's (“UI”) Pootatuck Substation, located at 14 Old Stratford Road in Shelton (“Pootatuck”) to Eversource’s West Devon Junction, located near River Valley Road in Stratford (“West Devon”). Project work will also include replacing the existing shield wire.

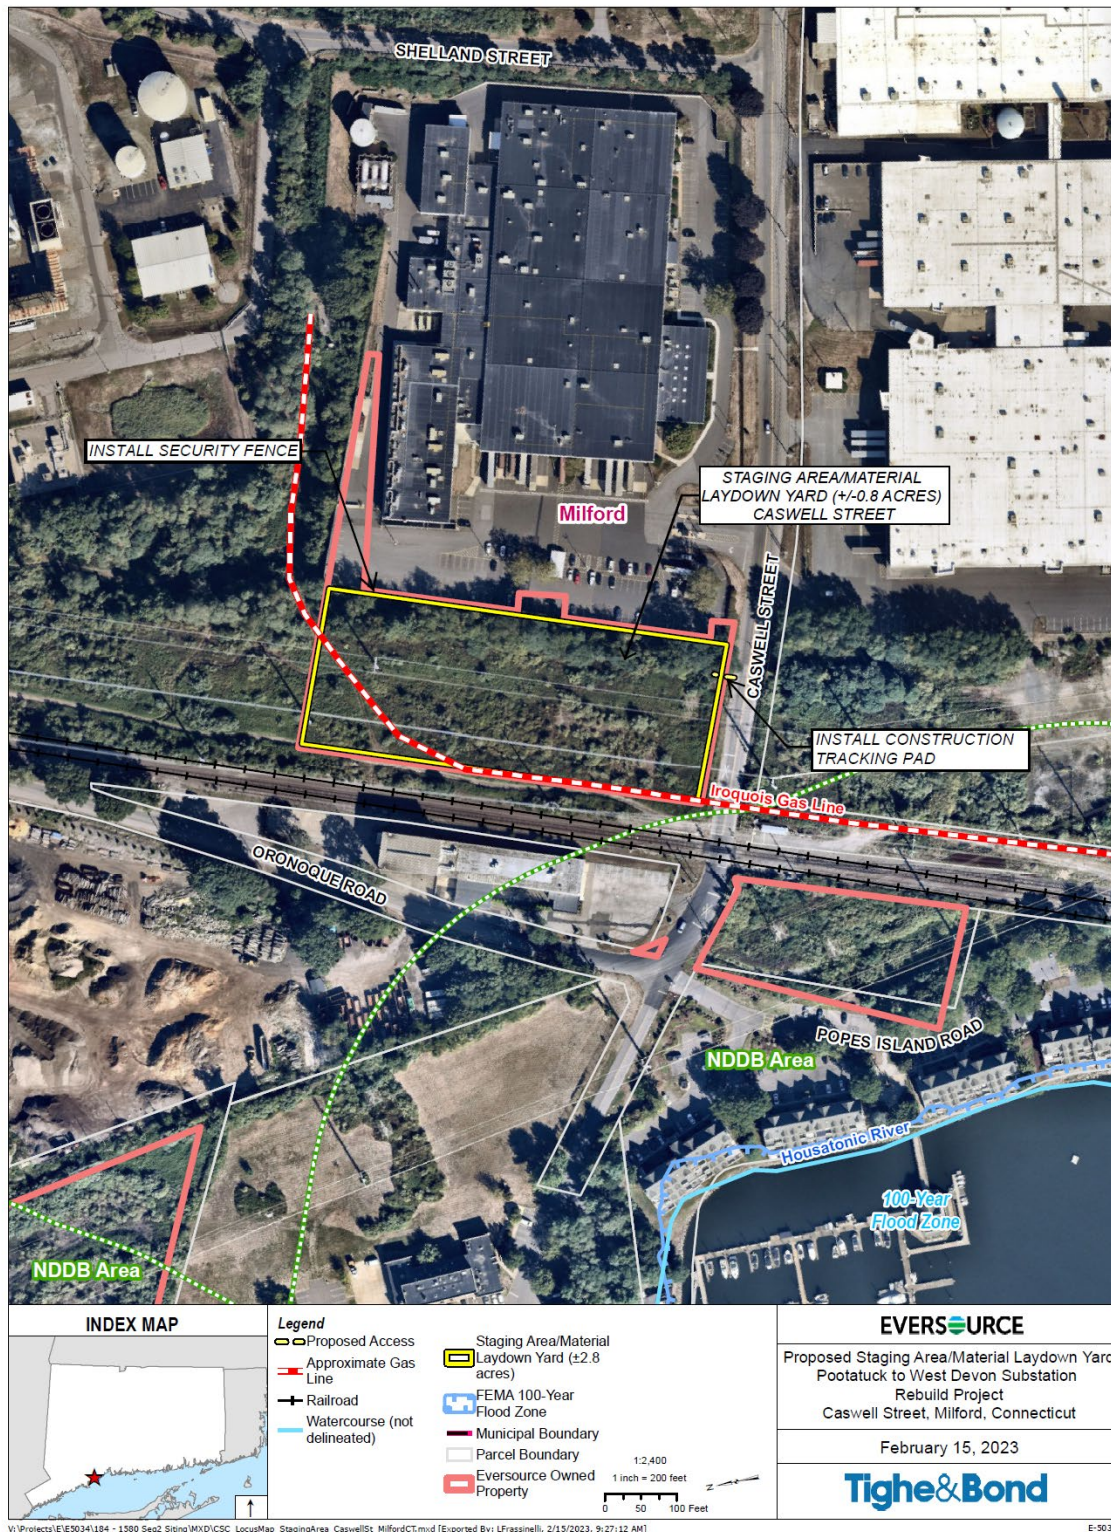
Figure 2: Staging Area/Laydown Yard

Eversource proposes to establish a staging area/laydown yard for the Project on Caswell Street located near 61 Caswell Street in Milford. This staging area/laydown yard is approximately 3 acres. This staging area/laydown yard would be used to store construction equipment and materials, (including tools, and supplies) conductor, insulators, hardware, poles and construction mats, for the Project. Office trailers may also be located at the staging area/laydown area, and transmission line components removed during the work (structure steel, conductor, hardware and insulators) may be temporarily accumulated and stored prior to removal off-site for salvage and/or disposal. The staging area/laydown may also be used by construction crew members for parking personal vehicles as well as for construction vehicles, and for performing minor maintenance, when needed, on construction equipment. Erosion and sedimentation (“E&S”) controls would be installed and maintained until completion of the work in accordance with Project permits and Eversource’s BMP’s. See Figure 2.

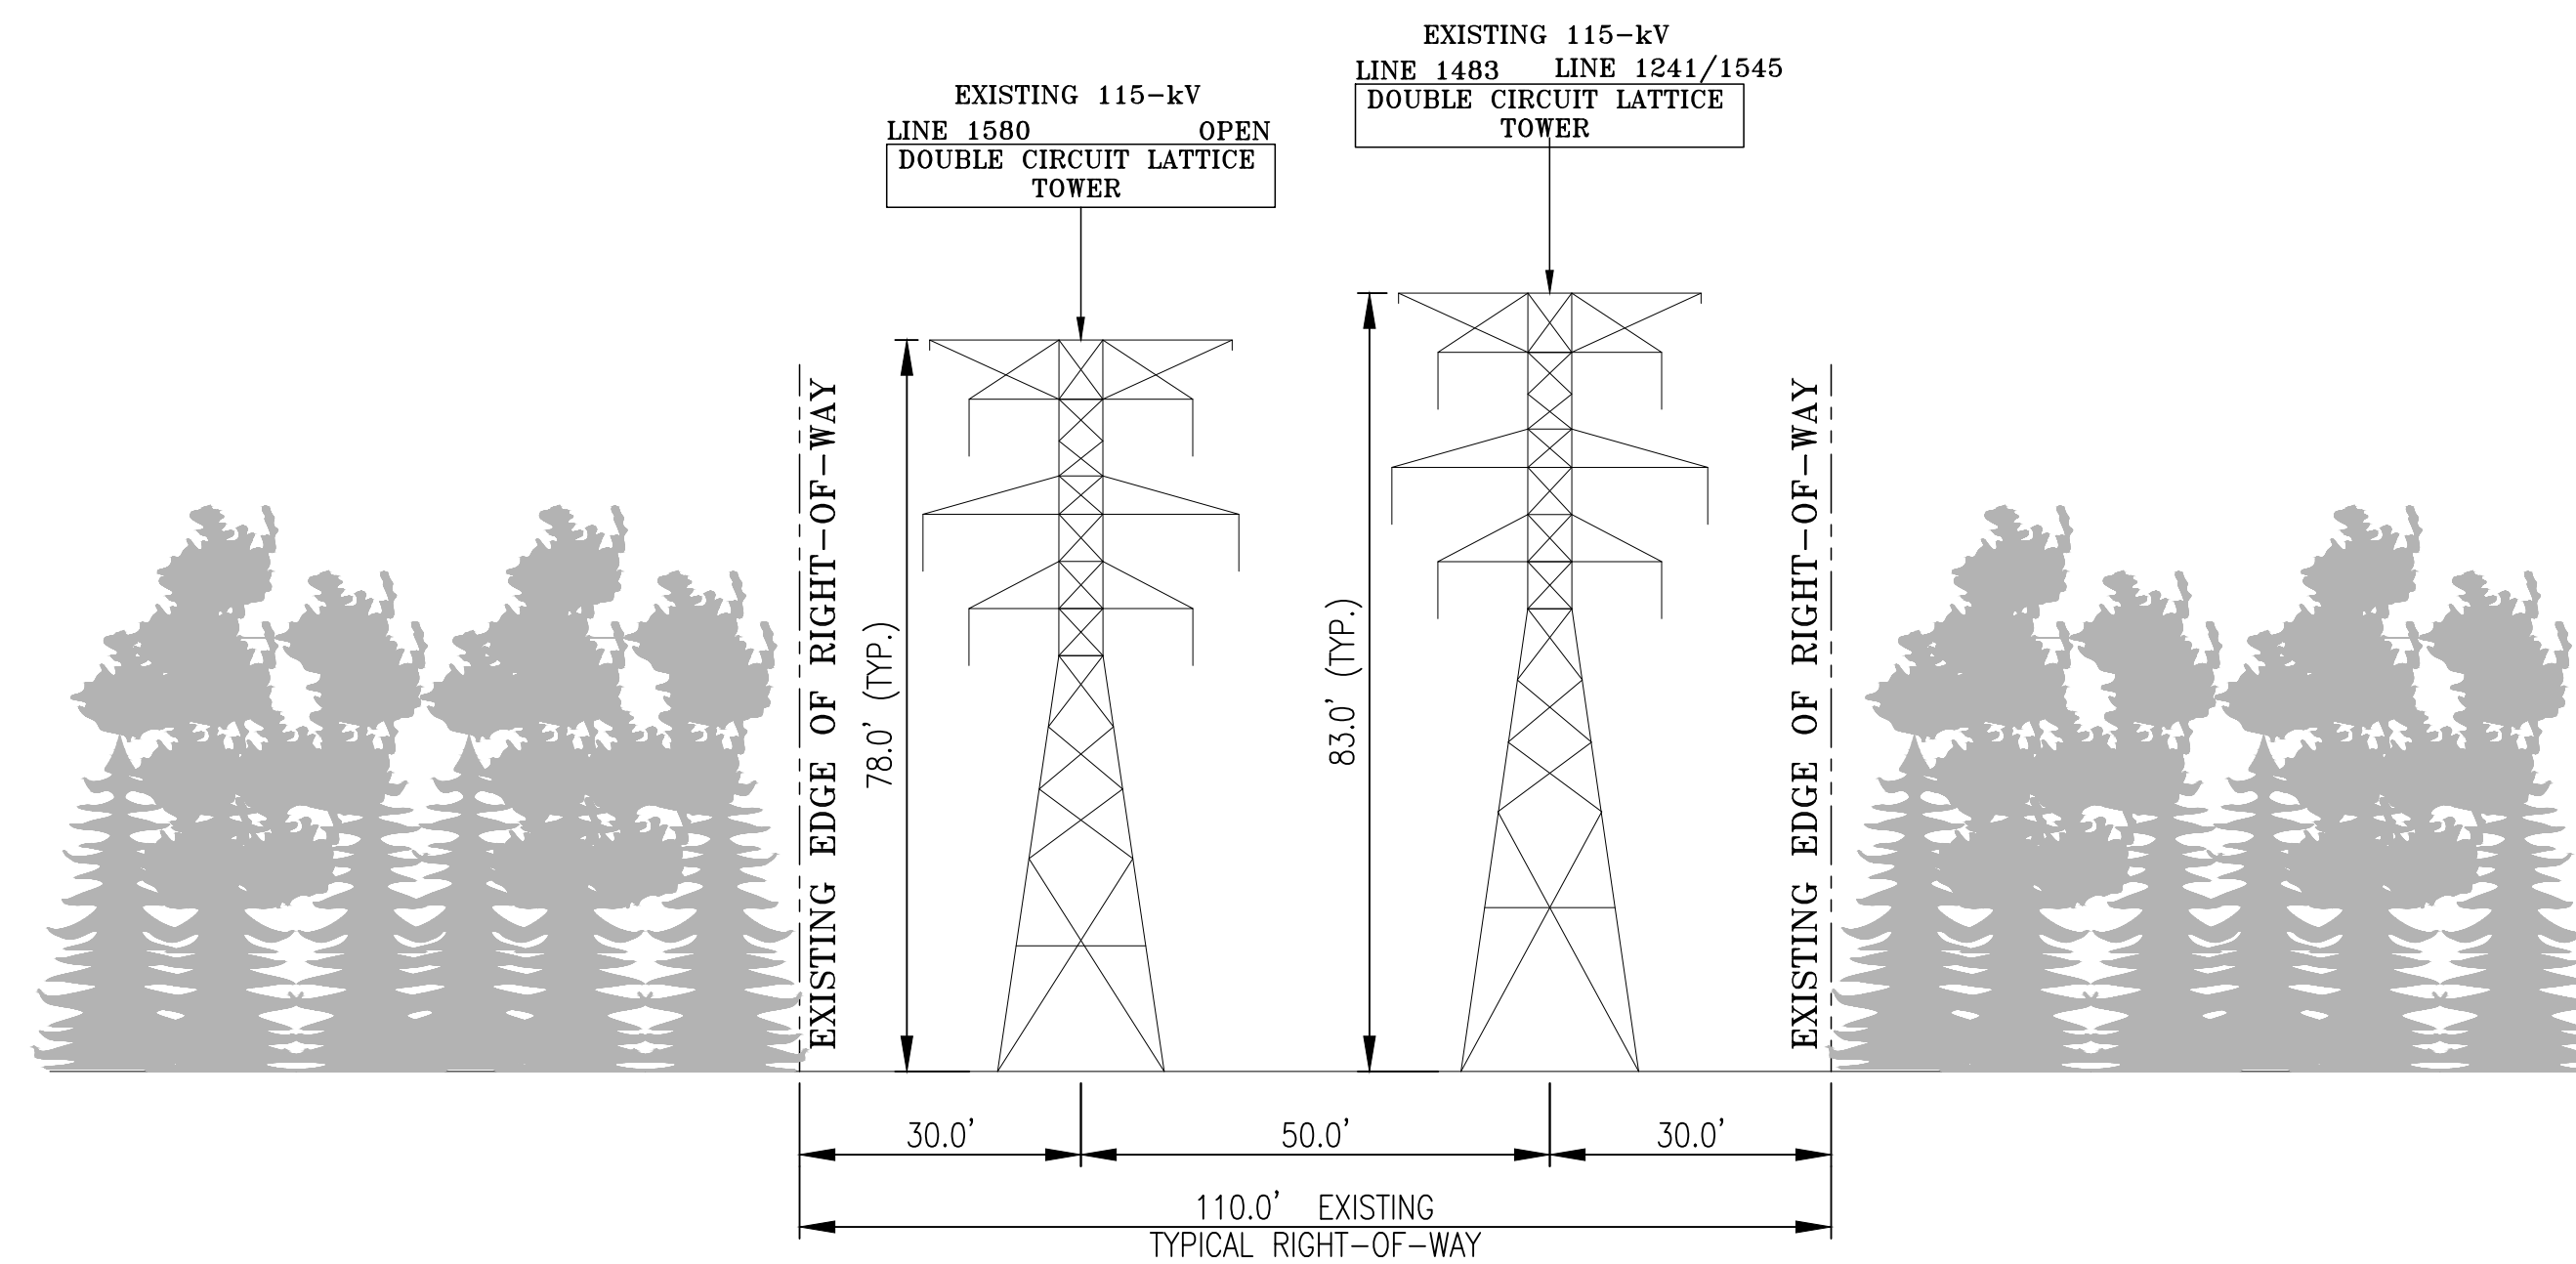
**EXISTING R.O.W. CONFIGURATION
DOUBLE CIRCUIT STEEL LATTICE VERTICAL DESIGN
LOOKING FROM W. DEVON JCT. TO POOTATUCK S/S**

Project elements to be used for the Project. The cross-section drawings provided in Attachment B: Right of Way Cross Section depict typical views along the ROW of the existing and proposed structures. Attachment C: List of Structure Replacements provides more specific information on the heights of the existing and proposed structures.

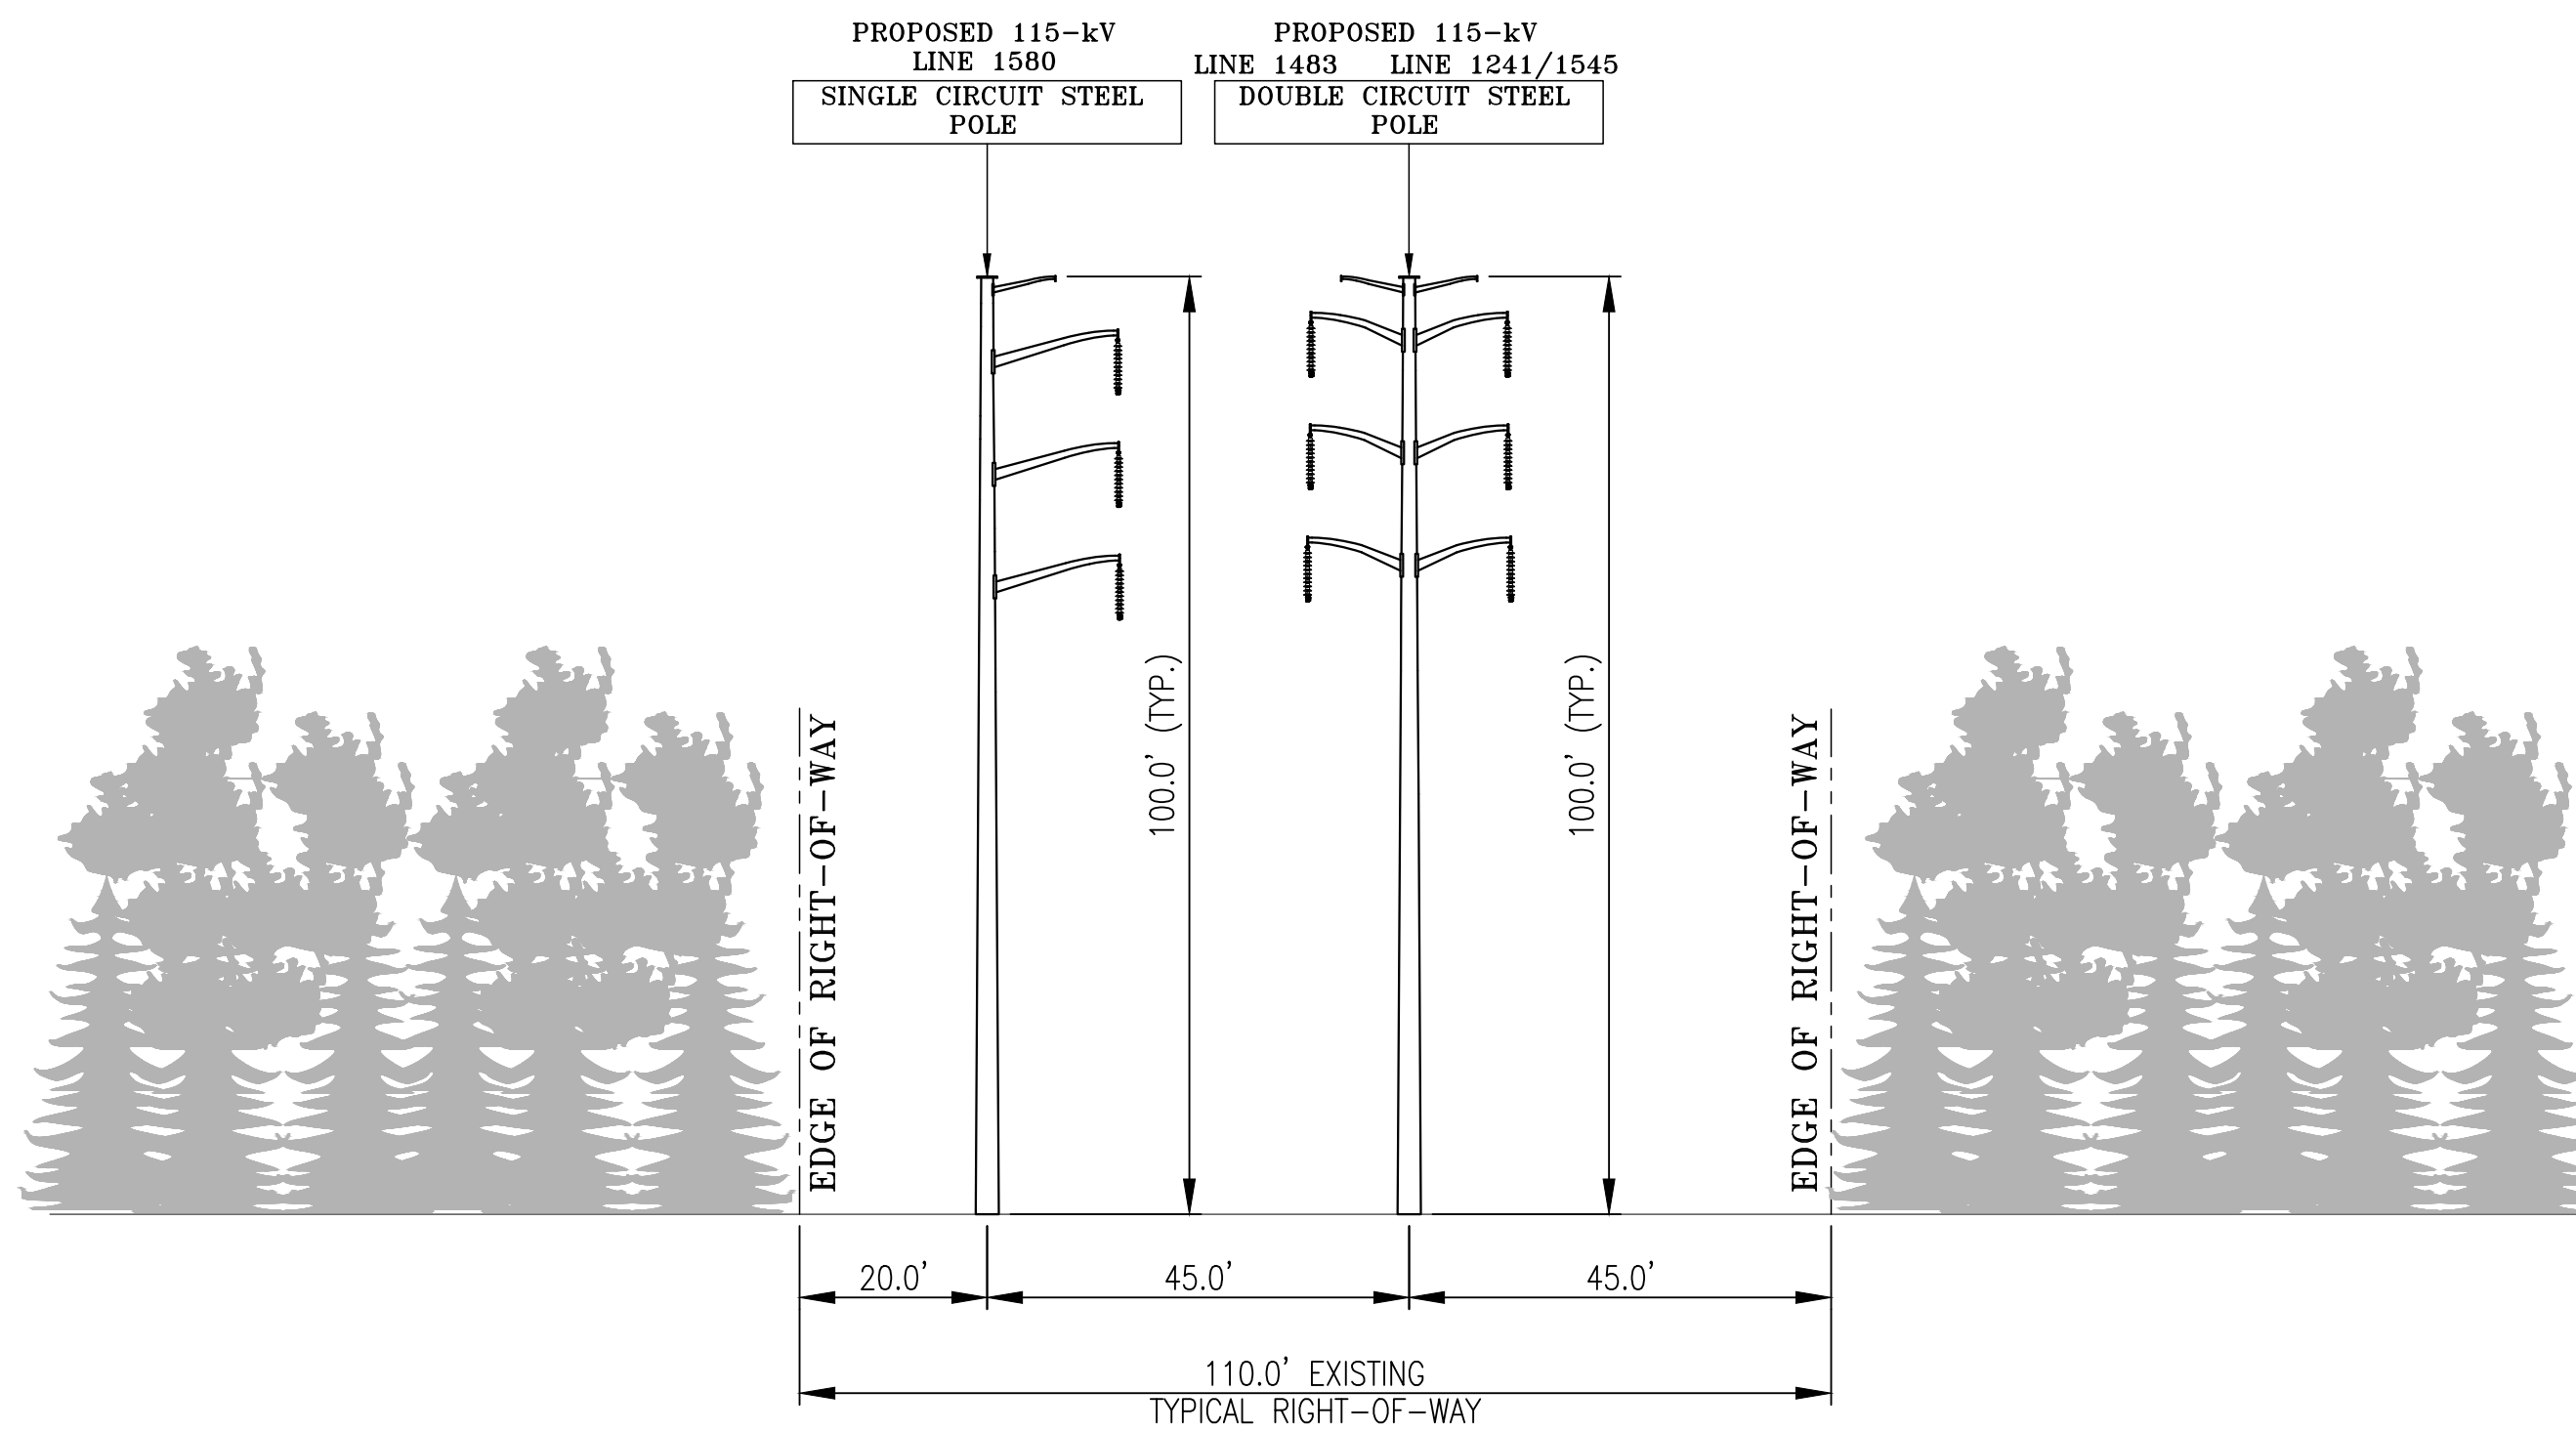
**PROPOSED R.O.W. CONFIGURATION
SINGLE CIRCUIT STEEL MONOPOLE/DOUBLE
CIRCUIT STEEL VERTICAL DESIGN
LOOKING FROM W. DEVON JCT. TO POOTATUCK S/S**

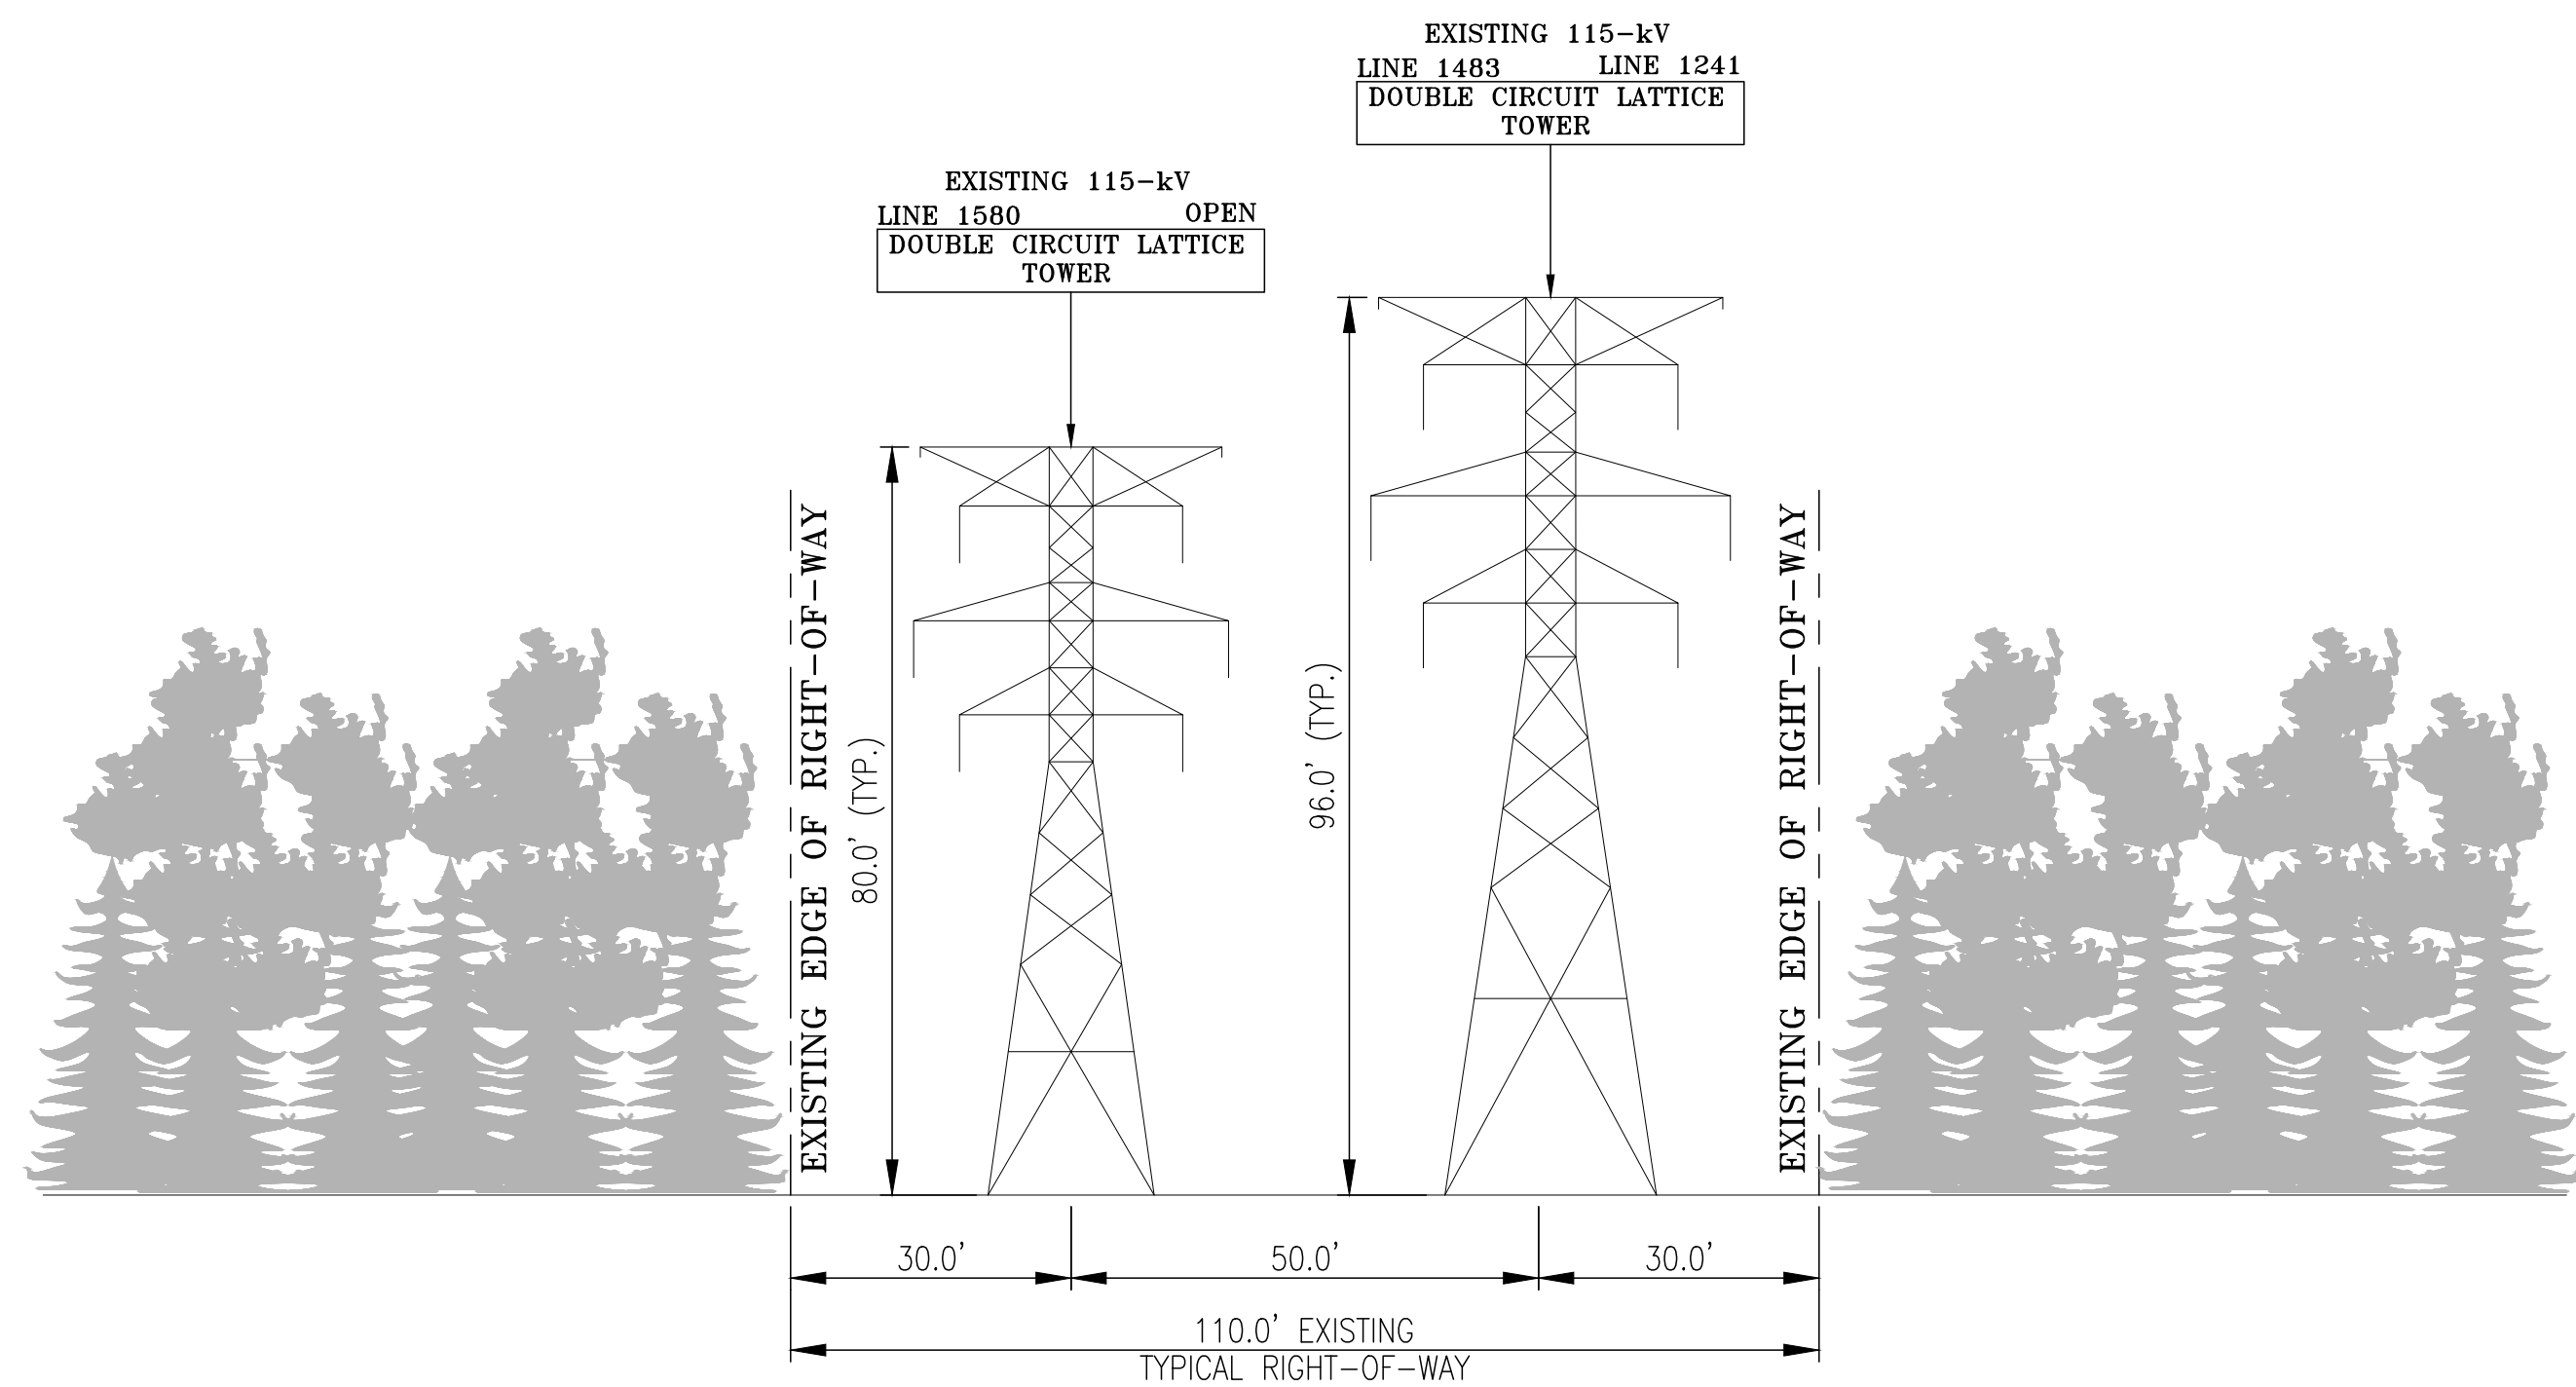
**EXISTING R.O.W. CONFIGURATION
DOUBLE CIRCUIT STEEL LATTICE VERTICAL DESIGN
LOOKING FROM TRAP FALLS S/S TO POOTATUCK S/S**

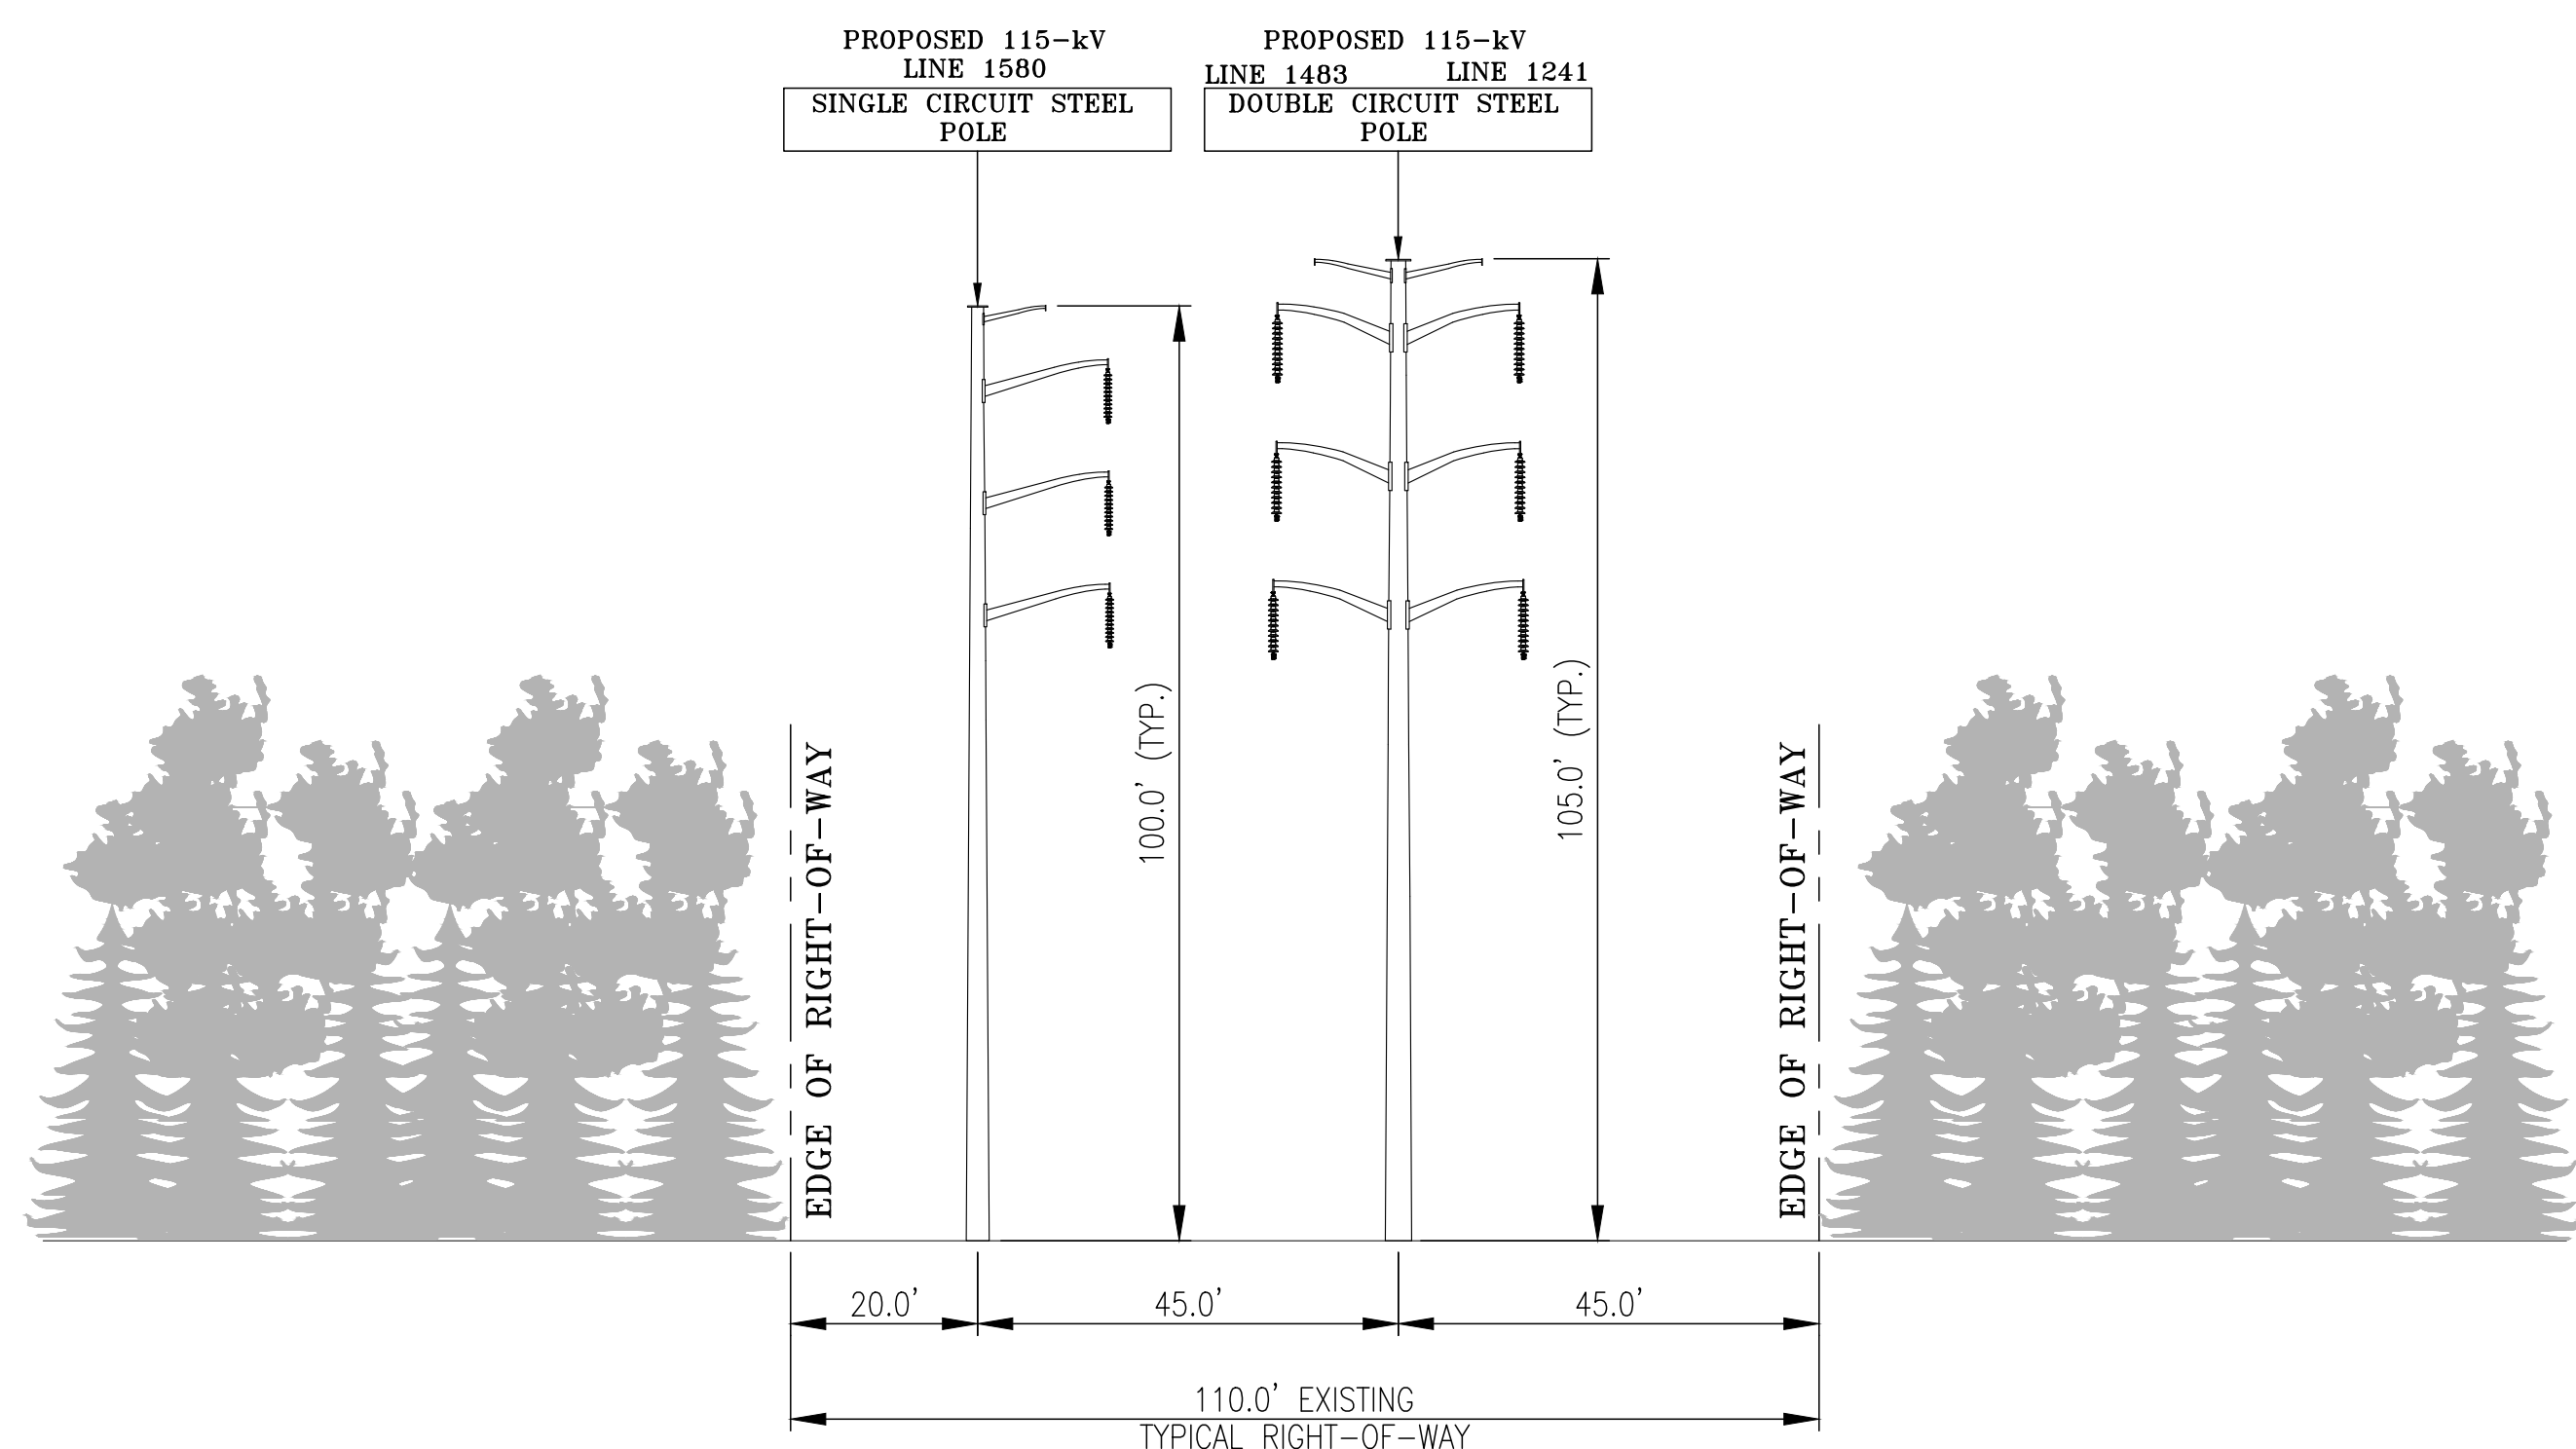
**PROPOSED R.O.W. CONFIGURATION
SINGLE CIRCUIT STEEL MONOPOLE/DOUBLE
CIRCUIT STEEL VERTICAL DESIGN
LOOKING FROM TRAP FALLS S/S TO POOTATUCK S/S**

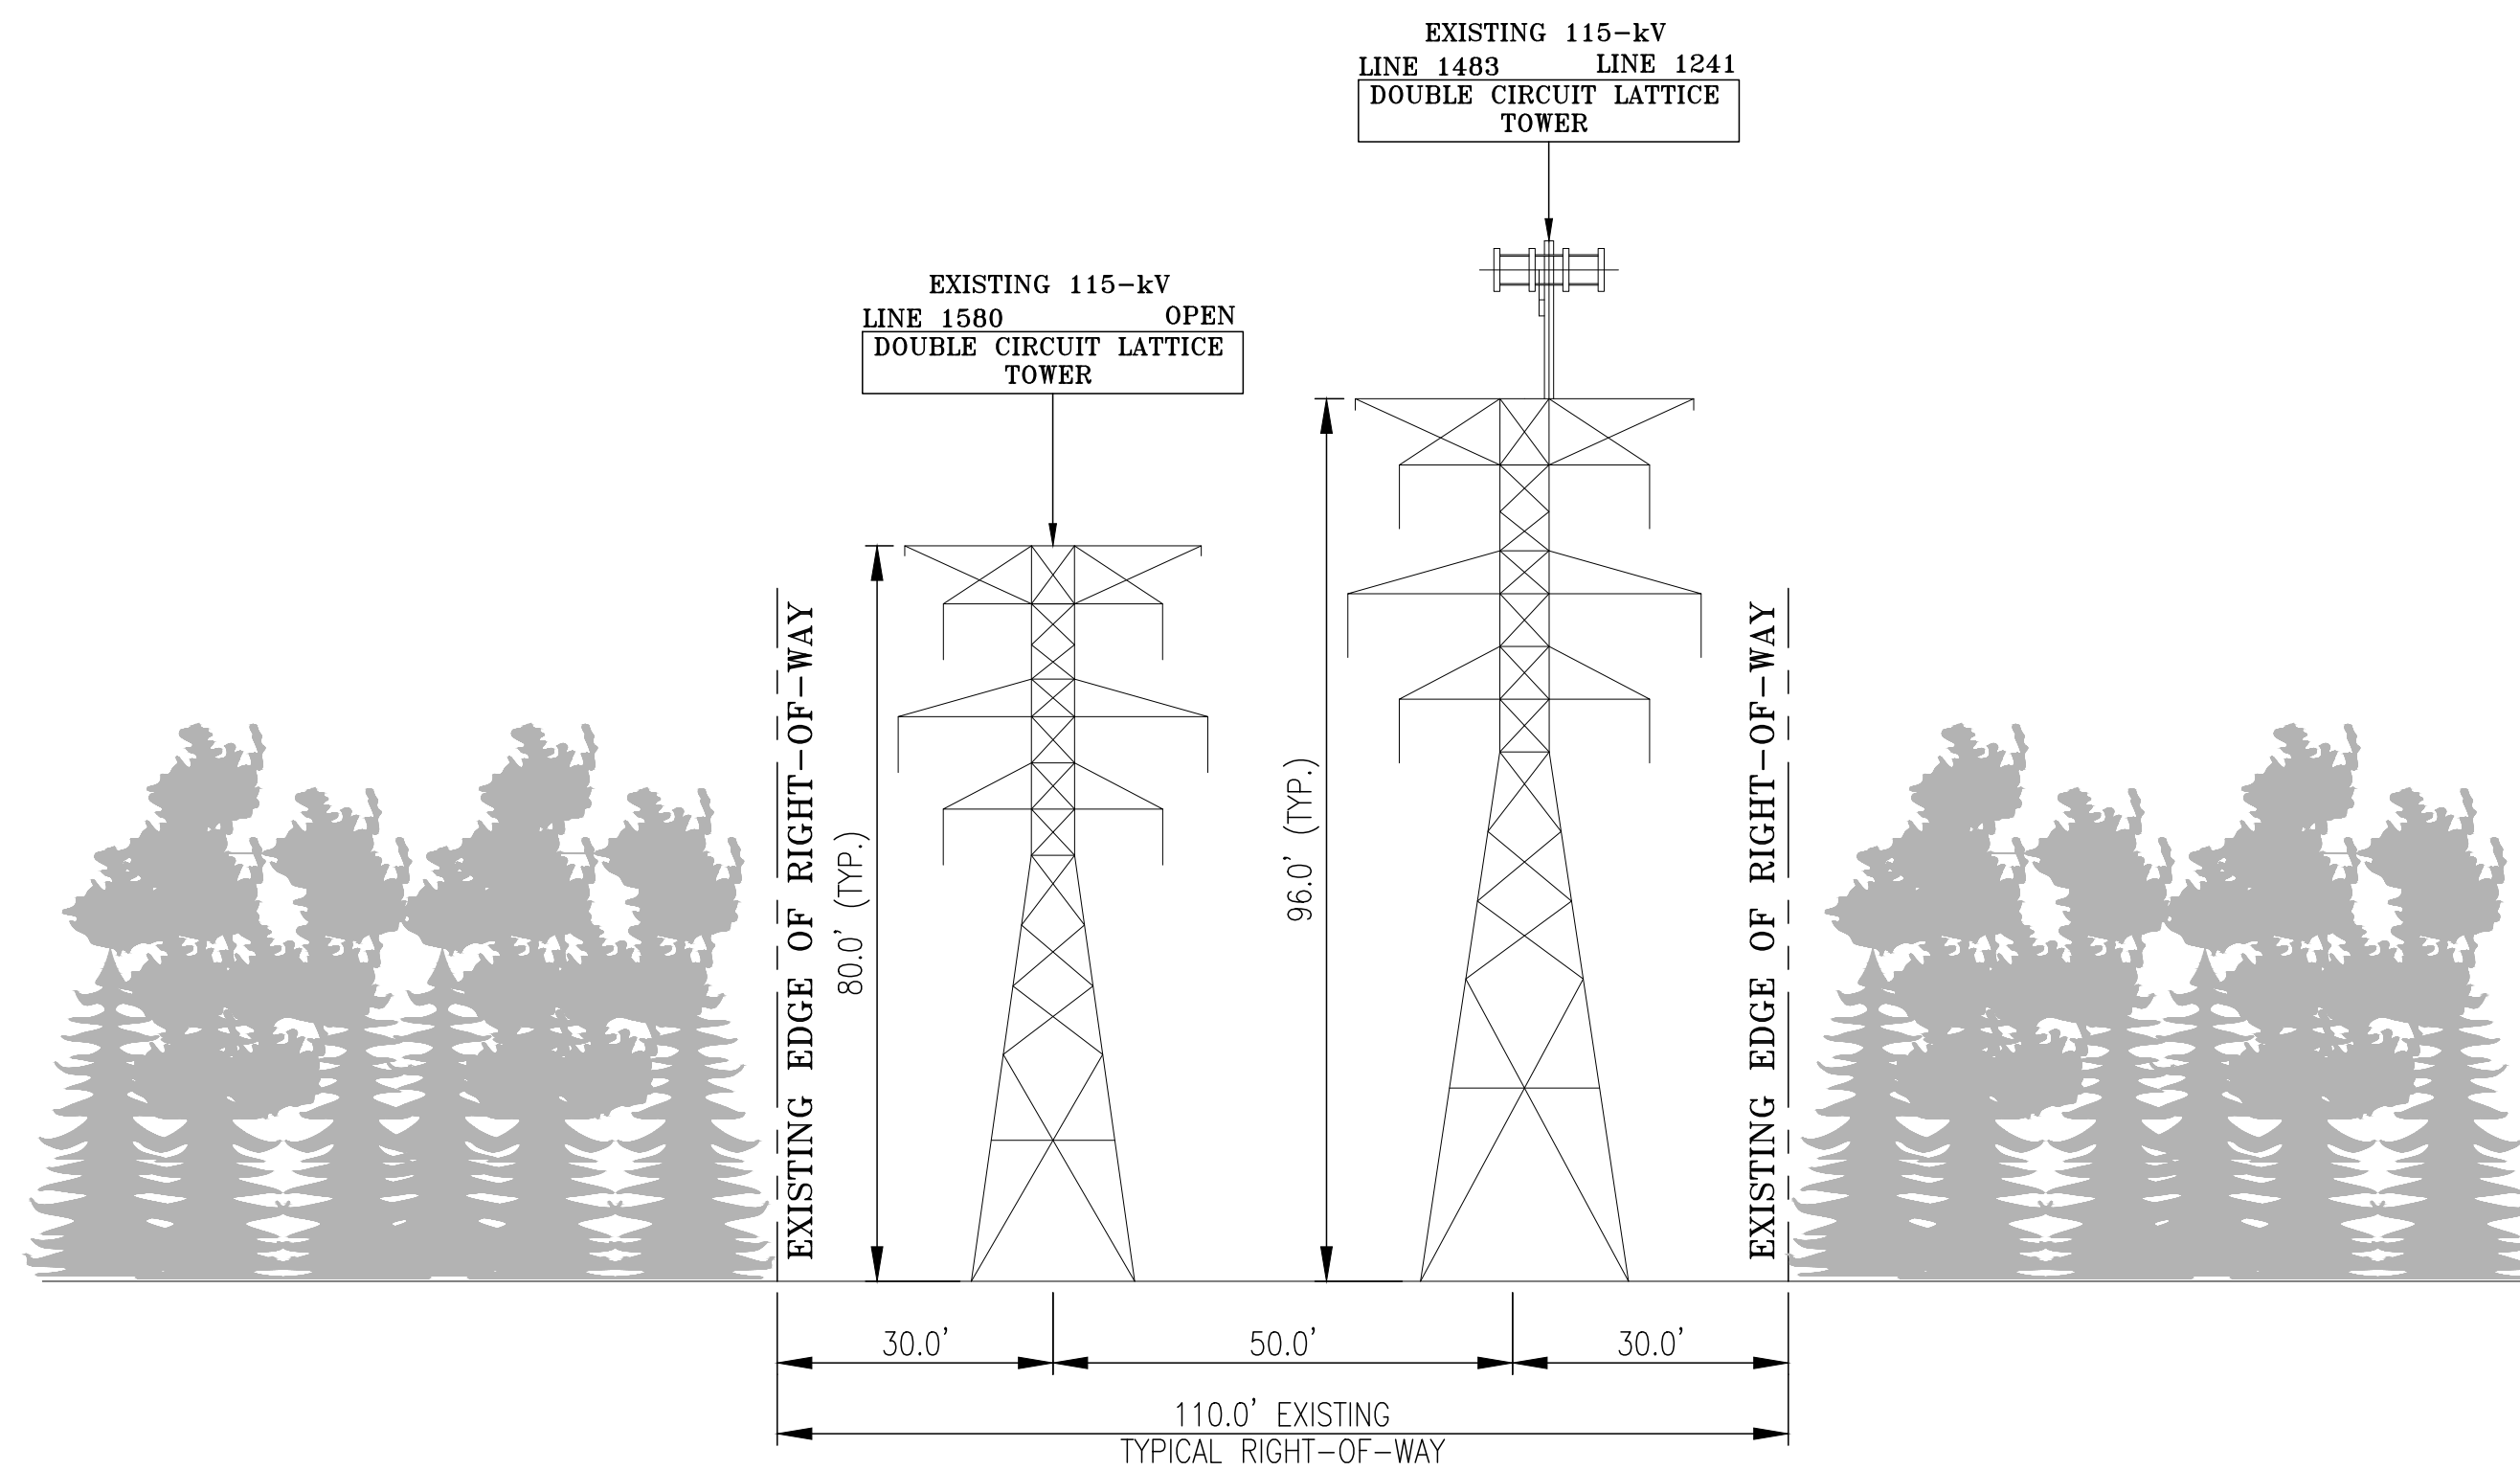
**EXISTING R.O.W. CONFIGURATION
DOUBLE CIRCUIT STEEL LATTICE VERTICAL DESIGN
LOOKING FROM TRAP FALLS S/S TO POOTATUCK S/S**
