Re: Pootatuck to West Devon Rebuild Project

PETITION TO THE CONNECTICUT SITING COUNCIL
FOR A DECLARATORY RULING OF
NO SUBSTANTIAL ADVERSE ENVIRONMENTAL EFFECT
FOR THE PROPOSED MODIFICATIONS TO THE EXISTING
1580, 1241, 1483, AND 1545 LINES IN THE CITY OF SHELTON
AND TOWN OF STRATFORD, CONNECTICUT

The purpose of the Project is to replace structures and reconductor along approximately 3.3 miles of the 1580, 1241, 1483 and 1545 lines within the existing ROW that connects United Illuminating's (“UI”) Pootatuck Substation, located at 14 Old Stratford Road in Shelton (“Pootatuck”) to Eversource’s West Devon Junction, located near River Valley Road in Stratford (“West Devon”). Project work will also include replacing the existing shield wire.

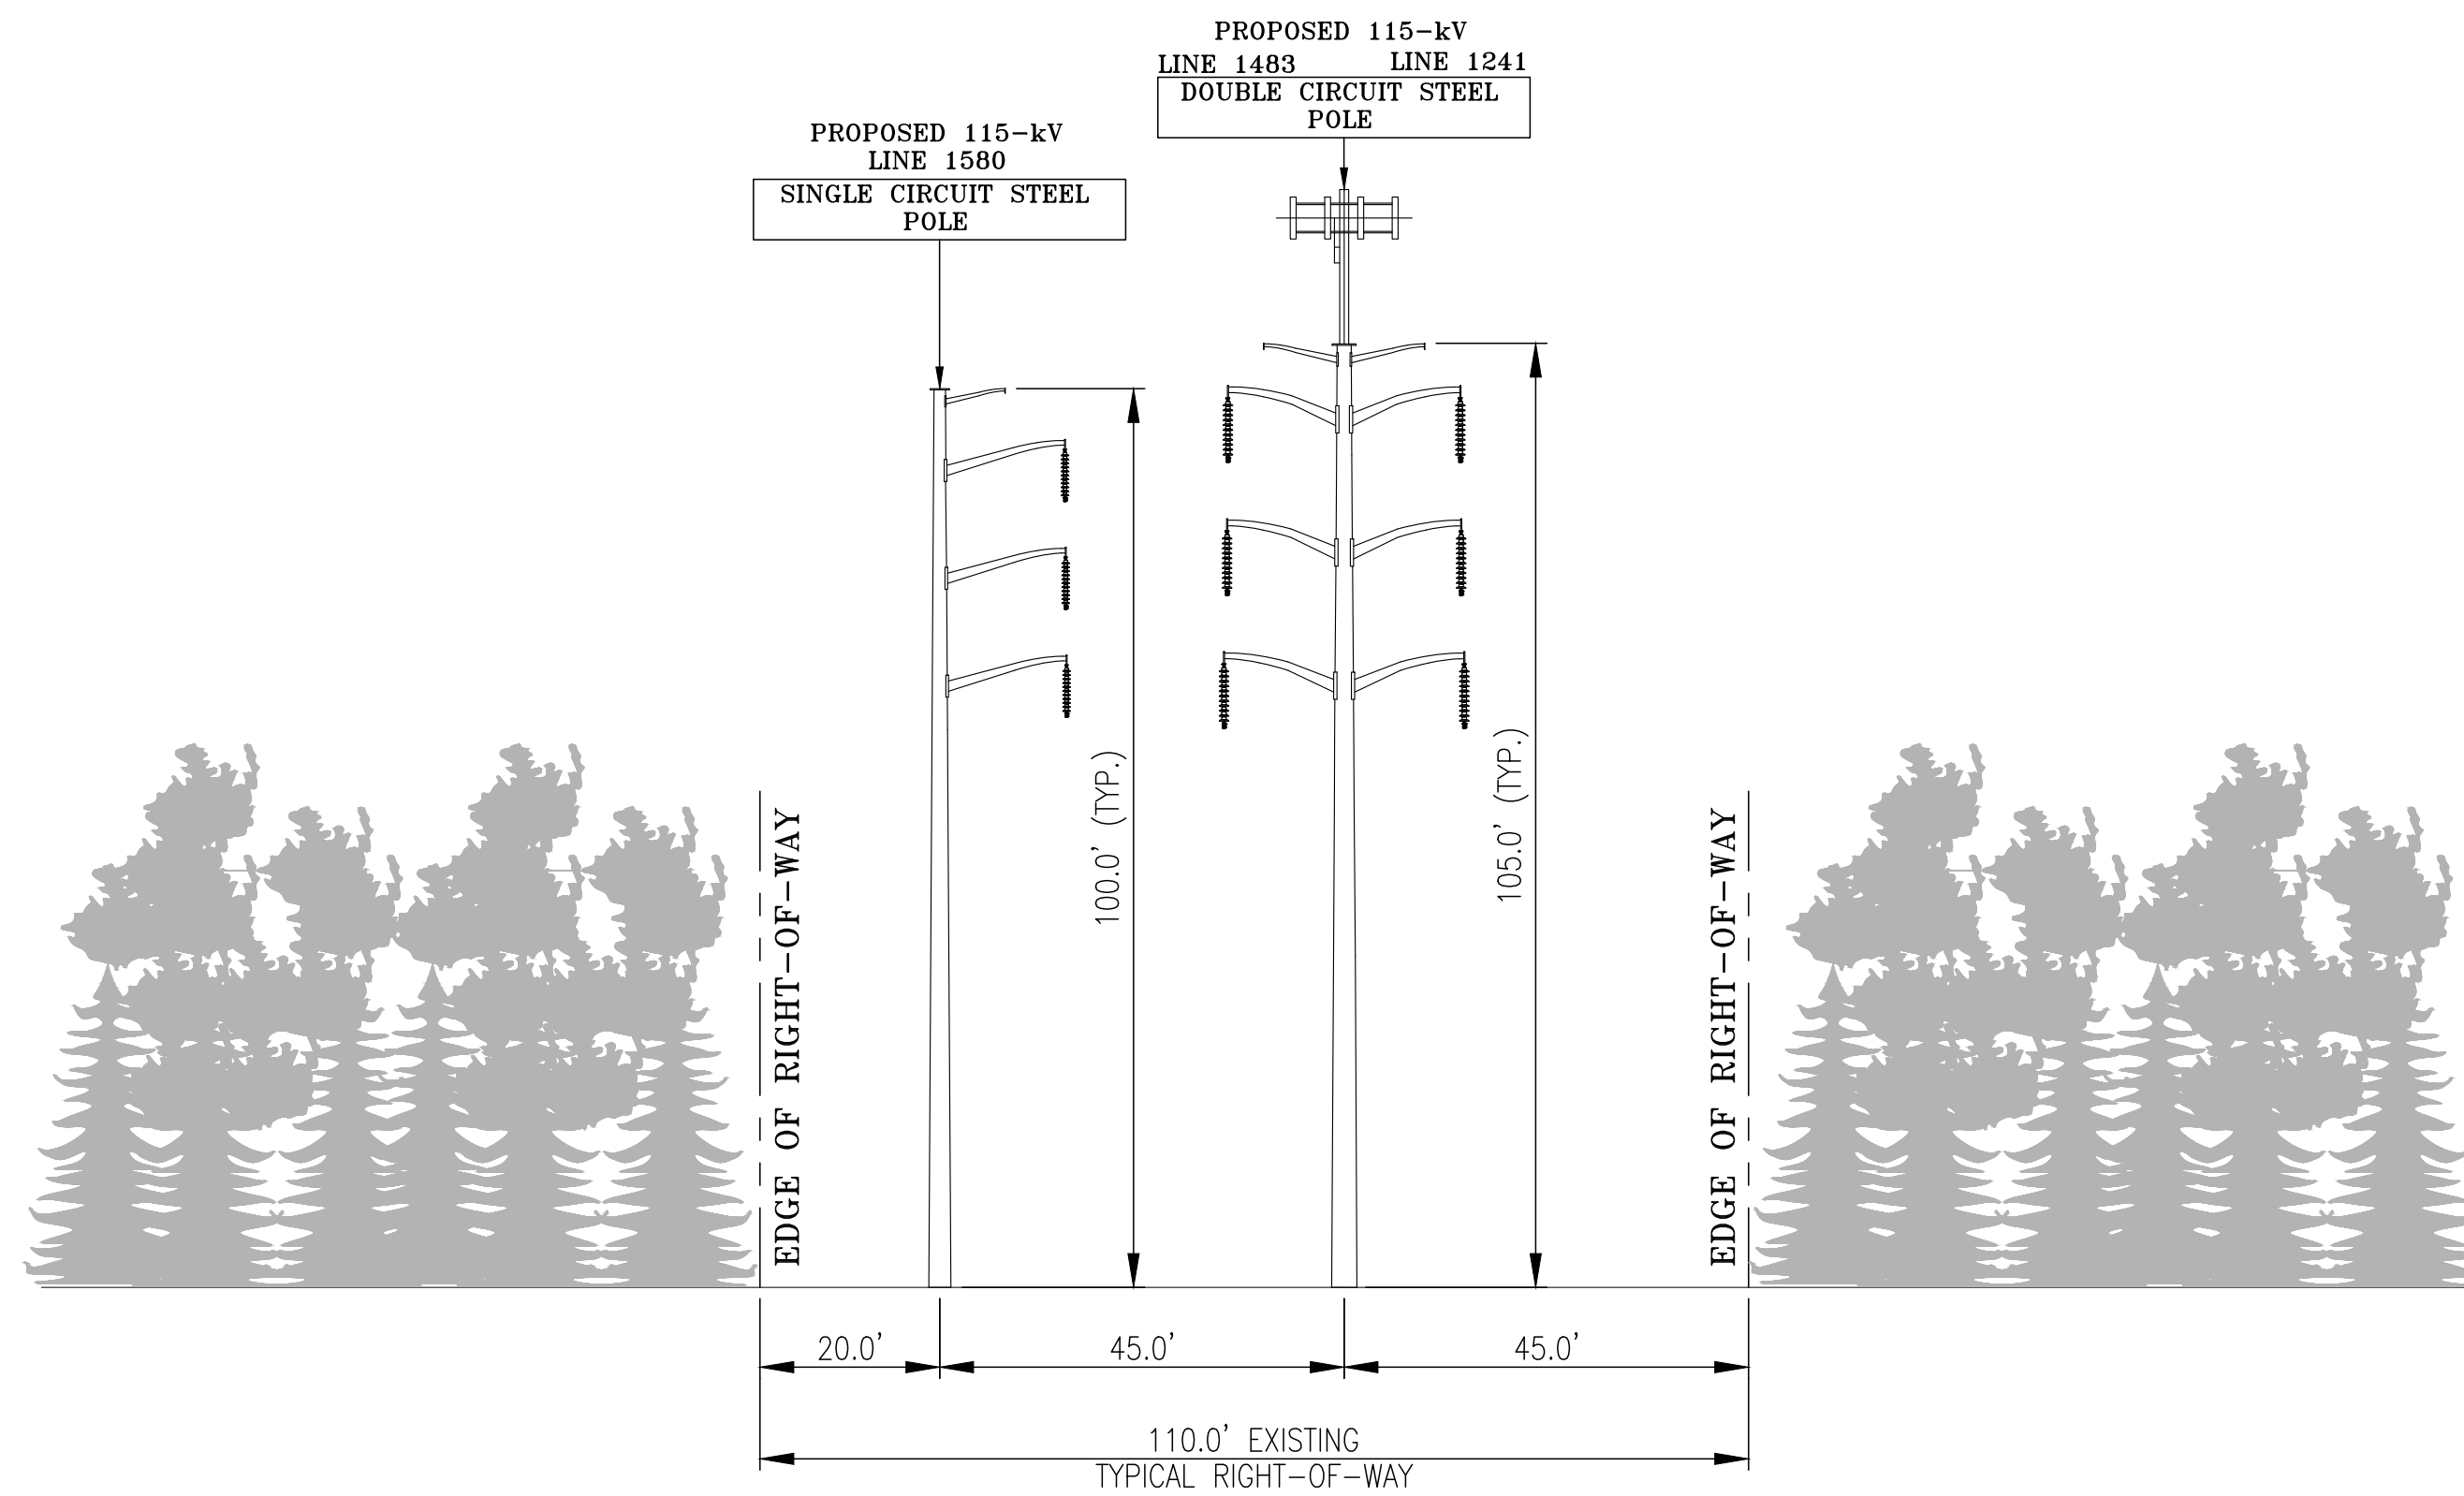
**PROPOSED R.O.W. CONFIGURATION
SINGLE CIRCUIT STEEL MONOPOLE/DOUBLE
CIRCUIT STEEL VERTICAL DESIGN
LOOKING FROM TRAP FALLS S/S TO POOTATUCK S/S**

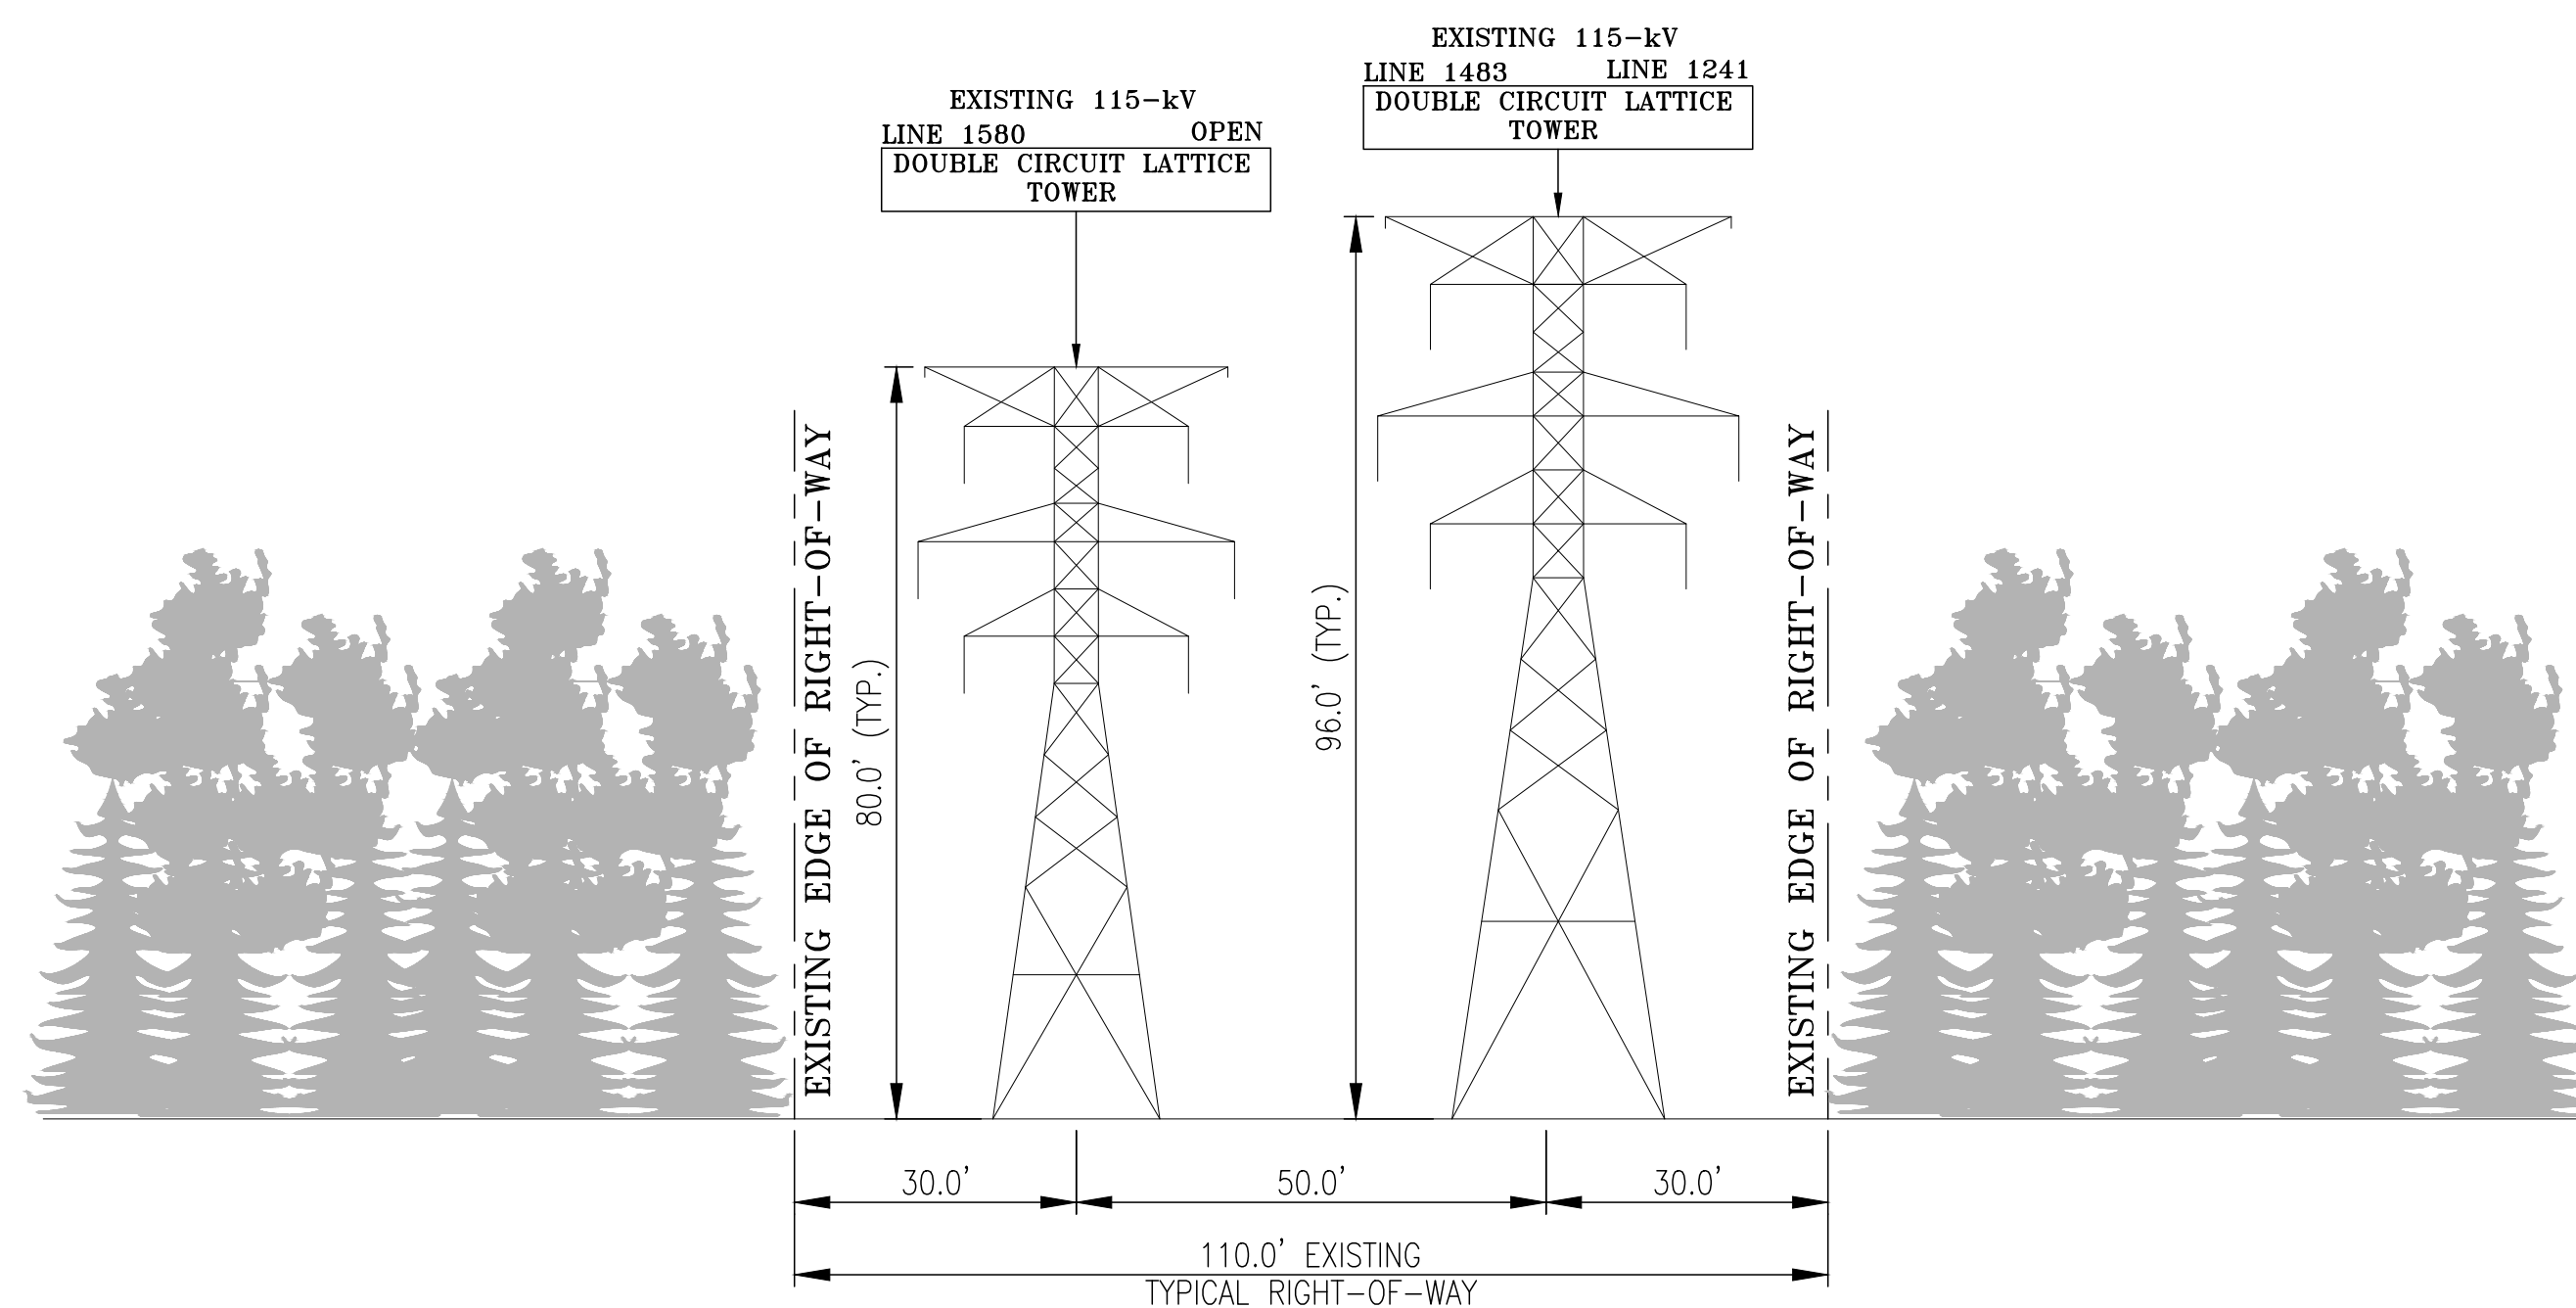
**EXISTING R.O.W. CONFIGURATION
DOUBLE CIRCUIT STEEL LATTICE VERTICAL DESIGN
LOOKING FROM TRAP FALLS S/S TO POOTATUCK S/S**

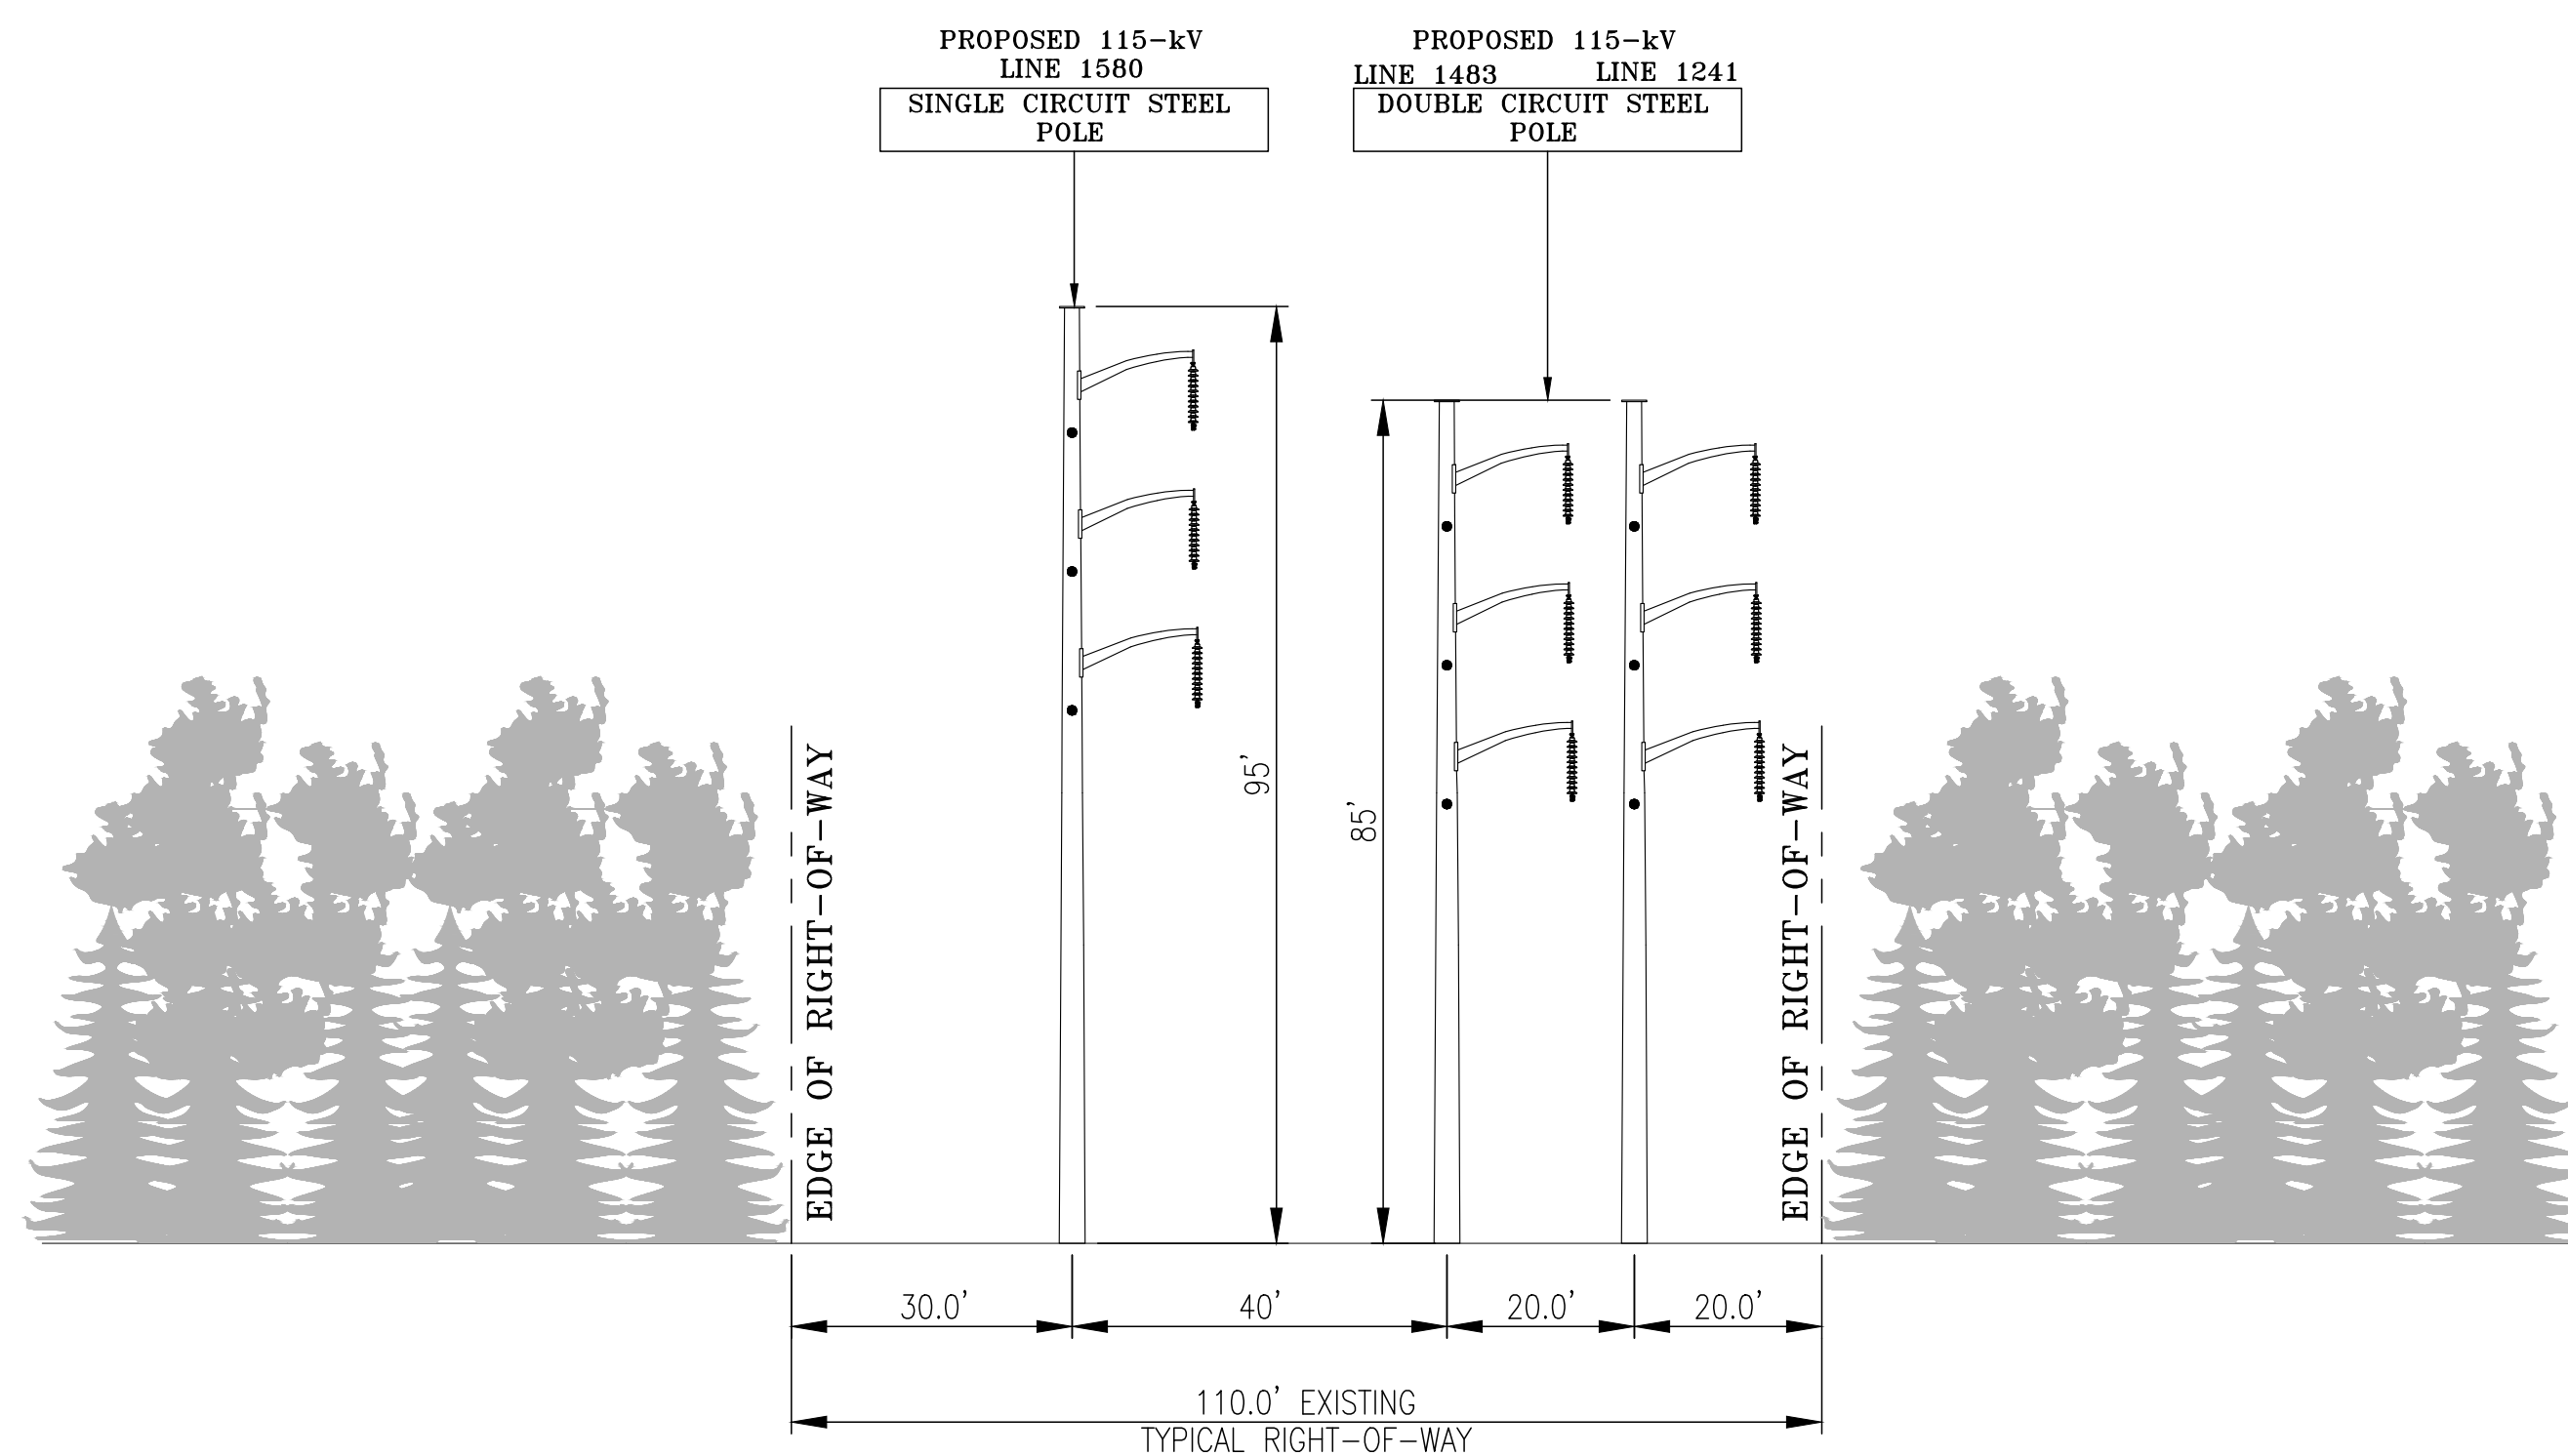
**PROPOSED R.O.W. CONFIGURATION
SINGLE CIRCUIT STEEL MONOPOLE/DOUBLE
CIRCUIT STEEL VERTICAL DESIGN
LOOKING FROM TRAP FALLS S/S TO POOTATUCK S/S**

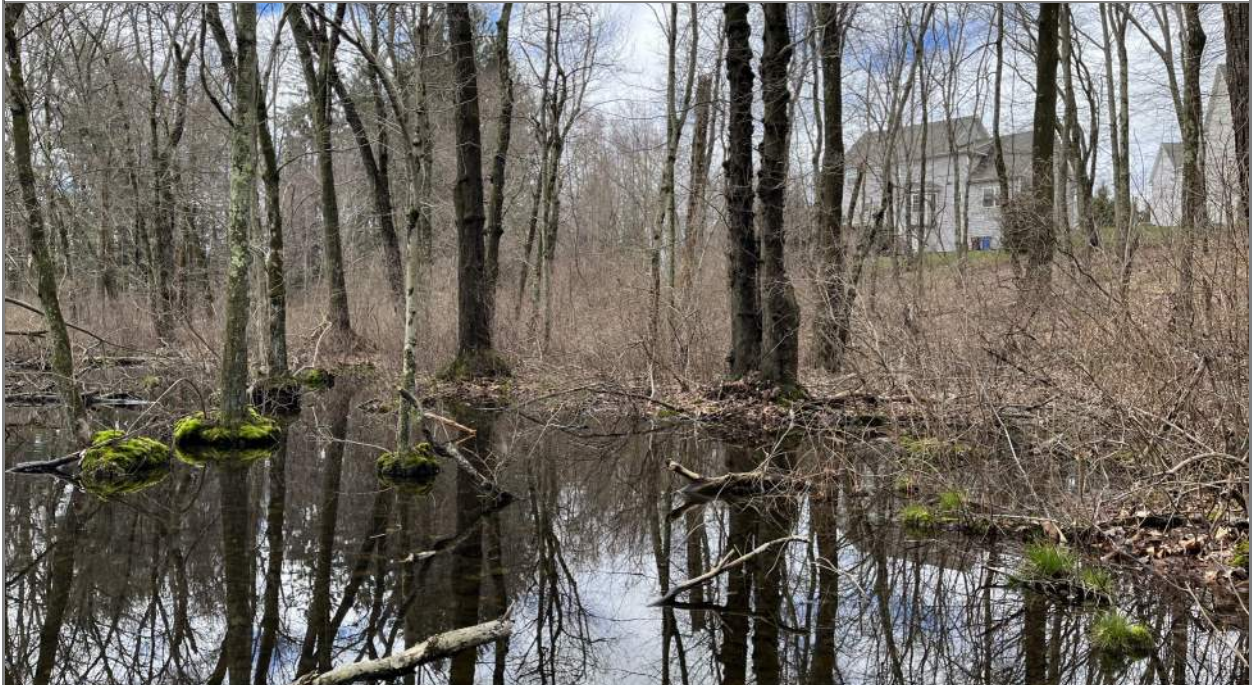
Photograph No.: 1	Date: 04/08/2022	Direction Taken: Southwest
--------------------------	-------------------------	-----------------------------------

Description: Overview of Vernal Pool 1 (PFO1C), taken during the site visit on April 8, 2022.

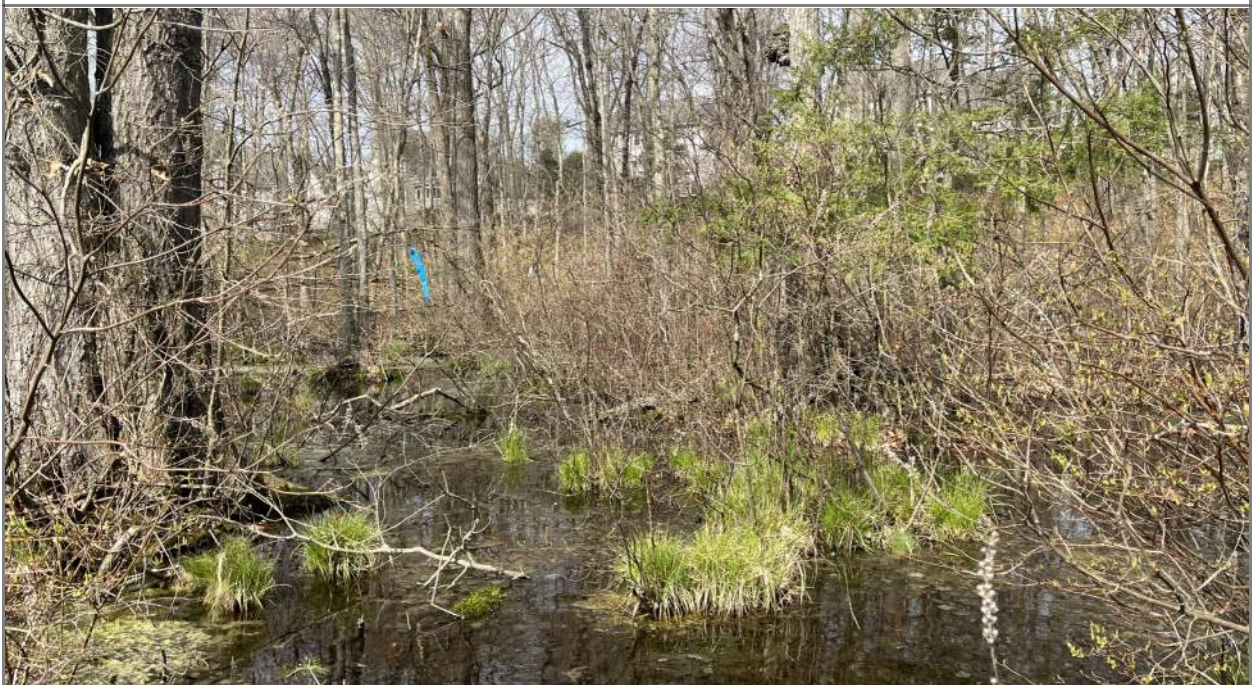
Photograph No.: 2	Date: 04/25/2022	Direction Taken: Southwest
--------------------------	-------------------------	-----------------------------------

Description: Overview of Vernal Pool 1, taken during the site visit on April 25, 2022.

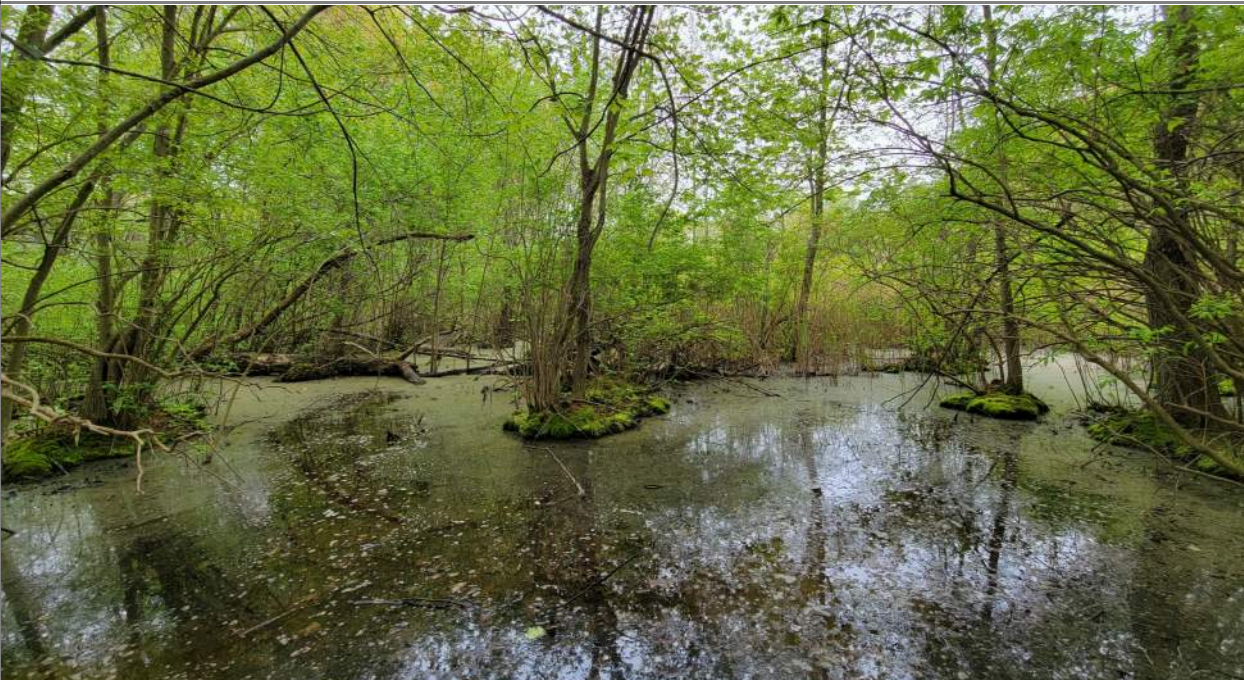
Photograph No.: 6	Date: 05/13/2022	Direction Taken: North
Description: Overview of Vernal Pool 2, taken during the site visit on May 13, 2022.

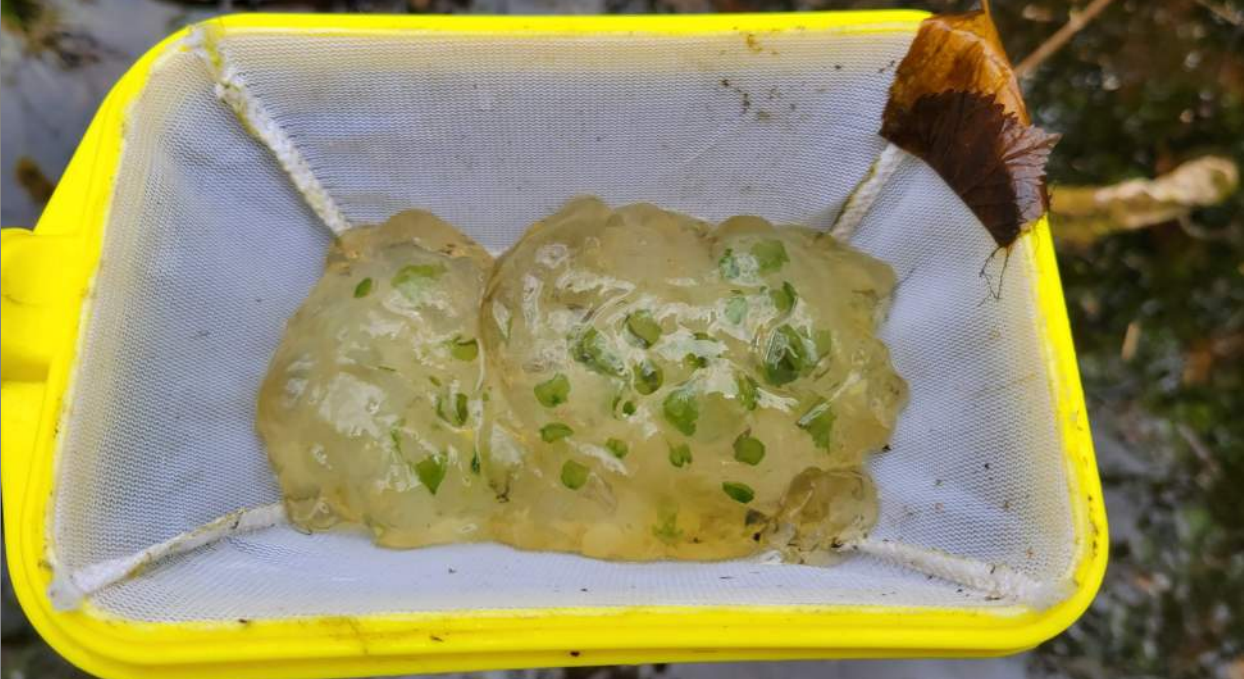
Photograph No.: 9	Date: 04/25/2022	Direction Taken: N/A
Description: Spotted salamander egg masses were observed within Vernal Pool 2 in 2022, at varying stages of maturity.

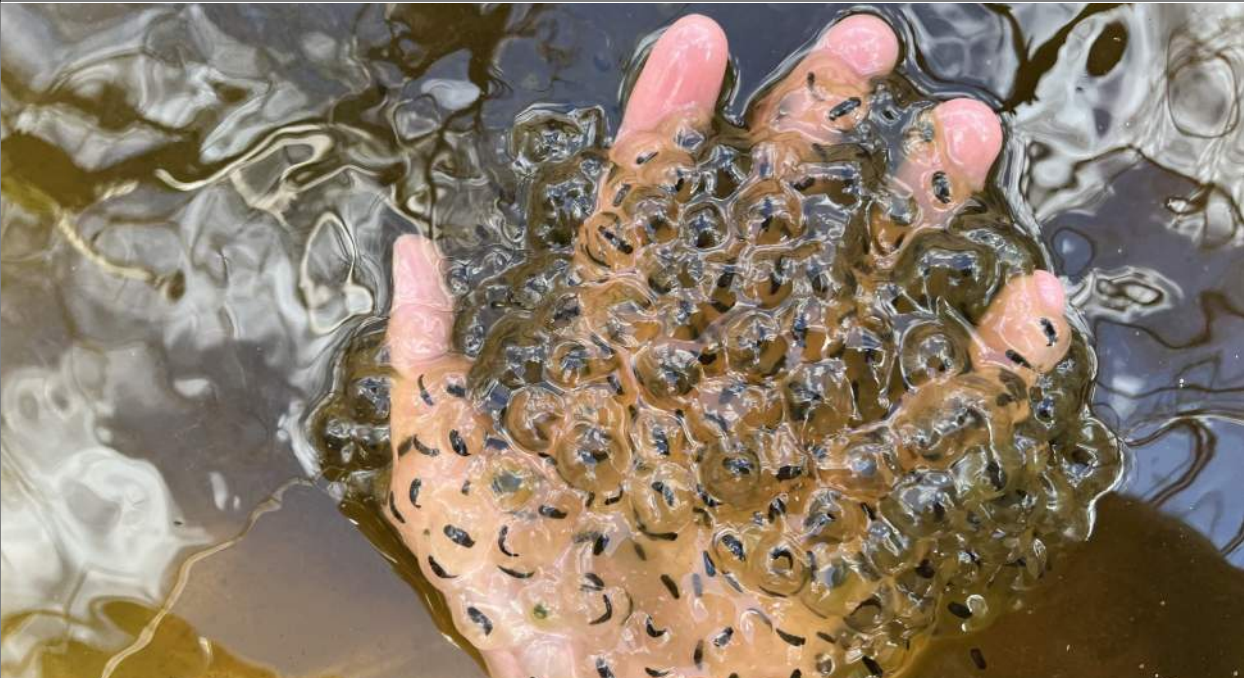
Photograph No.: 10	Date: 04/08/2022	Direction Taken: N/A
Description: Wood frog egg masses and tadpoles were observed within Vernal Pool 2 in 2022, at varying stages of maturity.

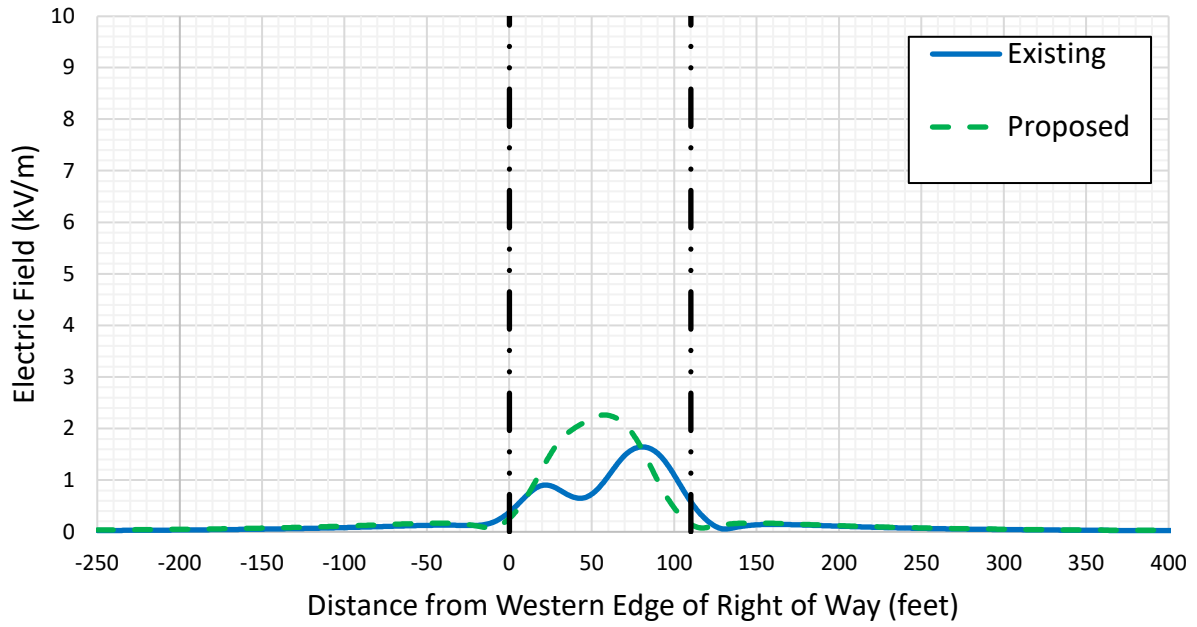
Calculated Electric Fields (Annual Average Loads) West Devon Junction - Pootatuck S/S

Eversource prepared calculations of the existing and post-Project Electric and Magnetic fields (“EMF”). The calculations were based on average annual loading conditions, as these are most representative of typical operating conditions. The calculations are made relative to the centerline of the proposed, modified transmission lines.
