# Wetland and Watercourse Delineation Report

For KCE CT 5 Battery Energy Storage System Project  
Willington and Stafford, Connecticut

**June 2, 2023**

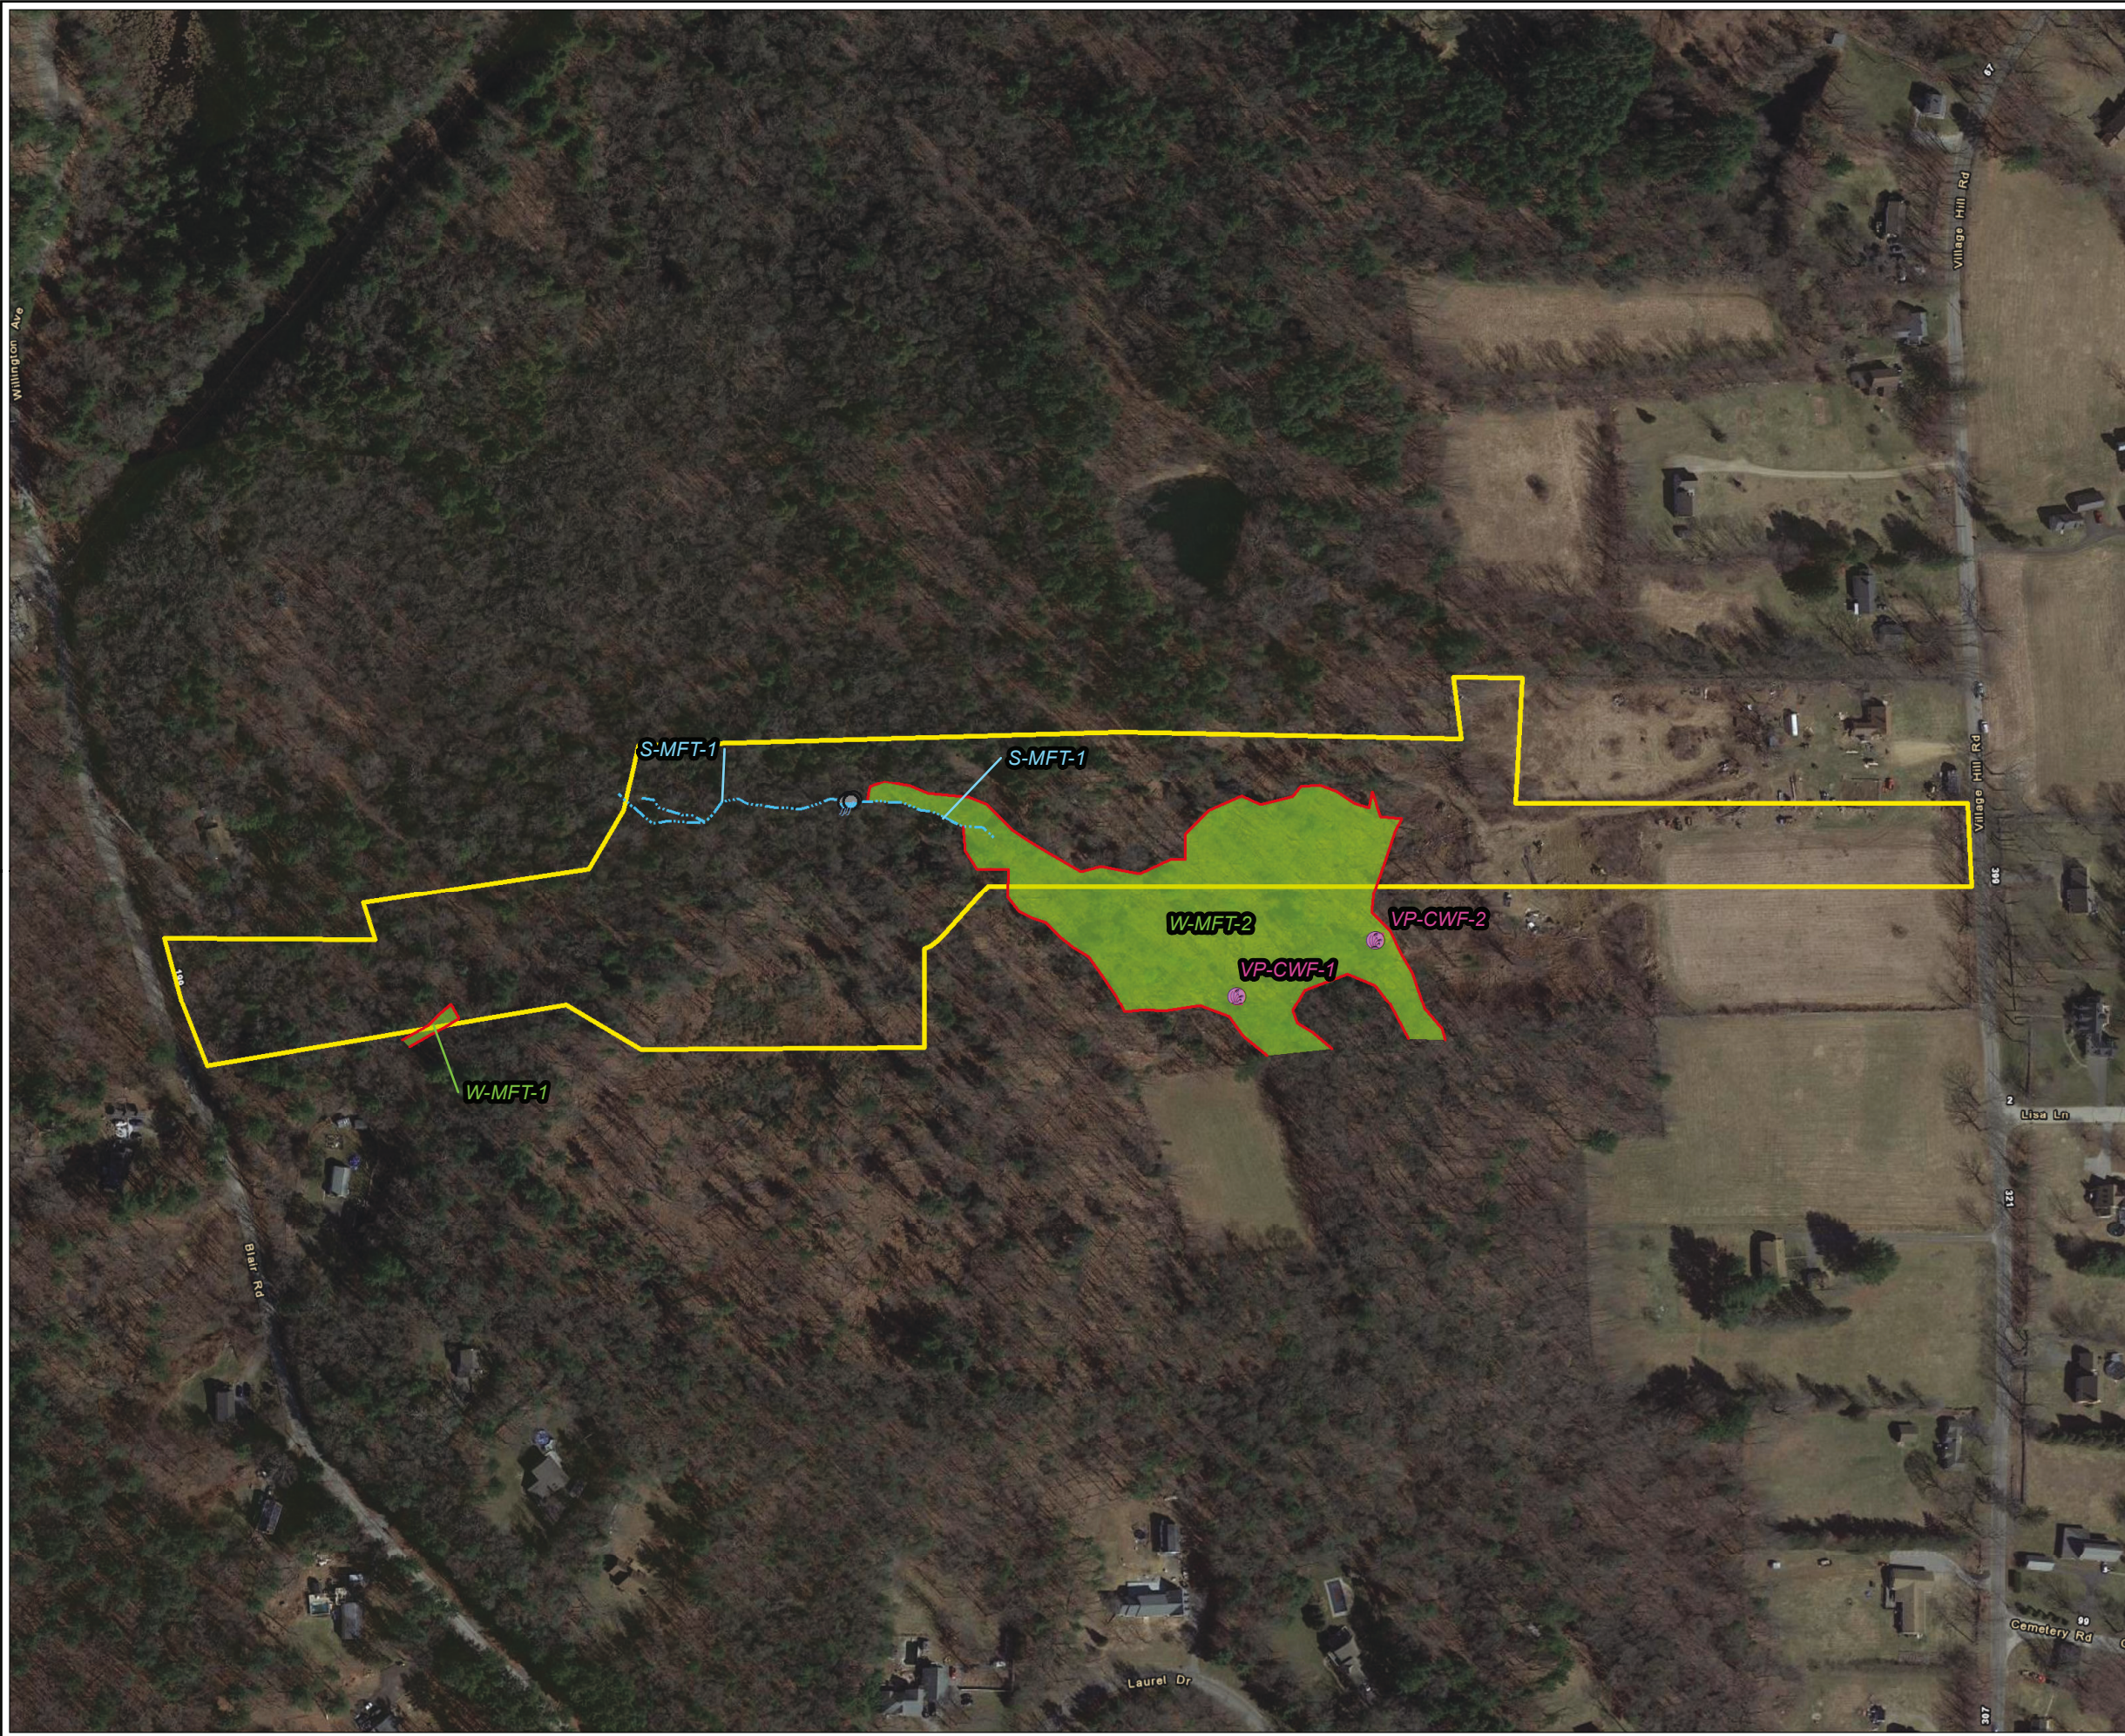
DRAWN BY: D. KENWORTHY	PROJ NO.: 22-F2
CHECKED BY: K. NICKERSON	<b>FIGURE 2</b>
MONTH: JUNE	
YEAR: 2023

Flycatcher mapped two (2) palustrine forested (PFO) wetlands within the Survey Area. Soils are characterized as mucky loam and stony sandy loam, and hydric indicators are *Histic Epipedon (A2)*, *Depleted Below Dark Surface (A11)*, and *Thick Dark Surface (A12)*. Summary descriptions of wetlands are provided in Table 1, below. The location of each wetland is mapped within the Survey Area depicted on Figure 2, in Attachment 1. Representative photographs of these resources are provided in Attachment 2.

Flycatcher mapped one (1) intermittent watercourse within the Survey Area. The watercourse flows west out of wetland W-MFT-2. The bank-full width is approximately 4 feet wide, bank depth is approximately 4 inches deep, and substrate consists of cobble and rock. The location of the watercourse is mapped within the Survey Area depicted on Figure 2, in Attachment 1.

Flycatcher mapped two (2) vernal pools within the Survey Area. Summary descriptions of each pool are provided in Table 2. The location of each vernal pool is mapped within the Survey Area depicted on Figure 2, in Attachment 1. Photographs of each pool are provided in Attachment 2, and completed Connecticut Association of Wetland Scientists (CAWS) Vernal Pool Monitoring Data Forms are provided in Attachment 3.

TITLE: **DELINEATED RESOURCE MAP**

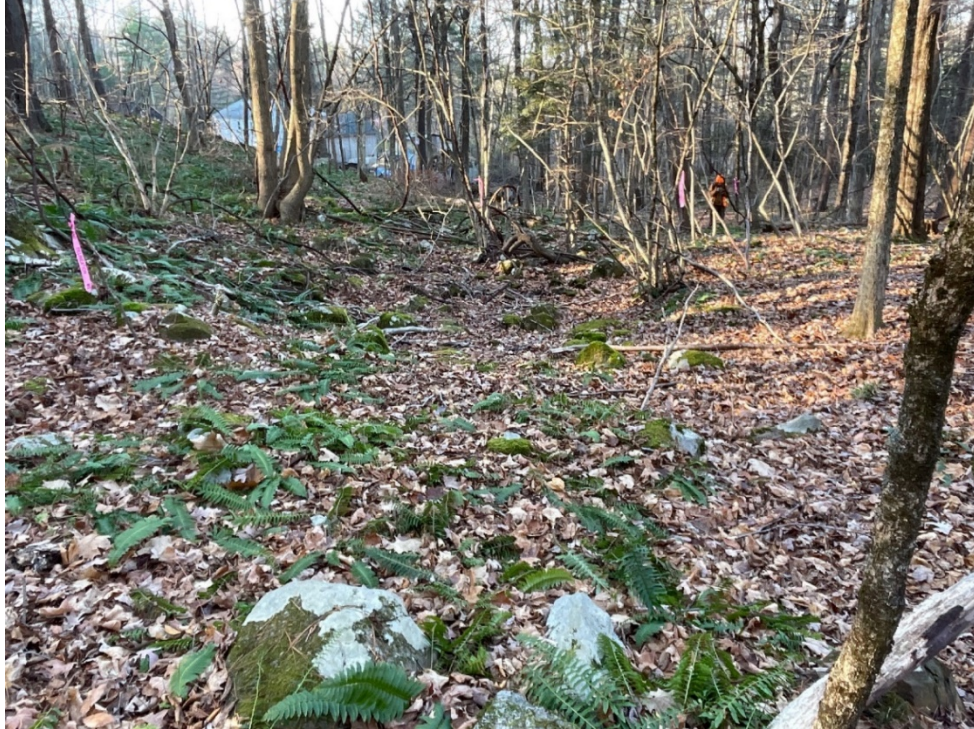
**Wetland W-MFT-1, November 18, 2022.**

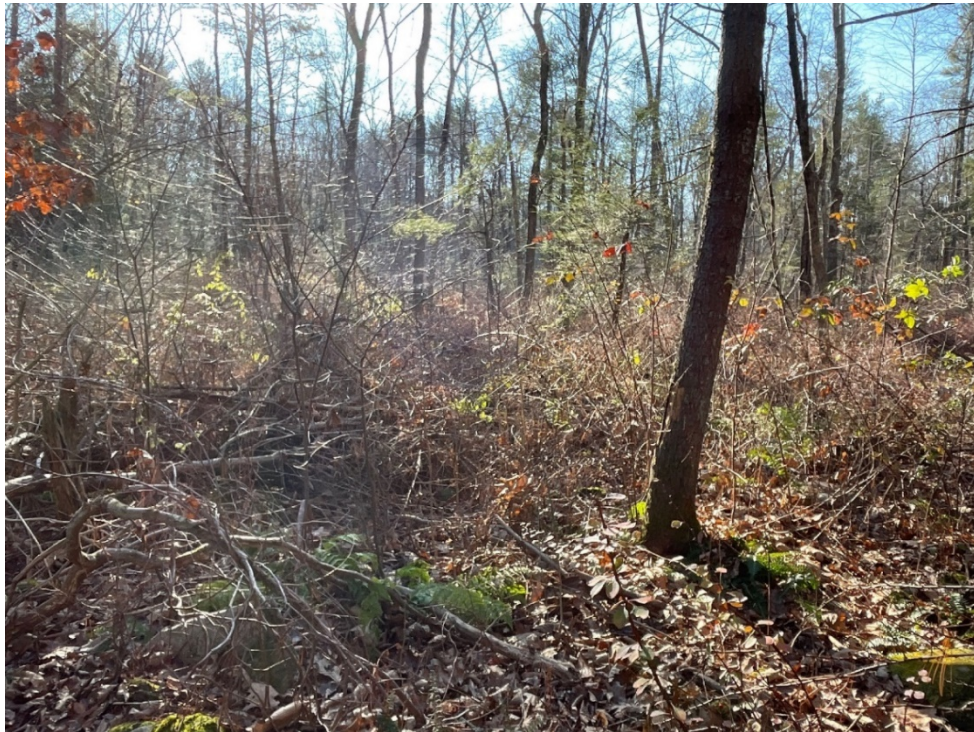
**Wetland W-MFT-2, November 18, 2022.**

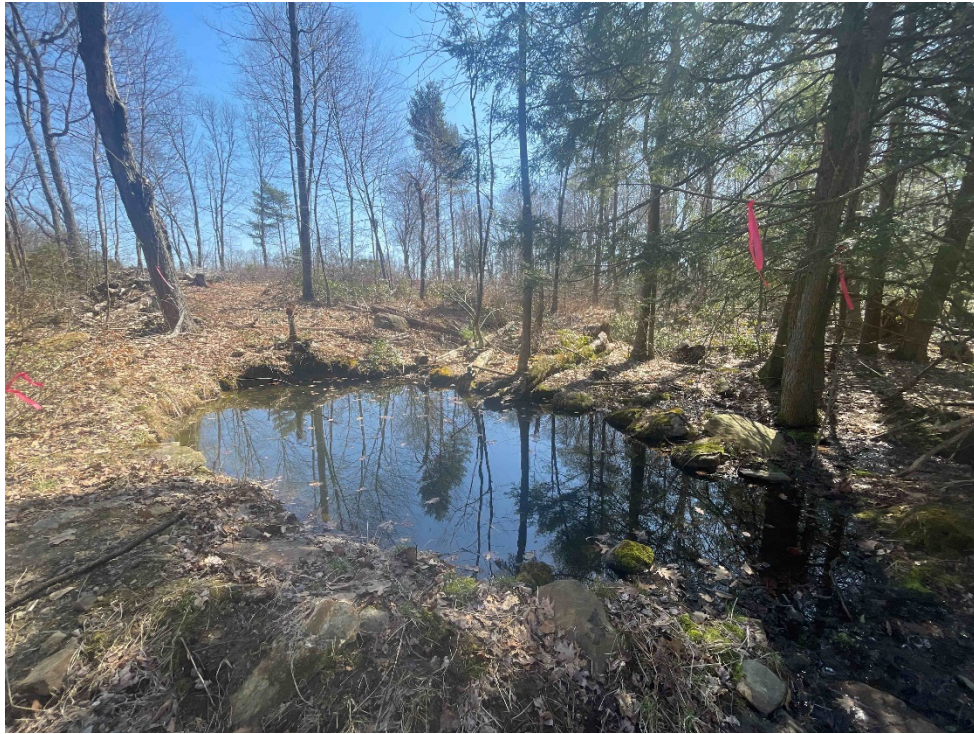
**VP-CWF-2 within W-MFT-2, April 4, 2023.**

Pool is very deep and excavated; appears to potentially be spring-fed. Is adjacent to a trail in a forested setting.

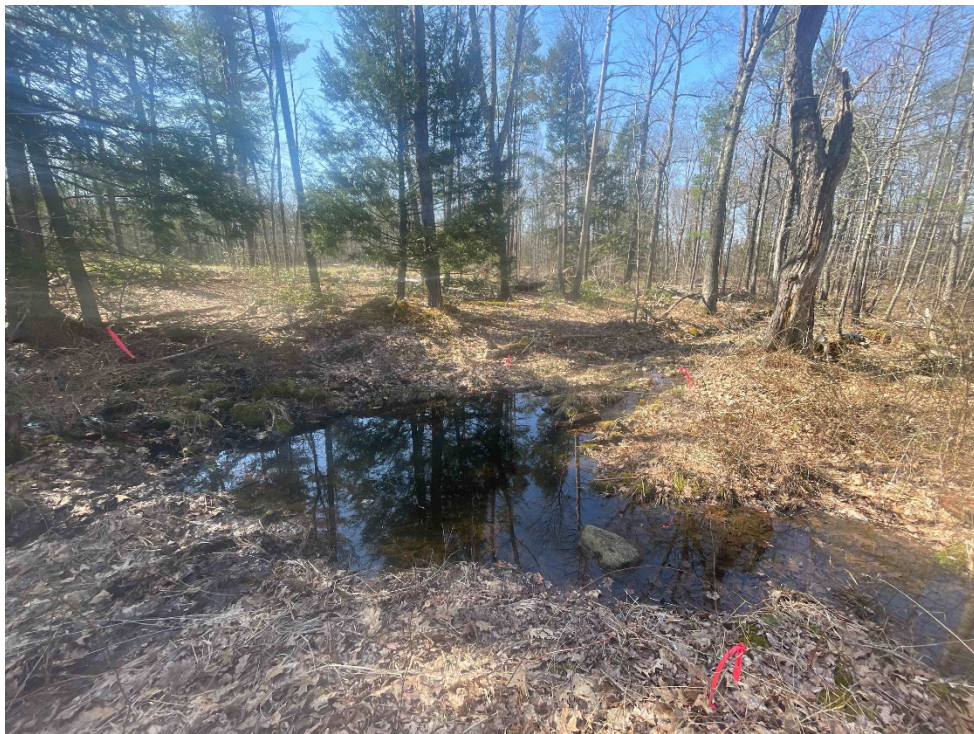
**VP-CWF-1 within W-MFT-2, April 4, 2023.**

Pool is an excavated area within an old road/trail within a forested setting. An ephemeral inlet flows into the pool from the south and an ephemeral outlet flows out of the pool through the trail to the west.

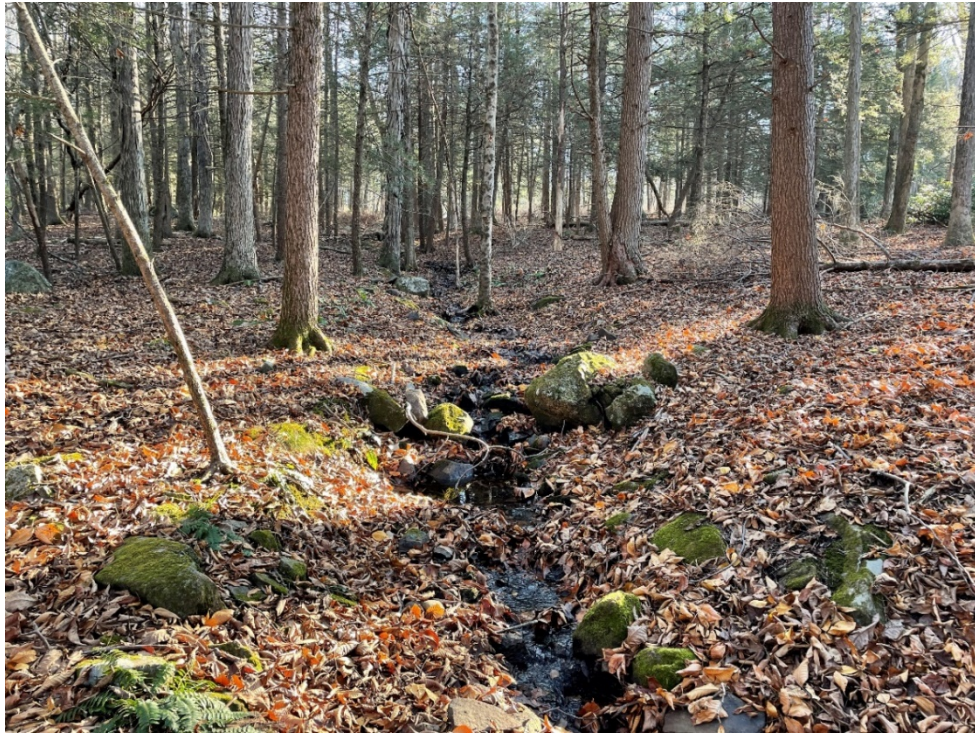
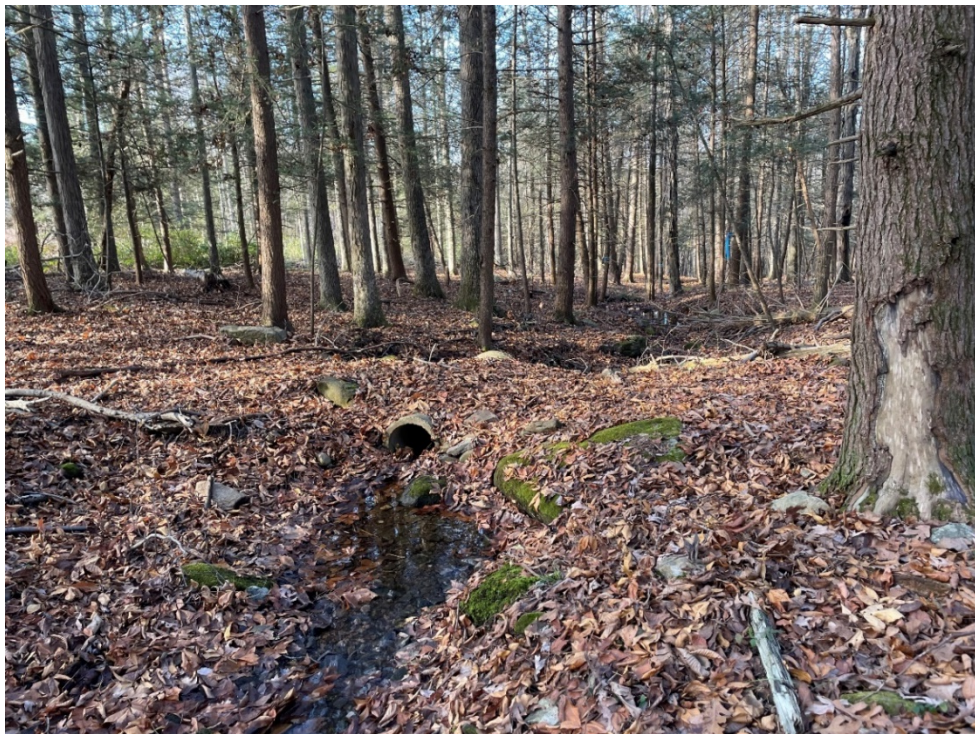
**Watercourse S-MFT-1, November 18, 2022.**

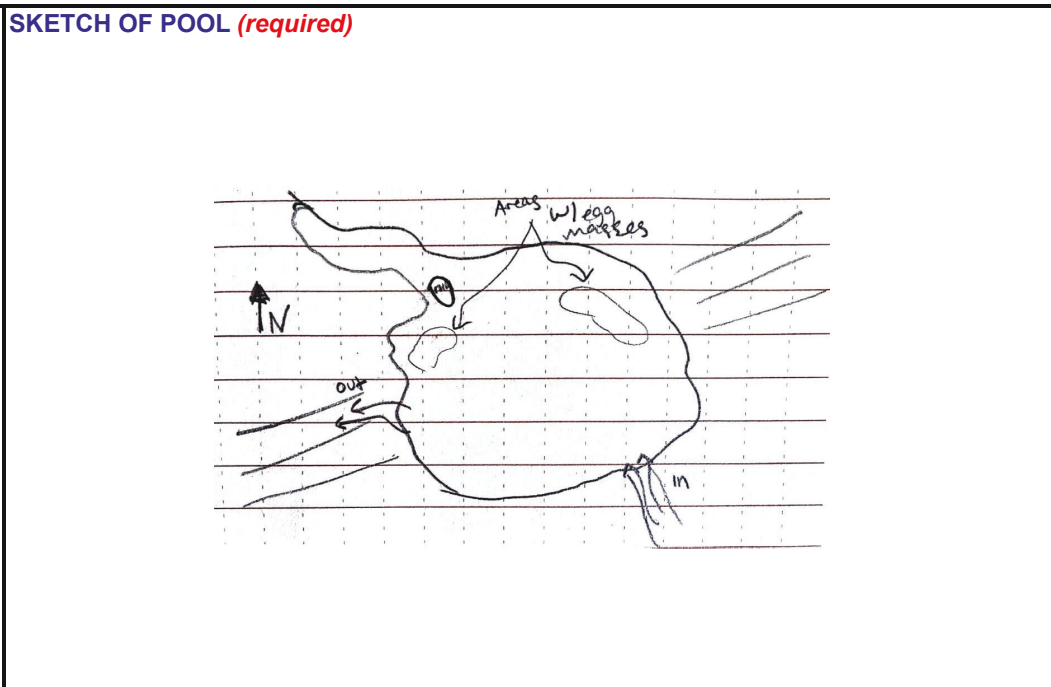
Draw a **rough, quick** sketch of the pool showing **approximate locations of egg mass rafts & clusters** in relation to pool features, like logs, algal mats, and islands. Show inlet/outlet if present. Include north arrow and approximate scale.
