Proposed solar facility located at an old landfill at 105 Vista Dr Torrington, ST 06790.

Proposed USS Torrington Landfill Solar Project

PROJECT:	PHASE I ESA; PROPOSED USS TORRINGTON LANDFILL SOLAR PROJECT TORRINGTON, CONNECTICUT	
TITLE:	SITE LAYOUT PLAN	
DRAWN BY:	CEC	PROJ NO.: 490953.0000.0000
CHECKED BY:	CEC	FIGURE 2
APPROVED BY:	FILE → MDP: TAGS	
DATE:	DECEMBER 2022

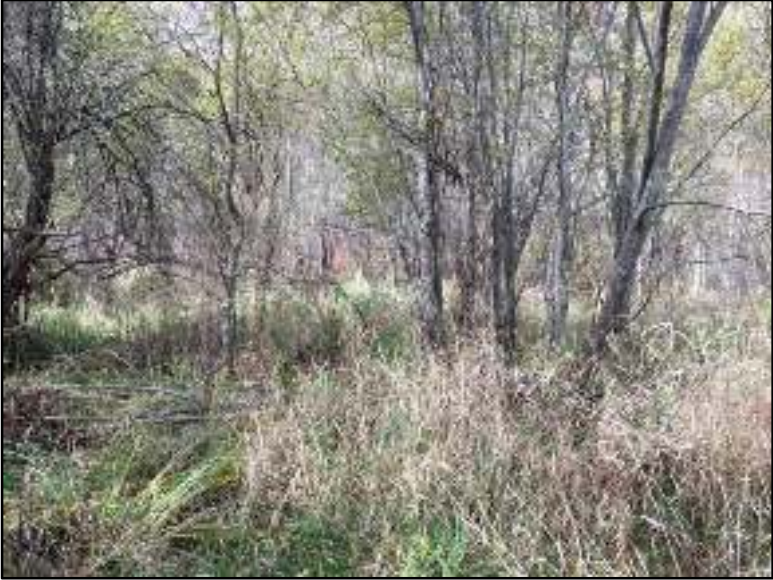
USS TORRINGTON SOLAR, LLC 105 VISTA DRIVE, TORRINGTON, CONECTICUT	
<p>Photograph: 1</p> <p>Date: 10/28/2022</p> <p>Direction: North</p> <p>Description: General overview of PSS wetland W-MJR-1.</p>

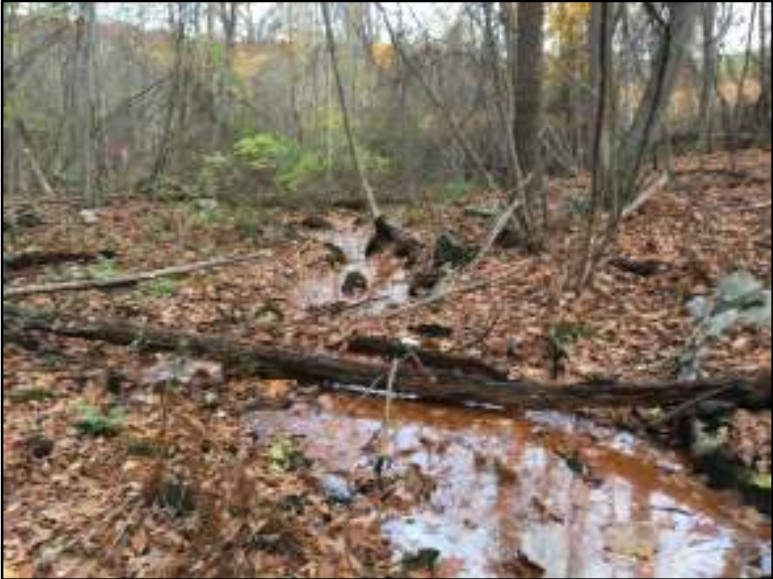
<p>Photograph: 2</p> <p>Date: 10/28/2022</p> <p>Direction: Northeast</p> <p>Description: View of intermittent stream S-MJR-2 facing downstream flowing through wetland W-MJR-1.</p>

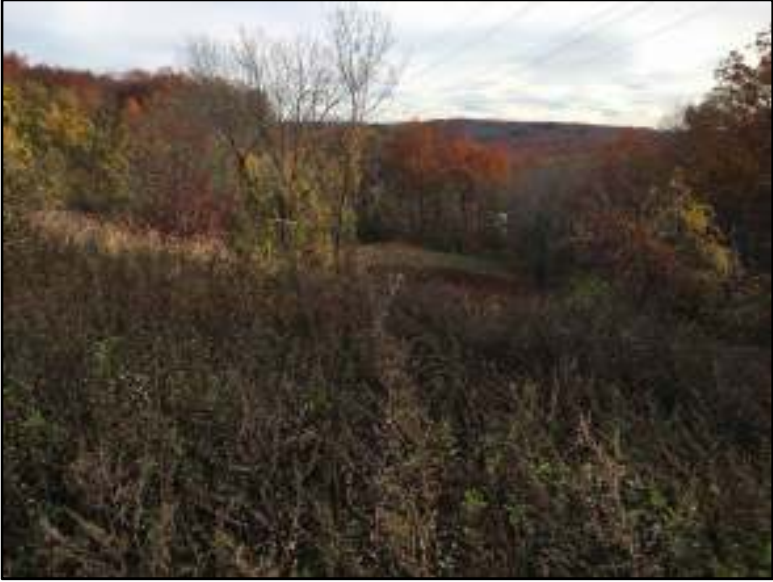
<p>Photograph: 6</p> <p>Date: 10/28/2022</p> <p>Direction: Southeast</p> <p>Description: View of transmission line along the southern boundary of the Project Area.</p>

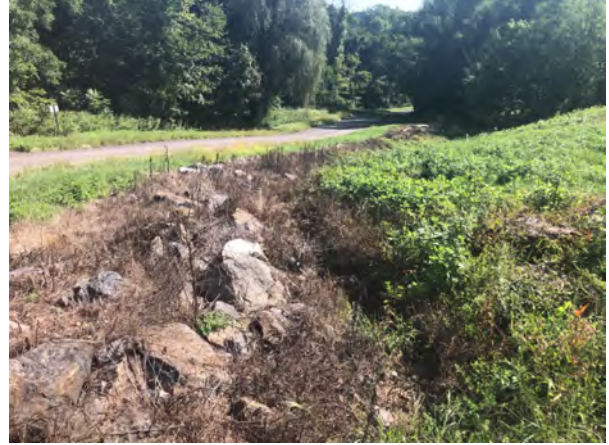
Photo 2: Looking northeast down drainage swale along main access road.

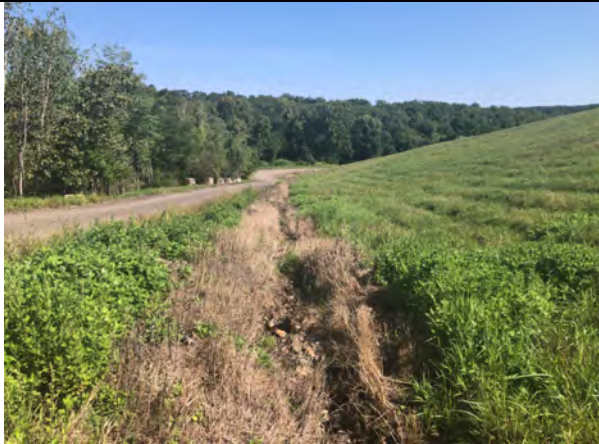
Photo 3: Looking north down drainage swale along main access road.

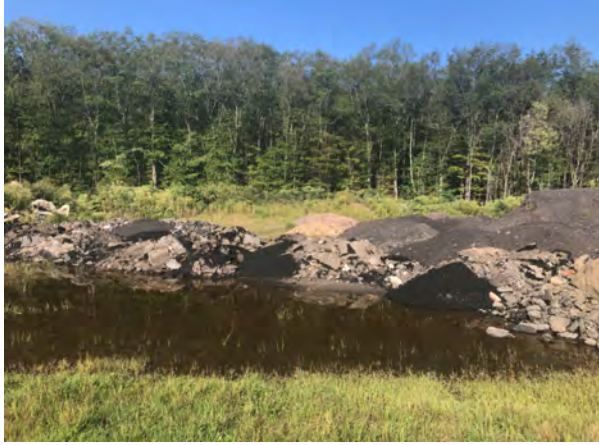
Photo 13: Pondered water in area of Torrington DPW dumping area.

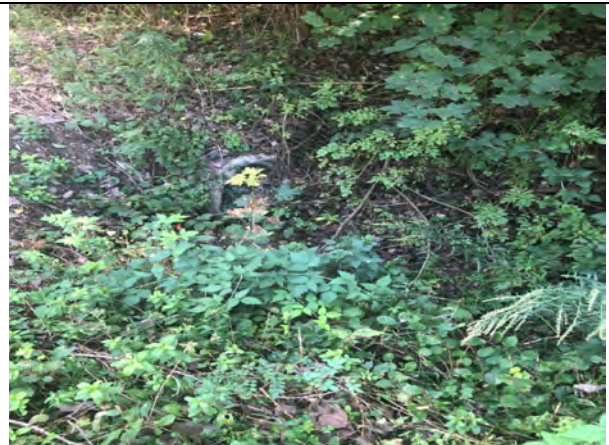
Photo 18: Discharge culvert pipe for landfill drainage swales.
