Re: PETITION NO. 1614 - The Connecticut Light and Power Company d/b/a Eversource Energy petition for a declaratory ruling, pursuant to Connecticut General Statutes §4-176 and §16-50k, for the proposed Christian Street Junction to Stevenson Substation Rebuild Project on the 1580 and 1808 Lines in Monroe and Oxford, Connecticut – **Supplemental Information**

In reference to Petition No. 1614 (“Petition”), as filed with the Connecticut Siting Council (“Council”) on February 20, 2024, for the Christian Street Junction to Stevenson Substation Rebuild Project (“Project”), Eversource submits this Supplemental Information associated with corrections to wetlands and watercourse mapping and reporting.

The wetland and watercourse mapping revisions are shown in the attached *Revised Attachment A - Map Sheets* and are listed in the Summary Table below:

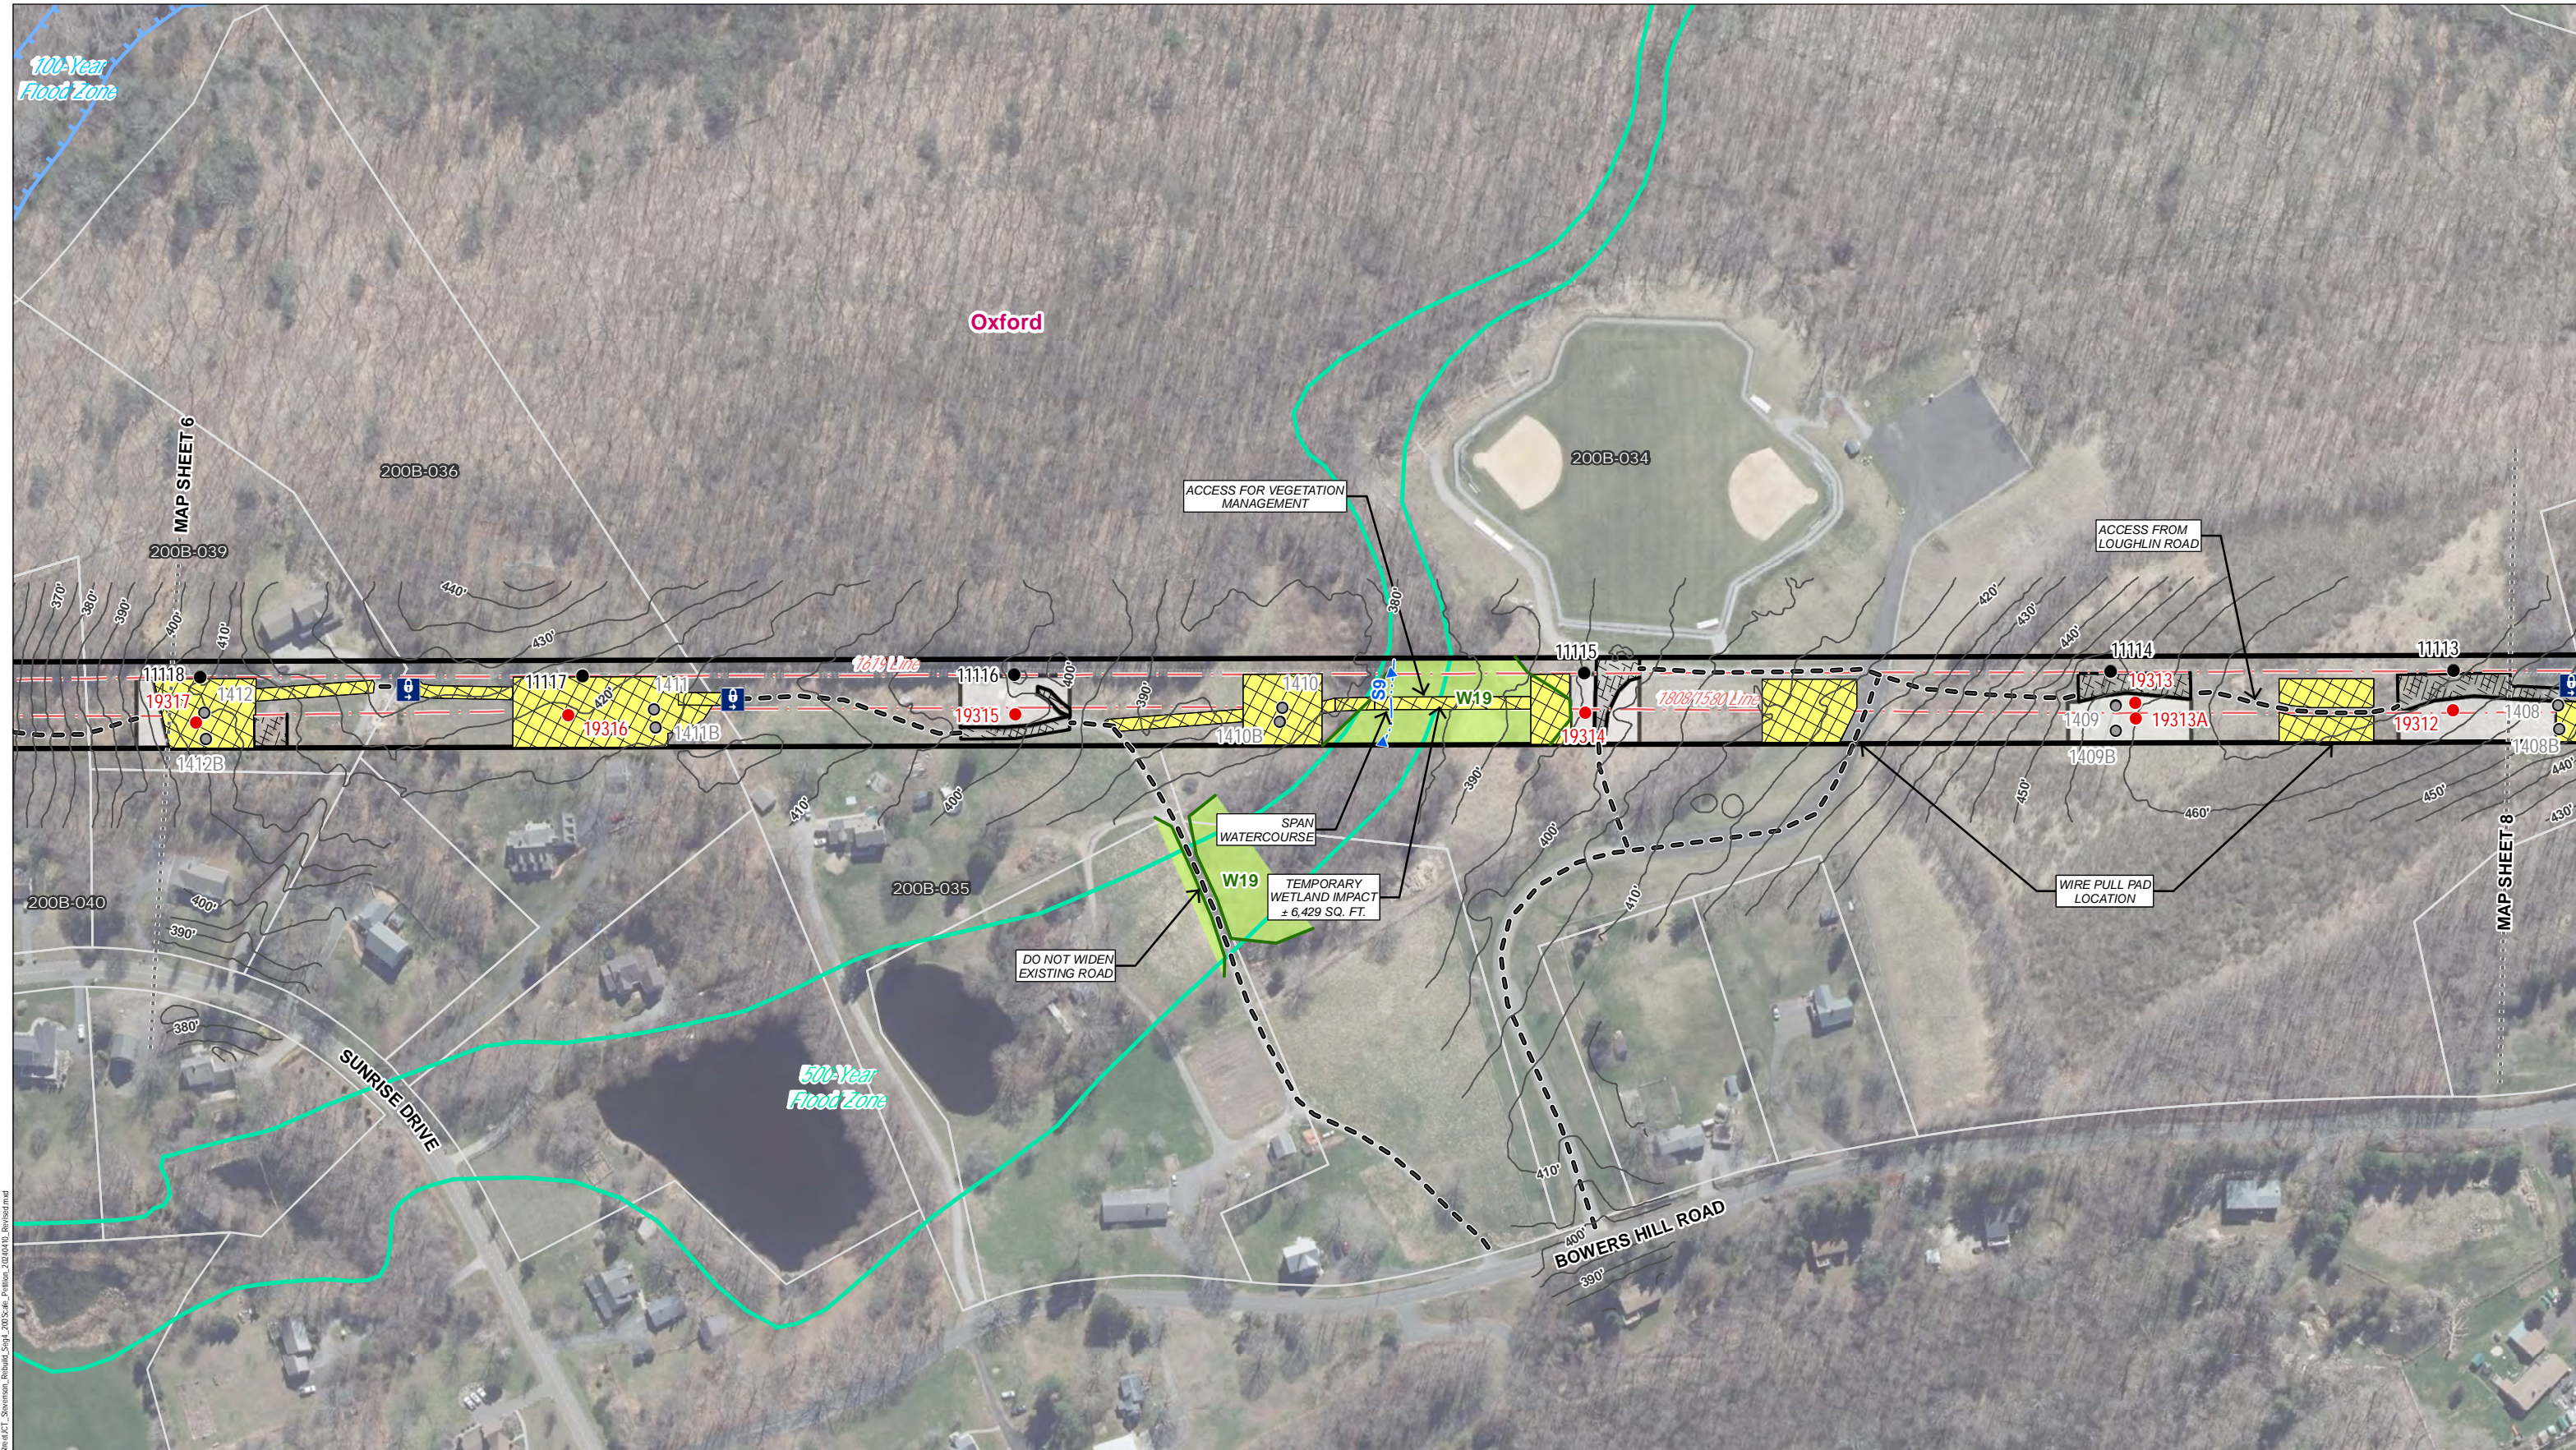
NO.	DATE	REVISIONS	BY	CHK	APP	APP
1	4/2/2024	Wetland and watercourse limits	SM	RC	SF
