Re: Christian Street Junction to Stevenson Substation Rebuild Project

PETITION TO THE CONNECTICUT SITING COUNCIL  
FOR A DECLARATORY RULING OF  
NO SUBSTANTIAL ADVERSE ENVIRONMENTAL EFFECT  
FOR THE PROPOSED MODIFICATIONS TO THE EXISTING  
1580 AND 1808 LINES IN THE TOWN OF OXFORD  
AND TOWN OF MONROE, CONNECTICUT

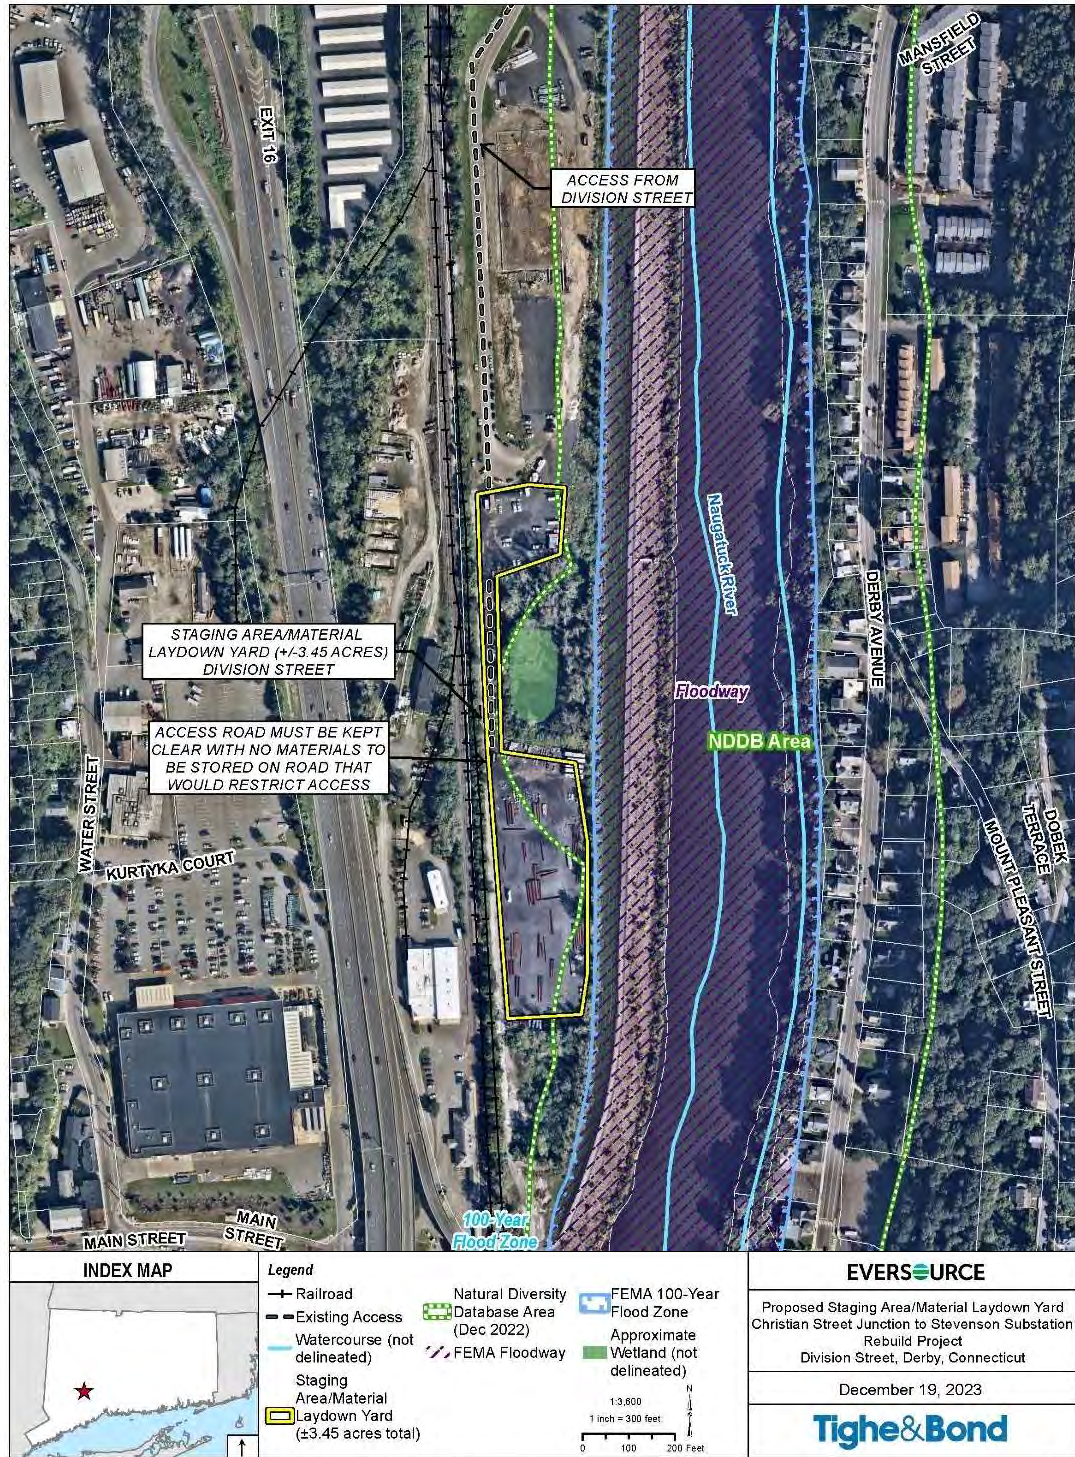
Figure 2: Staging Area/Laydown Yard - Division Street, Derby

Eversource proposes to use two previously established staging area/laydown yards for the Project. The Division Street, Derby yard is approximately 3.45 acres and would be used to store construction equipment and materials, (including tools, and supplies) conductor, insulators, hardware, poles, and construction mats for the Project. The Bic Drive, Milford staging area/laydown yard is approximately 1.7 acres and would be used for office trailers and may also be used to store construction equipment and materials. Transmission line components removed during the work (structure steel, conductor, hardware, and insulators) also may be temporarily stored prior to removal off-site for salvage and/or disposal. The staging area/laydown yards may also be used by construction crew members for parking personal vehicles as well as for construction vehicles, and for performing minor maintenance, when needed, on construction equipment. Erosion and sedimentation (“E&S”) controls would be installed and maintained until completion of the work in accordance with Project permits and Eversource’s BMP’s. (Refer to Figures 2 and 3 below.)

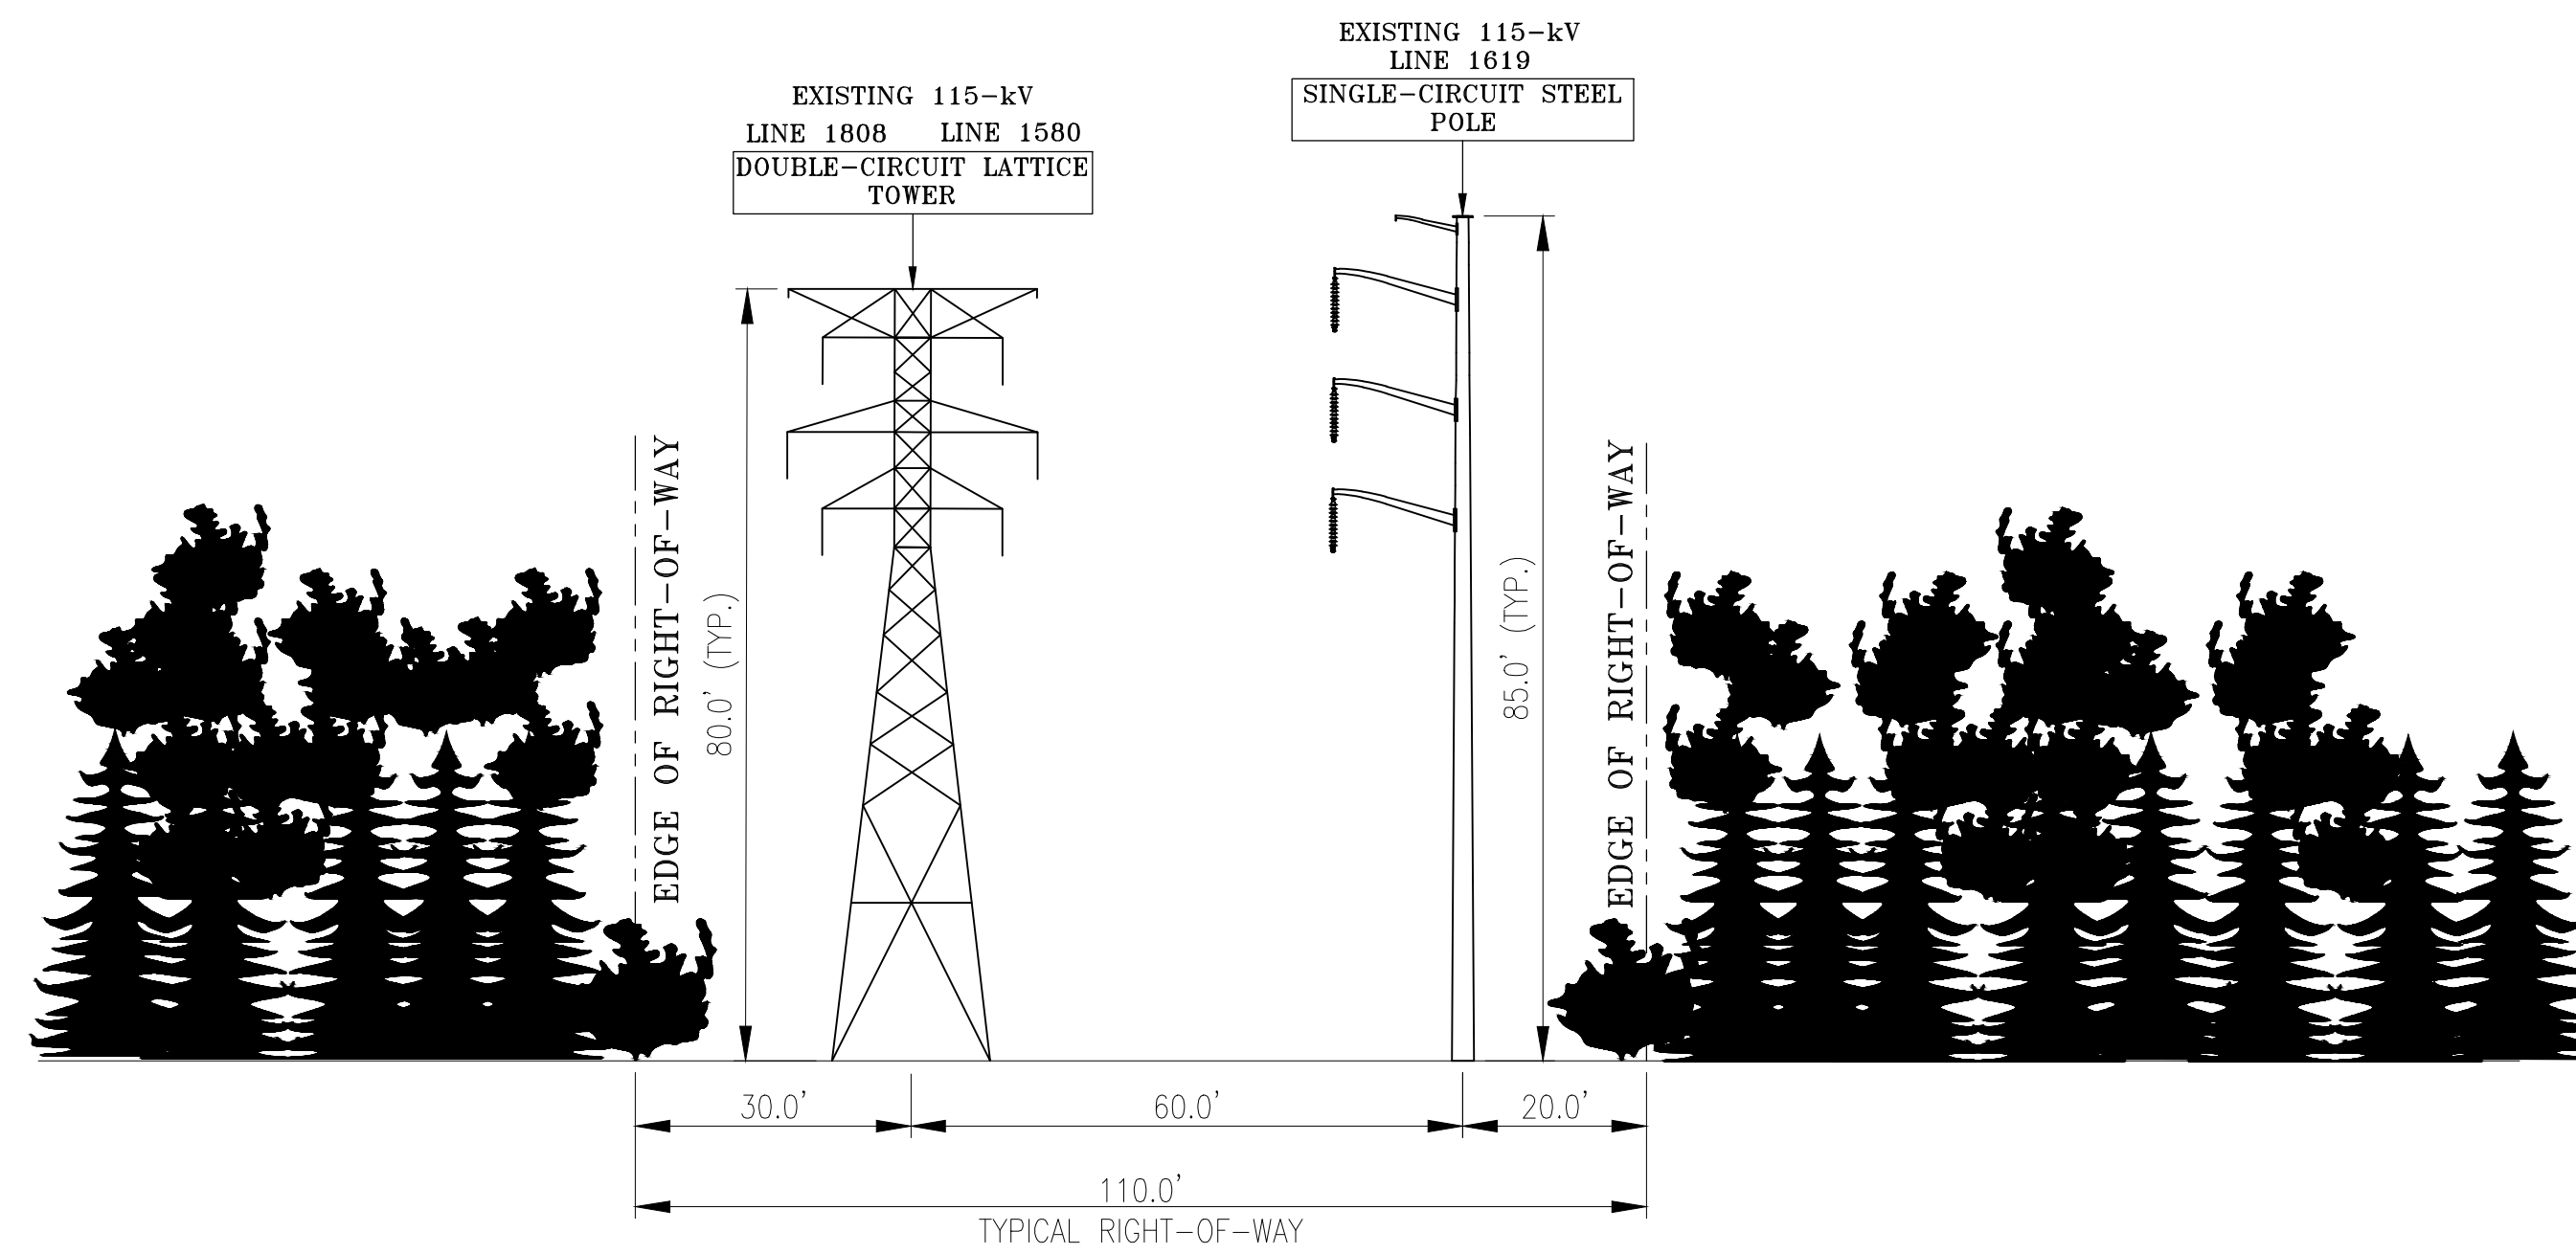
**EXISTING R.O.W. CONFIGURATION  
(TYPICAL)**

**DOUBLE-CIRCUIT STEEL LATTICE/SINGLE-CIRCUIT STEEL  
MONOPOLE VERTICAL DESIGN  
LOOKING FROM STEVENSON S/S TO CHRISTIAN ST. JCT.  
IN THE TOWN OF OXFORD, CT**

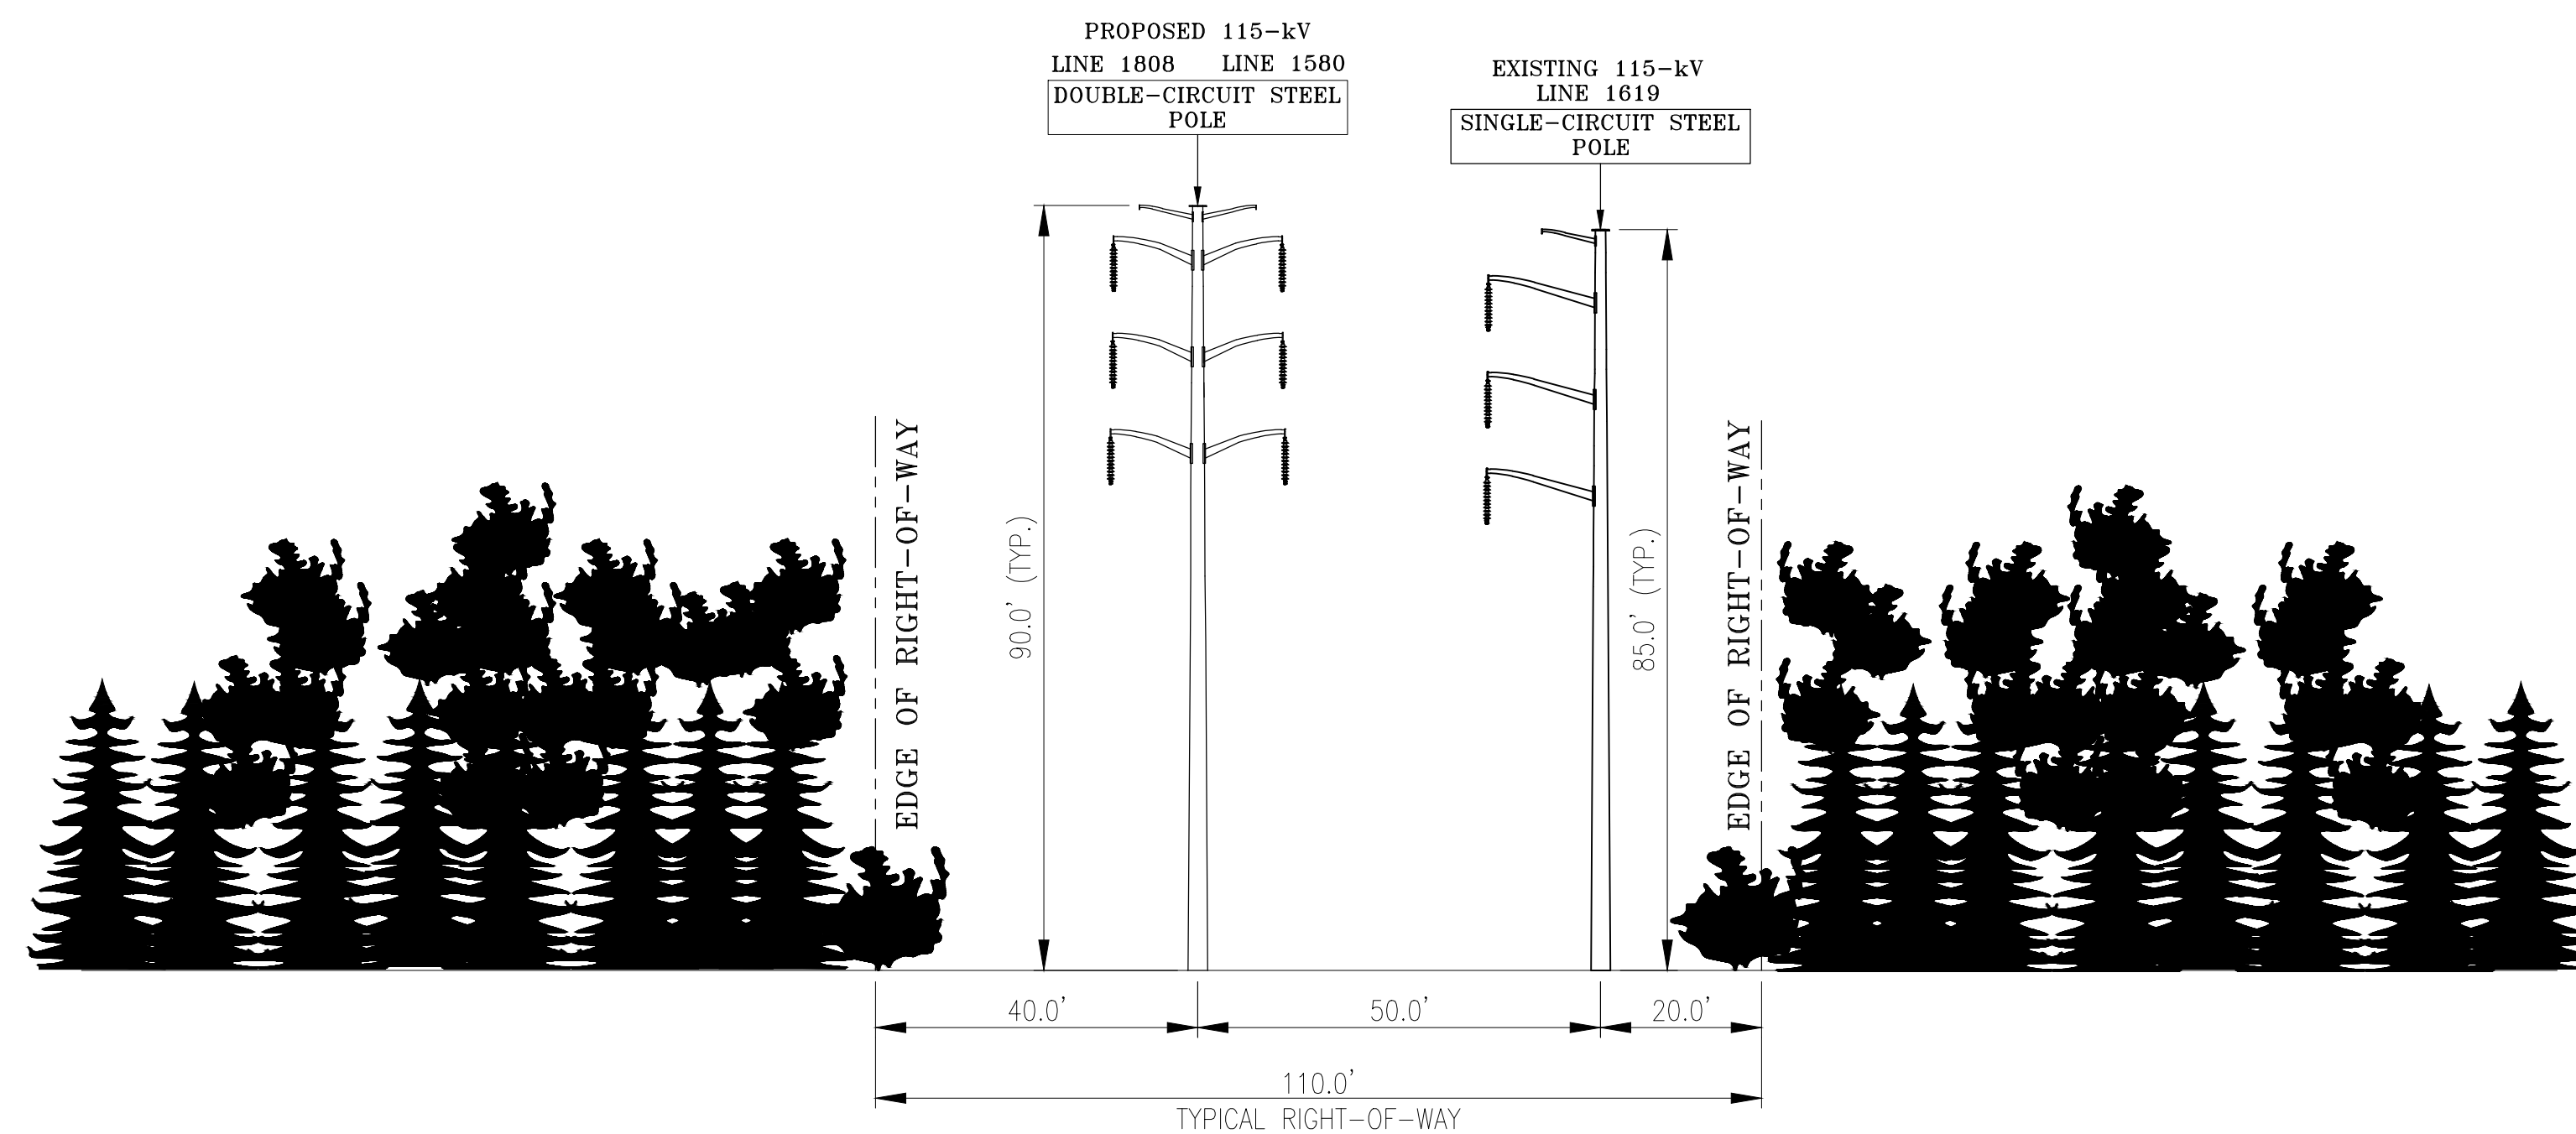
**PROPOSED R.O.W. CONFIGURATION  
(TYPICAL)**

**NO ADDITIONAL RIGHT-OF-WAY REQUIRED  
DOUBLE-CIRCUIT/SINGLE-CIRCUIT STEEL MONOPOLE VERTICAL DESIGN  
LOOKING FROM STEVENSON S/S TO CHRISTIAN ST. JCT.  
IN THE TOWN OF OXFORD, CT**

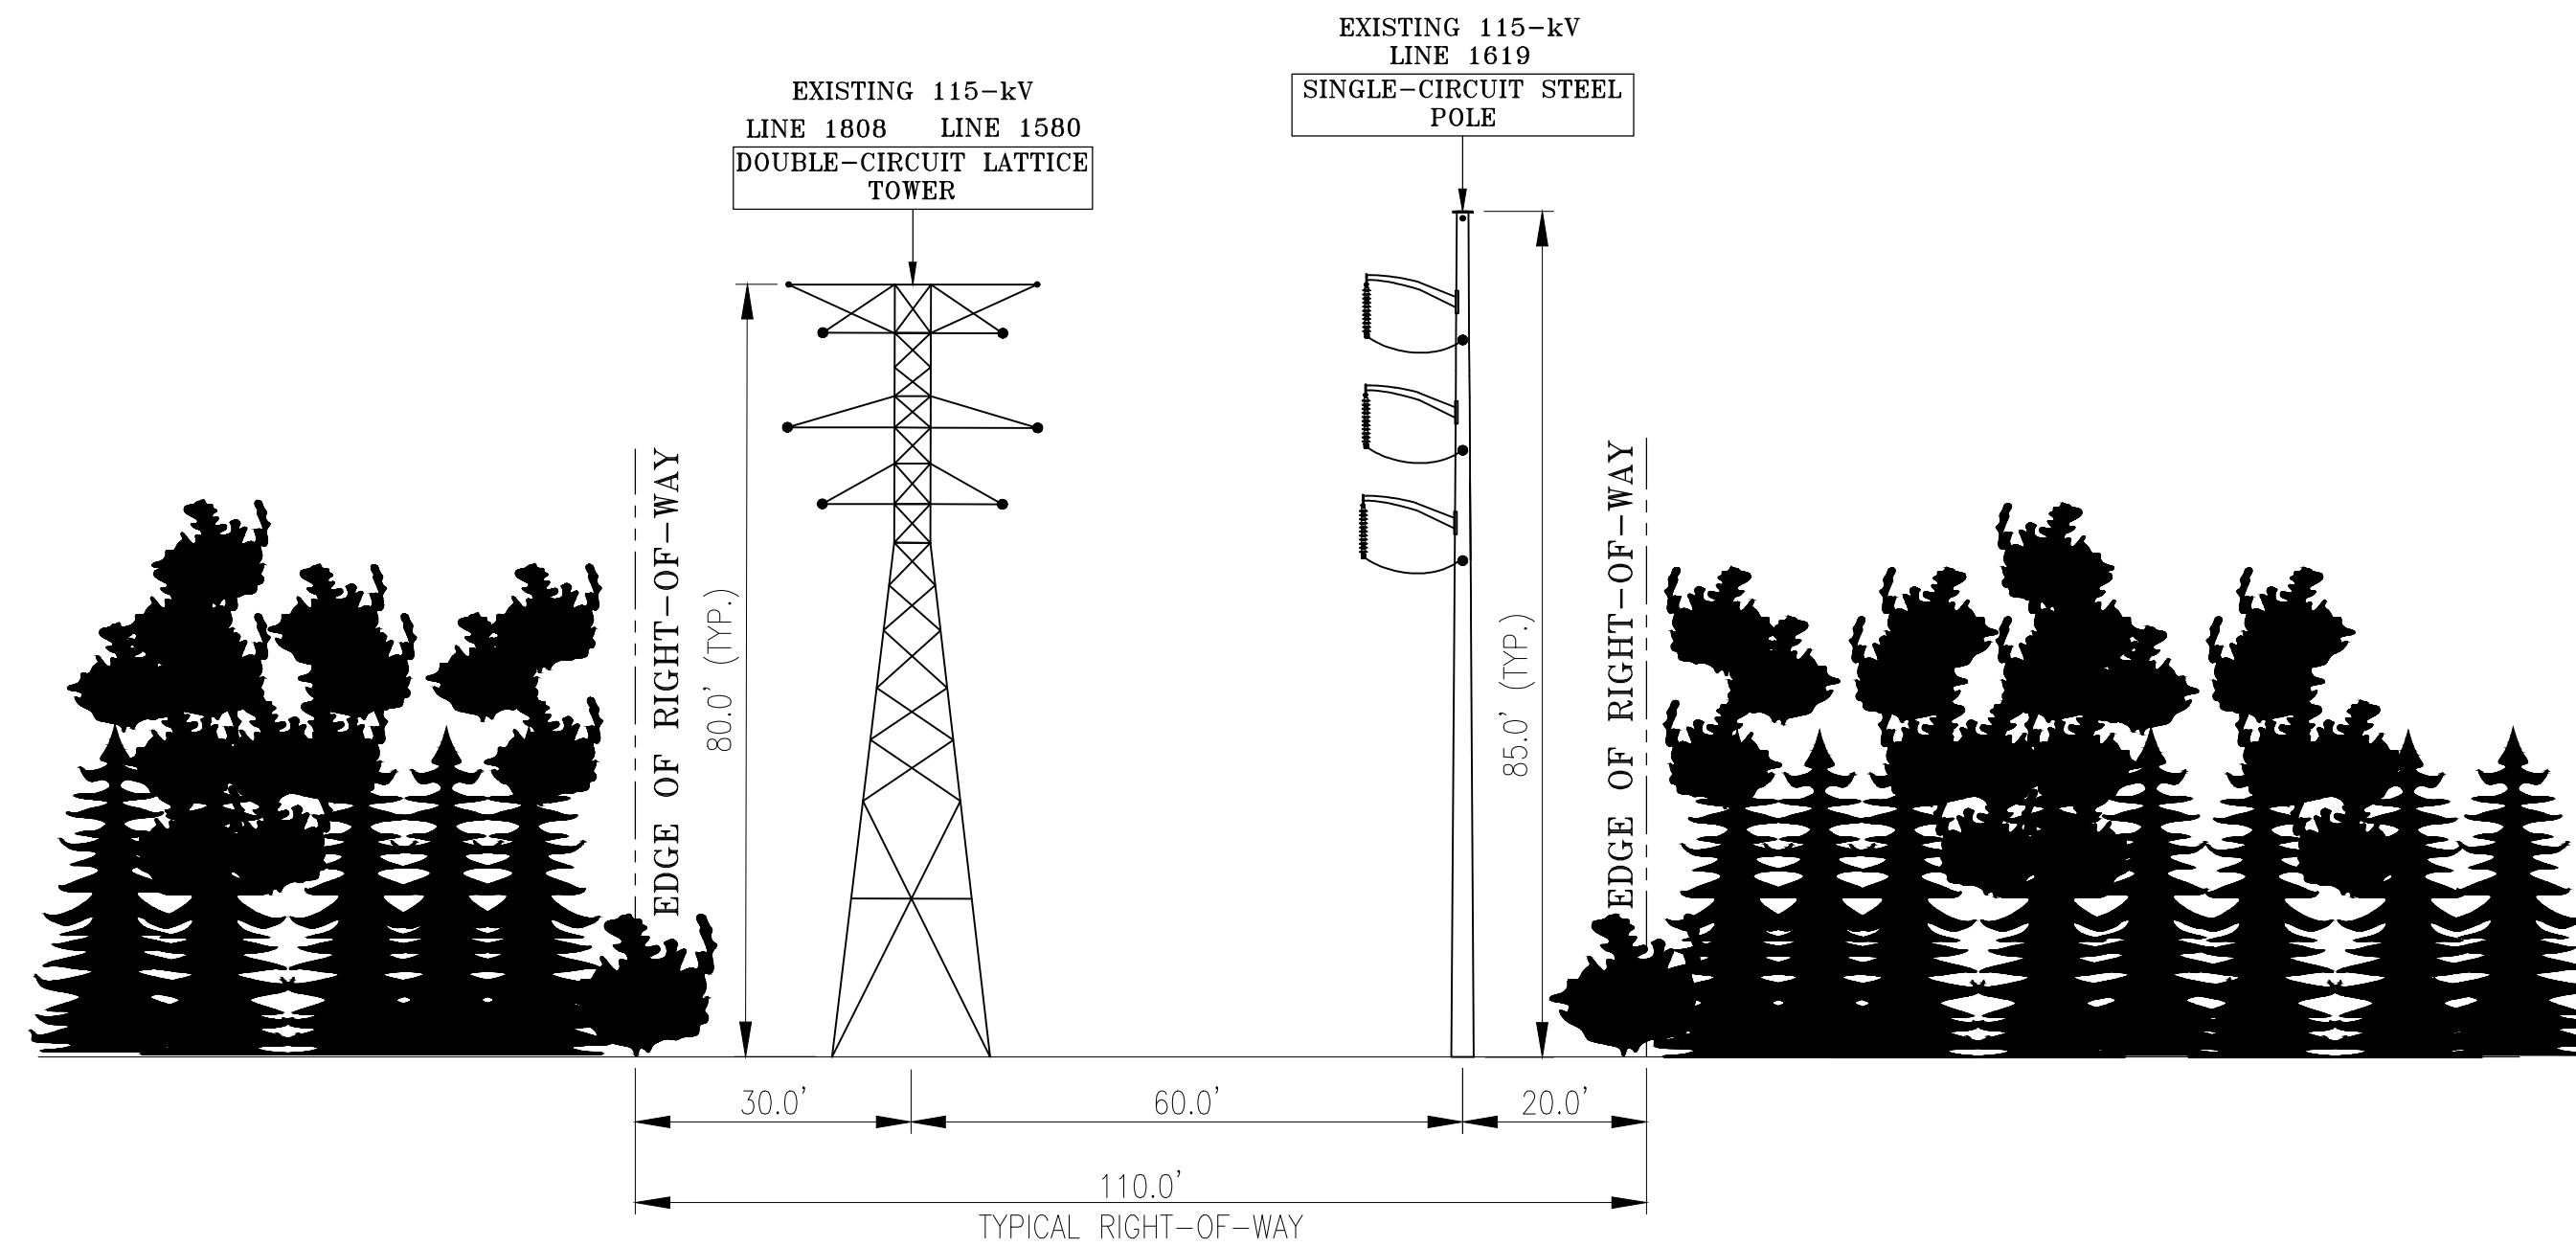
**EXISTING R.O.W. CONFIGURATION  
(TYPICAL)**  
**DOUBLE-CIRCUIT STEEL LATTICE/SINGLE-CIRCUIT STEEL  
 MONOPOLE VERTICAL DESIGN**  
**LOOKING FROM STEVENSON S/S TO CHRISTIAN ST. JCT.  
 IN THE TOWN OF OXFORD, CT**

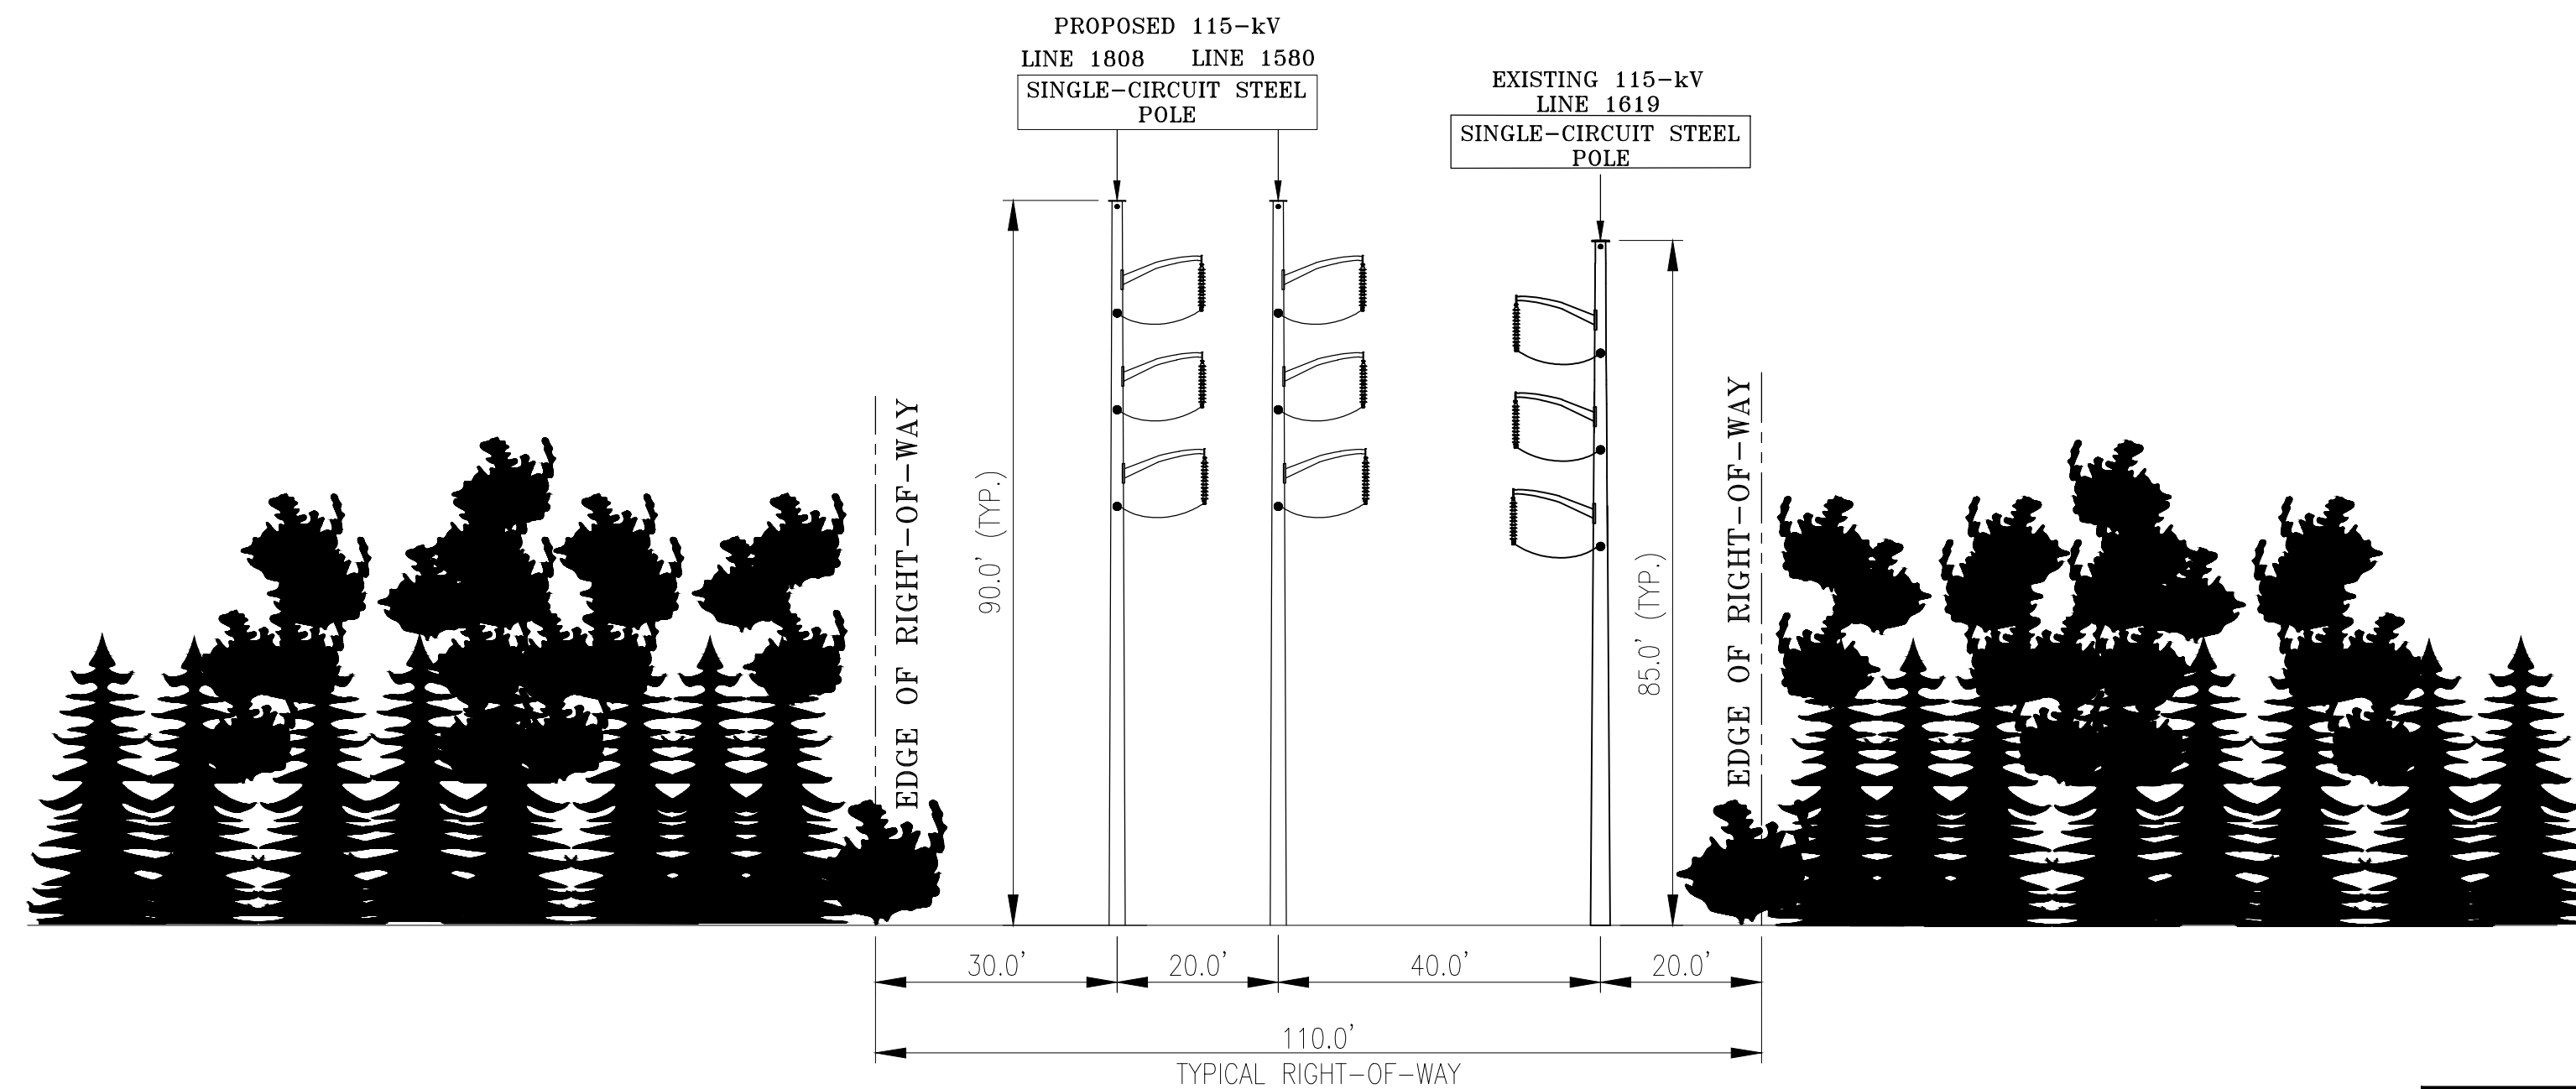
**PROPOSED R.O.W. CONFIGURATION  
(TYPICAL)**  
**NO ADDITIONAL RIGHT-OF-WAY REQUIRED**  
**SINGLE-CIRCUIT STEEL MONOPOLE VERTICAL DESIGN**  
**LOOKING FROM STEVENSON S/S TO CHRISTIAN ST. JCT.  
 IN THE TOWN OF OXFORD, CT**

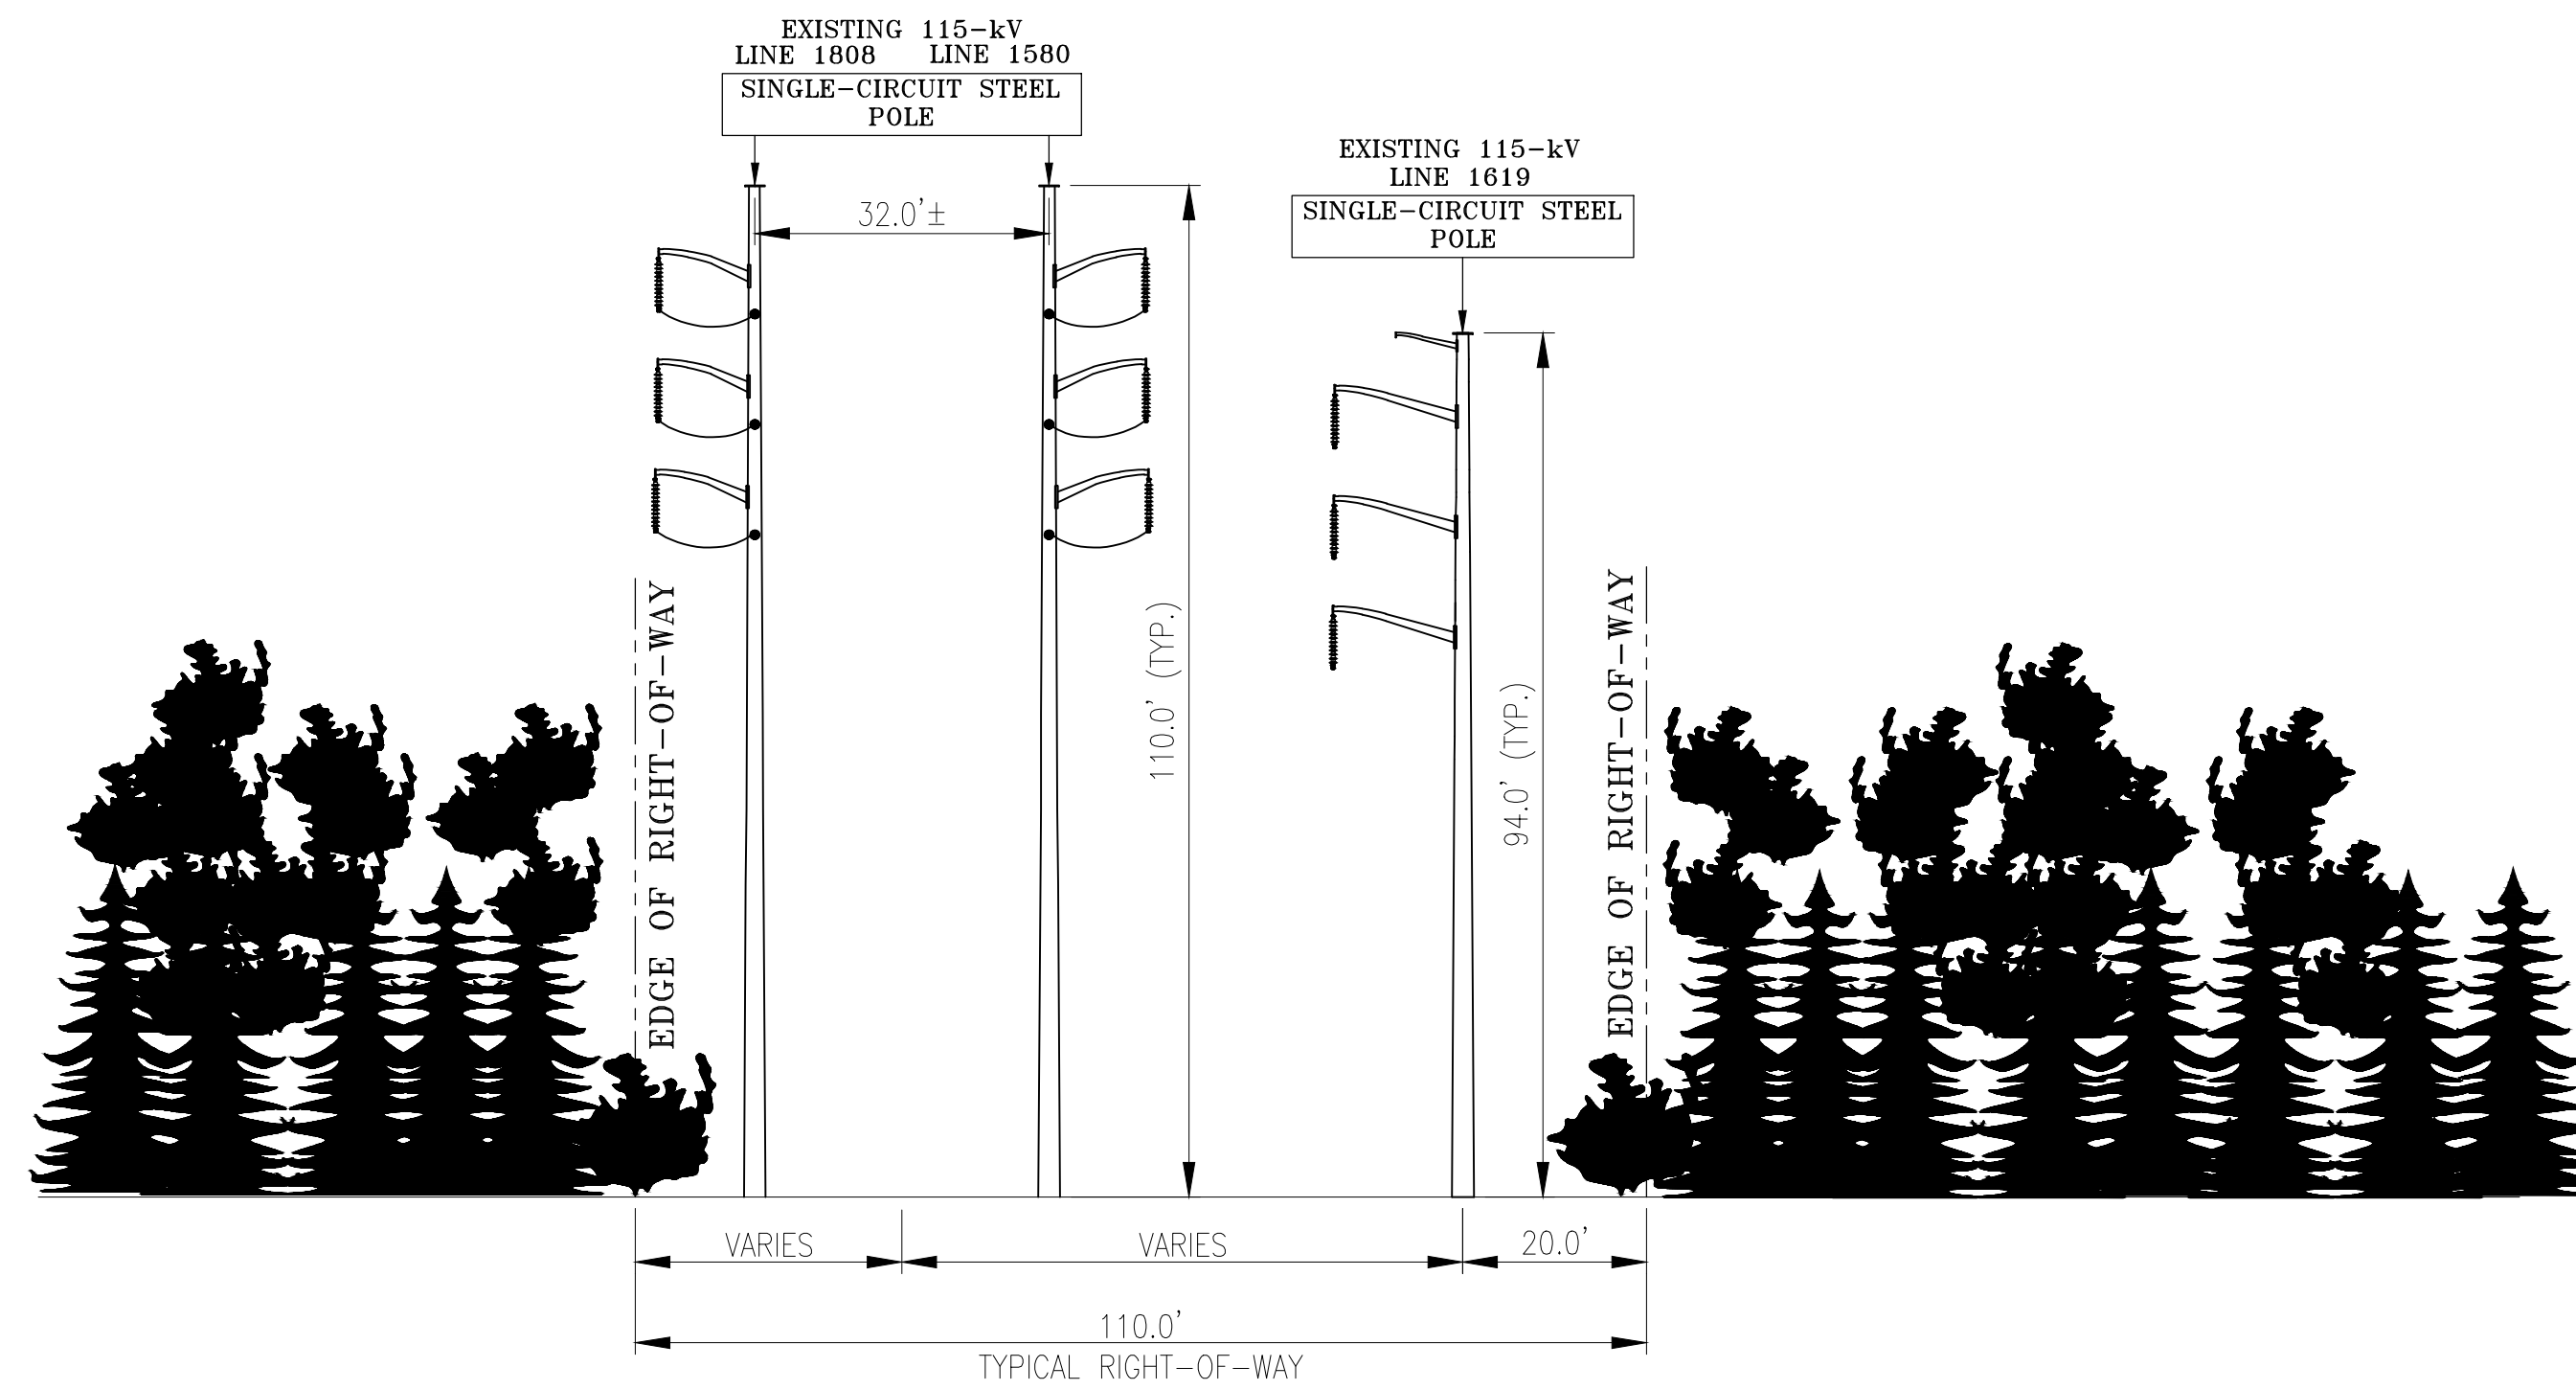
**EXISTING R.O.W. CONFIGURATION  
(TYPICAL)**

**SINGLE-CIRCUIT STEEL MONOPOLE VERTICAL DESIGN  
LOOKING FROM STEVENSON S/S TO CHRISTIAN ST. JCT.  
IN THE TOWN OF OXFORD, CT**

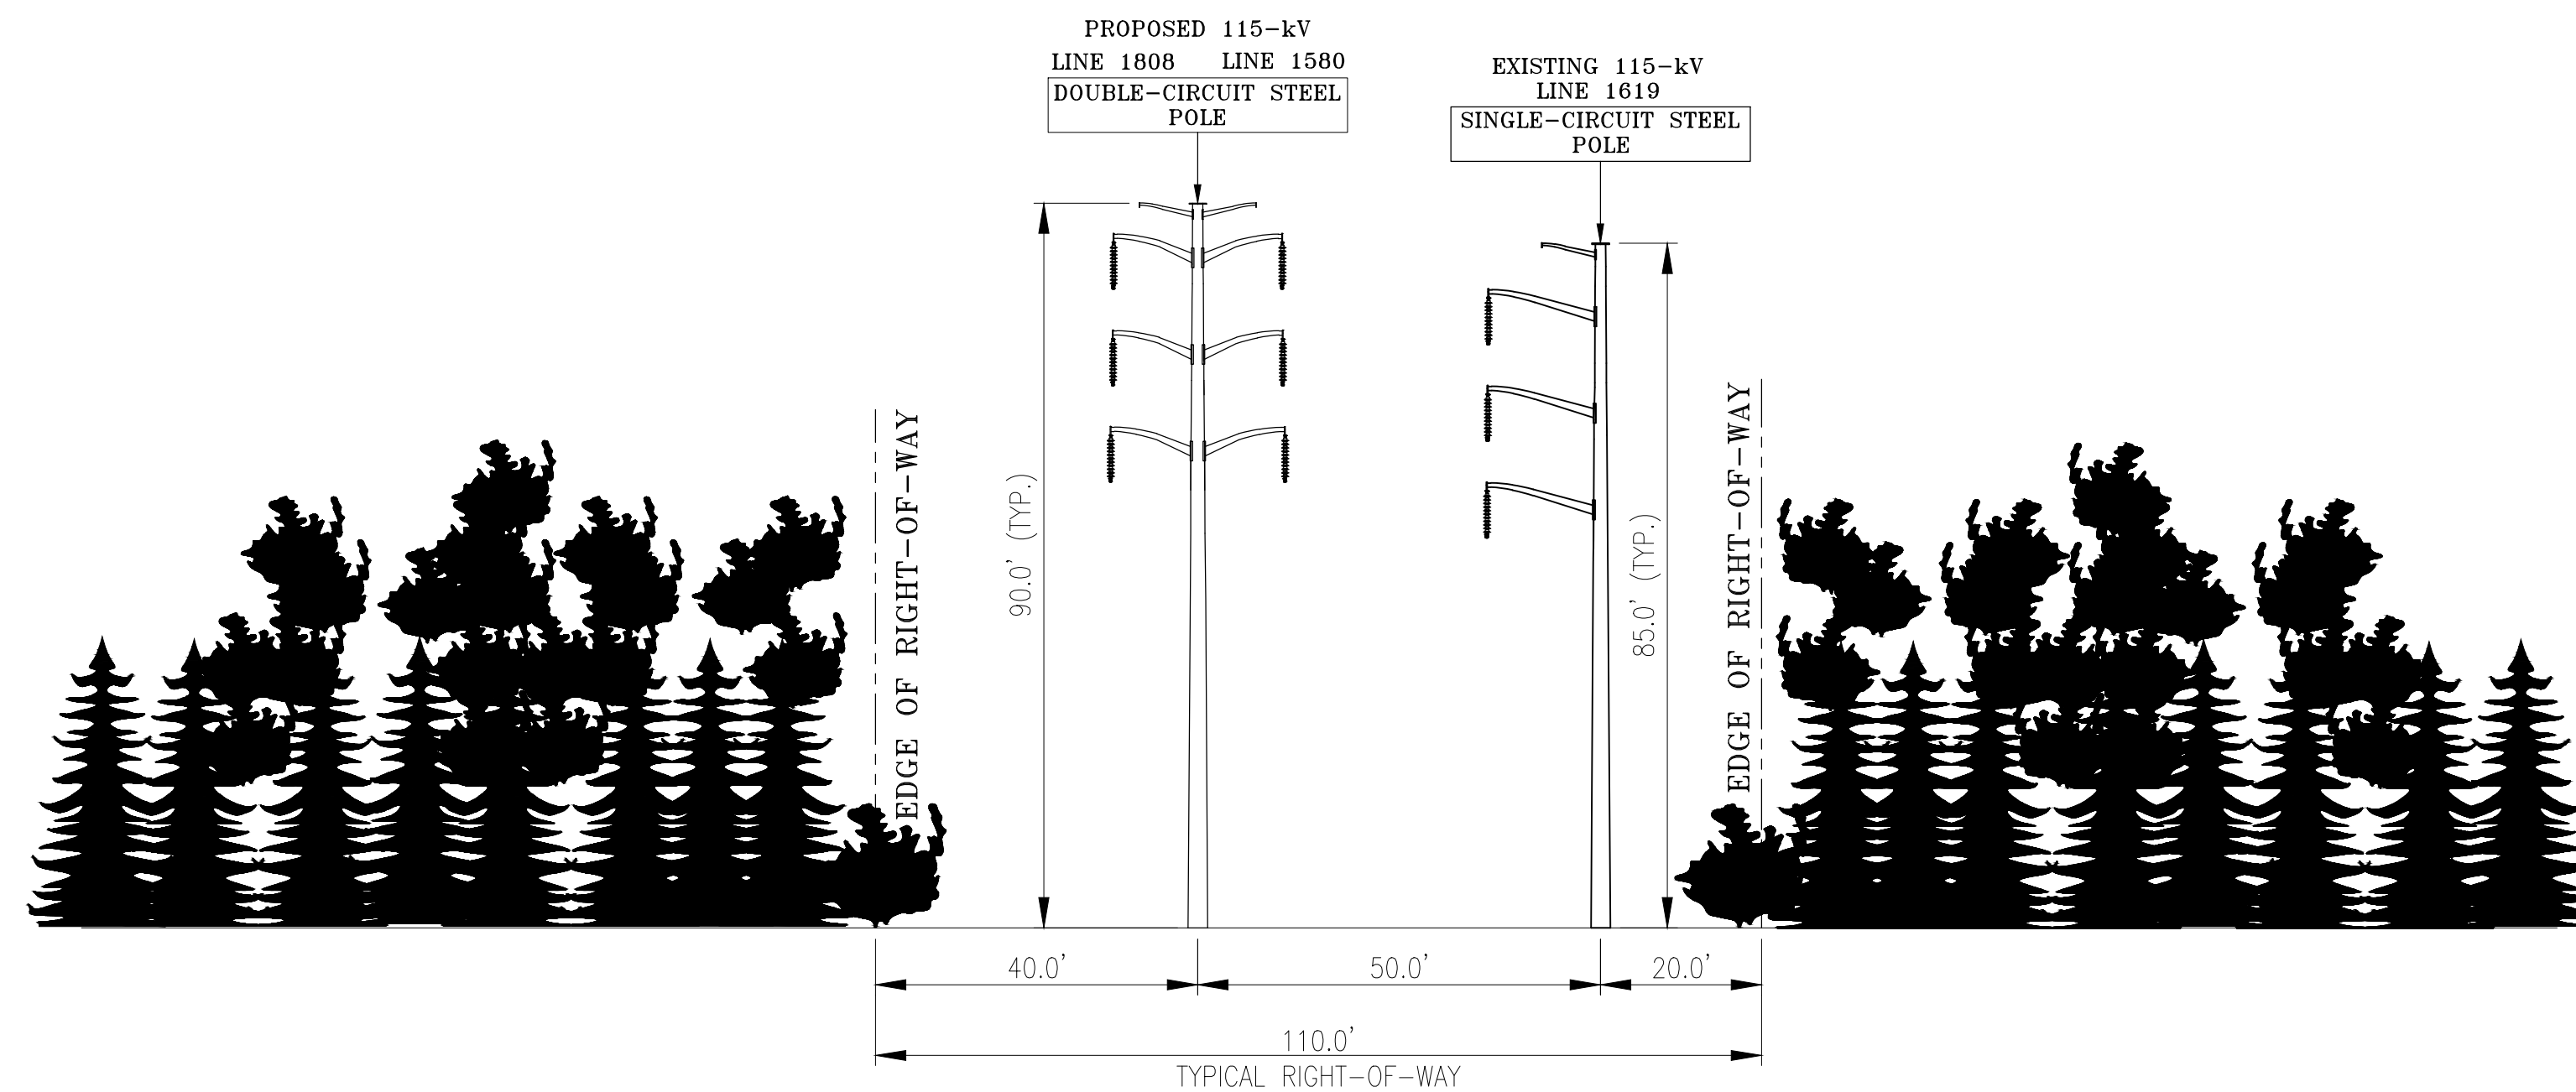
**PROPOSED R.O.W. CONFIGURATION  
(TYPICAL)**

**NO ADDITIONAL RIGHT-OF-WAY REQUIRED  
DOUBLE-CIRCUIT/SINGLE-CIRCUIT STEEL MONOPOLE VERTICAL DESIGN  
LOOKING FROM STEVENSON S/S TO CHRISTIAN ST. JCT.  
IN THE TOWN OF OXFORD, CT**

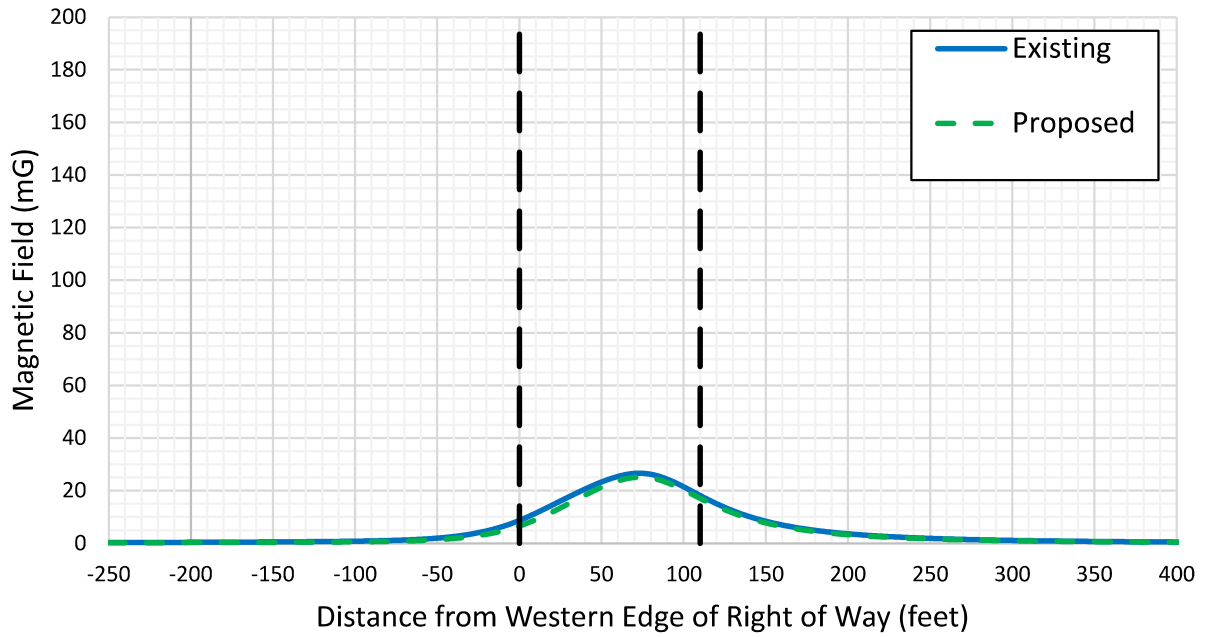
### Calculated Magnetic Fields (Annual Average Loads) Stevenson S/S - Christian Road Junction

Eversource prepared calculations of the existing and post-Project electric and magnetic fields (“EMF”). The calculations were based on average annual loading conditions, as these are most representative of typical operating conditions. The calculations are made relative to the centerline of the proposed, modified transmission lines.

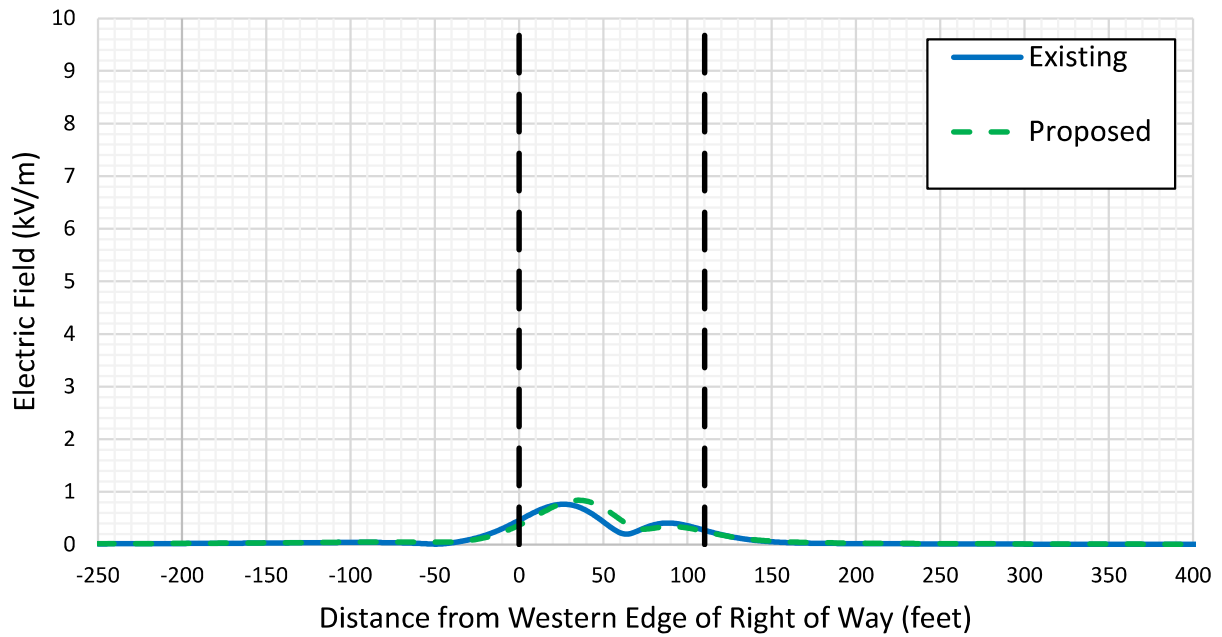
### Calculated Electric Fields (Annual Average Loads) Stevenson S/S - Christian Road Junction
