December 19, 2023

Ref: 43362.00

Re: Wetland & Watercourse Delineation Report
Castle Rock Road, Woodstock, Connecticut

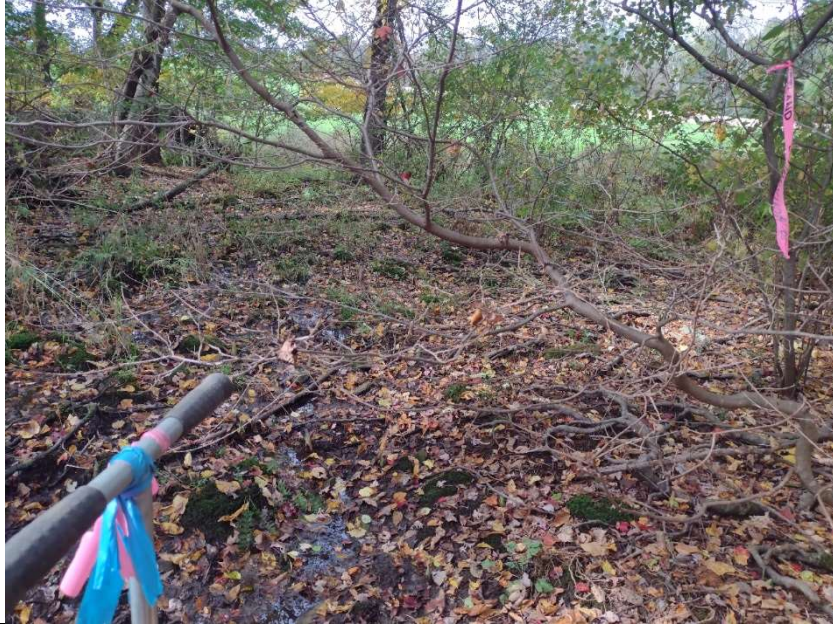
Photo No.: 1

Description: Facing west, a view of Wetland 1 in the foreground, and the grassing agricultural field uplands in the background.

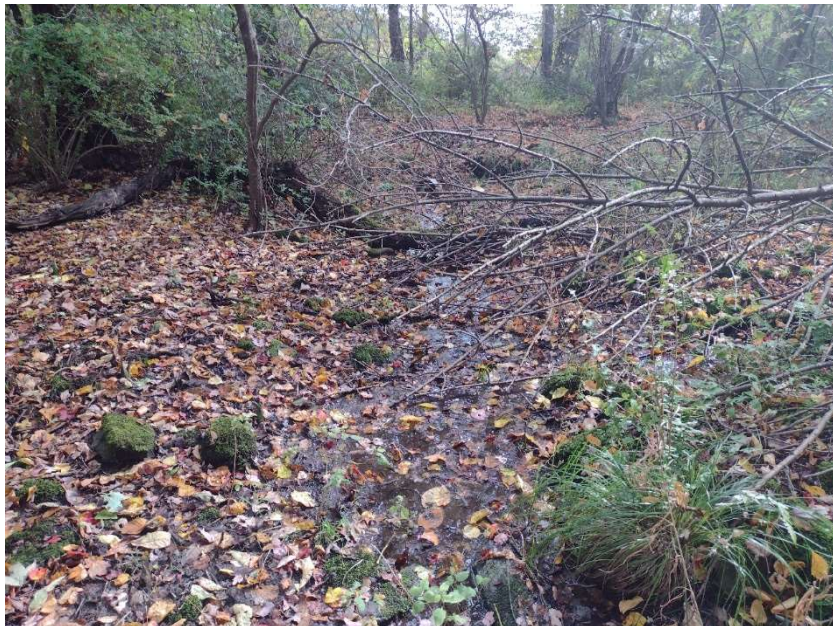
Photo No.: 2

Description: Facing south, a view of Wetland 1.

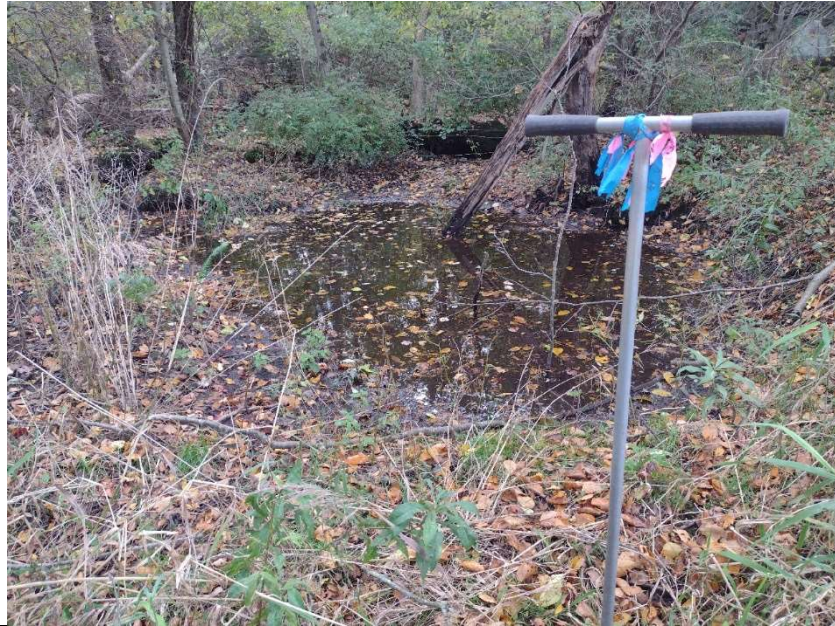
Photo No.: 3

During the delineation a potential vernal pool was observed that may allow for amphibian breeding and is located near Wetland Flag W1-162 and identified on the attached Figure 2. This pool appears to be the result from a berm constructed around the wetland. It is recommended that a biological survey of this pool be conducted in the spring to confirm if amphibians are using this pool for breeding as well as identify the species that may occur in this location.

Description: Facing southeast, a view of a potential vernal pool located within Wetland 1.

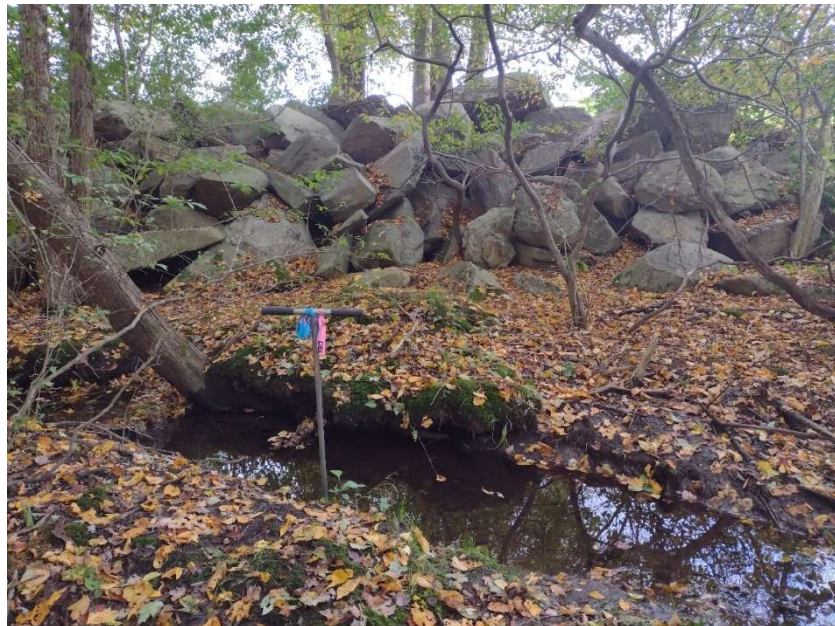
Photo No.: 4

Description: Facing west in Wetland 1, a view of a stream channel in the foreground, and a boulder stockpile in the background.

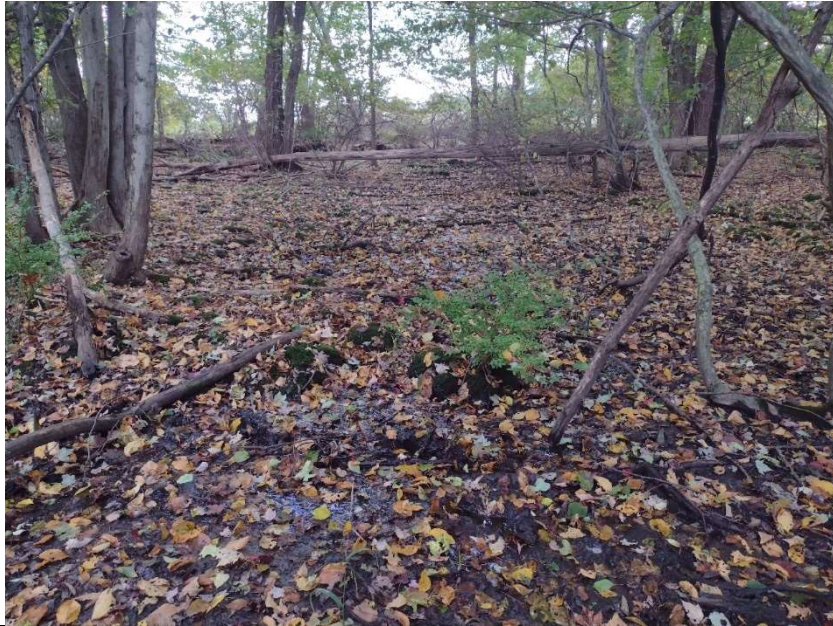
Photo No.: 5

Description: Facing east in Wetland 1, a view of the forested wetland area.

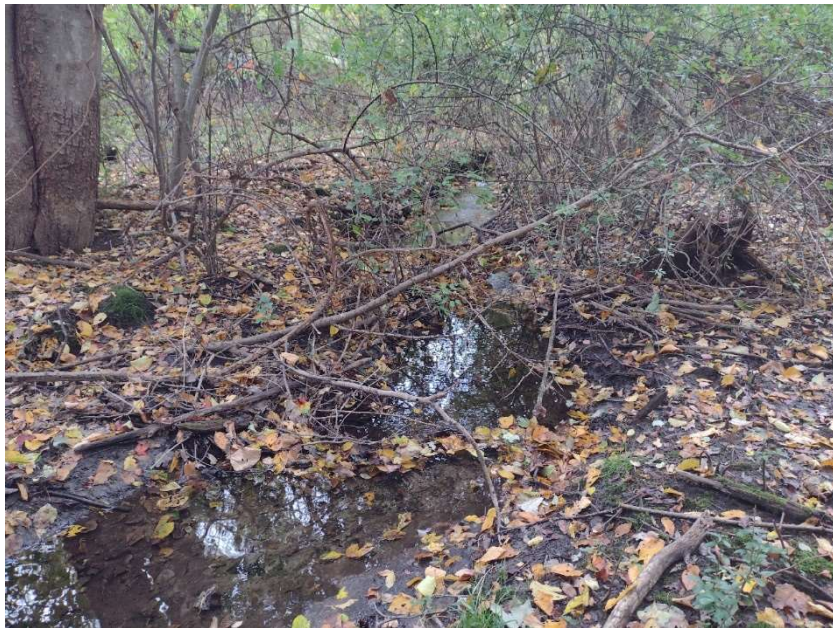
Photo No.: 6

Description: Facing south in Wetland 1, a view of the forested stream.

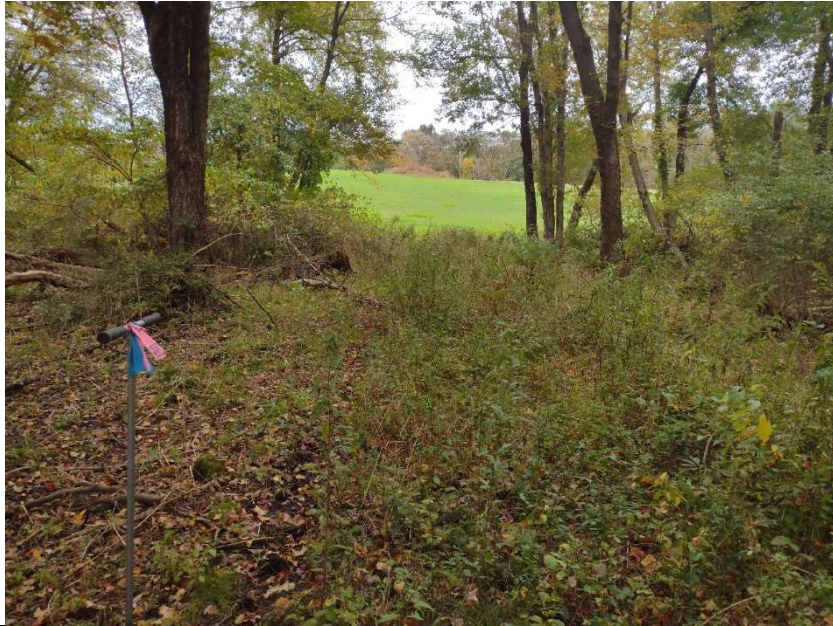
Photo No.: 7

Description: Facing west in Wetland 1, a view of the compacted pathway bisecting the wetland area.

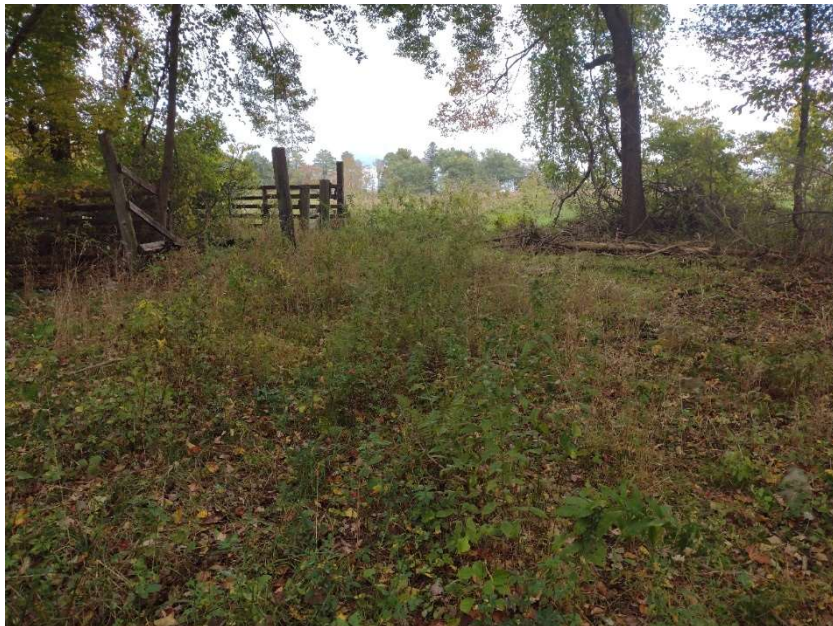
Photo No.: 8

Description: Facing east in Wetland 1, a view of the compacted pathway bisecting the wetland area.

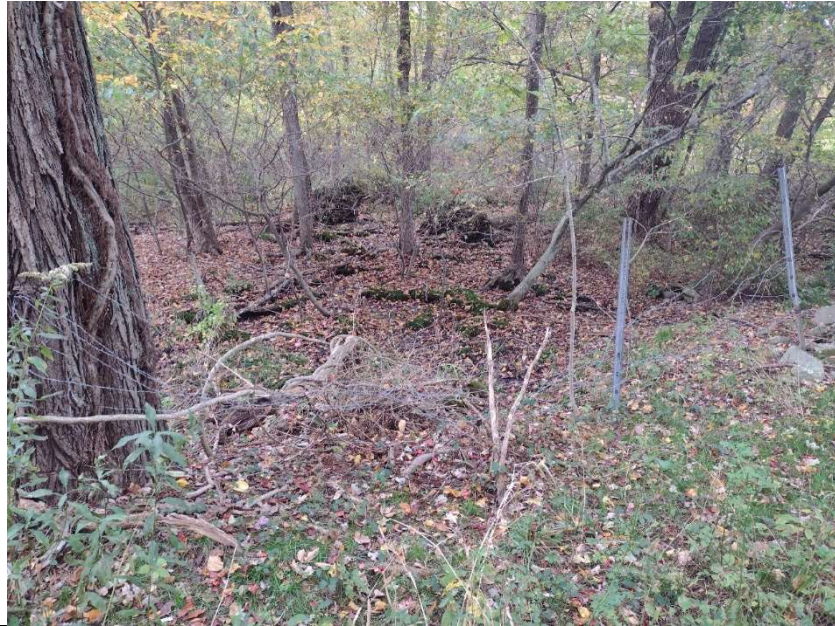
Photo No.: 9

Description: Facing north in Wetland 1, a view of the wetland adjacent to the pathway.

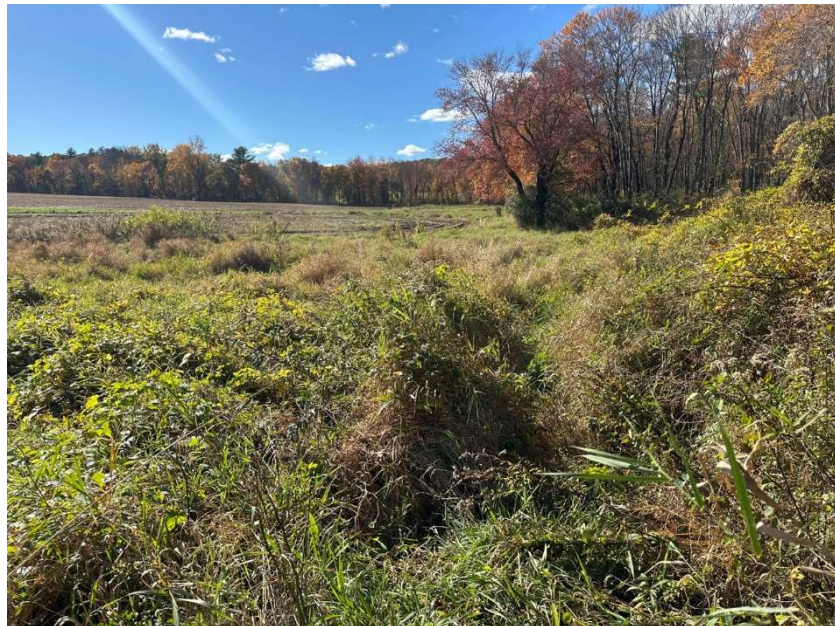
Photo No.: 10

Description: Facing west, a view of a continuation of Wetland 3 through a vegetated portion of the agricultural field. The agricultural field is in the background.

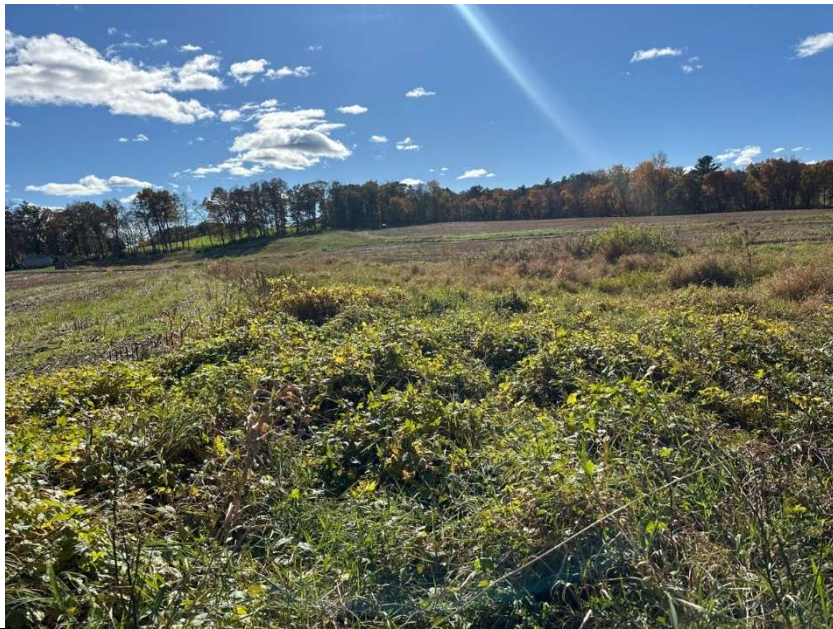
Photo No.: 11

Description: Facing south at the northern property boundary, a view of a continuation of Wetland 3 through a vegetated portion of the agricultural field.

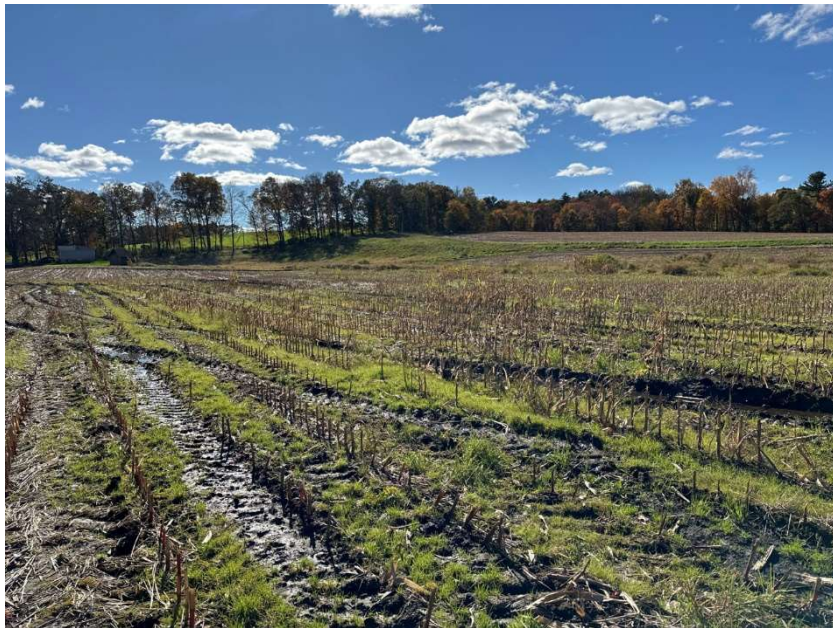
Photo No.: 12

Description: Facing southwest at the northern property boundary, a view of a continuation of Wetland 3 through a vegetated portion of the agricultural field.

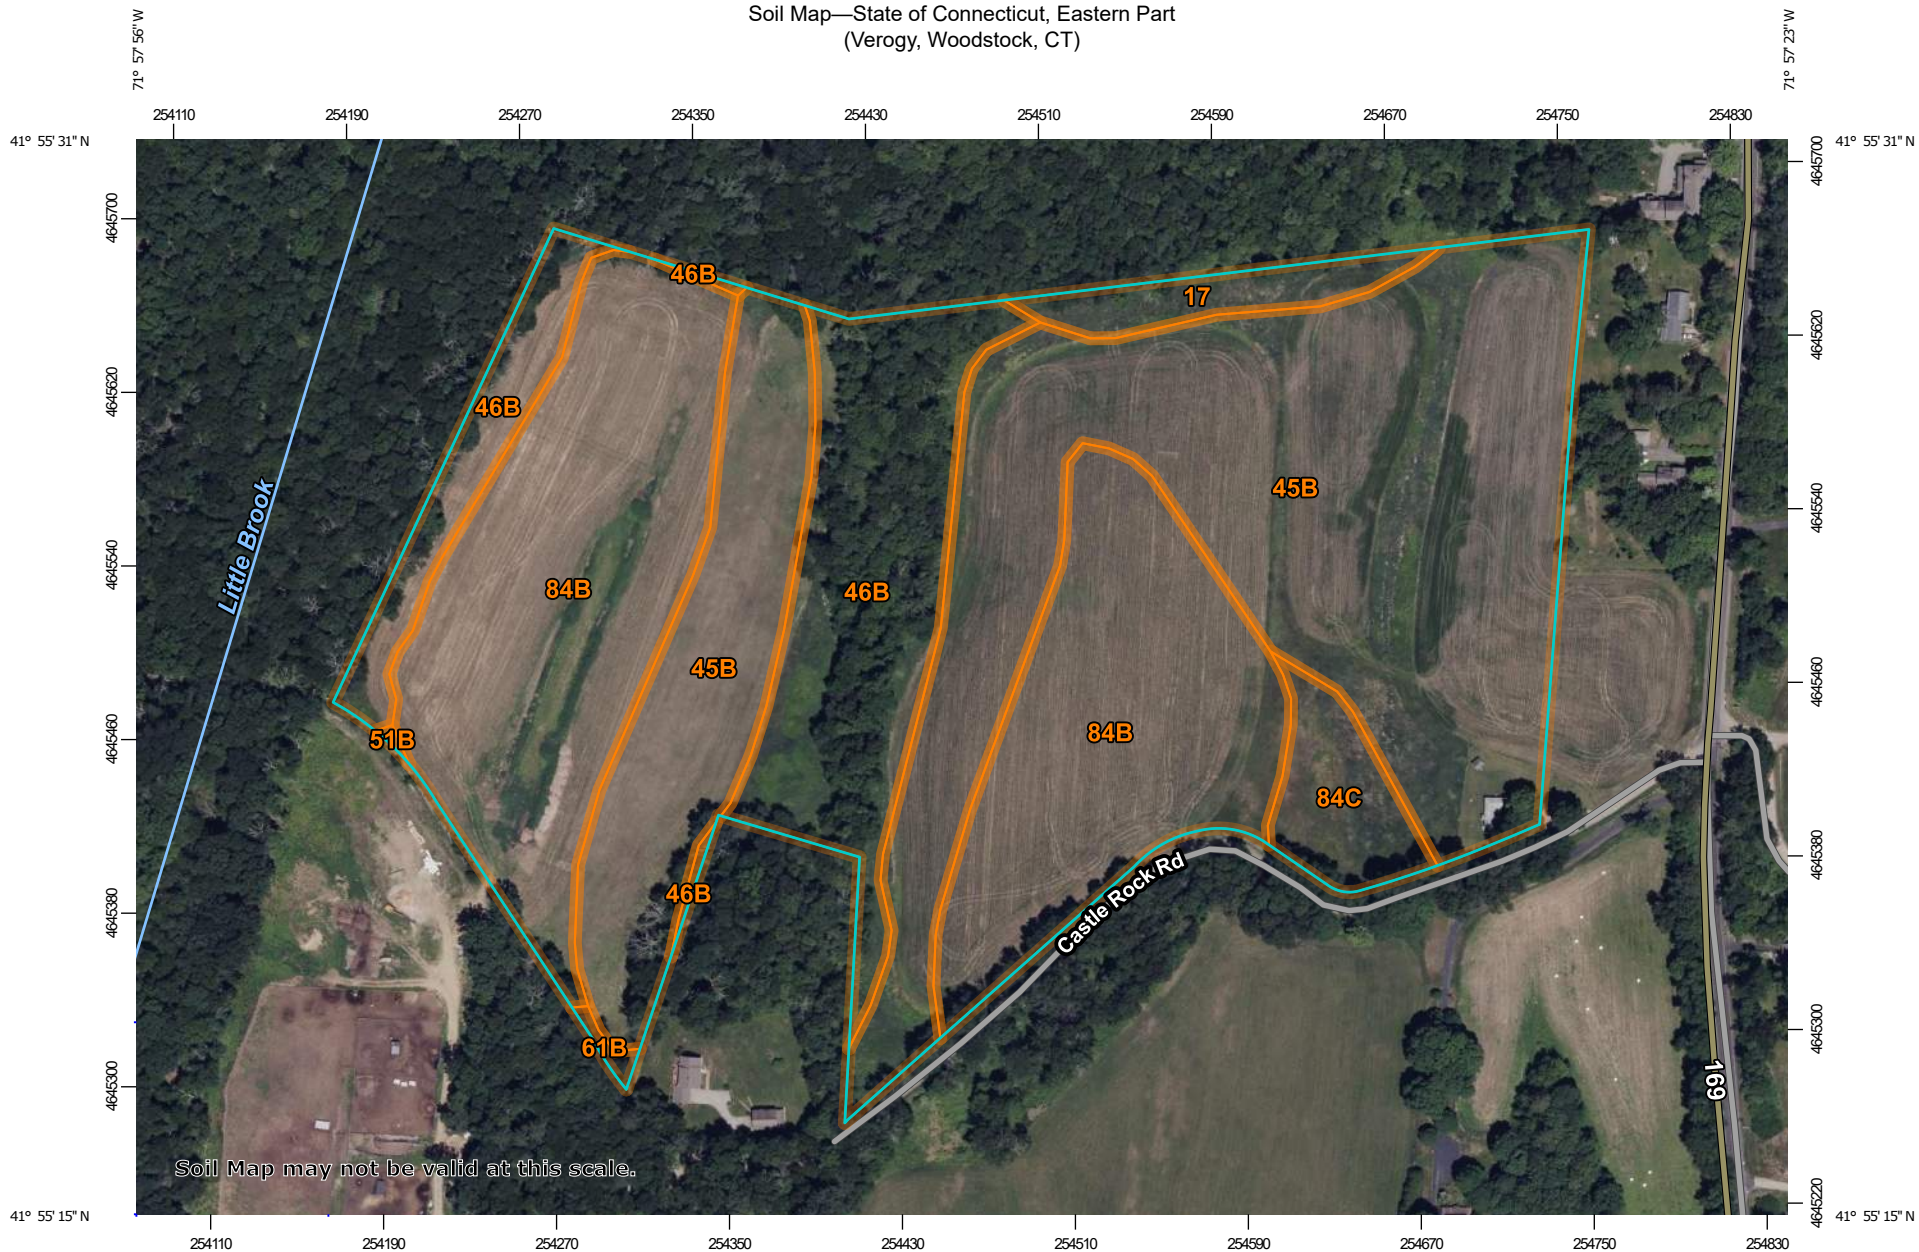
Soil Map—State of Connecticut, Eastern Part
(Verogy, Woodstock, CT)

The Cooperative Soil Survey used three map units when they mapped the Site. Uplands were mapped Udorthents-Urban land complex; uplands and wetlands are included in the mapped Windsor loamy sand area, and the southwest corner of the property was mapped as Walpole sandy loam. Descriptions of the named series which make up these map units are presented below including information from the United States Department of Agriculture (USDA) Natural Resources Conservation Service (NRCS) Official Series Descriptions. Mapping from the NRCS Web Soil Survey tool is included in Appendix B. For further information on these and other soils, please refer to the internet site at <http://soils.usda.gov/technical/classification/osd/index.html>.
