Memorandum

ATTACHMENT 3
Project #: 43362.00

Re: Vernal Pool Investigation Memo
11 Castle Rock Road, Woodstock, Connecticut

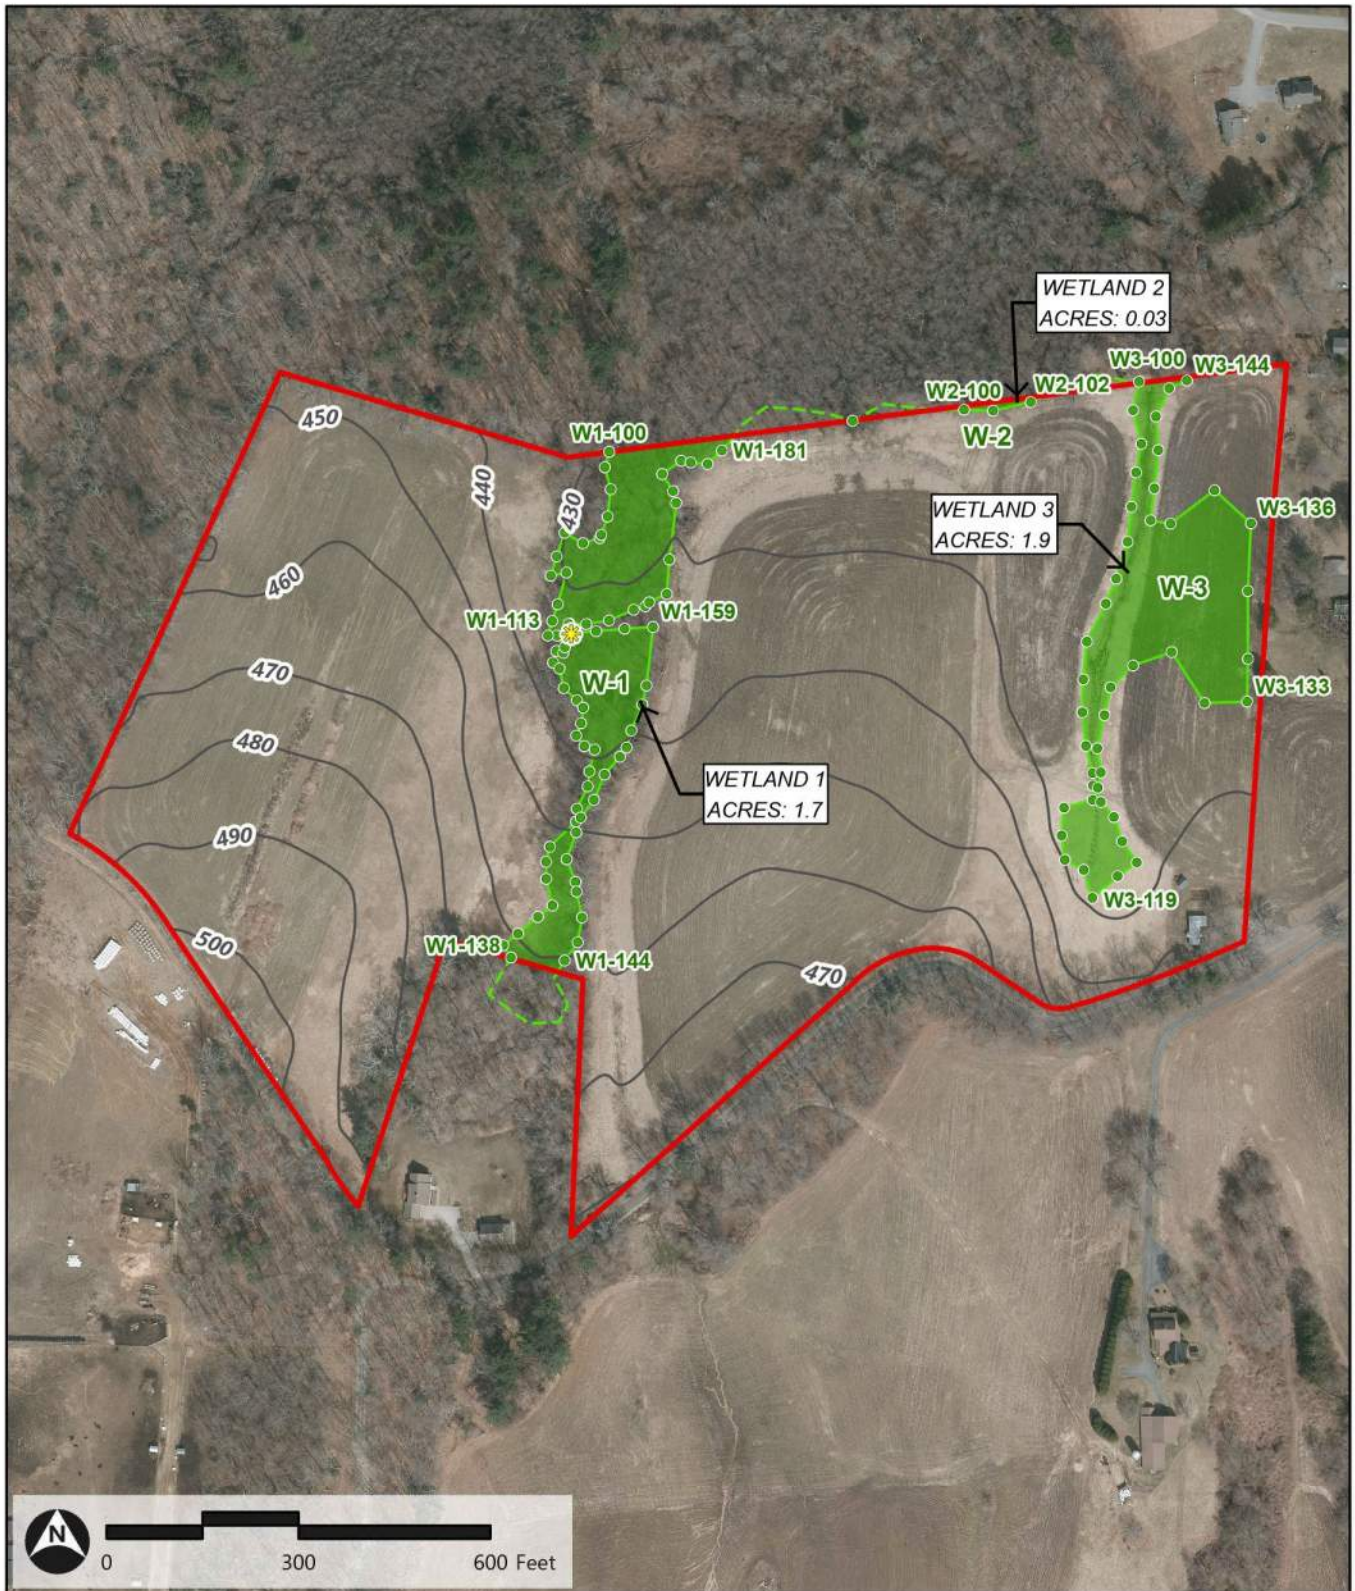
Figure 2: Wetlands and Watercourse Delineation Sketch

At ±1.7 acres, Wetland 1 is a palustrine forested (Cowardin USFWS: PFO) wetland that extends across the center of the site in a north-south orientation. In the southern portion of Wetland 1, the wetland is sloped to the north where topography levels out and the wetland becomes a depressional feature. A dilapidated pathway partially bisects Wetland 1, but an intermittent stream has overtopped the pathway and flows from the south to the north where Wetland 1 continues to the east. The potential vernal pool is located in the dilapidated pathway area, as shown Figure 2 and per VHB's 2023 delineation report.

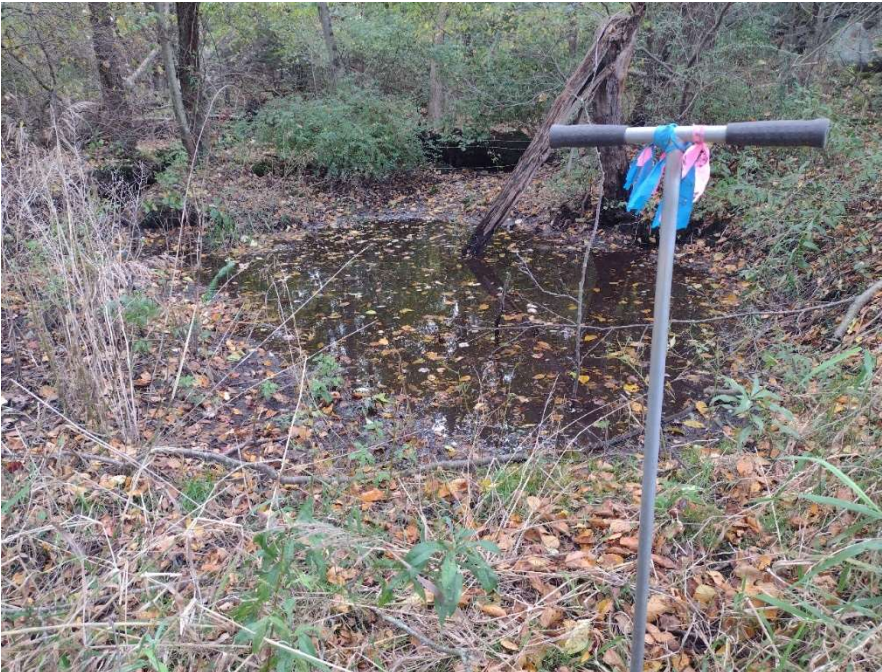
Description: Photo of potential vernal pool in Wetland 1 (W1), taken during wetland delineation efforts, looking south from the northern edge of pool.

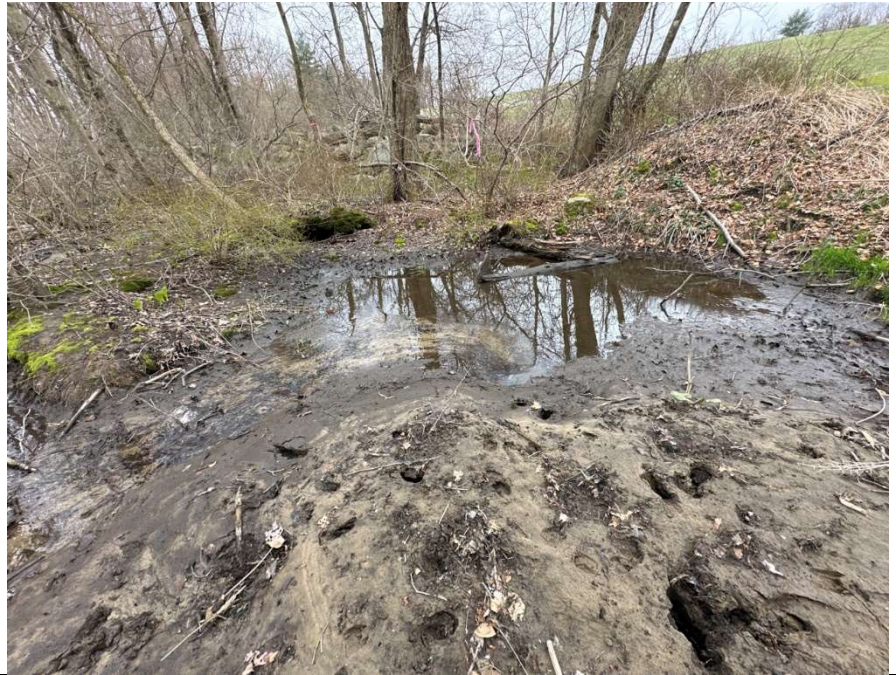
Photo No.: 3

Description: Photo of potential vernal pool in W1, taken during vernal pool assessment, looking southwest from the northeastern edge of pool. No evidence of breeding amphibians was observed.
