Ian Cole, LLC

RE: Wetland Delineation Report: QCELLS Battery Energy Storage System Facility Site, 40 Norwich Road (State Highway Rte.32), HQCA Energy Solutions, LLC, Waterford, Connecticut.

WETLAND DELINEATION SURVEY PHOTOS MARCH 11, 2024 40 NORWICH ROAD WATERFORD CONNECTICUT

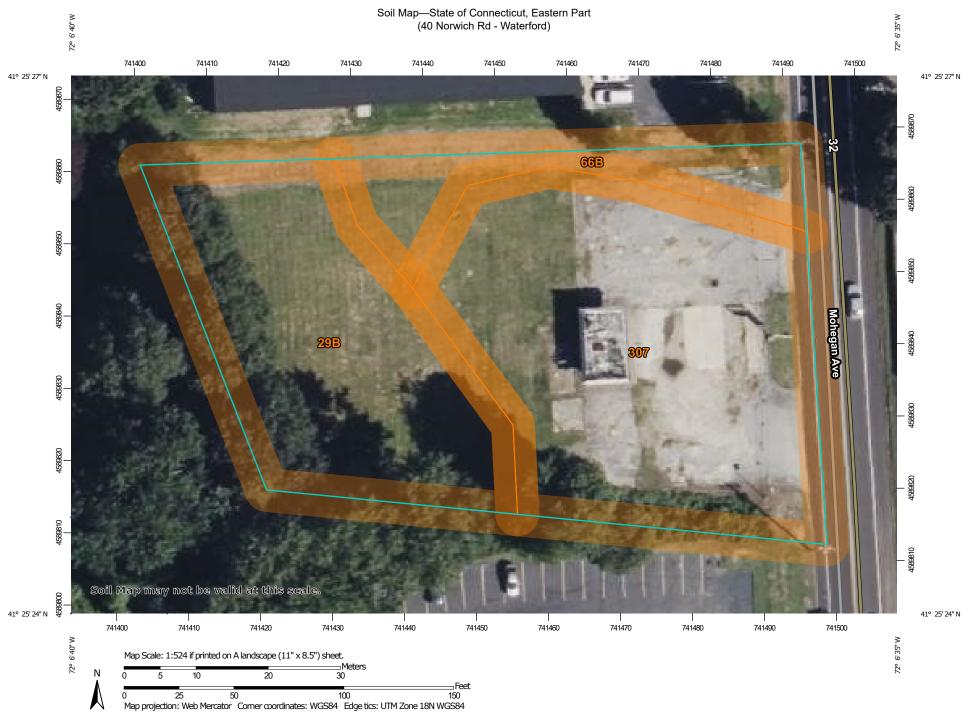
The soils identified on-site are a refinement of those mapped by the Natural Resources Conservation Service (NRCS) Websoil Soil Survey. The parcel has long been disturbed throughout. The soils are classified as belonging to the Urban Land which contains miscellaneous soil types that are present on the landscape in a complex pattern that is not practical or necessary to sperate. These soils are used to denote moderately well to well drained earthen material which has been so disturbed by cutting, filling, or grading, that the original soil profile can no longer be decerned and are co-associated with buildings, roads, parking lots and landscaping of developed areas. Minor inclusions of Agawam loamy sands and Narragansett silt loams may be found in undistrubed pockets at the

Map Unit Symbol	Map Unit Name	Acres in AOI	Percent of AOI
29B	Agawam fine sandy loam, 3 to 8 percent slopes	0.4	36.0%
66B	Narragansett silt loam, 2 to 8 percent slopes	0.1	11.2%
307	Urban land	0.6	52.7%
Totals for Area of Interest		1.1	100.0%

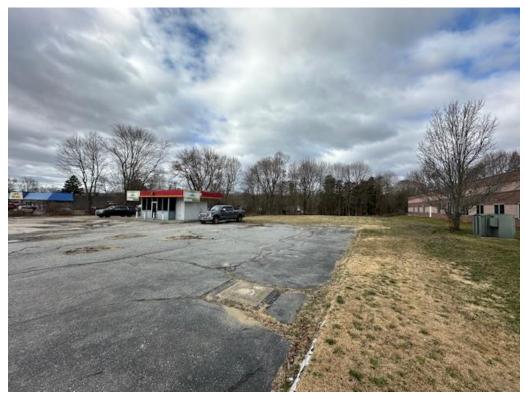
After examining the existing soil, hydrology, and vegetation it is my professional opinion that there are <u>no</u> jurisdictional inland wetlands or watercourses on the subject parcel. The parcel is developed with the bulk of the eastern half of the property covered by impervious surface by either asphalt parking, other impervious surface and/or buildings with a strip of lawn along the road frontage.

Photo 1: View of Parcel from Norwich Road at Northeast Corner Looking Southwest

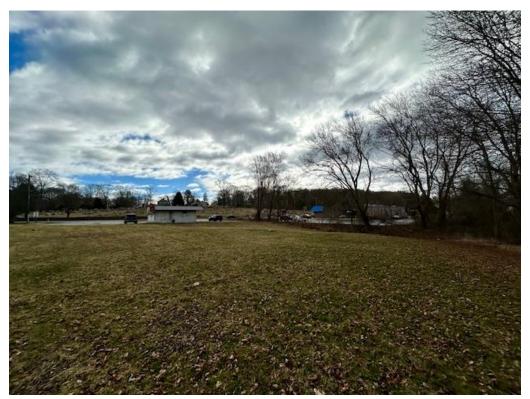
Photo 2: View of Parcel from Northwest Corner Looking East Across the Property.

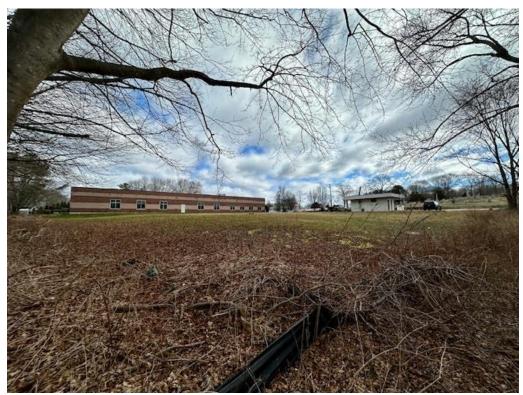
Photo 3: View of Parcel from Southwest Corner Standing on Wetland Boundary Looking Towards the Proposed Battery Storage Area, Note Remnants of Silt Fence from Previous Site Work.

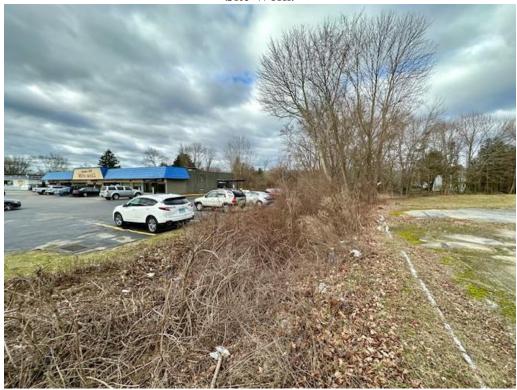
It should be noted that a stormwater swale parallels the south property line (Photo 4). The swale periodically receives stormwater runoff from Norwich Road, but the swale does not qualify as a regulated wetland or watercourse feature because 1. The stormwater drainage feature lacks stream bed and bank channel development, 2; does not host a predominance of hydrophytic vegetation, lacks evidence of detritus, erosion, or signs of alluvial deposition, 3; does not contain hydric soils 4; does not show evidence of persistent flow for longer than a particular storm event, and 5; the watershed and source of hydrology is generated solely from roadside runoff discharging from Norwich Road and is not from a naturally contributing source of hydrology.

Photo 4: Existing Conditions of the Drainage Ditch Between 40 Norwich Road and 30 Norwich Road.

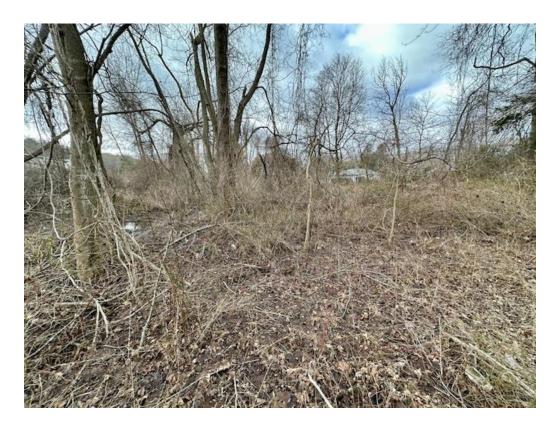
The subject drainage ditch directs untreated stormwater into a topographically isolated scrub-shrub / forested wetland depression situated on the adjacent northwest corner of 30 Norwich Road (Photo 5). The neighboring wetland pocket is proximal to the southwestern corner of 40 Norwich Road, but the wetland feature does not encroach over the property line (see Photo 3 for reference). As illustrated on the Wetland Delineation Map, the offsite wet basin is solely on the adjacent 30 Norwich Road land which seasonally floods, collecting stormwater runoff and attenuating it as it slowly infiltrates back into the surrounding sandy soils.

Photo 5: Example of the General Scrub-Shrub Conditions of the Adjacent Wetland on 30 Norwich Road.
