RE: Preliminary Archaeological Assessment of a Proposed Battery Storage Facility at 40 Norwich Road in Waterford, Connecticut

Heritage Consultants, LLC (Heritage) is pleased to have this opportunity to provide Tobin, Carberry, O'Malley, Riley & Selinger P.C. (TCORS) with the following preliminary archaeological assessment of a proposed battery storage facility in Waterford, Connecticut (Figure 1). The project will include the construction of a series of batteries for electricity storage, inverters, and an access road (Figure 2). The current project entails completion of a cultural resources summary based on the examination of data obtained from the Connecticut State Historic Preservation Office (CT-SHPO), as well as geospatial data, including historical mapping, aerial photographs, and topographic quadrangles, maintained by Heritage. This investigation is based upon project location information provided to Heritage by the client. The objectives of this study were to gather and present data regarding previously identified cultural resources situated within 1.6 km (1 mi) of the proposed battery storage facility and to investigate the proposed project area in terms of its natural and

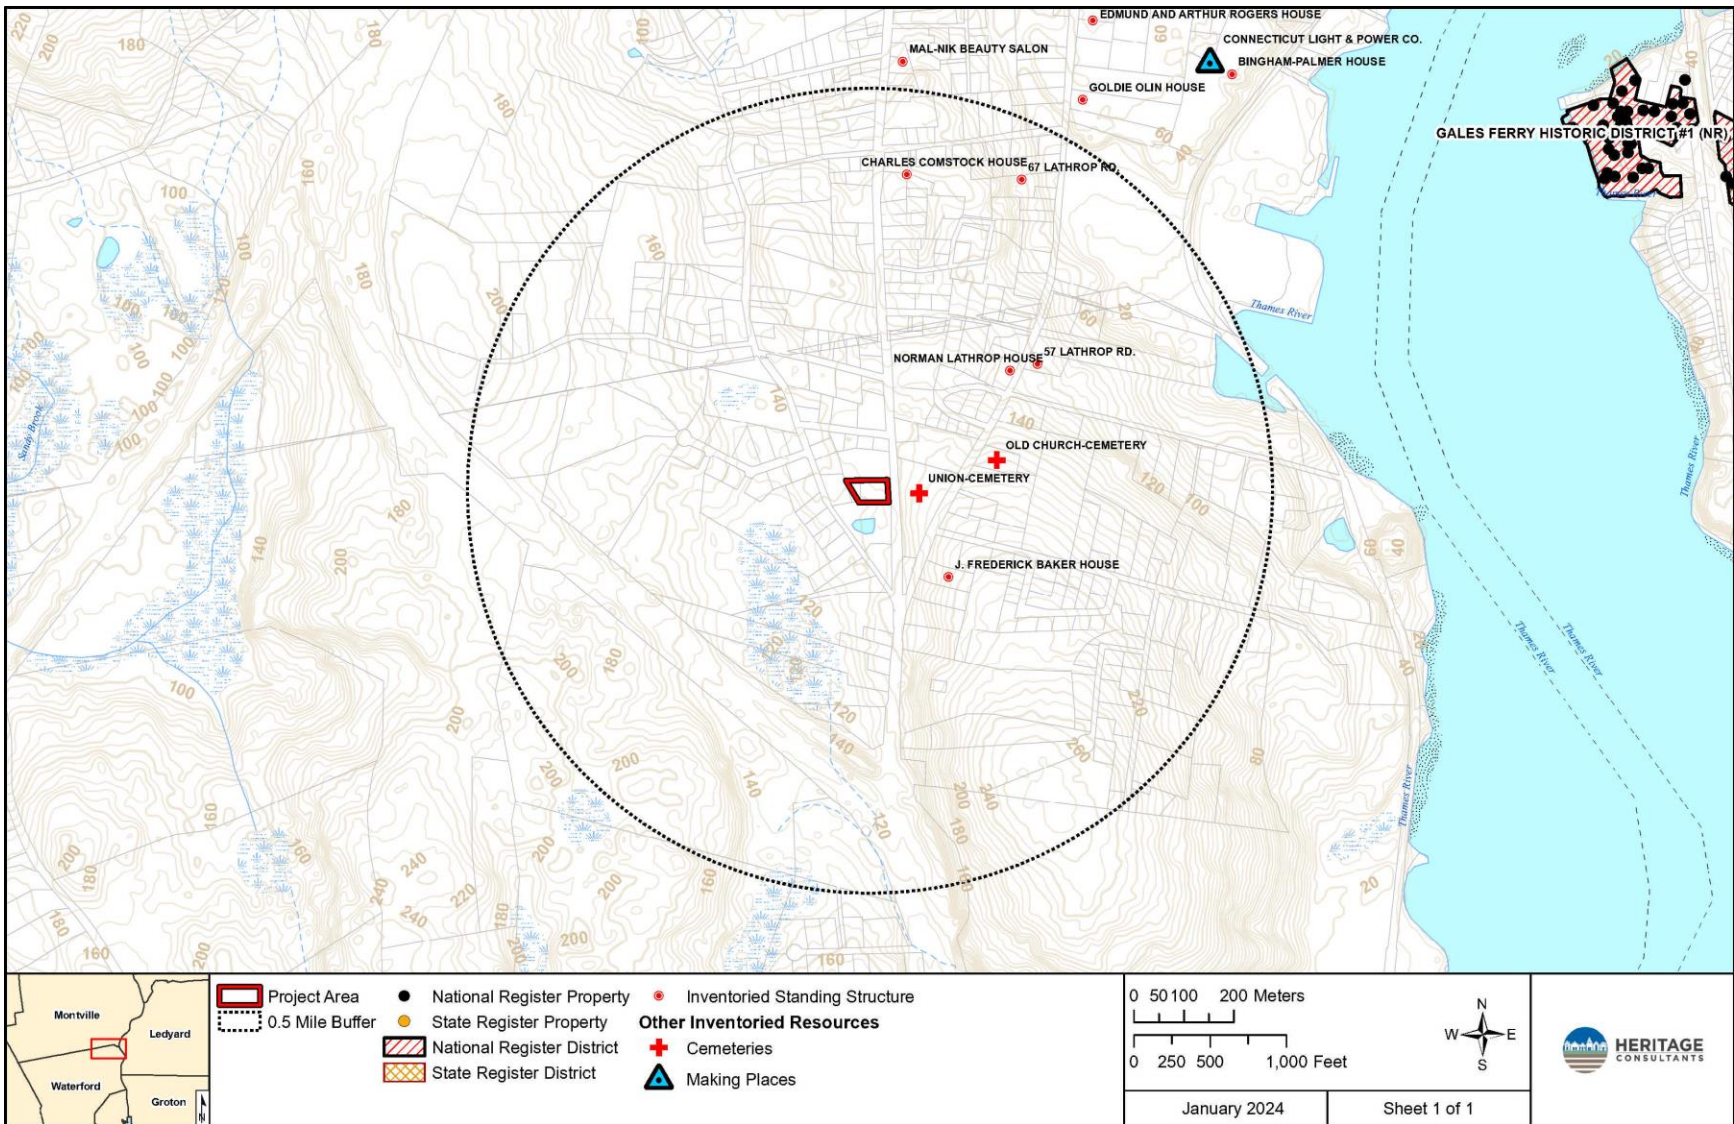
Figure 5. Digital map depicting the locations of the previously identified National Register of Historic Places and State Register of Historic places properties in the vicinity of the proposed project area in Waterford, Connecticut.

A review of inventoried standing structures within 0.8 km (0.5 mi) of the facility area revealed five buildings older than 50 years (Figure 5; Table 1). Of these buildings, four were constructed as residential buildings while one is characterized as commercial. Most of the buildings date from the early twentieth century, except for the Charles Comstock House, which was constructed around the year 1850. Three of the buildings were constructed in a vernacular style, while two were built in the Colonial Revival style. These two are the Norman Lathrop House and another unnamed building which represents the Dutch Colonial Revival style. None of these five buildings have been assessed applying the NRHP criteria for evaluation. All inventoried standing structures are between 0.24 km (0.15 mi) and 0.7 km (0.43 mi) from the facility area and will not be impacted by construction.

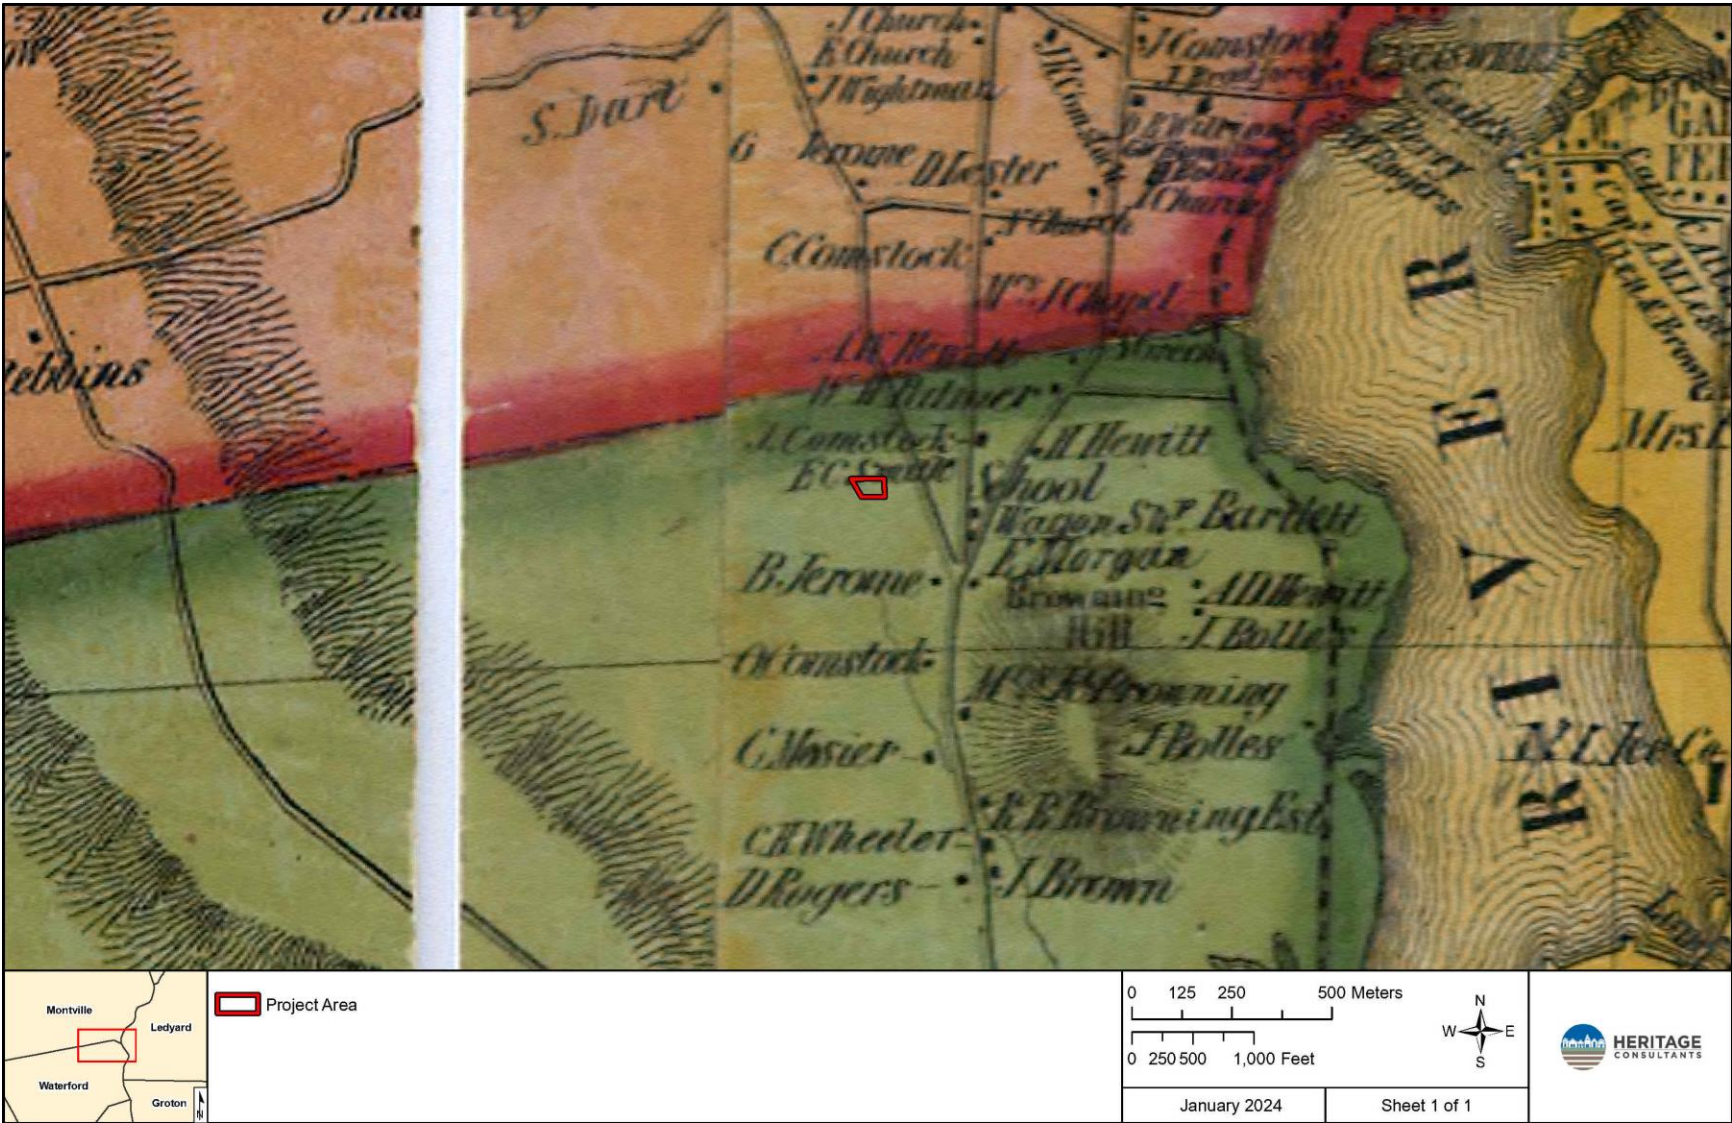
Figure 6. Excerpt from an 1854 map showing the location of the proposed project area in Waterford, Connecticut.

Figure 6, which is a map excerpt dating from 1854, shows that the region containing the proposed battery storage area was largely developed as of the middle of the nineteenth century, with much of the current road network in place by that time. Residences located in the general vicinity of the project area as of 1854 included those belonging to J. Comstock, B. Jerome and E. Morgan. A railroad that runs along the river can be seen to the east of the project area. A subsequent historic map dating from 1868 shows further development of the road network as well as the addition of a cemetery immediately to the east of the project parcel (Figure 7).

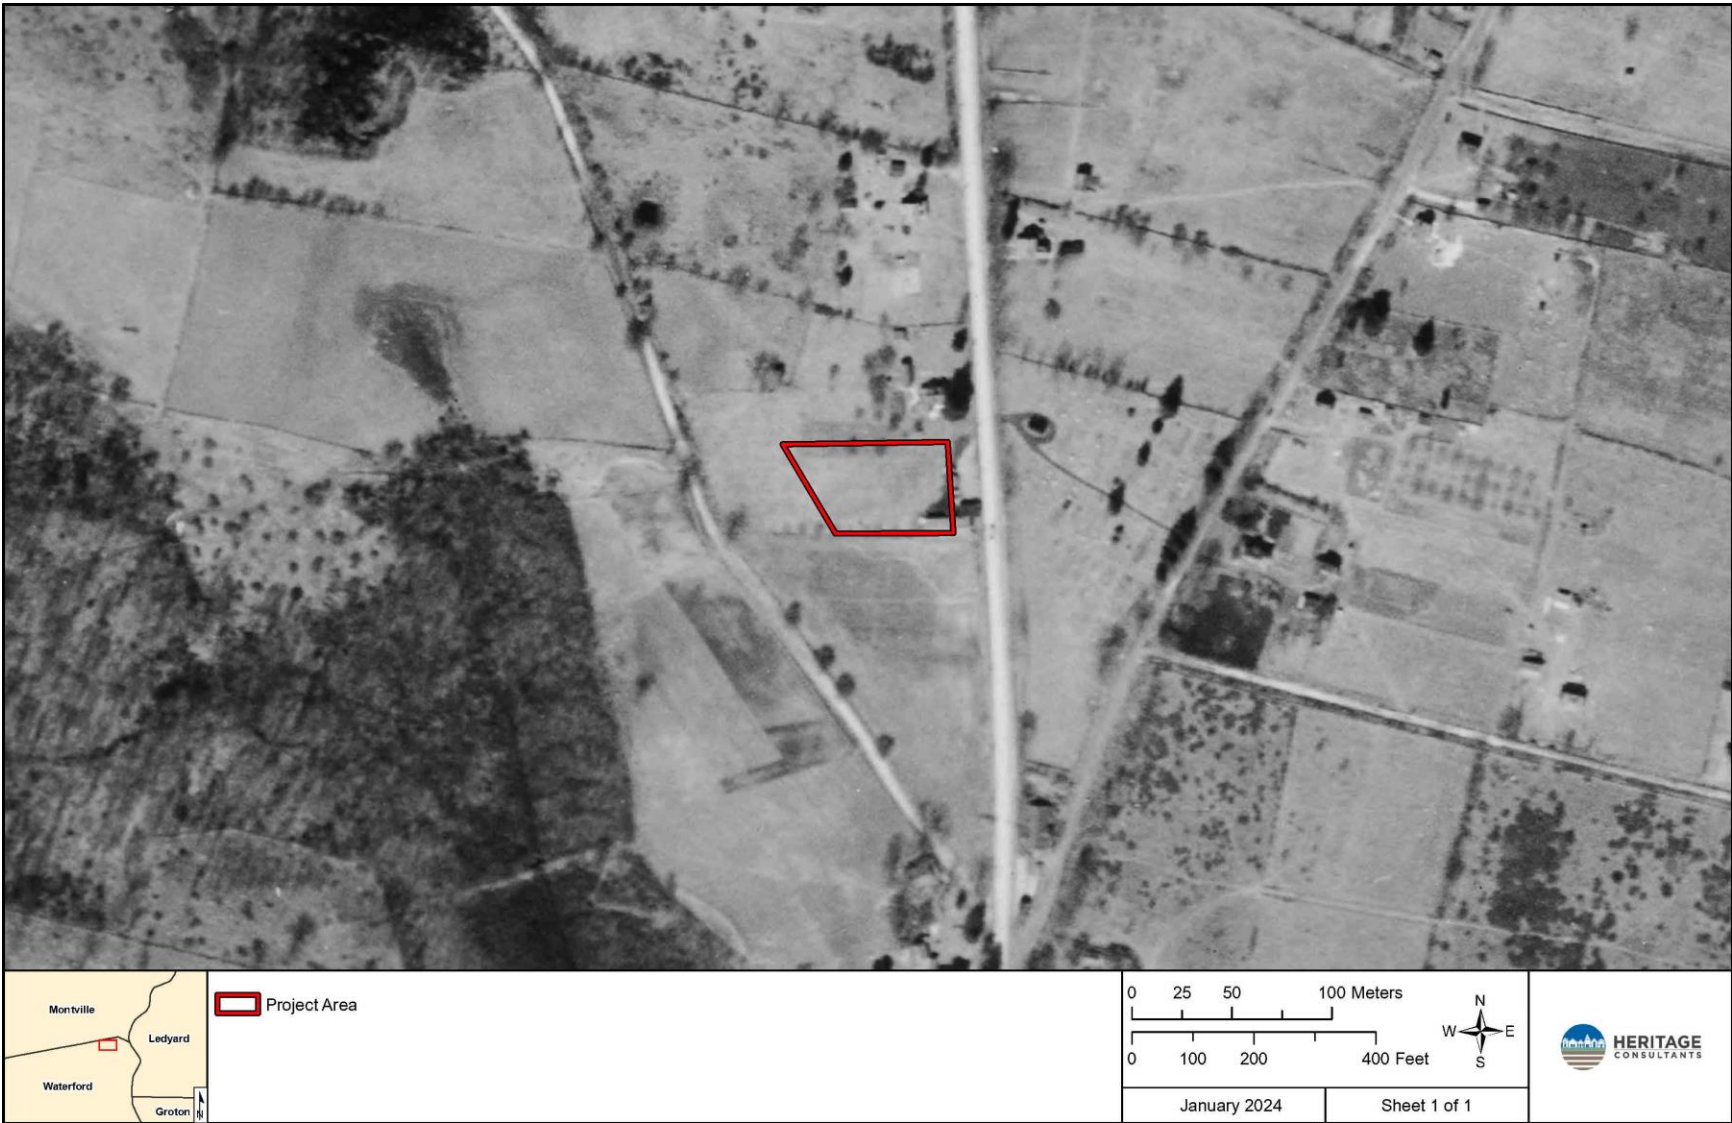
Figure 8. Excerpt from a 1934 aerial photograph showing the location of the proposed project area in Waterford, Connecticut.

The earliest readily available aerial image of the region containing the proposed battery storage facility dates from 1934 (Figure 8). This image confirms that the land surrounding the parcel was largely wooded and agrarian, and that the area within the parcel consisted of an open field. In addition, this photo shows Union Cemetery immediately across from the Facility parcel on the eastern side of Norwich Road. A subsequent 1951 aerial photograph of the region shows increased forested areas, as well as sparse residential development to the north and east of the project parcel (Figure 9). A residential structure appears in the eastern portion of the parcel itself (Figure 9). A 1970 aerial image of the project region shows increased industrial activity and residential infrastructure. Otherwise, there appears to be minimal change to the landscape, with the parcel itself appearing unaltered since 1951 (Figure 10). An aerial image dating from 2004 shows significant industrial activity, with several industrial structures surrounding the project area (Figure 11). The landscape remains in a similar state to that of 1970, however, many of the previously open fields have been filled in with infrastructure. Two large structures can be seen to the north and south of the project parcel. In addition, the eastern portion of the parcel appears to have been paved for a parking lot and contains a gas station. A 2019 aerial image shows the project area in its essentially modern state (Figure 12). The project parcel consists of disturbed land, with surrounding land use being residential and commercial. The current parcel contains a building and parking lot, as well as in the northwest corner, with the remainder containing open land and deciduous trees lining the southern edge.

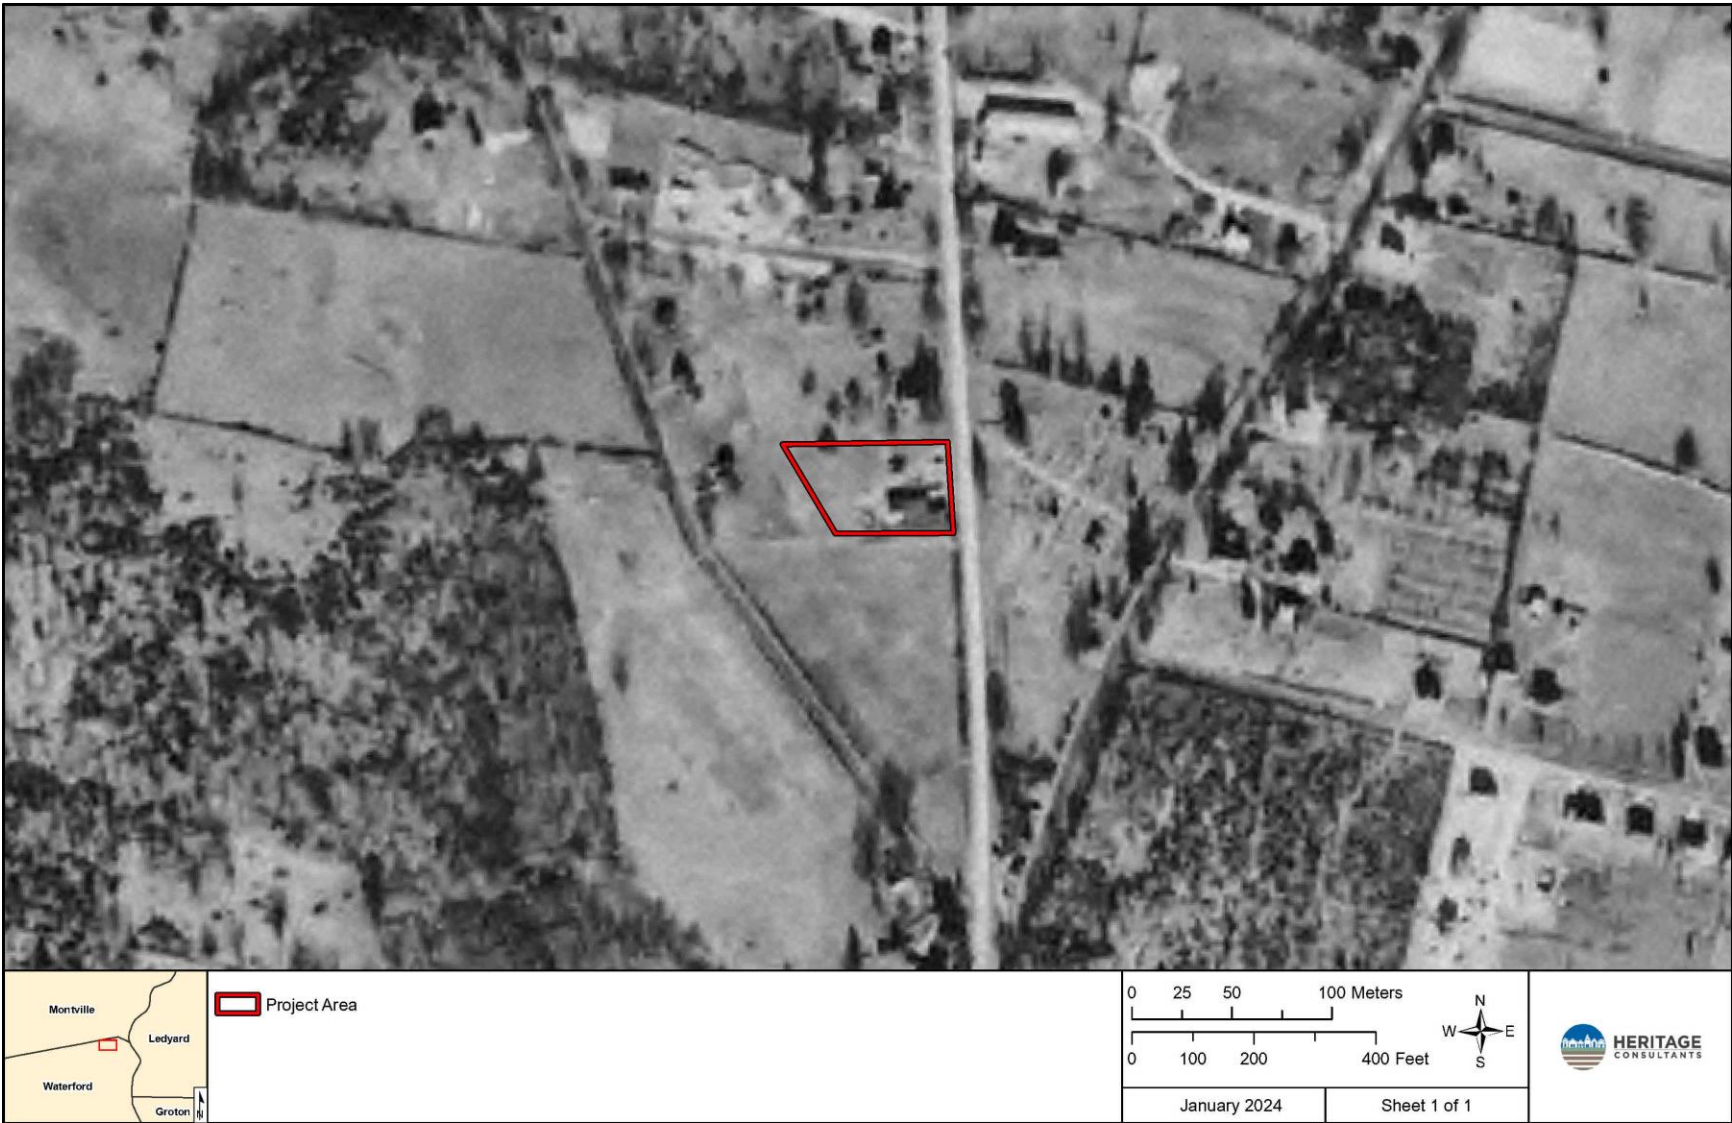
Figure 9. Excerpt from a 1951 aerial photograph showing the location of the proposed project area in Waterford, Connecticut.

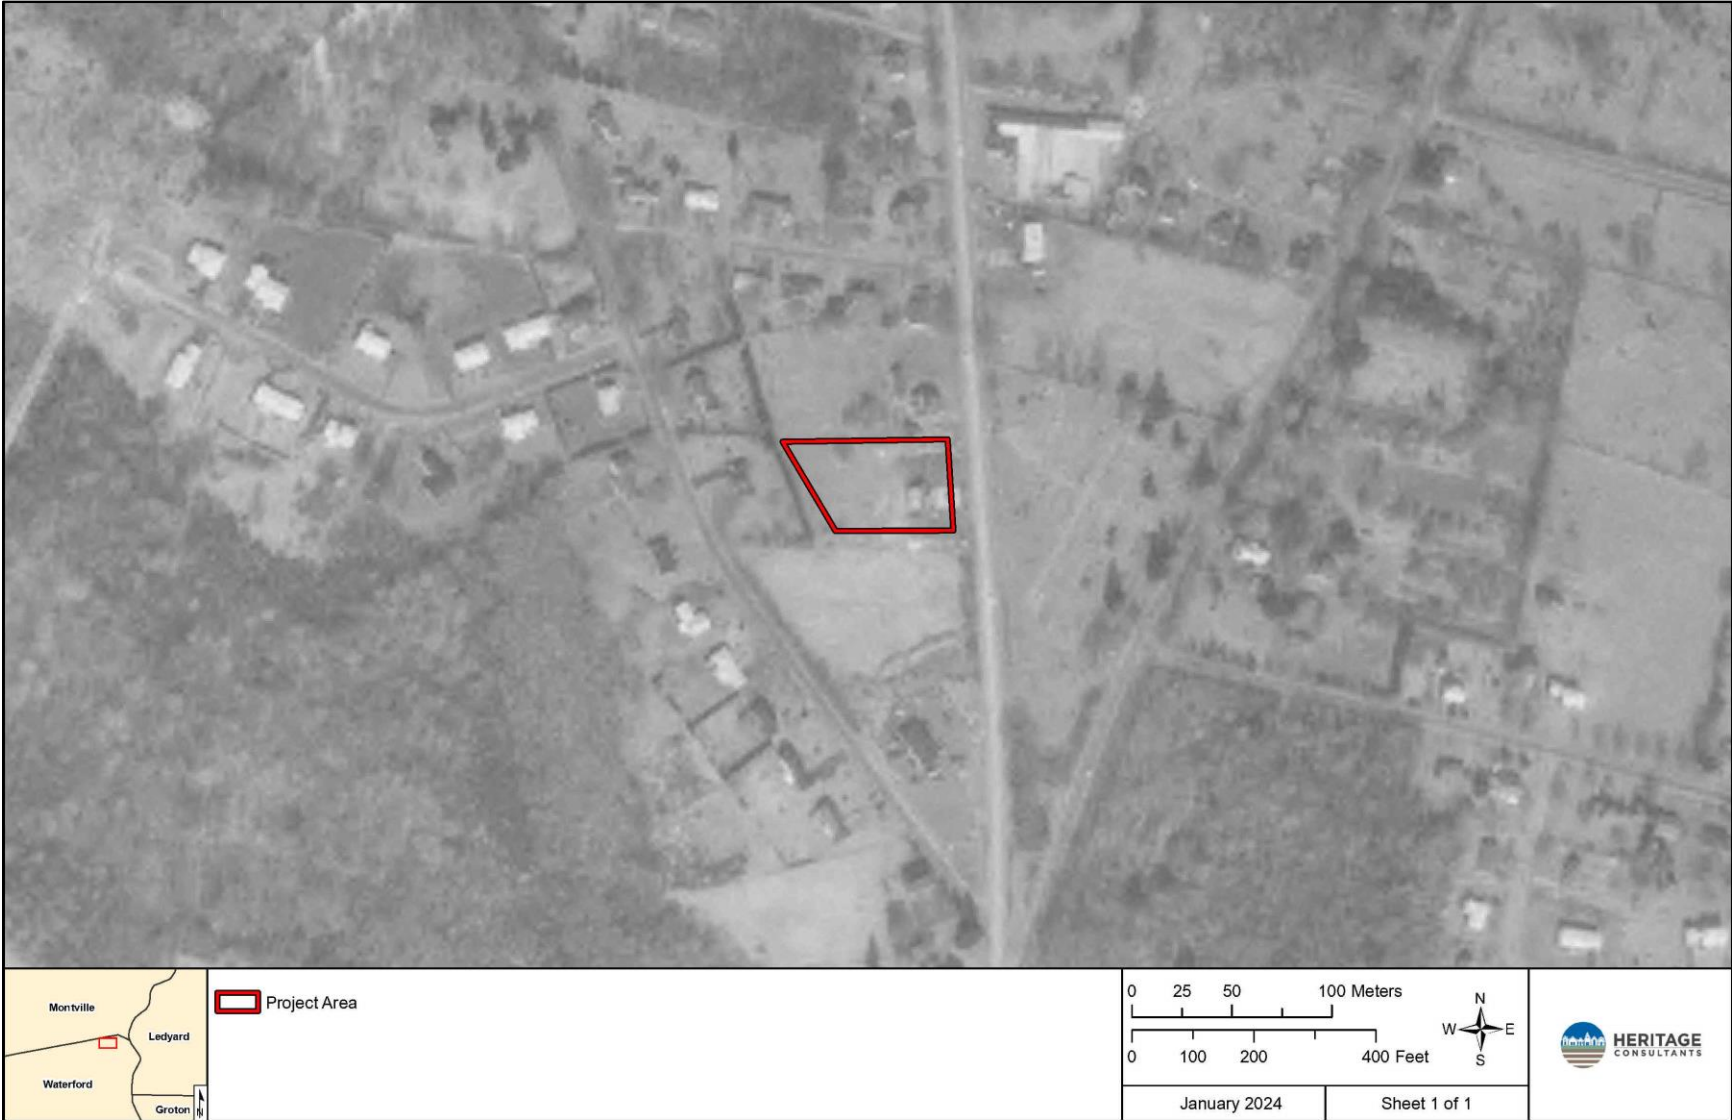
Figure 10. Excerpt from a 1970 aerial photograph showing the location of the proposed project area in Waterford, Connecticut.

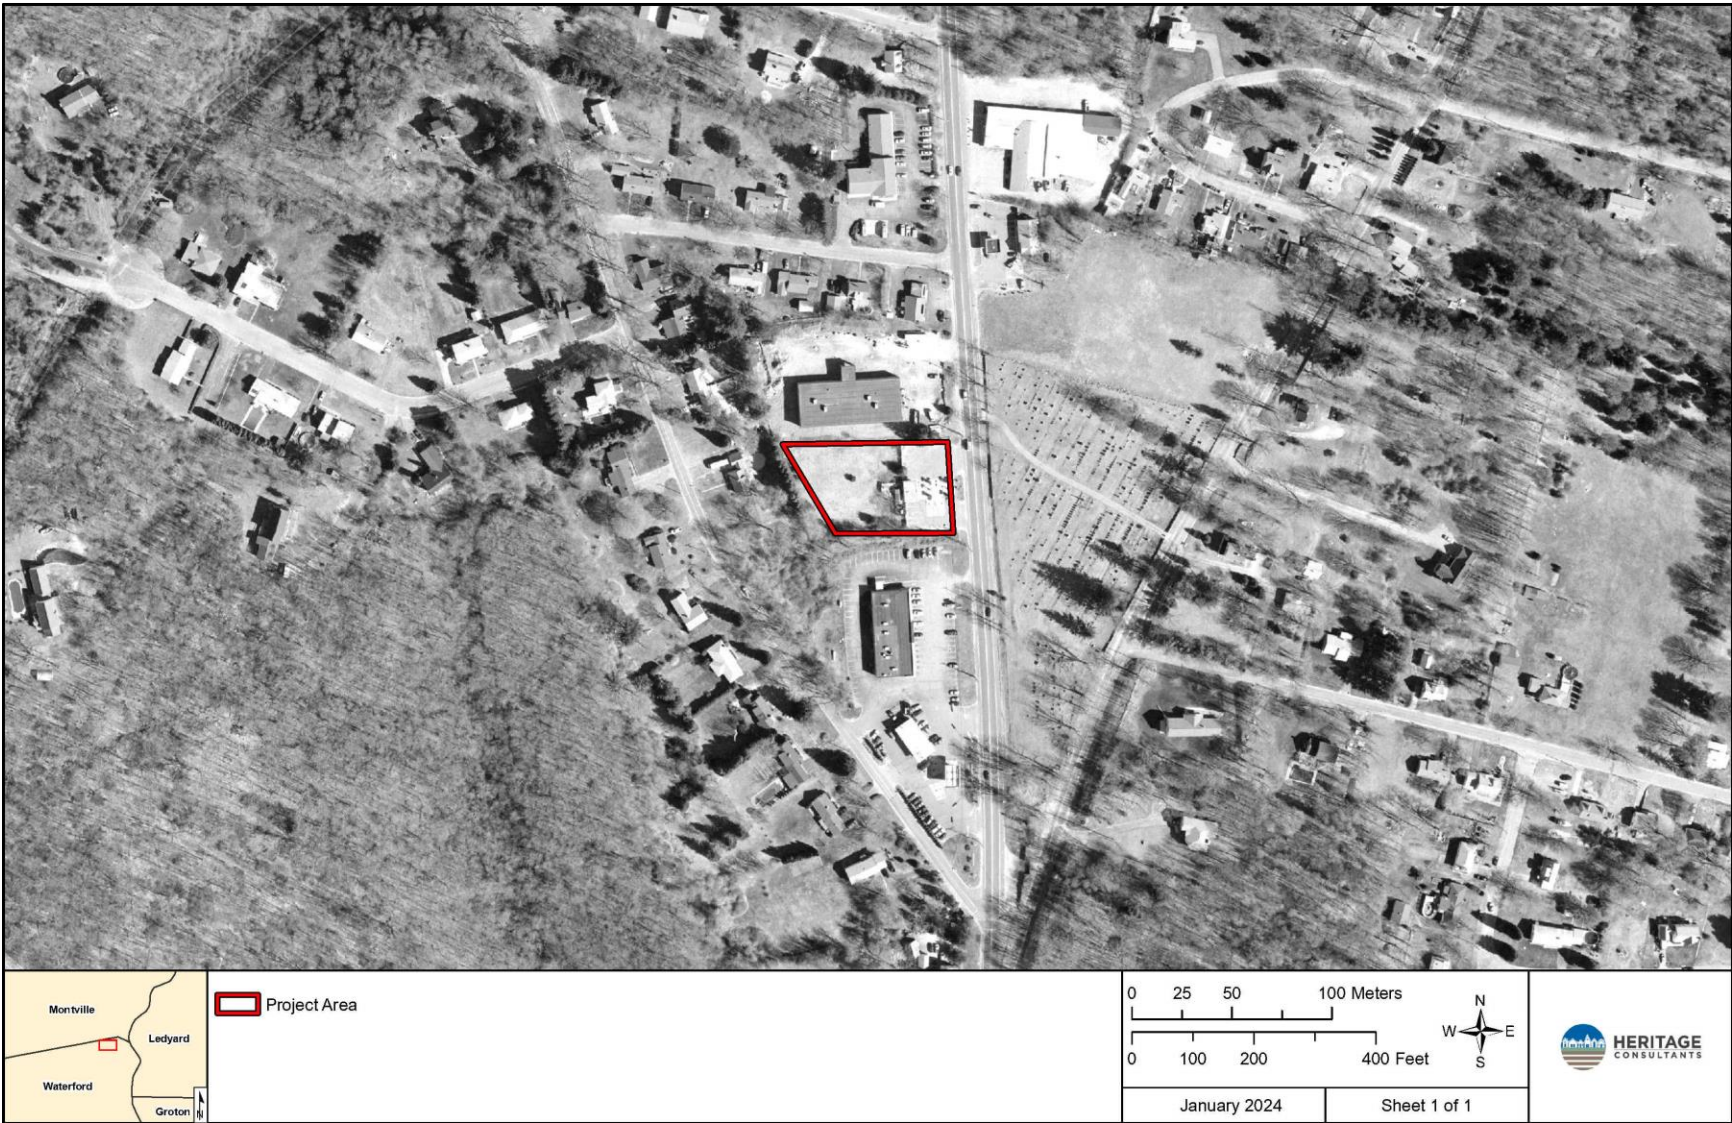
Figure 11. Excerpt from a 2004 aerial photograph showing the location of the proposed project area in Waterford, Connecticut.

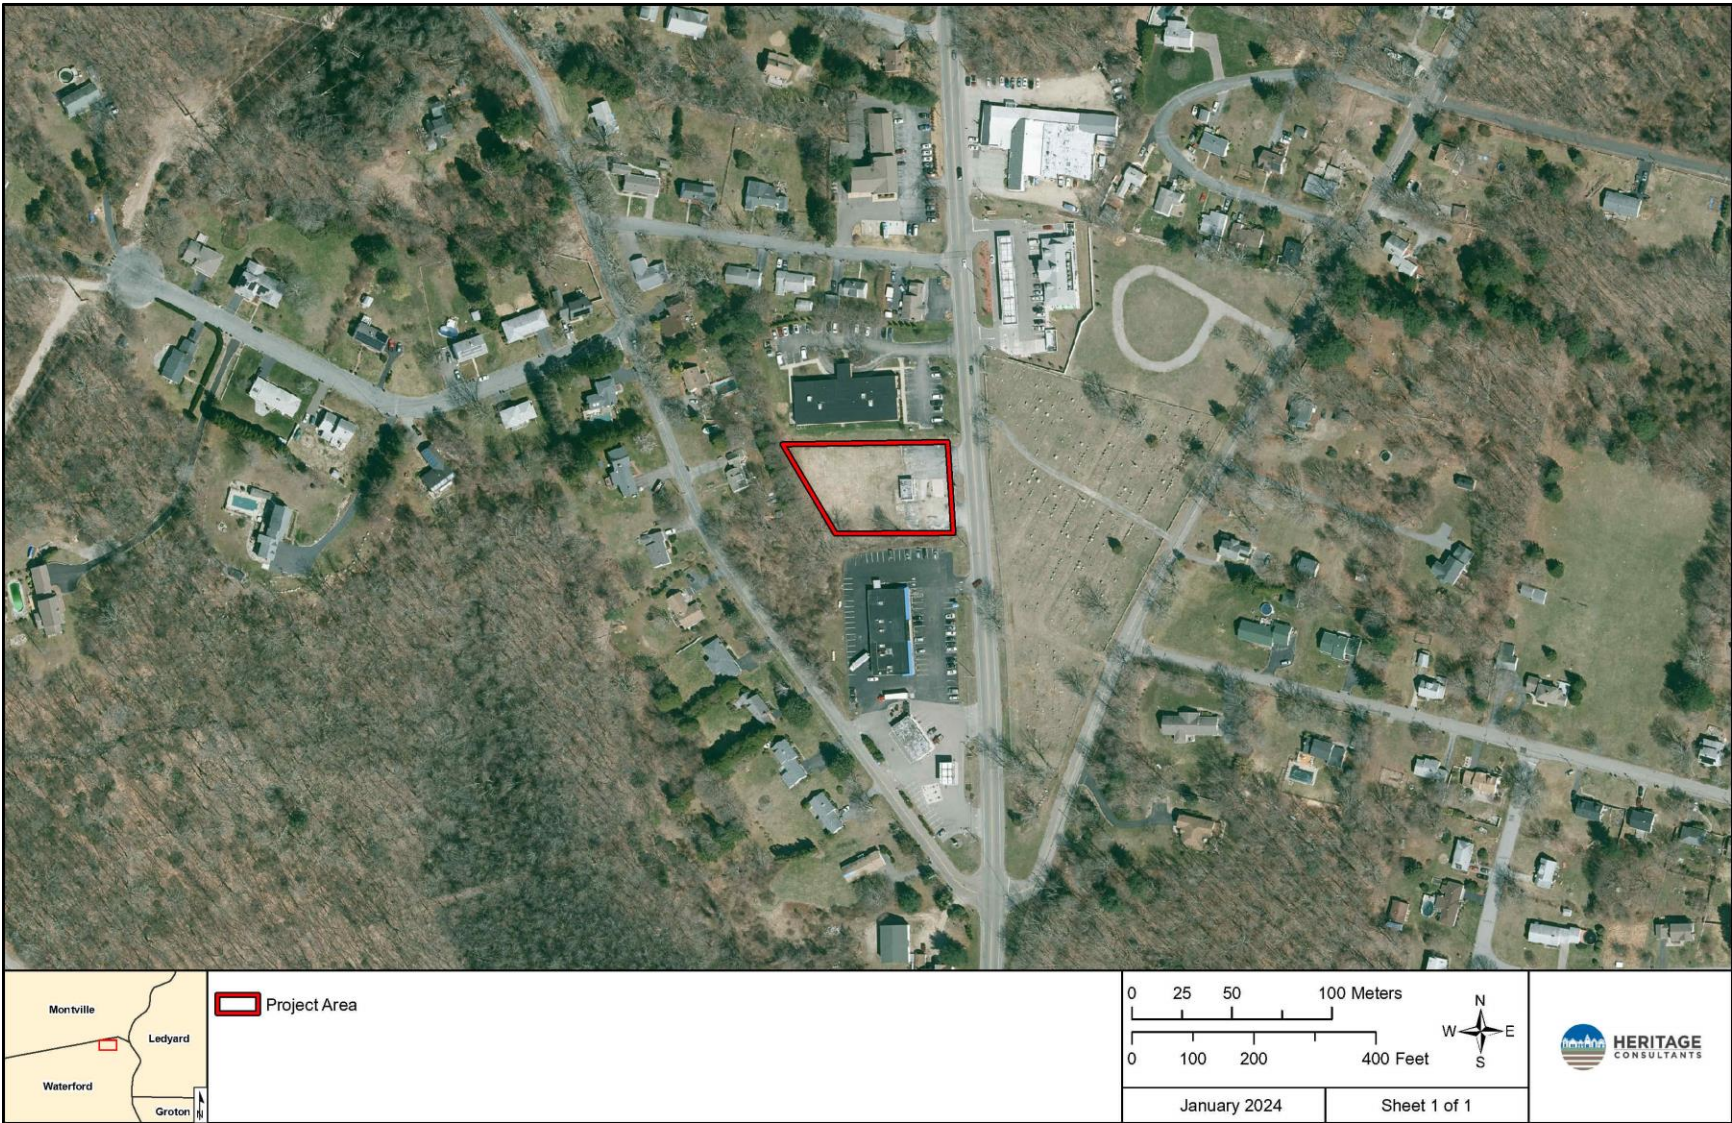
Figure 12. Excerpt of a 2019 aerial photograph showing the location of the project parcel and sensitivity areas in Waterford, Connecticut.

Based on the desktop data shown in Figures 1 through 12, those areas containing Urban Land soils have been designated as no/low potential areas in terms of their likelihood to produce intact archaeological deposits; it encompasses 0.31 acres of land on the eastern side of the parcel. The remaining 0.48 acres were assessed as retaining high/moderate archaeological sensitivity because it contained well drained soils, had a low slope and was within close proximity to previously identified archaeological sites and buildings over 50 years in age. In order to determine the veracity of the desktop data, Heritage personnel visited the Project area and conducted pedestrian survey, the results of which are discussed below.

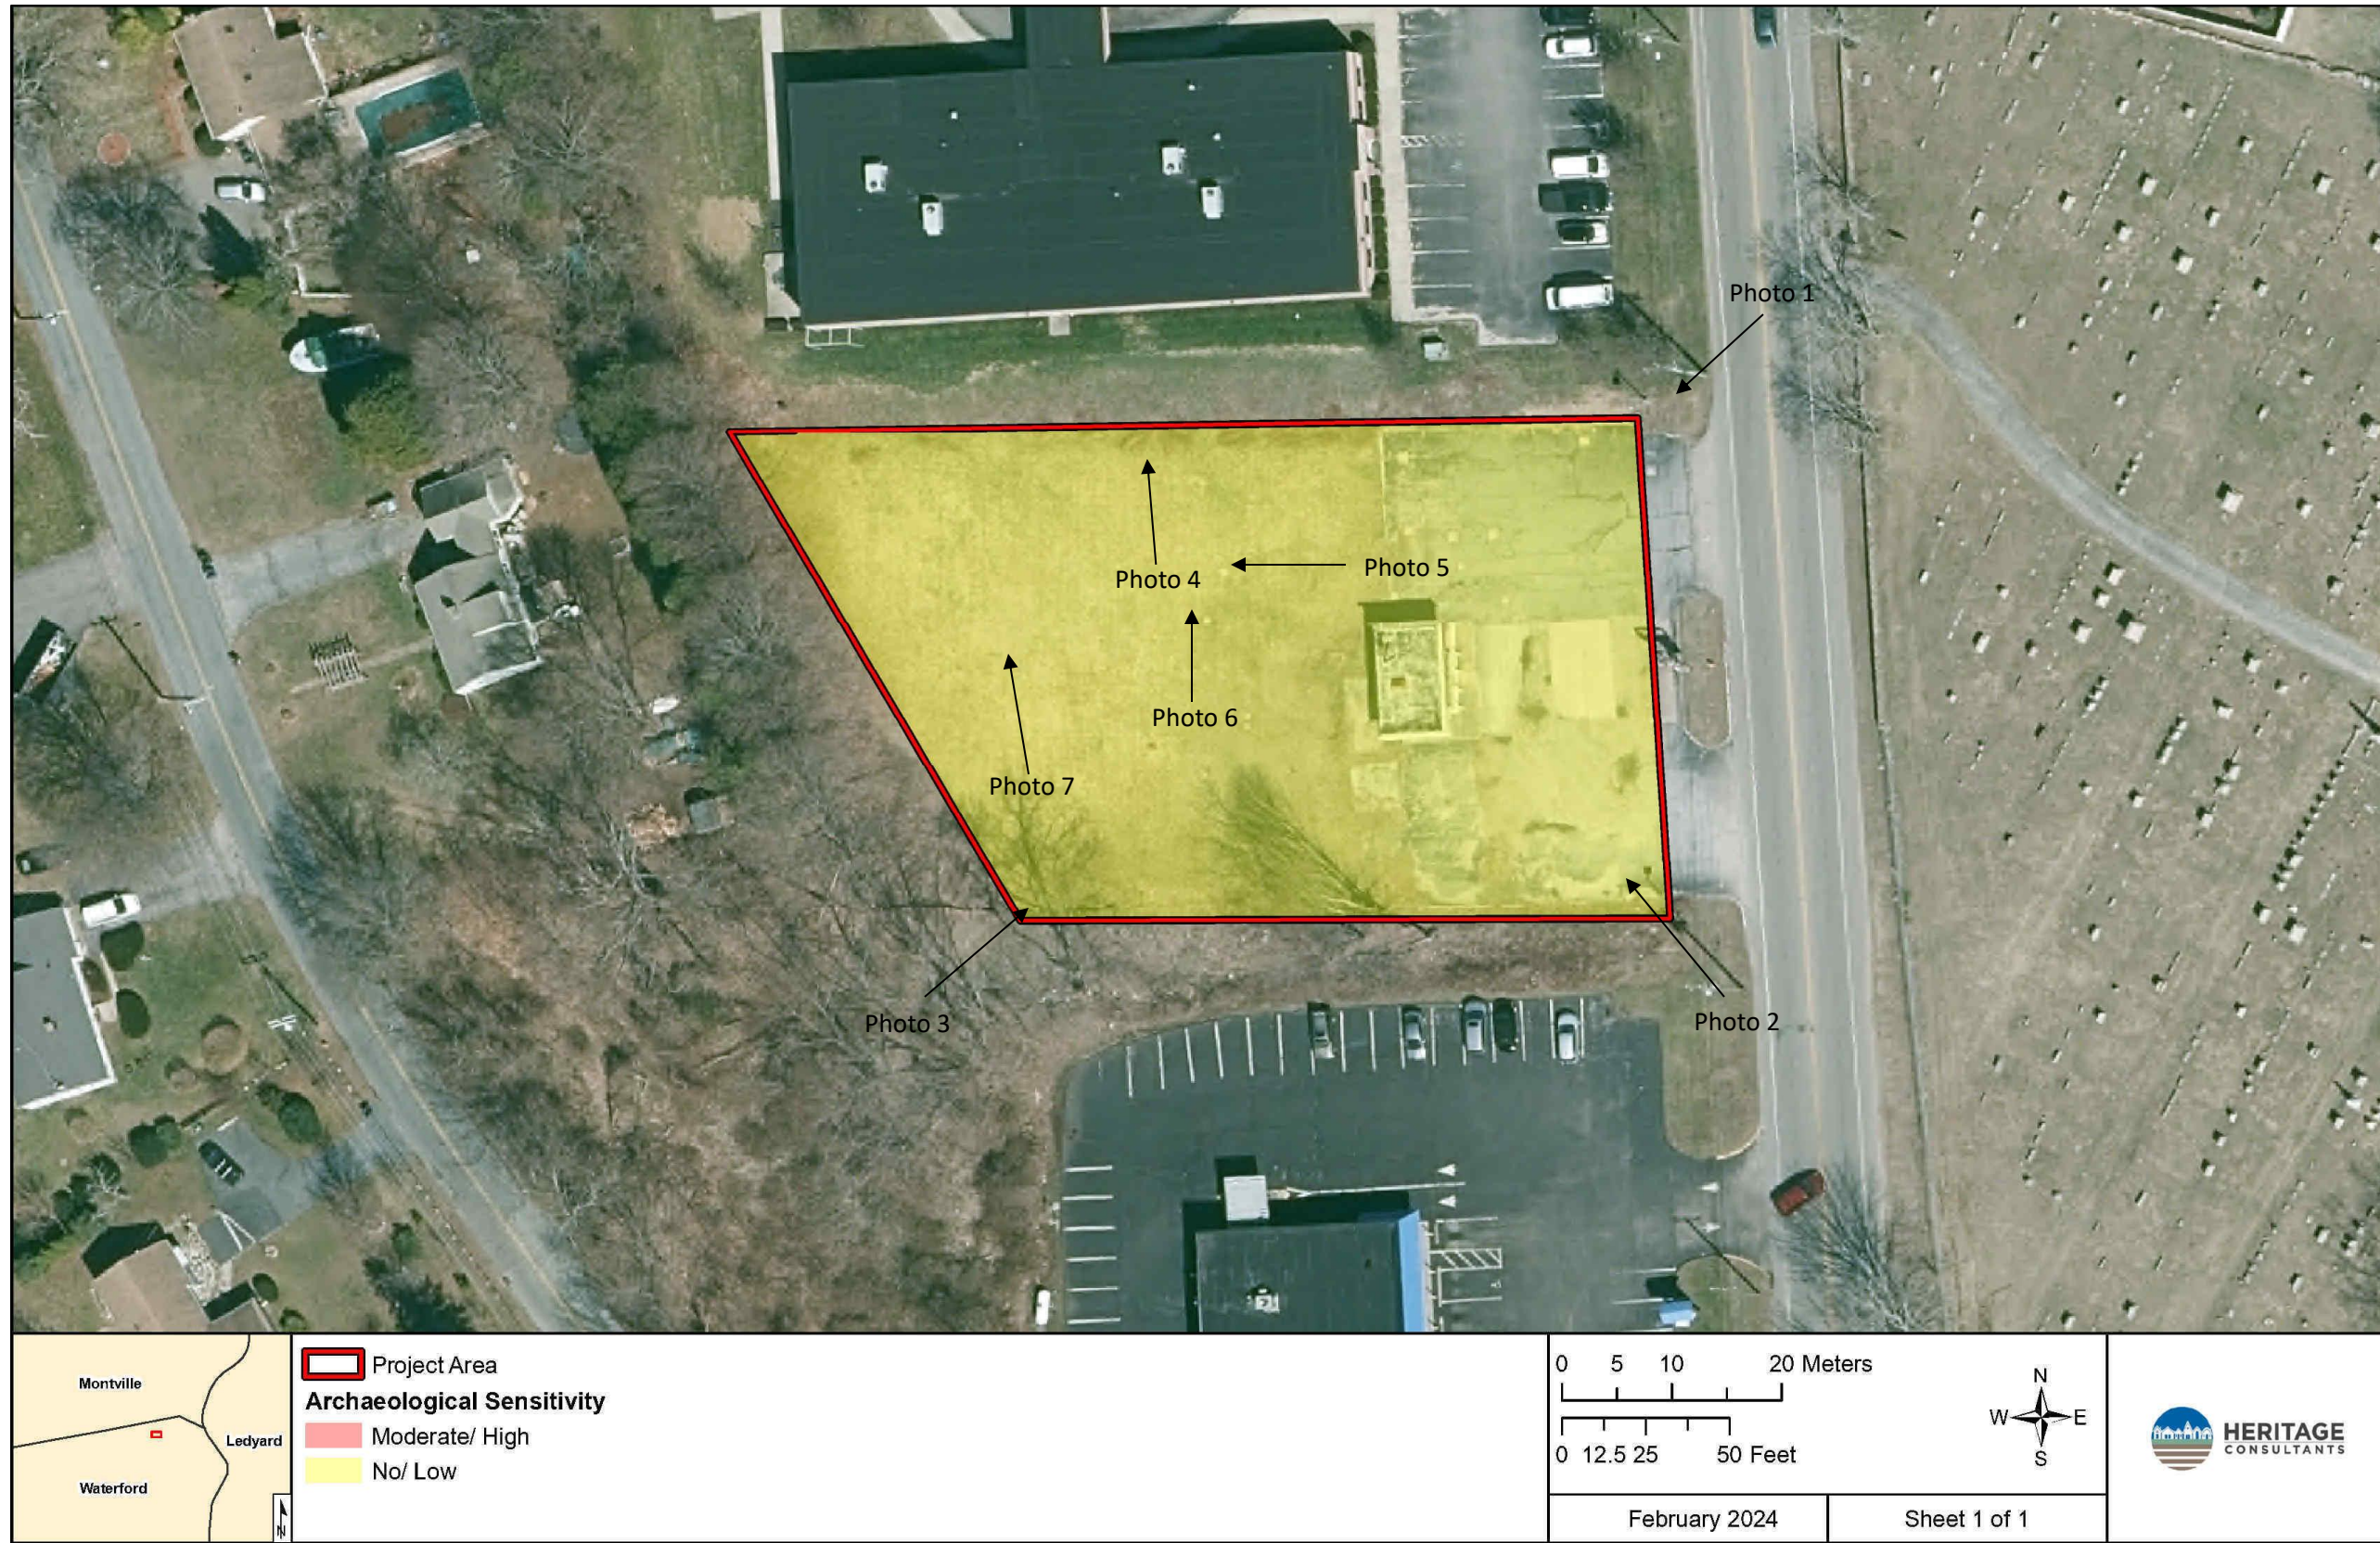
Figure 13. Excerpt of a 2019 aerial photograph with directional arrows of photo points taken of the project parcel and sensitivity areas in Waterford, Connecticut.

Pedestrian survey of the Facility area, including the parcel that will house the battery storage facility, was completed in January of 2024 (Figure 13; Photos 1 through 7). The pedestrian survey revealed that the proposed storage area has been highly disturbed in the past. The eastern section of the parcel is on urban land and has been disturbed by the construction of a gas station and parking lot (photos 1 and 2). This has been identified as an area of no/low sensitivity in terms of producing evidence of intact archaeological deposits from either the precontact era or the post-European Contact period. In addition, the grass field behind the structure on the west side of the parcel shows evidence of thorough disturbance. These disturbances include manholes and pits filled with concrete (Photos 3 through 7). These indicate the presence of buried tanks or other utilities likely associated with the gas station. While the lot may contain post-European Contact period artifacts, there is little, if any chance, that such cultural deposits would be undisturbed and/or retain any research potential.

Based on the above referenced historical data, cultural resources information, and environmental factors, it appears that the entire project parcel has been subjected to disturbances associated with the urbanization and industrialization of the area. It was determined that the project area retains a no/low sensitivity to produce intact cultural deposits. (Figure 13). No additional archaeological examination of the project area is recommended prior to construction.

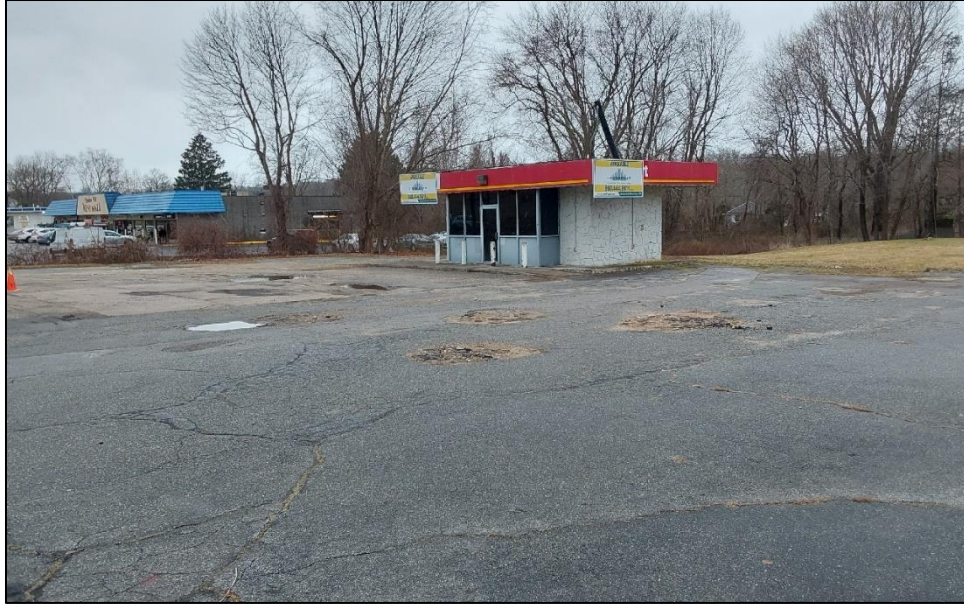
Photo 1. Overview photo from northeastern corner of the parking lot. Photo taken facing southwest.

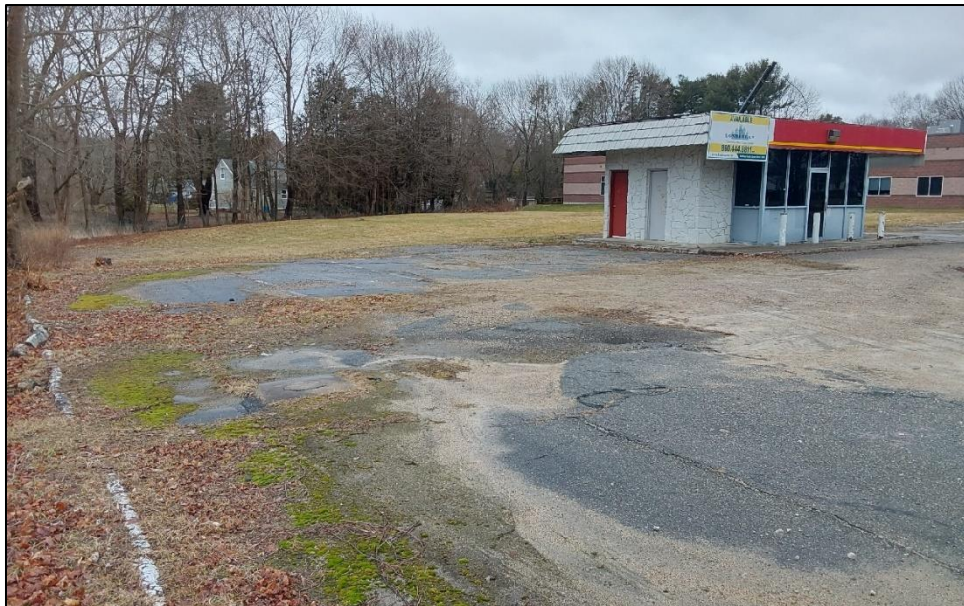
Photo 2. Overview photo from southeastern corner of the parking lot. Photo taken facing northwest.

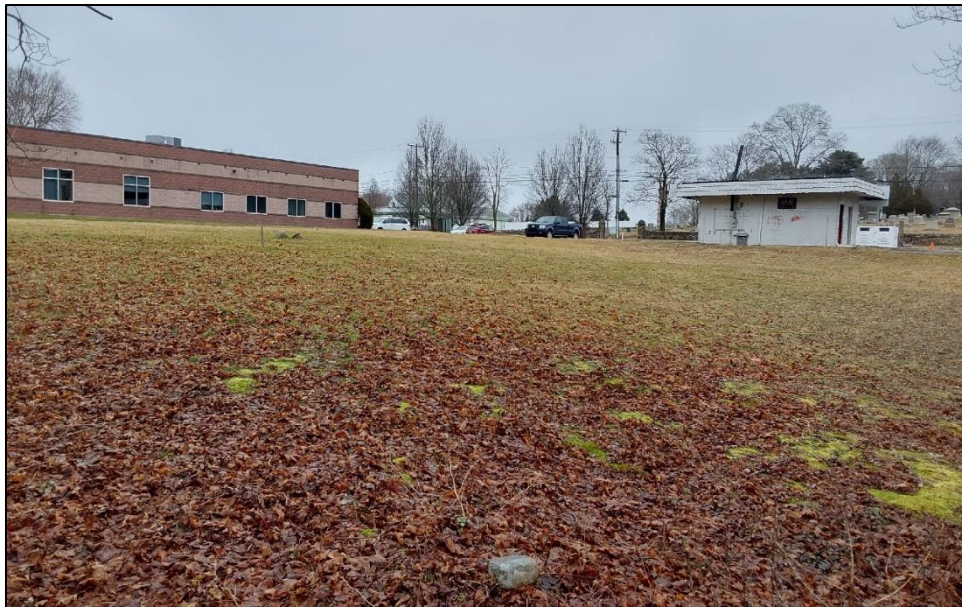
Photo 3. Overview photo from southwestern corner of the field. Photo taken facing northeast.

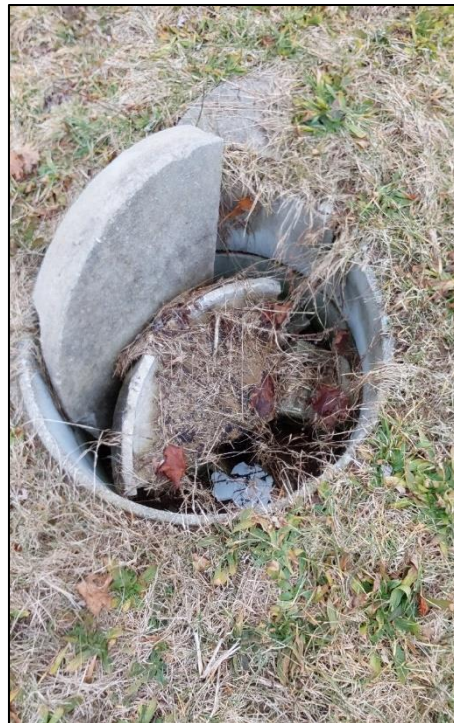
Photo 4. Close up of manhole in the facility area.

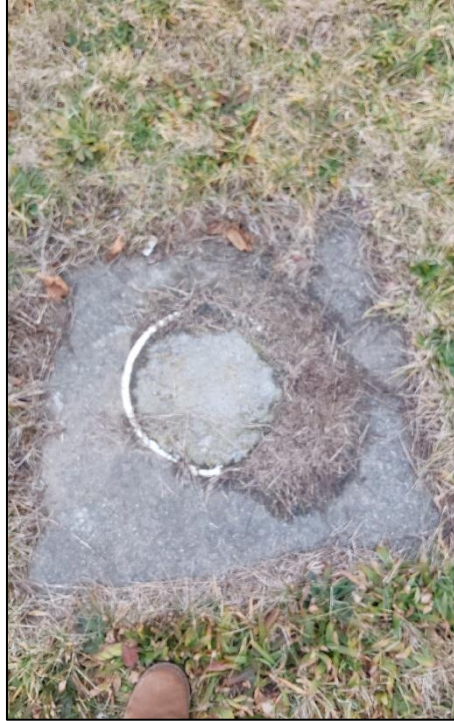
Photo 5. Close up of hole filled in with concrete in the facility area.

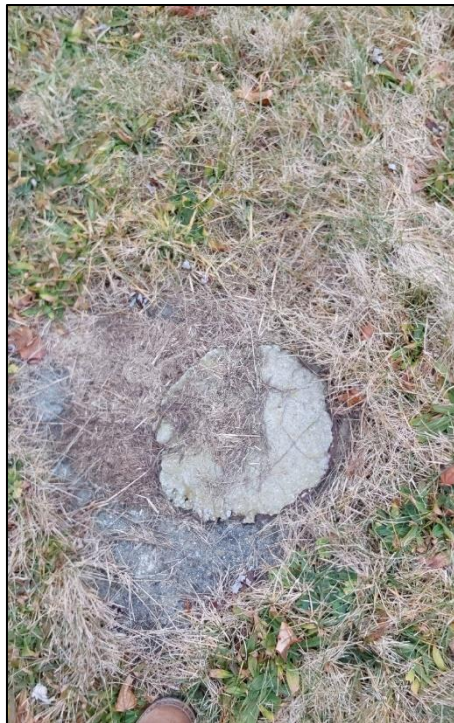
Photo 6. Close up of hole filled in with concrete in the facility area.

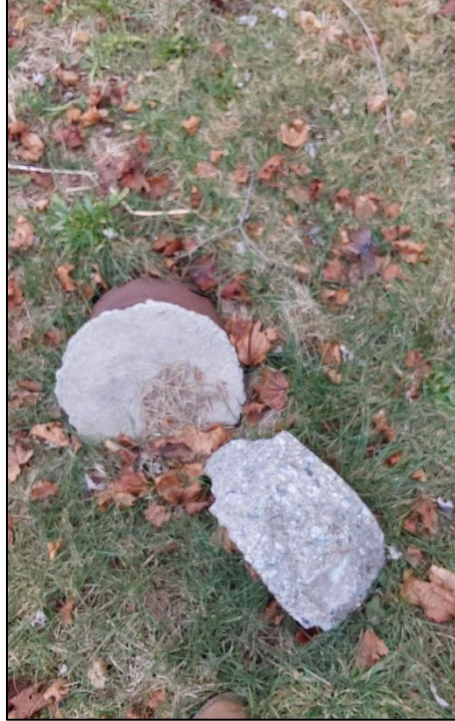
Photo 7. Close up of concrete debris indicative of disturbance in the facility area.
