Re: Towantic Substation to Beacon Falls Junction Rebuild Project

PETITION TO THE CONNECTICUT SITING COUNCIL  
FOR A DECLARATORY RULING OF  
NO SUBSTANTIAL ADVERSE ENVIRONMENTAL EFFECT  
FOR THE PROPOSED MODIFICATIONS TO THE EXISTING  
1142, 1319, 1403, 1580, 1619 AND 1808 LINES IN THE TOWN OF OXFORD CONNECTICUT

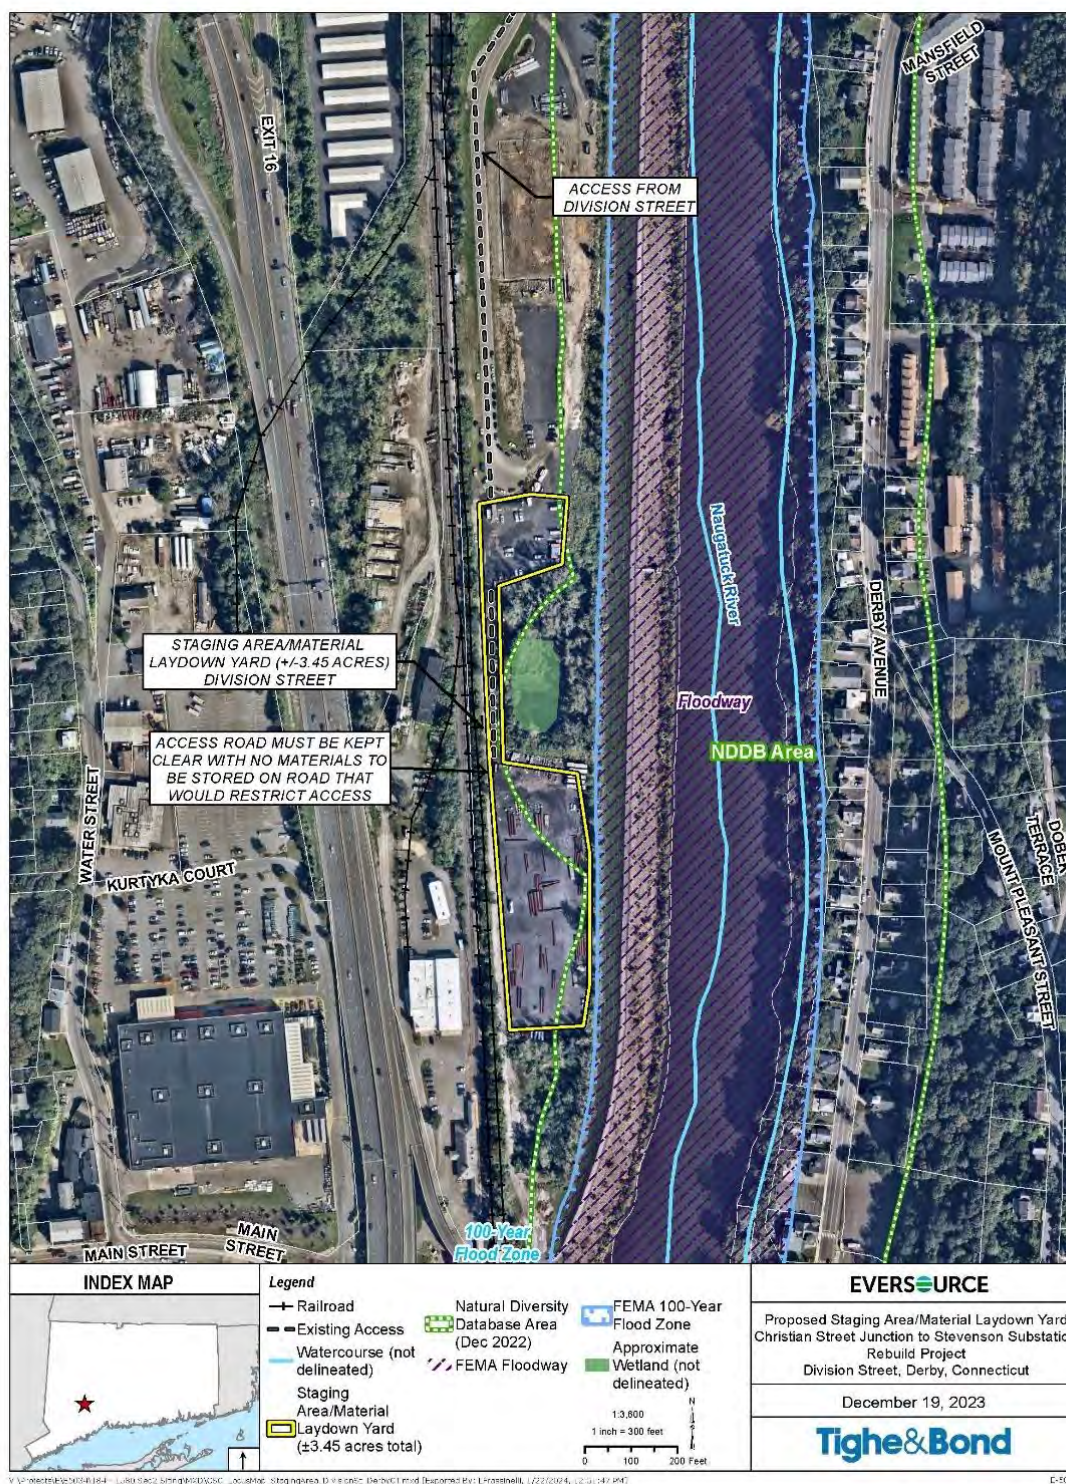
Figure 2: Staging Area/Laydown Yard

Erosion and sedimentation ("E&S") controls would be installed and maintained until completion of the work in accordance with Project permits and Eversource's BMPs (Refer to Figure 2 below).

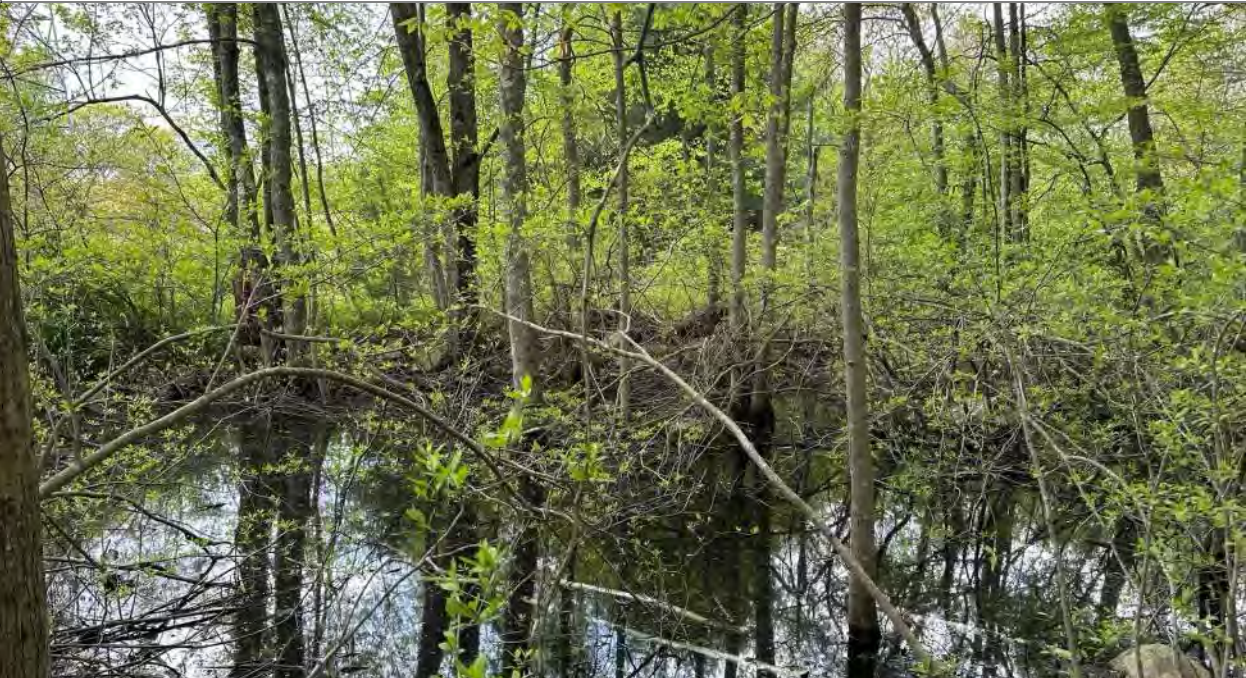
<b>Photograph No.:</b> 6	<b>Date:</b> 05/09/2024	<b>Direction Taken:</b> West
<b>Description:</b> Overview of Vernal Pool 2 (PFO1C), taken during the site visit on May 9, 2024.

Vernal Pool 2 (VP2) is located on the northern edge of the ROW, within Wetland 37 and east of STRs 315 and 1585 (Photographs No. 6 and 7, Attachment A). The cryptic vernal pool depression is largely dominated with scattered scrub-shrub vegetation, with forested land and residential properties surrounding the pool outside of the ROW. Dominant vegetation observed during the site visits included sweet pepperbush (*Clethra alnifolia*) and Morrow's honeysuckle (*Lonicera morrowii*).

During the May 9<sup>th</sup> 2024 survey, over 75 wood frog tadpoles and 12 spotted salamander egg masses were observed. Additionally, 6 adult green frogs were observed.

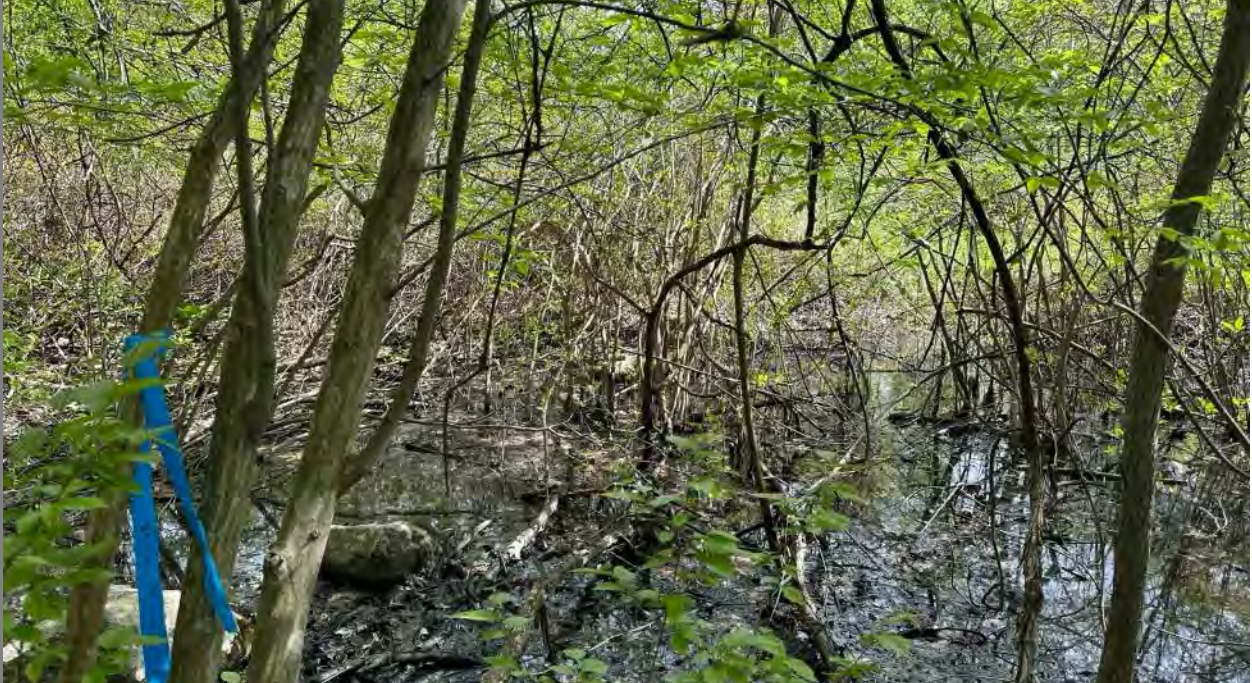
<b>Photograph No.:</b> 7	<b>Date:</b> 05/09/2024	<b>Direction Taken:</b> South
--------------------------	-------------------------	-------------------------------

**Description:** Overview of Vernal Pool 2, taken during the site visit on May 9, 2024.

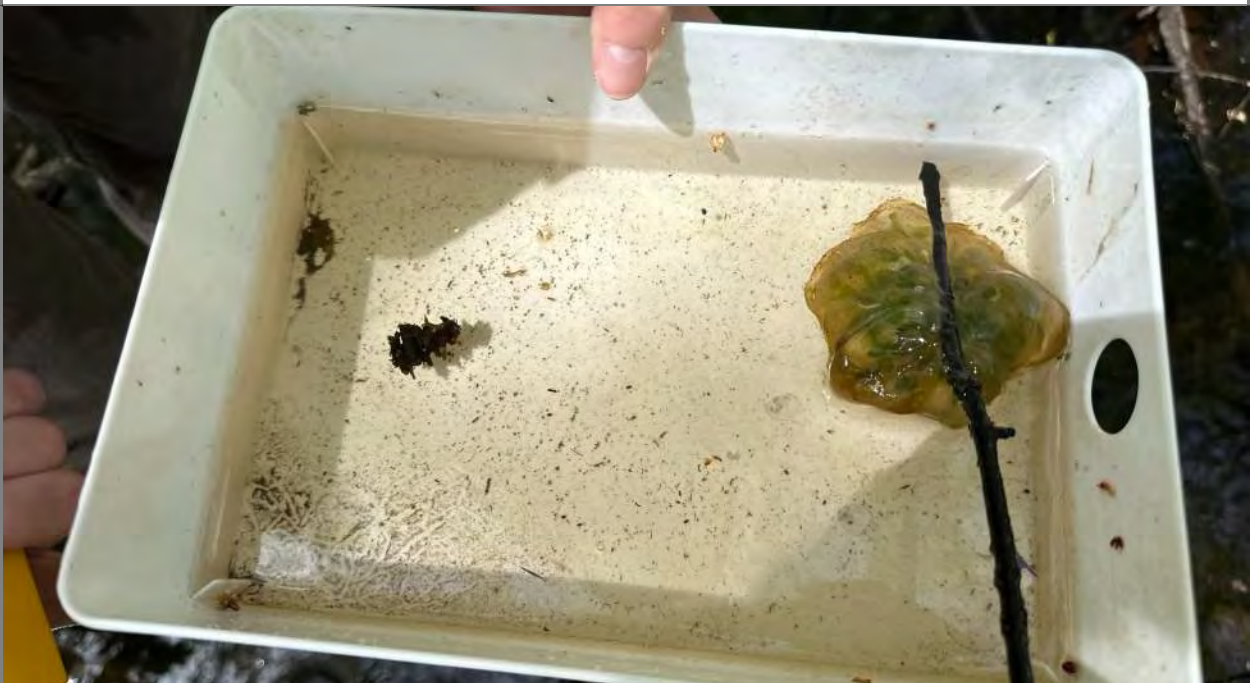
<b>Photograph No.:</b> 8	<b>Date:</b> 05/09/2024	<b>Direction Taken:</b> N/A
--------------------------	-------------------------	-----------------------------

**Description:** Spotted salamander (*Ambystoma maculatum*) egg masses were observed within VP1 in 2024, in varying stages of maturity.

During the May 9, 2024 survey, wood frog tadpoles and 2 spotted salamander egg masses were observed. Additionally, adult spring peepers and more than 50 adult green frogs were observed. During the April 8, 2022 survey, 3 adult wood frogs and 2 spotted

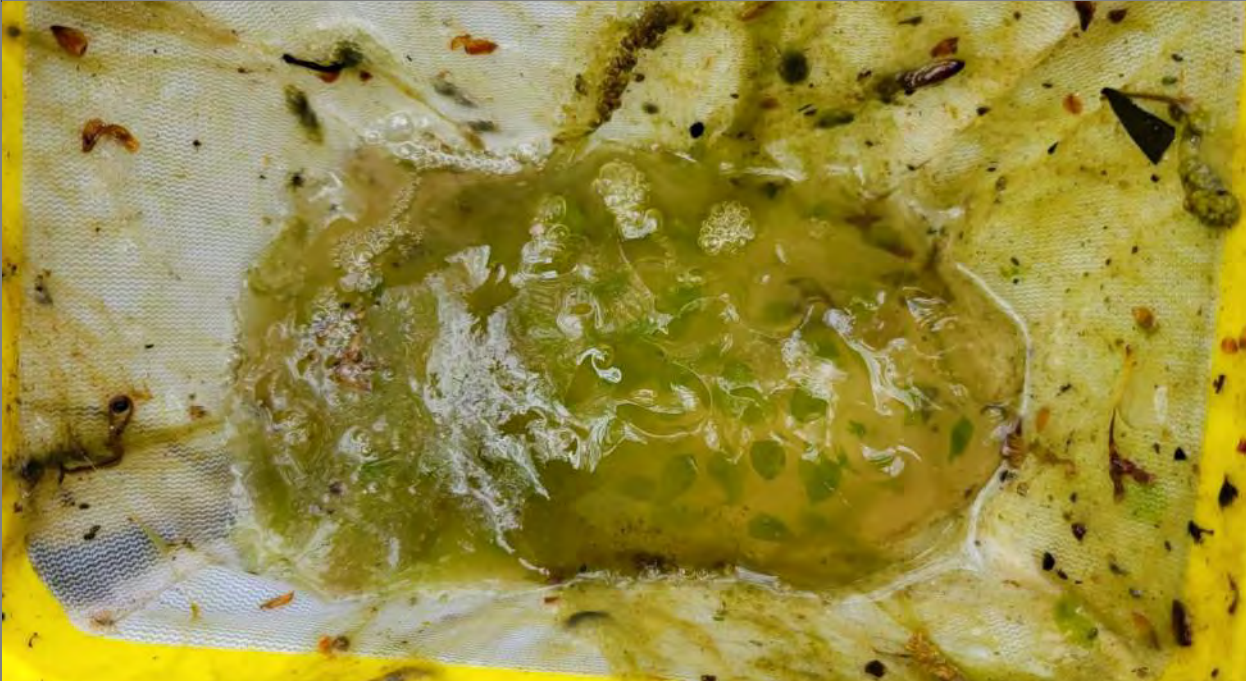
<b>Photograph No.:</b> 9	<b>Date:</b> 05/13/2022	<b>Direction Taken:</b> N/A
<b>Description:</b> Spotted salamander ( <i>Ambystoma maculatum</i> ) egg masses were observed within Vernal Pool 1 in 2022, in varying stages of maturity over the study period.

salamander egg masses were observed. On April 25, 2022, a total of 1 wood frog and 2 spotted salamander egg masses were counted and 2 adult wood frogs were observed. During the final May 13, 2022 monitoring event, all egg masses of each species were found to be fully hatched and hundreds of wood frog tadpoles were observed within the pool. Additionally, 2 adult green frogs were observed. These results are similar to those observed in 2021, where a maximum of 12 wood frog and four spotted salamander egg masses were observed in the month of April, and hundreds of wood frog tadpoles were observed in May and June.

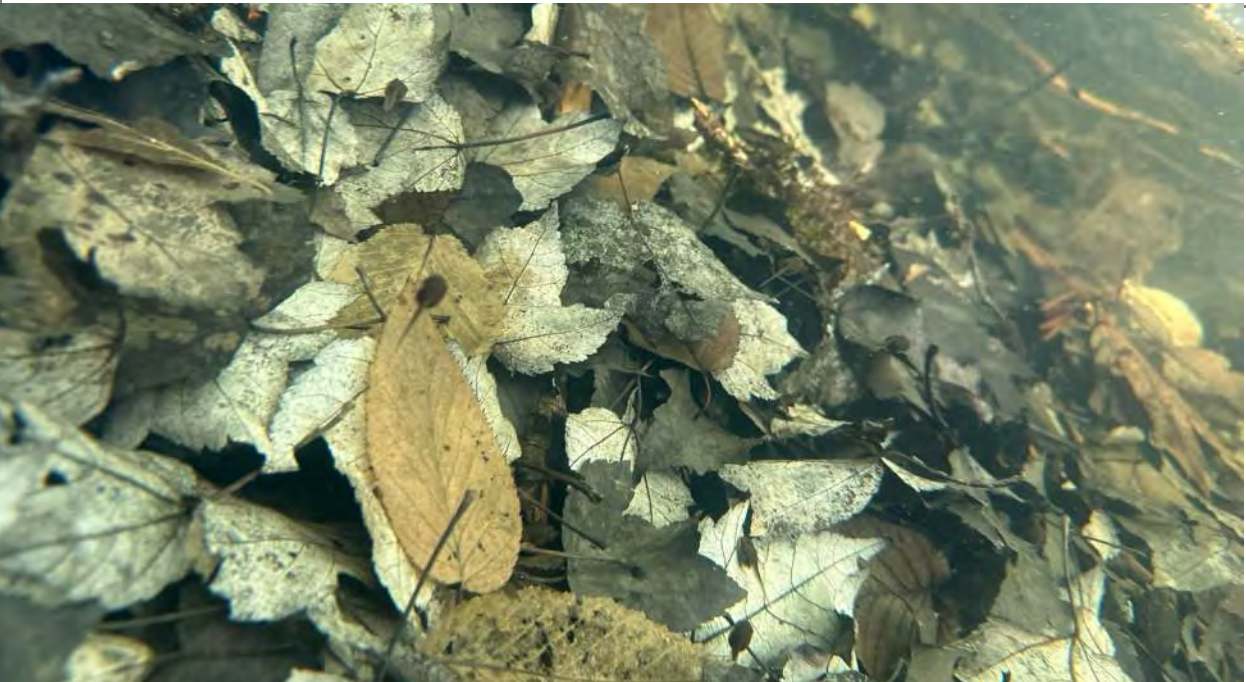
<b>Photograph No.: 12</b>	<b>Date:</b> 04/08/2022	<b>Direction Taken:</b> N/A
<b>Description:</b> Wood frog ( <i>Lithobates sylvaticus</i> ) tadpoles were observed within Vernal Pool 2 in 2024.
