APPENDIX C WETLAND DELINATION REPORT

RE: Bristol Landfill Wetland Delineation Report
Lake Avenue
Bristol, CT

Wetland Delineation Report
Bristol Landfill

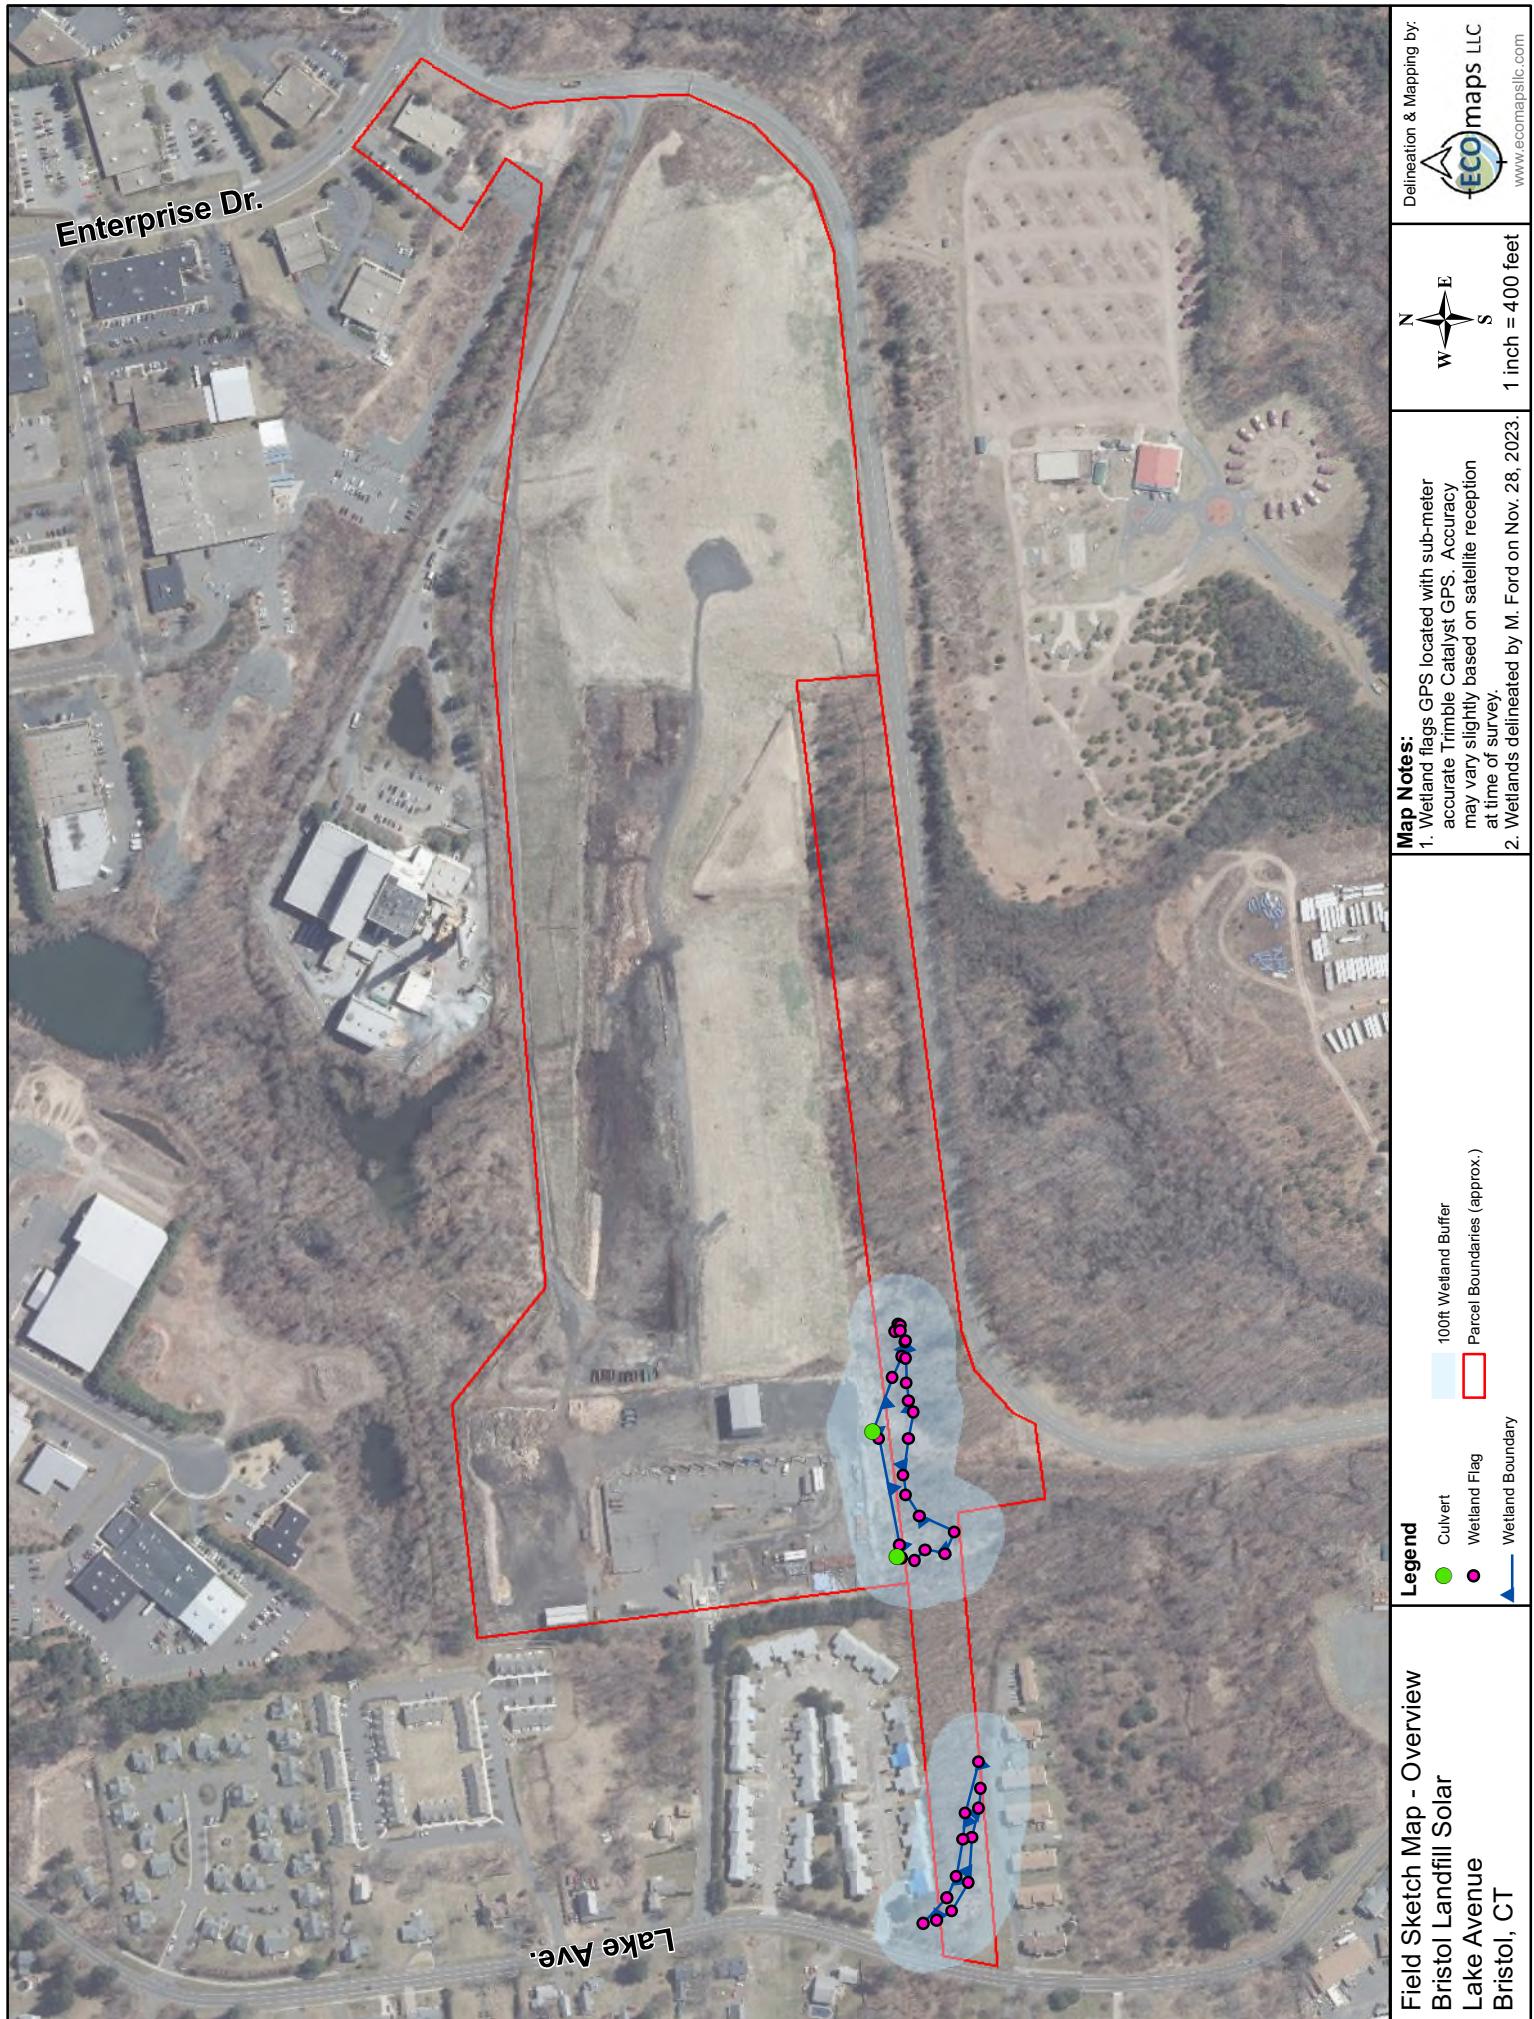
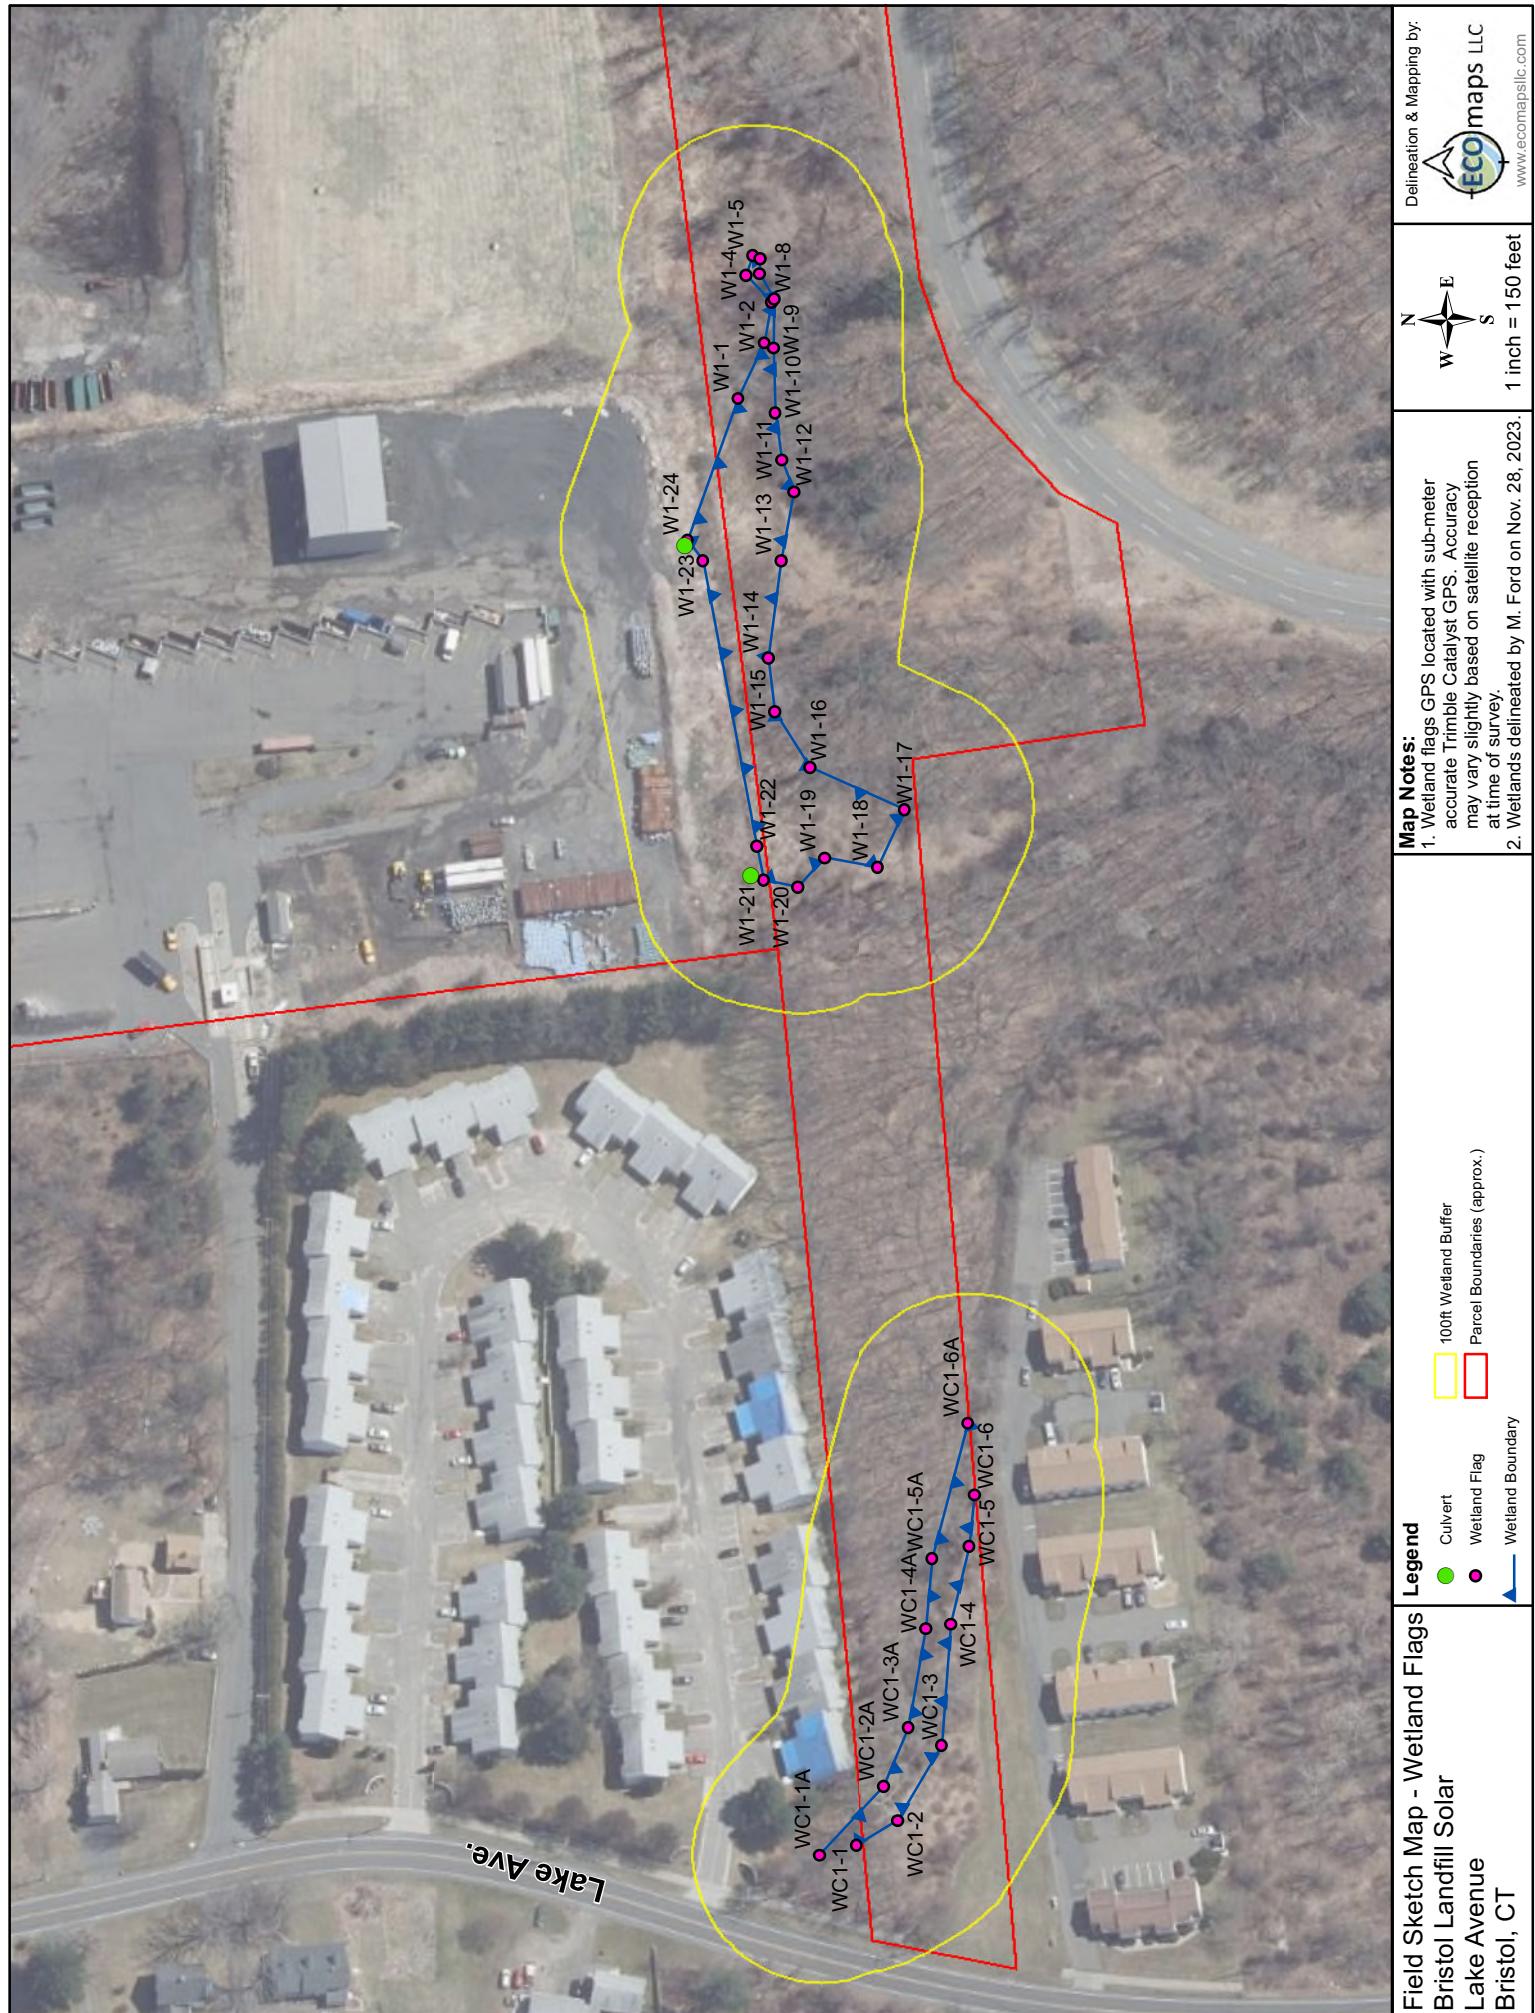
Wetland Sketch Maps

Delineated wetland resources at the Site include two areas located predominantly in the Town-owned parcel south of the active landfill nearest to Lake Avenue and the Lake Compounce Campground access road as shown in Attachment A: Wetland Sketch Maps. A description of each resource area is provided below.

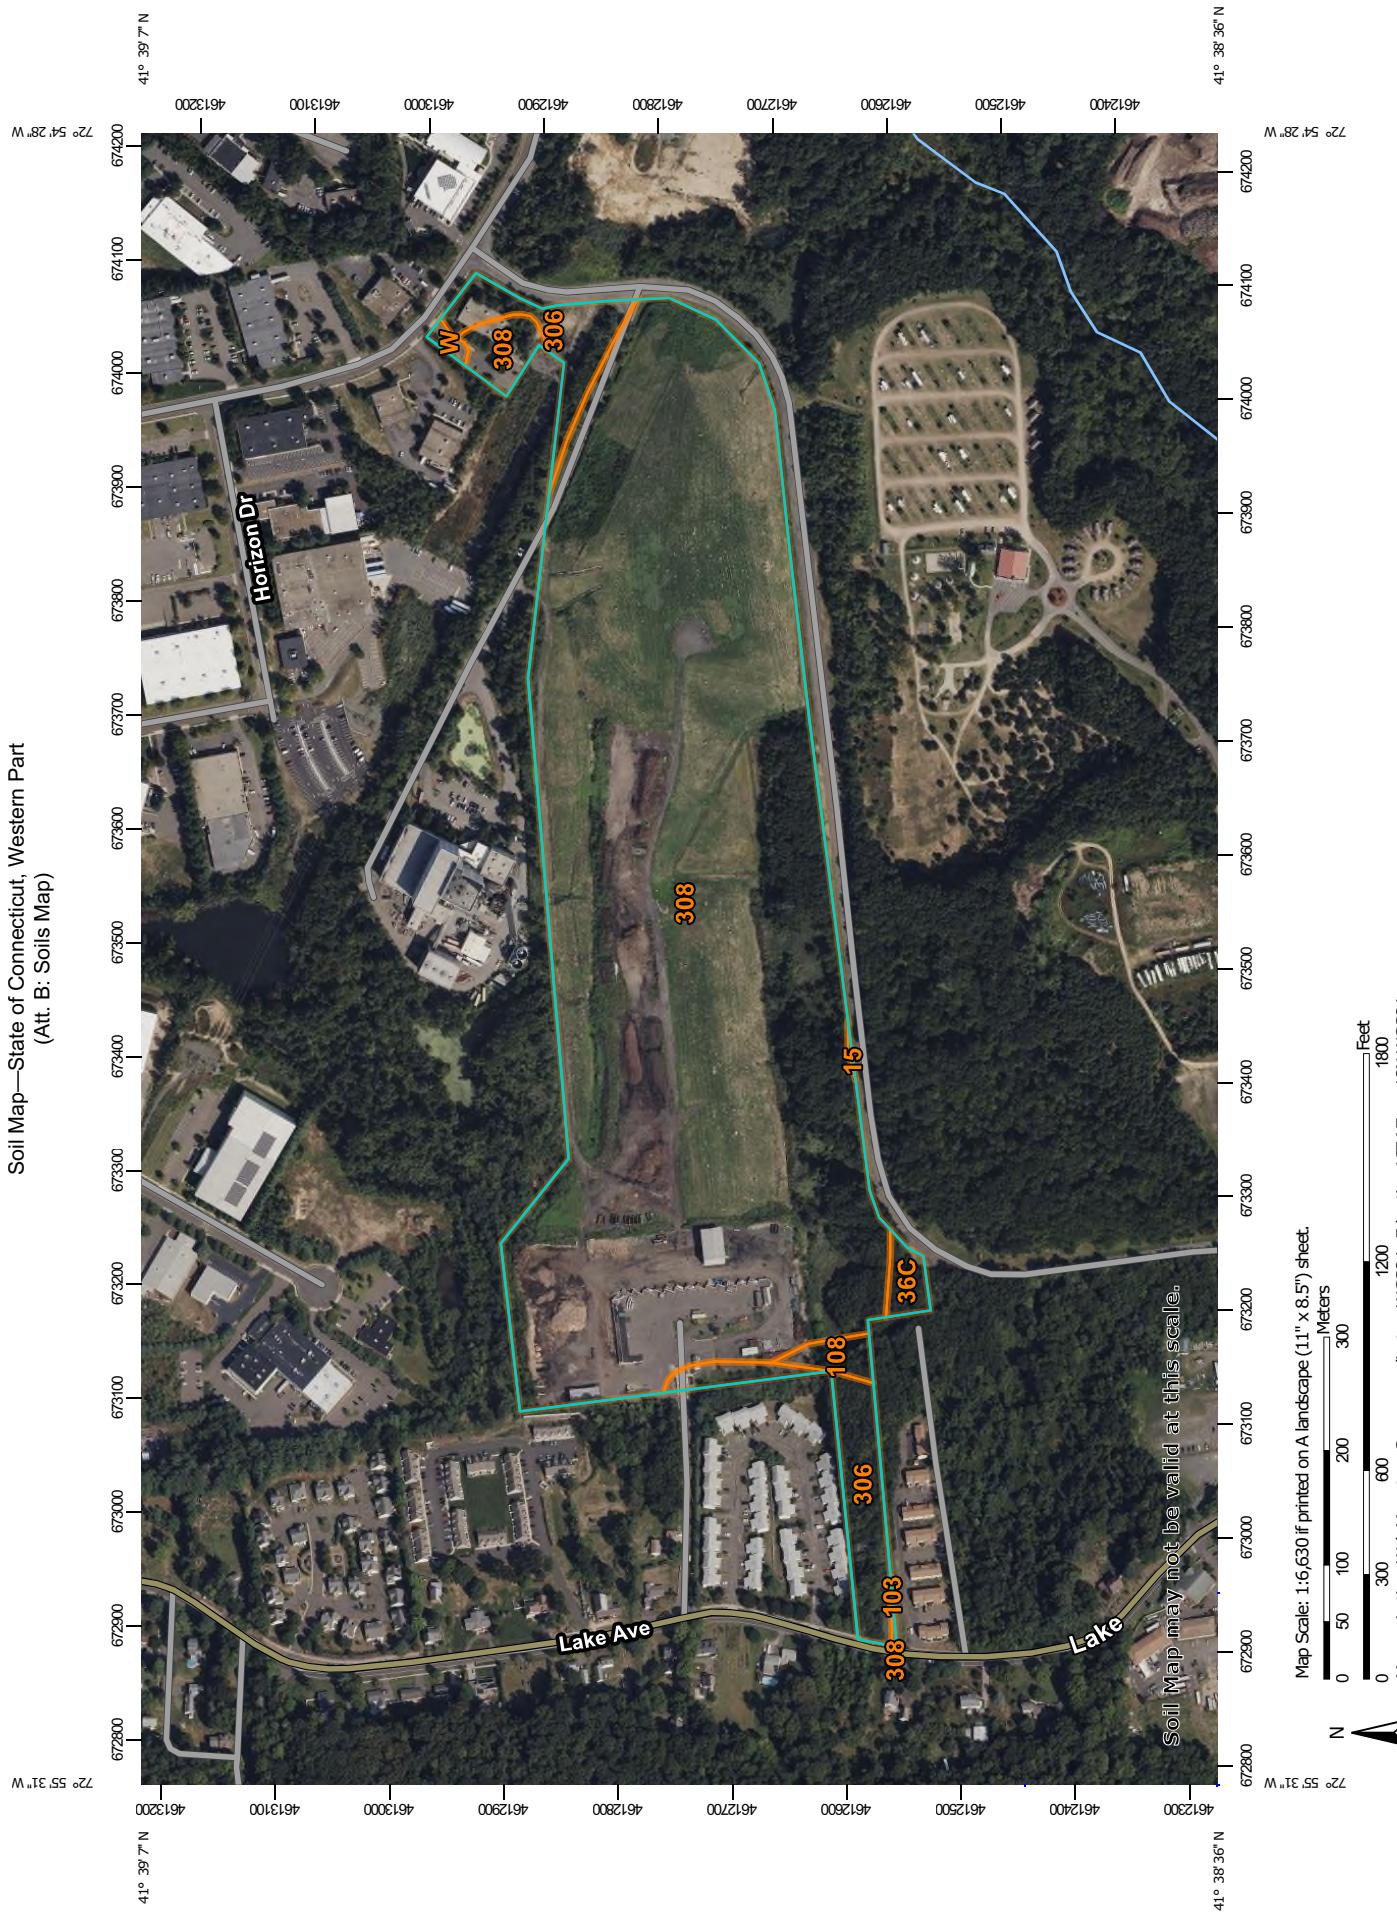
**Soil Map—State of Connecticut, Western Part
(Att. B: Soils Map)**

The NRCS Soil Survey Geographic Database (SSURGO) maps the soils within most of the landfill property as Udorthents Urban Land Complex. Soils within the mapped wetland areas include Scarboro muck, Windsor loamy sand, Rippowam fine, sandy loam and Saco silt loam, all of which are described below:

According to the Soil Survey Geographic Database made available through CT DEEP, only soils within the far western portion of wetland W1 are mapped as inland wetland soils.

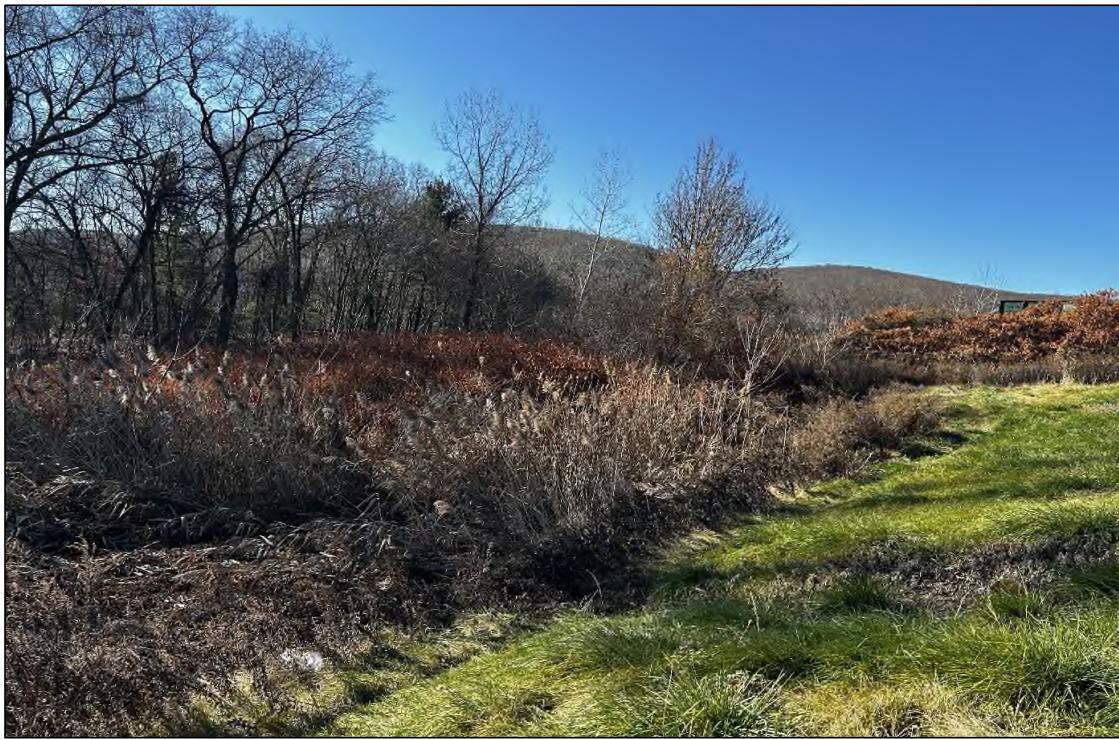
This wetland is located at the toe-of-slope south of the active transfer station portion of the landfill and is hydrologically supported by stormwater runoff. Although soils within the upper 12-18" would be classified as well-drained, sandy material, the underlying substrate and an otherwise restrictive layer retains water within the topographical depression thus resulting in the development and establishment of hydric soils, vegetation and hydrology. Although the wetland is dominated by non-native common reed (*Phragmites australis*), other invasive vegetation such as Asiatic bittersweet (*Celastrus orbiculatus*), autumn olive (*Elaeagnus umbellata*) and multiflora rose (*Rosa multiflora*) were also observed. Although the wetland limit was flagged within the delineation area, the wetland system continues off-Site to the south between flags W1-18 and W1-17. Very dense, nearly impenetrable vegetation and steep slopes were observed along the northern wetland boundary near the toe-of-slope.

Photo 1. View facing the eastern end of wetland W1. Photo facing southeast toward the toe-of-slope adjacent to the landfill.

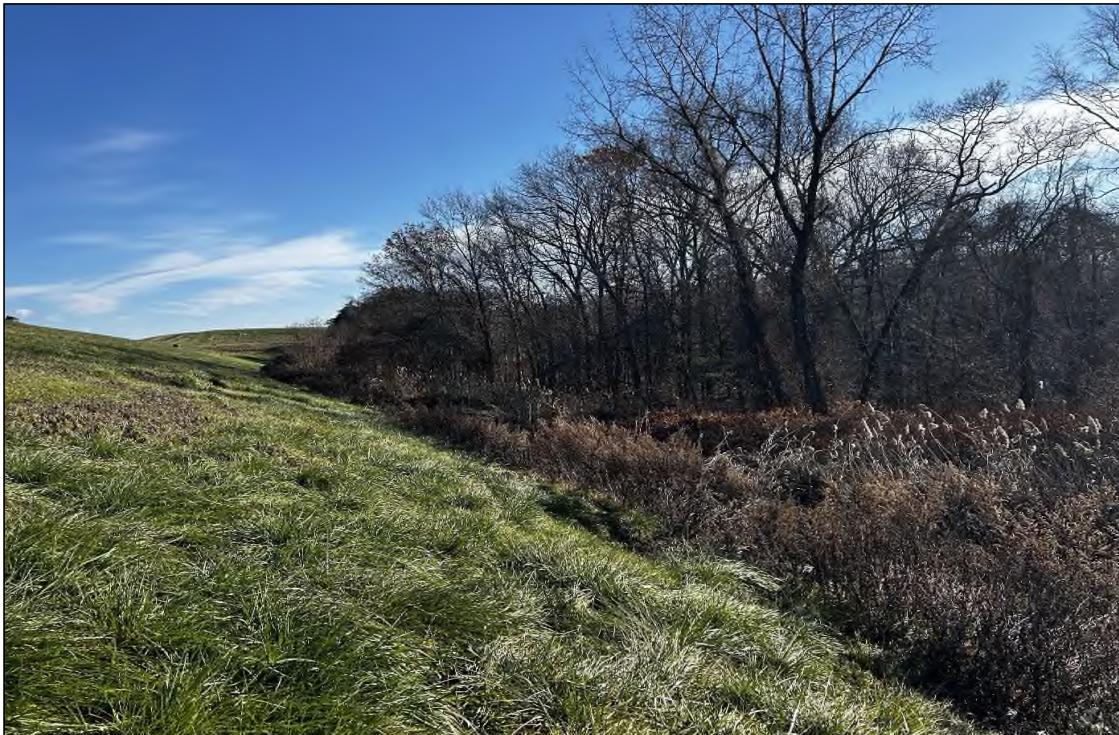
Photo 2. View facing the southern edge of the landfill east of wetland W1. Photo facing east.

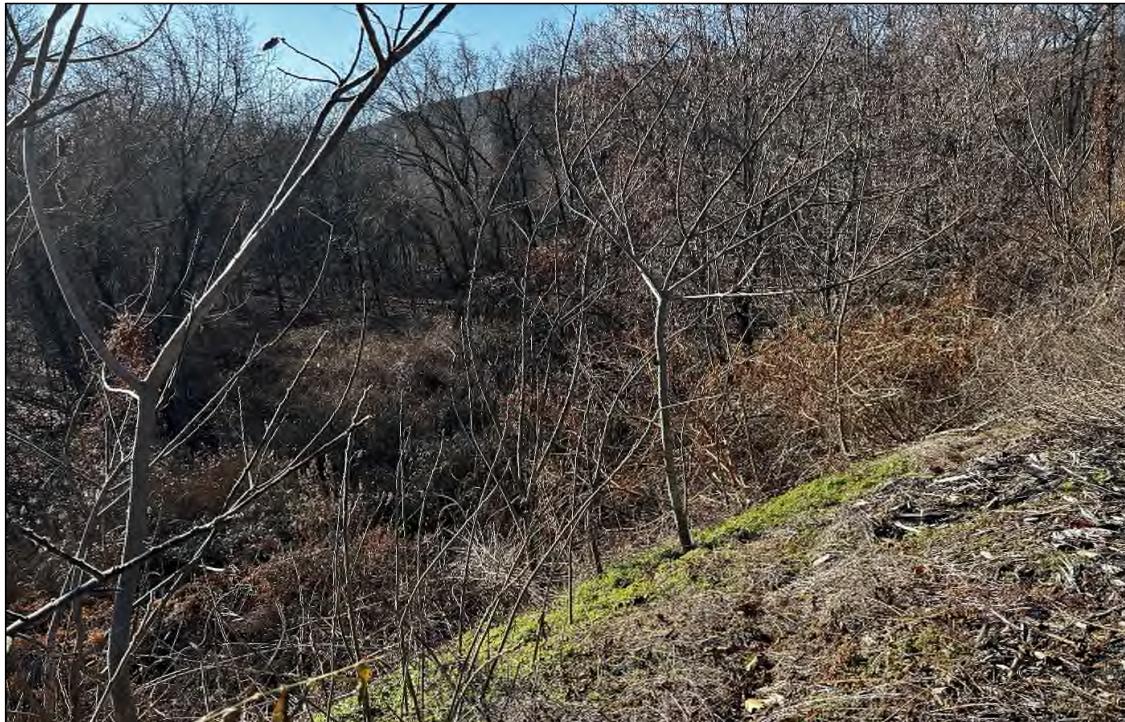
Photo 3. Overview of a portion of wetland W1 from the top of the slope near the active transfer station. Photo facing southwest.

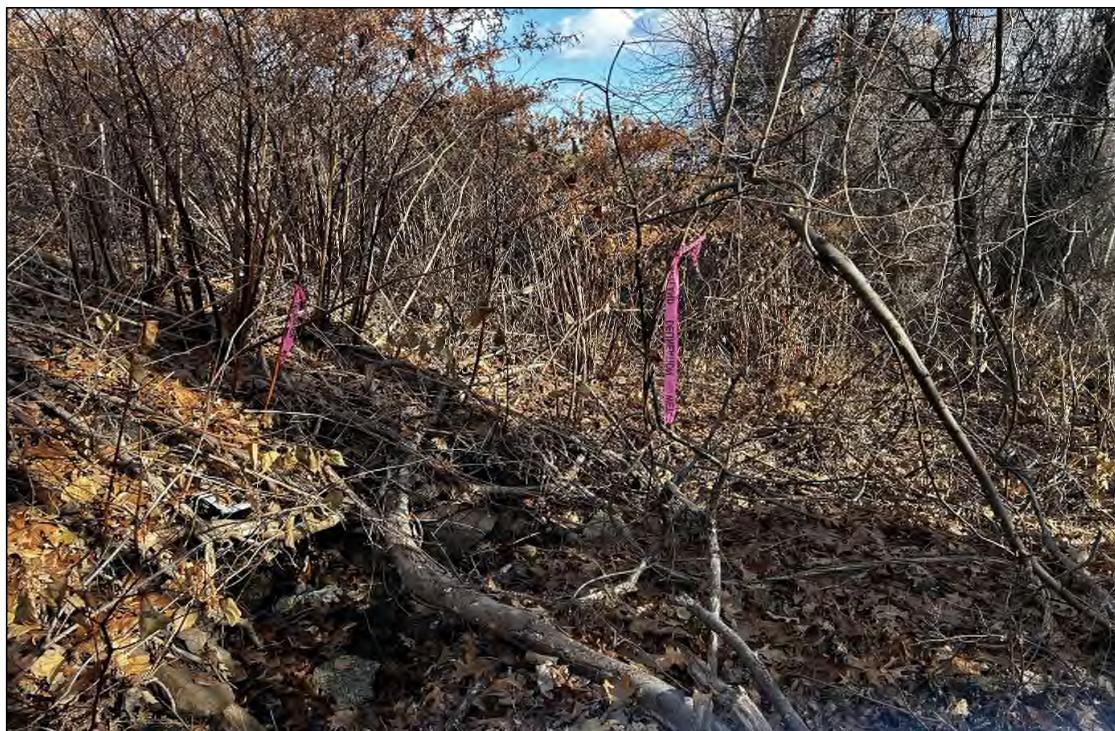
Photo 4. Small, embedded intermittent watercourse located at the eastern end of wetland W1 near flag W1-8. Photo facing northeast.

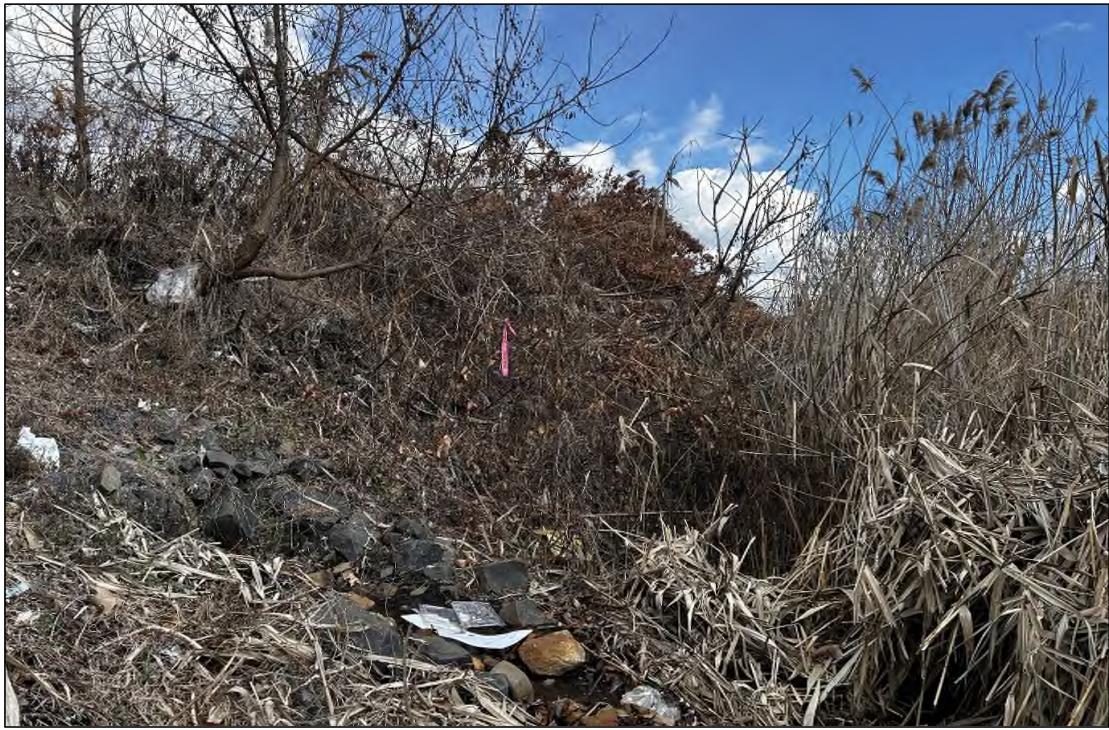
Two culverts that emerge from the base of the slope as shown in Attachment A discharge directly into the wetland and contribute to the wetland's hydrology. Although their primary function is likely stormwater conveyance, active flow from both culverts, though diminutive, was observed at the time of the delineation over 24 hours post-rain event.

Photo 5. Eastern-most culvert at the base of the active transfer station that discharges into wetland W1. Photo facing northeast.

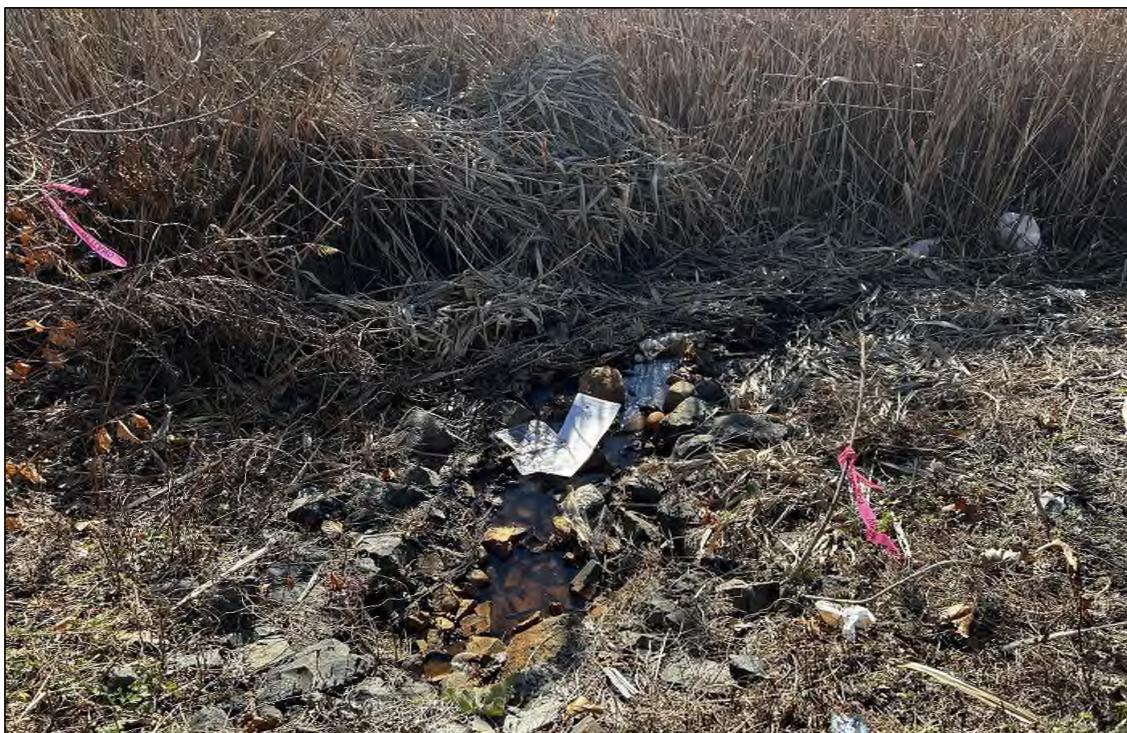
Photo 6. Discharge and debris from within the eastern-most culvert flowing into wetland W1. Photo facing south.

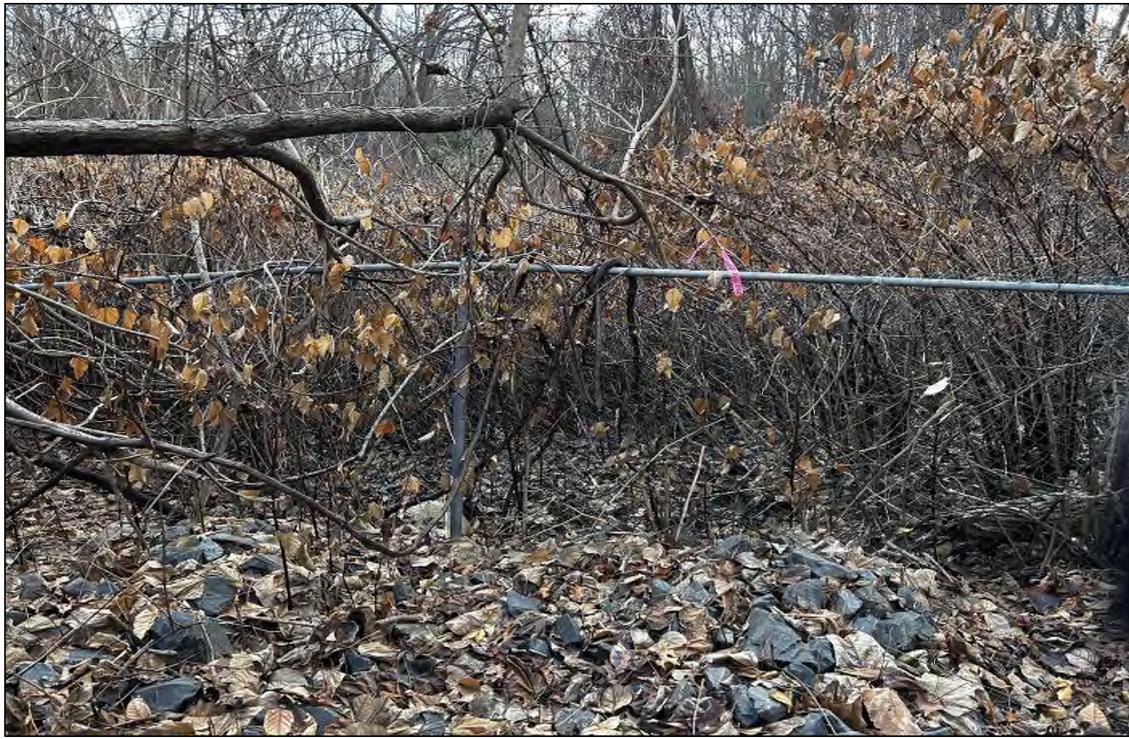
Photo 7: Rip-rap immediately downgradient of the western-most culvert flowing from beneath the active transfer station into the western end of wetland W1. Photo facing south.

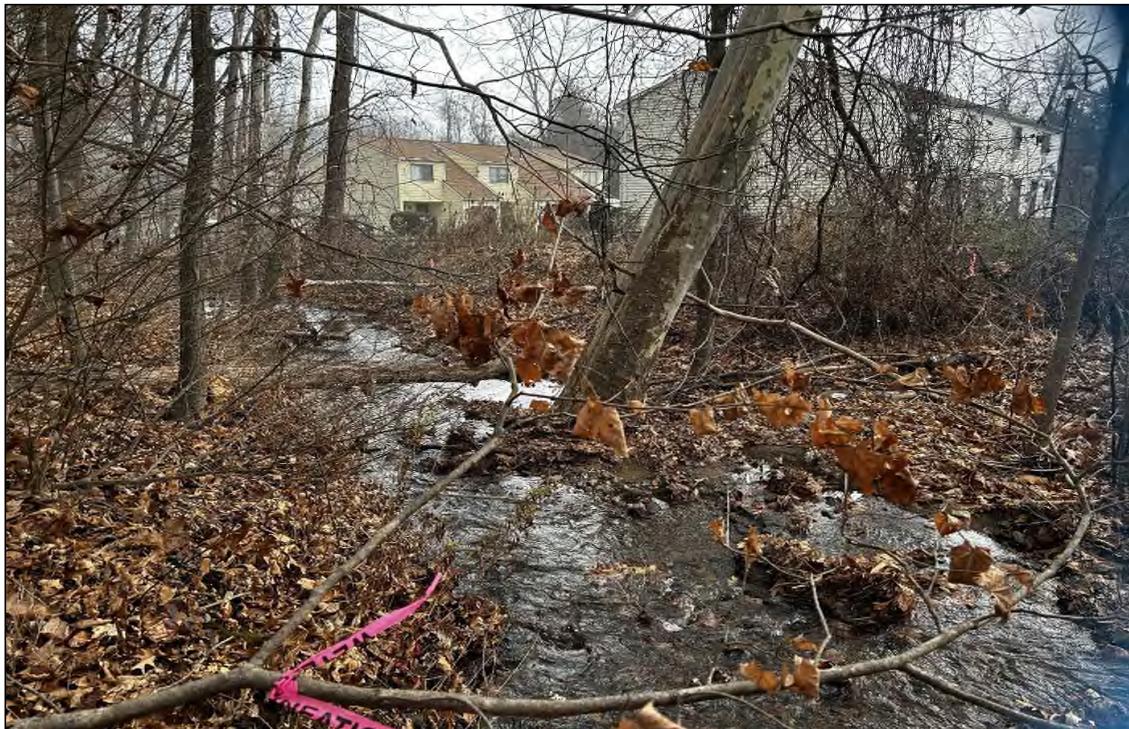
Mix Brook flows from west to east beneath Lake Avenue in the southwestern corner of the delineation area. The substrate throughout the brook is predominantly sand and gravel. At the time of the delineation, the water level was low to average, ranging from 4 to 12 inches, consisting primarily of runs and riffles with few pools. The Brook is likely influenced by stormwater runoff that result in highly variable and high-energy flows throughout the year. The Brook is classified by the Connecticut Department of Energy and Environmental Protection (CT DEEP) as a Class 2 watercourse meaning that it is a minimally altered, free-flowing stream.

Photo 8. View of Mix Brook which flows southwest of the Bristol landfill. Photo facing southeast.

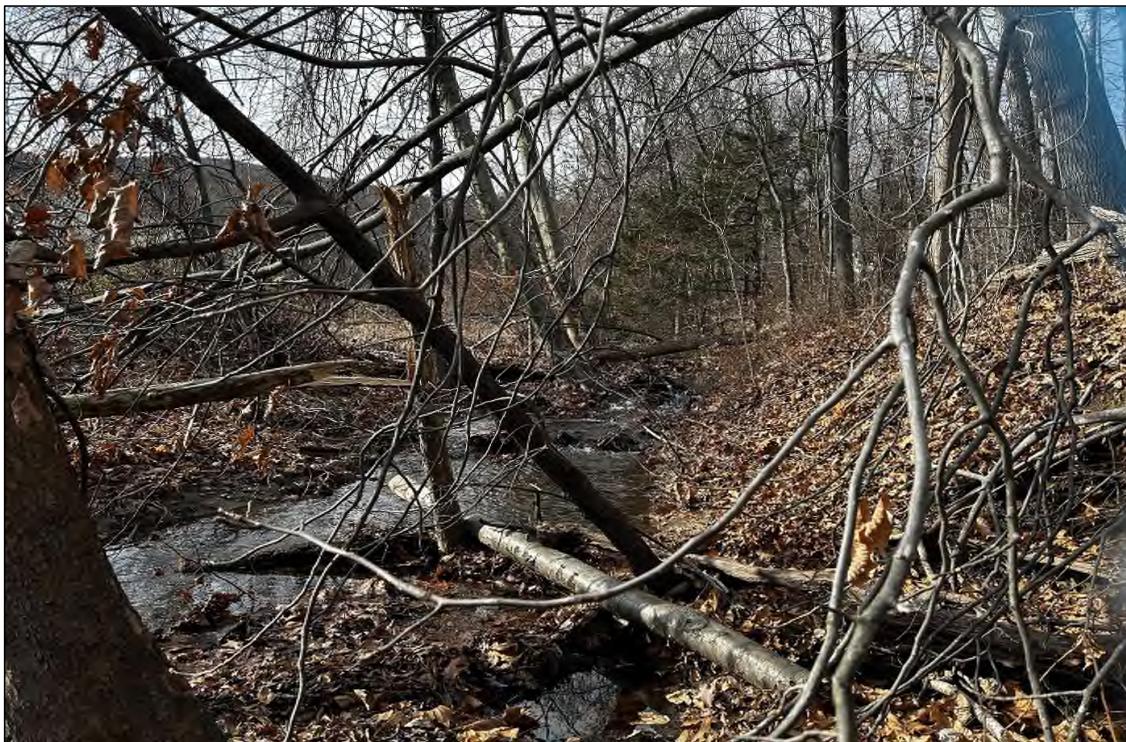
Photo 9. View of a portion of Mix Brook southwest of the landfill. Photo facing northwest.
