Memorandum

Re: Amendment to Wetland and Watercourse Delineation Report, Oxford
Energy Center, LLC, dated June 24, 2021

Site B: Oxford Energy Center, LLC | Oxford, Connecticut

Re: Wetland & Watercourse Delineation Report
Oxford Energy Center, LLC

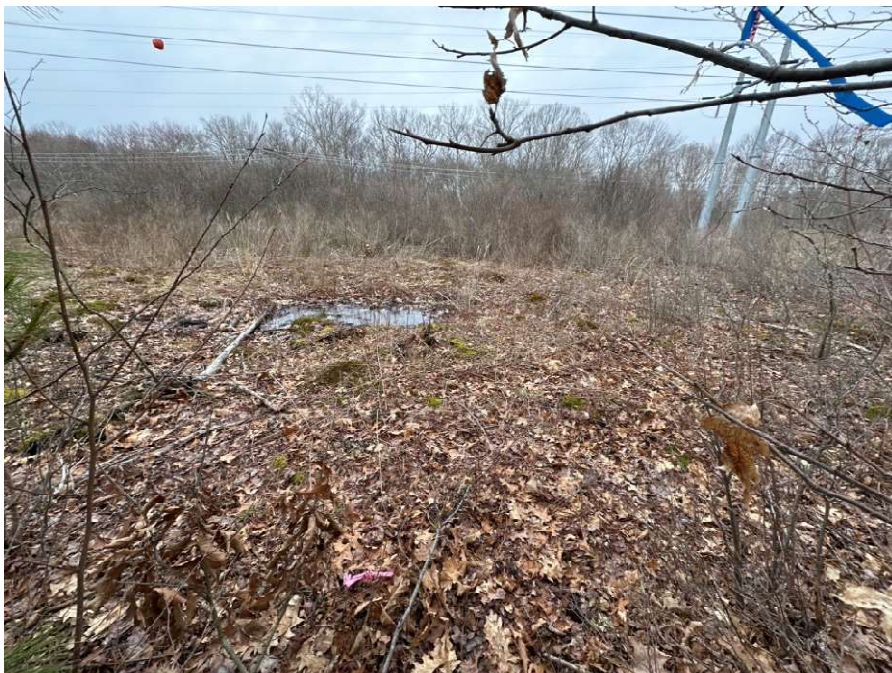
Photo 1 – Looking west from treeline in Wetland Area 4

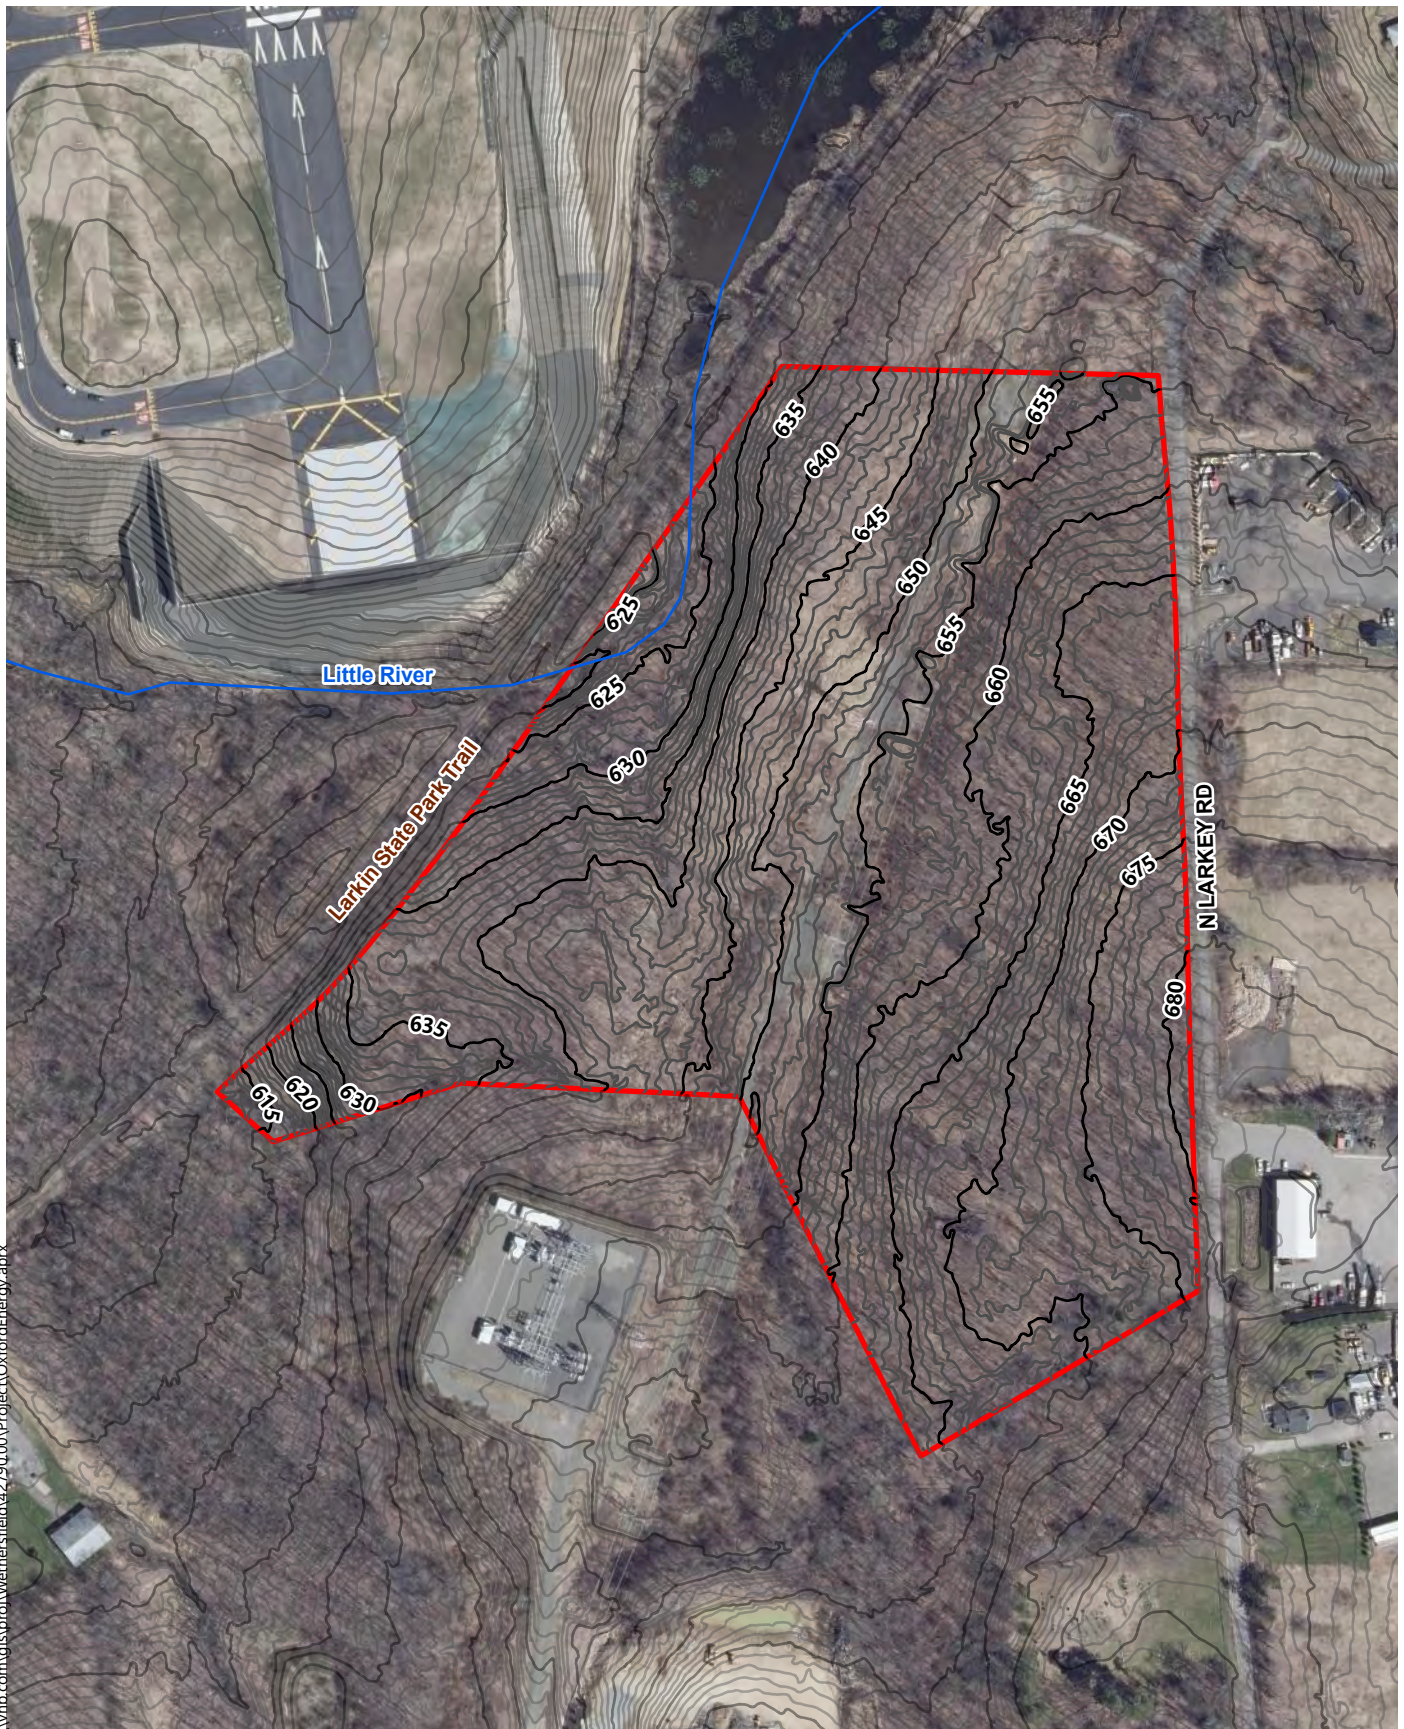
NRCS Soils Map

- Study Site Boundary
- NRCS Soils Boundary
- NRCS Poorly Drained Soils

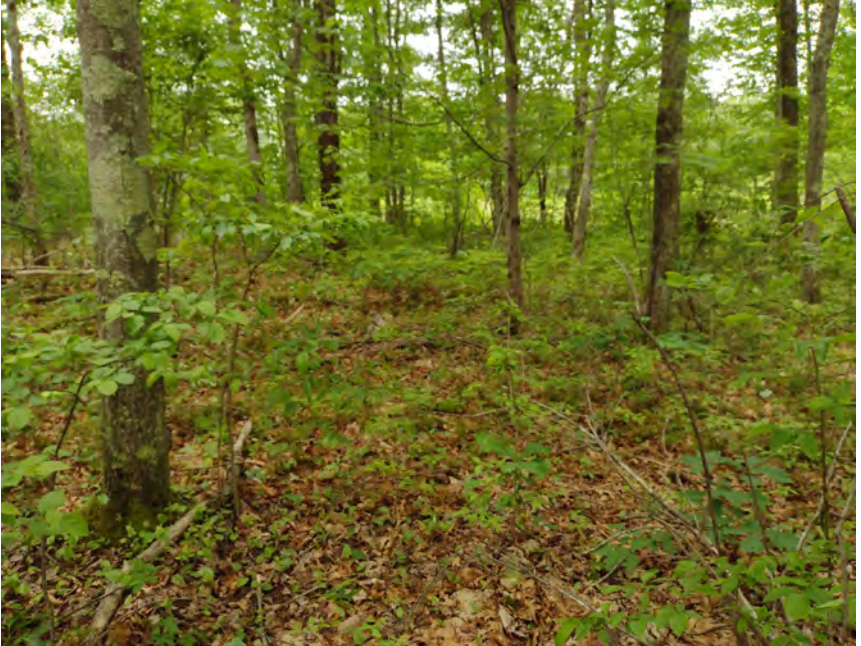
vhb Engineers Scientists Planners Designers		PHOTOGRAPHIC LOG	
Client Name: Oxford Energy Center, LLC		Site Location: Oxford Energy Center, Site B	
Project No: 42790.00			
Photo No. 1	Date: 6/01/2021

Description: View of upland area in the most northeastern portion of the site. Forest floor is primarily clear of vegetation, consisting of fallen leaves, while samplings make up the understory. Mature canopy trees with 10-35 dbh are present.

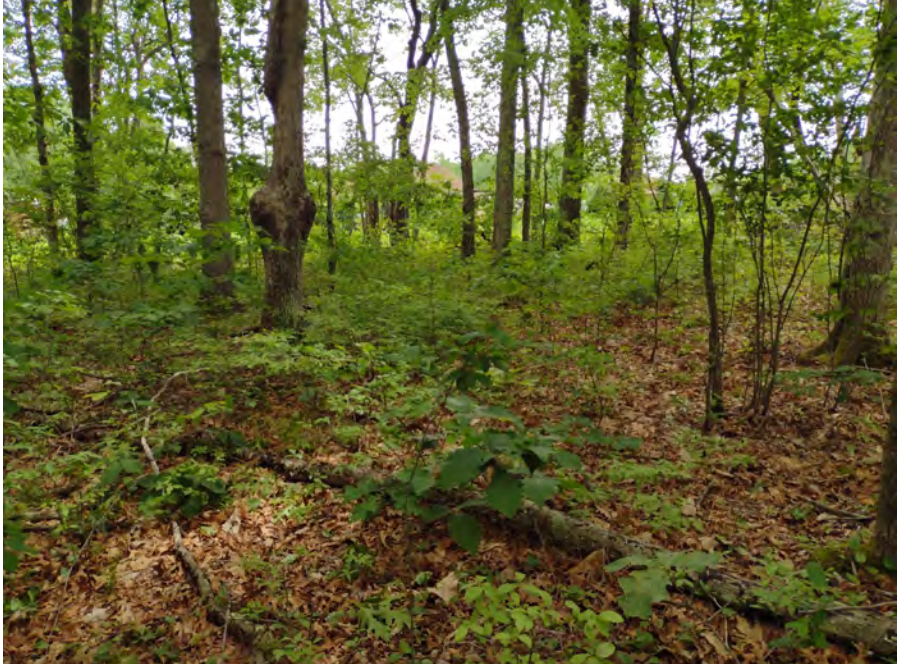
vhb Engineers Scientists Planners Designers		PHOTOGRAPHIC LOG	
Client Name: Oxford Energy Center, LLC		Site Location: Oxford Energy Center, Site B	
Project No: 42790.00			
Photo No. 2	Date: 6/01/2021

Description: View of upland area in the north eastern portion of the site, looking east towards North Larkey Road. Upland vegetation and characteristics, including dry leaf forest floor cover, are present.

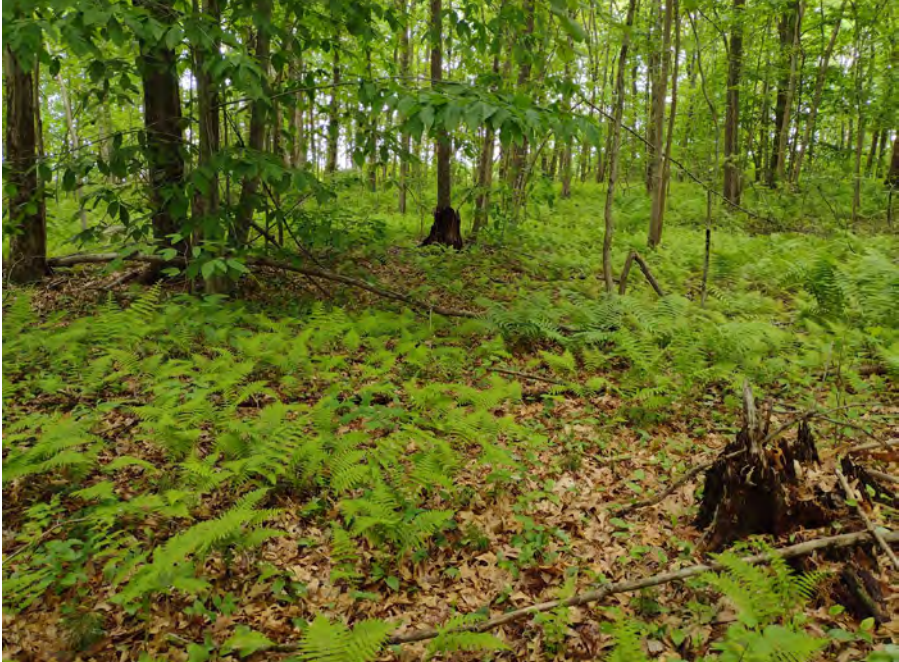
vhb Engineers Scientists Planners Designers		PHOTOGRAPHIC LOG	
Client Name: Oxford Energy Center, LLC		Site Location: Oxford Energy Center, Site B	
Project No: 42790.00			
Photo No. 3	Date: 6/01/2021

Description: View of upland area in central eastern portion of the site looking west towards the utility right-of-way. Fern vegetation is dominant, with mature canopy trees spread apart, and decomposing stumps are frequent.

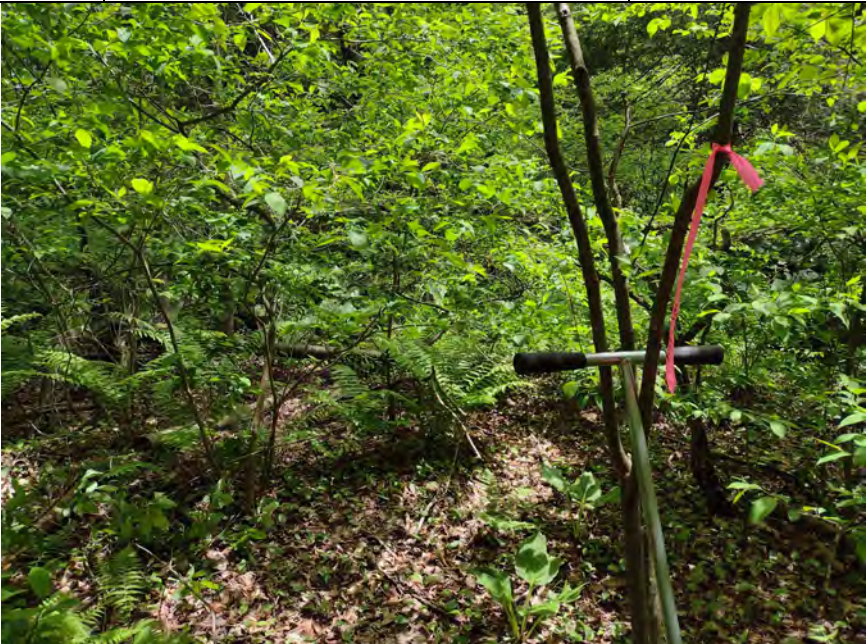
vhb Engineers Scientists Planners Designers		PHOTOGRAPHIC LOG	
Client Name: Oxford Energy Center, LLC		Site Location: Oxford Energy Center, Site B	
Project No: 42790.00			
Photo No. 4	Date: 6/01/2021

Description: View of Wetland Area 1 near Flag No. 104. Vegetation is dense and buttressing of tree roots was observed.

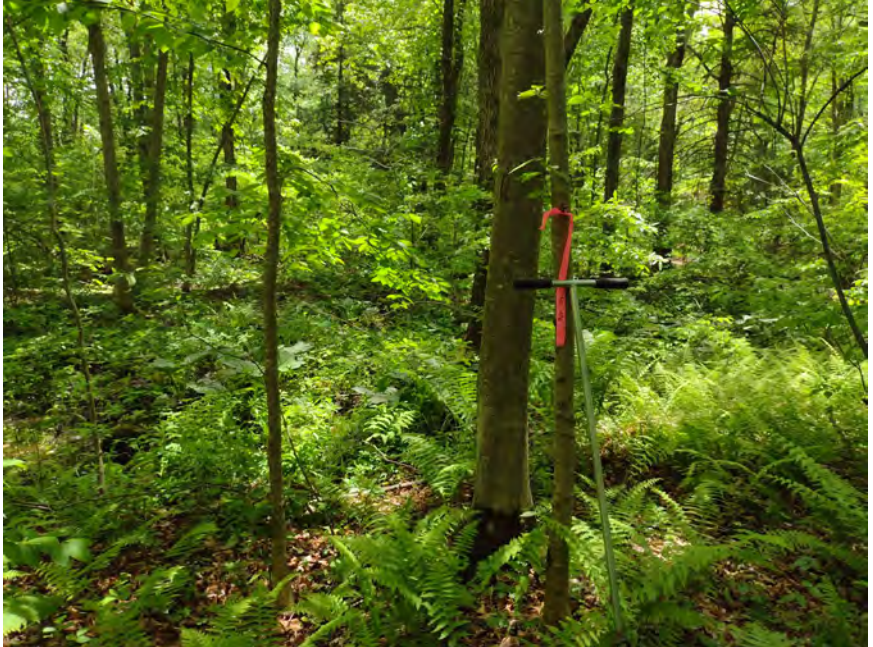
Engineers Scientists Planners Designers		<h2 style="text-align: center;">PHOTOGRAPHIC LOG</h2>	
Client Name: Oxford Energy Center, LLC		Site Location: Oxford Energy Center, Site B	
Project No: 42790.00			
Photo No. 5	Date: 6/01/2021

Description: View of Wetland Area 1 near Flag No. 106. Standing water is visible beneath the dense herbaceous vegetation, and moss lines and water stained leaves were observed. The area is primarily flat.

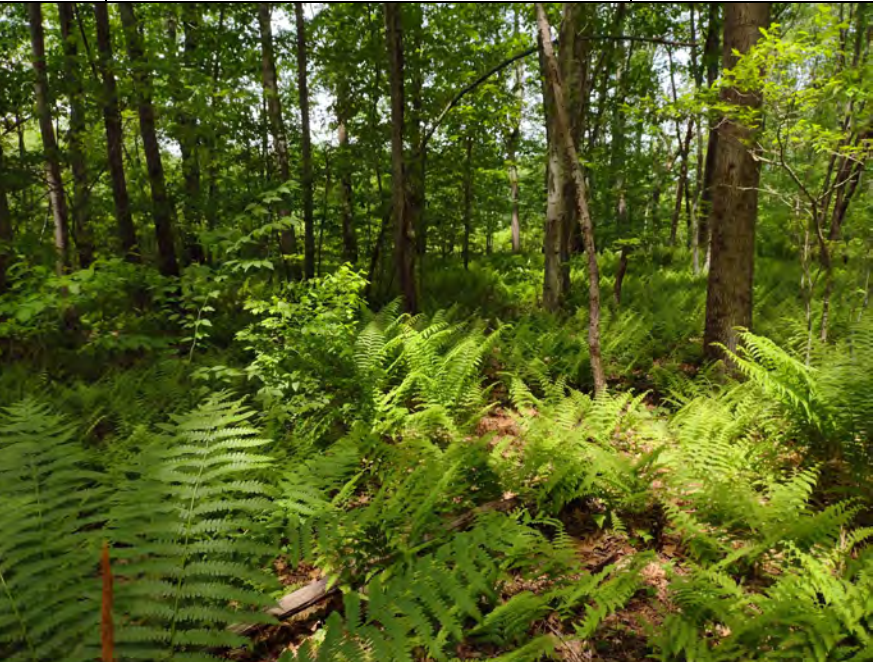
Engineers Scientists Planners Designers		<h2 style="text-align: center;">PHOTOGRAPHIC LOG</h2>	
Client Name: Oxford Energy Center, LLC		Site Location: Oxford Energy Center, Site B	
Project No: 42790.00			
Photo No. 6	Date: 6/01/2021

Description: View of upland area along the eastern portion of the site, along the southern boundary.

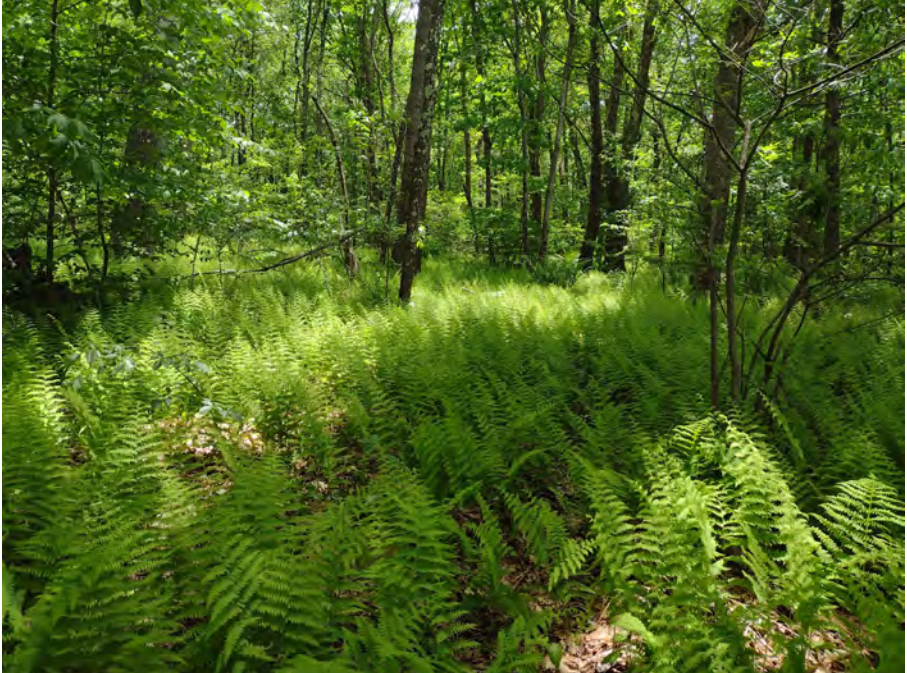
vhb Engineers Scientists Planners Designers		PHOTOGRAPHIC LOG	
Client Name: Oxford Energy Center, LLC		Site Location: Oxford Energy Center, Site B	Project No: 42790.00
Photo No. 7	Date: 6/01/2021

Description: View of upland area along the eastern portion of the site near Wetland Area 4.

Remarks: (Include photo numbers here or on a separate sheet.)
 Photograph No. 7

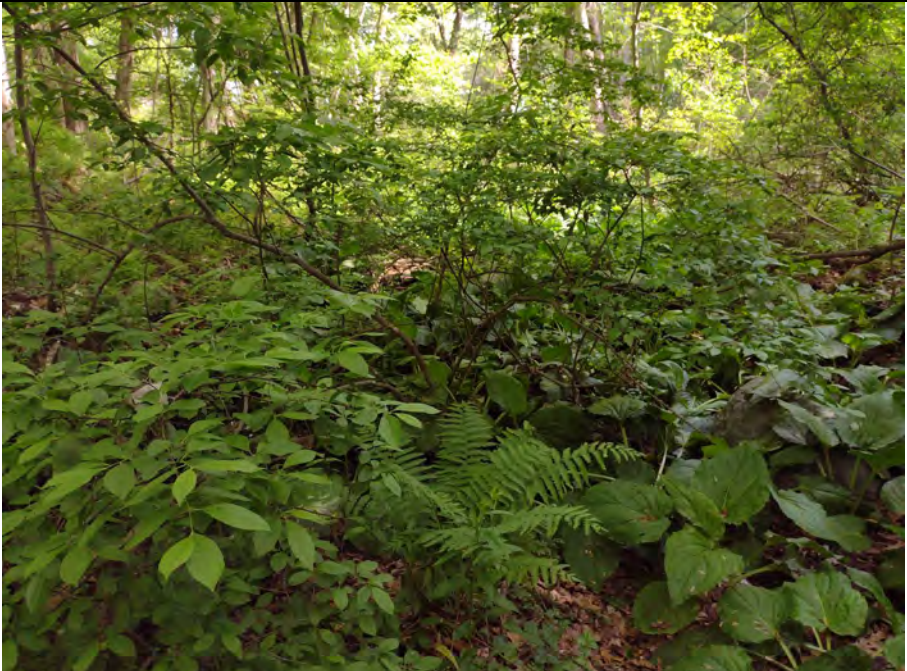
vhb Engineers Scientists Planners Designers		PHOTOGRAPHIC LOG	
Client Name: Oxford Energy Center, LLC		Site Location: Oxford Energy Center, Site B	Project No: 42790.00
Photo No. 8	Date: 6/02/2021

Description: View of Wetland Area 2 near Flag No. 107. Area is dominated by saplings and herbaceous vegetation.

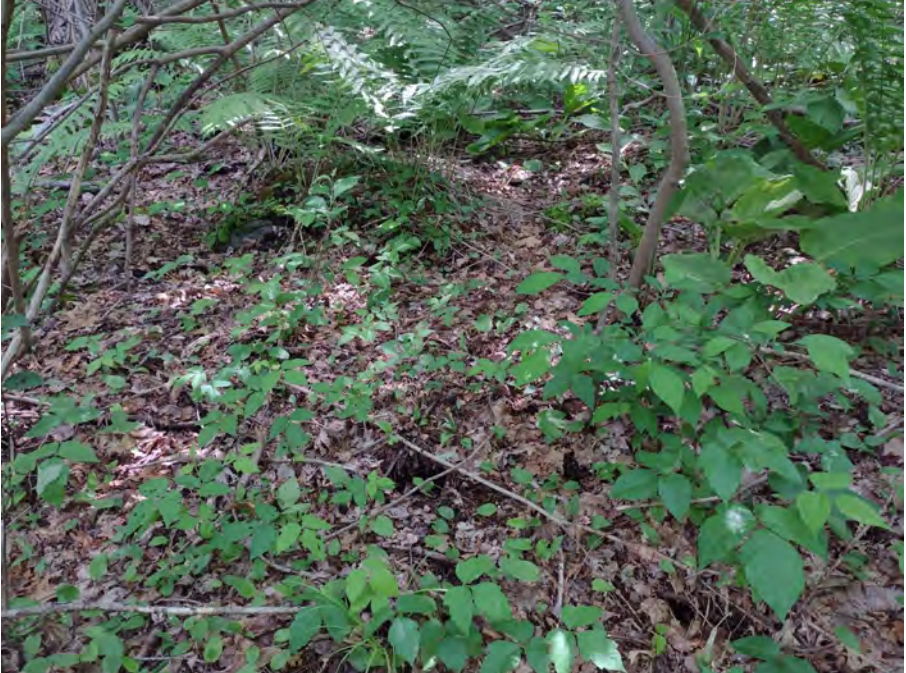
Engineers Scientists Planners Designers		<h2 style="text-align: center;">PHOTOGRAPHIC LOG</h2>	
Client Name: Oxford Energy Center, LLC		Site Location: Oxford Energy Center, Site B	
Project No: 42790.00			
Photo No. 9	Date: 6/02/2021

Description: View of Wetland Area 2 near Flag No. 109. Moss lines and surface water are present.

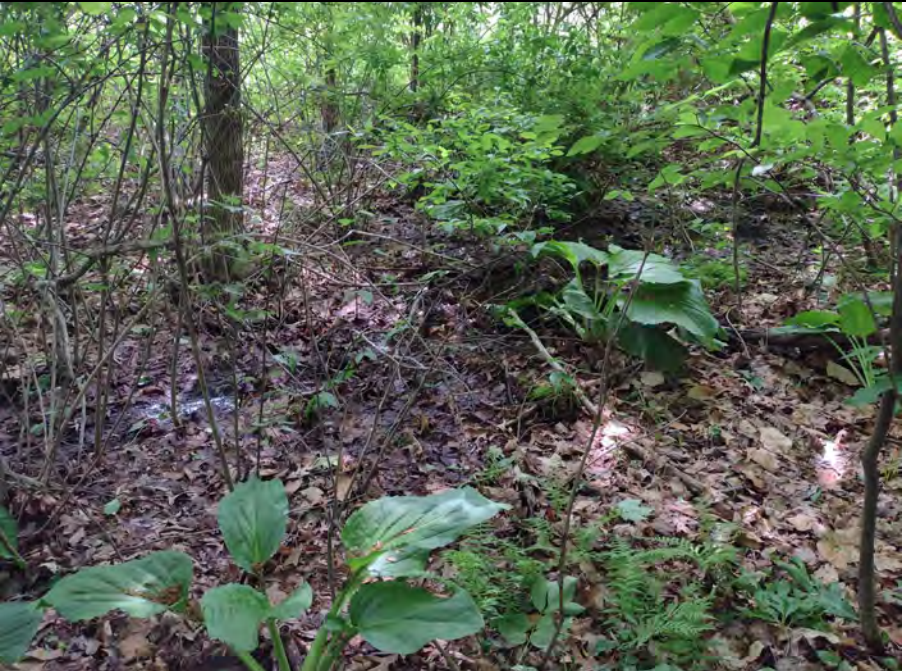
Engineers Scientists Planners Designers		<h2 style="text-align: center;">PHOTOGRAPHIC LOG</h2>	
Client Name: Oxford Energy Center, LLC		Site Location: Oxford Energy Center, Site B	
Project No: 42790.00			
Photo No. 10	Date: 6/02/2021

Description: View of Wetland Area 2 near Flag No. 206. Saturation and standing water are visible

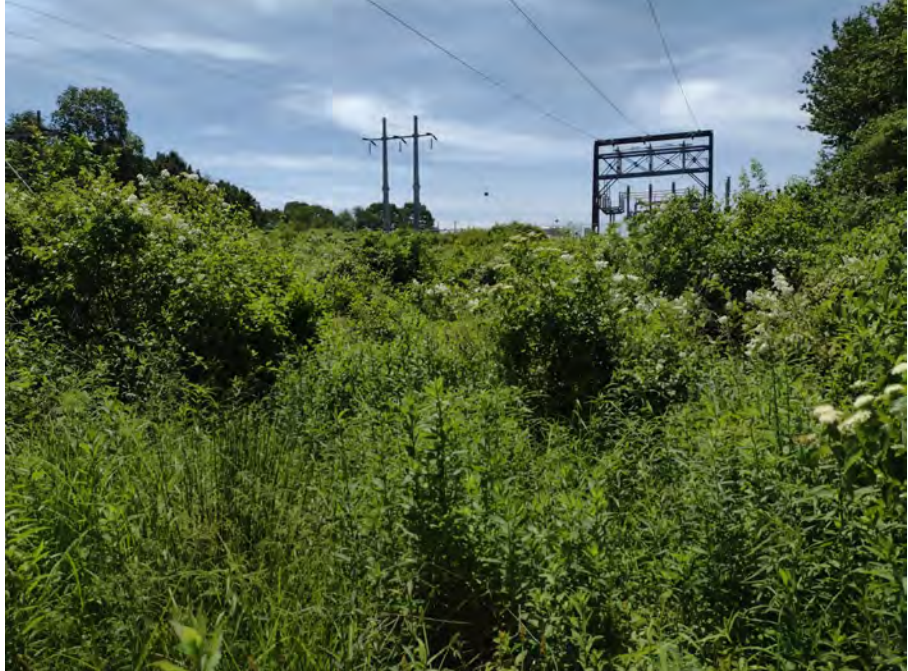
Engineers Scientists Planners Designers		<h2 style="text-align: center;">PHOTOGRAPHIC LOG</h2>	
Client Name: Oxford Energy Center, LLC		Site Location: Oxford Energy Center, Site B	
Project No: 42790.00			
Photo No. 11	Date: 6/02/2021

Description: View of Wetland Area 2 near Flag No. 3-110. This portion of the wetland has transitioned into scrub-shrub due to it's location in a maintained right-of-way.

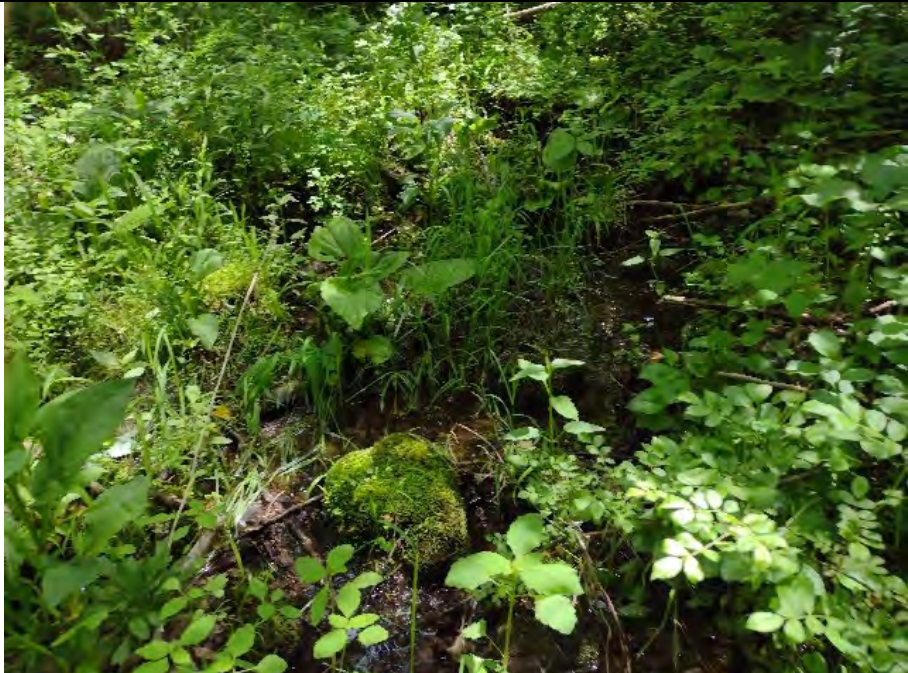
Engineers Scientists Planners Designers		<h2 style="text-align: center;">PHOTOGRAPHIC LOG</h2>	
Client Name: Oxford Energy Center, LLC		Site Location: Oxford Energy Center, Site B	
Project No: 42790.00			
Photo No. 12	Date: 6/02/2021

Description: View of Wetland Area 3 near Flag No. 106.

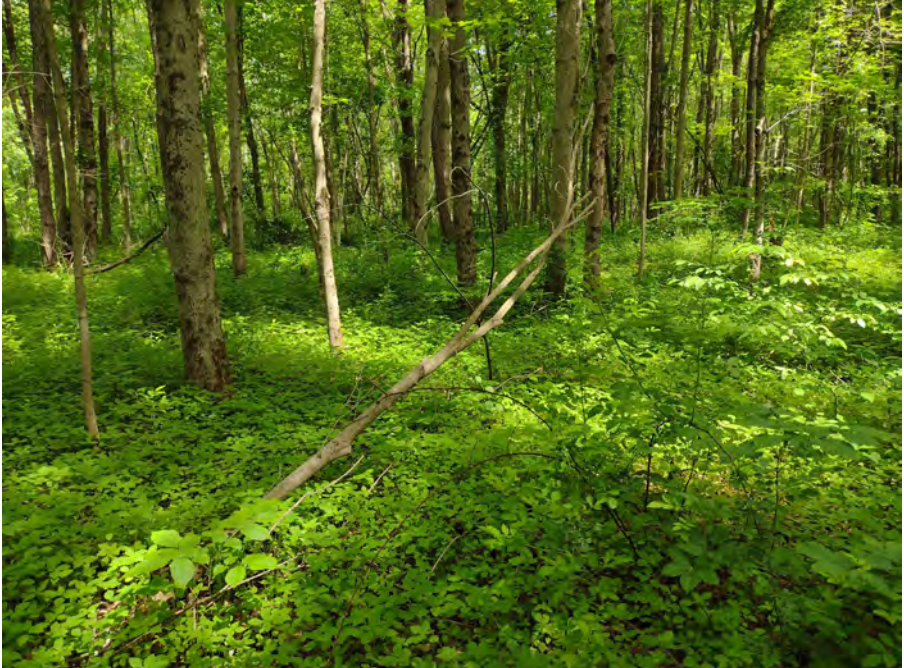
Engineers Scientists Planners Designers		<h2 style="text-align: center;">PHOTOGRAPHIC LOG</h2>	
Client Name: Oxford Energy Center, LLC		Site Location: Oxford Energy Center, Site B	Project No: 42790.00
Photo No. 13	Date: 6/02/2021

Description: View of upland near Wetland Area 3 Flag No. 105.

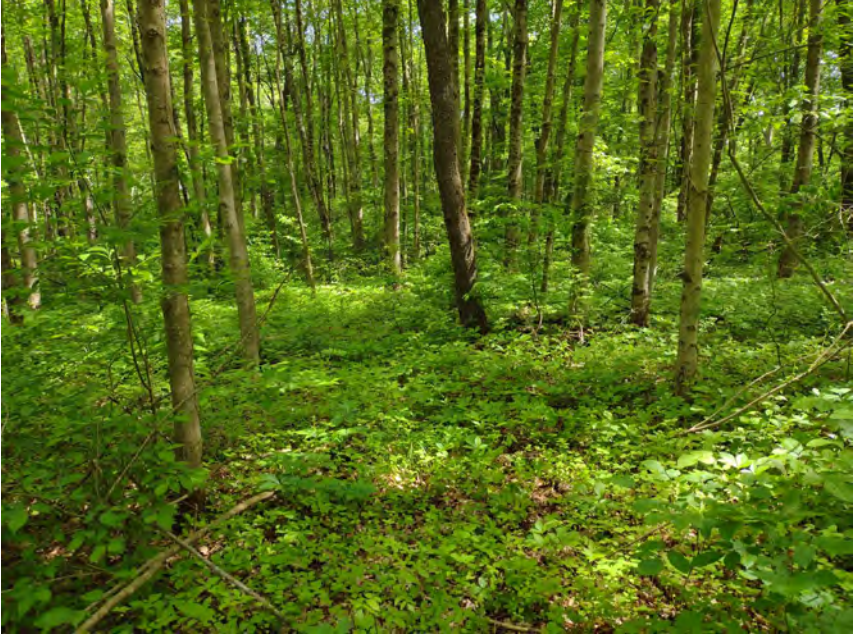
vhb Engineers Scientists Planners Designers		PHOTOGRAPHIC LOG	
Client Name: Oxford Energy Center, LLC		Site Location: Oxford Energy Center, Site B	
Project No: 42790.00			
Photo No. 15	Date: 6/02/2021

Description: View of uplands in the western portion of the site.

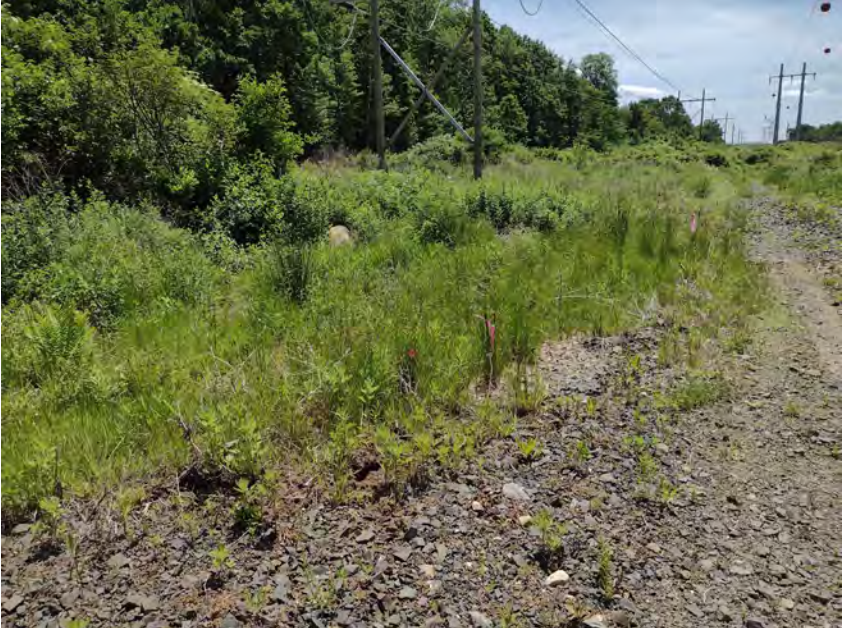
vhb Engineers Scientists Planners Designers		PHOTOGRAPHIC LOG	
Client Name: Oxford Energy Center, LLC		Site Location: Oxford Energy Center, Site B	
Project No: 42790.00			
Photo No. 16	Date: 6/02/2021

Description: View of Wetland Area 4, near Flag No. 101. Wetland Area is sourced by a runoff ditch that crosses the gravel utility access road.

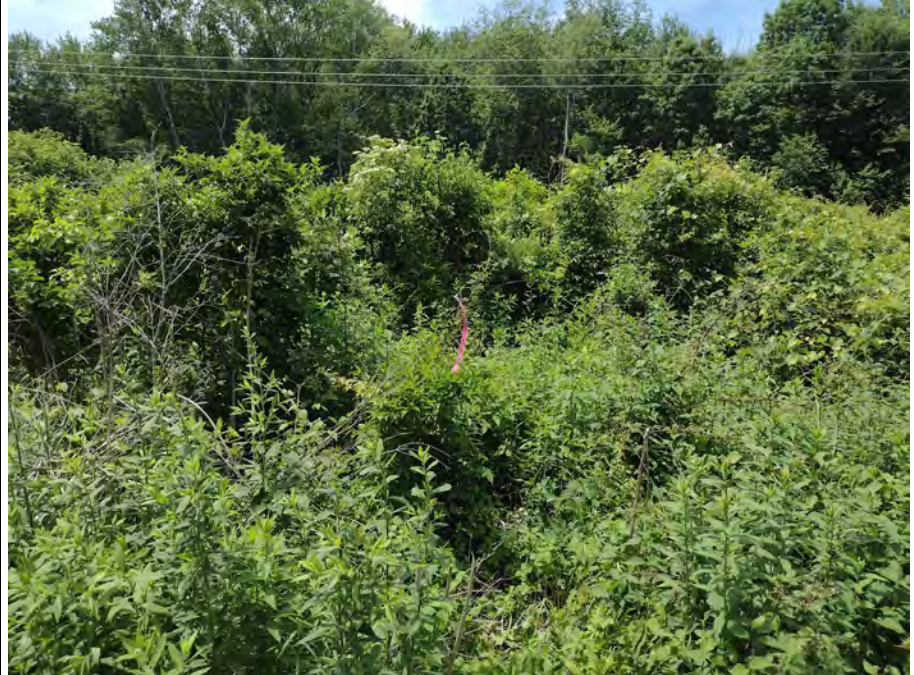
Photo No. 17 **Date:** 6/02/2021

Description: View of Wetland Area 5, near Flag No. 101. This wetland is sourced by a ditch that is culverted beneath the access road.
