RE: West Devon Junction to Devon Substation Rebuild Project

PETITION TO THE CONNECTICUT SITING COUNCIL  
FOR A DECLARATORY RULING OF  
NO SUBSTANTIAL ADVERSE ENVIRONMENTAL EFFECT  
FOR THE PROPOSED MODIFICATIONS TO THE EXISTING  
1483, 1545, 1580, 1590, 1710, and 1730 LINES  
IN THE TOWN OF STRATFORD AND CITY OF MILFORD CONNECTICUT

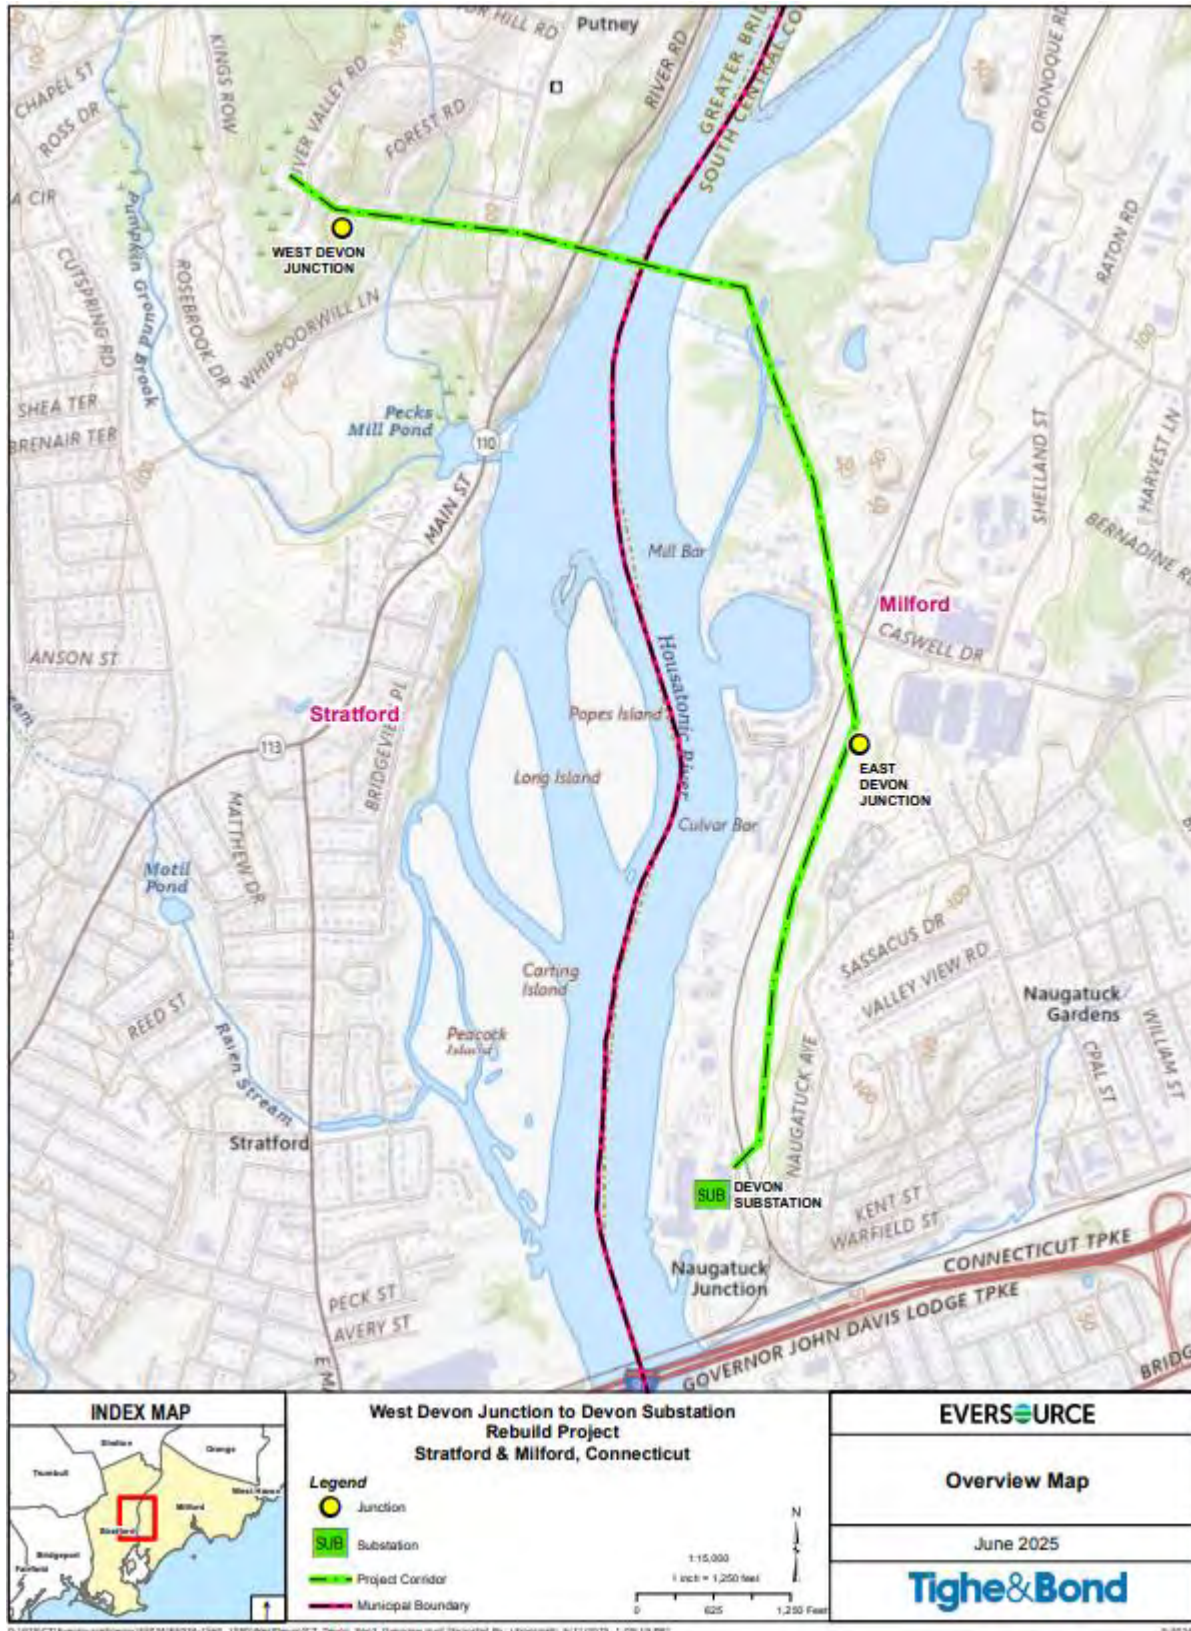
Figure 1: Project Overview Map

Figure 1 illustrates the location of the proposed Project.

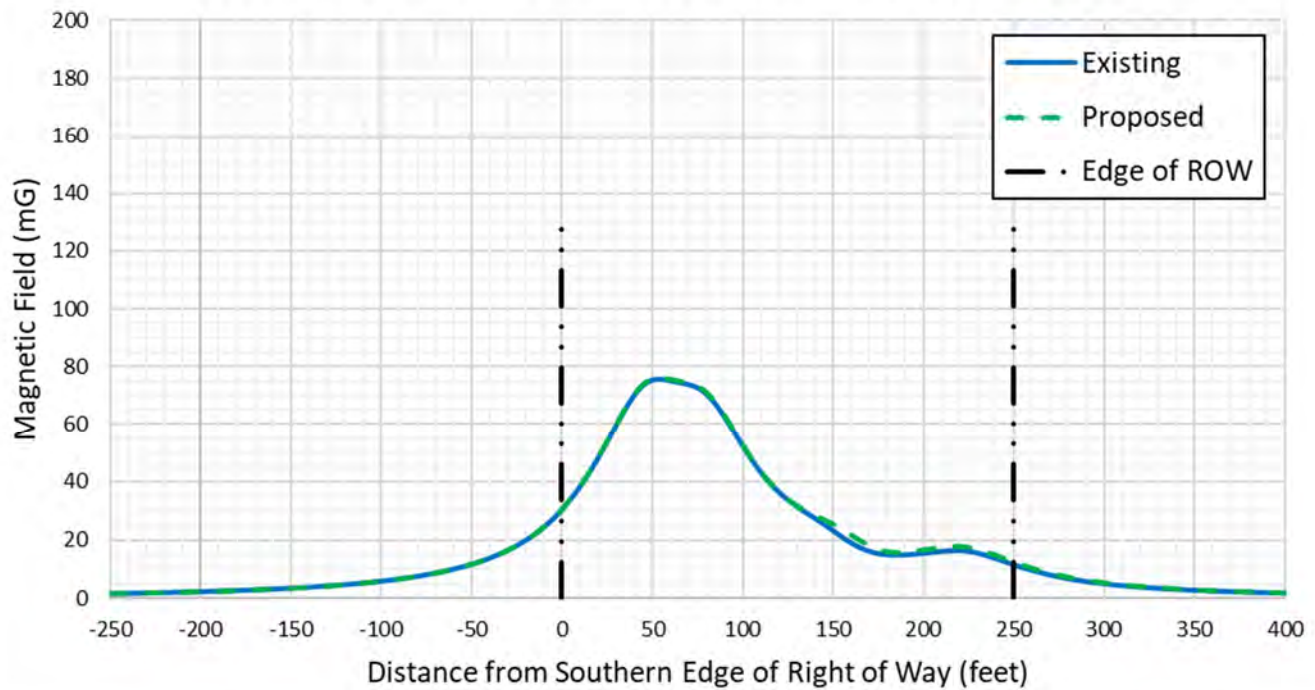
## Calculated Magnetic Fields (Annual Average Loads) West Devon Junction - West of Housatonic River

Eversource prepared calculations of the existing and post-Project electric and magnetic fields ("EMF"). The calculations were based on average annual loading conditions, as these are most representative of typical operating conditions. The calculations are made relative to the centerline of the proposed, modified transmission lines.

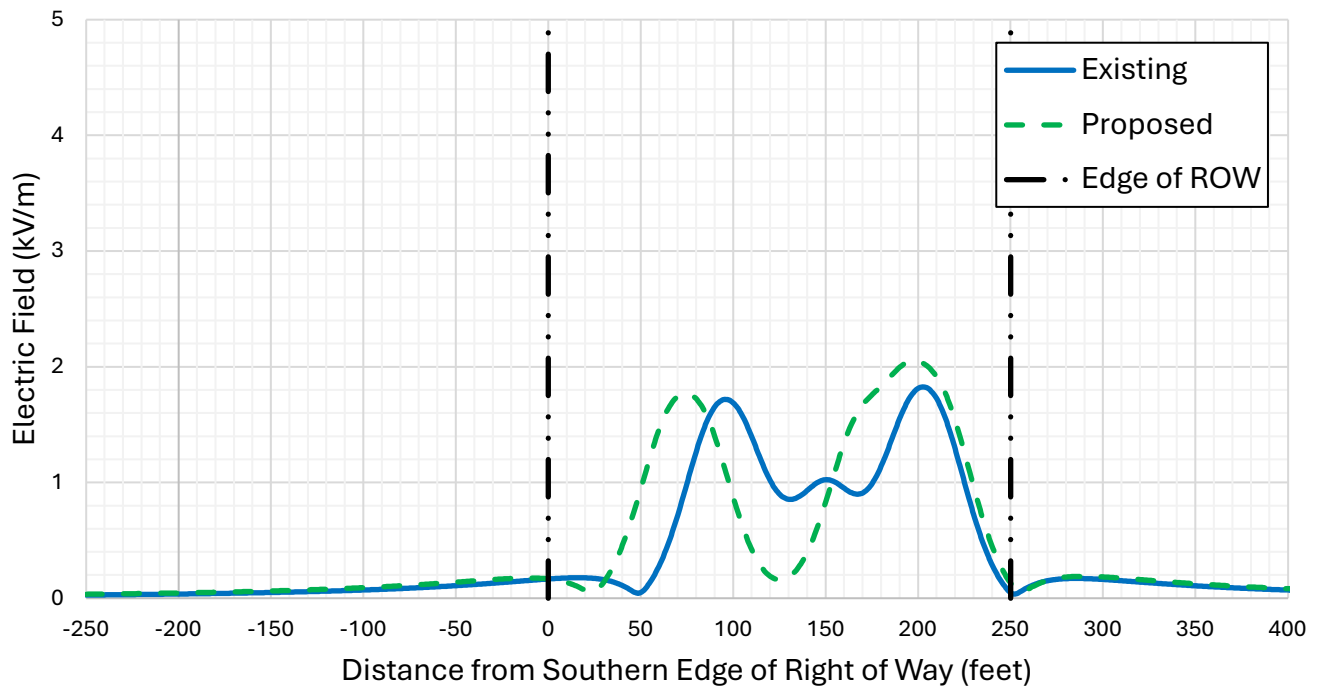
## Calculated Electric Fields (Annual Average Loads) Housatonic River Crossing

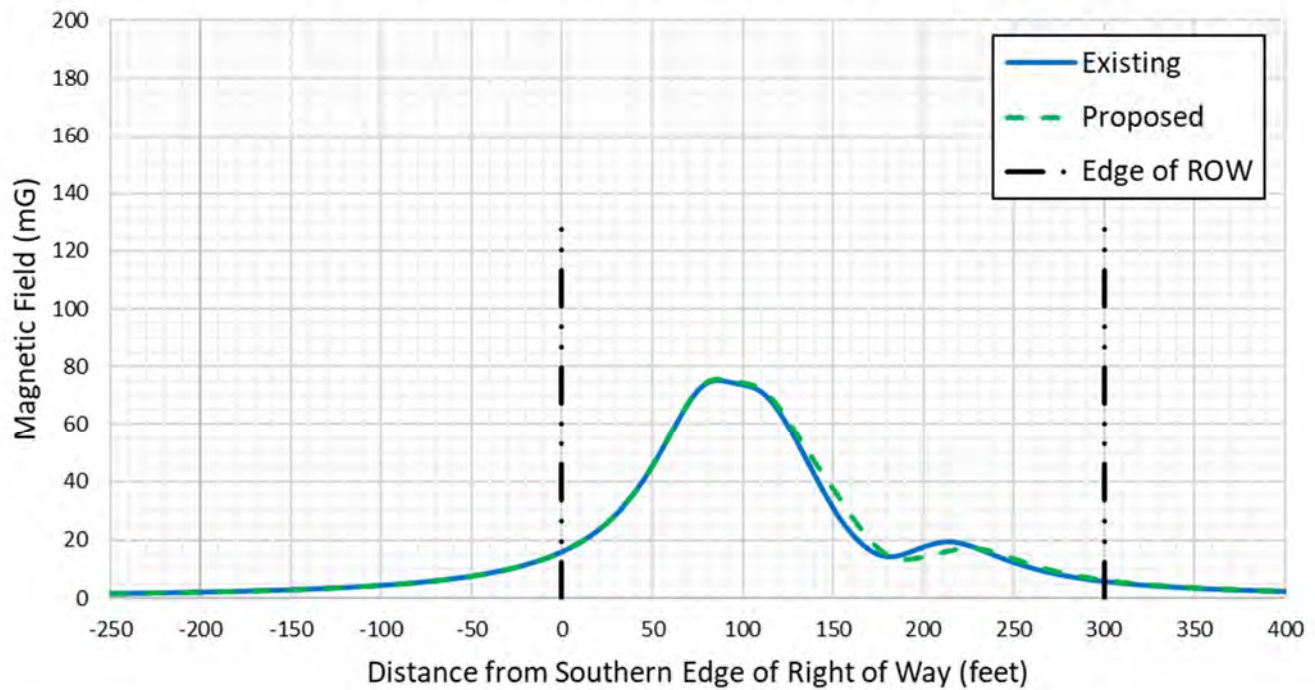
## Calculated Magnetic Fields (Annual Average Loads) East of Housatonic River - East Devon Junction

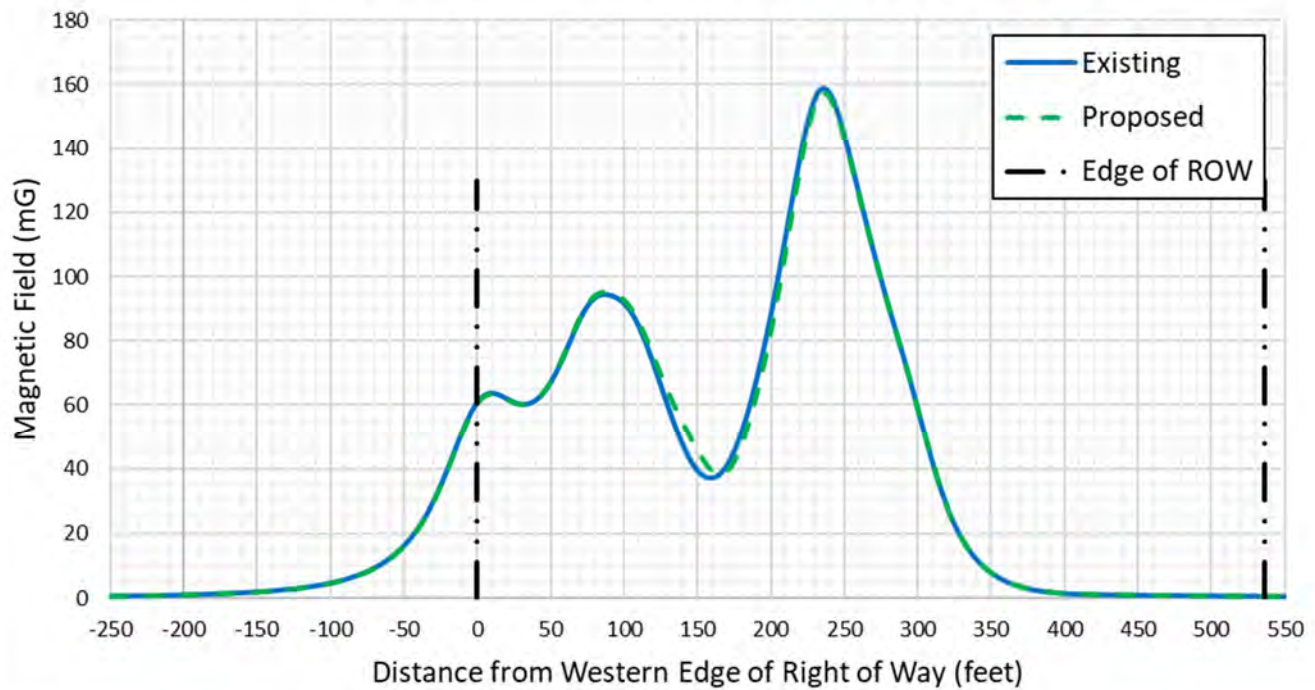
## Calculated Magnetic Fields (Annual Average Loads) East Devon Junction - Devon Substation

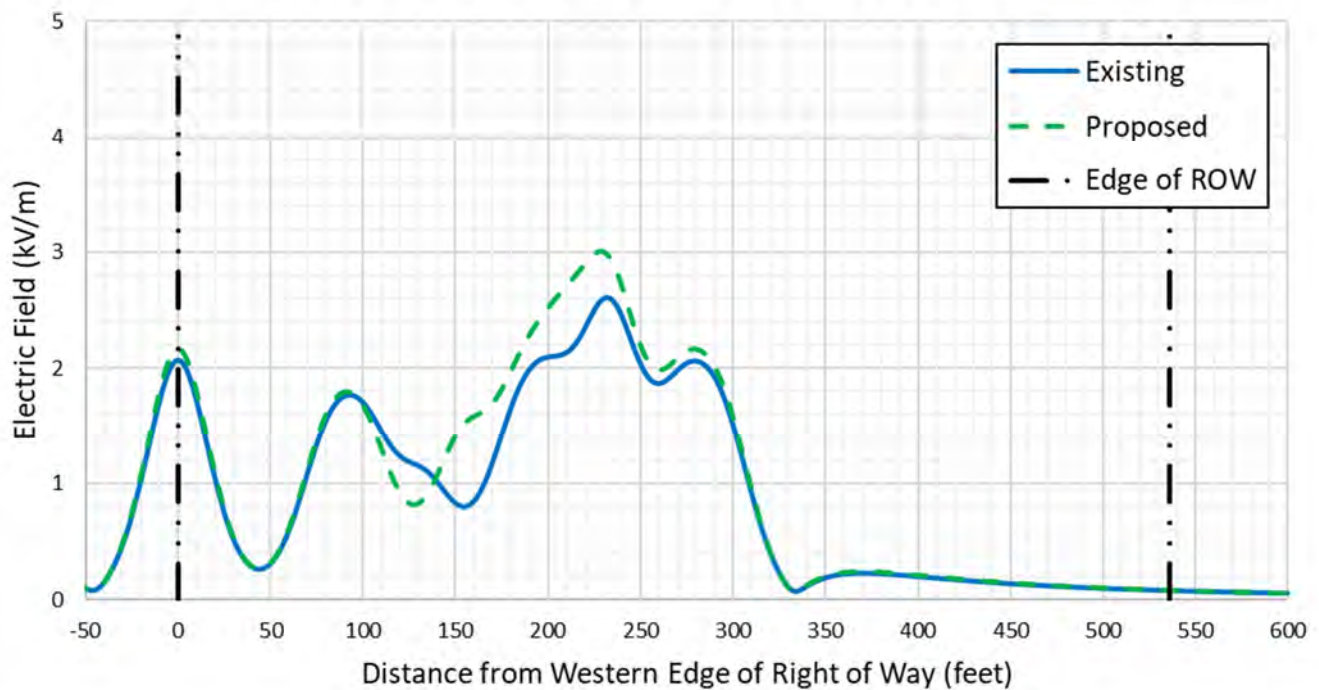
## Calculated Electric Fields (Annual Average Loads) East Devon Junction - Devon Substation
