**Docket No. 217 – Development and Management Plan Inspection**

**Date:** March 9, 2006

**Location:** 115 kV Underground Route

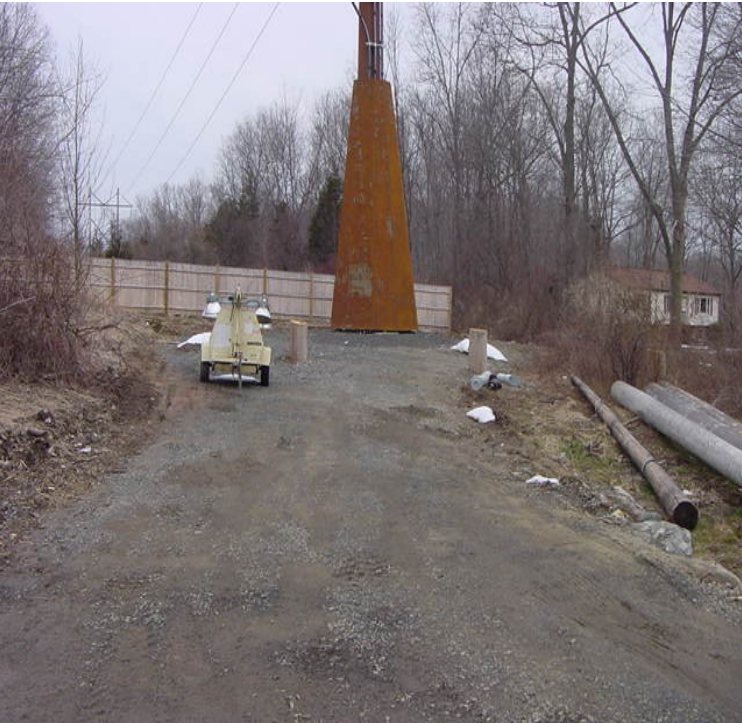
115kV (Hoyts Hill and Bethel Ed): Photo on the left shows the riser pole across from Hoyts Hill. Any materials remaining here will need to be removed if it was resulting from the 115kV work. Photo on the right shows the ROW at Bethel Ed. 3/9/06

Areas of Inspection	Observation	Recommended Action	Corrected Action
<b>Hoyts Hill Riser Transition Structure (Off Rt. 58)</b>  <b>Route 58</b>  <b>Rt. 107 (Lonetown Rd)</b>  <b>Broad Street, ROW, and Rt. 7 Norwalk</b>	-Minor litter such as bungee cords were left behind. 2/22-3/9/06  - With snow cover gone, larger items such as cross arms, ceramic bushings and some other metal equipment was also noted. 3/9/06	-Some of the material may be either from recent removal of poles in other portions of the project. If materials belongs to 115kV crews, it should be removed. 3/9/06

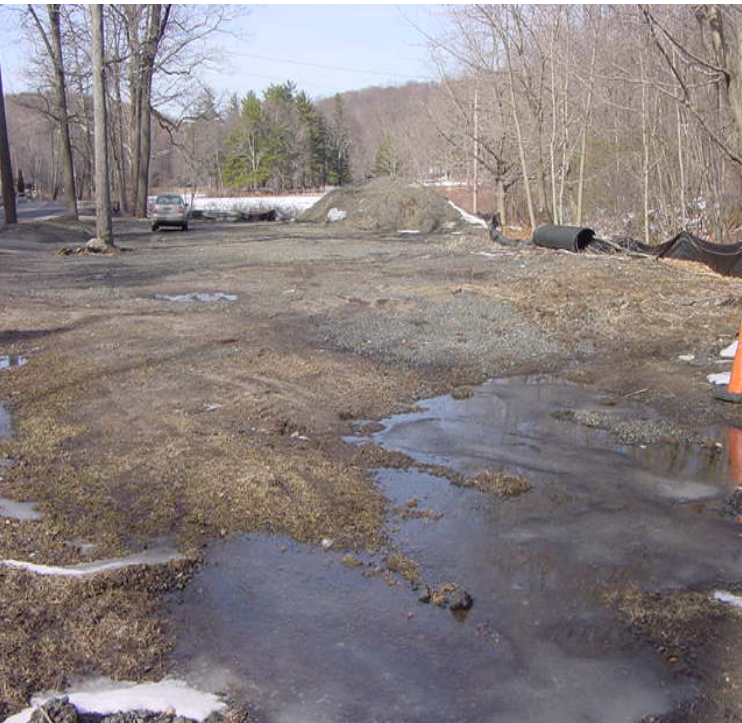
115kV (Putnam Park and Broad St. ROW): Photo on the left shows the Putnam Park storage area with good controls in place. Photo on the right shows the ROW off Broad St. 3/9/06

- A few areas of bare soil had remained around some of the recently accessed vaults. 1/4-3/9/06 - The Putnam Park storage area remains in good shape. 3/9/06 -The Sunset Hill Rd. storage area controls remain in good shape. 3/9/06	-Plan to return and restore the edge of roadway in the spring as necessary. 1/4-3/9/06  - All controls here are in good shape. 3/9/06  -Continue to monitor the spot where run-off concentrates from the roadway. 3/9/06	- N/A until the growing season.  - Repairs were made to the silt fence at Putnam Park near the road. 3/2/06  - N/A
